WHALE TAIL MINE

WATER MANAGEMENT INFRASTRUCTURE

**Operation, Maintenance and
Surveillance Manual**

Version 3
December 2022

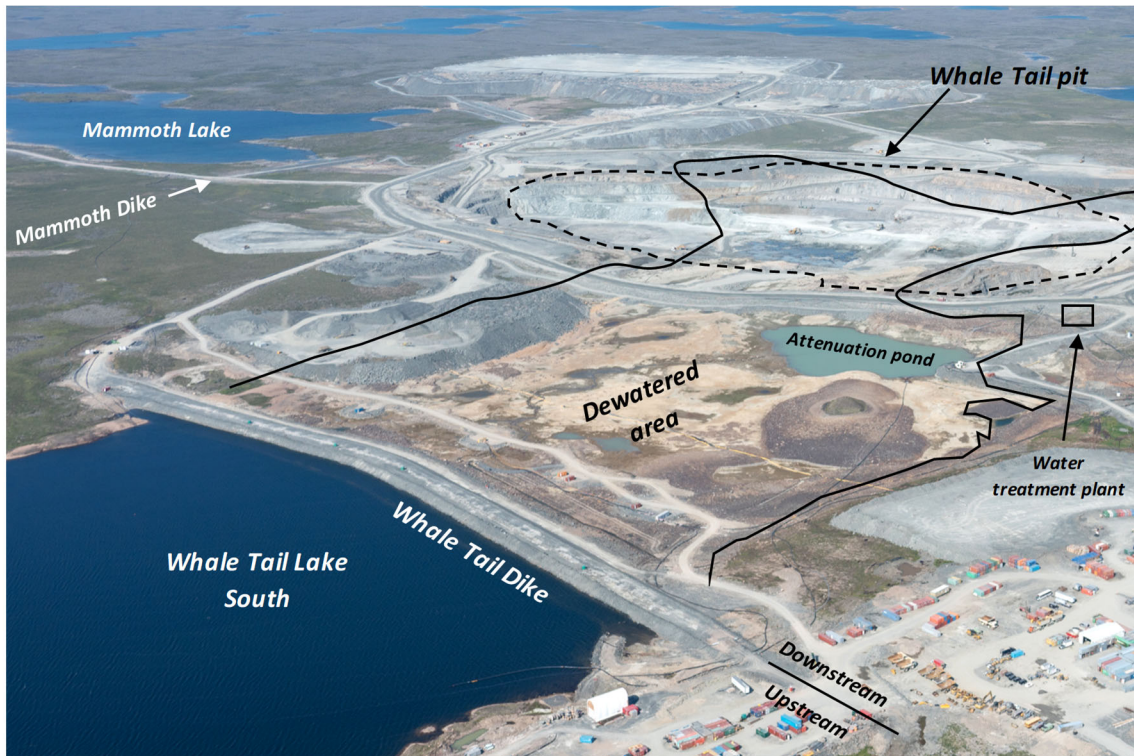
Figure 3-1 : Aerial View of Whale Tail Dike

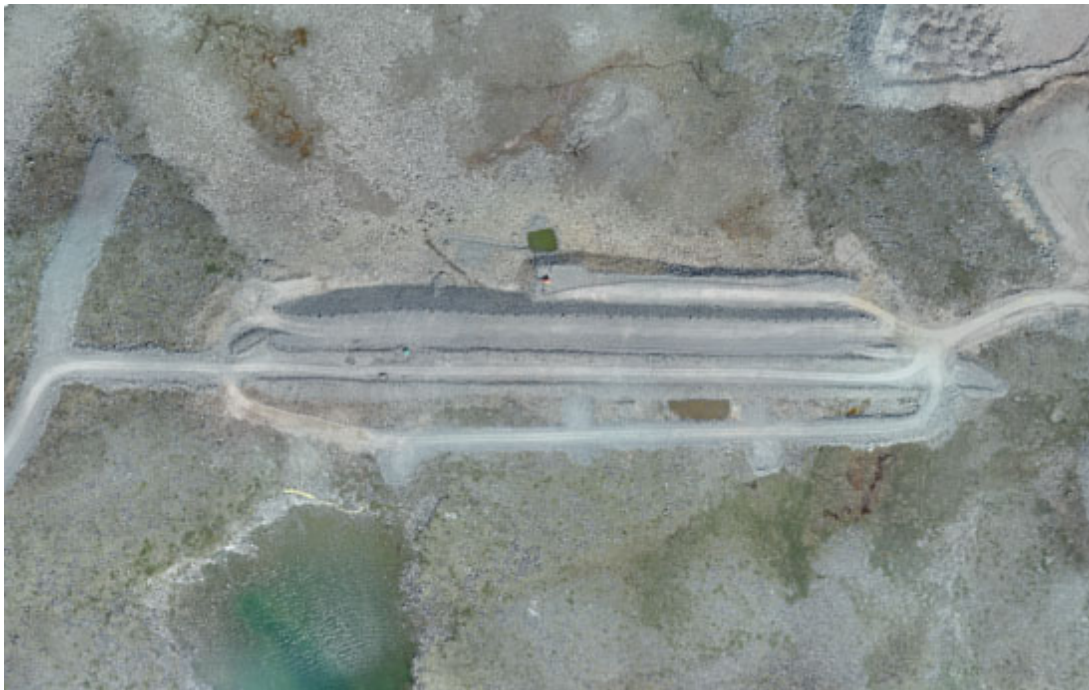
Figure 3-5 : Aerial View of WRSF Dike

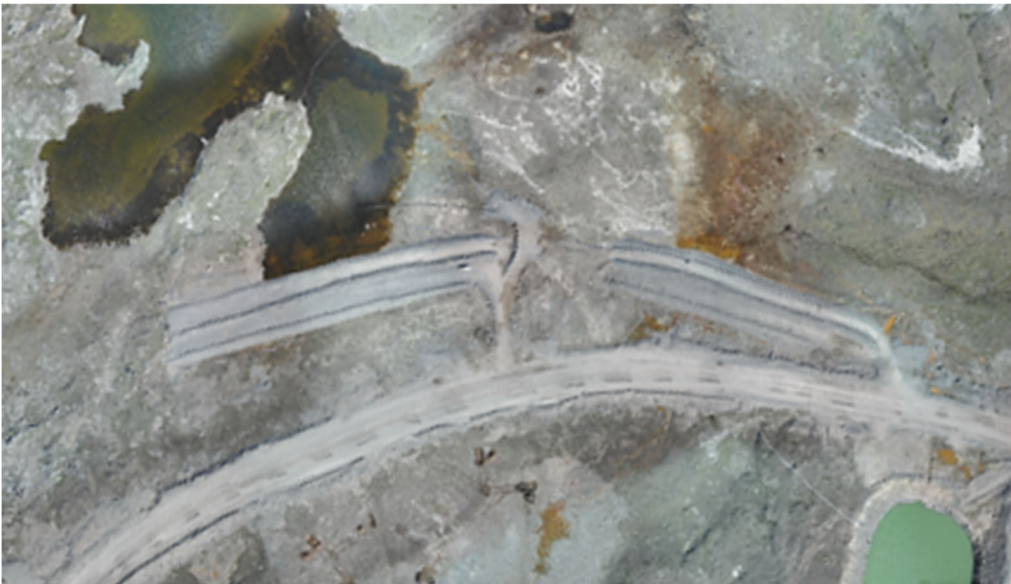
Figure 3-8 : Aerial View of North-East Dike (before dismantling)

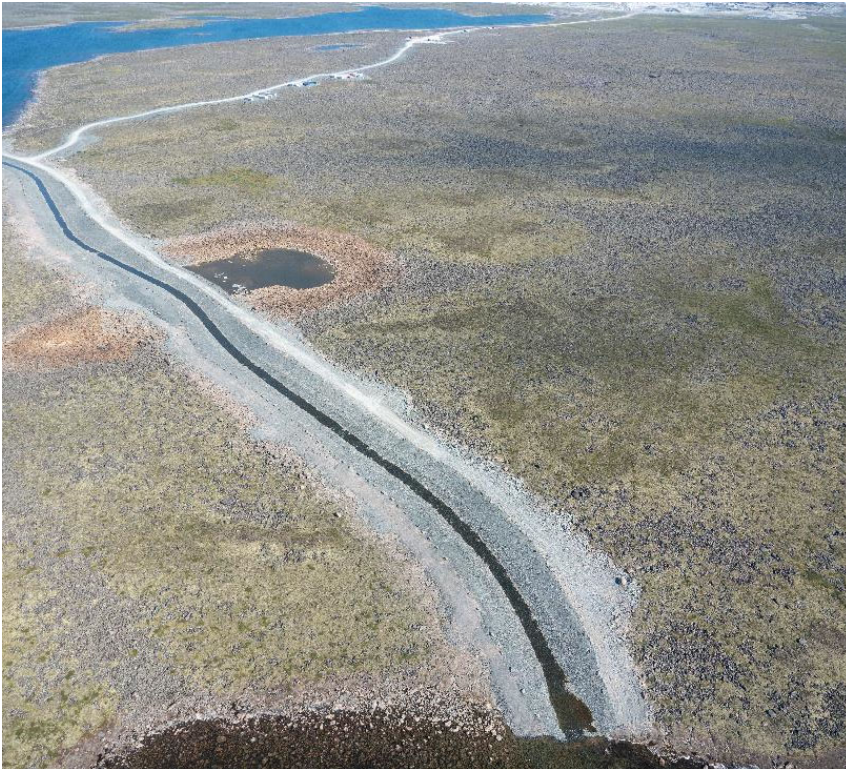
Figure 3-10 : Plan View of SWTDC
