### **As-built Landfarm**

**Re: Water License 2AM-MEA1525 Part D, Item 14 - Submission of Landfarm As-Built Report**

**APPENDIX A**  
**Landfarm 1 Modification As-built**

**APPENDIX B**  
**Landfarm 2 As-built**

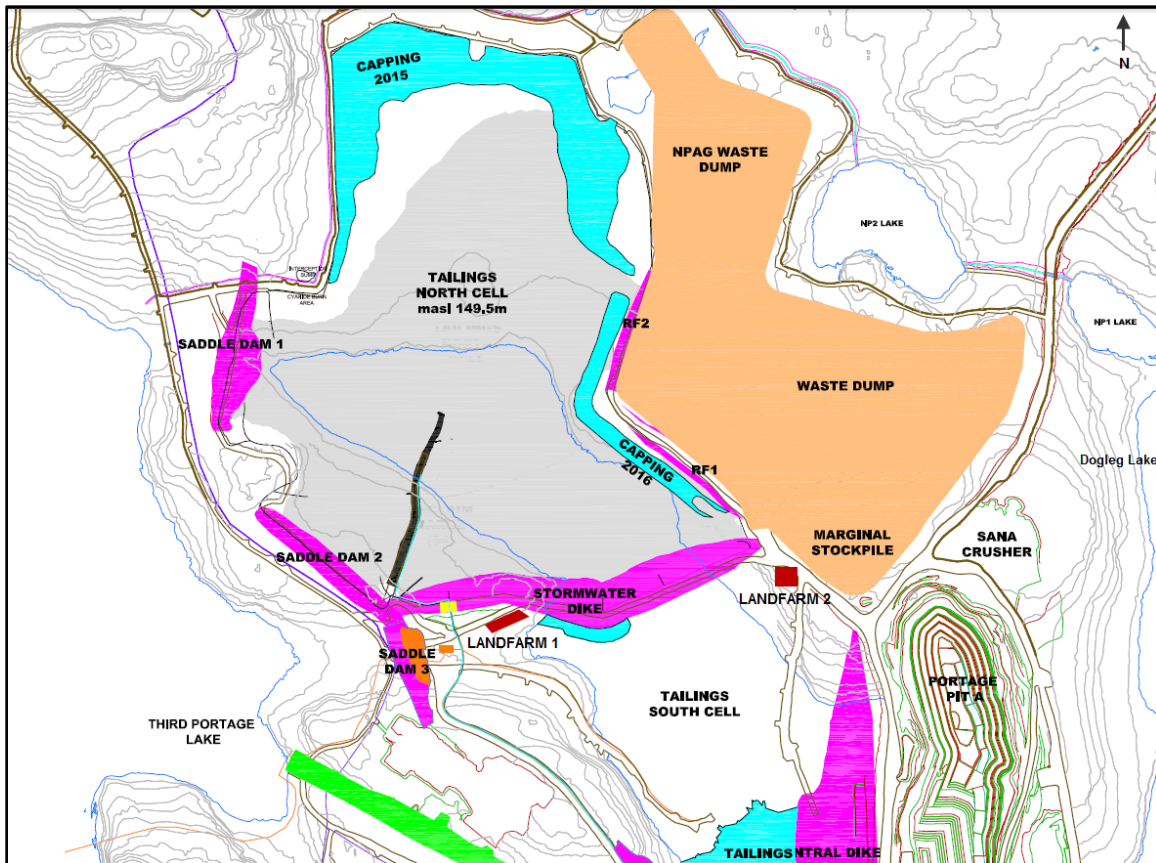
Figure 1 – Landfarm 1 and Landfarm 2 General Location

The landfarm design was submitted by Agnico to the Nunavut Water Board in October 2012 and has been in use for soil decontamination since then. As presented on Figure 1 below, the previous landfarm is located on the north-west side of the South Tailings Cell (Tailing Storage Facility – TSF). The South Tailings Cell is currently active; tailings are deposited and water is reclaimed from the cell. The tailings and water level in the South Tailings Cell are increasing in elevation over time. With the current tailings deposition plan and water balance models, the Landfarm 1 is predicted to be flooded with reclaim water in summer 2017. For this reason, AEM decided to find an alternate location for a new landfarm (Landfarm 2), in order to continue the treatment of contaminated soil. Also, due to operational work at the buttress of Stormwater Dike an extension of the Landfarm 1 was also constructed to a higher elevation in order to continue treatment of soil in the Landfarm 1.

The Landfarm 1 is in operation since October 2012. As mentioned, the Landfarm 1 is located in the South Tailings Cell as presented on Figure 1. Due to operational work required in September 2016 at the buttress of Stormwater Dike (as-built of these works to be submitted under a separate document), a part of the east section of the Landfarm 1 could not be used anymore. To ensure

As presented on Figure 1, the Landfarm 2 is located on the north east side of the South Tailings Cell, north of the Central Dike. This location was chosen to minimize the waste footprint on site and the transport distance of contaminated material from spill locations. All of the waste generated at Meadowbank in the form of tailings, waste rock and site landfill is in close proximity. This location will facilitate the landfarm operation at closure. The Landfarm 2 is located within the South Tailings Cell, providing containment in case of runoff water from the contaminated material.

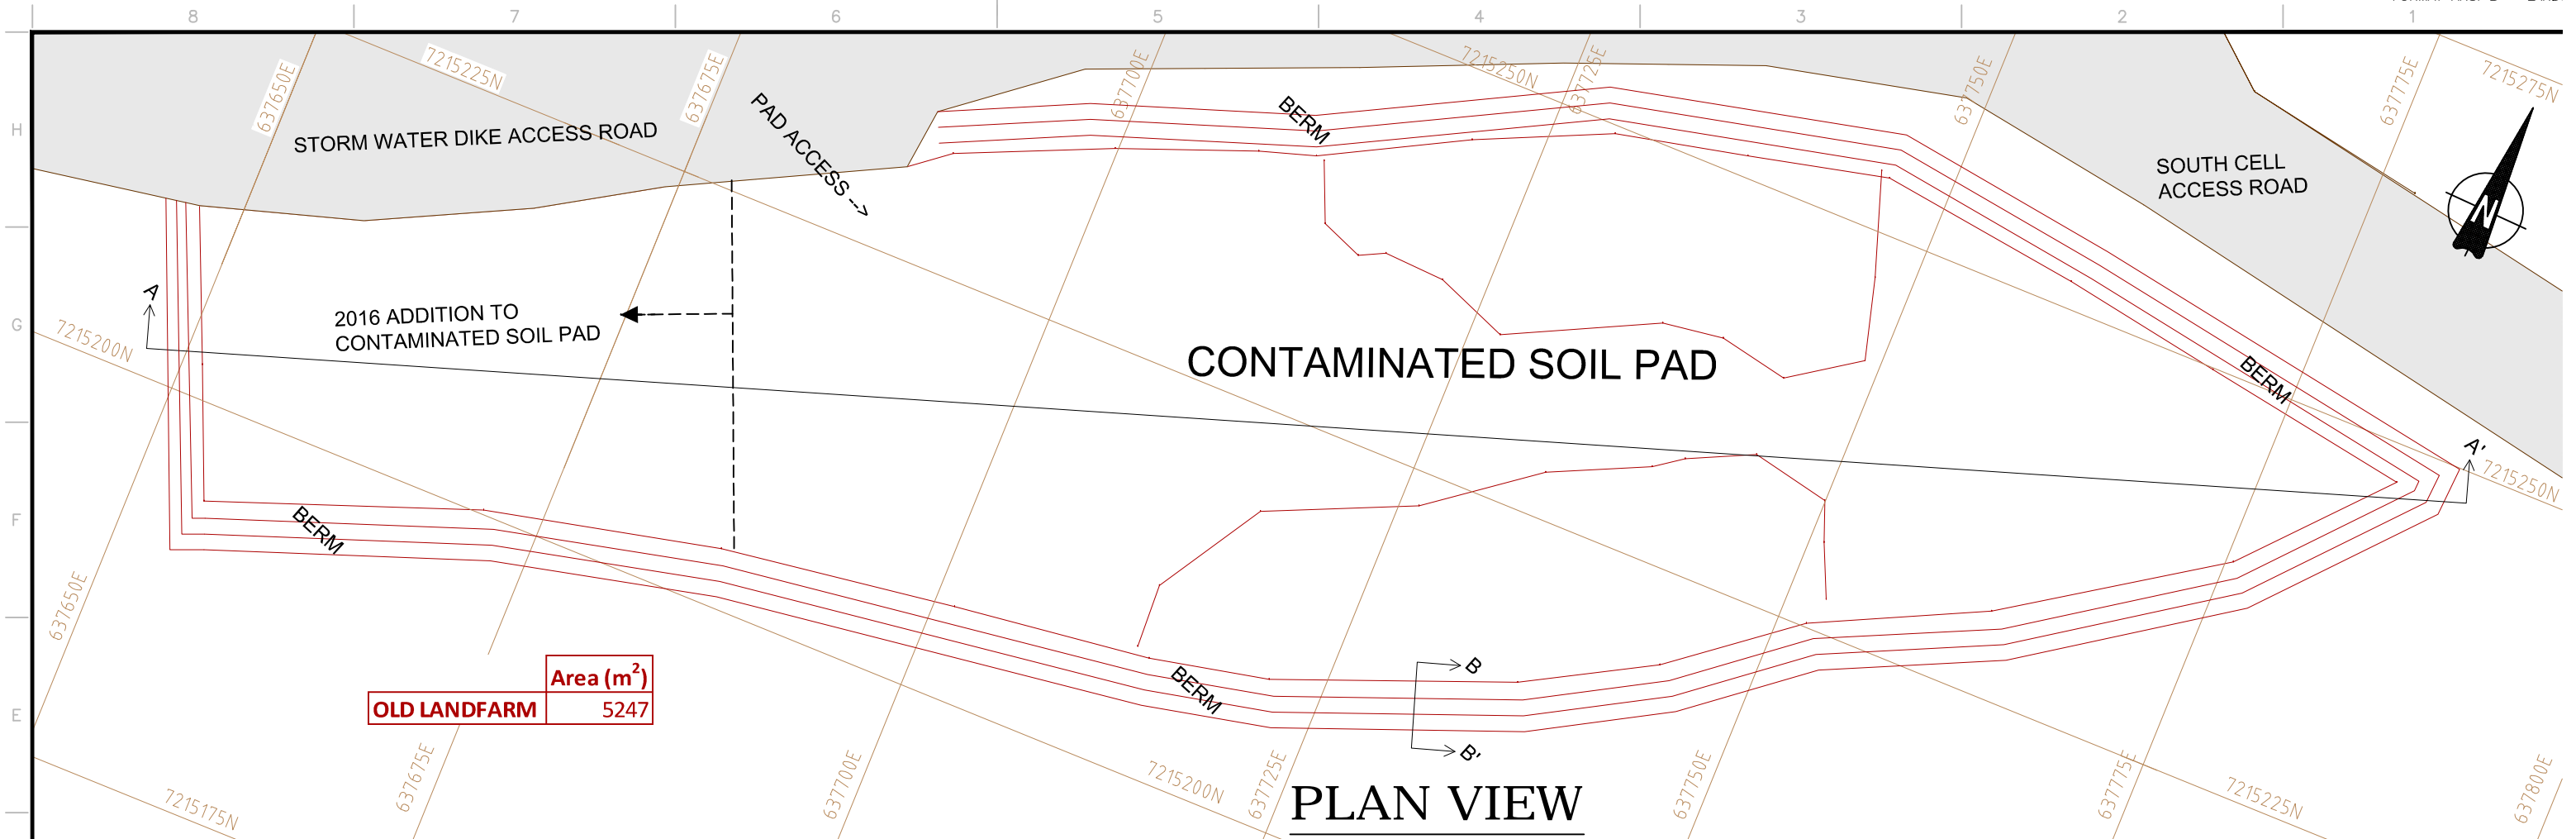
**PLAN VIEW**

<b>OLD LANDFARM</b>	<b>Area (m<sup>2</sup>)</b>
	5247

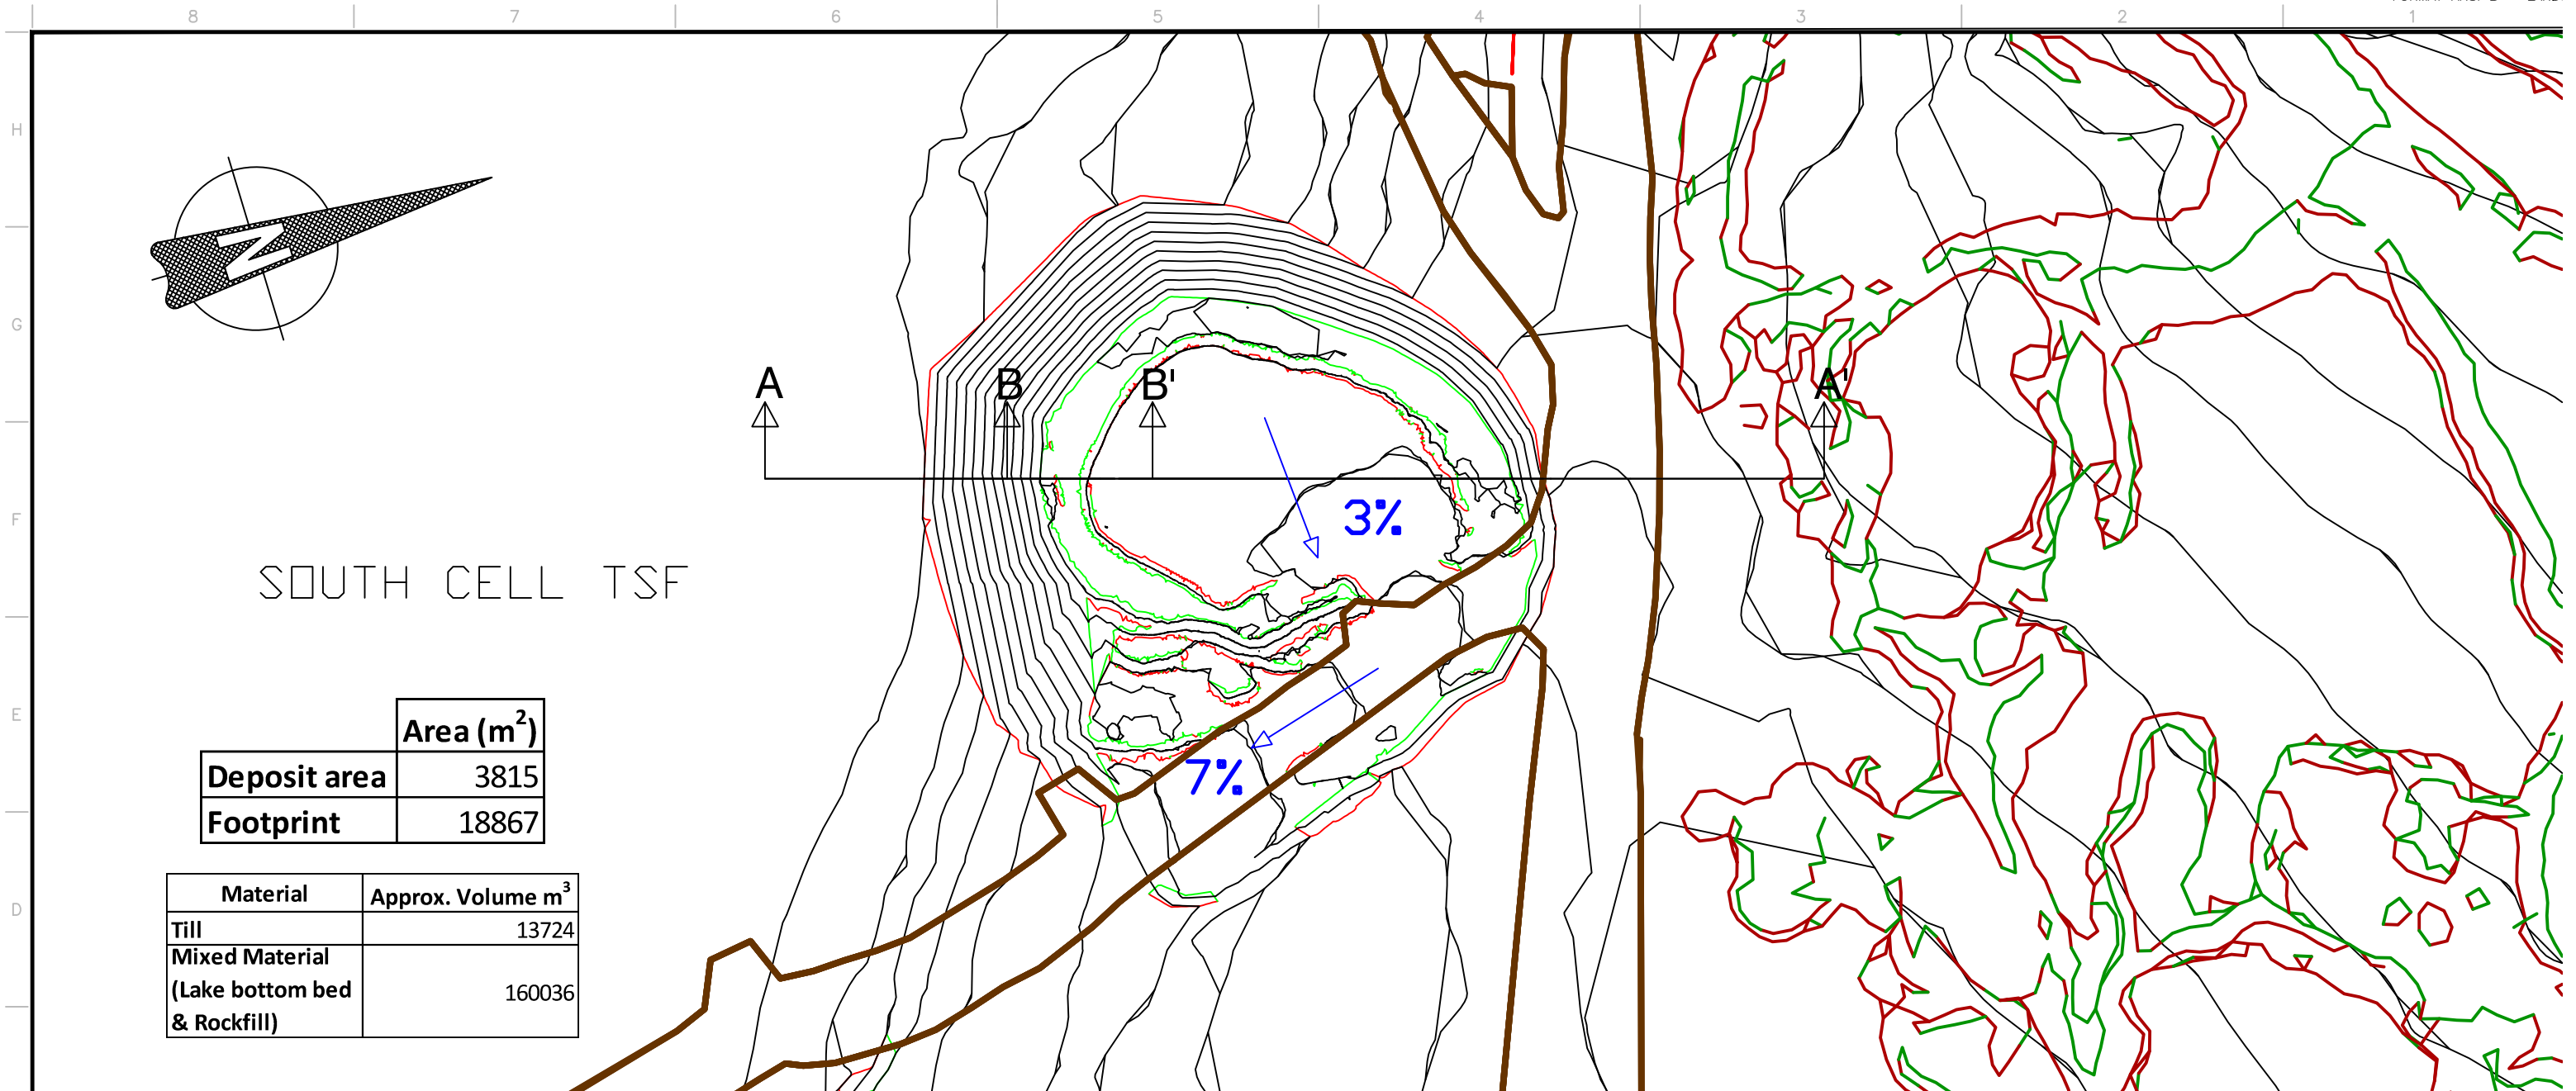
Area (m <sup>2</sup> )
Deposit area	3815
Footprint	18867

Material	Approx. Volume m <sup>3</sup>
Till	13724
Mixed Material (Lake bottom bed & Rockfill)	160036
