AGNICO EAGLE

MEADOWBANK SITE

DEWATERING DIKES

**Operation, Maintenance and
Surveillance Manual**

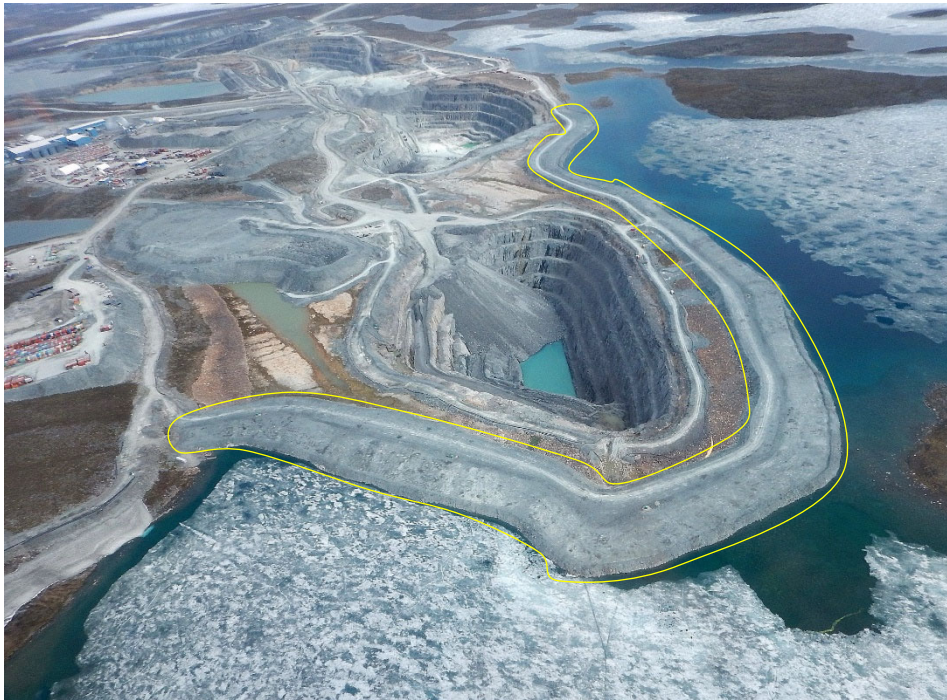
Figure 3-3 : Aerial View of Bay-Goose Dike

Bay-Goose Dike						
Designer : Golder Construction Period : 2009 – 2011 Operation Period : 2011 - 2026 Planned Closure Period : 2027-2051						
Design Criteria						
Use	Water type	Classification (CDA, 2007)	Inflow Design Flood	Water Level (m)		Crest Elevation (m) (max height)
				Normal	Design Flood	
Water Retention/Dewatering	Non-contact	High	1/3 between 1000-year and PMF	134.1	135.1	137.1 (15 m)

2.2 km long rockfill embankment with cement-soil-bentonite cutoff wall with filter system. To reach bedrock depths – used injection jet-grouting to create the full cutoff wall. After cutoff wall, a 5 m deep injection curtain into the bedrock						
Operation Highlight <ul style="list-style-type: none"> • Settlement and tension cracks observed in the thermal capping of the structure • Small seepage observed at the toe of the structure. Naturally report to Goose Pit 						
Risk assessment performed on water management infrastructure in 2022. Annual Probability of Failure and design Factor of Safety in Appendix B.

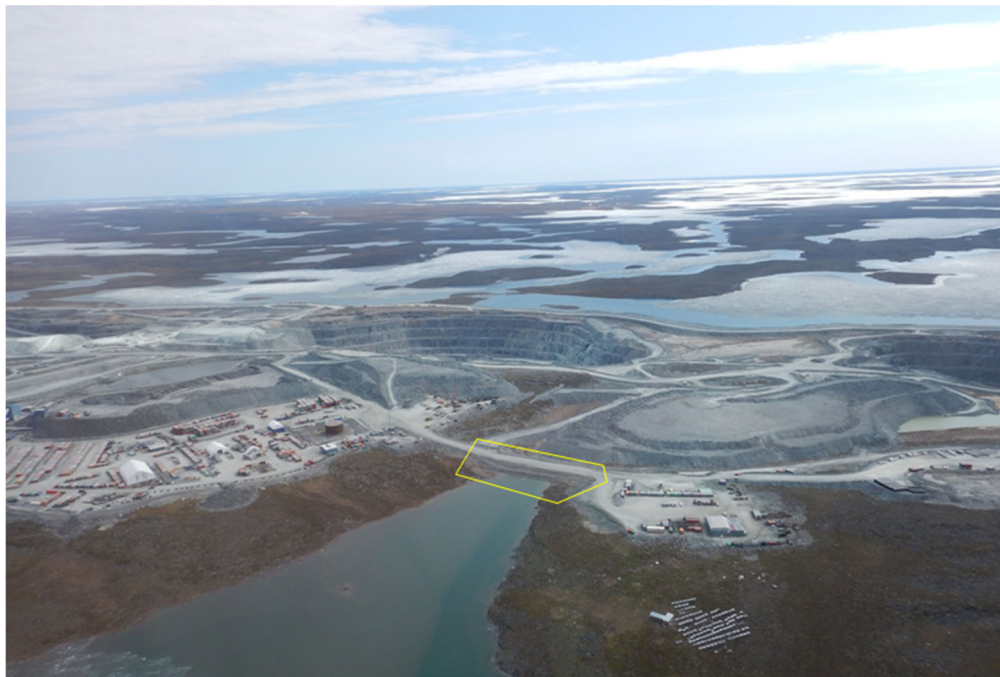
Figure 3-5 : Aerial View of South Camp Dike

The South Camp Dike was primarily constructed between April and June of 2009, prior to ice breakup. During the winter of 2009-2010 additional thermal capping material and rockfill for the haul road was added to the dike. The South Camp Dike has a broad rockfill shell with a bituminous geomembrane liner installed on the upstream side of the shell. The liner was founded on native frozen (permafrost) till material, in a trench approximately 3 to 5 m below the lakebed surface. Compacted granular material mixed with bentonite was placed above the toe of the liner. The haul road is located on the downstream side of the dike.

SOUTH CAMP DIKE						
Designer : Golder Construction Period : 2009 Operation Period : 2009 - 2026 Planned Closure Period : 2027-2051						
Design Criteria						
Use	Water type	Classification (CDA, 2007)	Inflow Design Flood	Water Level (m)		Crest Elevation (m) (max height)
				Normal	Design Flood	
Water Retention	Non-contact	Significant	-	134.1	136.3	137.6 (3 m)
Rockfill embankment with bituminous liner, and shear key about 1/3 distance from upstream face. Liner ties into fine filter amended with bentonite. Built on permafrost foundation.						
Operation Highlight						
<ul style="list-style-type: none"> - 						
Risk assessment performed on water management infrastructure in 2022. Annual Probability of Failure and design Factor of Safety in Appendix B.

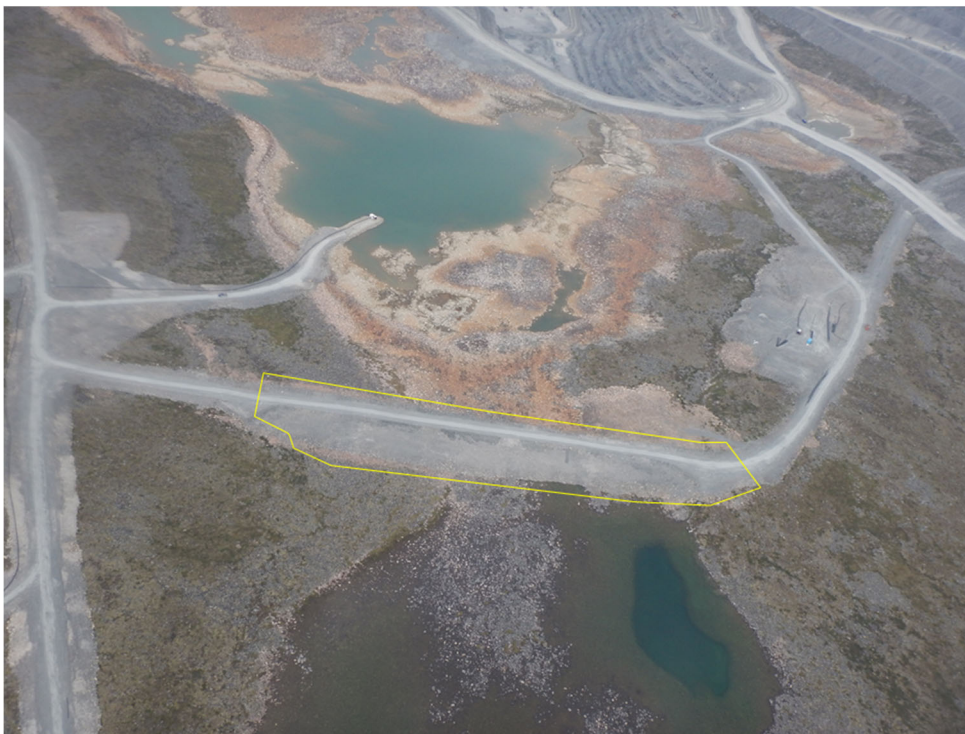
Figure 3-7 : Aerial View of Vault Dike

Vault Dike						
Designer : Golder Construction Period : 2013 Operation Period : 2013 - 2026 Planned Closure Period : 2027-2051						
Design Criteria						
Use	Water type	Classification (CDA, 2007)	Inflow Design Flood	Water Level (m)		Crest Elevation (m) (max height)
				Normal	Design Flood	
Water Retention/Dewatering	Non-contact	Low	1-100 year snow melt + 1-100 year rainfall	139.52	141	142.5 (3 m)
Rockfill embankment with filtering system and bituminous liner. Sitting on permafrost condition. Allowed dewatering of Vault Lake						
Operation Highlight						
<ul style="list-style-type: none"> - Risk assessment performed on water management infrastructure in 2022. Annual Probability of Failure and design Factor of Safety in Appendix B.

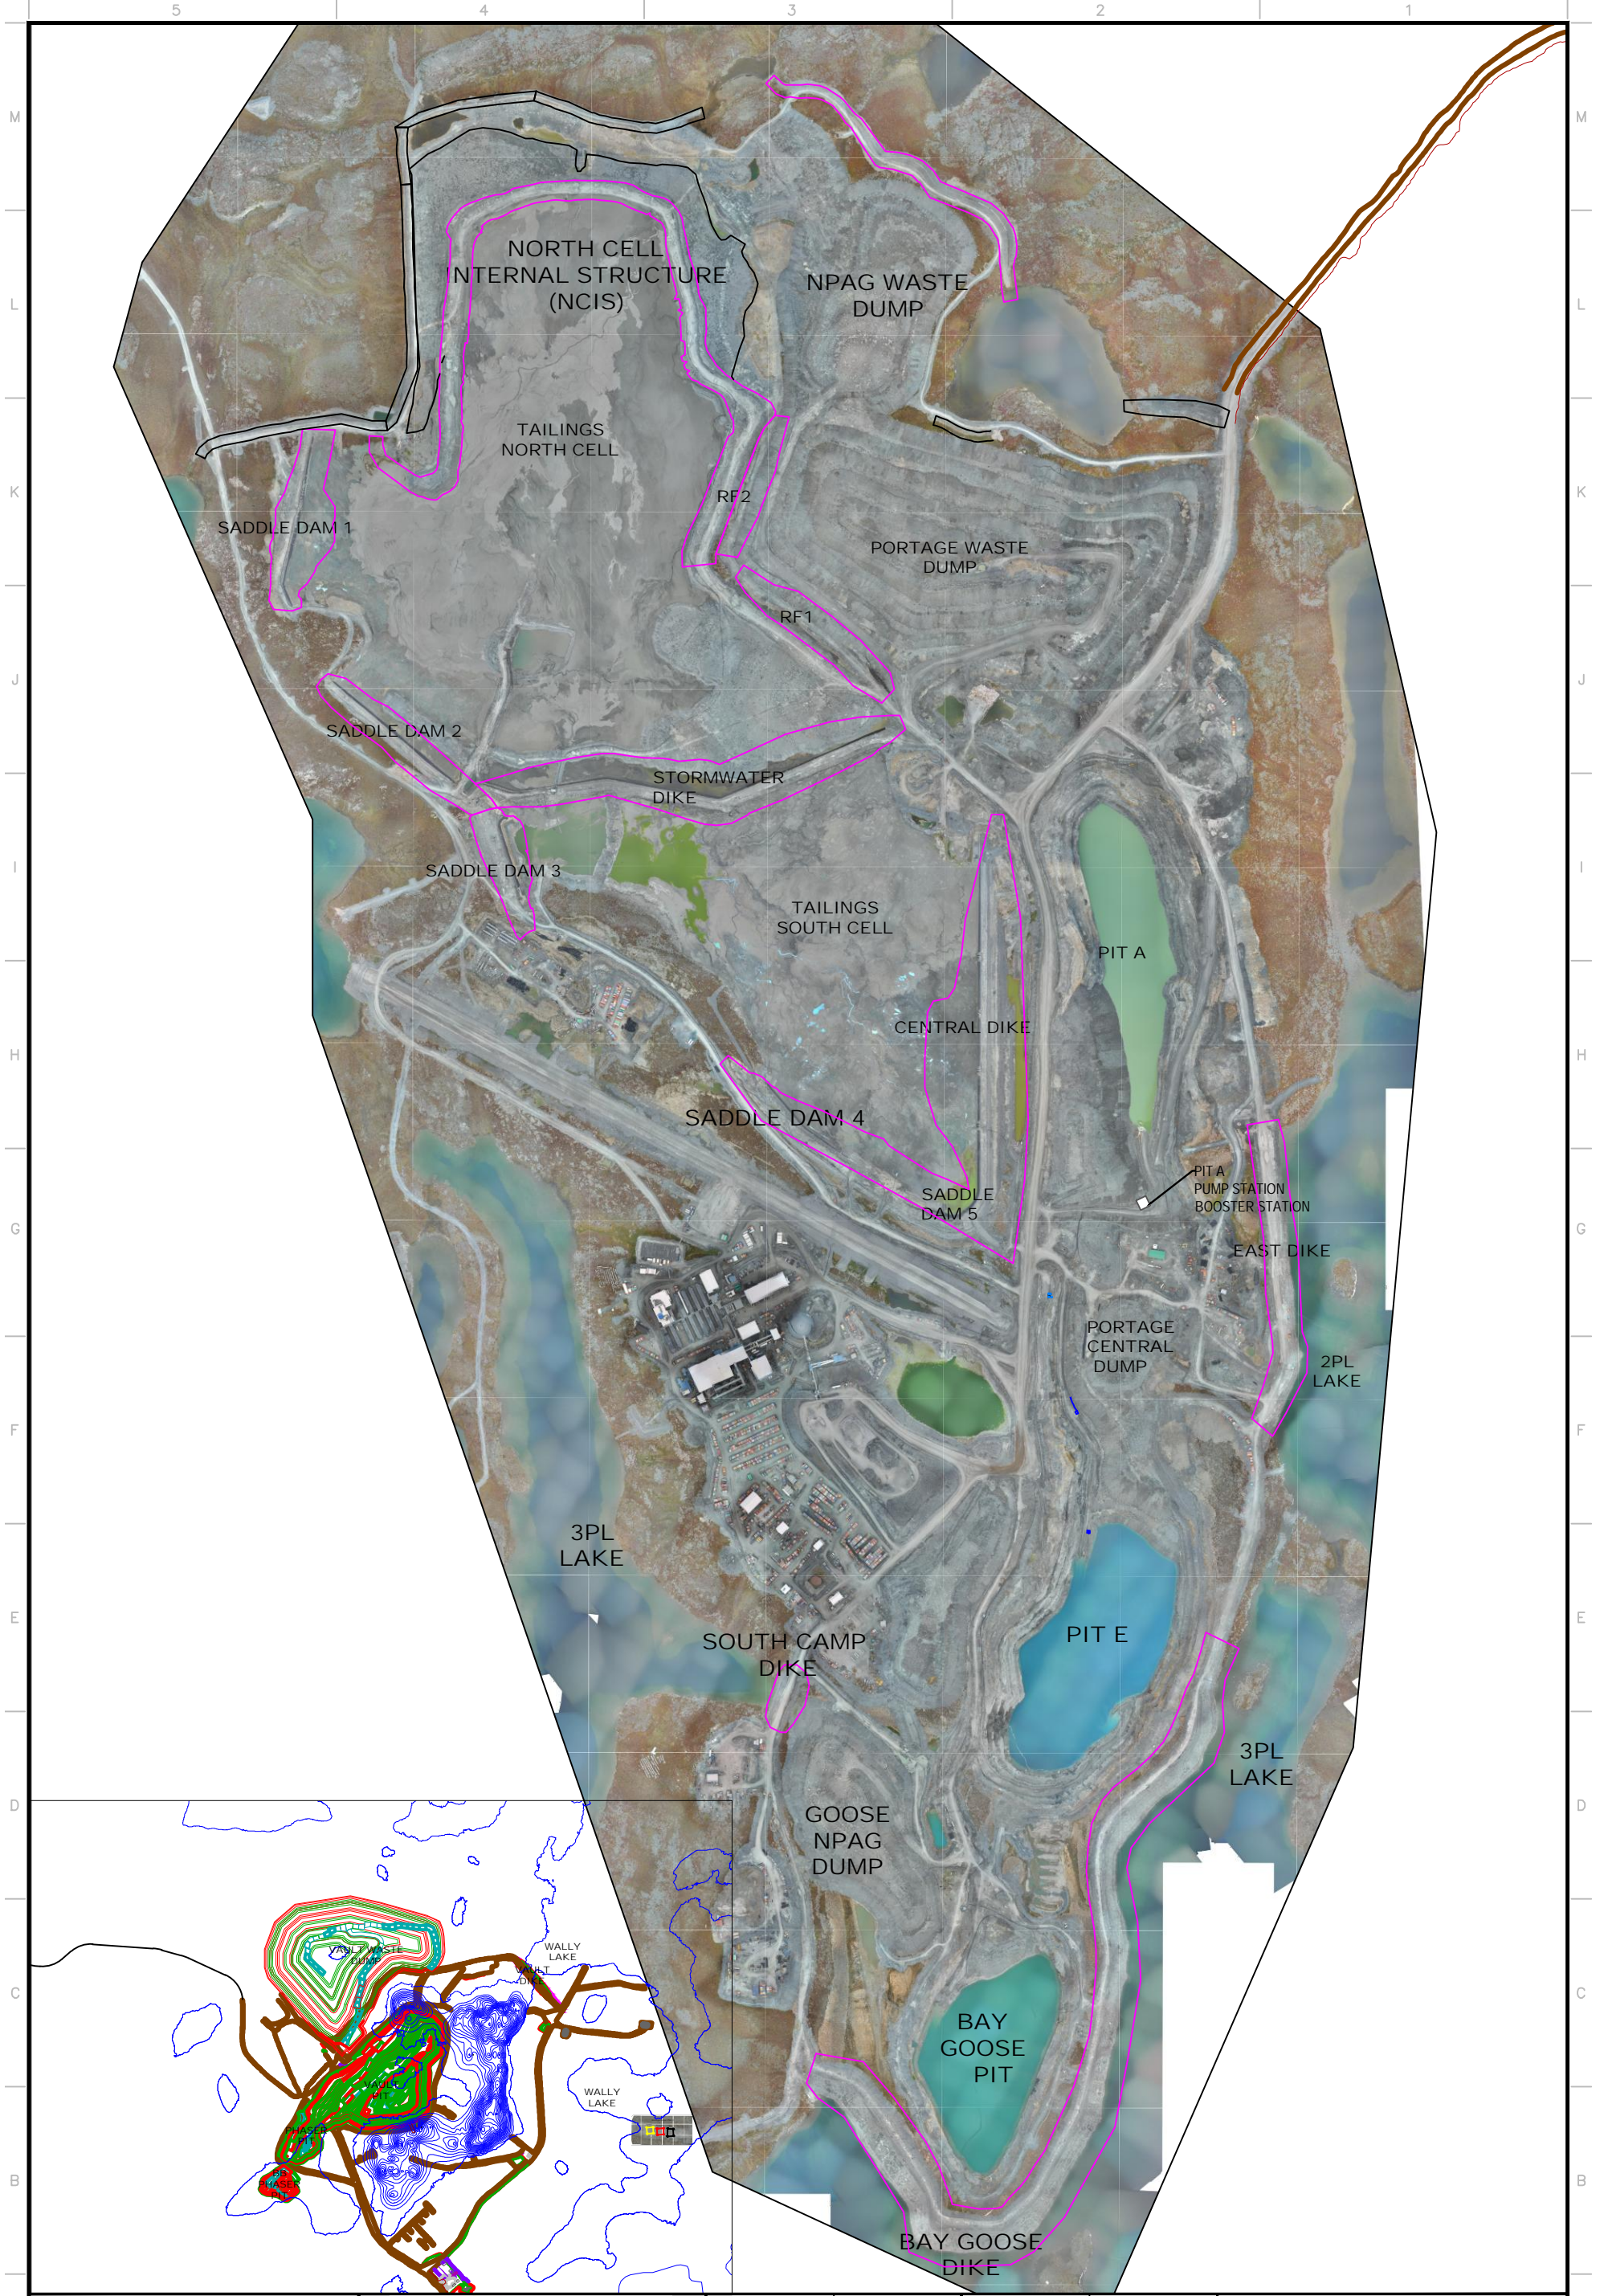
SITE LAYOUT

MEADOWBANK DIVISION	
ENVIRONMENT	
Water Management Critical Infrastructure	
SCALE N.T.S.	DATE
FILE .DWG

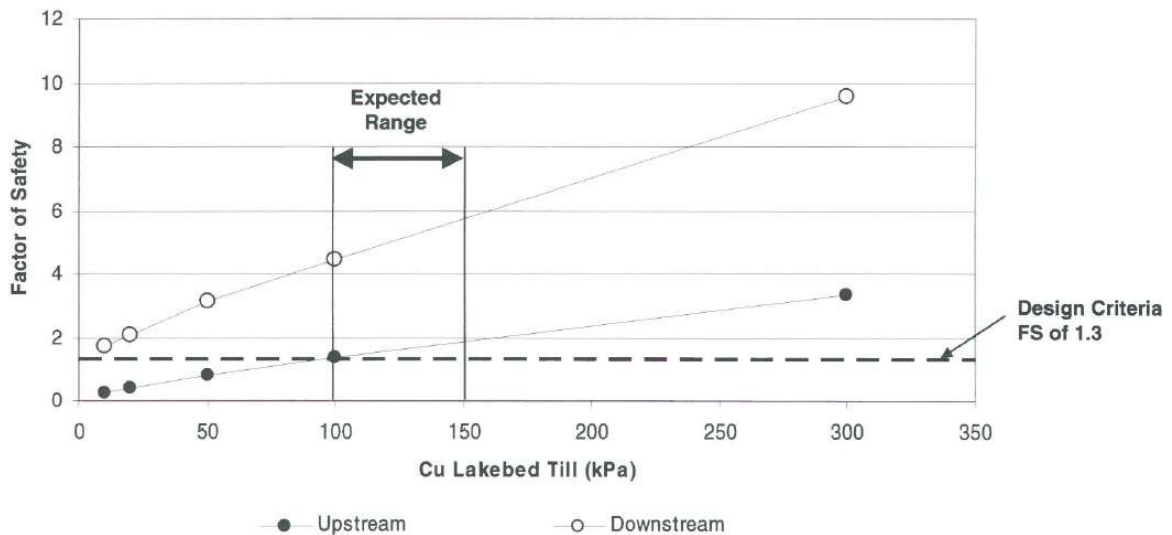
Figure B-1: Factor of safety VS foundation undrained strength (rapid drawdown condition with undrained foundation) (Golder, 2007)

The FoS obtained in the detailed design of the structures are illustrated in Figures B-1 and B-2 as well as Table B-2 below for different analyzed conditions. Detailed stability results are available in the detailed design report for the dewatering dikes (Golder, 2007, for Bay-Goose Dike, East Dike and South Camp Dike; SNC, 2013, for Vault Dike).
