WHALE TAIL MINE

**WATER MANAGEMENT INFRASTRUCTURE**

**Operation, Maintenance and  
Surveillance Manual**

Prepared by  
Agnico Eagle Mines Limited

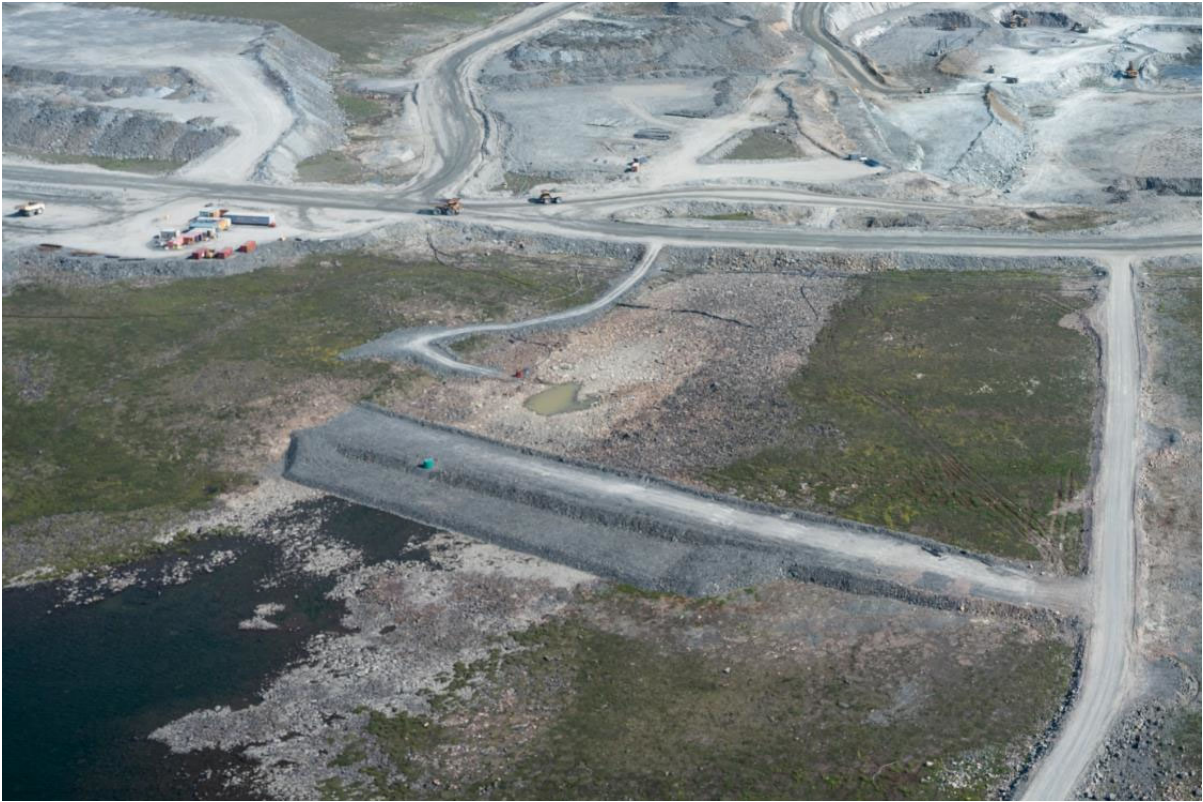
Figure 3-3 : Aerial View of Mammoth Dike

The construction of Mammoth Dike occurred from February 2019 to March 2019 to maintain the frozen condition of the foundation. This structure is a zoned rockfill dike with a filter system. The low permeability element of the dike consists of a bituminous geomembrane (BGM) installed on the upstream face anchored in a key trench with fine filter amended with bentonite (FFAB). The key trench is approximately 3 m deep and is founded on bedrock. Blasting was required during the construction of this infrastructure.

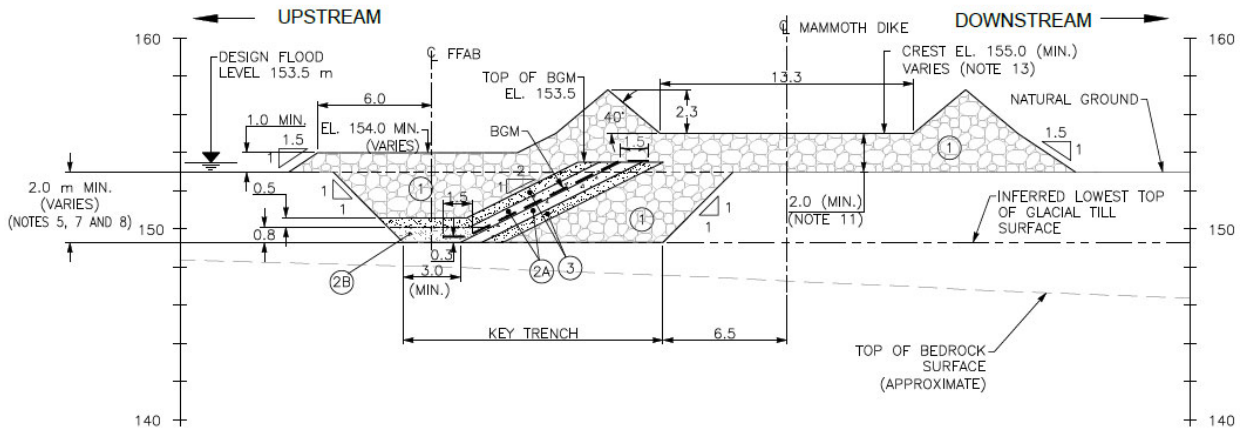
Figure 3-4 : Typical Cross-Section of Mammoth Dike

Scenario	Upstream water level (m)	Downstream water level (m)	Stability criteria	FOS		Appendix A
				Surficial slip surface	Global slip surface	
End of construction	152.5	152.5	1.0	1.37	1.66	A-5
Water level between 152.5 and 157.0 m	155 (see Fig. 3-4)	Dewatered		1.43	1.57	A-6

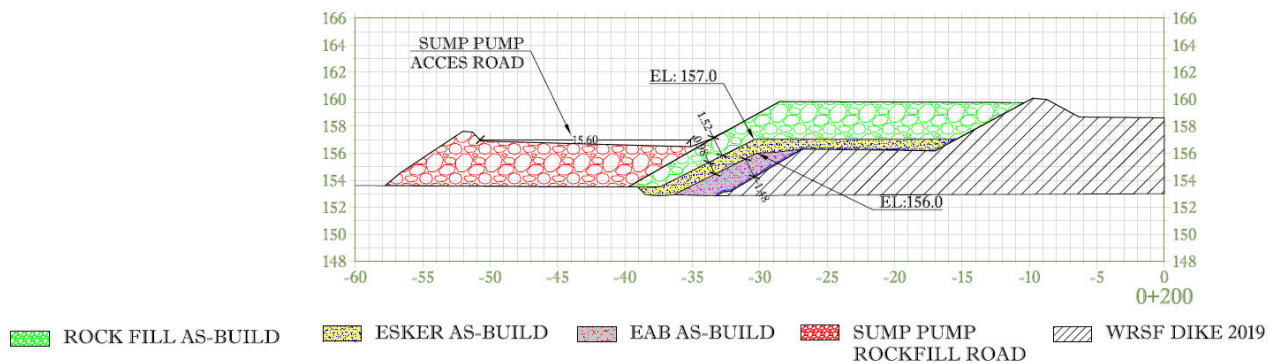
**Figure 3-7 : Typical Cross-Sections of WRSF Dike Thermal Berm**

The TARP level of the WRSF Dike was decreased to green in May 2020 once the remediation work was completed. No seepage was observed since then and the thermistor response has demonstrated the success of the mitigation measures implemented.

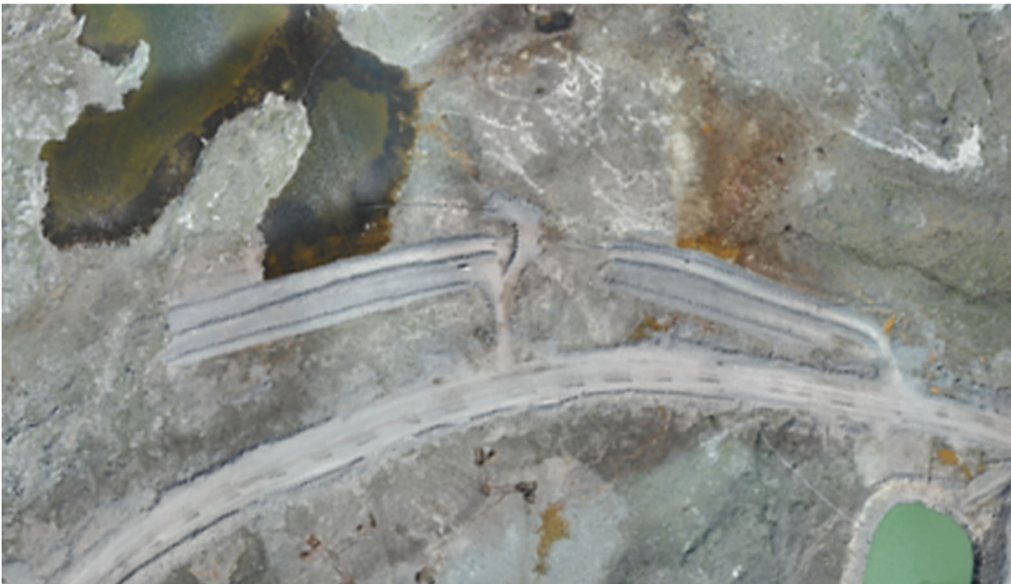
**Figure 3-8 : Aerial View of North-East Dike (before dismantling)**

The construction of NE Dike occurred from January to February 2019 to maintain the frozen condition of the foundation. This structure is a zoned rockfill dike with a filter system. The low permeability element of the dike consists of a bituminous geomembrane (BGM) installed on the upstream face anchored in a key trench with fine filter amended with bentonite (FFAB). The key trench is excavated in frozen glacial till or bedrock.

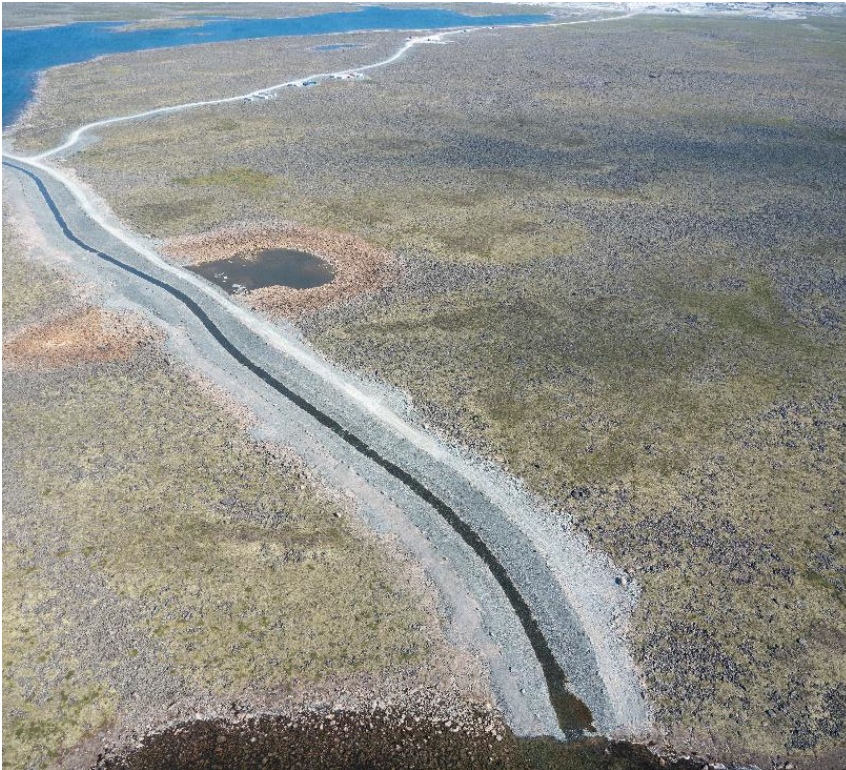
**Figure 3-10 : Plan View of SWTDC**
