### **Meadowbank Dewatering Dikes OMS Version 11**

**DEWATERING DIKES**

**Operation, Maintenance and  
Surveillance Manual**

Version 11  
January 2024

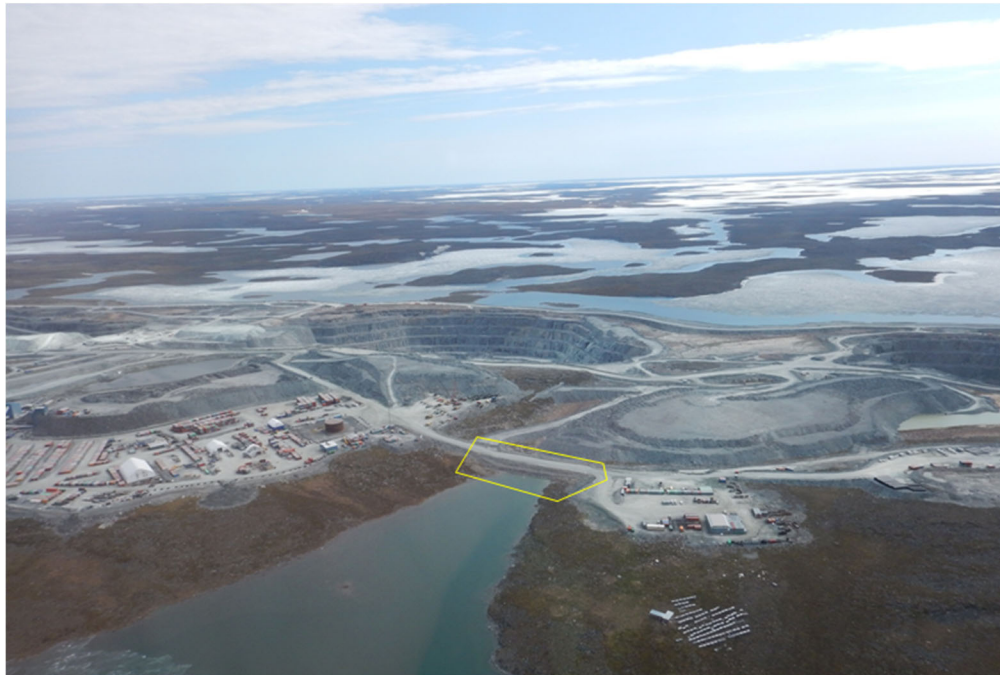
**Figure 3-5 : Aerial View of South Camp Dike**

The South Camp Dike was primarily constructed between April and June of 2009, prior to ice breakup. During the winter of 2009-2010 additional thermal capping material and rockfill for the haul road was added to the dike. The South Camp Dike has a broad rockfill shell with a bituminous geomembrane liner installed on the upstream side of the shell. The liner was founded on native frozen (permafrost) till material, in a trench approximately 3 to 5 m below the lakebed surface. Compacted granular material mixed with bentonite was placed above the toe of the liner. The haul road is located on the downstream side of the dike.

Figure 3-1 : Aerial View of East Dike.....	15
Figure 3-2 : Typical Cross-Section of East Dike.....	16
Figure 3-3 : Aerial View of Bay-Goose Dike .....	20
Figure 3-4 : Typical Cross-Section of Bay-Goose Dike.....	21
Figure 3-5 : Aerial View of South Camp Dike .....	27
Figure 3-6 : Typical Cross-Section of South Camp Dike.....	28
Figure 3-7 : Aerial View of Vault Dike.....	30
Figure 3-8 : Typical Cross-Section of Vault Dike.....	31
Figure 5-1 : Communication and Decision Process for Water Management Infrastructure TARP .....	43
