# **Whale Tail Water Management Infrastructure OMS Version 4**

**WATER MANAGEMENT INFRASTRUCTURE**

**Operation, Maintenance and  
Surveillance Manual**

Version 4  
January 2024

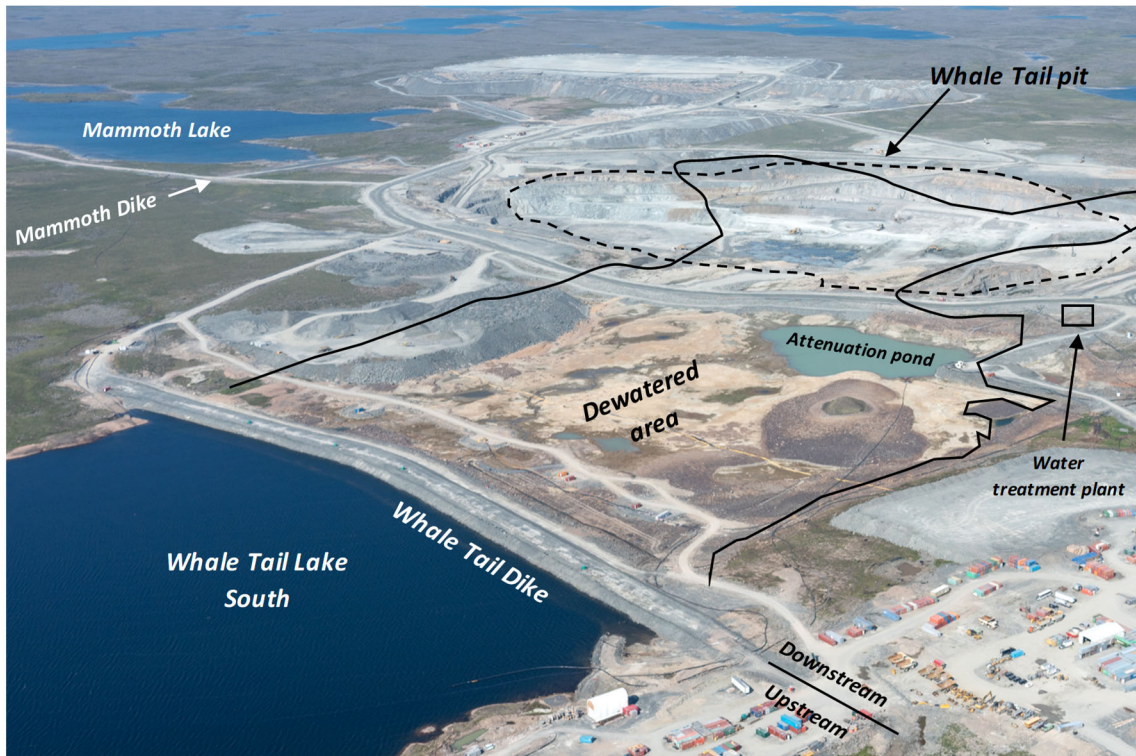
Figure 3-1 : Aerial View of Whale Tail Dike

References to key documents for the design and construction of Whale Tail Dike are presented in Table 3-2. Table 3-3 summarizes the main highlights of Whale Tail Dike.

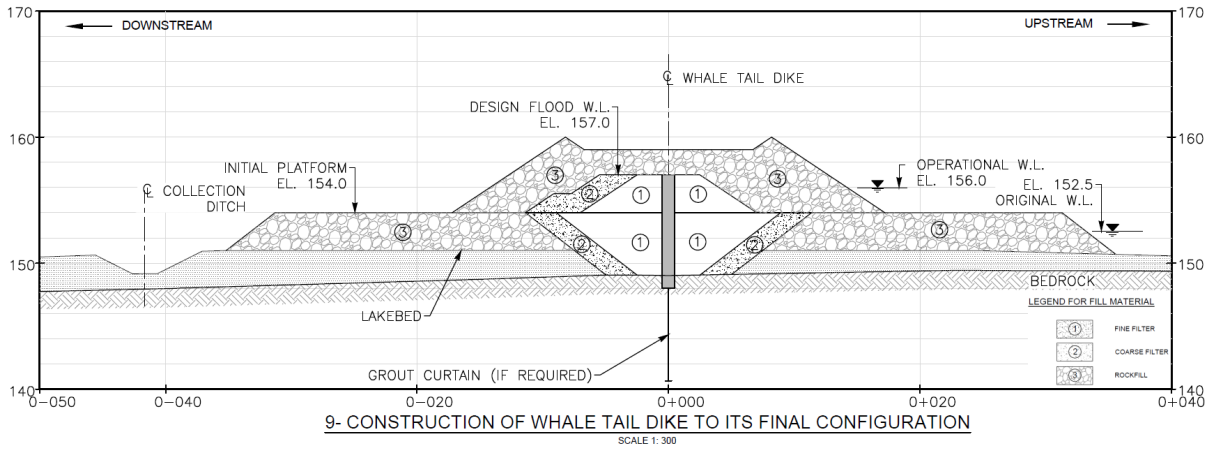
**Figure 3-2 : Typical Cross-Section of Whale Tail Dike**

- Two rockfill platforms were pushed in the lake to El. 154 m. The foundation preparation within the lake section of the key trench of WTD consisted of underwater excavation of the lakebed soils to the bedrock surface. From the initial platform the filter system and the rockfill was placed to El. 157 m. The filter material was densified using dynamic compaction.

- A 10 m depth curtain was initially constructed. During construction, permafrost bedrock conditions were observed in Thermistor strings from Stations 0+516 to 0+730 and the initial grout curtain was installed from Stations 0+180 to 0+516. To preserve the integrity of the cut-off wall, the curtain holes were cased through the fine filter materials approximately 0.3 m into bedrock using ODEX drilling methods with an off-set of  $\pm 0.7$  m from the centreline of the Dike to the upstream (South Pond) side and extended  $\pm 10$  m into the bedrock using top-hammer, water-flush drilling methods. The grouting was carried out at a Primary Hole spacing of 12 m

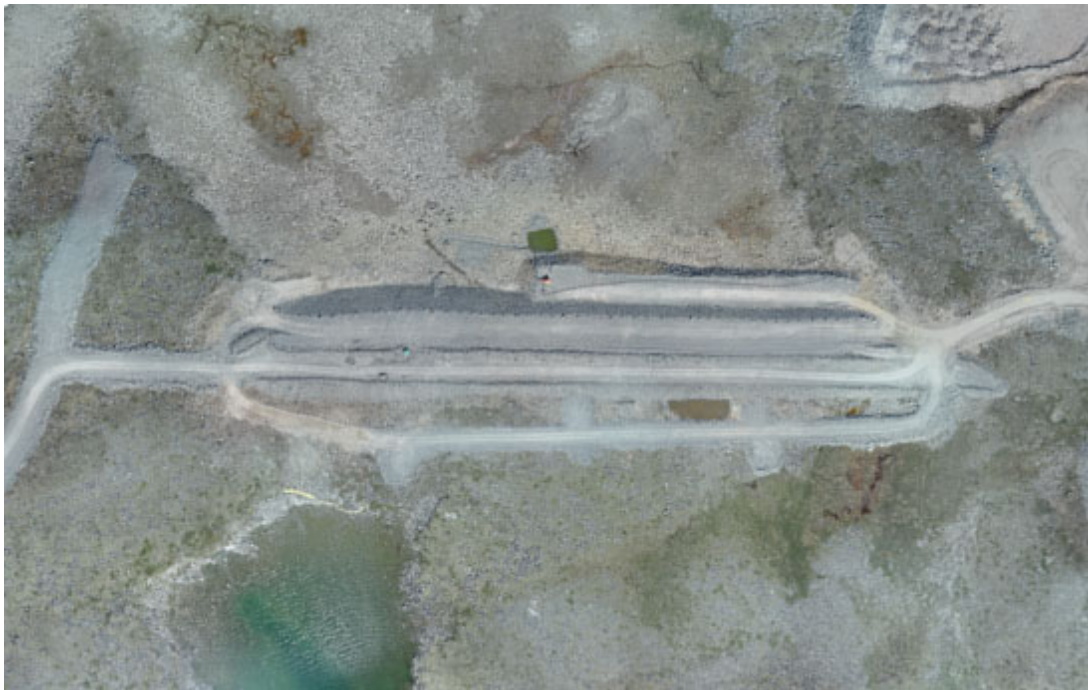
**Figure 3-5 : Aerial View of WRSF Dike**

Foundation excavation in the key trench area was done in the fall of 2018 to avoid blasting and aggrade frost penetration. The construction of WRSF Dike mainly occurred from January to February 2019 to maintain the frozen condition of the foundation. This structure is a zoned rockfill dike with a filter system. The low permeability element of the dike consists of a bituminous geomembrane (BGM) installed on the upstream face anchored in a key trench with fine filter amended with bentonite (FFAB). The key trench is 3 m deep approximately and founded on frozen glacial till or bedrock.

References to key documents for the design and construction of WRSF Dike are presented in Table 3-6. Table 3-7 summarizes the main highlights of WRSF Dike.

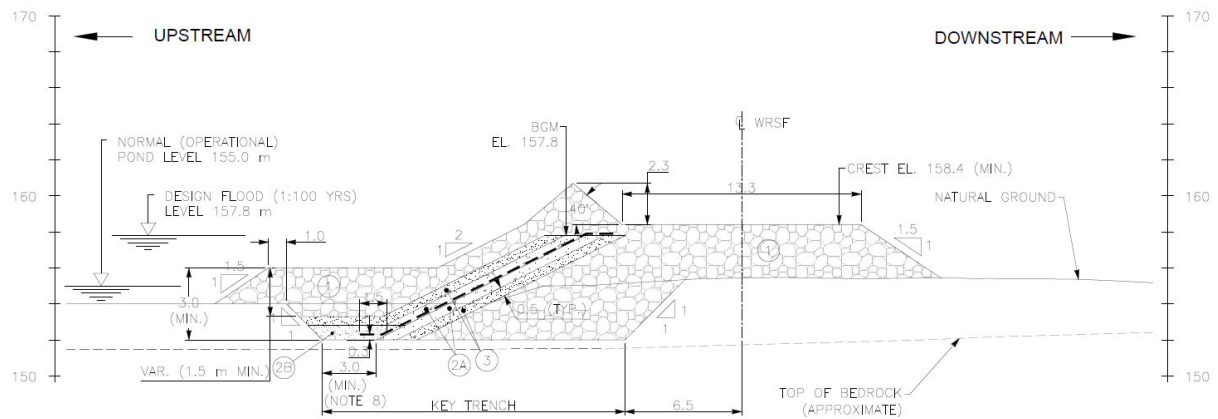
**Figure 3-6 : Typical Cross-Sections of WRSF Dike (Without Thermal Berm)**

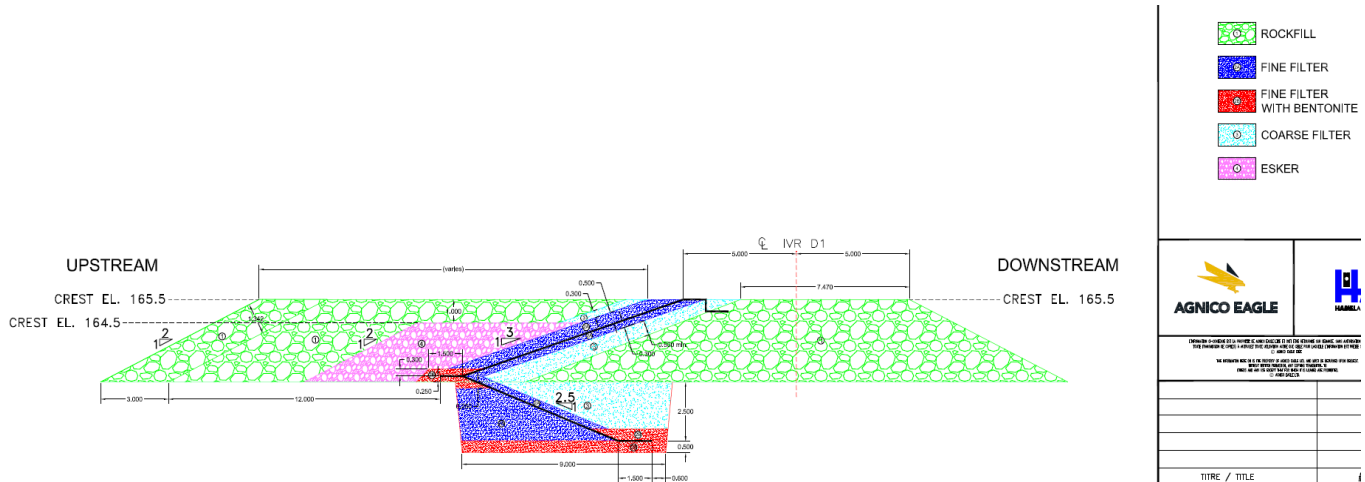
**Figure 3-9 : Typical Cross-Section of IVR Dike D-1 (0+080 to 0+320)**

The construction of IVR Dike D-1 was completed in Q2 2021. The structure was constructed as a zoned rockfill dike with a filter system. The low permeability element of the dike consists of a bituminous geomembrane (BGM) installed on the upstream face anchored in a 3 m deep key trench located below the centerline of the structure surrounded by fine filter amended with bentonite (FFAB). The key trench is excavated in frozen glacial till or bedrock. To improve the thermal condition of the key trench a rockfill and esker thermal berm was placed on the upstream side.

During the 2022 freshet, localised deformation of the crest was observed on the area located above the upstream hinge of the liner. The settlement had a magnitude of 0.2-0.3 m over an area about 150m long, 6-8m wide and extending from STA 0+100 to 0+300. It had an offset of about 14m upstream of the centerline. The TARP level was raised to yellow in September 2022 to increase inspection and monitoring. The IVR Dike foundation remained in frozen conditions. It is believed that the observed settlement is related to a surficial mechanism linked to the thawing of the esker material placed above the liner in winter condition and does not affect the integrity of liner or the key trench.

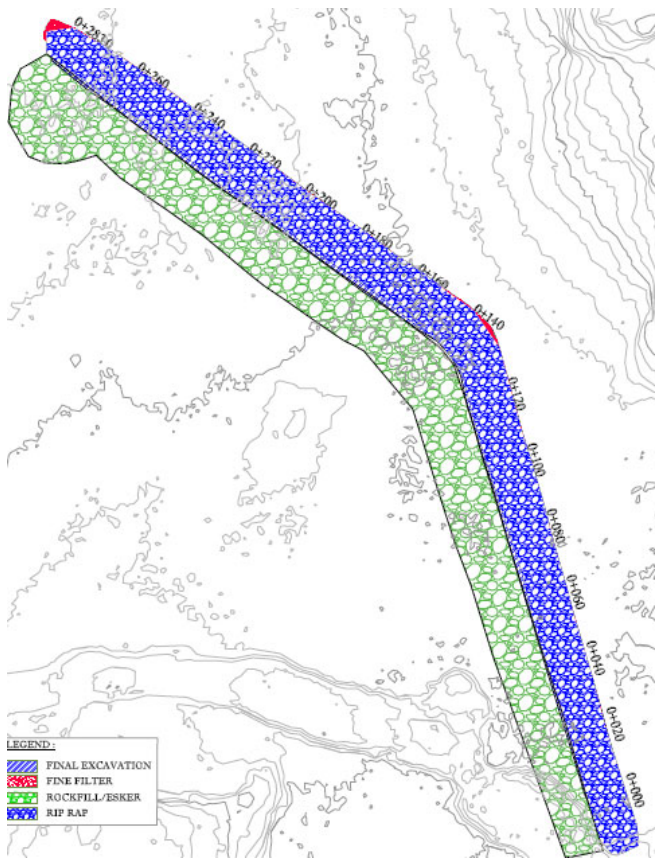
**Figure 3-11 : Plan View of IVR Diversion**

The construction of the IVR DC occurred from September to October 2020 and it was commissioned during freshet 2021. The channel has a trapezoidal shape with lateral slopes of 2H:1V to 3H:1V, a base width of 3.0 m, and a bed-slope of 0.3%, in combination with a pervious rockfill perimeter berm that is delimiting the west boundary of the channel and also acts as an access road. The IVR DC was constructed with a layer of fine filter material placed on top of the excavated foundation followed by geotextile and overlain by riprap.

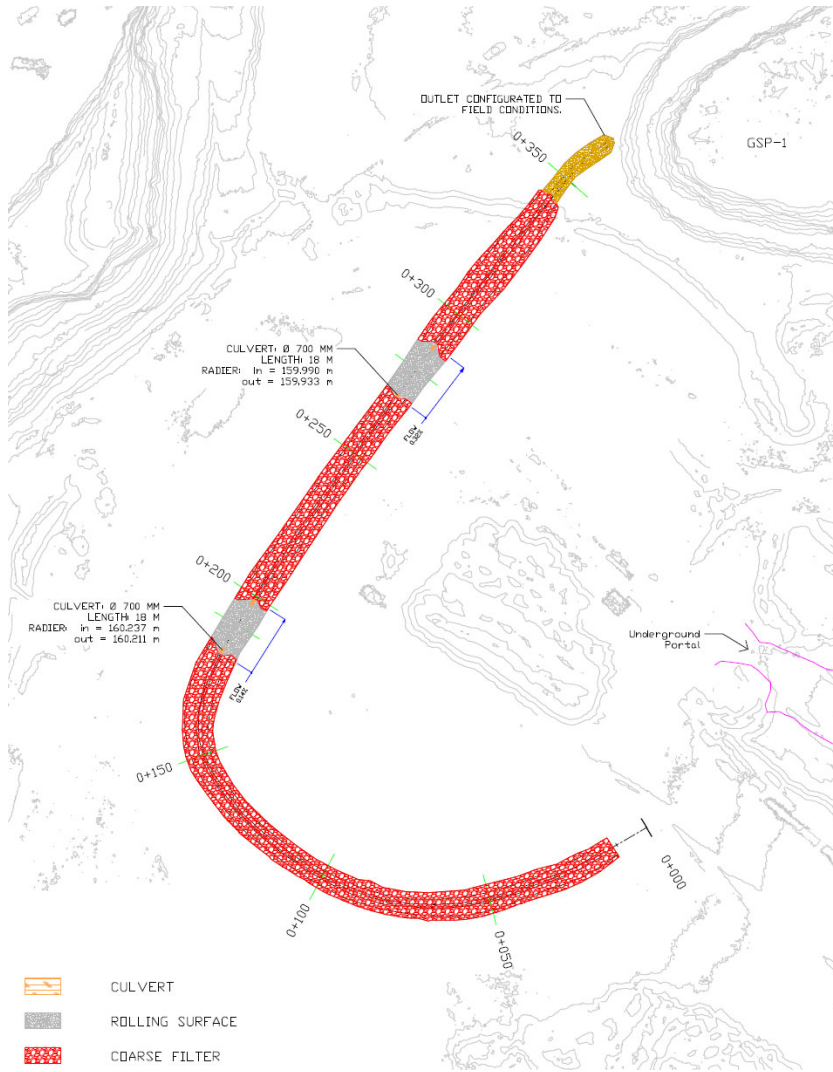
Figure 3-13 : Plan View of Underground Ore Stockpile Saline Ditch

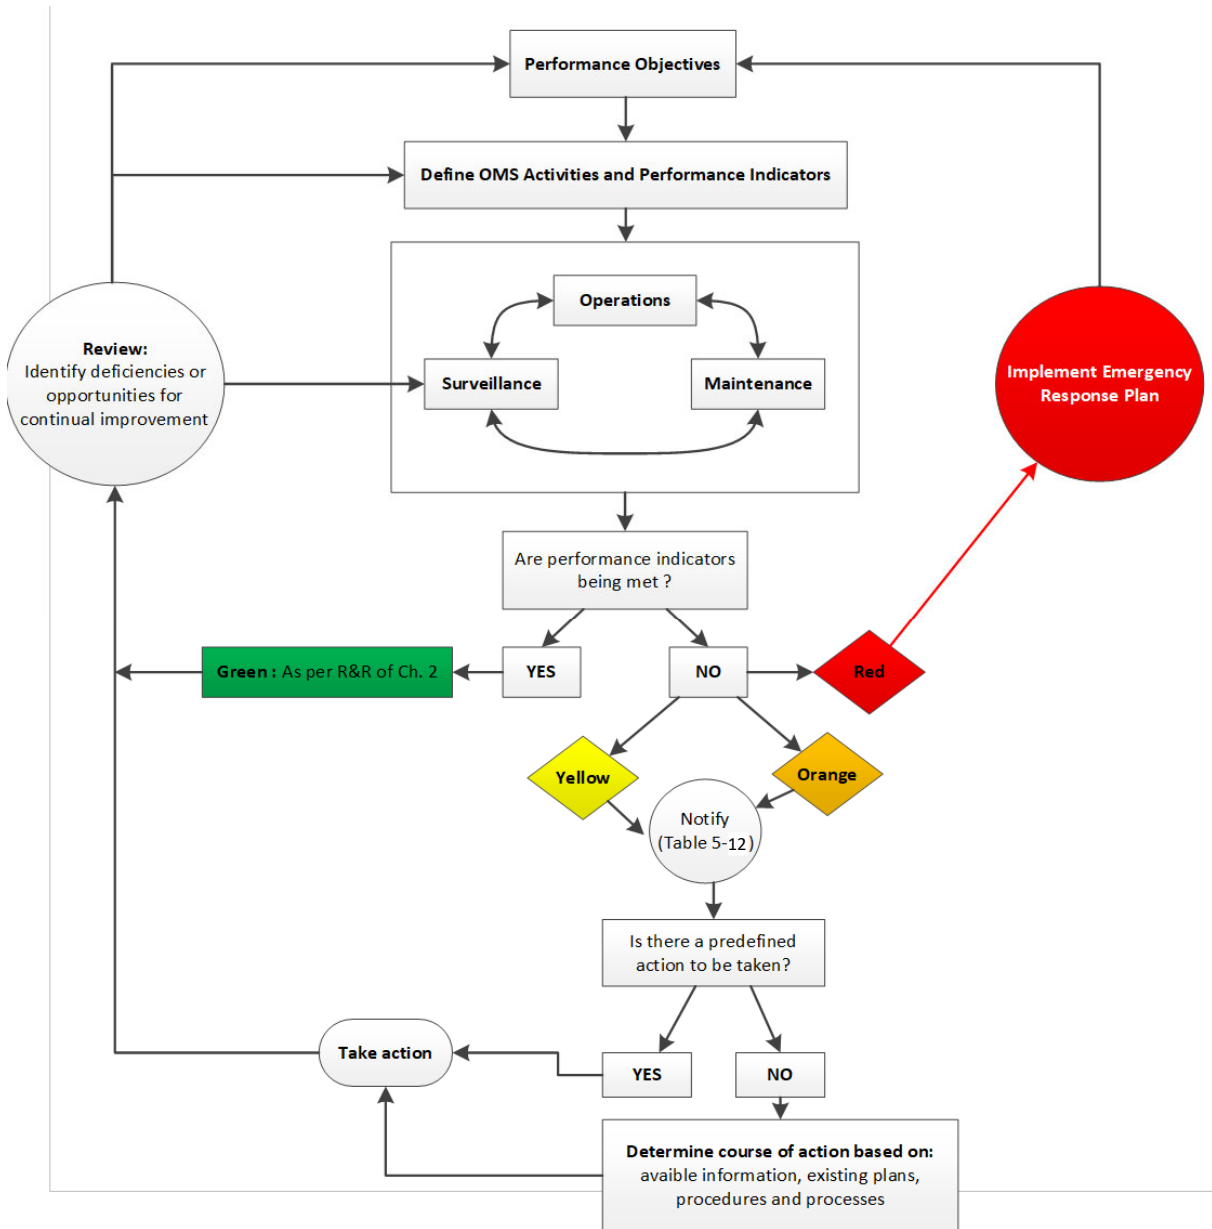
Figure 5-1 : Communication and Decision Process for Water Management Infrastructure TARP

Figure 5-1 indicates the communication and decision processes when the threshold criteria are met and when pre-defined actions need to be implemented. Table 5-12 indicates the communication procedure to follow when changing the TARP level.

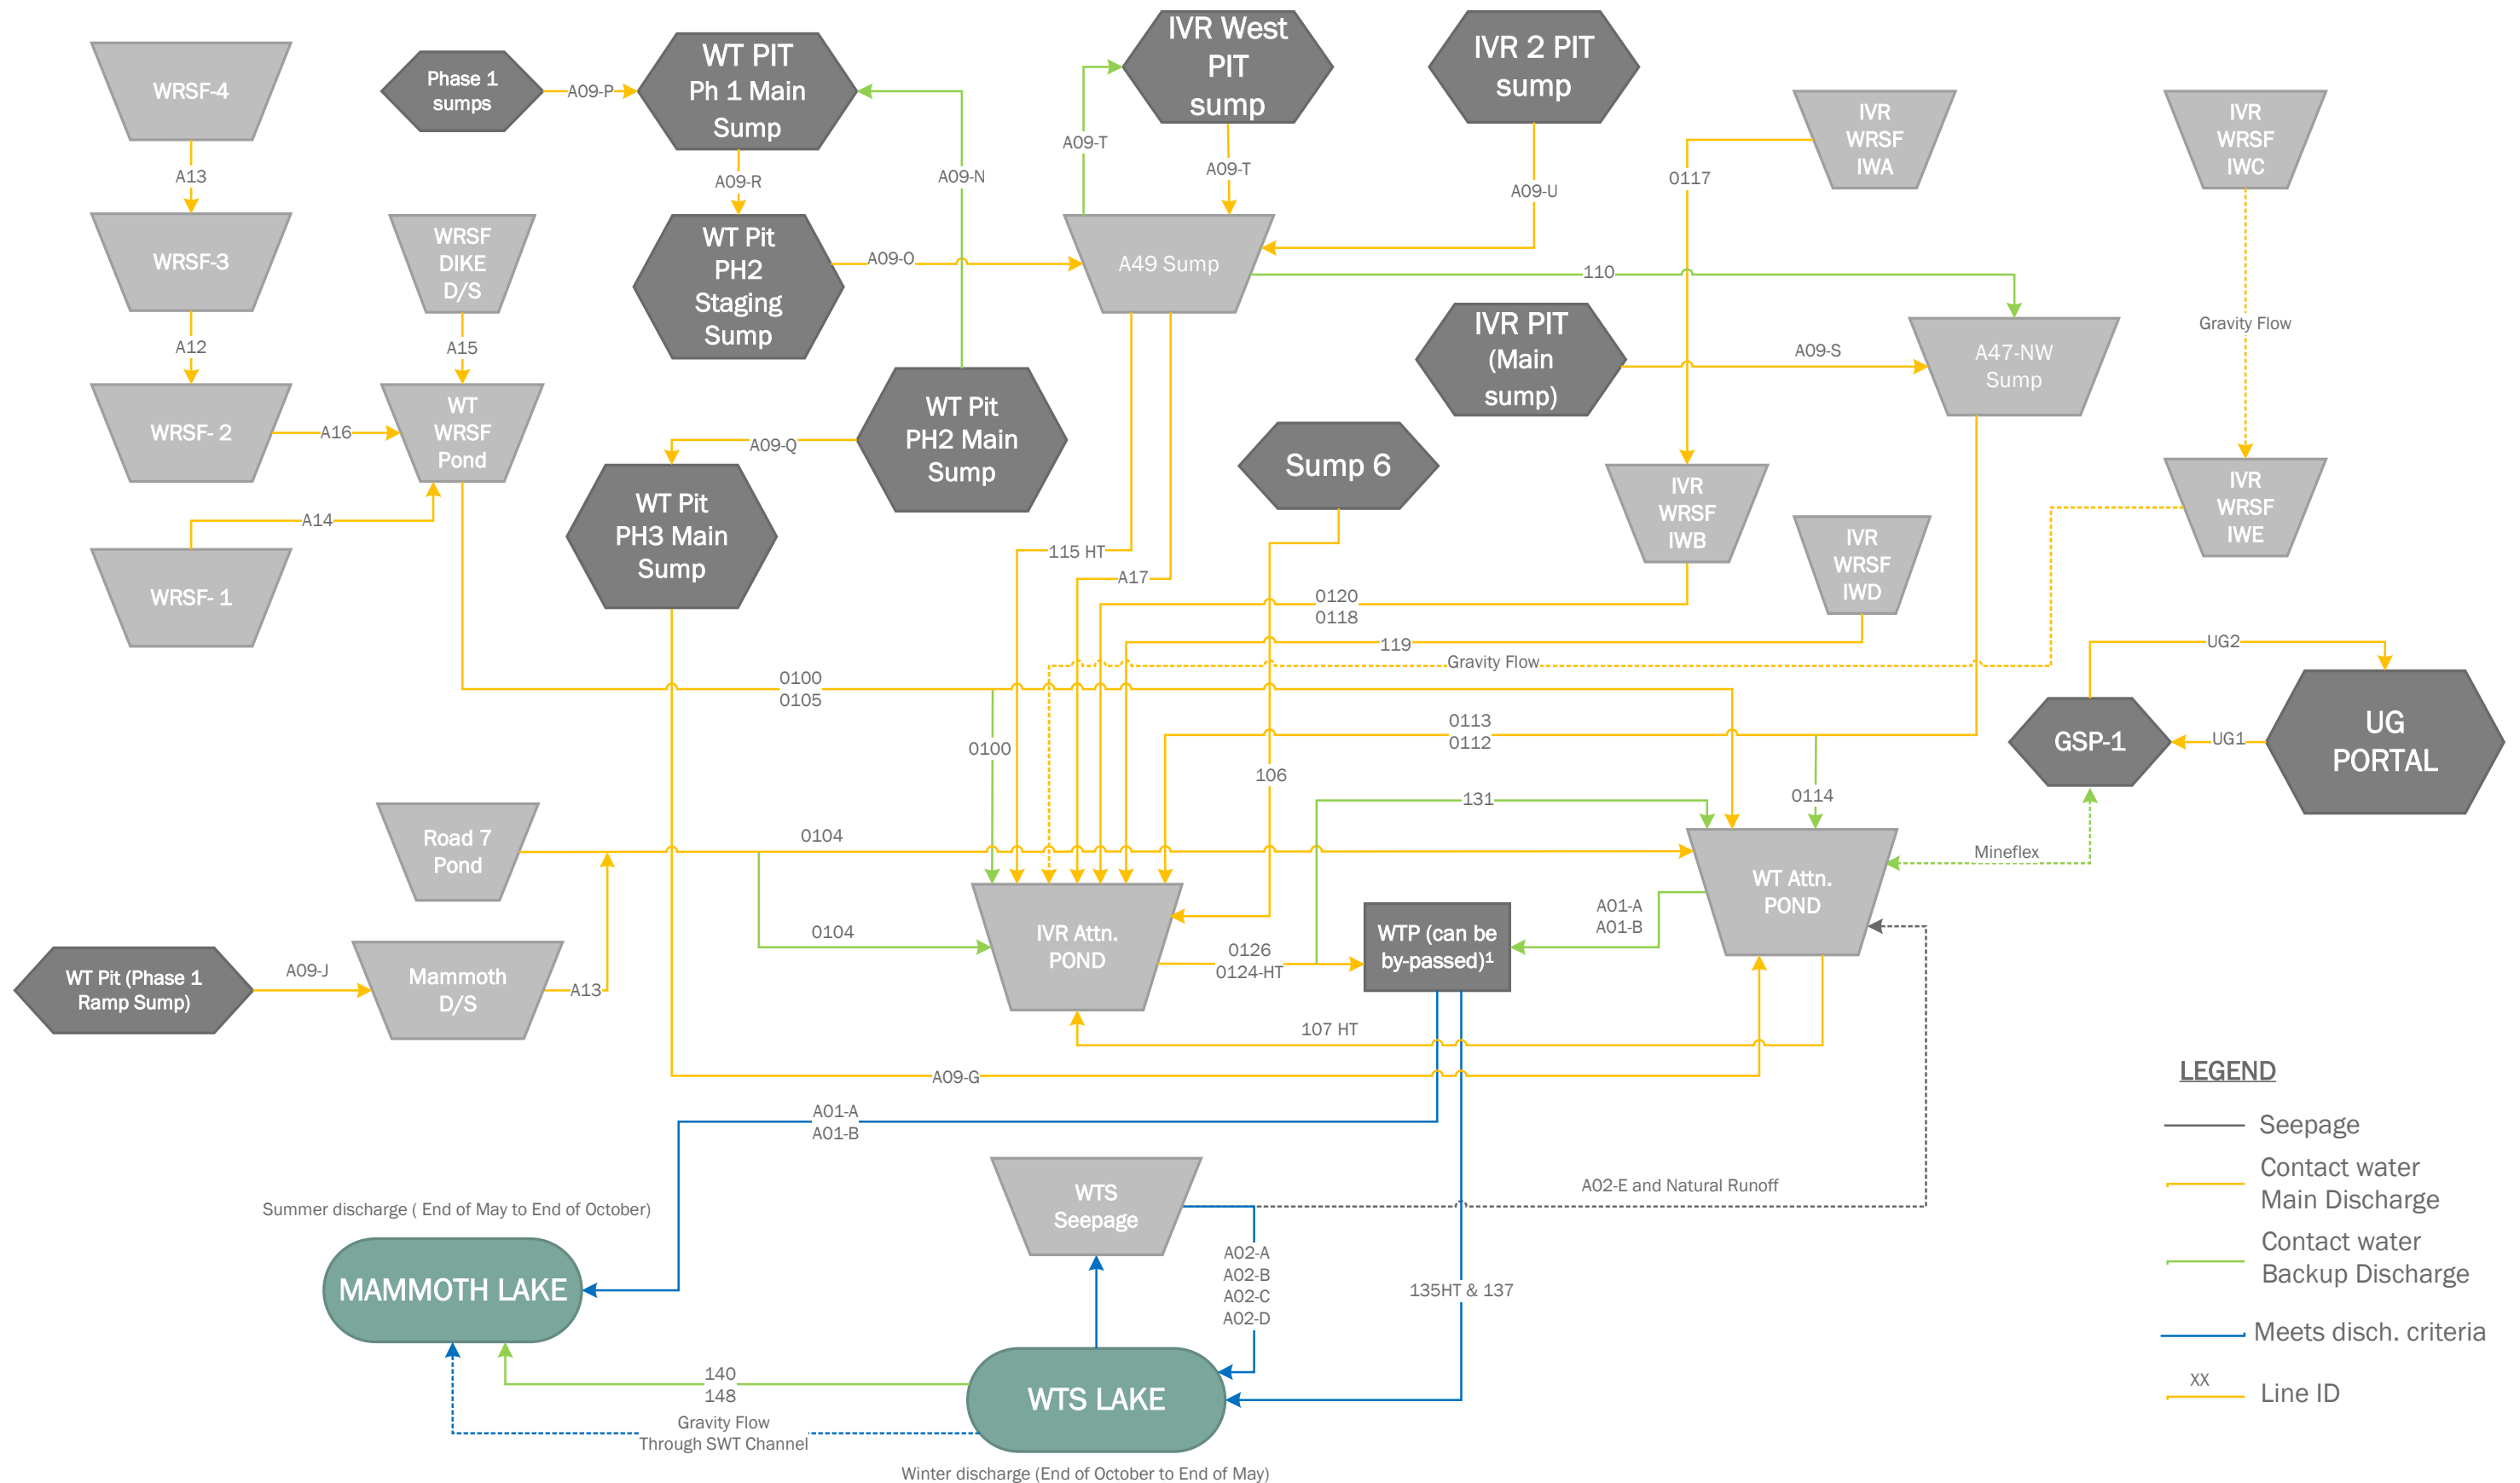
# Amaruq 2022 Detailed Freshet Flowsheet

- Seepage
- Contact water
- Main Discharge
- Backup Discharge
- Meets disch. criteria
- XX Line ID
