OPERATIONS, MAINTENANCE AND SURVEILLANCE MANUAL: HOPE BAY DORIS TAILINGS IMPOUNDMENT AREA

REVISION 8

HOPE BAY, NUNAVUT

MARCH 2025

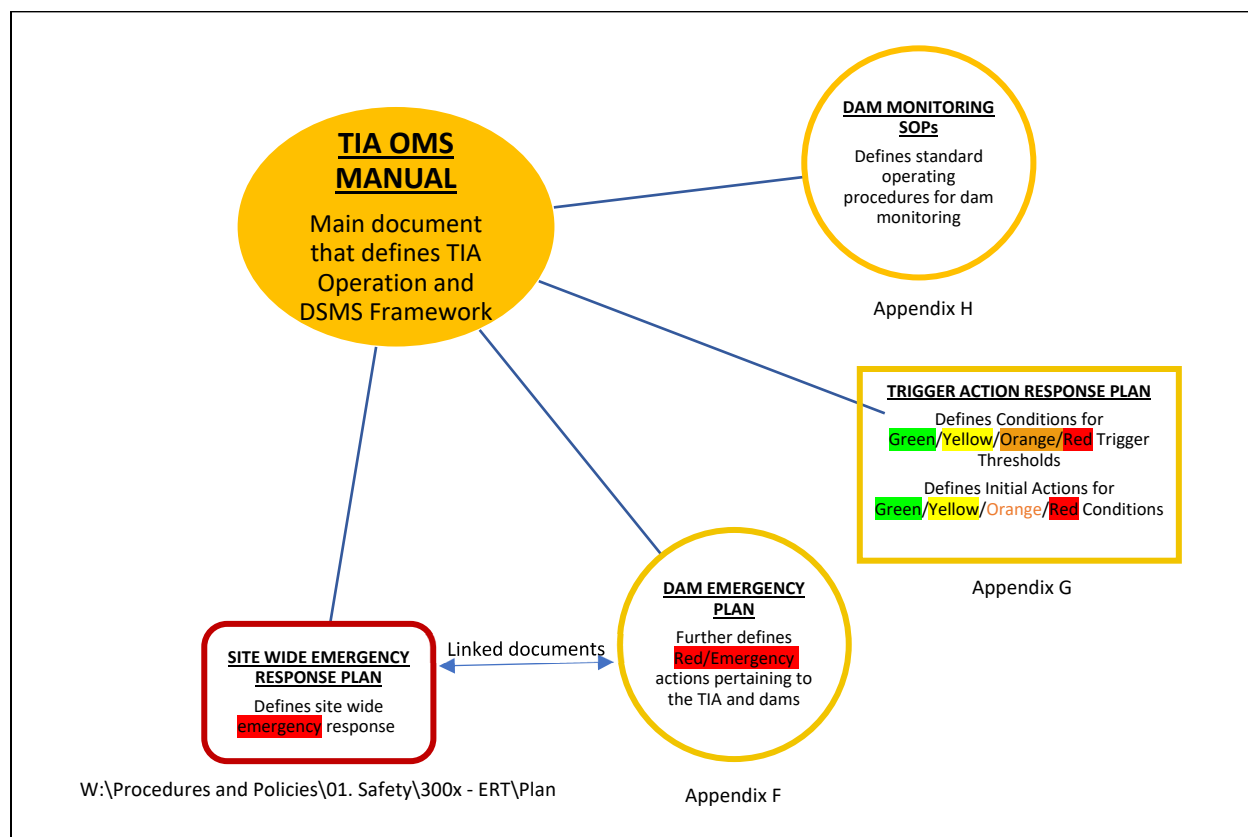
Figure 4-1 – DSMS Document Relationships

<ul style="list-style-type: none"> • Defines the Dam Safety Management System framework for Hope Bay • Contains (as Appendices) or references other key DSMS documents such as the DEP (see below)
Doris TIA Trigger Action Response Plan	<ul style="list-style-type: none"> • Appendix G of the Hope Bay TIA OMS Manual • Defines the conditions and thresholds corresponding to each trigger level for the North Dam, South Dam, and the TIA Reclaim Pond Water Elevation • Defines initial actions to be taken for operational trigger levels: <ul style="list-style-type: none"> ○ Green: Normal Operating Conditions ○ Yellow: Early Warning Conditions ○ Orange: Corrective Action Conditions ○ Red: Emergency/Uncontrolled Condition • Specific conditions and thresholds are defined for instrumentation data readings, as well as visual observations from inspections.
Dam Monitoring Standard Operating Procedures	<ul style="list-style-type: none"> • Appendix H of the Hope Bay TIA OMS Manual • Describe in detail the requirements and procedures for dam monitoring under normal operating (Green) conditions

Hope Bay Project Dam Emergency Plan	<ul style="list-style-type: none"> • Activates in the event of an emergency at any of the dams on site. • Appendix F of the Hope Bay TIA OMS Manual • Further defines the initial response to an emergency condition at the dams (Red Trigger Level). • Includes the personnel, equipment and communication systems available to respond to an emergency situation at the dams. • Is linked the Hope Bay Project ERP
Hope Bay Project Emergency Response Plan	<ul style="list-style-type: none"> • Stored on Hope Bay server (W:\Procedures and Policies\01. Safety\300x - ERT\Plan) and physical hardcopies located in the admin boardroom and goehub. • Activates in the event of an emergency on site. • Defines the initial response to an emergency. • Includes the personnel, equipment and communication systems available to respond to an emergency situation.

The function of each document is described in Table 4-1 below. The relationship and references between the documents are outline in Figure 4-1 below.

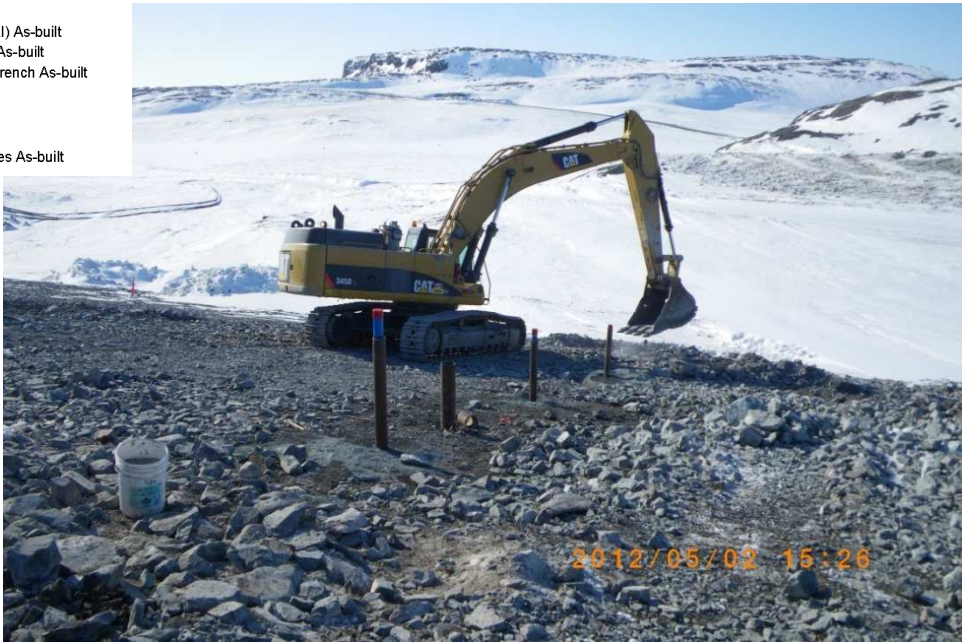
AGNICO EAGLE	DORIS TIA OMS MANUAL		
	North Dam Deformation Monitoring Instrumentation Layout		
HOPE BAY PROJECT	Date: March 2024	Approved: BJ	Figure: 14

Example of as-built instrumentation installed on the downstream of dam.

General Guidance	Additional guidance on the required instrument monitoring (how to perform and frequency) is presented in the dam surveillance SOPs (Appendix H).
North Dam	The locations of North Dam monitoring instruments are shown in Figures 11 to 14.
South Dam	The locations of South Dam monitoring instruments are shown in Figure 15.
Interim Dike	The locations of the Interim Dike monitoring instruments are shown in Figure 16.
