**AGNICO EAGLE**

MEADOWBANK SITE

**DEWATERING DIKES**

**Operation, Maintenance and  
Surveillance Manual**

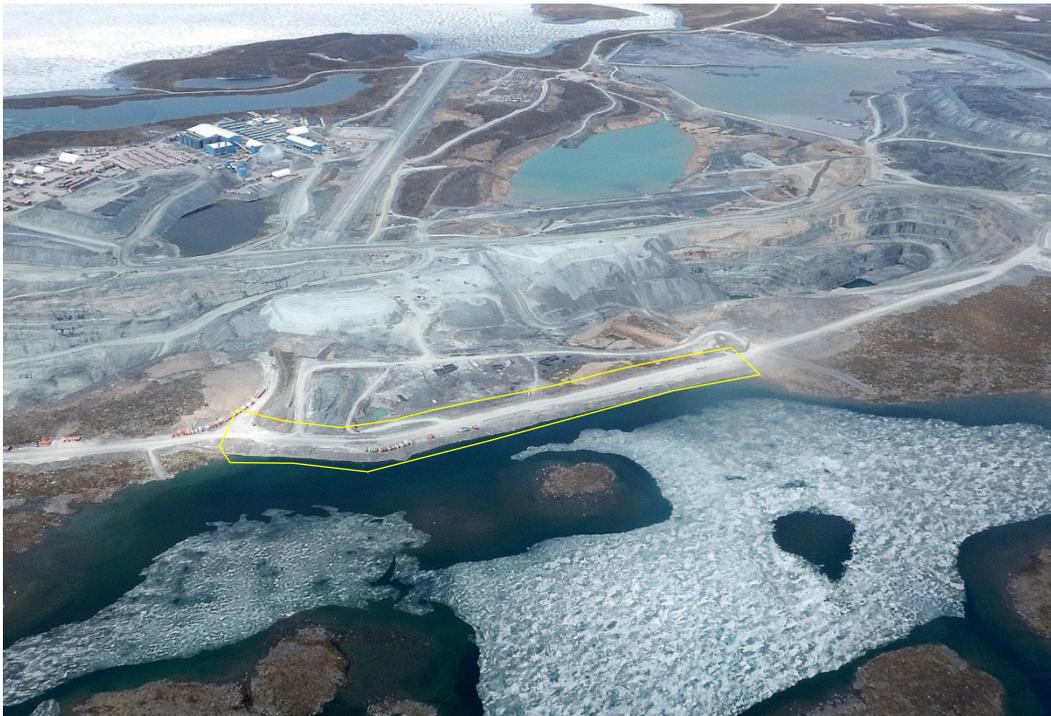
Figure 3-1 : Aerial View of East Dike

EAST DIKE						
<b>Designer :</b> Golder - WSP						
<b>Construction Period :</b> 2008 – 2009						
<b>Operation Period :</b> 2009 - 2028						
<b>Planned Closure Period :</b> 2028-2036						
Design Criteria						
Use	Water type	Classification (CDA, 2007)	Inflow Design Flood	Water Level (m)		Crest Elevation (m) (max height)
				Normal	Design Flood	
Water Retention / Dewatering	Non-contact	High	1/3 between 1000-year and PMF <sup>1</sup>	133.1	135.1	137.1 (10 m)
Built to dewater 2 <sup>nd</sup> Portage Arm Lake. 800 m long rockfill embankment with soil-bentonite cutoff wall with filter system +5 m deep injection curtain. The structure has been built to operate Portage Pit and is still in operation due to ongoing tailings deposition in Portage Pit						
<b>Operation Highlight</b>						
<ul style="list-style-type: none"> <li>• Sinkhole cavity due to SB erosion observed in 2009 and repaired with grouting. Stable since then (refer to Section 4.1)</li> <li>• Seepage managed by 2 pumping stations (slower rate)</li> </ul>

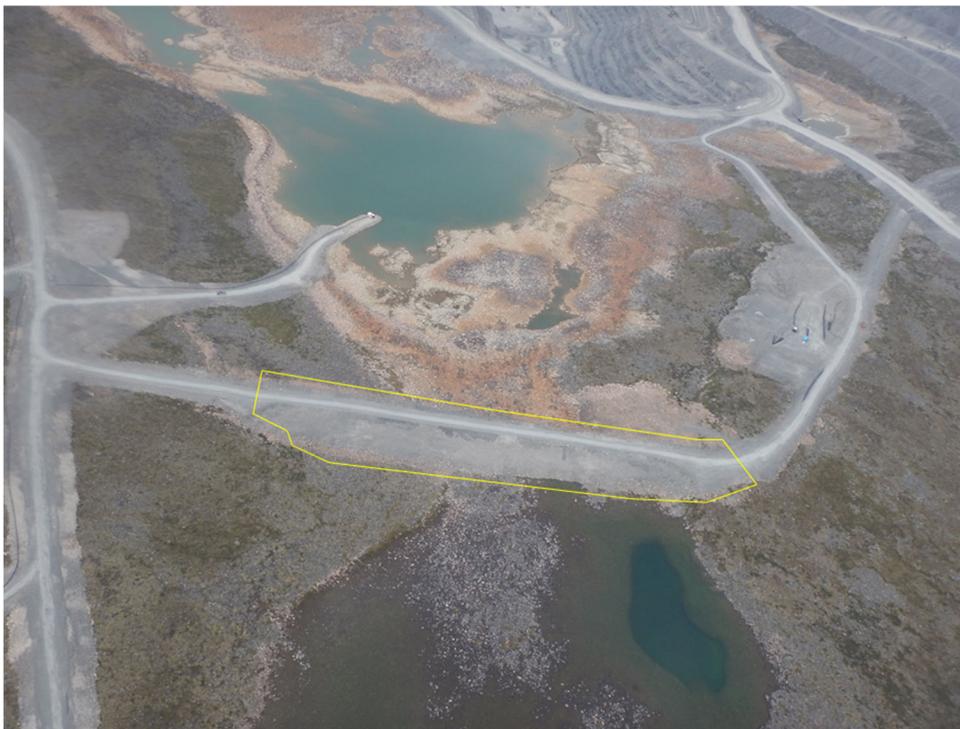
**Figure 3-7 : Aerial View of Vault Dike**

Vault Dike						
<b>Designer :</b> Golder <b>Construction Period :</b> 2013 <b>Operation Period :</b> 2013 - 2028 <b>Planned Closure Period :</b> 2028-2036						
Design Criteria						
Use	Water type	Classification (CDA, 2007)	Inflow Design Flood	Water Level (m)		Crest Elevation (m) (max height)
				Normal	Design Flood	
Water Retention/Dewatering	Non-contact	Low	1-100 year snow melt + 1-100 year rainfall	139.52	141	142.5 (3 m)
Rockfill embankment with filtering system and bituminous liner. Sitting on permafrost condition. Allowed dewatering of Vault Lake						
<b>Operation Highlight</b>						
<ul style="list-style-type: none"> <li>- Risk assessment performed on water management infrastructure in 2022. Annual Probability of Failure and design Factor of Safety in Appendix B.</li> </ul>
