### **Meadowbank Dewatering Dikes OMS Version 12**

**DEWATERING DIKES**

**Operation, Maintenance and  
Surveillance Manual**

Version 12  
March 2025

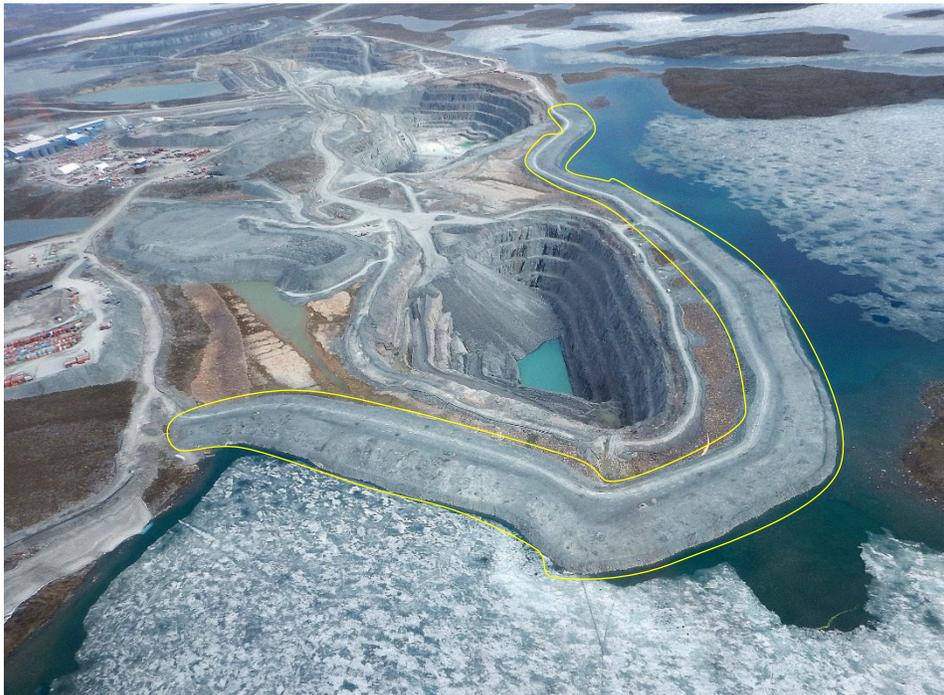
**Figure 3-3 : Aerial View of Bay-Goose Dike**

2.2 km long rockfill embankment with cement-soil-bentonite cutoff wall with filter system. To reach bedrock depths – used injection jet-grouting to create the full cutoff wall. After cutoff wall, a 5 m deep injection curtain into the bedrock						
<b>Operation Highlight</b> <ul style="list-style-type: none"> <li>• Settlement and tension cracks observed in the thermal capping of the structure</li> <li>• Small seepage observed at the toe of the structure. Naturally report to Goose Pit</li> <li>• Crest settlement resurfaced in 2023.</li> </ul>						
Risk assessment performed on water management infrastructure in 2022. Annual Probability of Failure and design Factor of Safety in Appendix B.

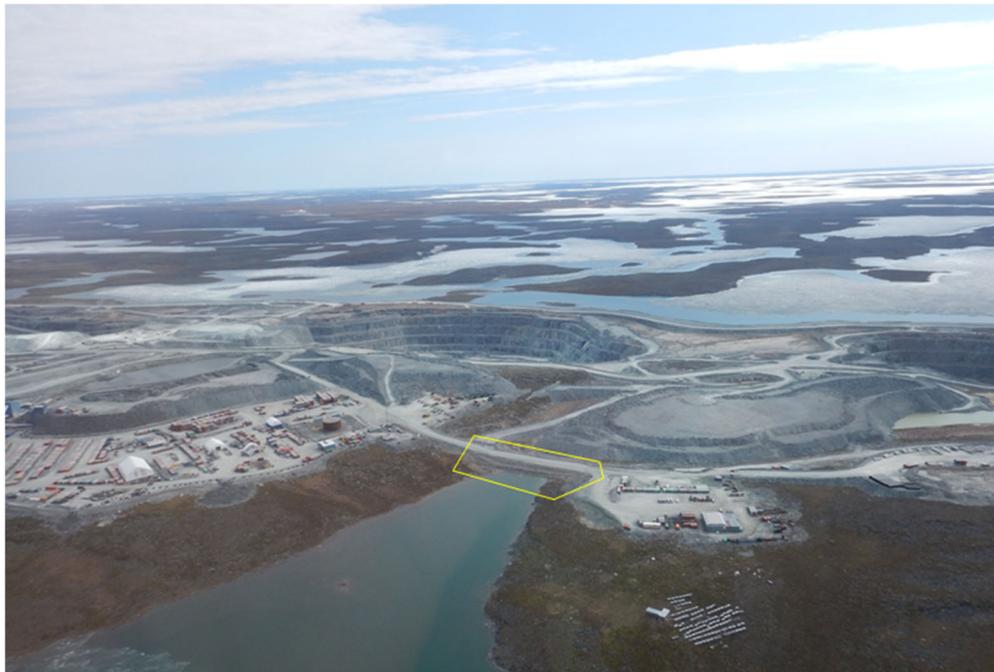
**Figure 3-5 : Aerial View of South Camp Dike**

The South Camp Dike was primarily constructed between April and June of 2009, prior to ice breakup. During the winter of 2009-2010 additional thermal capping material and rockfill for the haul road was added to the dike. The South Camp Dike has a broad rockfill shell with a bituminous geomembrane liner installed on the upstream side of the shell. The liner was founded on native frozen (permafrost) till material, in a trench approximately 3 to 5 m below the lakebed surface. Compacted granular material mixed with bentonite was placed above the toe of the liner. The haul road is located on the downstream side of the dike.
