AGNICO EAGLE

HOPE BAY

2025 Annual Report

Submitted to:
Nunavut Water Board

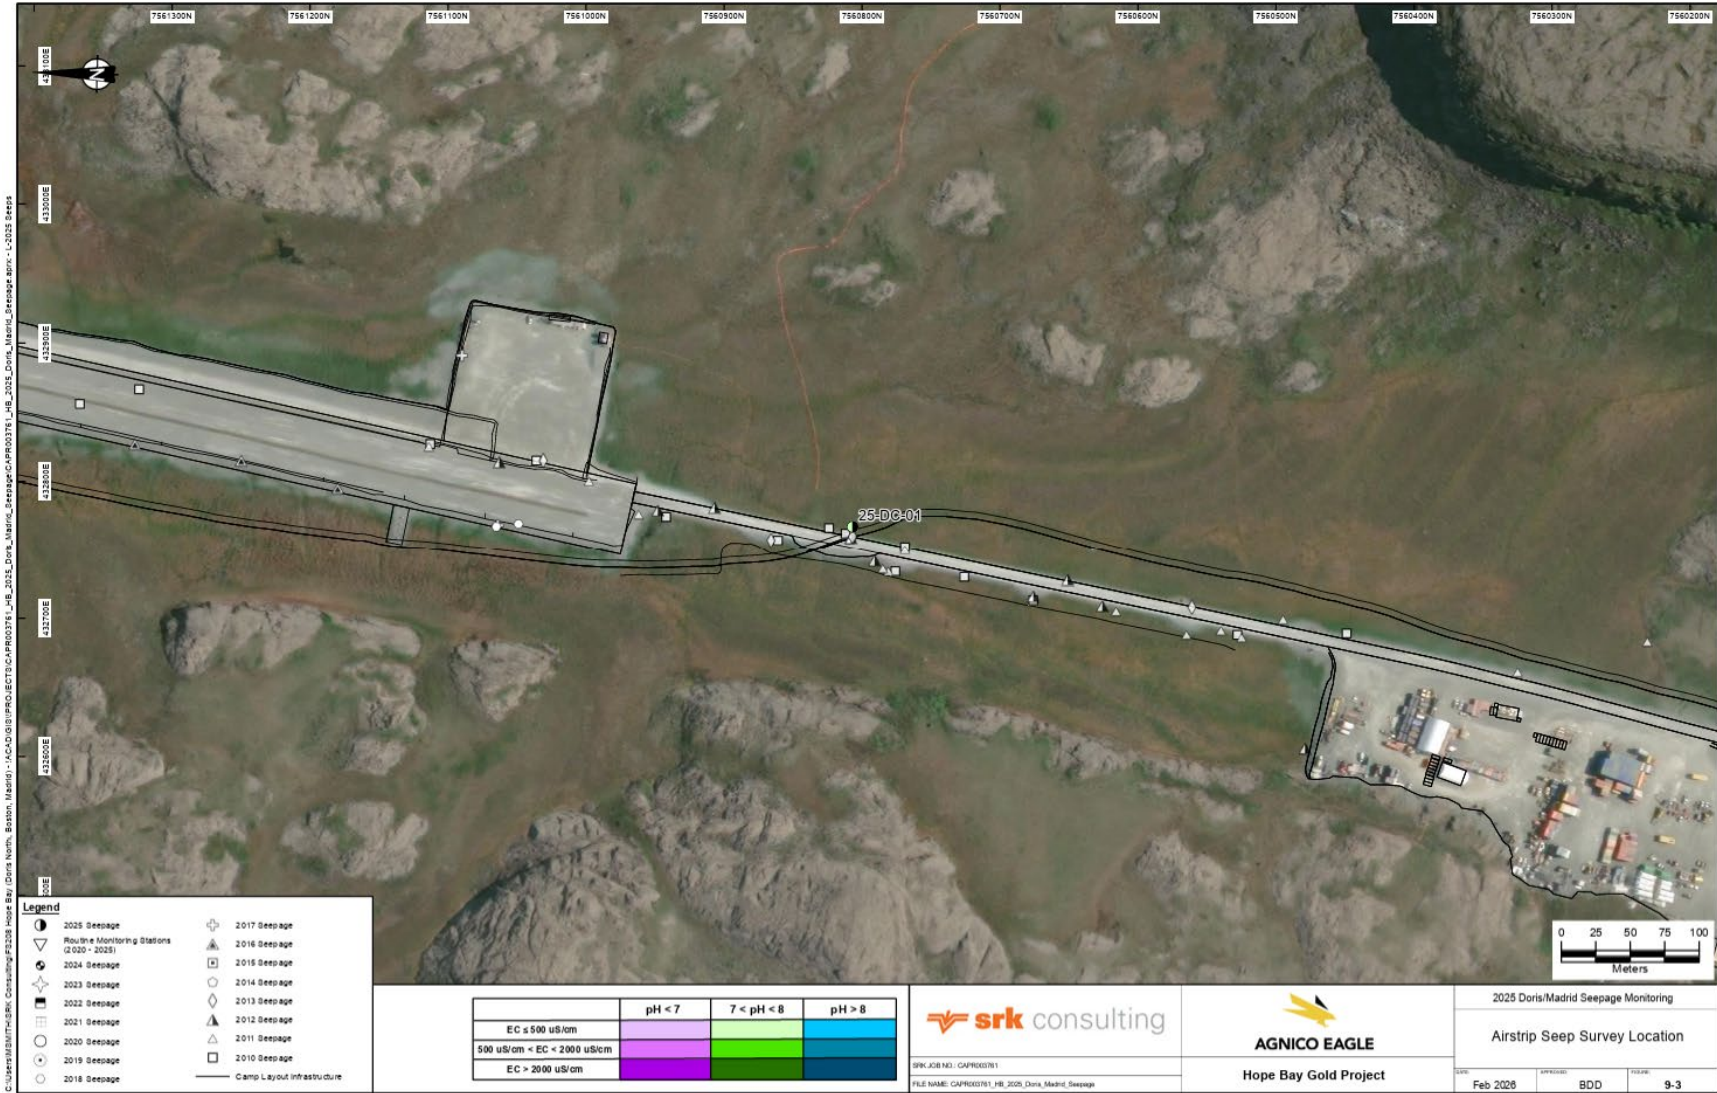
Figure 8-2: Doris Airstrip 2025 Seepage Survey Location

One seepage sample was collected from the Doris Airstrip area in 2025 (shown in Figure 8-2). Laboratory results indicated a pH of 8.0 and an EC of 220 $\mu\text{S}/\text{cm}$. Major ion chemistry was dominated by alkalinity and calcium, while nitrogen species concentrations were low and comparable to those observed at reference seepage stations. Dissolved metals concentrations were also low and within the range historically observed for reference seepage, indicating that seepage from the Doris Airstrip area is consistent with background water quality and shows no evidence of Mine-related loading.

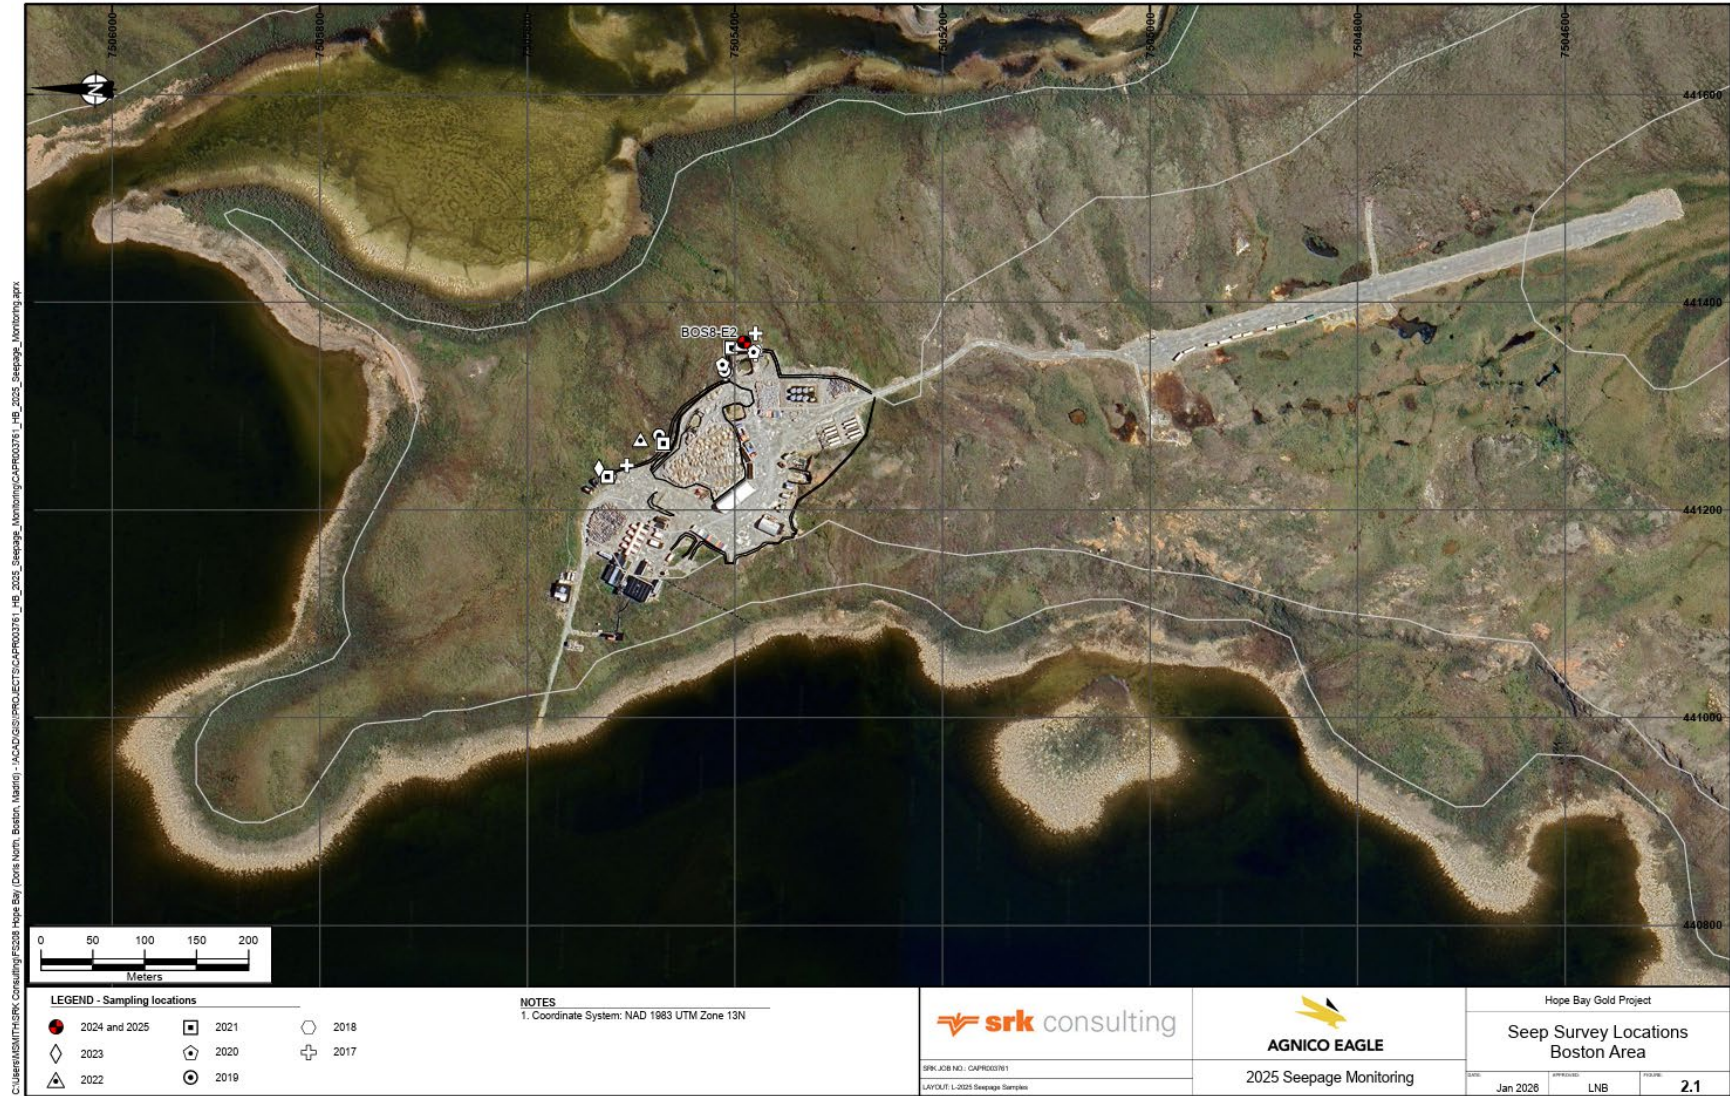
Figure 8-5: Boston (2BB-BOS1727) 2025 Seepage Survey Locations

The 2025 water quality samples had field and lab pH values ranging from 6.9 to 7.9, indicating that the drainage from the waste rock on the camp pad is not acidic. The samples indicated that concentrations for the parameters of concern were within the range of historic samples and/or stable with no indications of increasing trends. When compared to the model predictions, the 2025 monitoring data were within the acceptable range for all parameters.
