Whale Tail 2022 Fish Habitat Offset Monitoring Report

MEADOWBANK COMPLEX

2022 FISH HABITAT OFFSETS MONITORING REPORT

Prepared by: Agnico Eagle Mines Limited – Meadowbank Complex

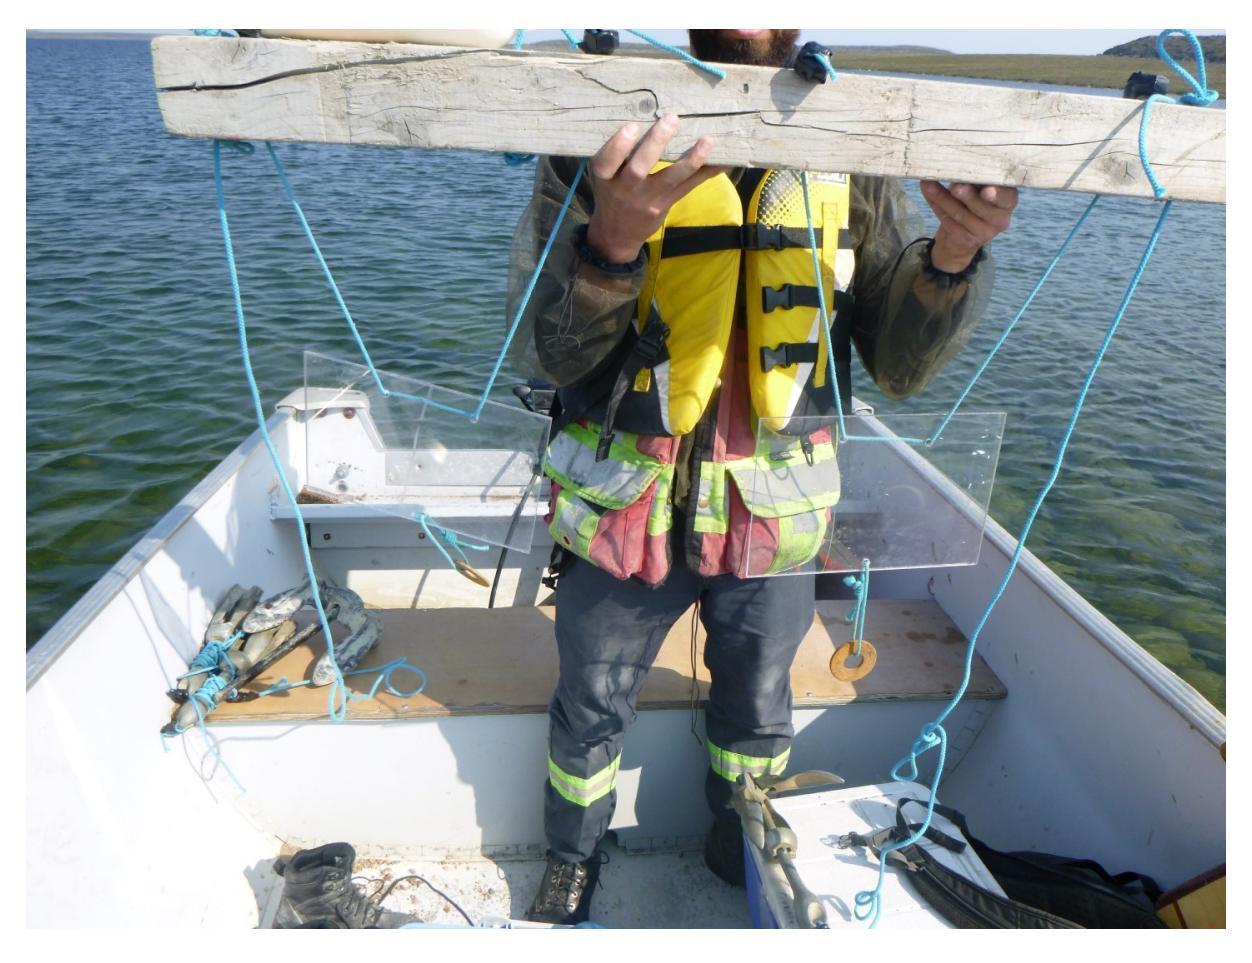
Artificial Substrate Samplers – Each periphyton sampler consisted of two Plexiglas slides (30.5 cm x 20.3 cm each) suspended side-by-side approximately 25 cm below a wood float, with supplemental rubber buoy. A metal weight (U-bolt or washer) was attached to each slide to help keep them suspended vertically in the water column (Figure 3).

Figure 3. Artificial substrate sampler for periphyton pilot study in 2022.

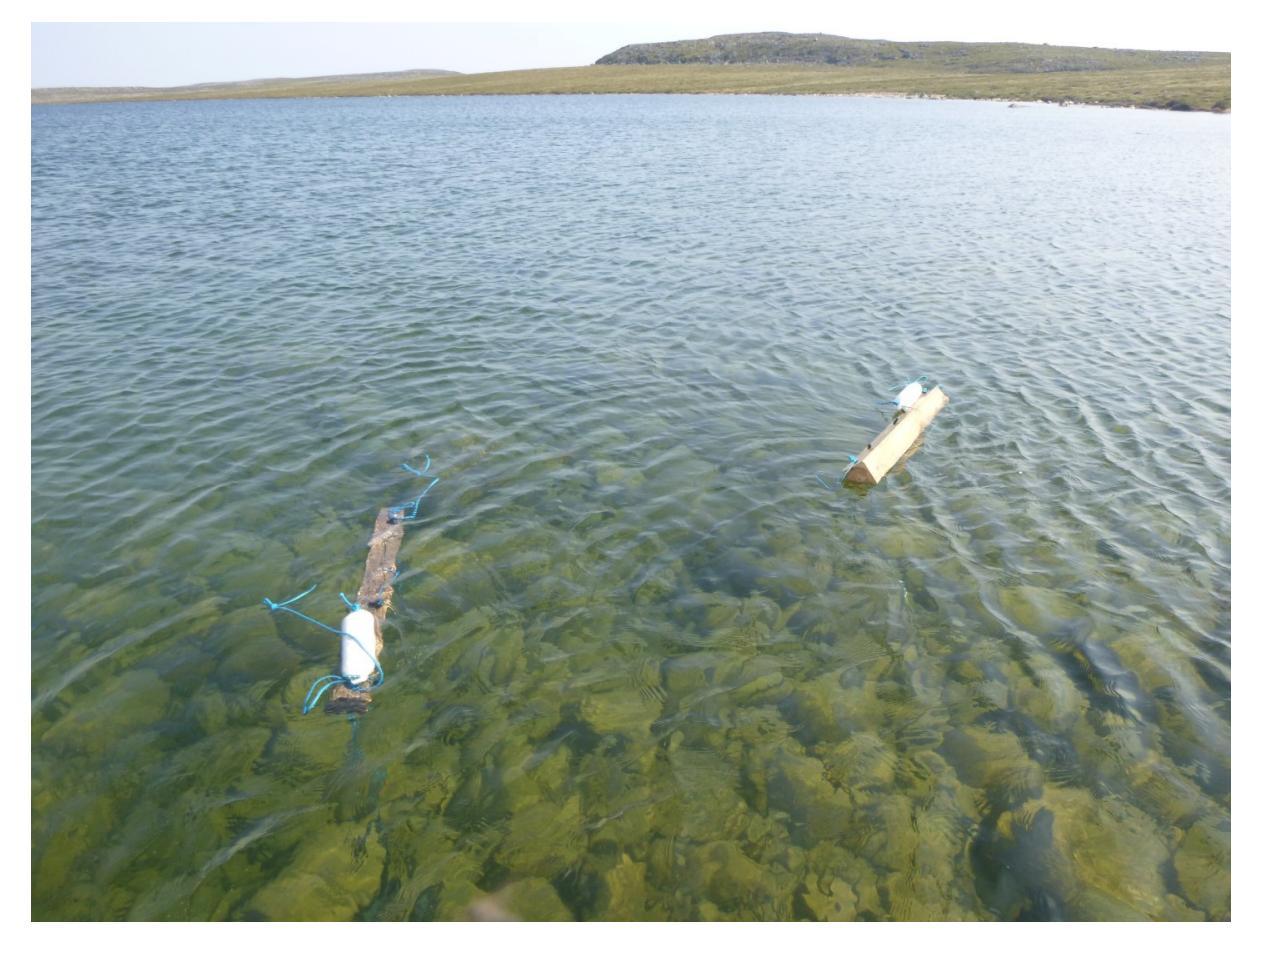
Sample Locations & Dates – For the 2022 study, two periphyton samplers, each holding two Plexiglas slides, were deployed at each monitoring station (Figures 1 & 2). Each sampler was deployed in a shoreline location in 1 - 2 m water depth and secured using two anchor weights affixed to the ends of the wood float (Figure 4).

Figure 4. Artificial substrate periphyton sampler in-situ.

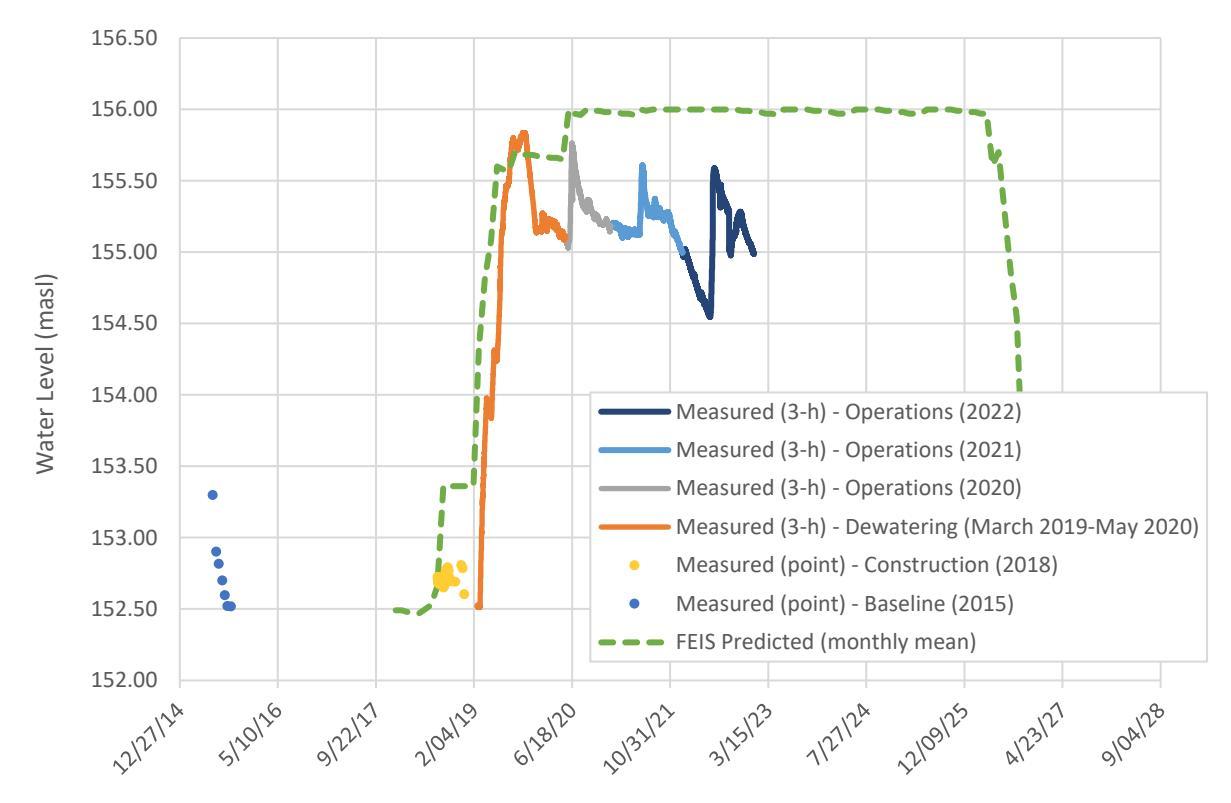
Figure 5. Measured and predicted water levels in the Whale Tail South flood zone (point measurement by GPS survey, 3-h interval by piezometer, or modeled monthly mean, as indicated). Predicted water levels from FEIS Addendum for the Whale Tail Pit Expansion Project, Appendix 6-O, Table D-14 (Agnico Eagle, 2018b).

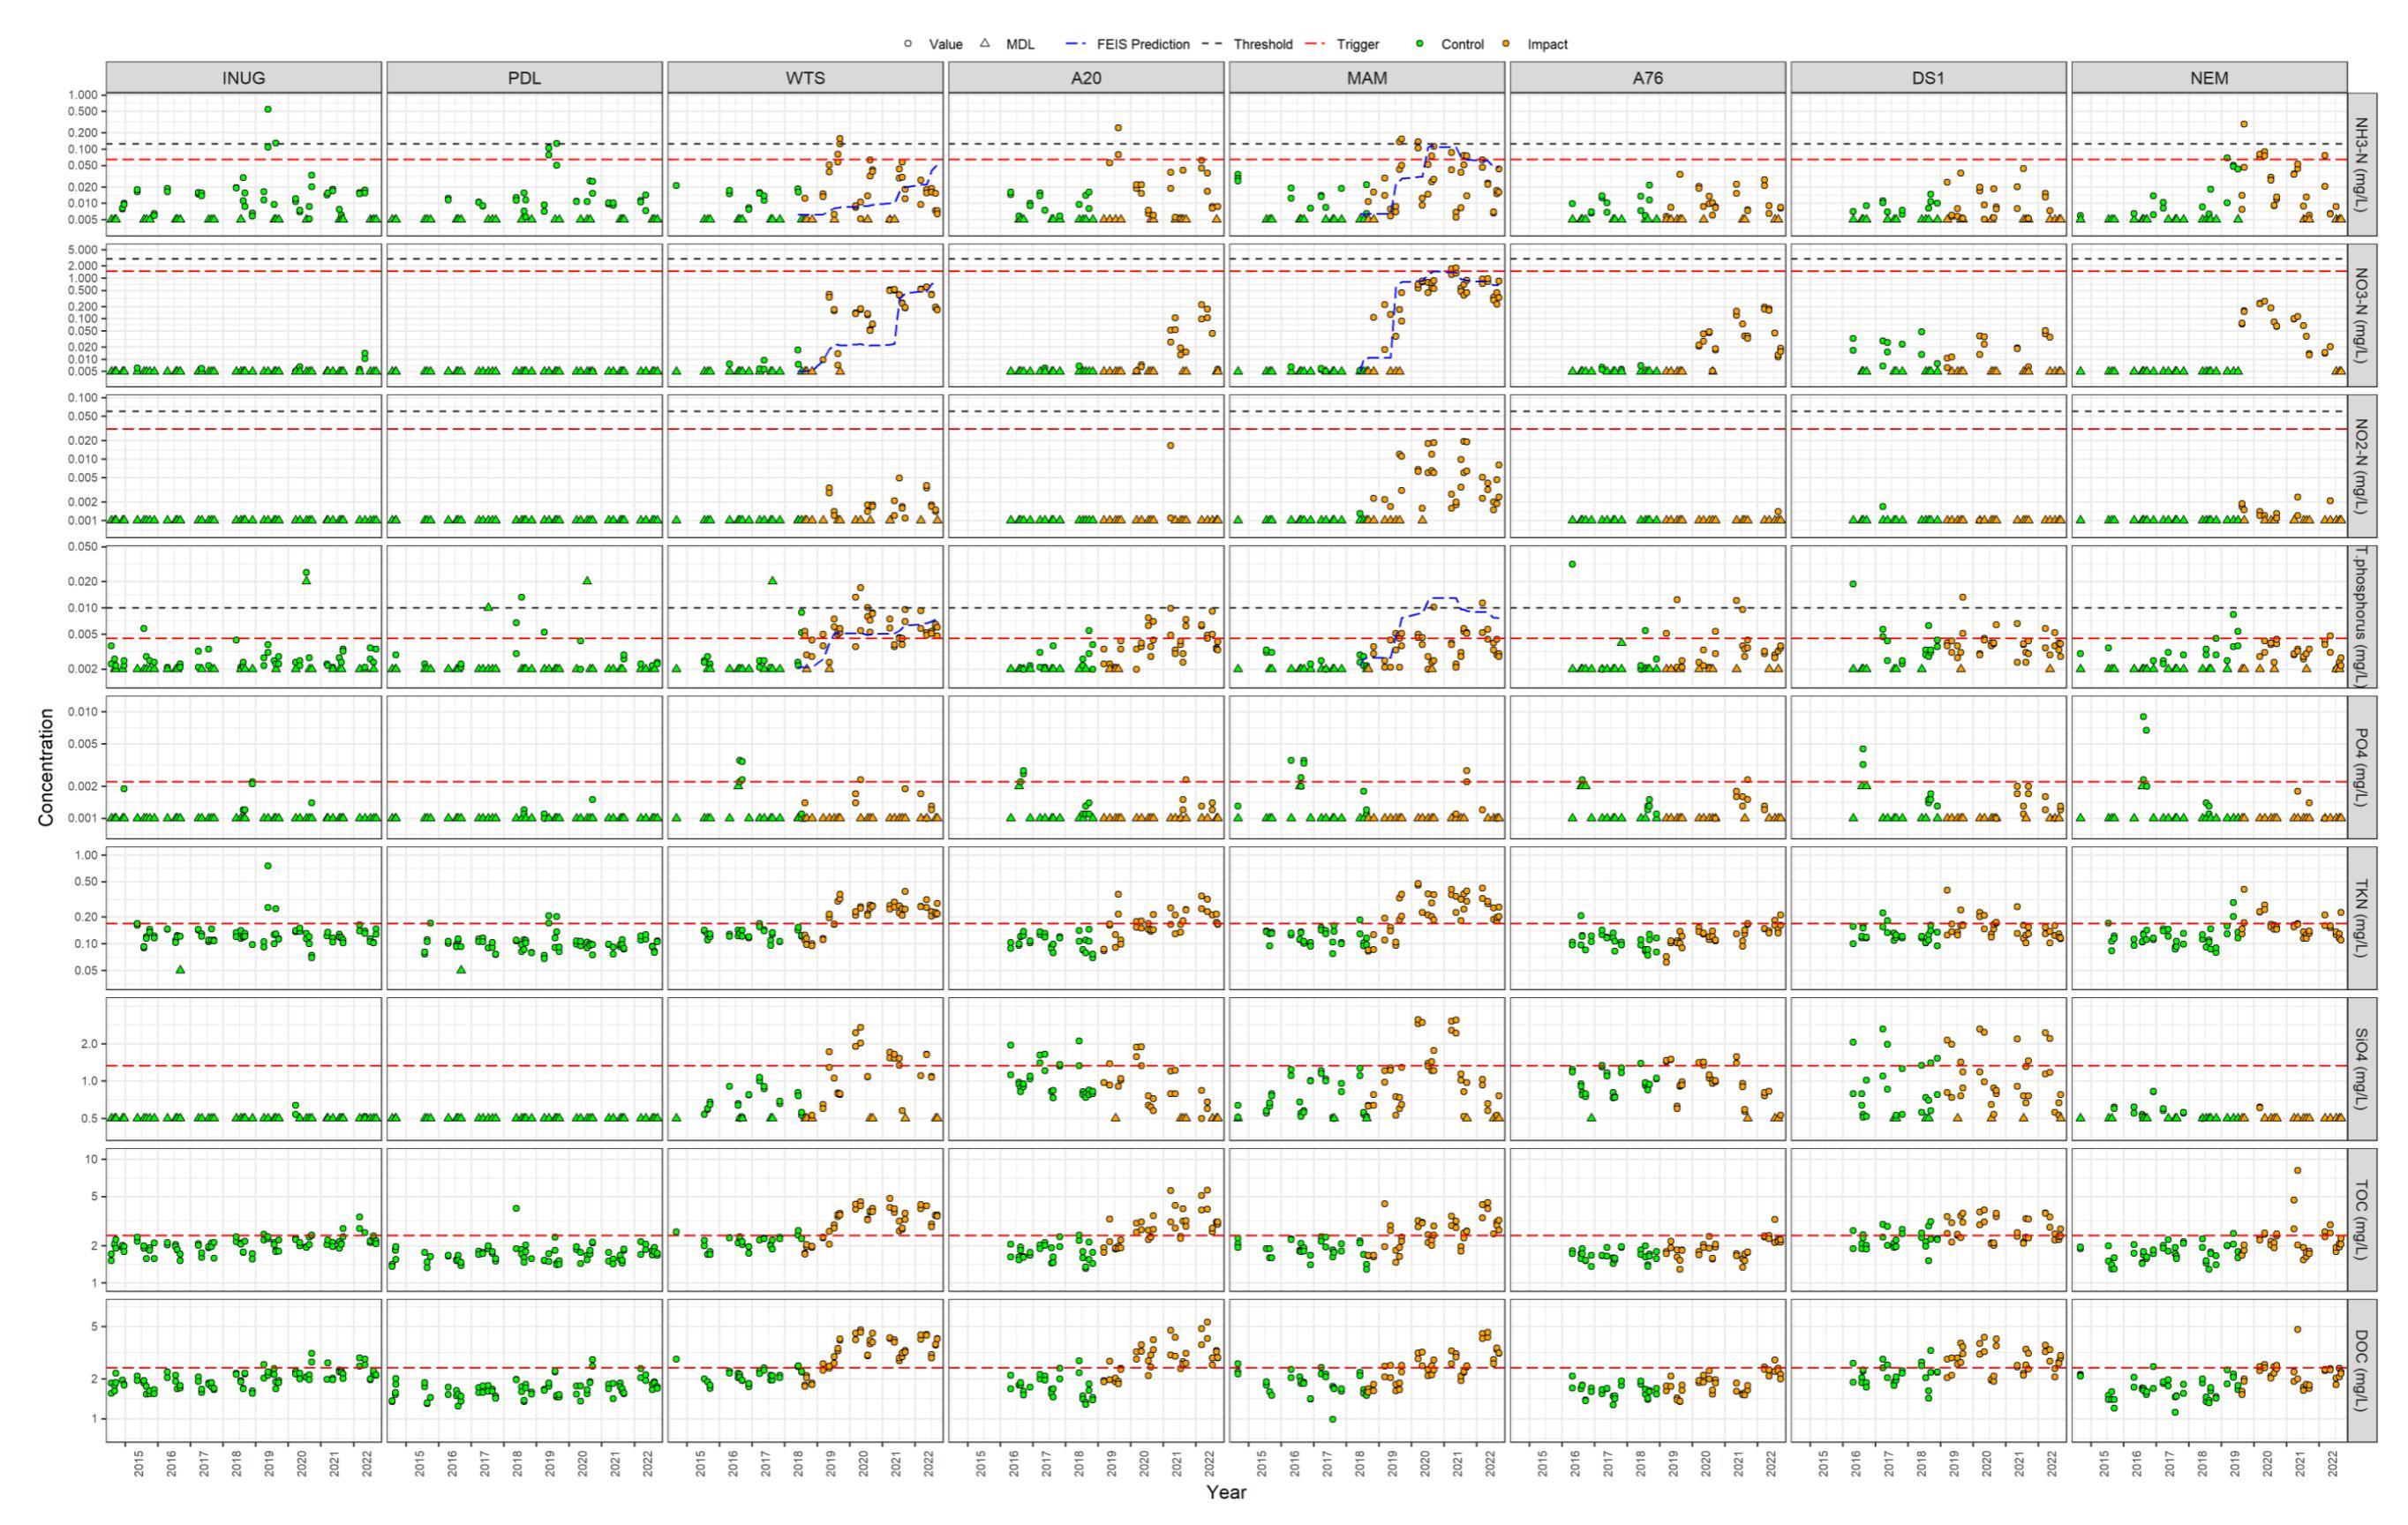
Similar to results seen over the years at the Meadowbank study lakes, these trends represent increases above baseline/reference conditions only; except for total phosphorus, none of these analytes have CCME effects-based guidelines for the protection of aguatic life and the observed changes are classified as "minor" according to the CREMP Adaptive Management Plan. While mine-related changes have occurred, changes are not expected to result in adverse effects to aquatic life. The one exception was mean annual total phosphorus at WTS and A20 which is classified as a moderate change because there were significant increases above the early warning trigger in 2022. The CREMP early warning trigger for total phosphorus is set at 0.004 mg/L, which is equivalent to the lower bound for oligotrophic lake classification (CCME, 2004), and is less than monthly FEIS predictions for the flood zone. FEIS-predicted (Agnico Eagle, 2018b) and measured concentrations of total phosphorus (and other nutrients) to date are shown in Figure 6. While some measured concentrations of phosphorus have exceeded monthly FEIS predictions in WTS, all were within an order of magnitude (the level of uncertainty assigned to these predictions in the FEIS), and measured concentrations have remained within predicted trophic levels to date. According to the FEIS, phosphorus and nitrate levels are predicted to increase in WTS until 2026, after which time concentrations are predicted to decline.

Figure 6. Nutrient parameters measured in Whale Tail Mine area lakes since 2014. Blue dashed line indicates FEIS Addendum model prediction. Figure from Azimuth (2023).

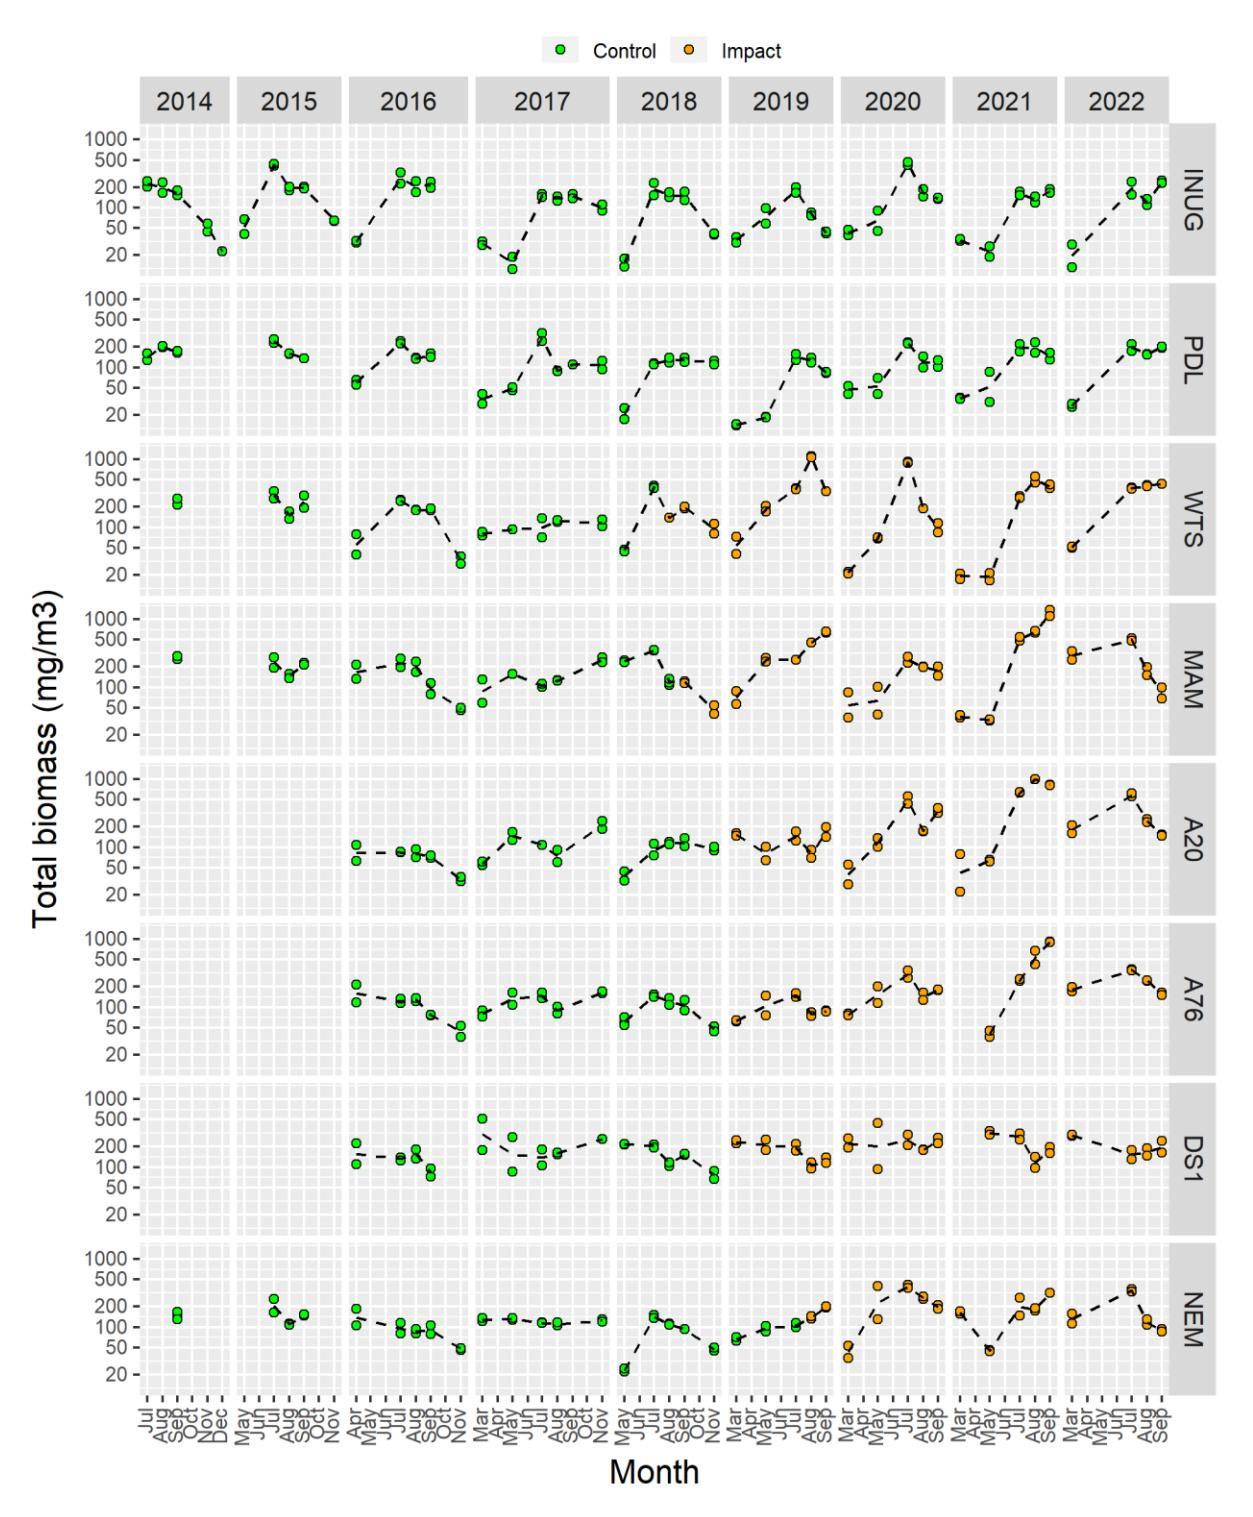
Under the CREMP, phytoplankton community sampling is also conducted at the same time as the water chemistry program. Though changes in phytoplankton biomass or species richness compared to baseline/reference in 2022 were not statistically significant due to high variability, effect sizes for biomass at FHOMP lakes WTS and A20 (along with other near-field lakes) exceeded the 20% trigger. These results follow an apparent but not always statistically significant increases in biomass from 2019 – 2021 (Figure 7). This increase in lower trophic level production was predicted in the FEIS Addendum, but not quantified (Agnico Eagle, 2018b).

Figure 7. Total phytoplankton biomass (mg/m³) from the Whale Tail Mine study lakes since 2015. Figure from Azimuth (2023).

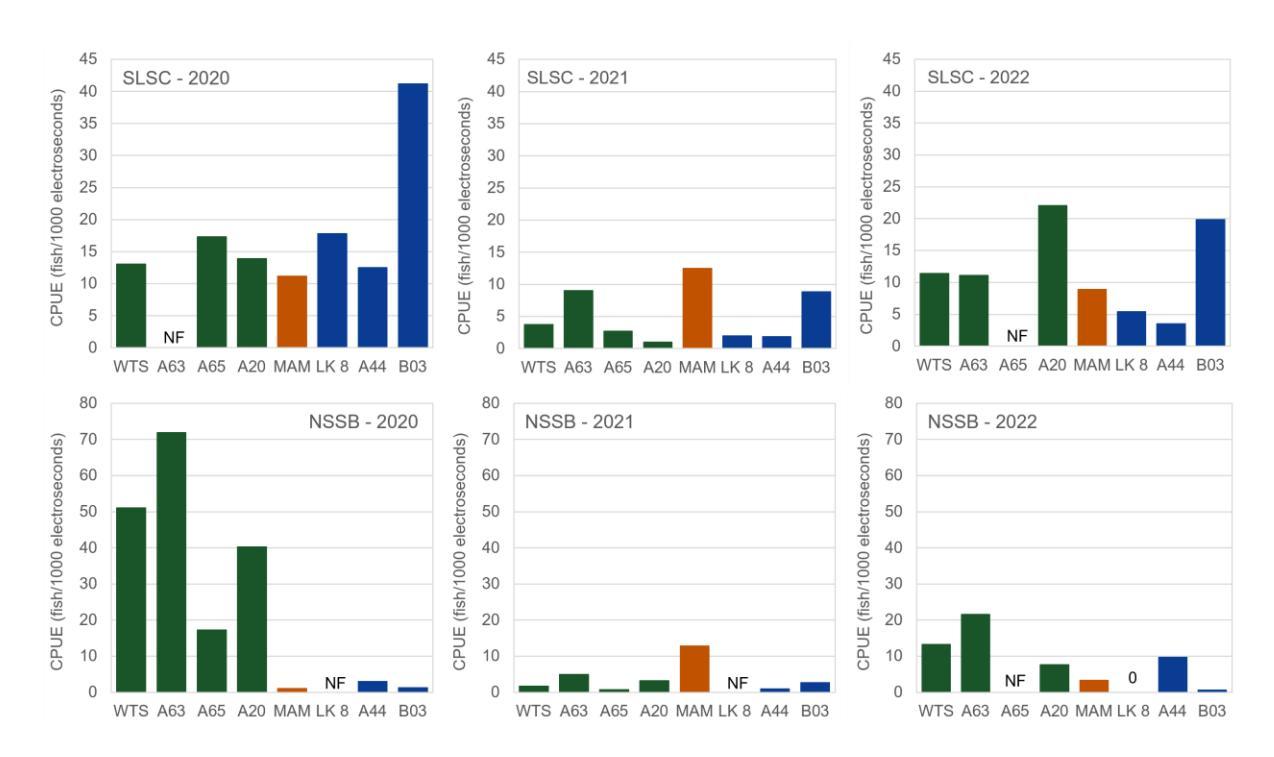
Total catch of fish captured through backpack electrofishing of shoreline habitat annually since 2020 is provided in Table 6, and catch-per-unit effort is shown in Figure 8. It is noted that total catch was greater in 2020 since additional fish were captured for research purposes.

Figure 8. Catch per unit effort of Slimy Sculpin and Ninespine Stickleback collected from 2020 - 2022 in the study lakes (green = flooded, orange = downstream, blue = reference). NF = not fished.

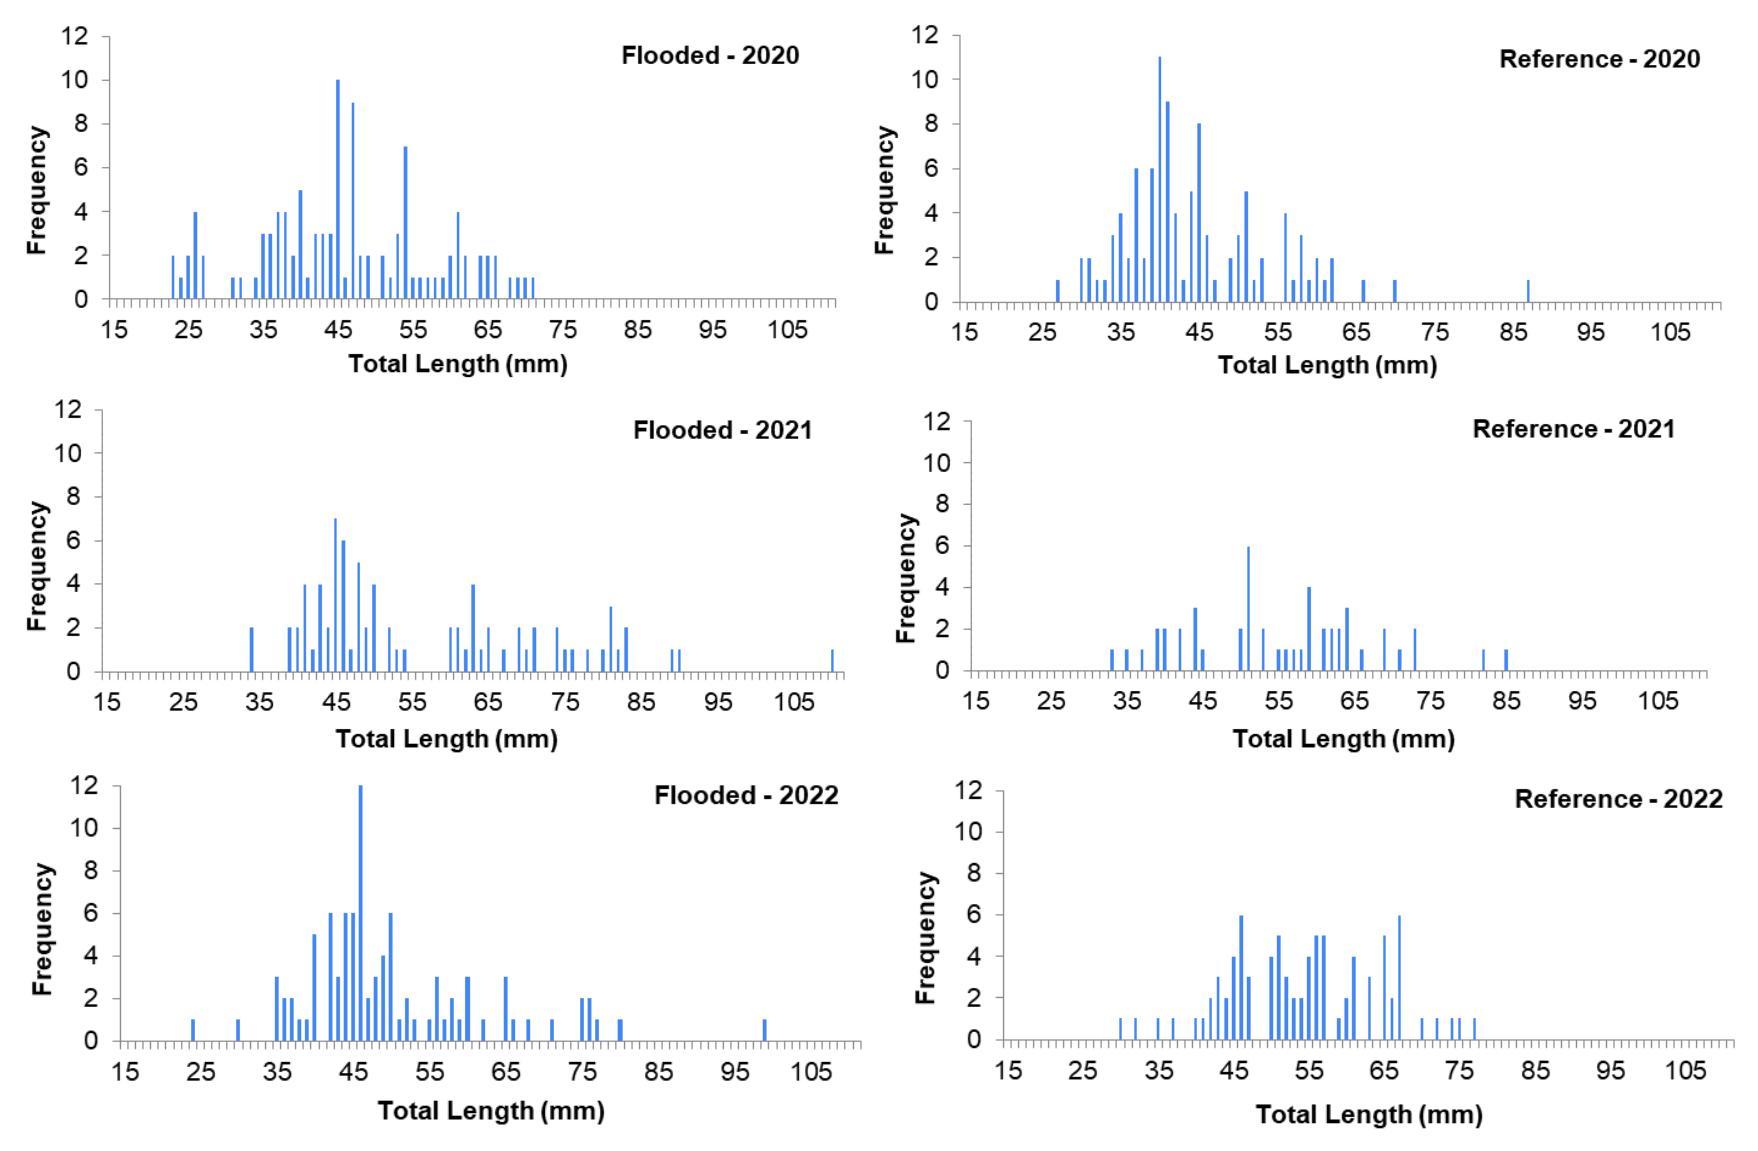
Length-frequency distributions for Slimy Sculpin and Ninespine Stickleback are provided in Figures 9 and 10. Though relatively few Ninespine Stickleback were captured in reference lakes until 2022, length-frequencies with sufficient data appear normally distributed each year for both flood and reference lakes. These data will be further analyzed in 2023 for the final data report, but suggest that population structure, growth, and recruitment of fish within flood zone populations are not substantially different from reference lake populations.

Figure 9. Length-frequency distributions for Slimy Sculpin collected in flooded lakes (WTS, A20, A63, A65) and reference lakes (A44, B3, Lake 8).

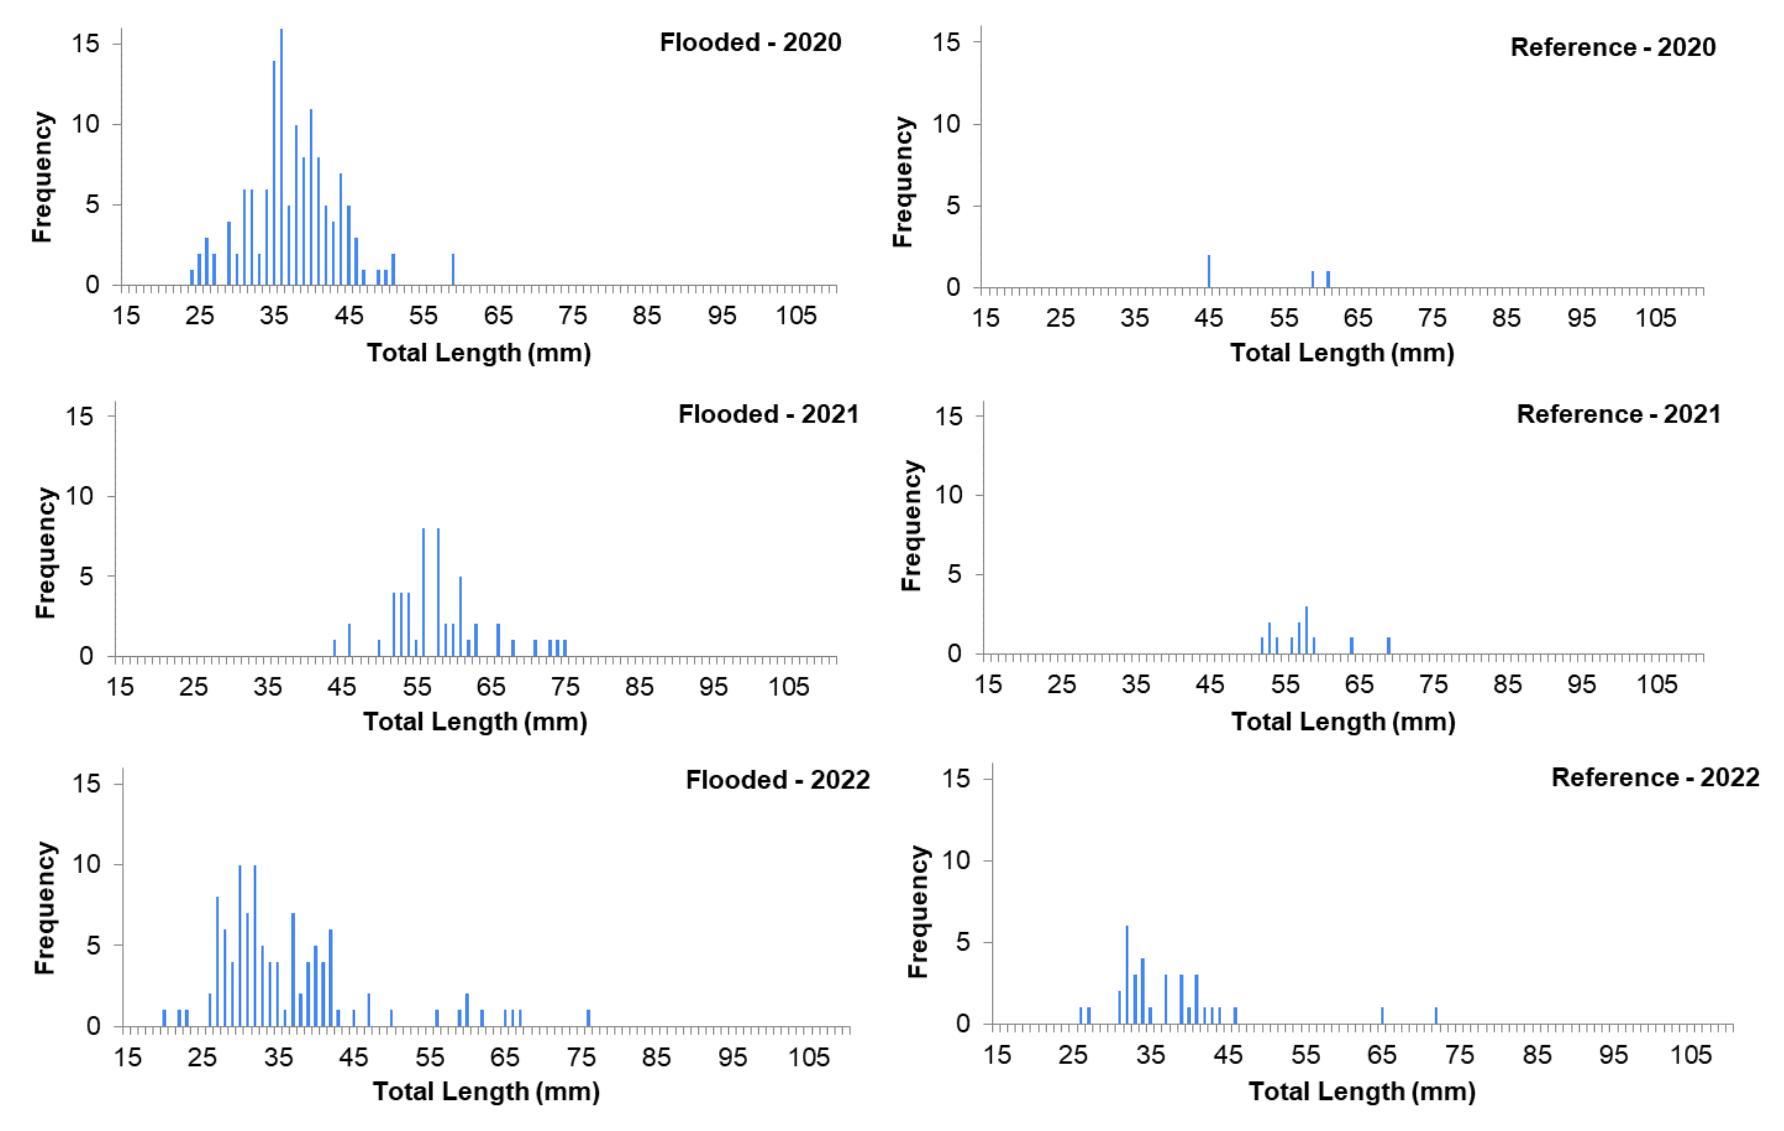
Figure 10. Length-frequency distributions for Ninespine Stickleback collected in flooded lakes (WTS, A20, A63, A65) and reference lakes (A44, B3, Lake 8).
3.2 COMPLEMENTARY MEASURES

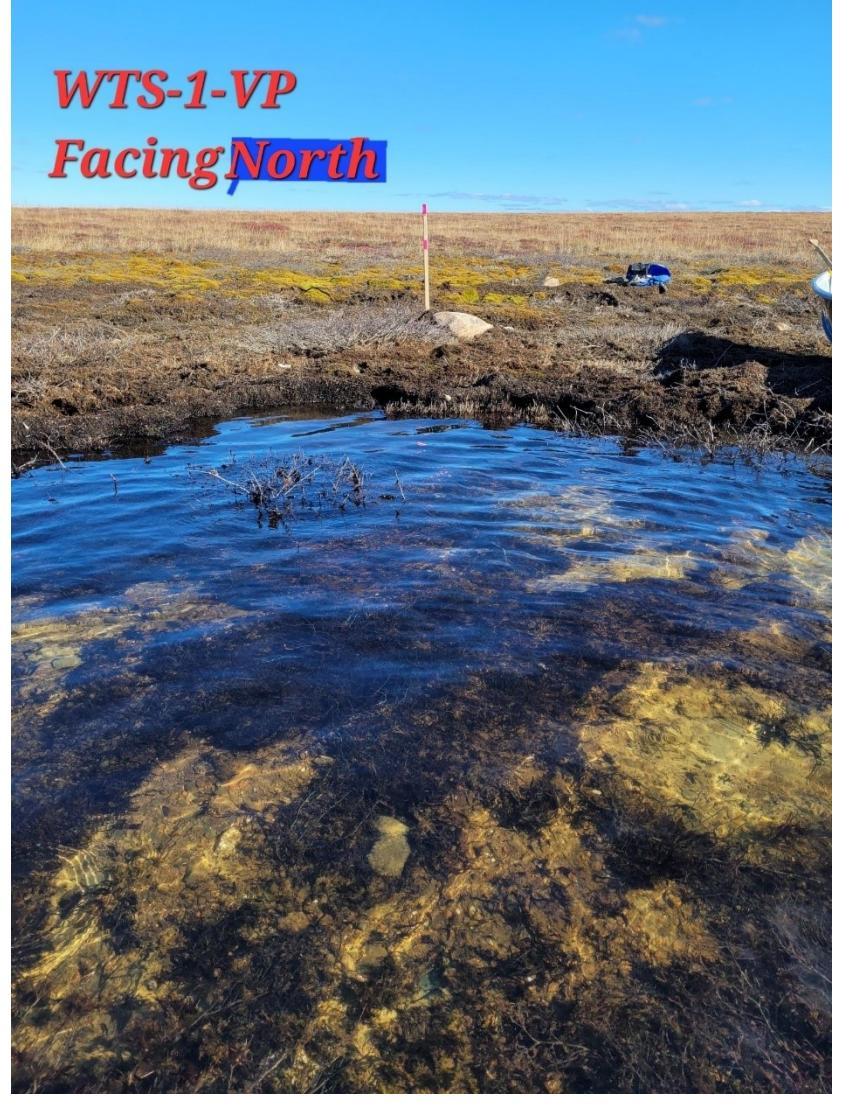
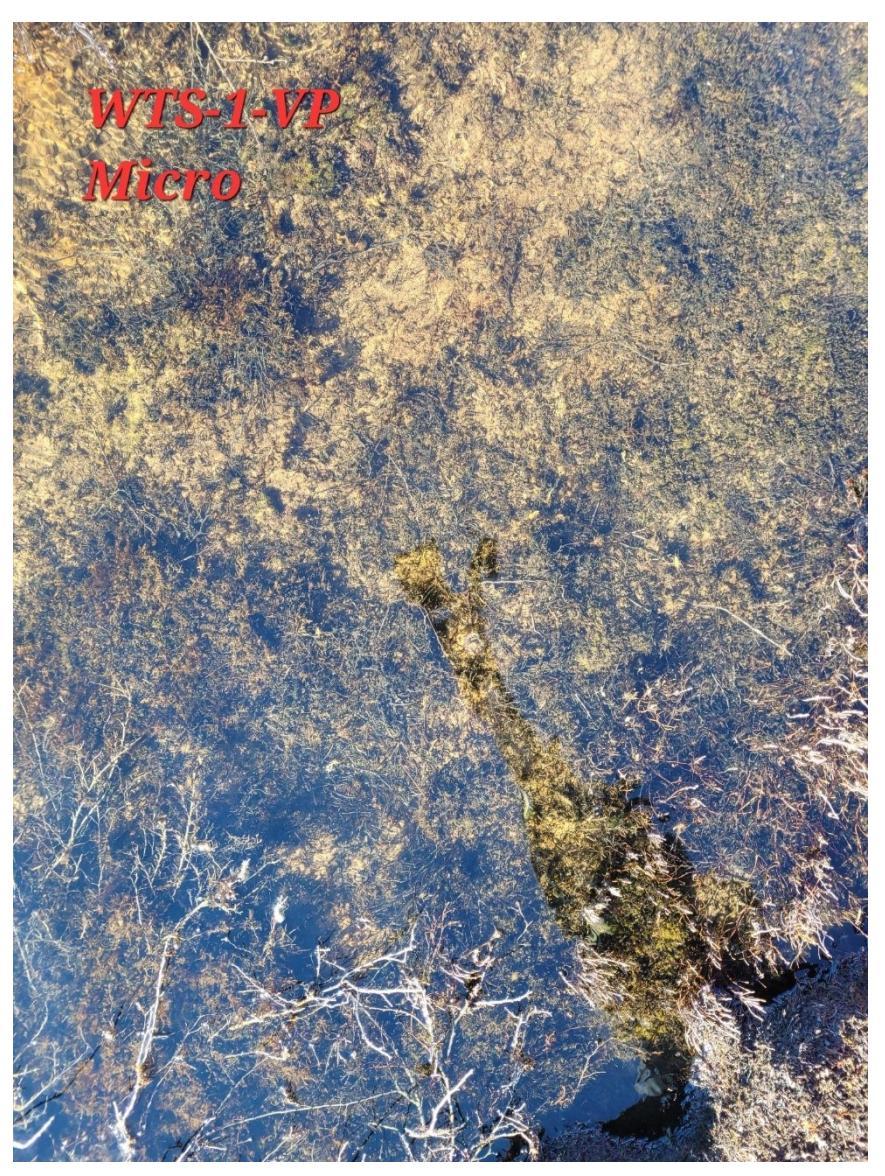
App A - Figure 1. Periphyton station WTS-VP-1 in 2022.

| Date/Time: | 2022-09-03 (15:53) | Initials: | EL LA KM | |
|--|--|---|---|--|
| Colour (e.g. brown, olive, bright green): | Brown | Organic matter (e.g. decaying plants in flooded terrestrial zone) | 80 | |

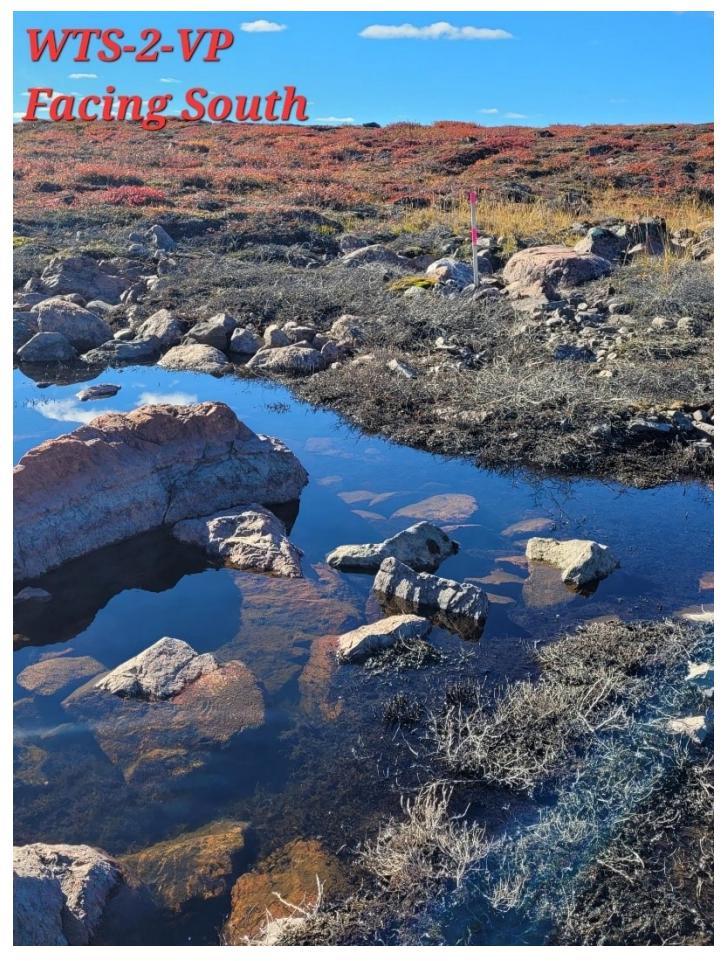
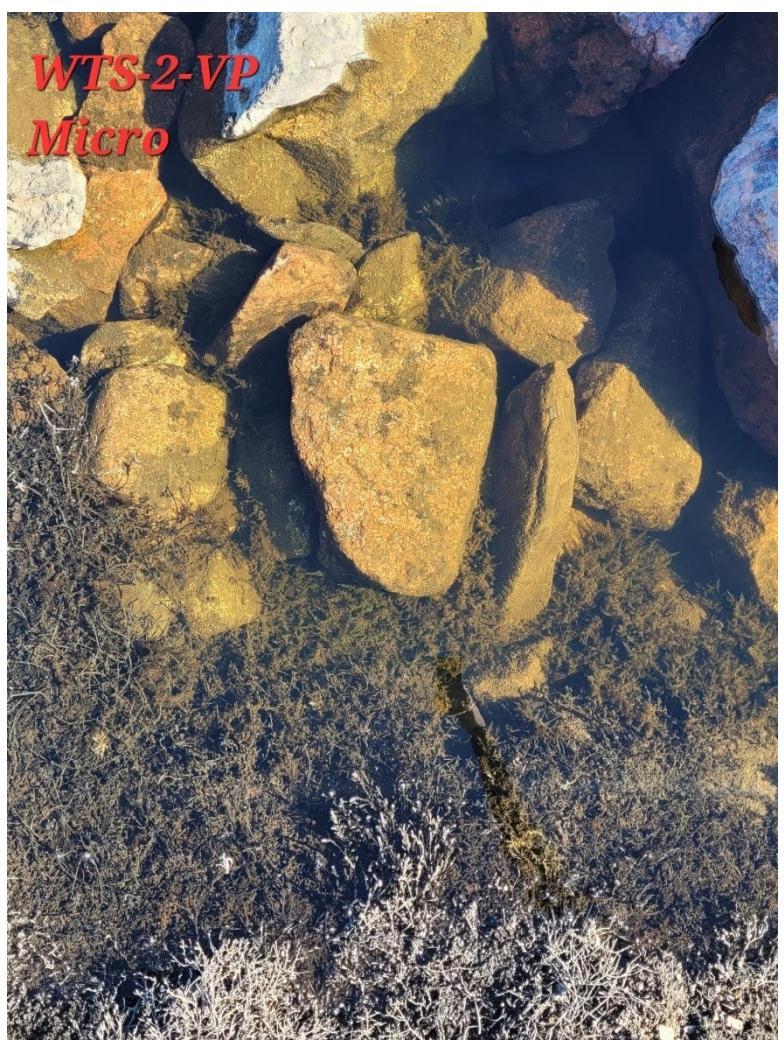
App A - Figure 3. Periphyton station WTS-VP-2 in 2022

| Date/Time: | 2022-09-03 (15:35) | Initials: | LA EL KM | | |
|--|--|---|---|--|--|
| Colour (e.g. brown, olive, bright green): | Brown | Organic matter (e.g. decaying plants in flooded terrestrial zone) | 15 | | |

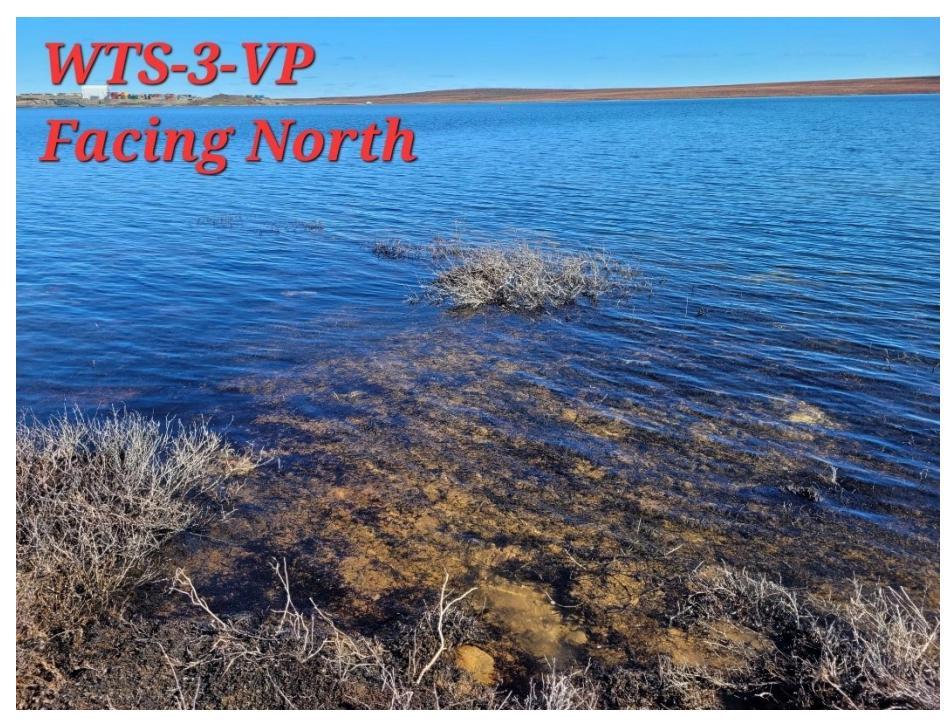
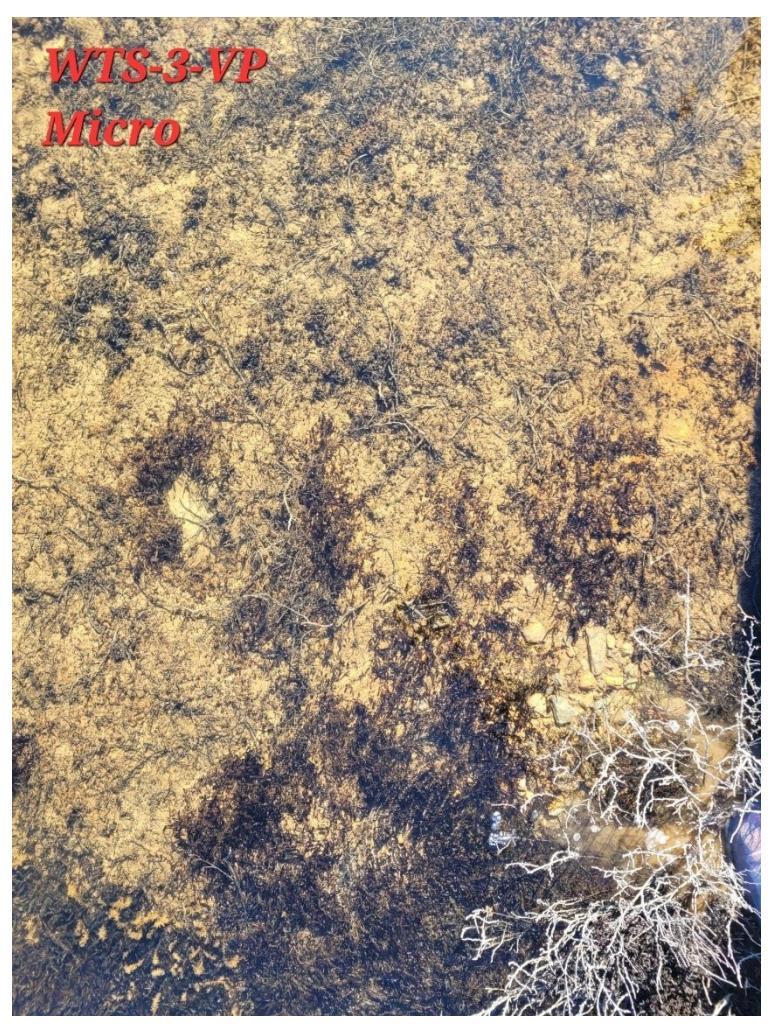
App A - Figure 5. Periphyton station WTS-VP-3 in 2022

| Date/Time: | 2022-09-03 (14:38) | Initials: | LA EL KM | |
|--|---|---|---|--|
| Colour (e.g. brown, olive, bright green): | N/A | Organic matter (e.g. decaying plants in flooded terrestrial zone) | 45 | |

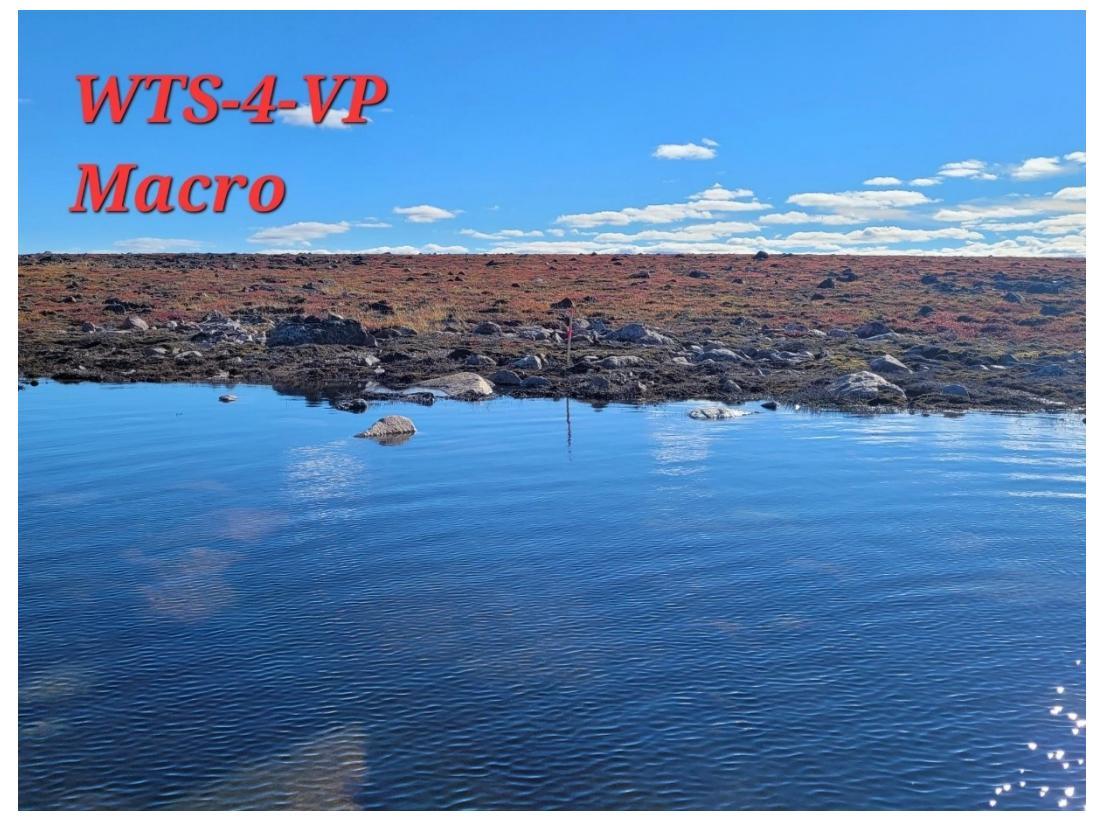
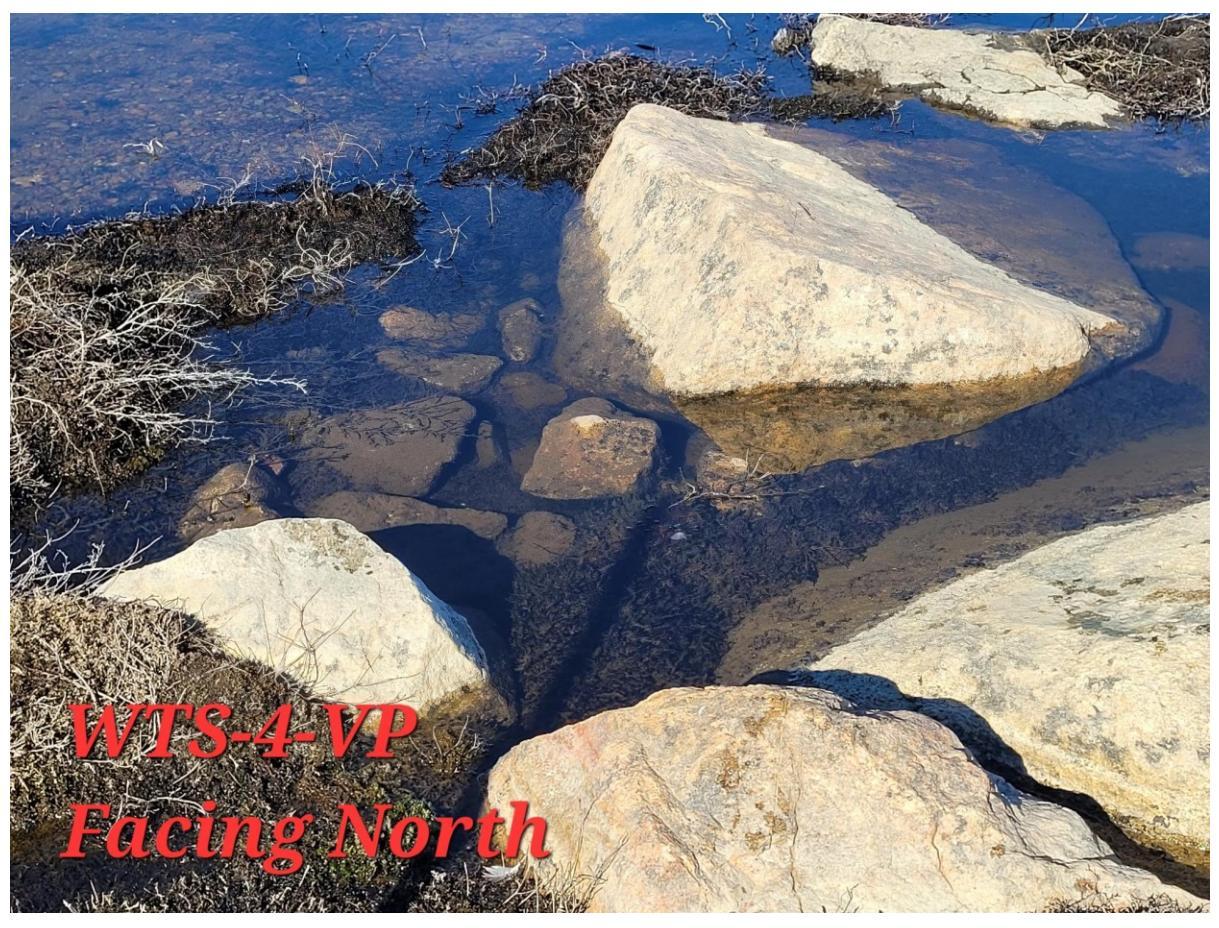
App A - Figure 7. Periphyton station WTS-VP-4 in 2022

| Date/Time: | 2022-09-02 (15:15) | Initials: | EL KM LA | |
|--|---|---|---|--|
| Colour (e.g. brown, olive, bright green): | Brown | Organic matter (e.g. decaying plants in flooded terrestrial zone) | 10 | |
