Whale Tail 2022 Fish Habitat Offset Monitoring Report

MEADOWBANK COMPLEX

2022 FISH HABITAT OFFSETS MONITORING REPORT

Prepared by: Agnico Eagle Mines Limited – Meadowbank Complex

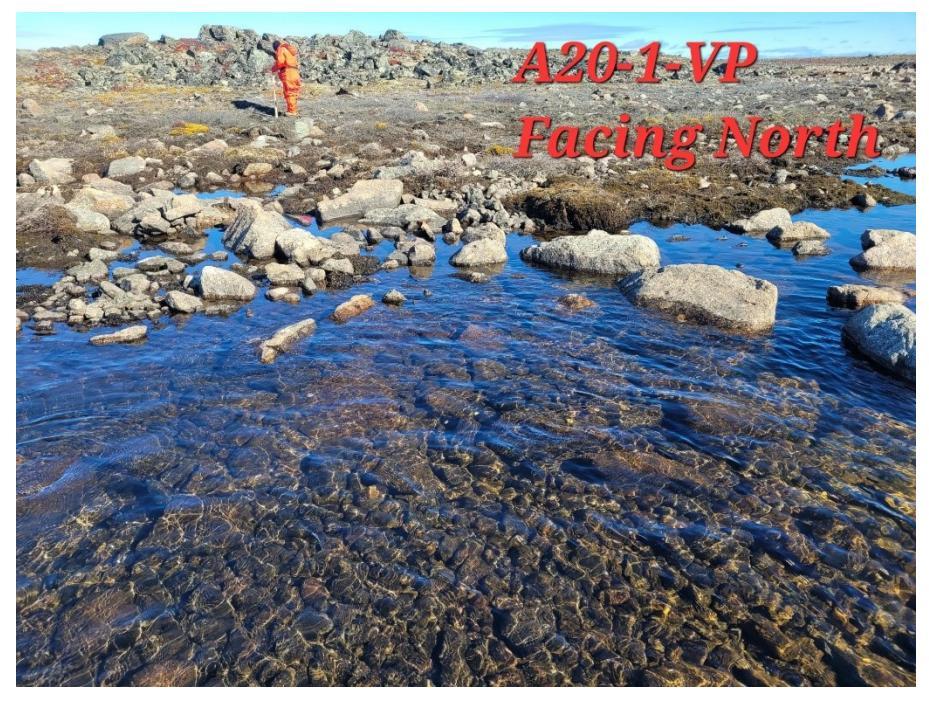
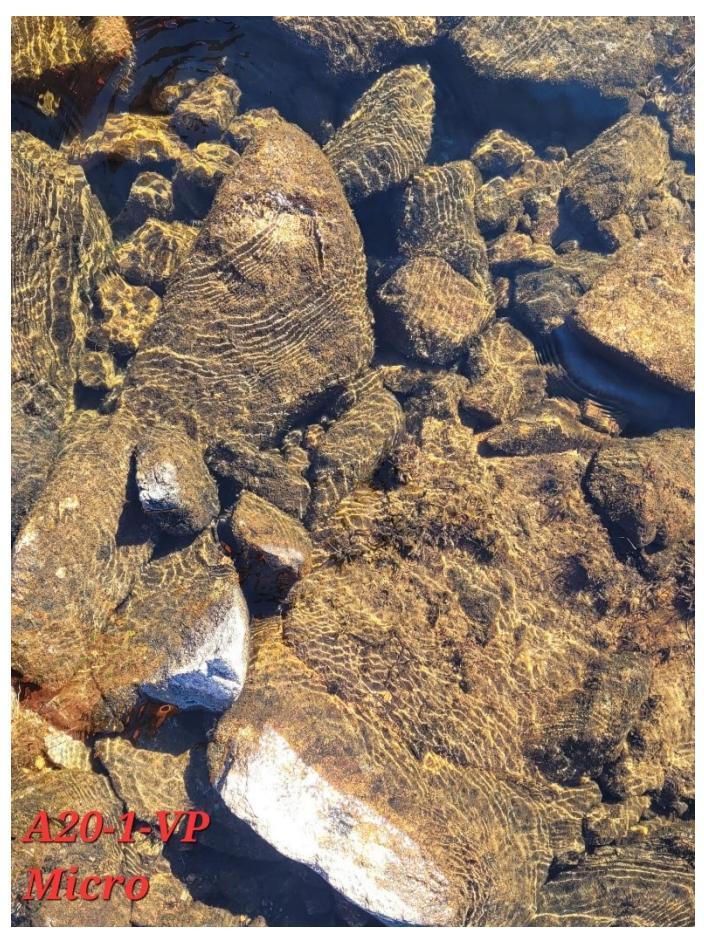
App A - Figure 9. Periphyton station A20-VP-1 in 2022

| Date/Time: | 2022-09-02 (11:56) | Initials: | LA, EL, KM | |
|--|---|---|---|--|
| Colour (e.g. brown, olive, bright green): | Brown | Organic matter (e.g. decaying plants in flooded terrestrial zone) | 5 | |

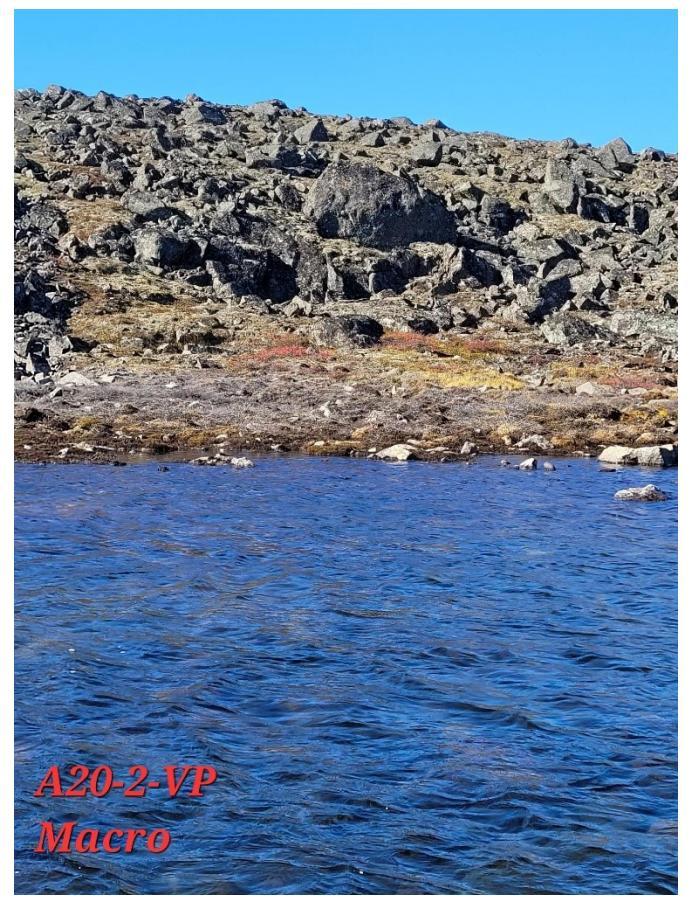
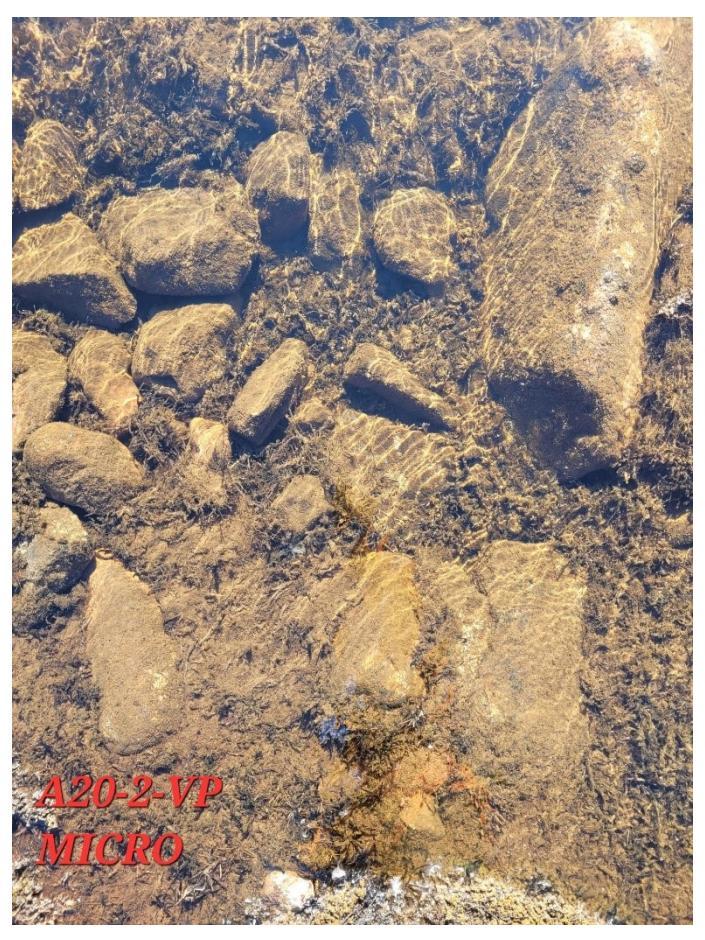
App A - Figure 11. Periphyton station A20-VP-2 in 2022

| Date/Time: | 2022-09-02 (11:06) | Initials: | LA, EL, KM | | |
|--|---|---|---|--|--|
| Colour (e.g. brown, olive, bright green): | Brown | Organic matter (e.g. decaying plants in flooded terrestrial zone) | 60 | | |

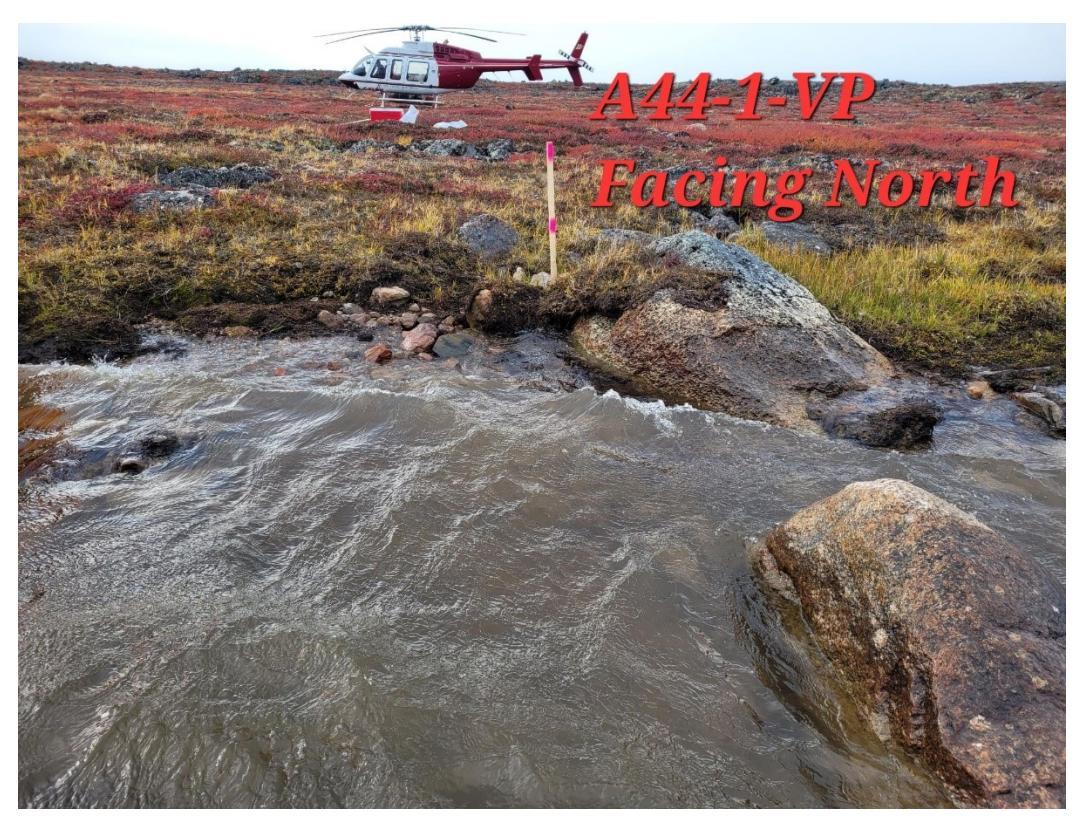
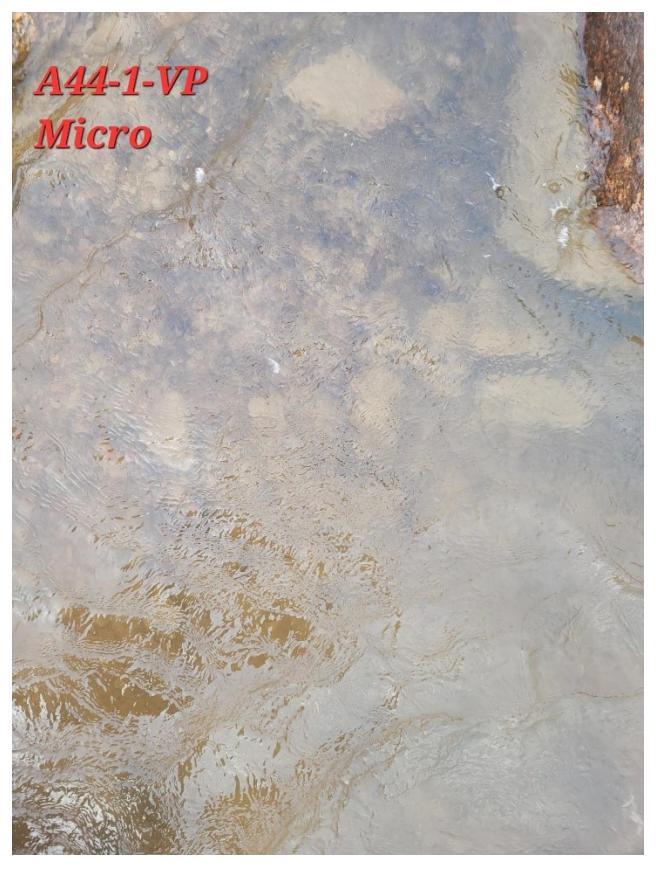
App A - Figure 13. Periphyton station A44-VP-1 in 2022.

| Date/Time: | 2022-09-05 (13:00) | Initials: | EL/LA/KM | | |
|---|---|---|---|--|--|
| Colour (e.g. brown, olive, bright green): | Brown/ beige | Organic matter (e.g. decaying plants in flooded terrestrial zone) | 5 | | |
| Other Notes (e.g. water clarity, variation, ice scour):Macro: _131021 Facing North: _130655 Facing South: _130859Windy conditions (35-50kmh-SE) water is turbid along this northern shoreline. The filter was visibly more saturated with solids than usual.Macro: _131021 Facing North: _130655 Facing South: _130859 Example of periphyton cover: _130752 | | | | | |

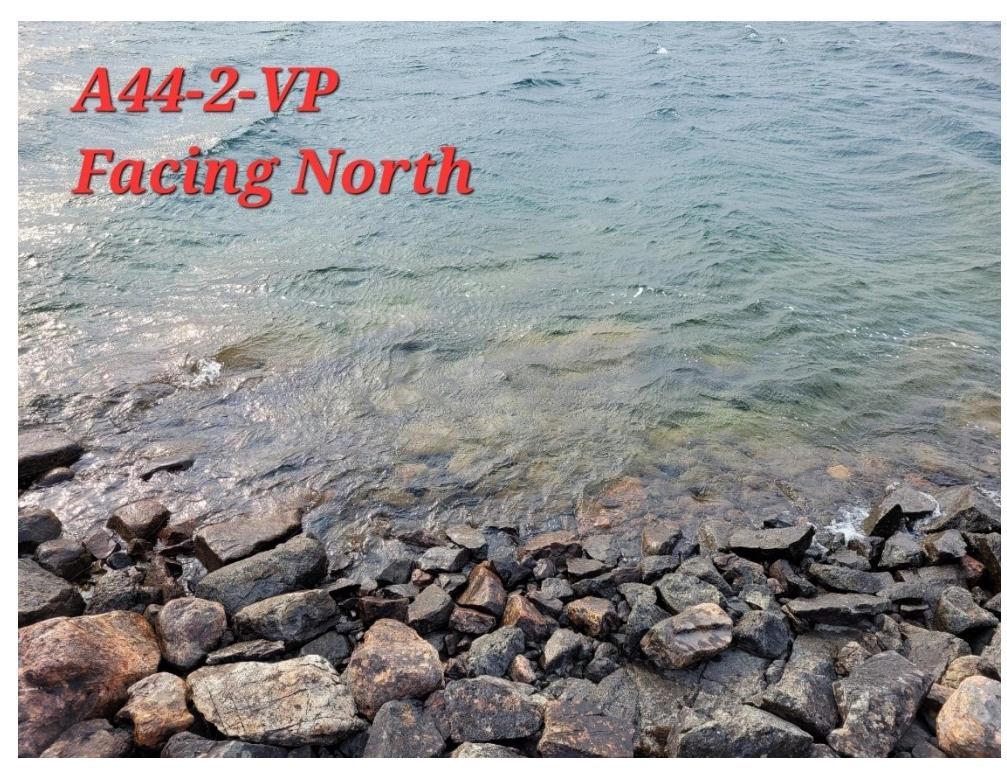
App A - Figure 15. Periphyton station A44-VP-2 in 2022.

| Date/Time: | 2022-09-05 (13:40) | Initials: | EL/LA/KM | |
|---|---|---|---|--|
| Colour (e.g. brown, olive, bright green): | Light brown | Organic matter (e.g. decaying plants in flooded terrestrial zone) | 0 | |

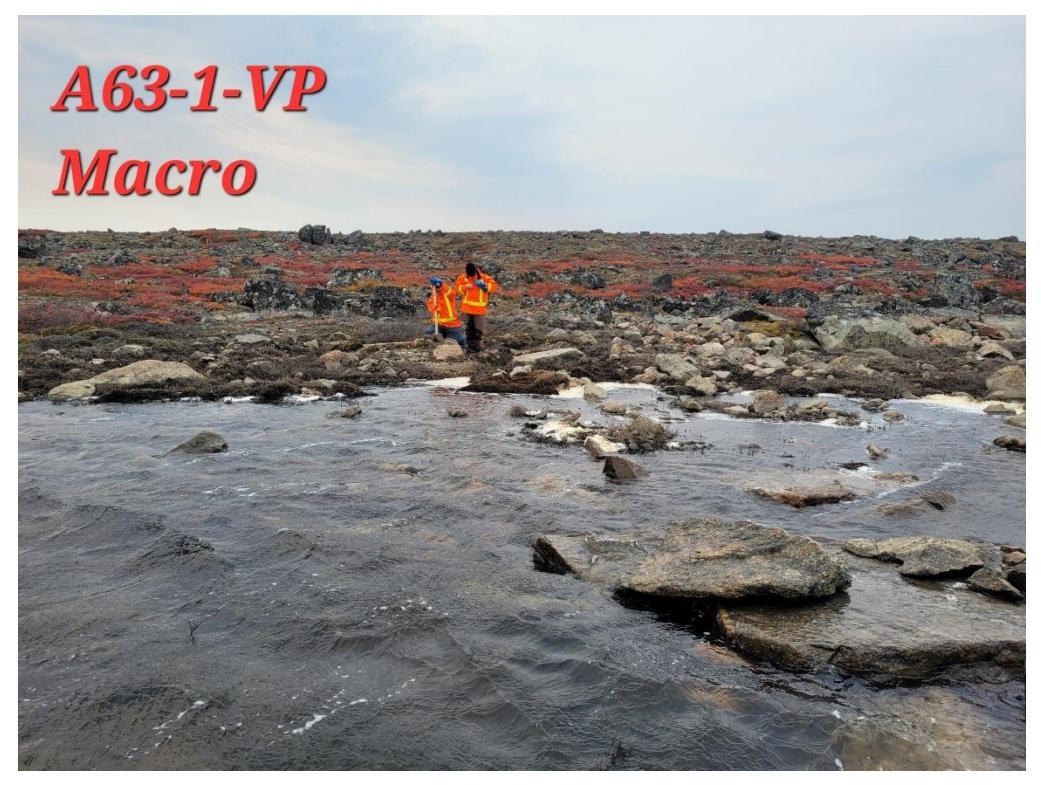
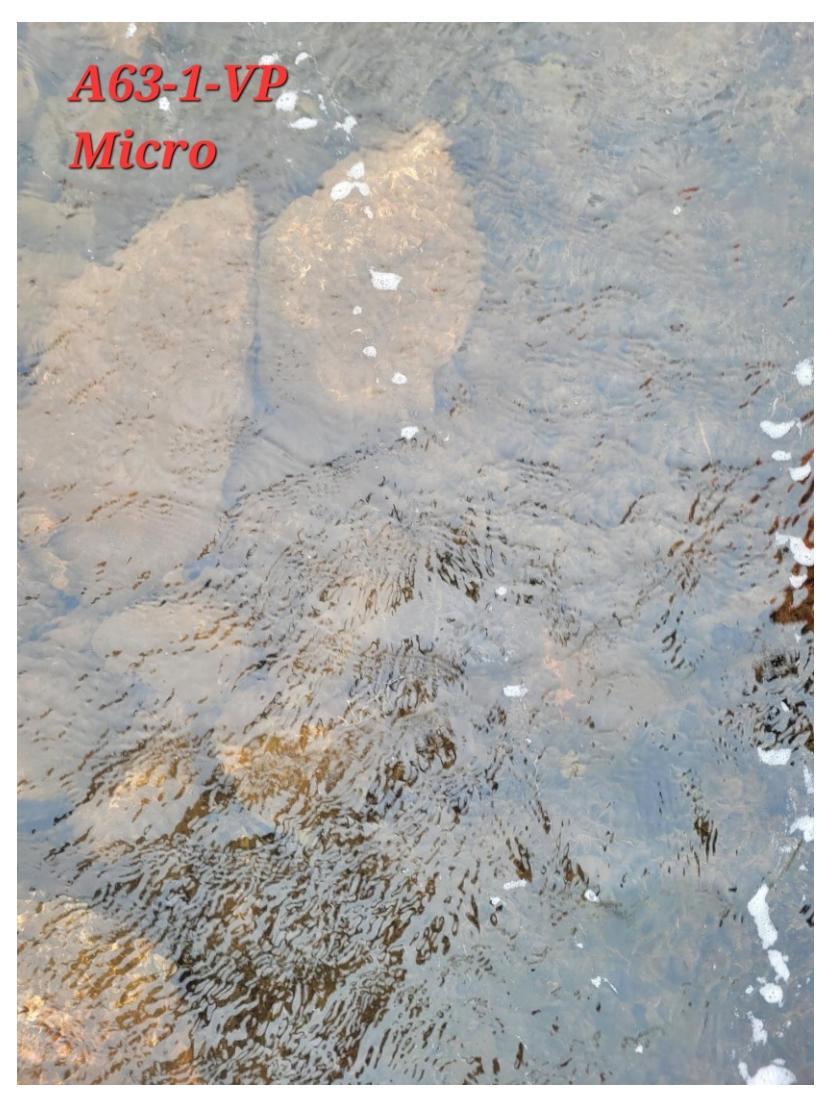
App A - Figure 16. Periphyton station A63-VP-1 in 2022.

| Date/Time: | 2022-09-05 (14:00) | Initials: EL/LA/KM | | |
|---|---|---|---|--|
| Colour (e.g. brown, olive, bright green): | brown | Organic matter (e.g. decaying plants in flooded terrestrial zone) | 15 | |

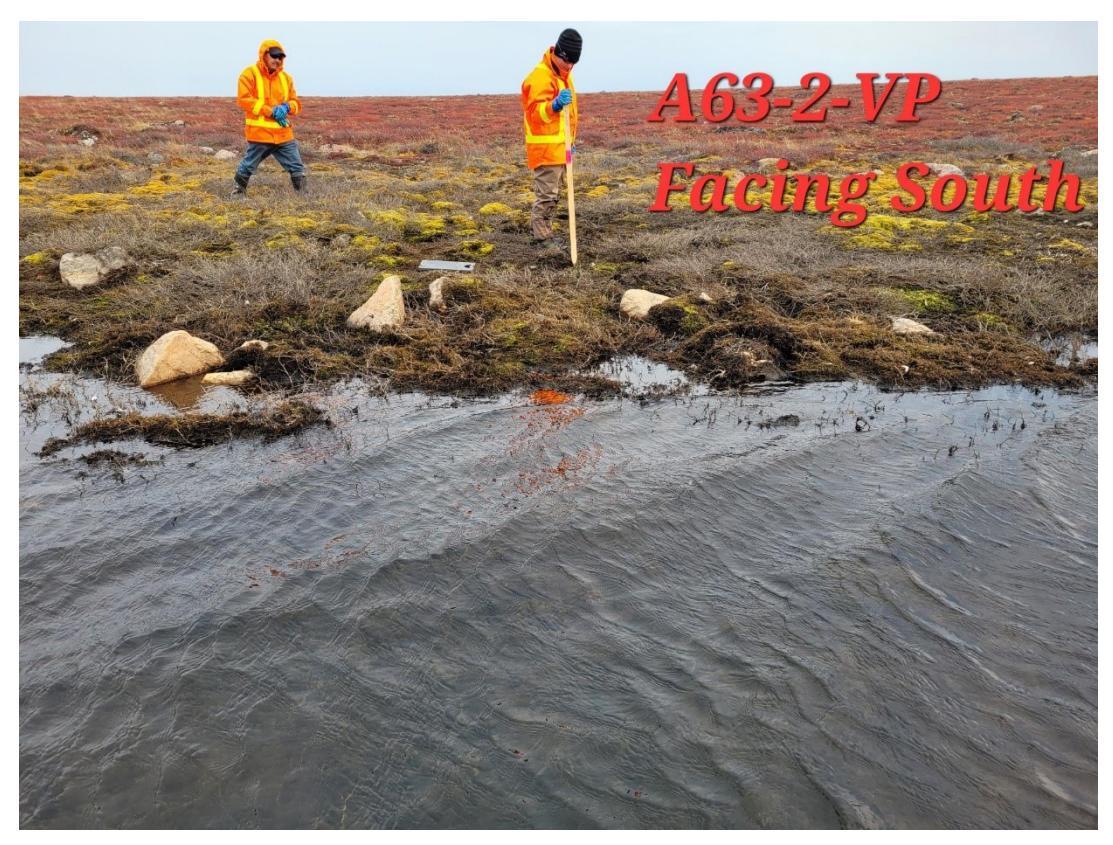
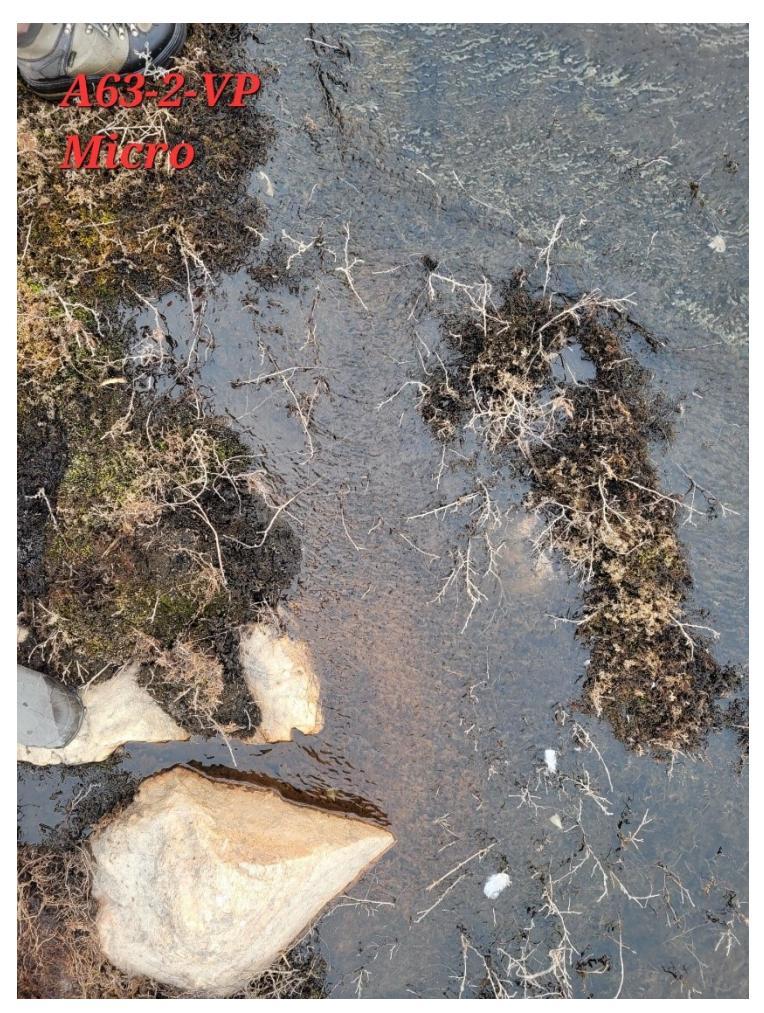
App A - Figure 18. Periphyton station A63-VP-2 in 2022.

| Date/Time: | 2022-09-05 (14:17) | Initials: EL/LA/KM | |
|--|---|--|---|
| Colour (e.g. brown, olive, bright green): | brown | Organic matter (e.g. decaying plants in flooded terrestrial zone) | 90 |

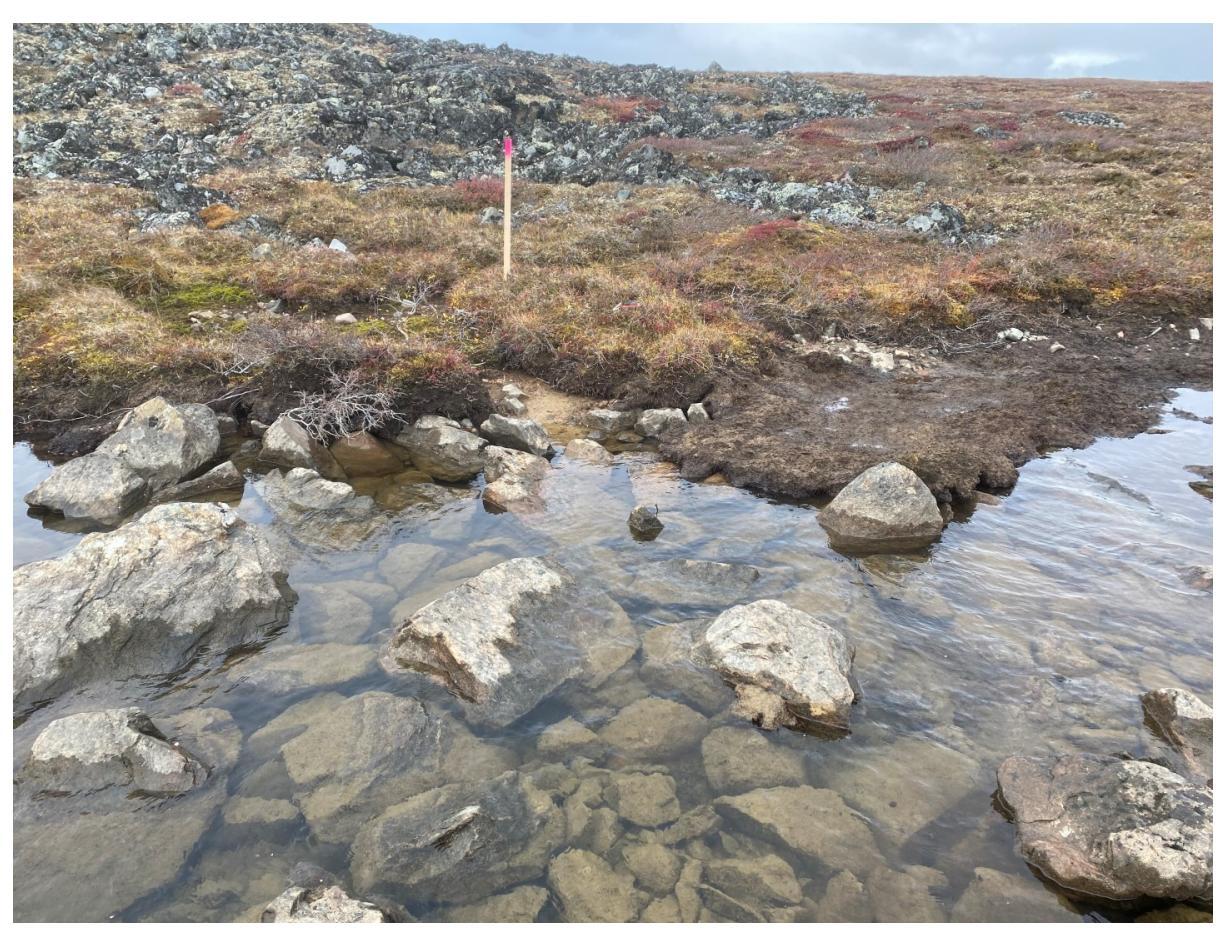
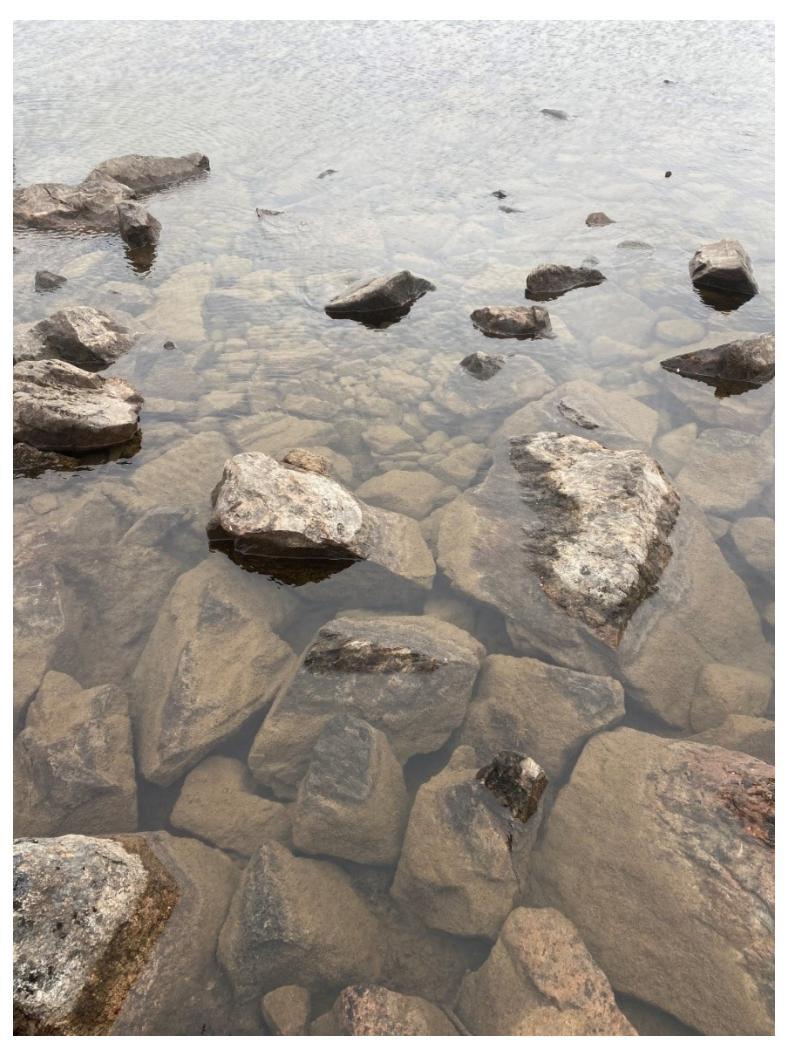
App A - Figure 20. Periphyton station B03-VP-1 in 2022.

| Date/Time: | 2022-09-15 10:20 | Initials: RW EM JO | | |
|---|---|---|---|--|
| Colour (e.g. brown, olive, bright green): | Light brown | Organic matter (e.g. decaying plants in flooded terrestrial zone) | | |
| Texture [‡] : | Looselv attached | Small gravel (2 – 16 mm) | | |
