# MEADOWBANK COMPLEX

# **TAILINGS MANAGEMENT**

# Operation, Maintenance and Surveillance Manual

> Version 13 February 2025

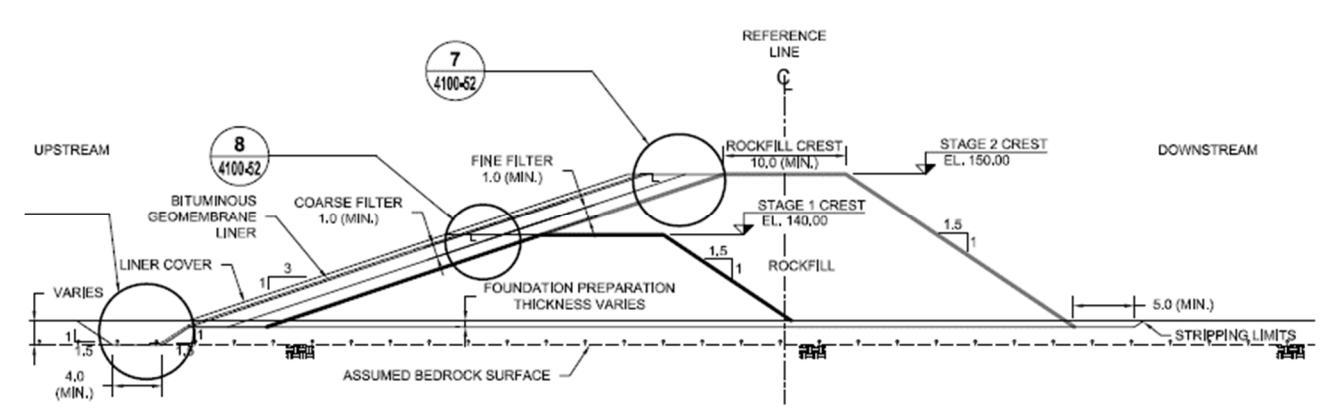
Figure 3-3: Typical Cross-section of Saddle Dam 1

0.3 m of granular material up to El. 140 m. No granular layer was placed above El. 140 m and the liner is exposed above that elevation. According to the design, a tailings beach must be maintained on the face of the structure to reduce the potential for ice damage to the liner. The abutments are founded on bedrock, while the central portion of the dike is founded on ice-poor soil. Till and/or crushed aggregate mixed with dry bentonite powder have been placed above the toe of the liner.

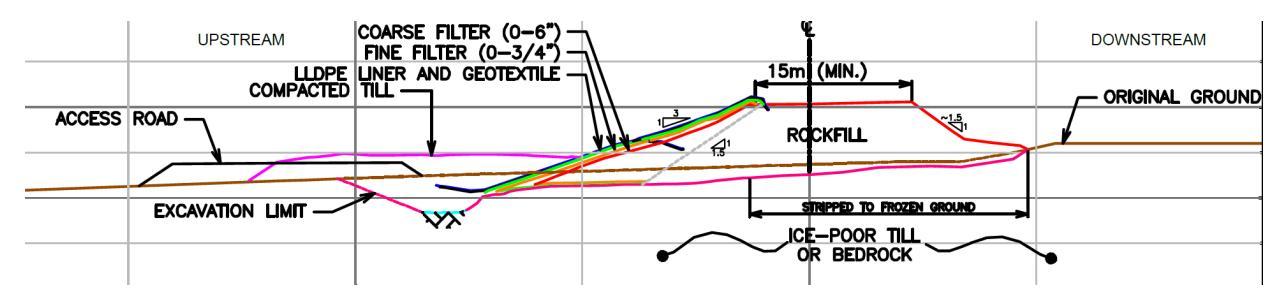
Figure 3-5: As-built Cross-section of Saddle Dam 2

Saddle Dam 2 was constructed in two stages to El. 150 m in 2010 and 2011. The upstream foundation of the dike and abutments are primarily founded on bedrock; however, some portions of the structure, underneath the inverted filter, are founded on ice-poor soil. During construction, a thin layer of low permeability till was placed and compacted along the toe liner tie-in connection with bedrock. A thin layer of crushed aggregate (0-22 mm) mixed with dry bentonite powder was also placed under the thin layer of low permeability till in areas where open fractures were observed within the bedrock. The toe liner tie-in was then covered with till.

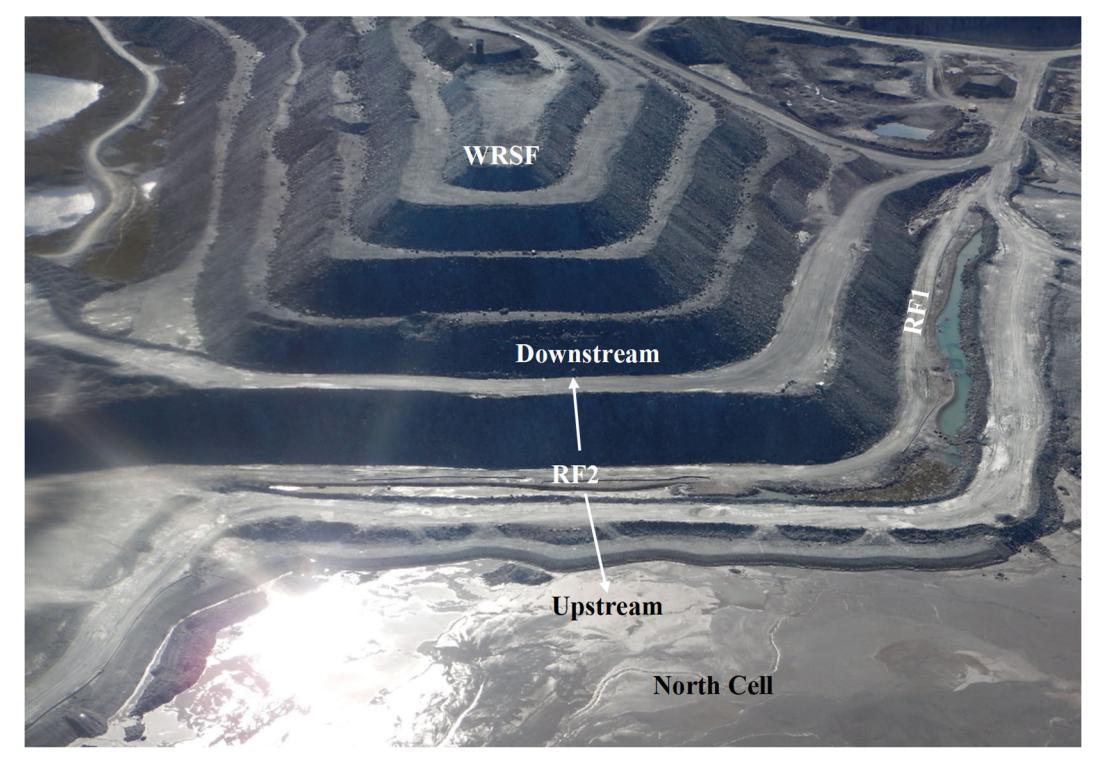
Figure 3-6: Aerial View of RF1/RF2

These access roads were not designed as a containment structure but during the operation of the North Cell, water and tailings ponded against them. In June 2013 water going through these structures infiltrated the Portage WRSF and then reached Lake NP2. Following this seepage event, a filter system was constructed in August 2014 on the upstream side of RF1 and RF2 to promote the build up of a tailings beach and prevent water exfiltration from the TSF at that location. The constructed filter berm consisted of till and/or fine ultramafic rock, coarse filter, geotextile, and fine filter. Since the construction of that structure a tailings beach covers these structures. Since the construction of the North Cell Internal Structure on the upstream side of RF1 and RF2 in 2018 these structures are now confined between the NCIS and the Portage WRSF.

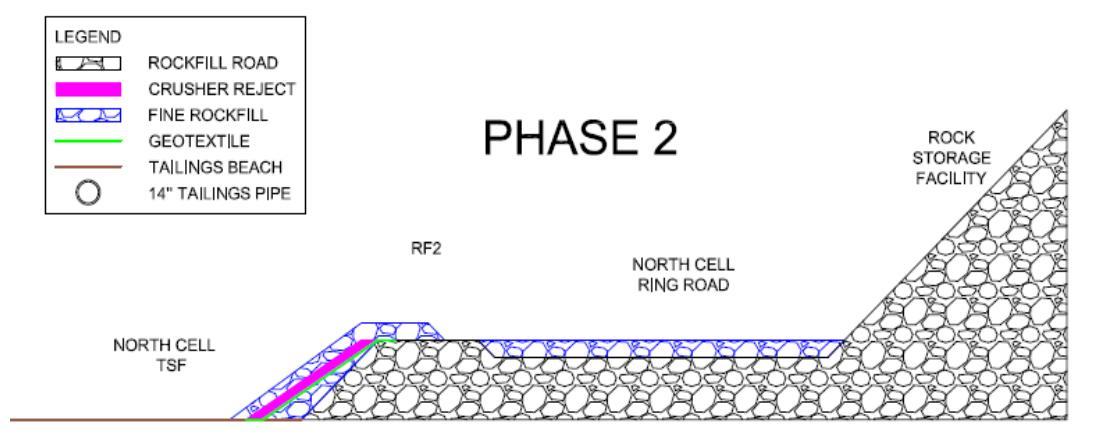
Figure 3-7: Typical Cross-section of RF1/RF2 (not representative of actual as-built condition of upstream filter)

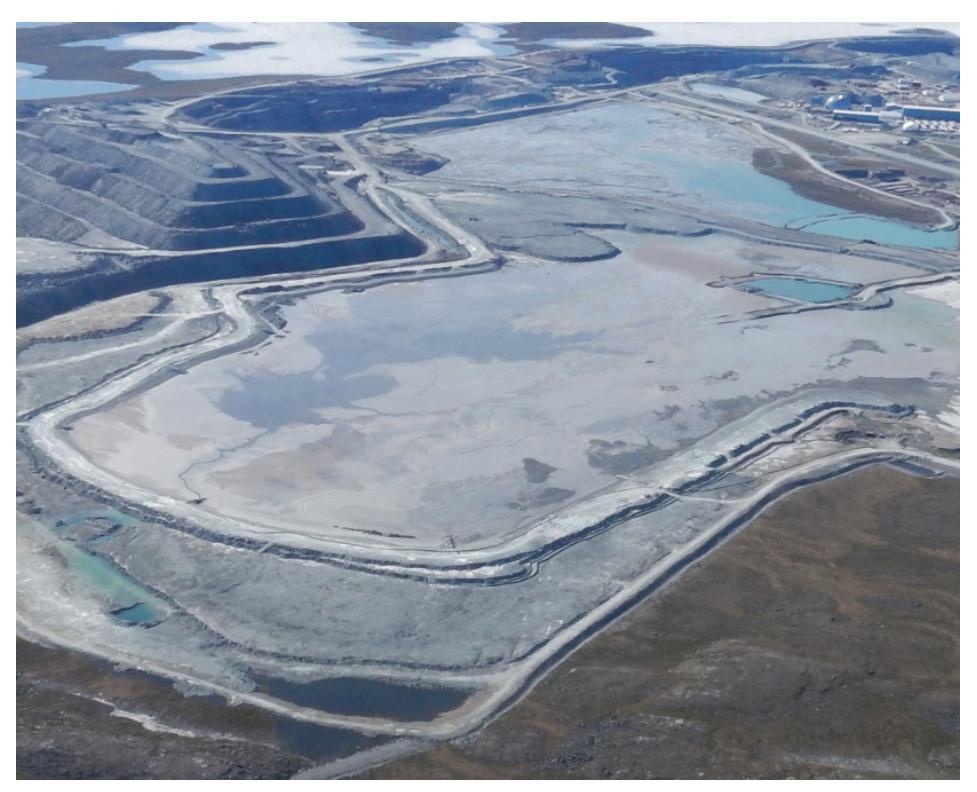
Figure 3-8: Aerial View of the North Cell Internal Structure

Channeling of water has been observed since 2019 at the upstream toe of the eastern part of the dike. The water flow is eroding fine filter material at the toe. Sloughing, deformation, and tension cracks in the upstream filter layer has been observed since 2020 in the eastern area and are caused by water eroding and undercutting the toe of the filters.

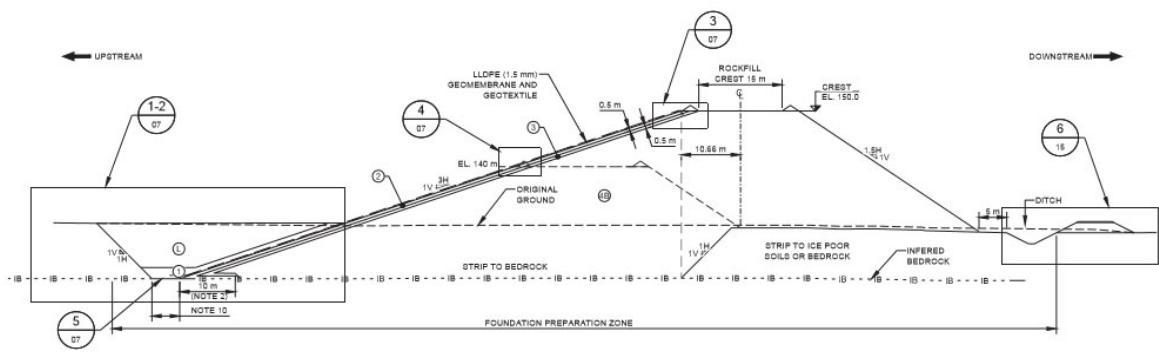
Figure 3-12: Typical Cross-section of the Saddle Dams 3/4/5
## 3.2.6 Central Dike – South Cell

Saddle Dams 3, 4, and 5 are designed and constructed as zoned rockfill dams with filter zones, low permeability upstream liners, and upstream toe liner tie-in key trenches. Cross-sections of Saddle Dams 3, 4 and 5 consist of a rockfill embankment, constructed from run-of-mine waste rock, placed in lifts and compacted. The upstream faces are designed at a 3H:1V slope and the downstream faces are designed at a 1.5H:1V slope. The upstream faces of Saddle Dams 3, 4 and 5 are comprised of two granular filter zones and a LLDPE liner extending along the upstream foundation. The filter zones are meant to keep the tailings inside the facility in case of liner puncture, but mainly act as appropriate

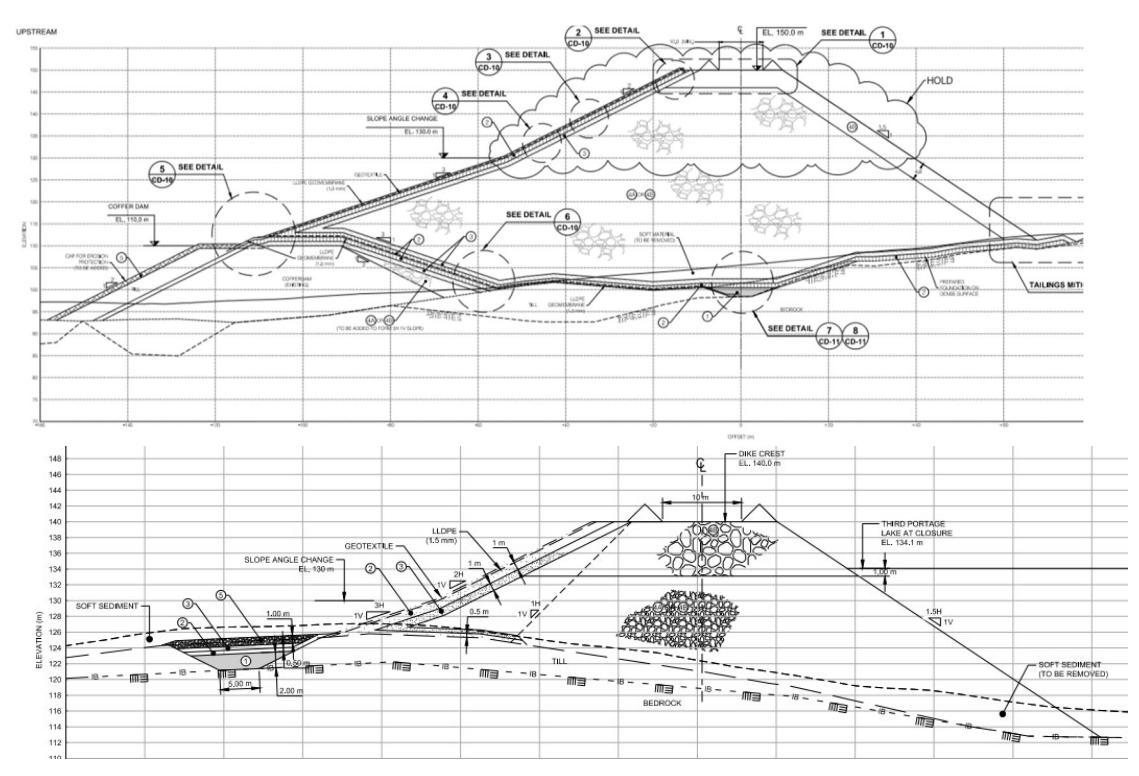
The Central Dike design includes a compacted rockfill embankment with an upstream seepage barrier, granular filters, and a key trench along the centerline of the dike transitioning on the upstream toe near both abutments. The foundation soils include lakebed sediments and till overlying bedrock. Soft and ice-rich soils were removed from the Central Dike footprint during construction.

Figure 3-14: Typical Cross-sections of Central Dike (top: highest dike section, bottom: section with upstream liner tie-in).

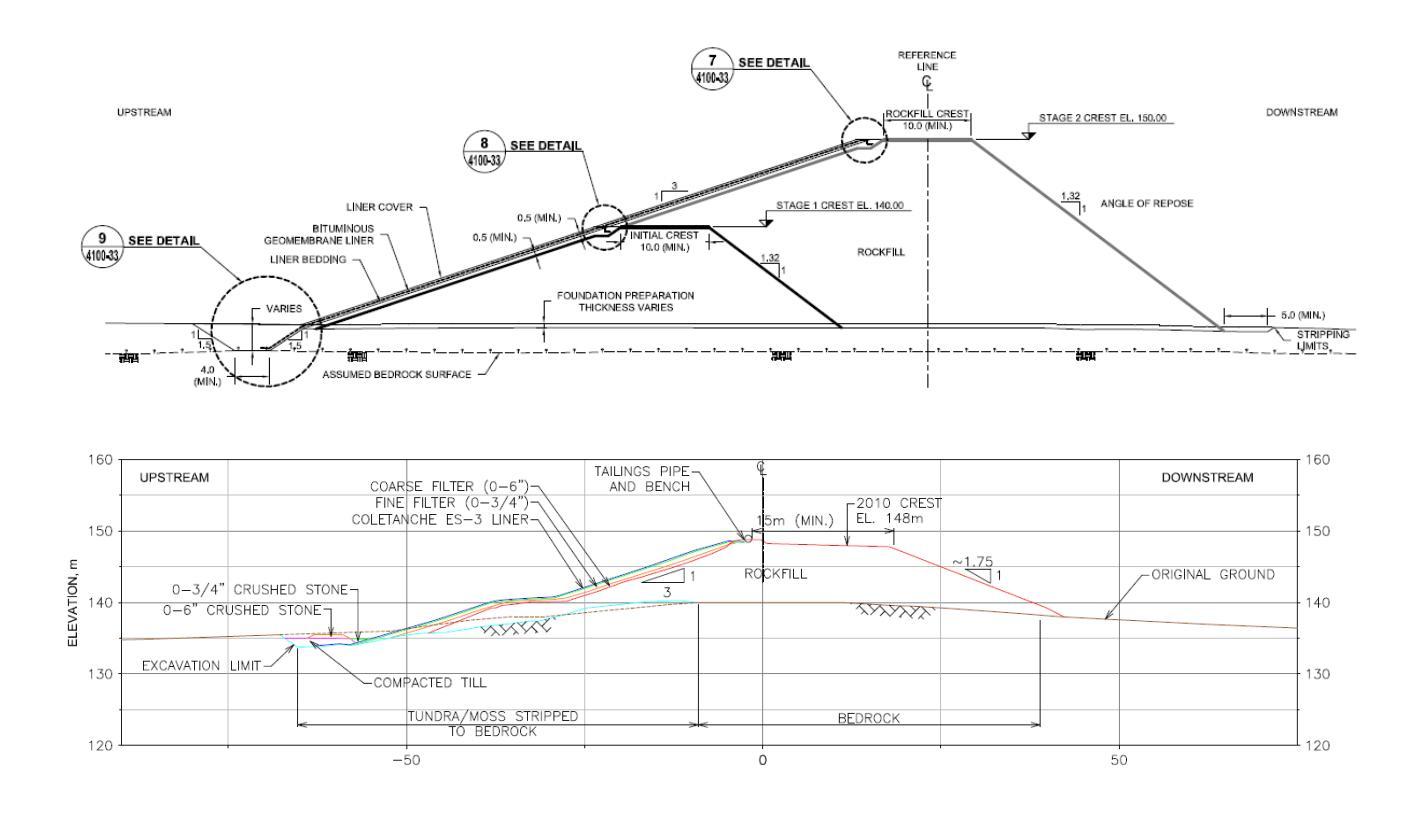
Stormwater Dike is a rockfill embankment structure founded on lakebed soils. The upstream slope is approximately 3H:1V and the downstream slope is about 1.3H:1V. A bituminous geomembrane liner has been installed above the graded filters on the upstream face of the dike. Low permeability till was placed and compacted along the upstream toe of the dike, above the liner. Stormwater Dike was initially designed and constructed as a temporary structure that would be encapsulated in tailings to equal elevation on both sides. With the change in tailings deposition strategy there is a 5 m difference in tailings elevation between the upstream and downstream area and this structure cannot be considered as a temporary one anymore.

Figure 3-16: Typical Cross-section of Stormwater Dike (top). As-built section of Phase 2 (bottom)

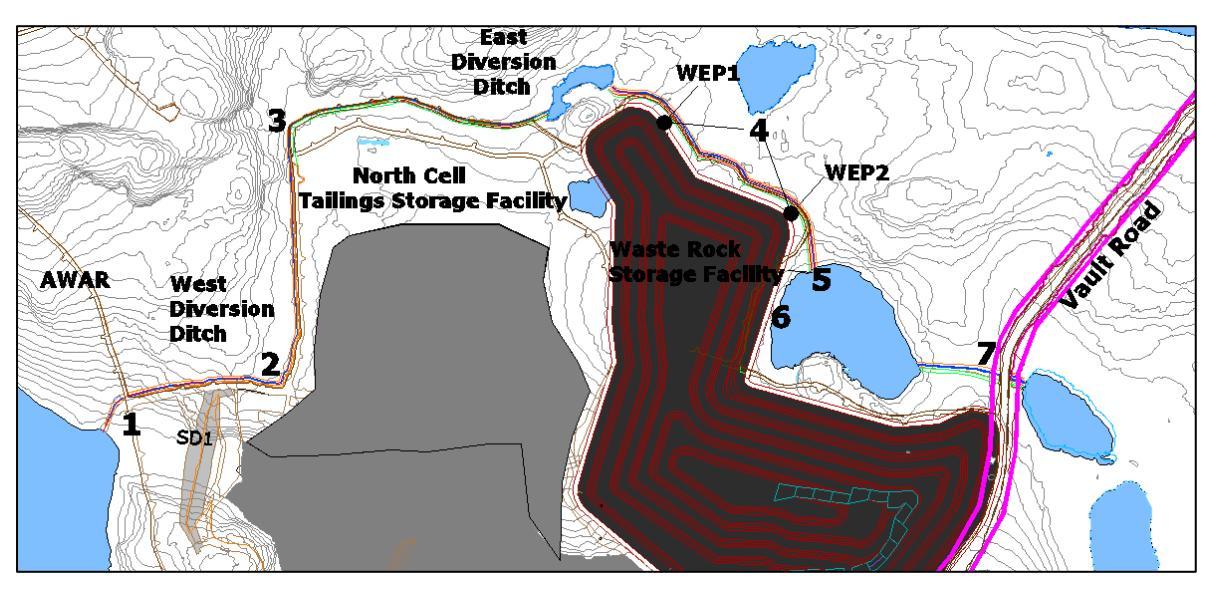
Figure 3-17: Diversion Ditches and Related Infrastructure

The diversion ditches (West and East), located around the perimeter of the North Cell TSF and the Portage RSF, are designed to collect the non-contact water runoff from the surrounding watershed before they reach the TSF area. The ditches are composed of the west section that divert water to the western interception sump and then Portage Lake and the east sections that divert water to NP2 Lake and then from another section to NP1-N Lake. These ditches were constructed in 2012 and are 2622 m long. In the summer of 2014 and 2015 sloughing and erosion damage were observed in the channel slopes. These events were corrected by reprofiling the channel slope and adding additional rockfill material. Since then, the North Cell diversion has been performing adequately.

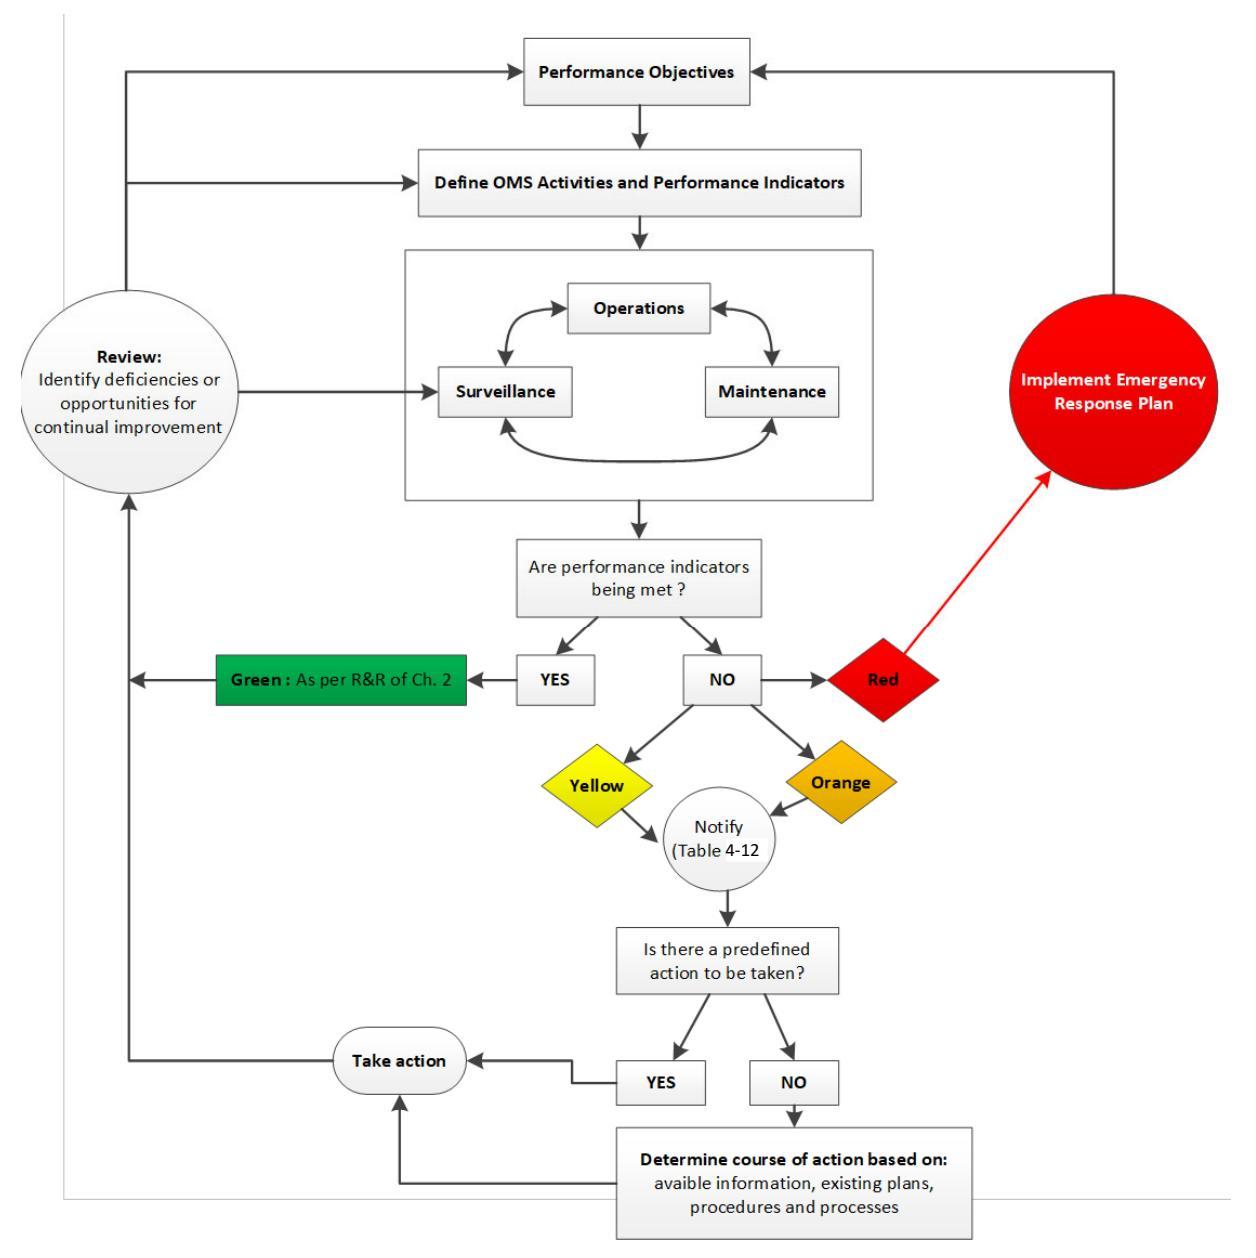
Figure 4-1: Communication and Decision Process for Tailings Management Infrastructure TARP

Figure 4-1 indicates the communication and decision processes when the threshold criteria are met and when pre-defined actions need to be implemented. Table 4-12 indicates the communication procedure to follow when changing the TARP level.

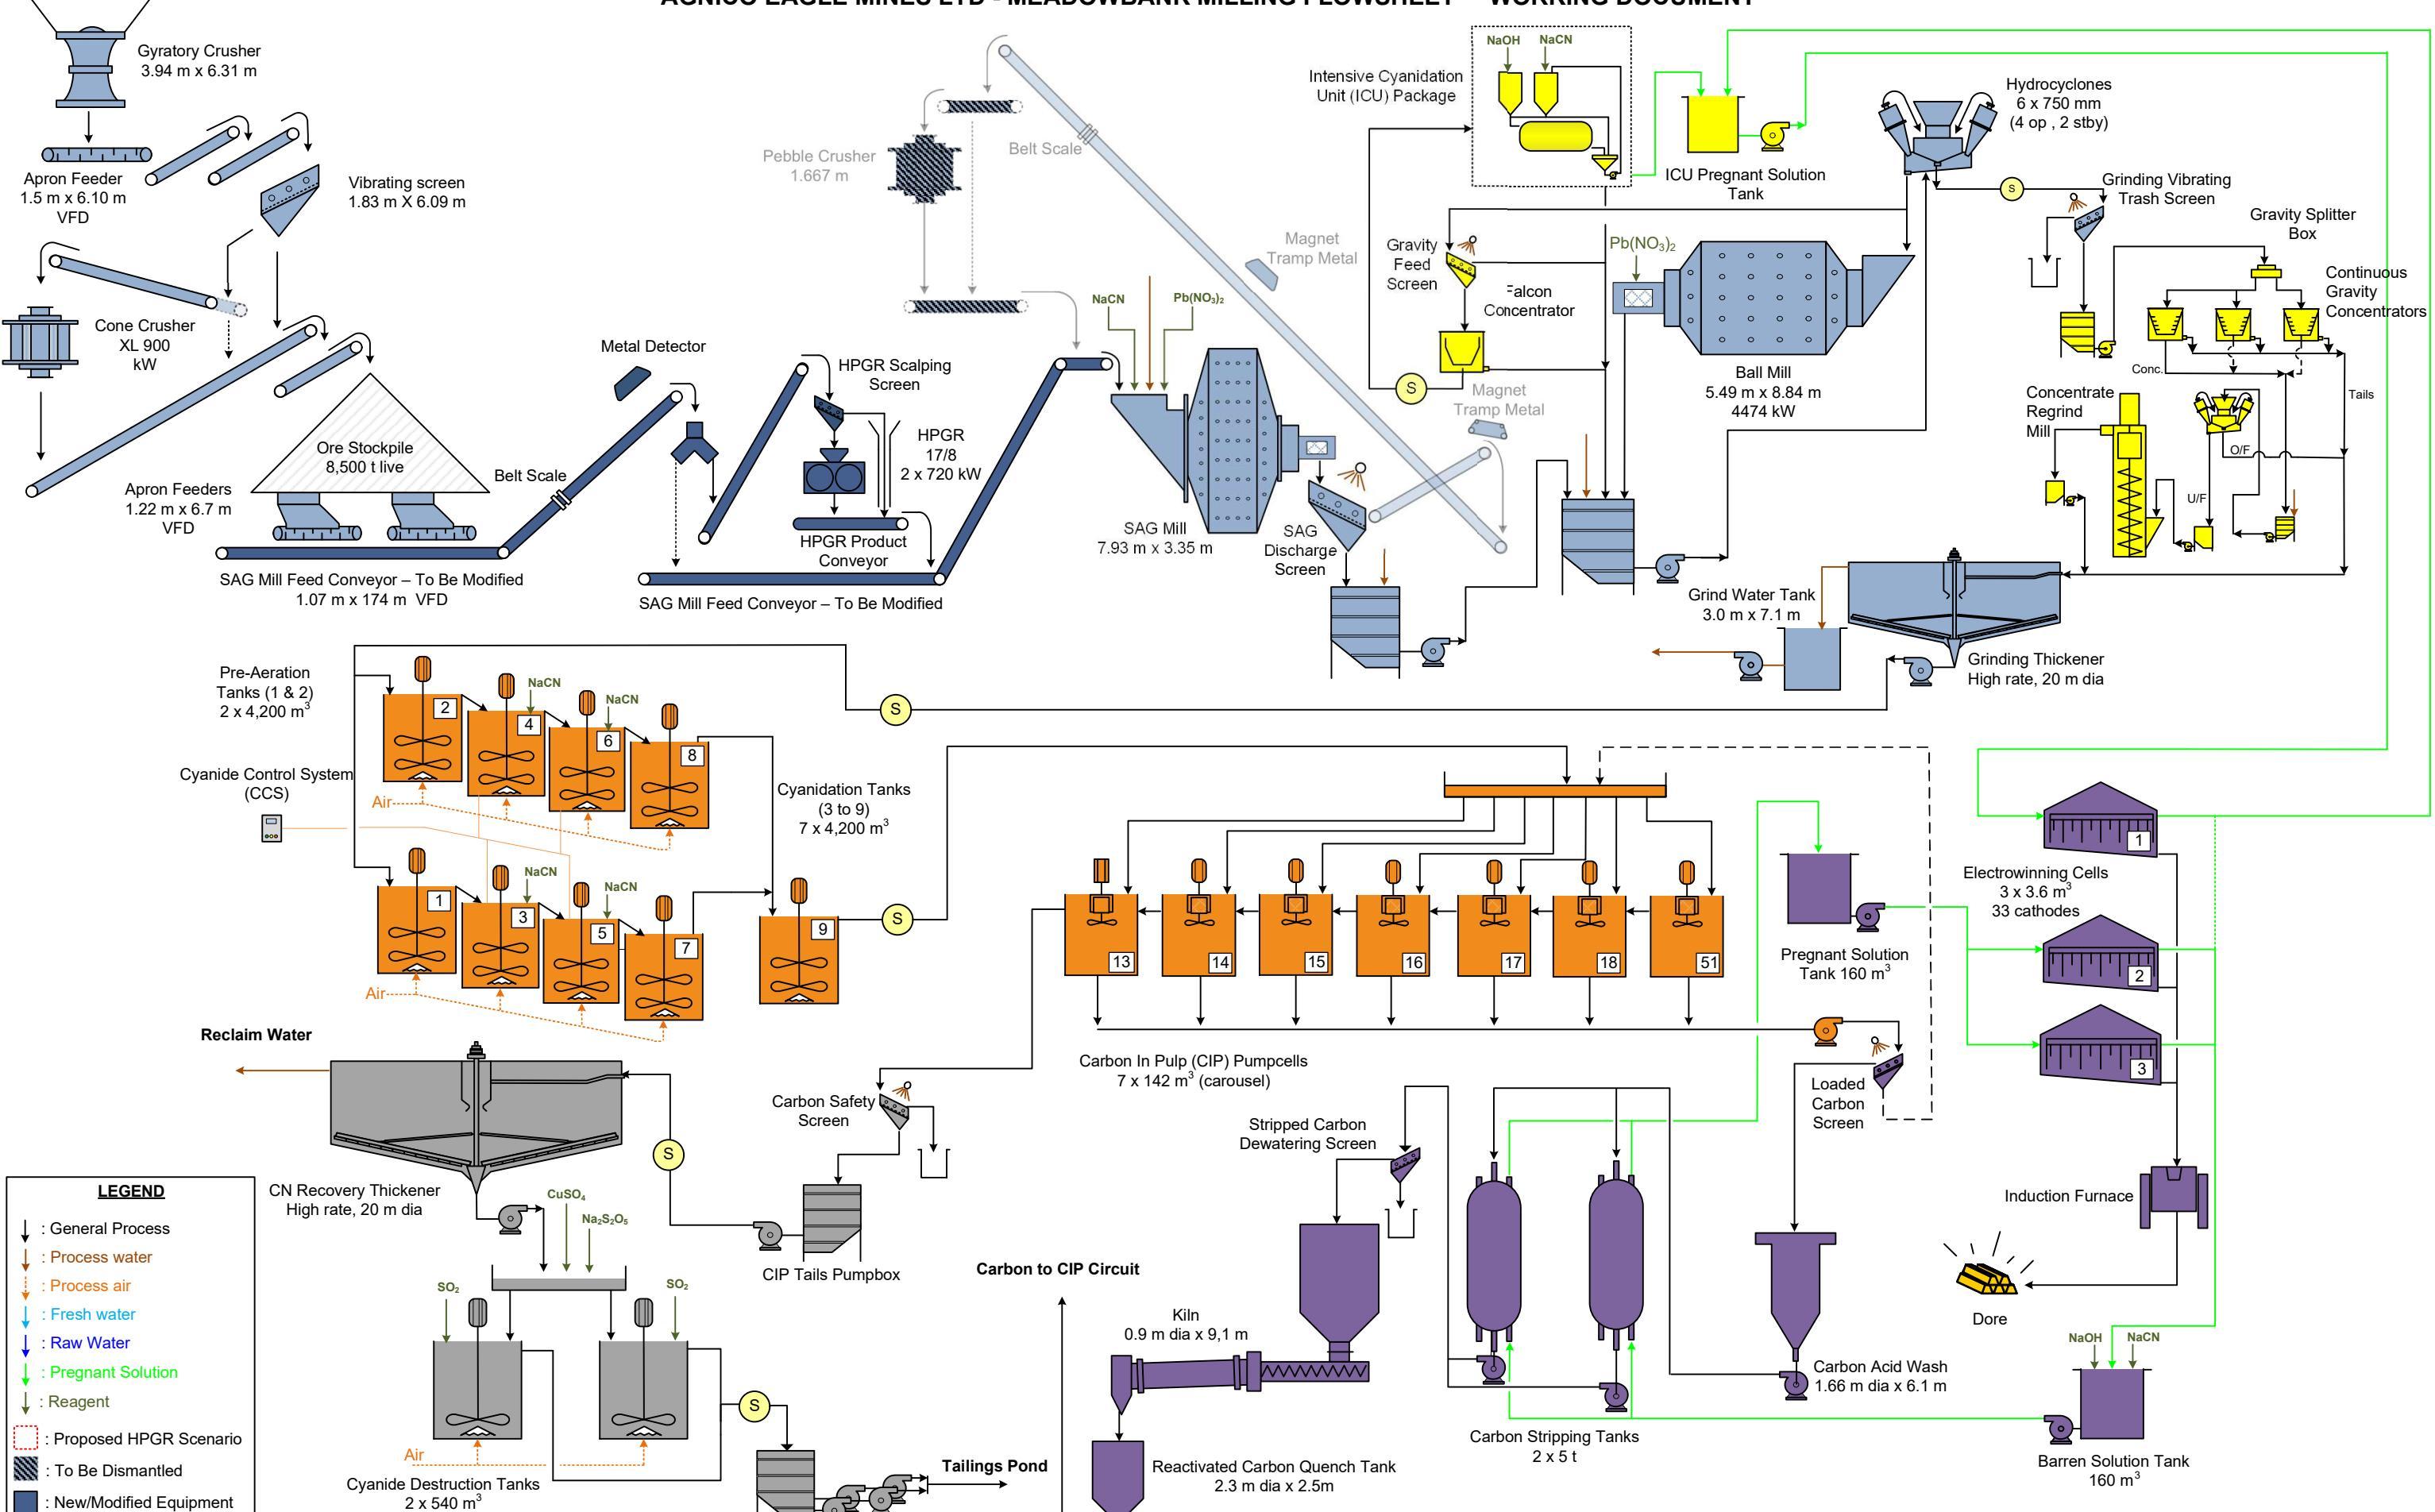
## AGNICO EAGLE MINES LTD - MEADOWBANK MILLING FLOWSHEET – WORKING DOCUMENT
