MEADOWBANK COMPLEX
2020 Annual Report
61-000-100-REP-003

Agnico Eagle Mines Limited – Meadowbank Complex

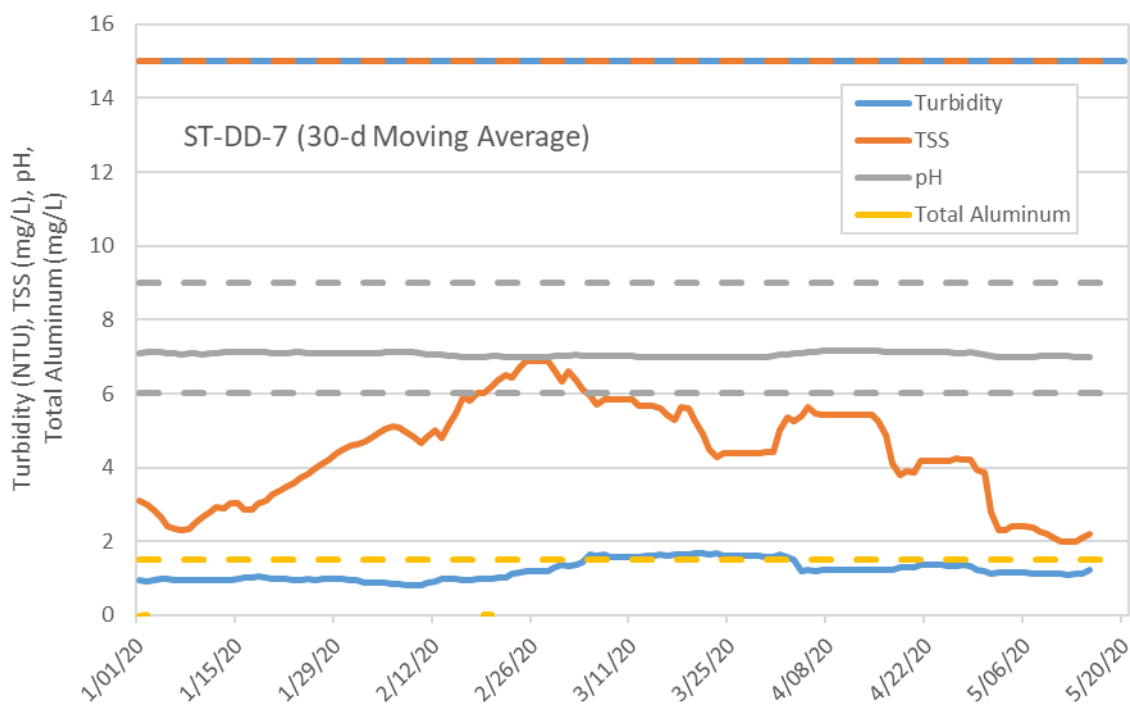
Figure 16. Calculated 30-d moving averages for turbidity, TSS, pH, and total aluminum in dewatering effluent from Whale Tail North Basin. Dashed lines indicate the NWB Water License criteria for the Maximum Monthly Mean for comparison to 30-d moving averages (for pH, a range of 6-9).

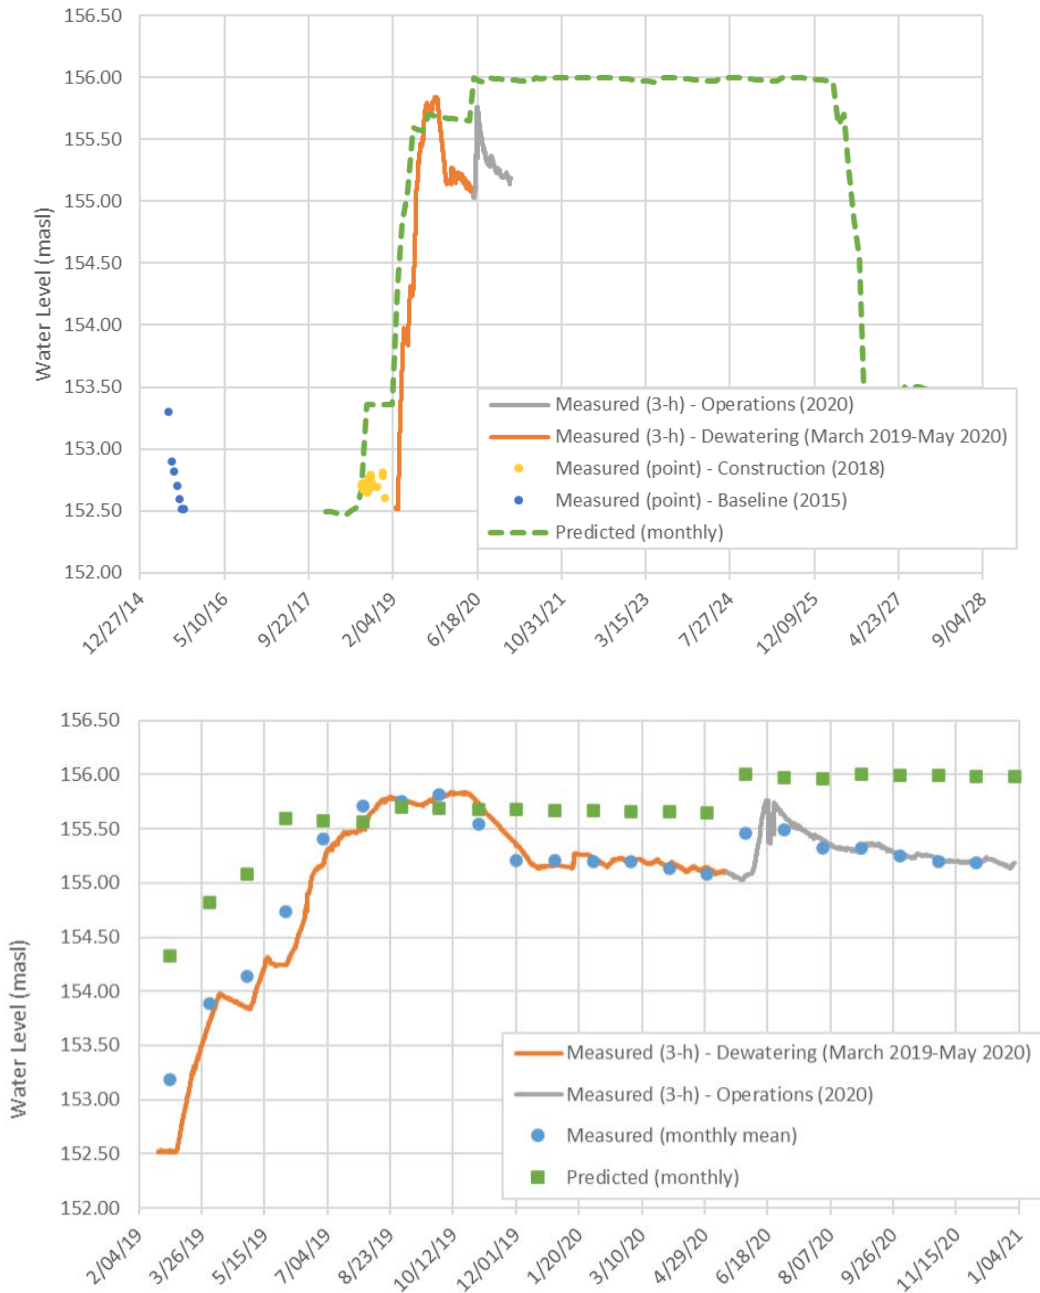
Figure 17a and b. Measured (3-h interval and monthly mean, as indicated) and predicted water levels in the Whale Tail South flood zone. Predicted water levels from FEIS Addendum for the Whale Tail Pit Expansion Project, Appendix 6-O, Table D-14. Monthly mean water levels are plotted by the month start date.

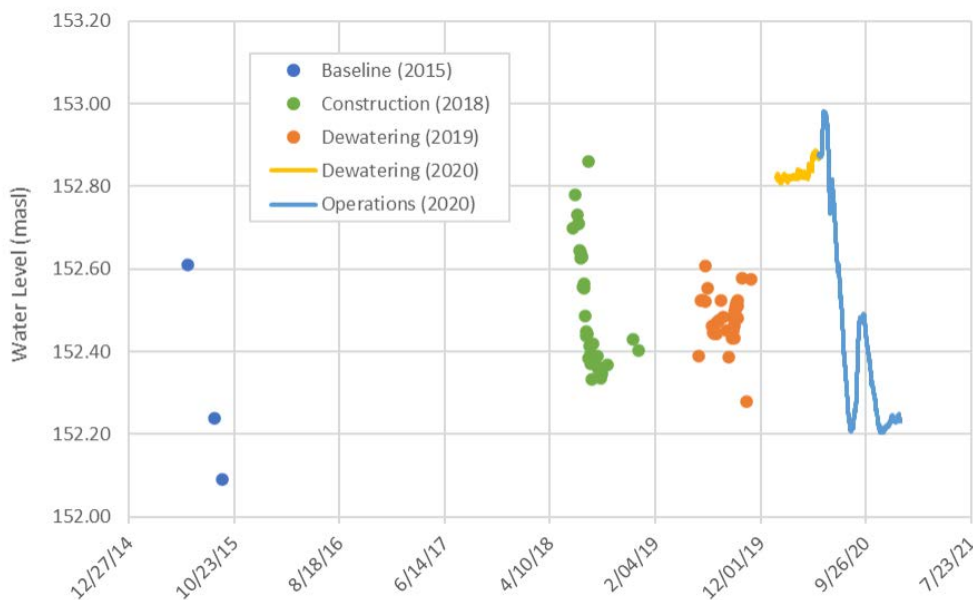
Figure 18 Measured water levels in Mammoth Lake. Results from 2015 – 2019 are by GPS survey, and results for 2020 are from piezometric data (3-h intervals).

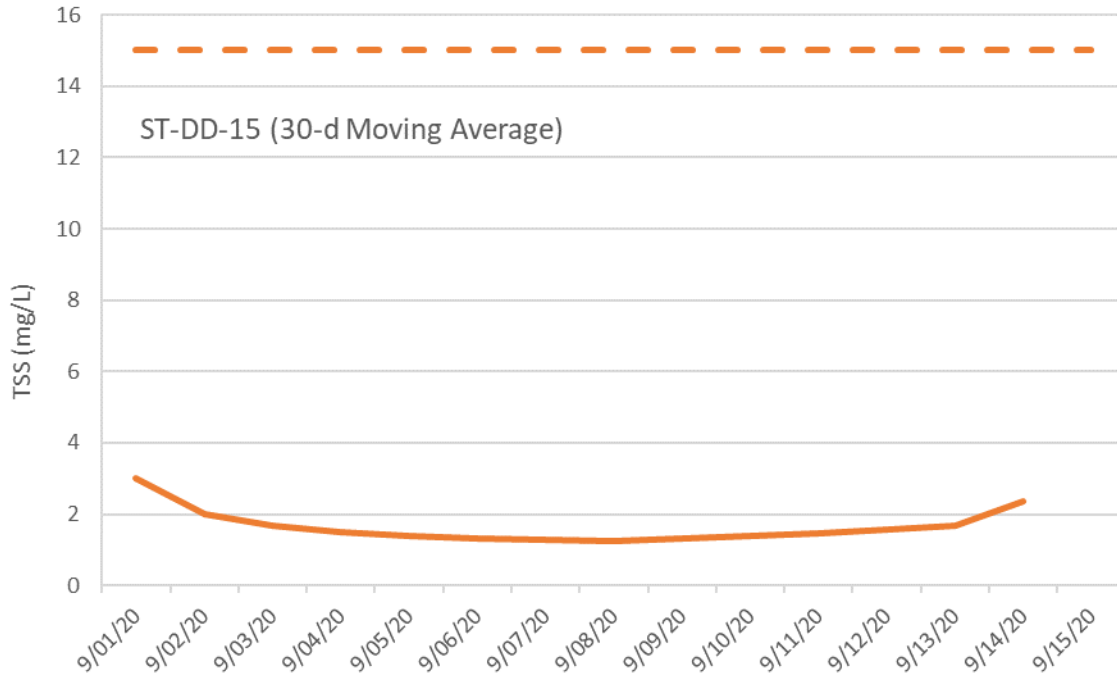
Figure 19 Calculated 30-d moving average for TSS in dewatering effluent from Lake A53. Dashed line indicates the NWB Water License criteria for the Maximum Monthly Mean for comparison to the 30-d moving average
