MEADOWBANK COMPLEX
2021 Annual Report
61-000-100-REP-004

Agnico Eagle Mines Limited – Meadowbank Complex

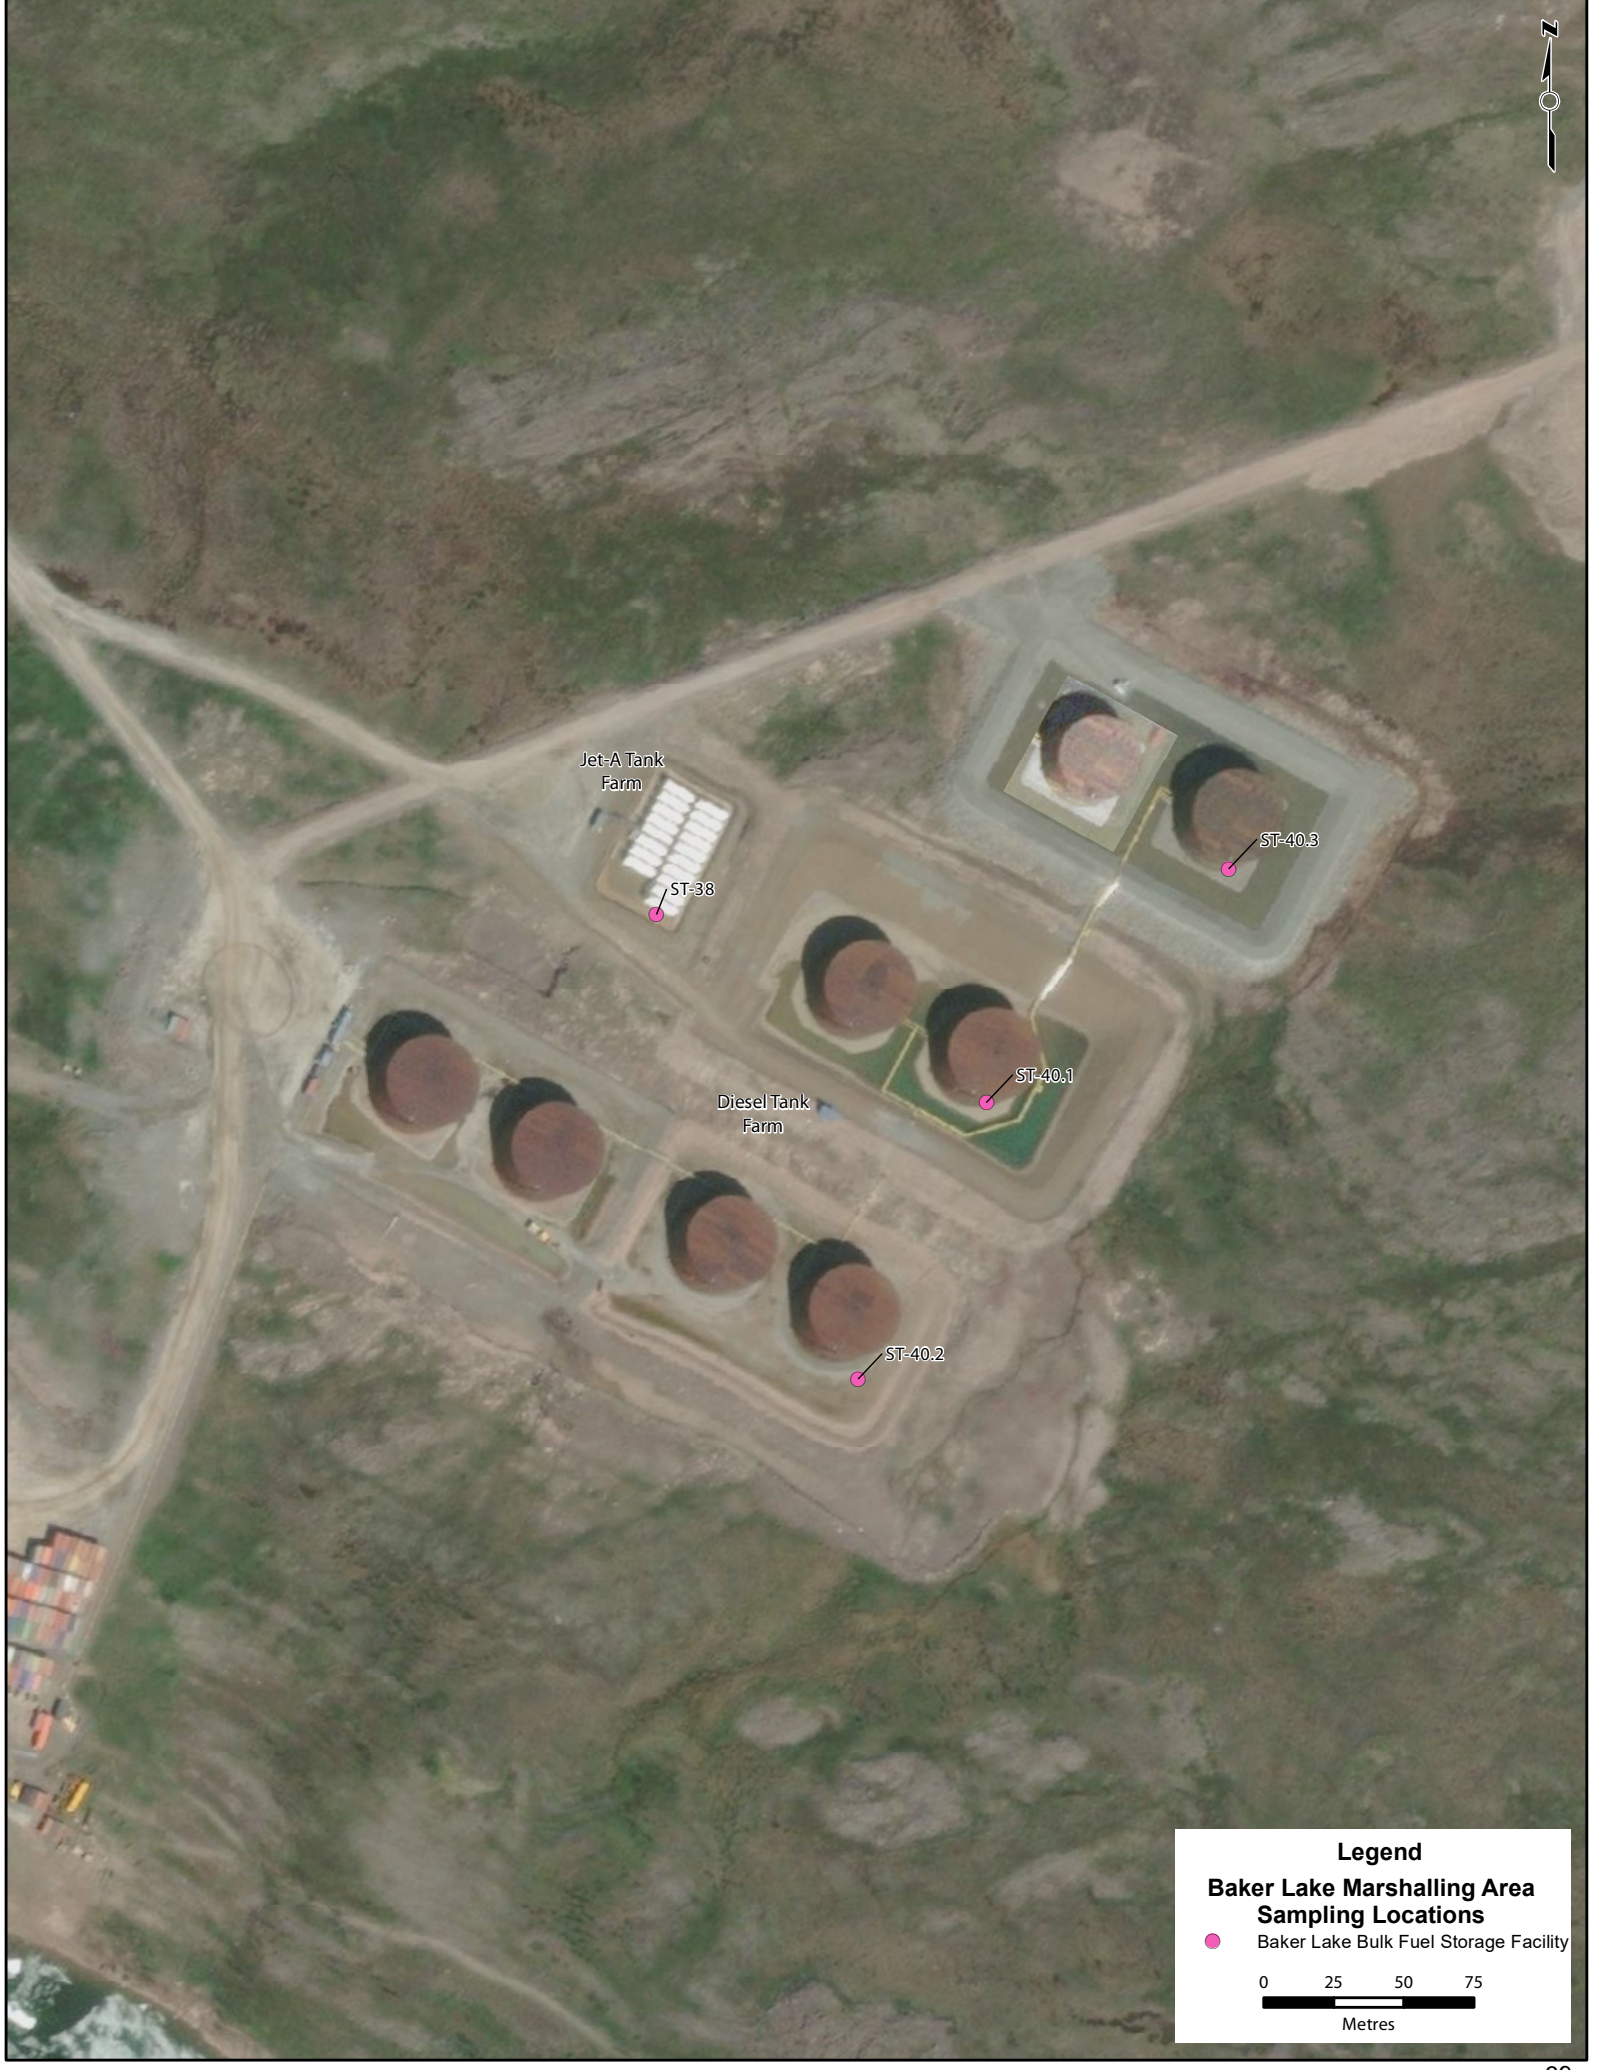
Figure 5 General View from Baker Lake to Whale Tail Project

Baker Lake Marshalling Area
Sampling Locations

Water was also sampled from Tanks 1 – 4 (ST-40.2) on October 19th. Second notification to the CIRNAC Inspector was sent on October 18th. In October, 1,730 m³ was pumped from Tank 1-4 containment area. The locations of these sampling stations (ST-38, ST-40.1, ST-40.2, and ST-40.3) are illustrated on Figure 5 and results are presented in Table 8-74.
