# Meadowbank Interim Closure and Reclamation Plan (ICRP)

## Update 2019

Final Report

Meadowbank Division - Agnico Eagle Mines Limited

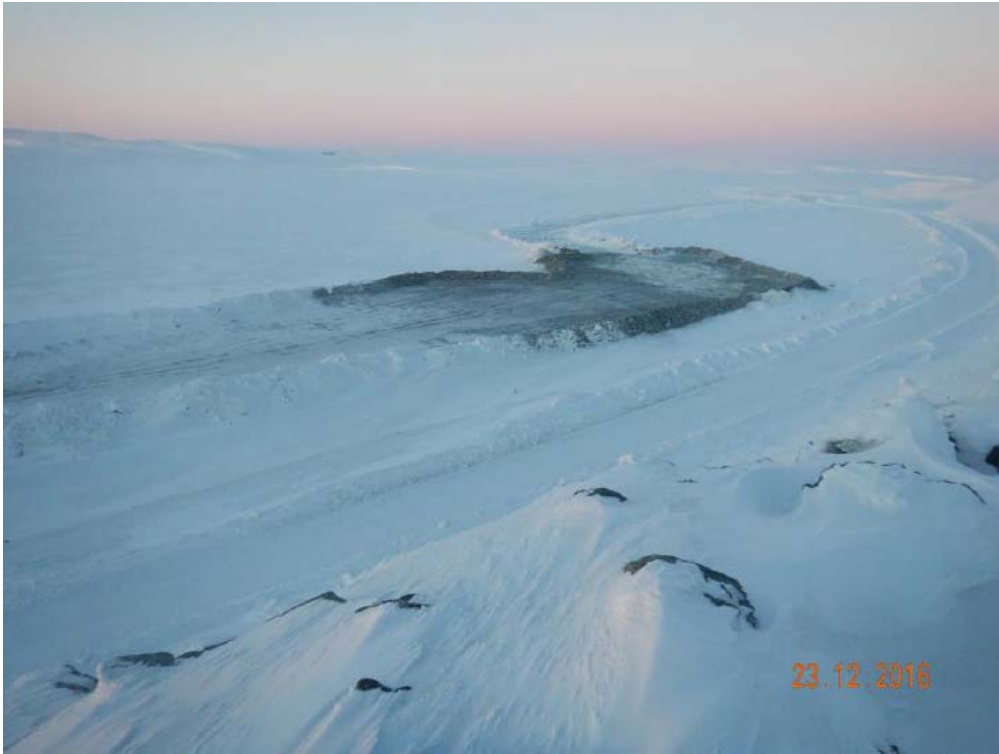
Photo 8: TSF North Cell, NPAG Cover construction, winter 2016

Preliminary design work was completed for the TSF cover in 2015 and 2016. The tailings cover will consist of non-acid generating granular material (NPAG) and ensures that the active layer remains within the NPAG layer. The objective for the cover system is to keep the tailings under 0°C in most conditions and to maintain saturation above 85%. Progressive reclamation of the North Cell has started in 2015 and continued to 2017 with the NPAG cover placement. The progressive cover is expected to continue in 2018 and 2019. The TSF North Cell is instrumented for thermal monitoring with thermistors installed in the tailings or the NPAG cover.

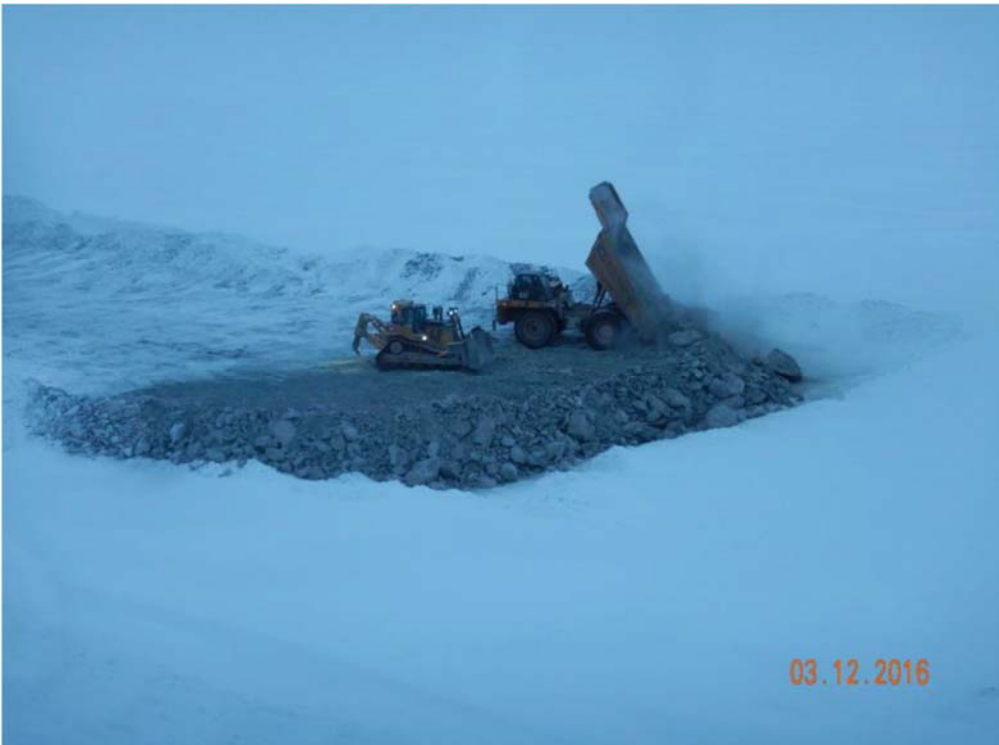
Photo 9: TSF North Cell, NPAG Cover construction, winter 2016
