MELIADINE GOLD MINE  
**2023 Annual Report**

Agnico Eagle Mines Limited – Meliadine Division

March 2024

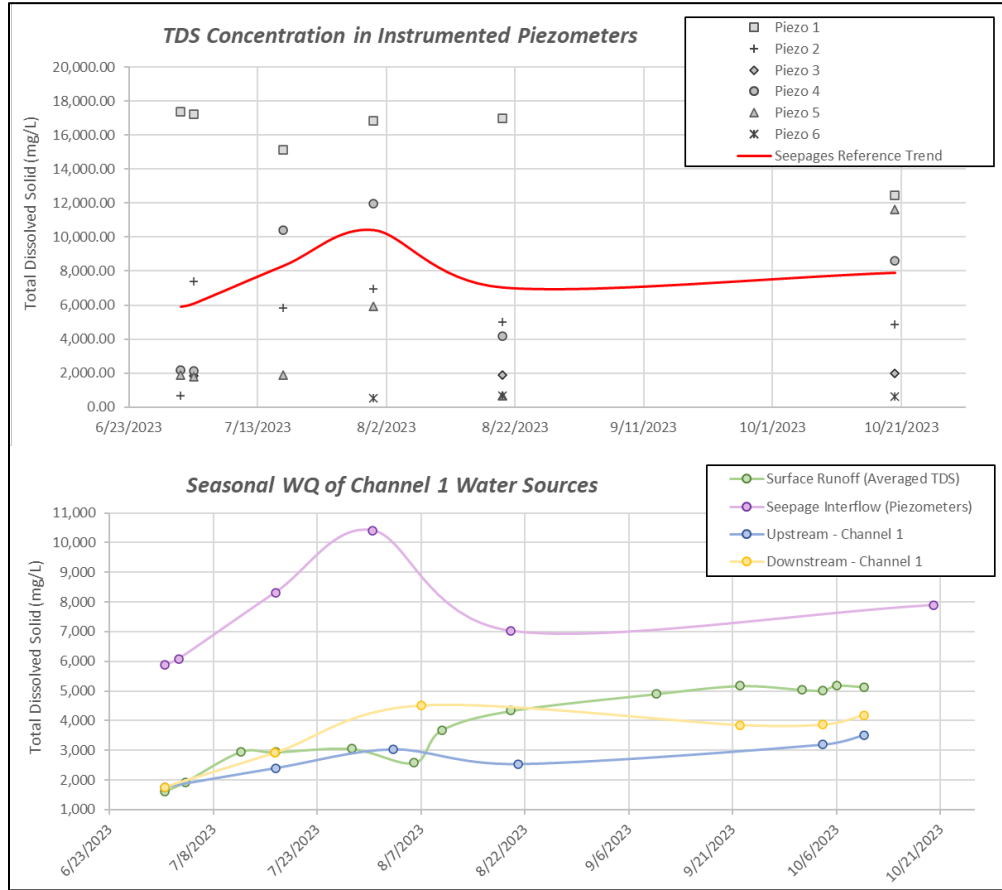
**Figure 9. Trend in TDS concentrations from piezometer measurements used as reference for OP2 seepage and TDS concentration of other key sources involved in the Channel 1 mass balance.**

Sampling of water in piezometers and measurements of TDS concentrations were conducted between July 1<sup>st</sup> and October 20<sup>th</sup> 2023. A wide range of TDS concentrations were observed among piezometers, but also between sampling dates for some piezometers (i.e., PZ-4 and PZ-5). To determine a reference trend for OP2 seepages that could be used in further modelling analysis of the Channel 1 and CP1 mass balance, an average of the TDS concentrations measured across all piezometers was calculated for each sampling date. The first graph on Figure 9. shows the resulting seepage TDS average, referred to as the reference trend.

TDS concentrations measured respectively upstream and downstream of Channel 1 were used to assess the potential impact of runoff and seepages from OP2 on the TDS mass balance of Channel 1. To distinguish the potential impacts of OP2 seepages from the surface runoff, a reference surface runoff TDS trend has been estimated from an average of TDS concentrations measured in CP3, CP4, and in surface water just upstream of Culvert 2. The use of these waterbodies to define a TDS reference trend for surface runoff (green line in Figure 9) is deemed to be a conservative TDS concentration estimate, since they capture the drainage from WRSF1 and the TSF, which present similar hydrothermal dynamics as OP2 (Okane Consultants Inc., 2022).

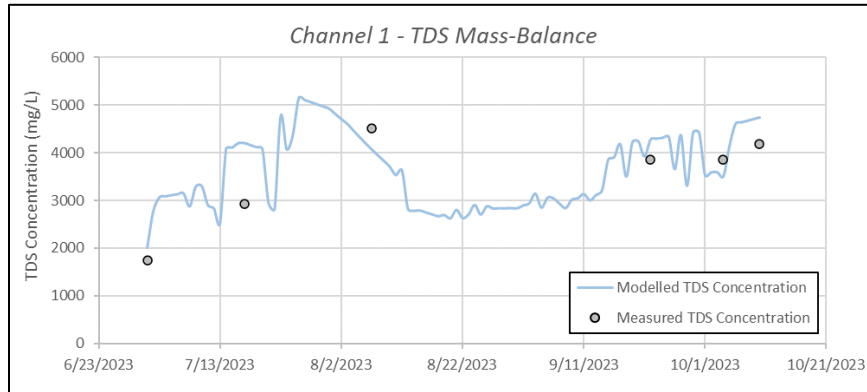
**Figure 10: Results of the modelled Channel 1 TDS mass balance compared to measured TDS concentrations downstream of Channel 1 during the 2023 season.**

The daily simulated inflow volume to Channel 1 (i.e., upstream of Channel 1 and OP2 surface runoff and seepage) were combined with the TDS concentration trends presented above to establish a continuous daily TDS concentration series for Channel 1. The resulting modelled TDS series is presented in Figure 10 along with the periodic TDS measurements conducted downstream of Channel 1. Good agreement between the modelled TDS concentration and the field measured values is observed, suggesting that the used TDS signatures and the modelled inflows are representative of the actual dynamics that occurred during the 2023 open water season.

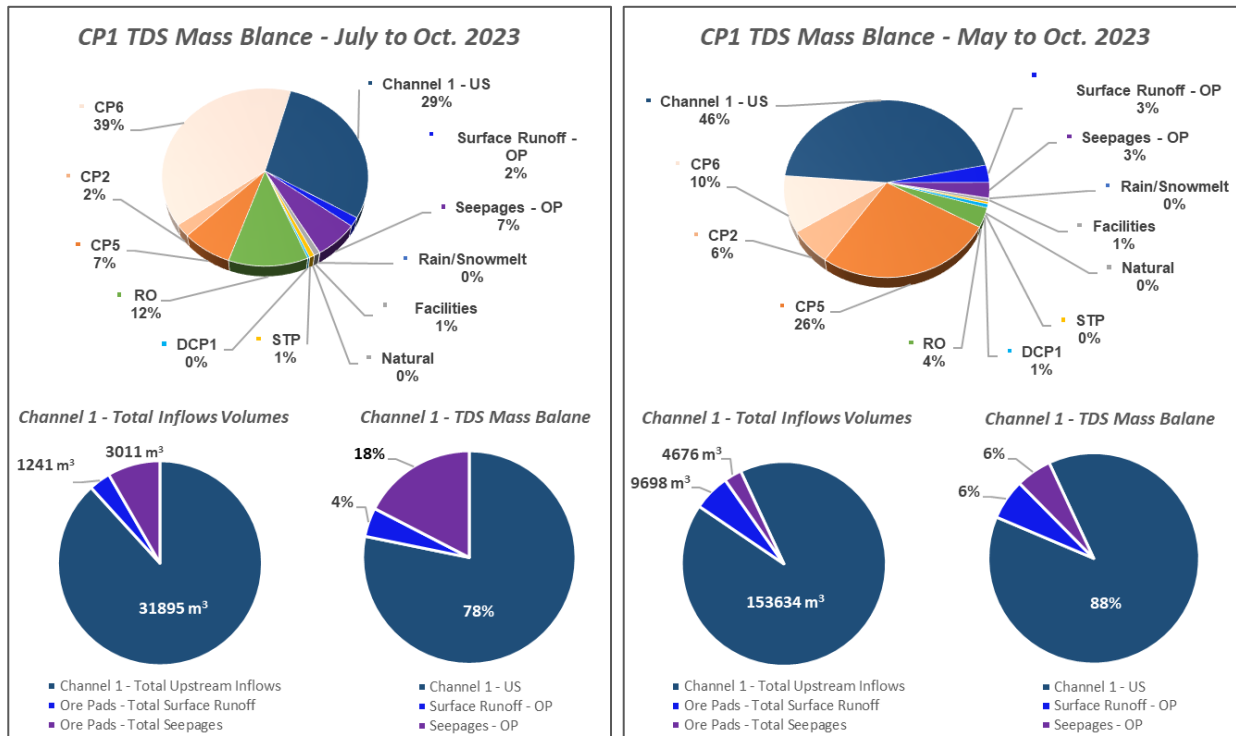
Figure 11. Results of the CP1 and Channel 1 TDS mass balance computation and proportion of the inflows volumes to Channel 1 for the a) July to October and b) May to October periods.

Two specific periods were investigated regarding the impact on CP1 TDS: July 1<sup>st</sup> to October 20<sup>th</sup> and May 1<sup>st</sup> to October 20<sup>th</sup>. The first period corresponds to the period for which TDS measurements were available downstream of Channel 1 and used for the validation of the modelled mass balance. The second period covers the whole open water season including freshet and should be interpreted with more caution since TDS is not validated for the entire period. Figure 11 shows the impact of OP2 runoff and seepage relative to all other sources of water, on the CP1 TDS mass balance for the two aforementioned periods.

The period of July 1st to October 20th of the 2023 open water season was one of the driest years recorded on site. The modelled TDS contributions from OP2 represent 7% of the CP1 TDS mass through seepage and 2% through surface runoff. This is explained by the limited contributions of all other sources dominated by surface runoff, which was negligible due to dry conditions during that period. In comparison, the contribution of TDS by OP2 over the whole open water season (May 1st to October 20th) on the CP1 mass balance is significantly less (3% seepage; 3% surface runoff). These results suggest that the impact of seepage and runoff from OP2 on CP1 TDS concentrations is limited and does not warrant additional intervention to manage this source.

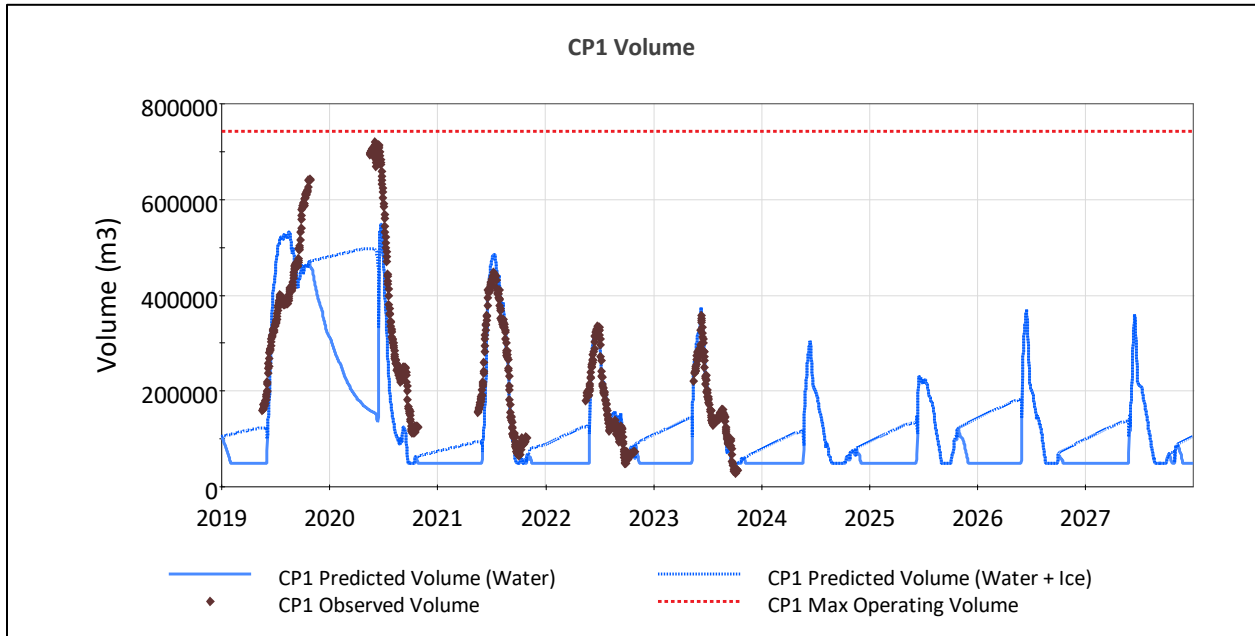
Figure 12: Forecasted and observed CP1 volume.

As shown in Figure 12, the model results indicate a cyclical water elevation and volume response in CP1 each year, characterized by a slight increase via winter inflows and a rapid increase during freshet. Water elevations are then drawn down through each discharge season before freeze-up in Q4 of each year.

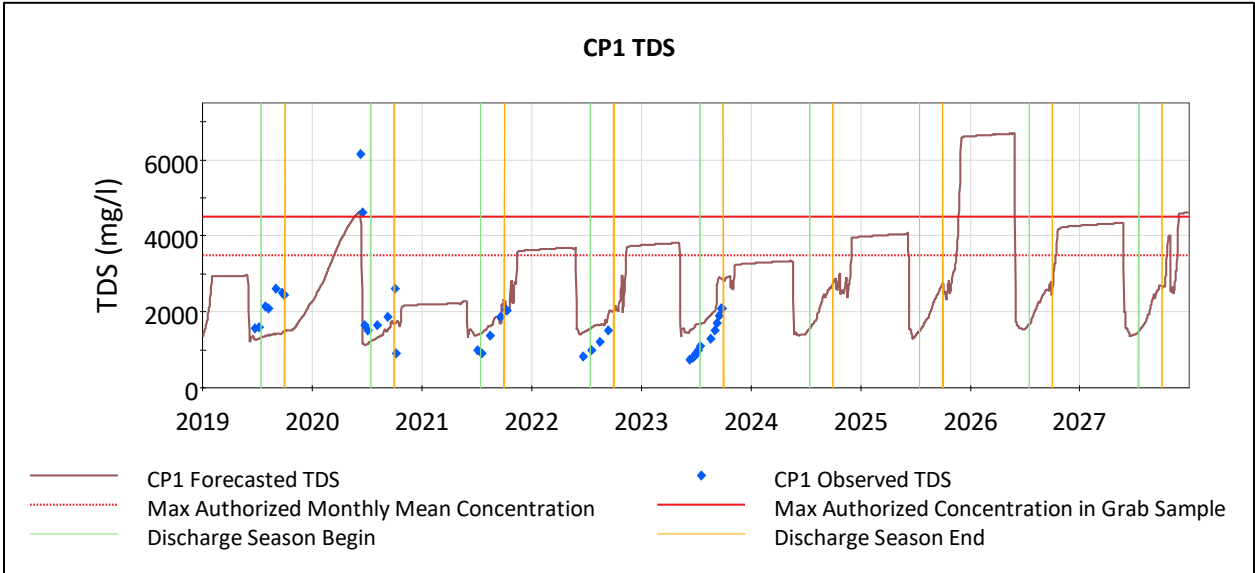
Figure 13: CP1 TDS concentrations for life of mine

An anomalously high TDS concentration is predicted in the 2025 to 2026 winter period. The model predicts a significant rainfall in October 2025, following the discharge period. This increase in volume corresponds to an increase in the mass of TDS in CP1 prior to ice formation. As ice forms in the 2025 to 2026 winter period, the liquid portion of water is reduced (driven by the ice growth algorithm), resulting in a higher concentration of TDS in the liquid portion, as the mass of TDS is held constant. The concentration then decreases at freshet, prior to the start of the 2026 discharge period. It is worth emphasizing that this predicted increase in TDS occurs outside of the discharge season (i.e., during winter months).

Similarly, it should be noted that although TDS concentrations rise above the Maximum Authorized Monthly Mean Concentration (MAMMC) of 3500 mg/L most winters, there is no discharge taking place during these periods. The TDS concentration in CP1 during the annual discharge period is predicted to remain below the MAMMC over the life of mine.

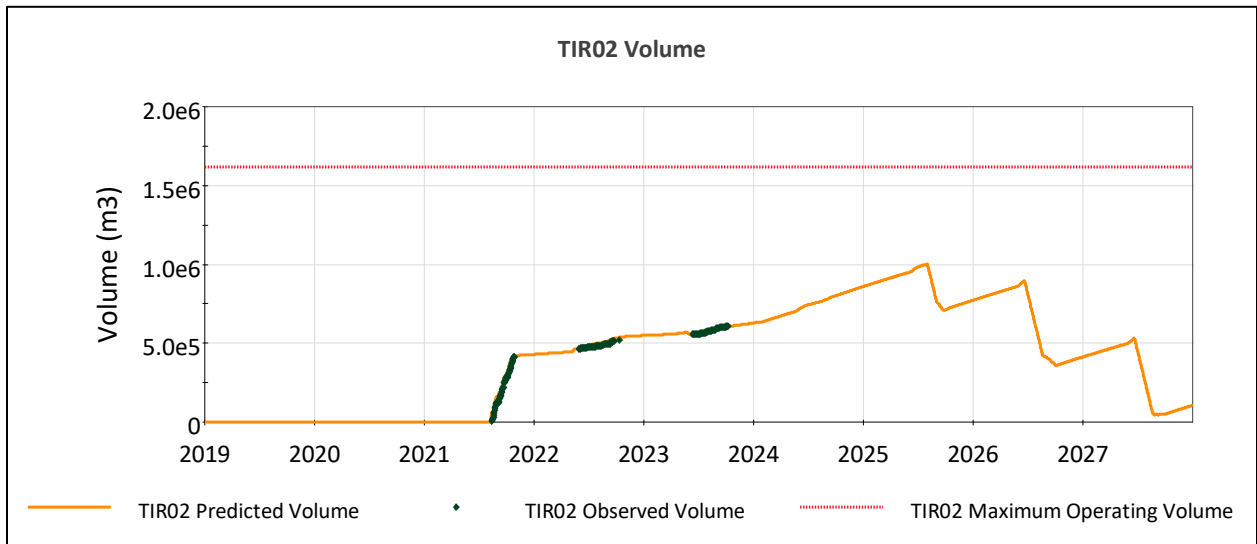
Figure 14: Forecasted saline water volume in TIRI02 against observed volumes.

Figure 14 shows the results of the modeled and observed volumes of saline water in TIRI02. Saline water pumped from Tiriganiaq underground will be stored in TIRI02 until 2025 after which the water will be discharged through the waterline to Itivia Harbour. Predicted groundwater inflow rates to the underground mine were updated in 2024 to reflect an updated mine plan scenario and included a limited calibration based on groundwater inflow monitoring over previous years. The updated results are discussed in the Groundwater Management Plan (GWMP).

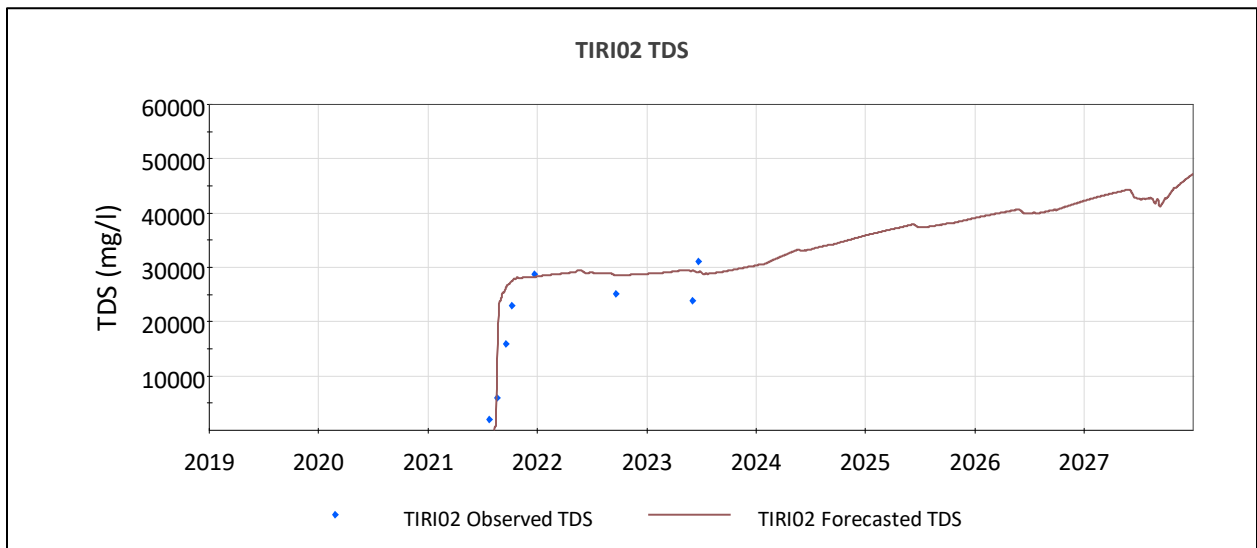
Figure 15. Forecasted versus observed TDS concentrations in TIRI02.

Model results and observed concentrations of TDS, Ammonia and Radium-226 concentrations are shown in Figure 15, Figure 16, and Figure 17. The summary of TDS, Ammonia and Radium-226 forecasted concentrations for TIRI02 is also presented in Appendix 4, Table 4.

Recently observed concentrations of TDS, ammonia and radium were collected from a water column profile conducted in early and end of June 2023. As stratification of the water column due to cryo-concentration (as discussed in section 3.1.8) occurs in TIRI02, a weighting was applied to concentrations measured at varying depth within the water column based on the respective volume associated with each sample depth.

Observed TDS and ammonia concentrations in TIRI02 generally trend well with predicted values. This is to be expected due to limited inputs and outputs from the facility. Historic water quality reporting to TIRI02 and flowmeter measured pumping data from underground and SP4 drive the water quality in storage, and thus any retrospective deviation in observed concentration would be due to inaccuracies in historic data or unknown runoff quantities reporting to TIRI02.

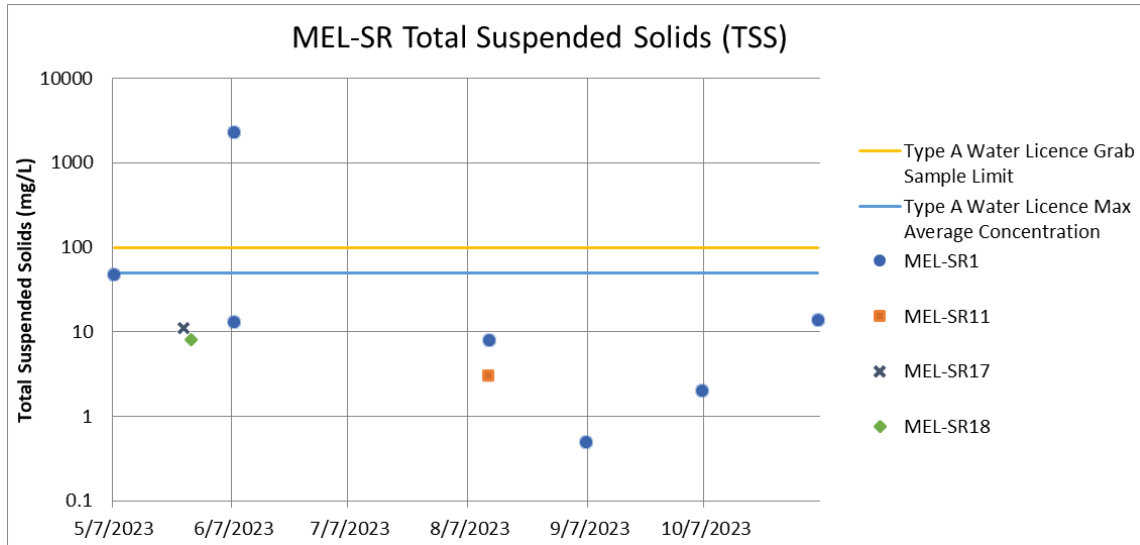
**Figure 21. Total Suspended Solids (TSS) results for MEL-SR samples**

MEL-SR-TBD are surface runoff sampling points pertaining to runoff downstream of construction areas at Meliadine Site and Itivia Site, seeps in contact with roads, earthworks and any runoff and/or discharge from borrow pits and quarries. These are regulated monitoring stations in the Water Licence which includes water quality criteria that must be achieved to maintain compliance. Total suspended solids (TSS) results for all MEL-SR samples collected in 2023 are presented in Figure 21.

One (1) TSS exceedance occurred in 2023, at the monitoring station MEL-SR1. Below is a brief description of the event and the mitigating actions taken to prevent further exceedances at this location. The complete follow-up report can be found in Appendix 14.

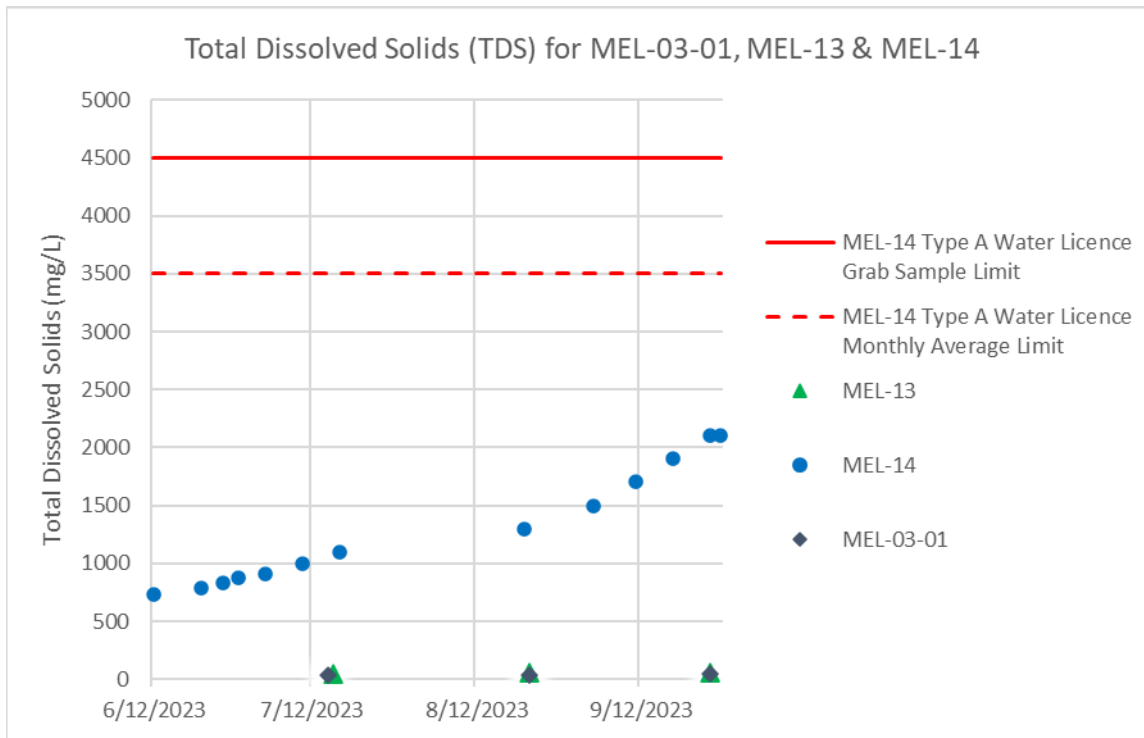
**Figure 23. Total Dissolved Solids (TDS) results for MEL-03-01, MEL-13, and MEL-14 monitoring stations.**

With regards to TDS (calculated), all MEL-14 samples were compliant with the 3,500 mg/L maximum average calculated TDS concentration and 4,500 mg/L maximum grab calculated TDS concentration from the Amended Type A Water Licence. The average calculated TDS concentration at MEL-14 was 1,295 mg/L and the highest measured calculated TDS concentration was 2,100 mg/L. TDS results from sampling at monitoring station MEL-14 in 2023 are presented in Figure 23. A discussion pertaining to the TDS loading sources on site can be found in Section 3.1.8.

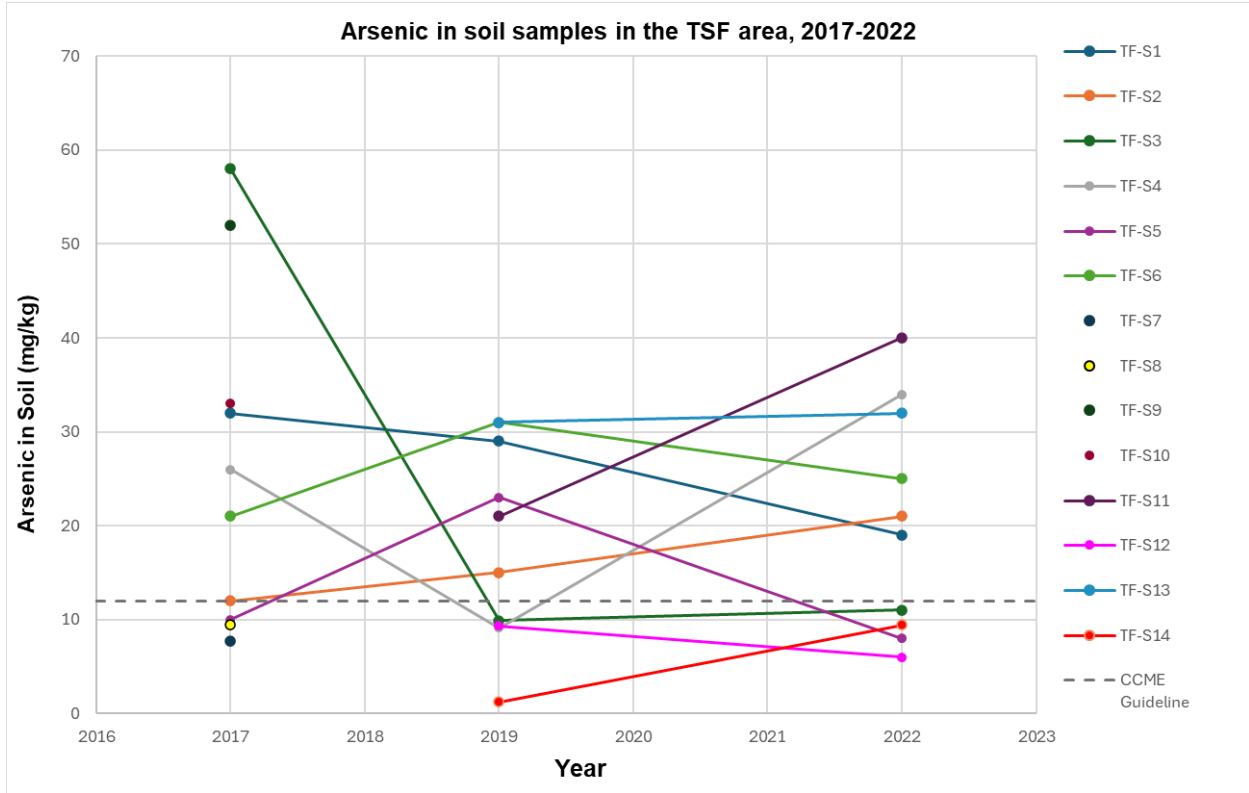
**Figure 27 : Arsenic in soil samples in the TSF area, 2017-2022**

Notes: Stations TF-S7 to TF-S10, sampled in 2017, were not revisited in 2019 and 2022 due to site disturbance. Stations TF-S11 to TF-S14 were created in 2019 to replace disturbed sites and were sampled again at the approximate same location in 2022.

Metal monitoring programs conducted in 2017, 2019, and 2022 reported a variety of arsenic levels in soil – some below the CCME Guideline (of 12 mg/kg) and some exceeding the Guideline, particularly in samples collected immediately adjacent to the Mine (Golder 2018, 2020, and 2023).

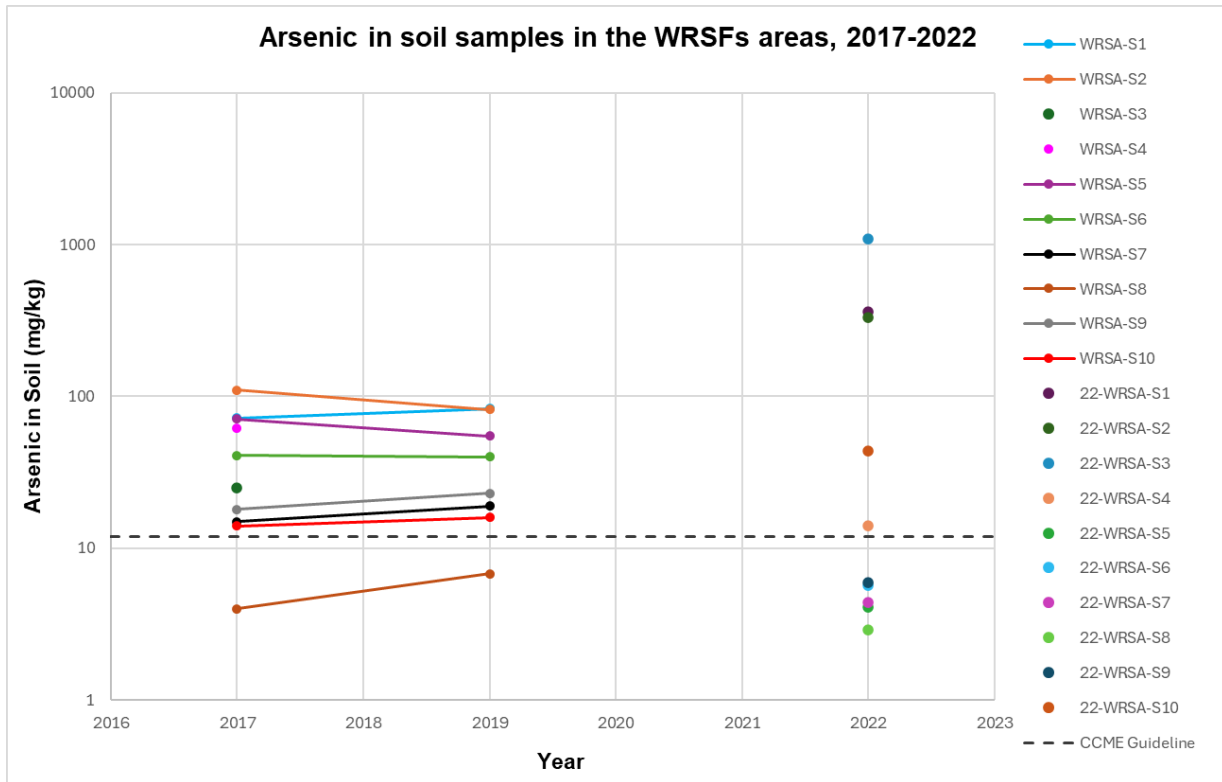
**Figure 28: : Arsenic in soil samples in the WRSFs area, 2017-2022**

Notes: Stations WRSA-S3 and WRSA-S4, sampled in 2017, were not revisited in 2019 and 2022 due to site disturbance. All WRSA stations in 2022 were relocated compared to previous sampling events to replace disturbed sites – they are therefore not linked to previous sampling on the Figure and are labelled 22-WRSA-XX. Arsenic results are presented on a logarithmic scale.
