Appendix 6: 2021 Annual Geotechnical Inspection Report

2021 Annual Geotechnical Inspection Meliadine Gold Project, Rankin Inlet, Nunavut

Agnico Eagle Mines Limited

MARCH 17, 2022 ISSUED FOR USE

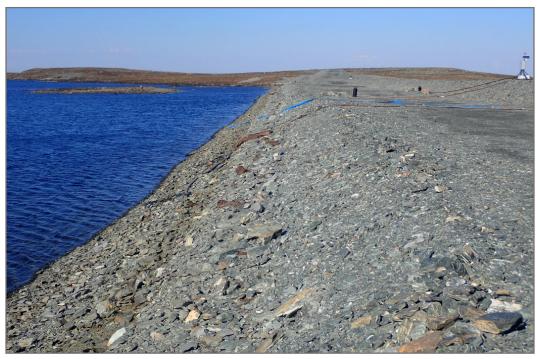
Photo 1: Dike D-CP1 - Upstream face—some wave erosion evident

CP1, Dike D-CP1, and Jetty1 are performing well. Some erosion has occurred on the upstream shell of Dike D-CP1. The erosion should be surveyed to determine if remedial measures are required.

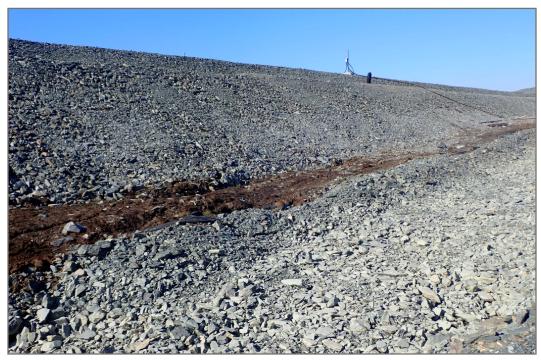
Photo 2: Dike D-CP1—Downstream face, looking south

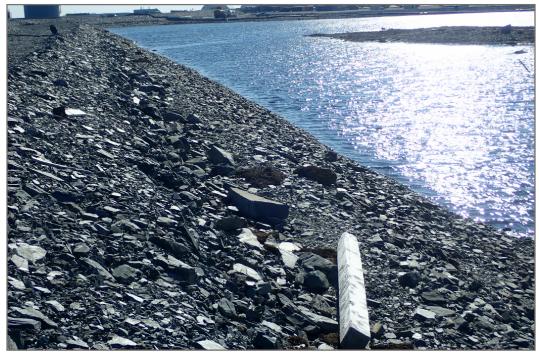
Photo 3: Dike D-CP1 - Upstream face—some wave erosion evident, scarp approximately 1 m high. Erosion also evident on lower portion of slope. Slope is self armouring with larger particles in ROM fill.

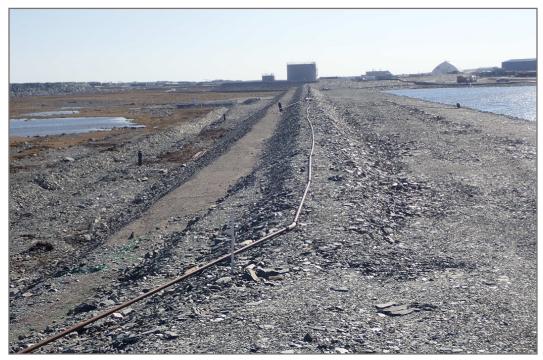
Photo 4: Dike D-CP1 - Crest. Upstream on right, downstream on left.

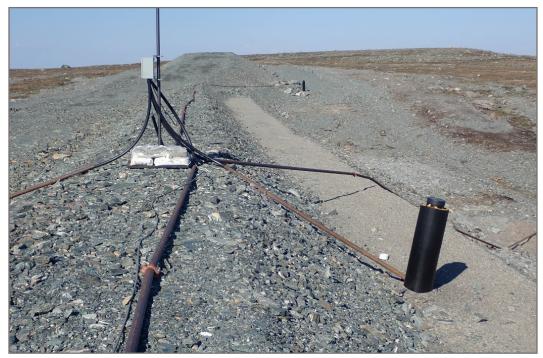
Photo 5: Dike D-CP1 - Crest—Center and downstream. GTC housing and datalogger.

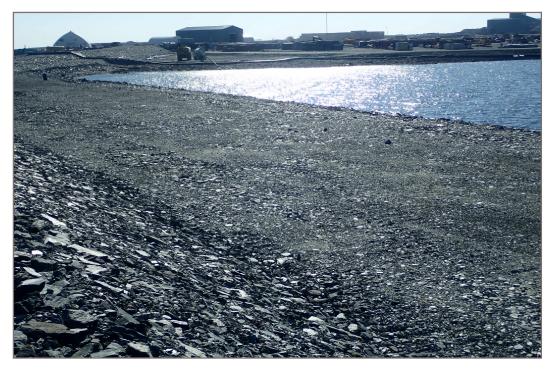
Photo 8: Dike D-CP1 - Upstream crest. Good conditions, west end of dyke.

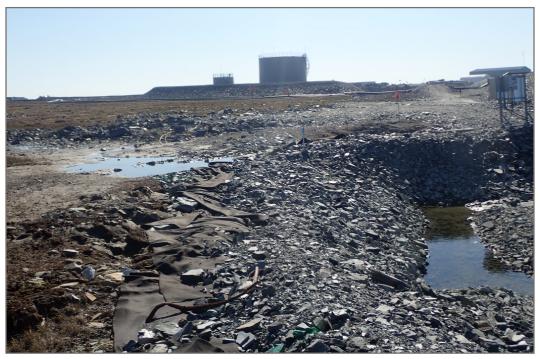
Photo 11: Dike D-CP1 - Water collection pond, southeast corner, deformed fill slope.

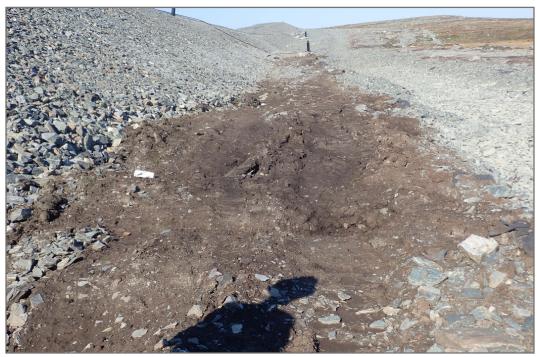
Photo 12: Dike D-CP1 - ground between the Dike toe and water collection channel, settlement and subsidence. Similar to 2020.

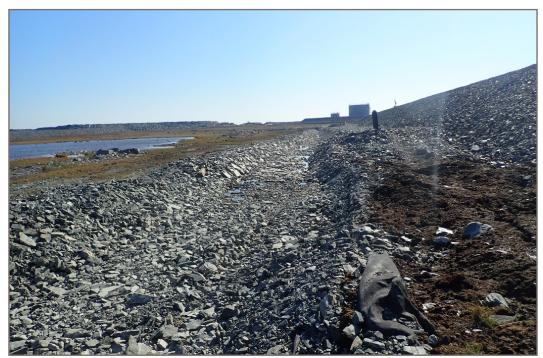
Photo 13: Dike D-CP1 - Seepage collection channel. Subsidence in ground between channel and downstream toe.

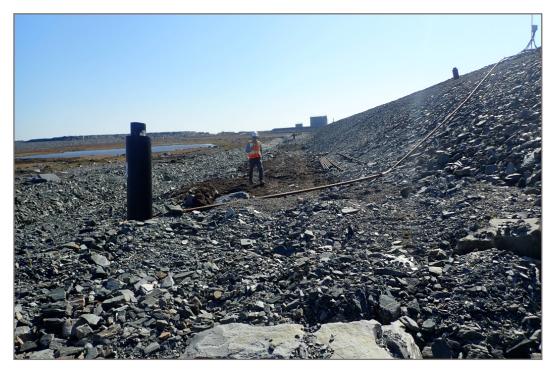
Photo 14: Dike D-CP1 - North end of disturbed ground between dyke toe and seepage collection channel.

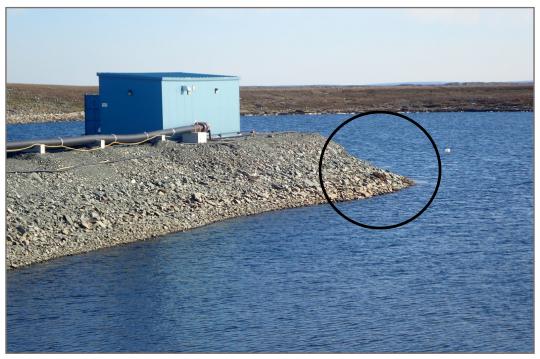
Photo 17: Dike D-CP1 Jetty 1 - Erosion at south east corner of Jetty 1

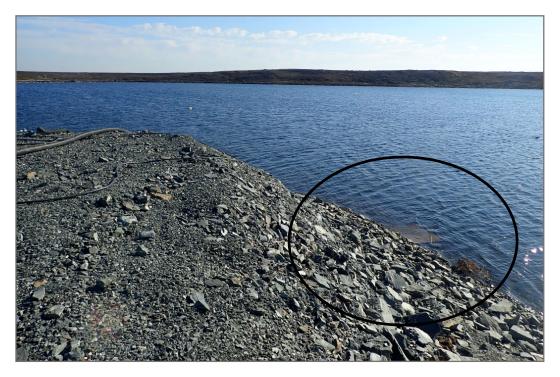
Photo 18: Dike D-CP1 Jetty 1—Erosion at southeast corner—under cutting top portion of fill.

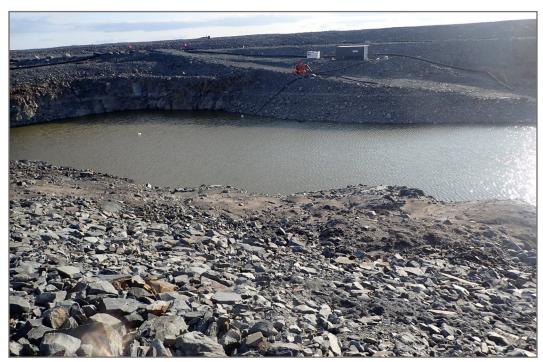
Photo 1: Pond CP3 - Looking southwest, bedrock overburden contact, access ramp into pond.

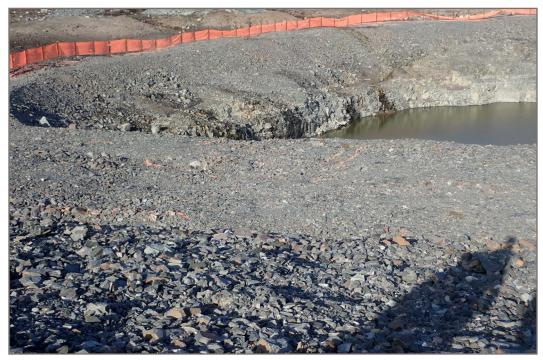
Photo 2: Pond CP3—Looking northeast, water running into CP3 along north side.

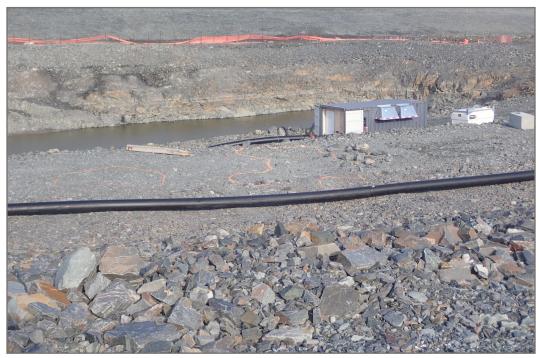
Photo 3: Pond CP3 - Looking east, CP3 berm and rockfill covered overburden in foreground. Settlement along the overburden between CP3 and berm.

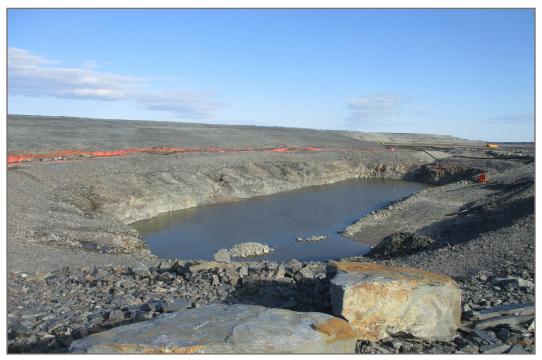
Photo 4: Pond CP3 - Looking south, water level within bedrock.

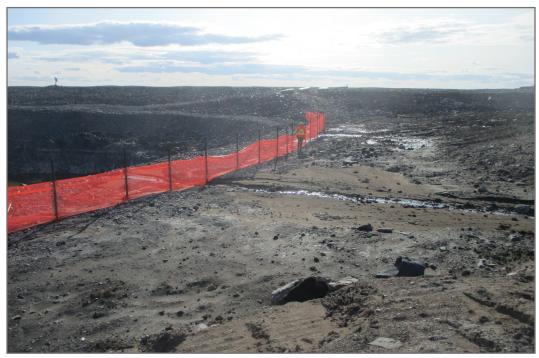
Photo 5: Pond CP3 - Runoff/erosion channels into pond from north end of TSF drainage, located on north side of pond.

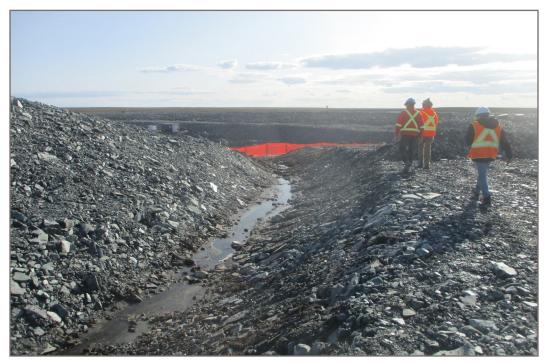
Photo 6: Pond CP3 - Improved runoff channel into pond from north end off TSF drainage , located on east side of pond.

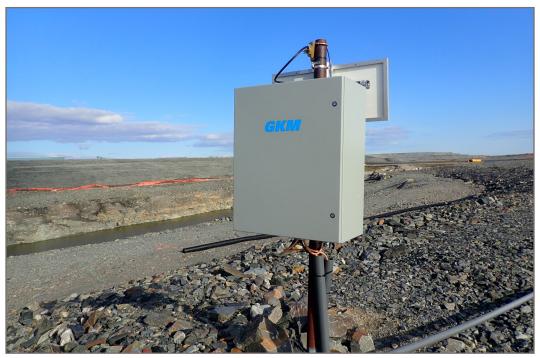
Photo 7: Berm CP3 - GTC instrumentation loggers installed on berm.

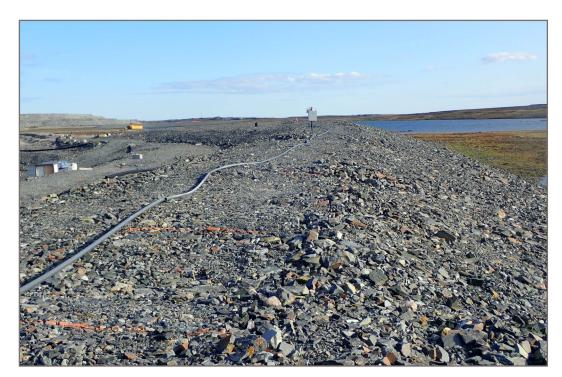
Photo 8: Berm CP3 - Looking south, surface of berm.. Settlement and subsidence.

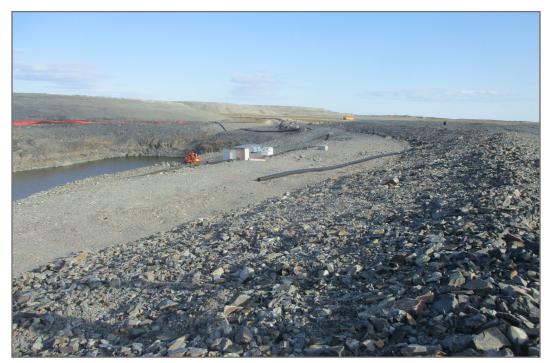
Photo 9: Berm CP3 - Berm crest, looking south. Undulations in crest 0.3 to 0.5 m.

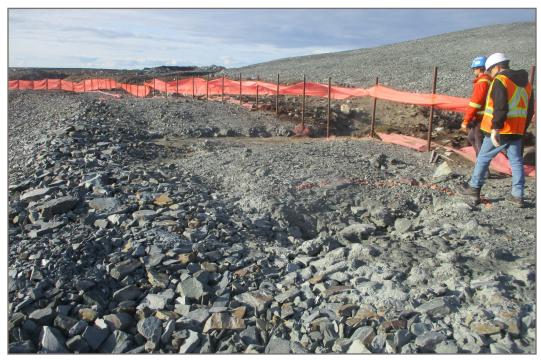
Photo 10: Pond CP3 - Looking north, settlement and erosion at overburden crest.

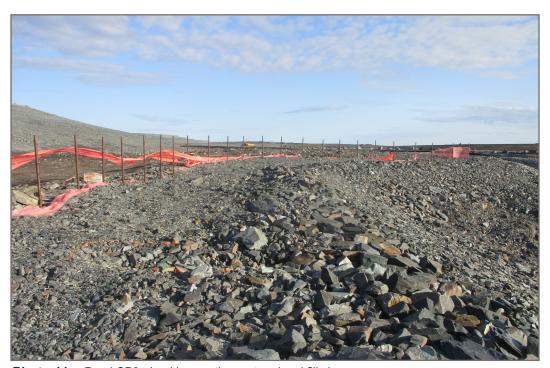
Photo 11: Pond CP3 - Looking south, crest and rockfill slope.

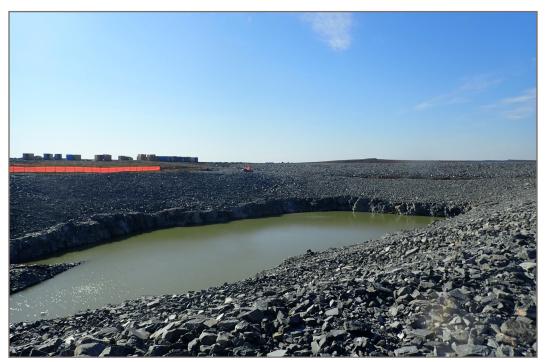
Photo 1: Pond CP4 - Looking west, Berm CP4 in the background.

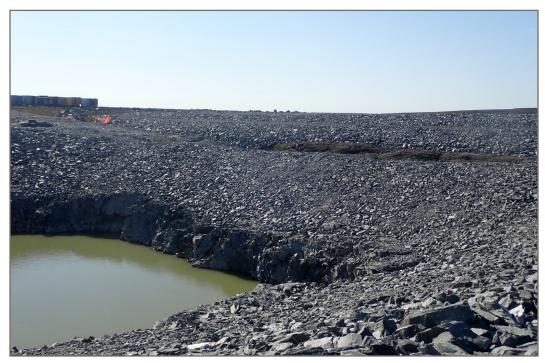
Photo 2: Pond CP4—West end of pond, Berm CP4 on right above pond. Original ground between the Berm CP4 and rockfill covered slope shown.

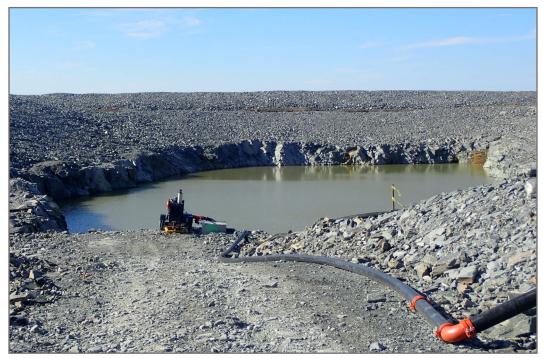
Photo 3: Pond CP4 - Looking north at the ramp into the pond.

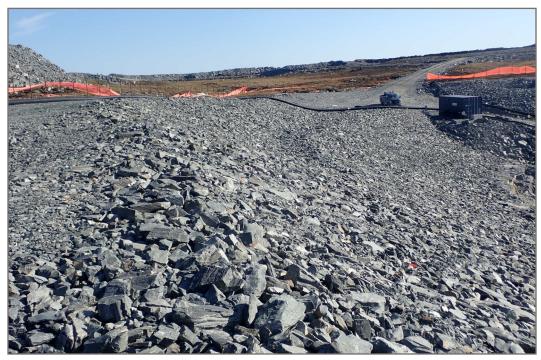
Photo 4: Pond CP4 - North slope—rockfill covered slope, no obvious signs of distress.

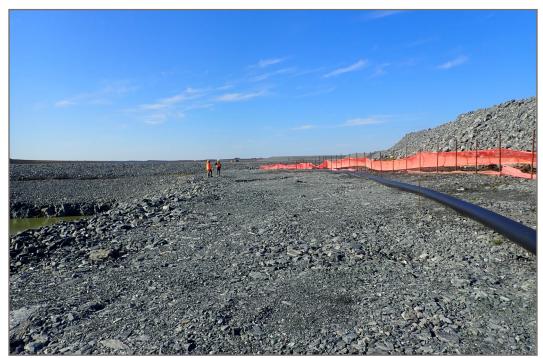
Photo 7: Pond CP4 - Ground above rockfill covered overburden slope. Settlement and subsidence in the area.

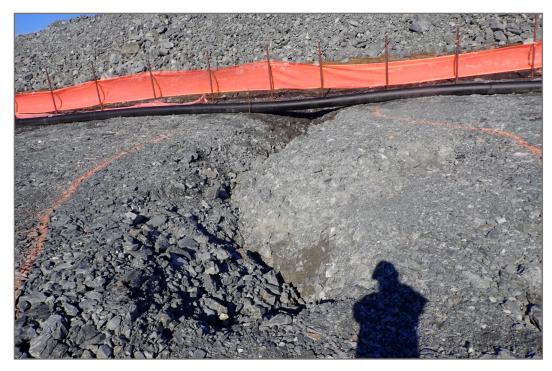
Photo 8: Pond CP4 - North slope, settlement in area between rockfill covered slope on original ground.

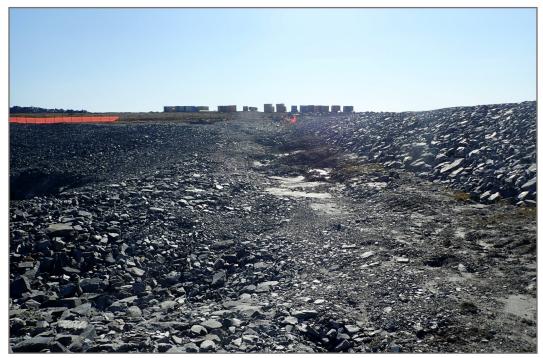
Photo 9: Pond CP4 - Settlement and subsidence between Berm CP4 and west pond slope.

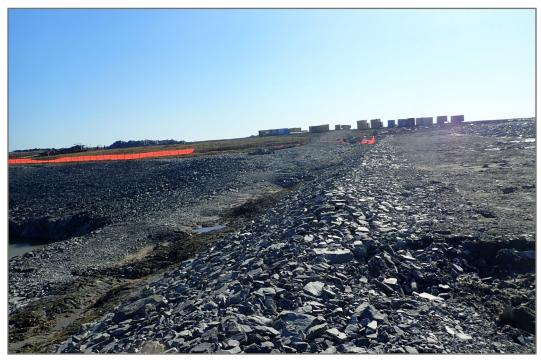
Photo 10: Berm CP4 - Upstream slope, thermal cover and original ground above Pond CP4

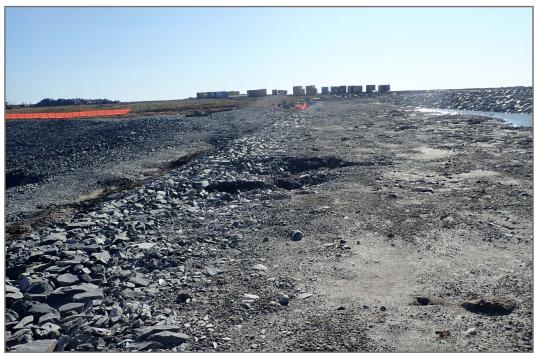
Photo 11: Berm CP4 - Settlement on surface of berm.

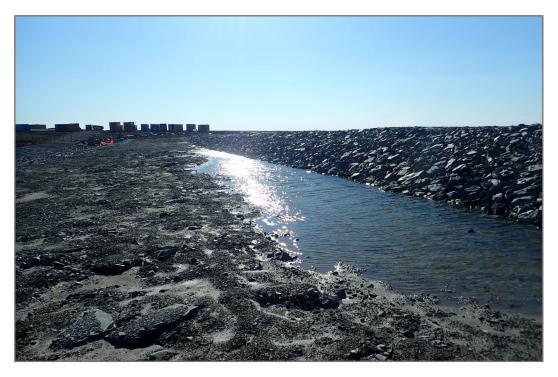
Photo 12: Berm CP4 - Pooling water on thermal berm.

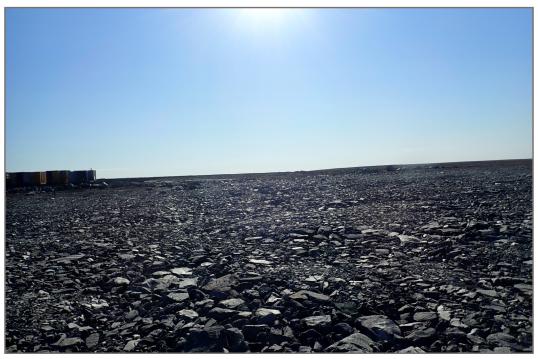
Photo 13: Berm CP4 - Undulating settlement up to 0.3 m throughout surface of berm.

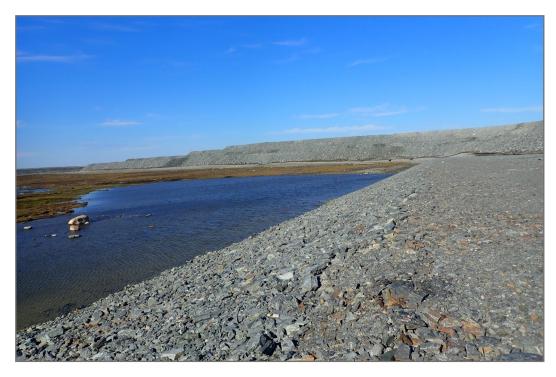
Photo 14: Berm CP4 - Downstream embankment of CP4 berm against lake B8.

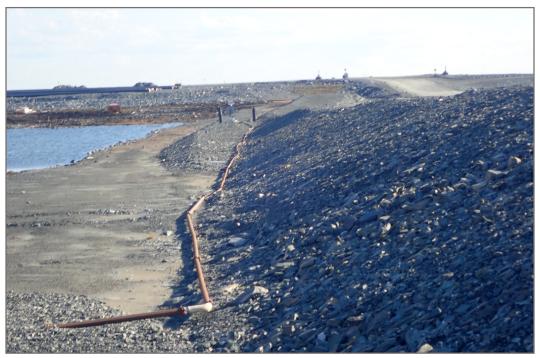
Photo 1: D-CP5 Dike - looking towards the north, upstream.

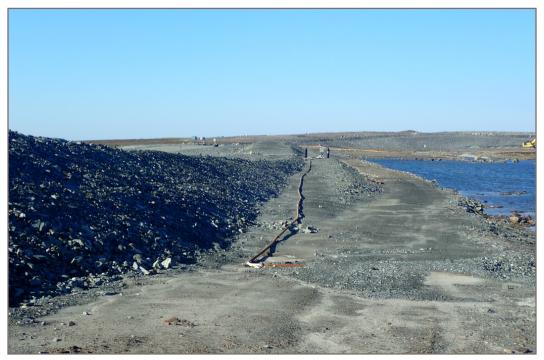
Photo 2: D-CP5 Dike - looking towards the south, upstream.

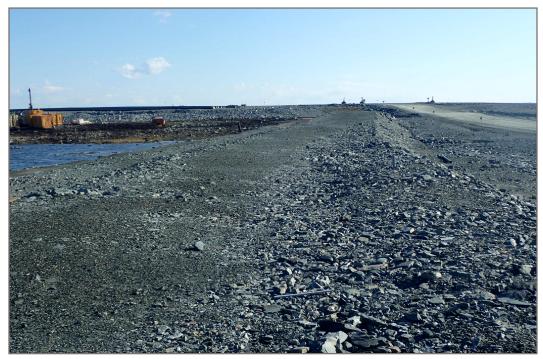
Photo 4: D-CP5 Dike - looking towards the north, centerline and downstream.

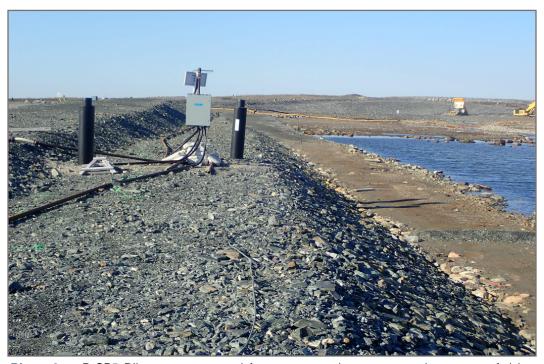
Photo 6: D-CP5 Dike - upstream, and former construction access road upstream of dyke, looking south.

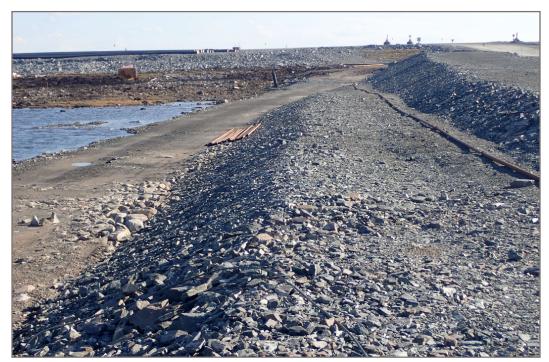
Photo 7: D-CP5 upstream crest, looking north.

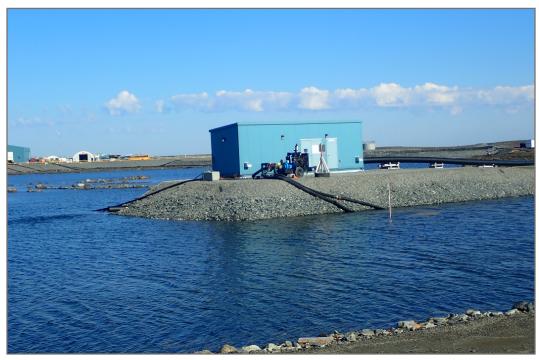
Photo 8: CP5 Jetty 5—Diesel Pumping into Jetty 5 pump well.

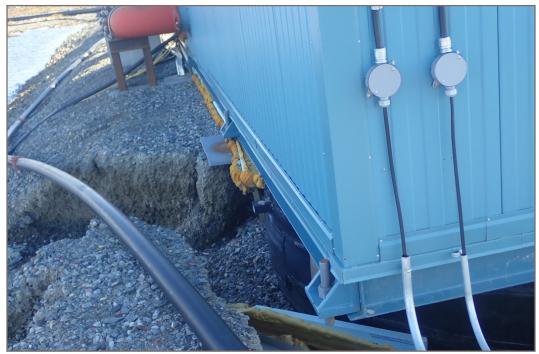
Photo 9: CP5 Jetty 5 - Footing Erosion

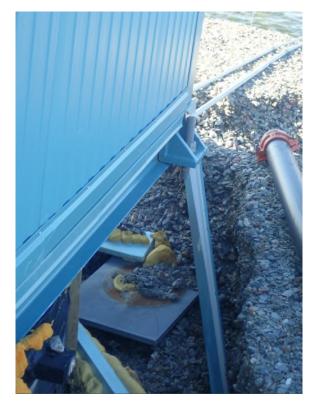
Photo 10: CP5 Jetty 5 - Footing Erosion—Southwest Corner

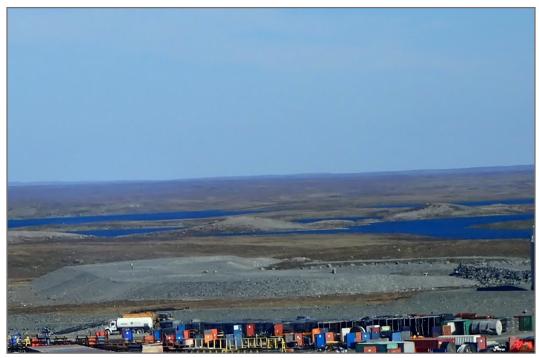
Photo 1: Pond CP6 - Looking east —Berm CP6, CP6.

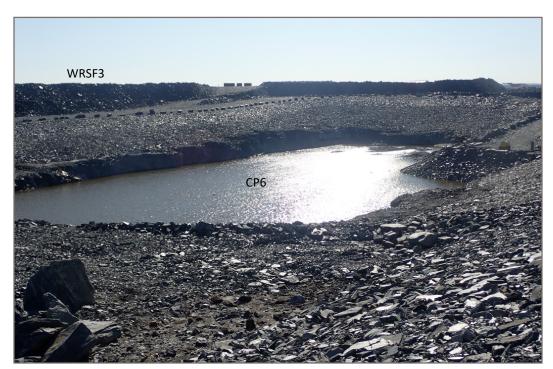
Photo 2: Pond CP6—Looking southwest, ramp into pond. Boulders along ramp. WRSF3

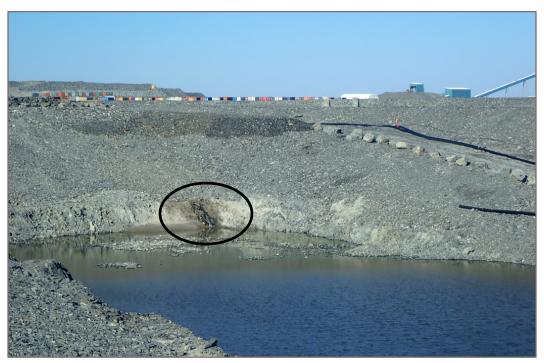
Photo 3: Pond CP6 - Exposed bedrock lower portion of pond, water inflow northwest corner.

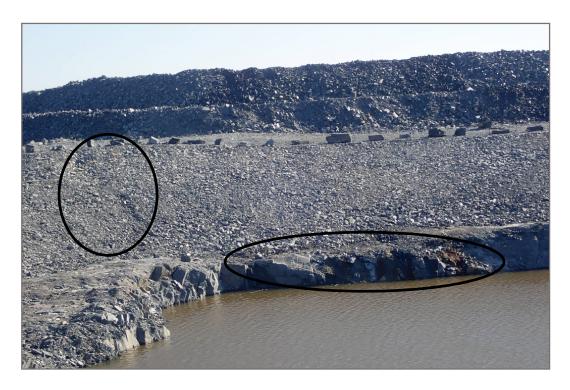
Photo 4: Pond CP6—South side of pond, WRSF3 above pond, water inflow on bedrock surface in southeast corner of pond, deformed ROM, may be indication of subsurface flow.

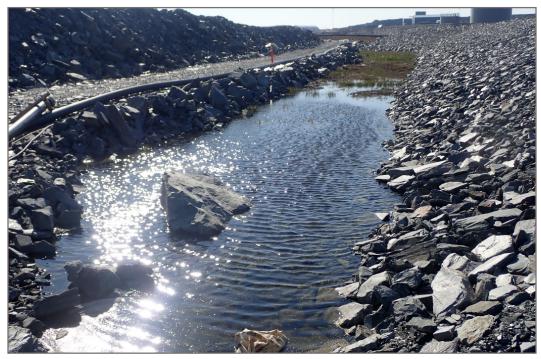
Photo 5: Pond CP6 - Ponded water adjacent to Berm CP6 and access road

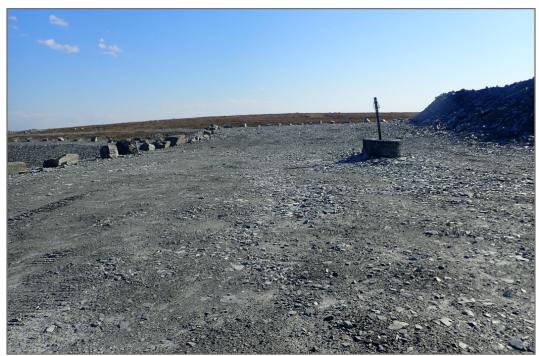
Photo 7: Pond CP6 - Ground between WRSF3 and CP6—filled with ROM June 2021. ROM placed to reduce erosion in former lakebed sediments.

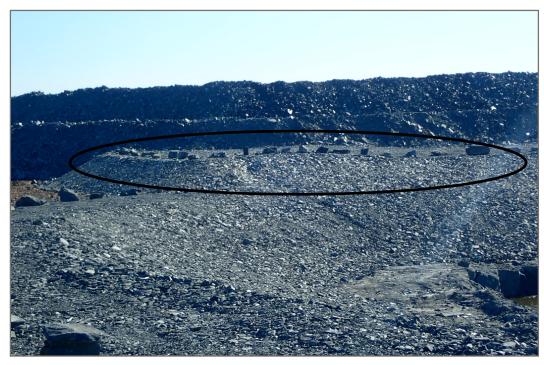
Photo 8: Pond CP6 - Ground between WRSF3 and CP6—filled with ROM June 2021. ROM placed to reduce erosion in former lakebed sediments.

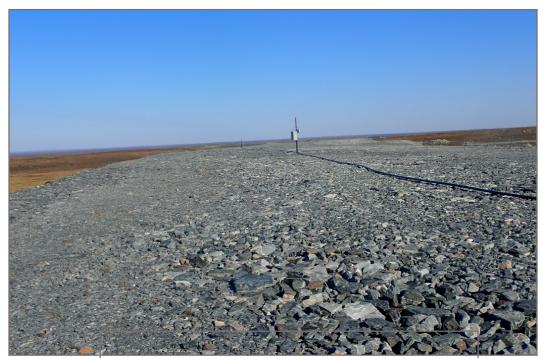
Photo 9: Pond CP6 - Berm CP6 crest. Minimal settlement.

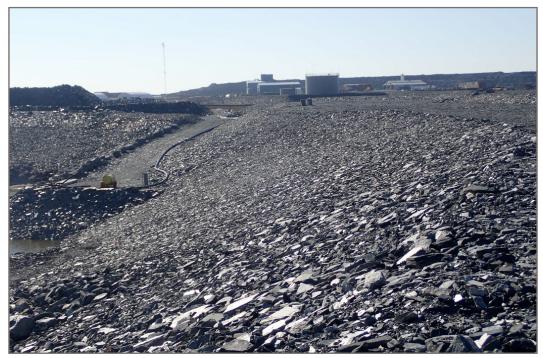
Photo 11: Pond CP6 - Berm CP6—upstream slope

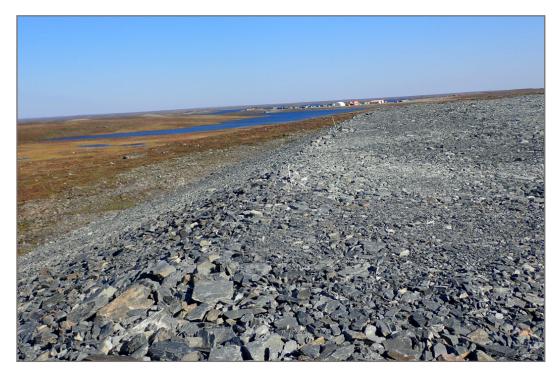
Photo 12: Pond CP6 - Berm CP6 Crest and downstream slope.

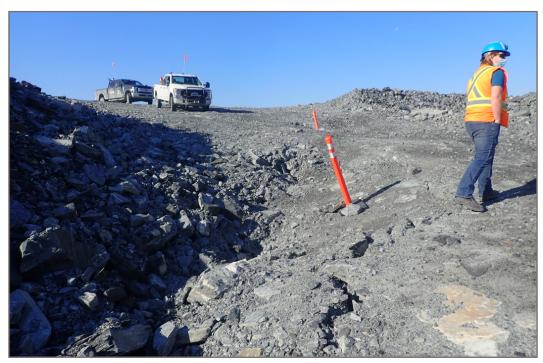
Photo 13: Pond CP6 - Settlement—on ramp from WRSF3 to CP6 area.

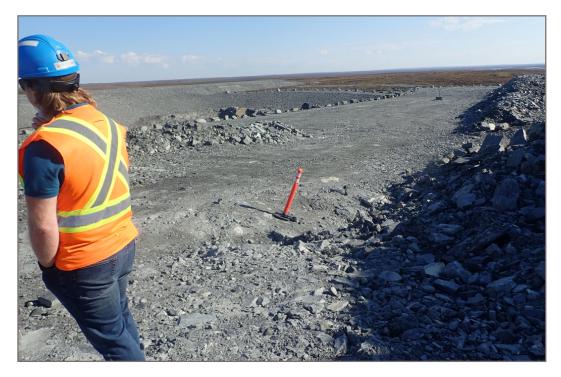
Photo 14: Pond CP6 - Settlement—on ramp from WRSF3 to CP6 area.

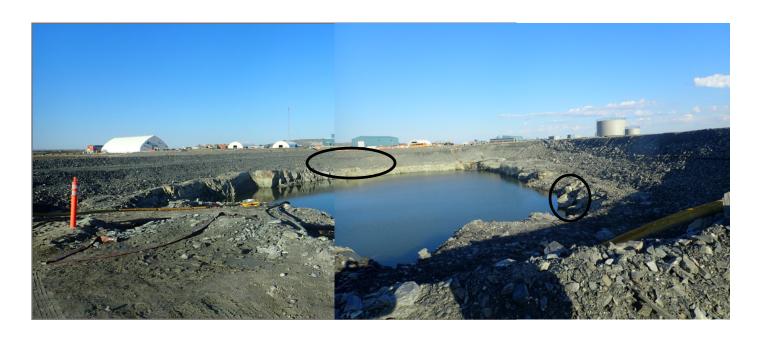
Photo 1: SP1 Saline Pond - looking towards the west. Pond in bedrock, ROM covered overburden slopes

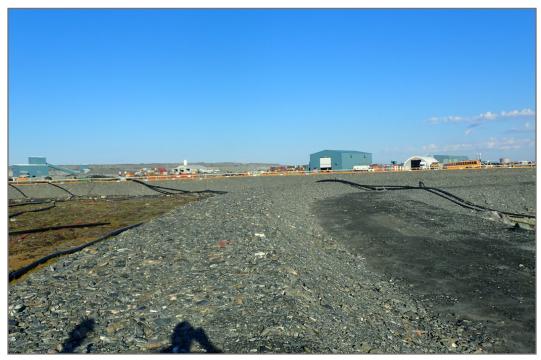
Photo 2: SP1 Saline Pond - Thermal Berm around the pond.

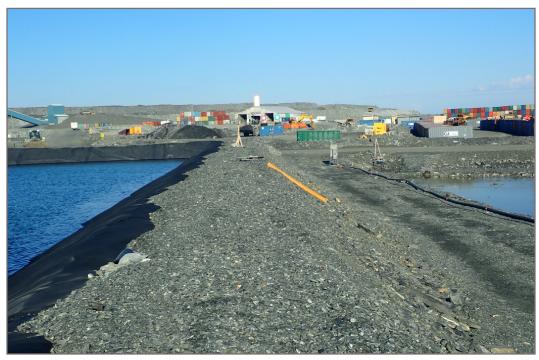
Photo 6: SP3 Saline Pond - looking west, north berm

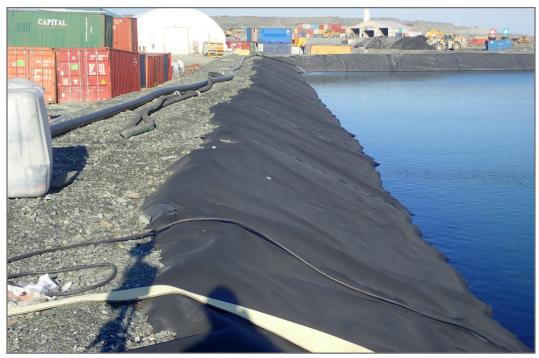
Photo 7: SP3 Saline Pond - looking west—south berm

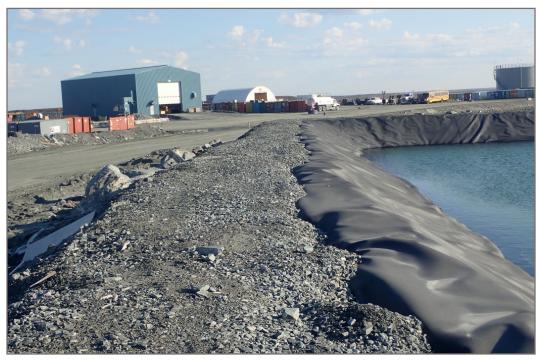
Photo 8: SP3 Saline Pond - west berm.

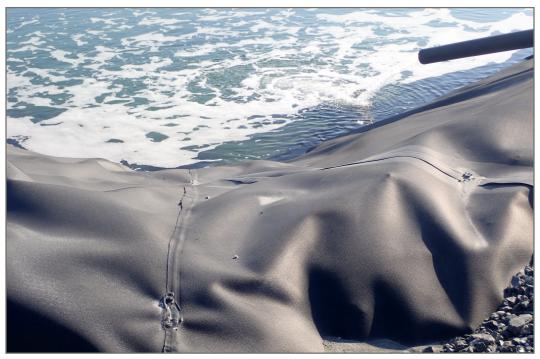
Photo 9: SP3 Saline Pond - discharge into pond.

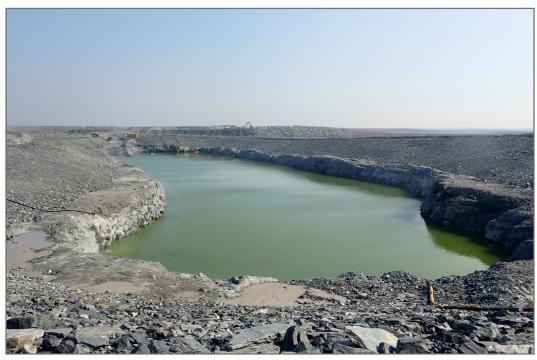
Photo 10: SP4—Looking east. Overburden covered slopes.

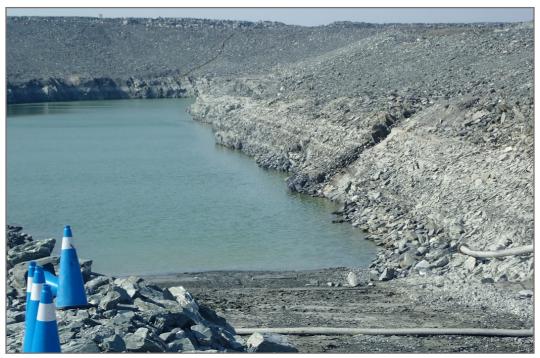
Photo 11: SP4 Saline Pond - looking west—unstable rock area adjacent to ramp.

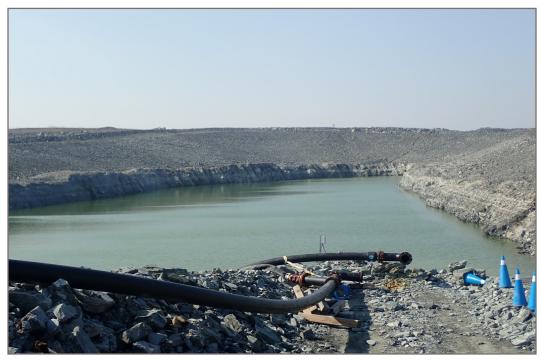
Photo 12: SP4 Saline Pond - looking west. Ramp into pond.

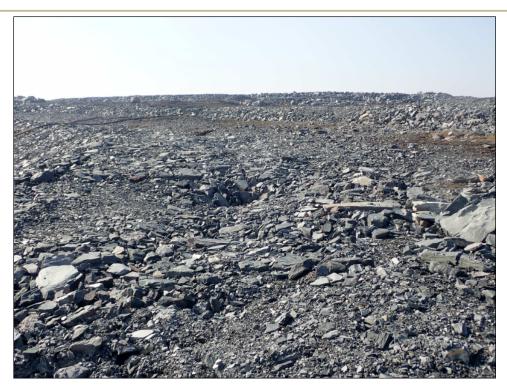
Photo 13: SP4 Saline Pond - Thaw subsidence in crest of rockfill cover.

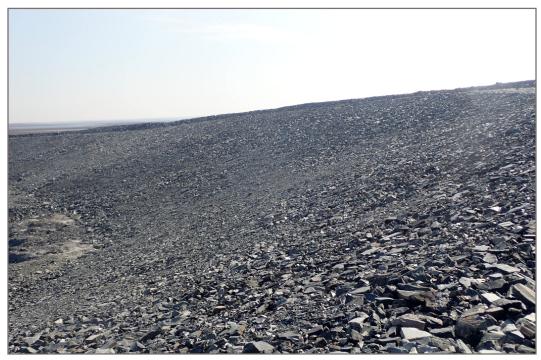
Photo 14: SP4—Rockfill covered overburden slope.

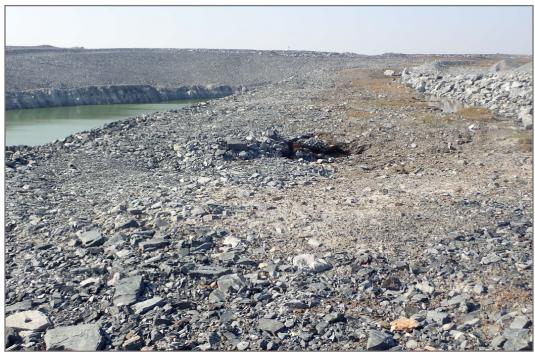
Photo 15: SP4 Saline Pond—Subsidence in original ground at crest of slope, behind rockfill cover.

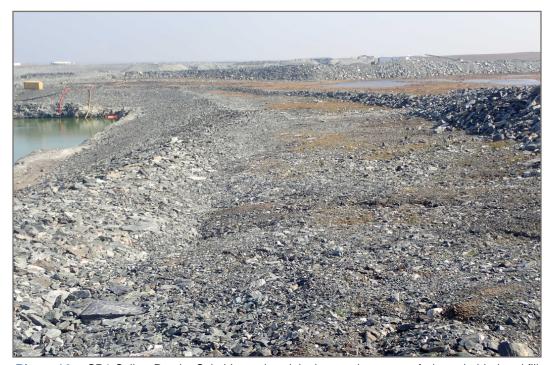
Photo 16: SP4 Saline Pond - Subsidence in original ground at crest of slope, behind rockfill cover.

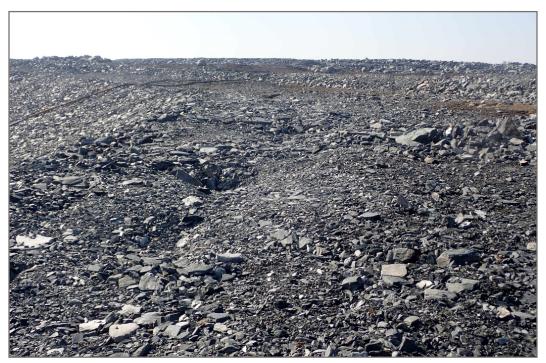
Photo 17: SP4 Saline Pond —Settlement in rockfill crest covering overburden slope.

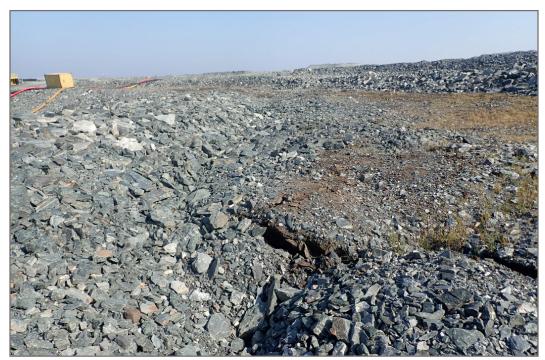
Photo 19: SP4 Saline Pond —Settlement in behind rockfill cover.

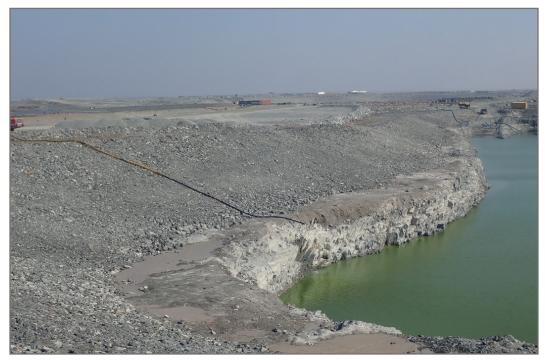
Photo 20: SP4 Saline Pond—Rockfill cover, no significant deformation. Bedrock below slope.

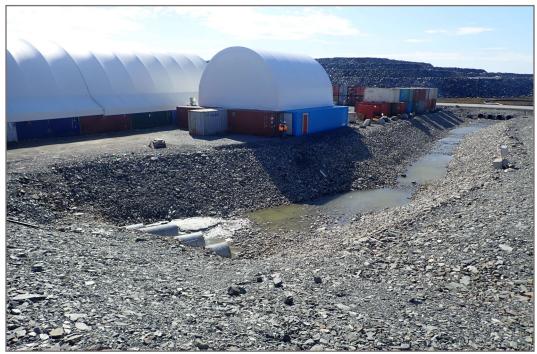
Photo 1: Channel 1—Upper reach, crusher ramp embankment in foreground, looking southwest.

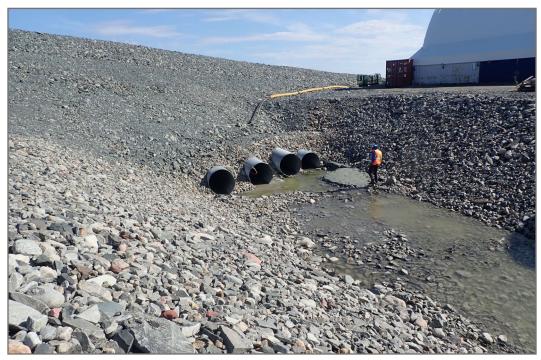
Photo 2: Channel 1—Culvert under the crusher ramp, Berm 1 on the right.

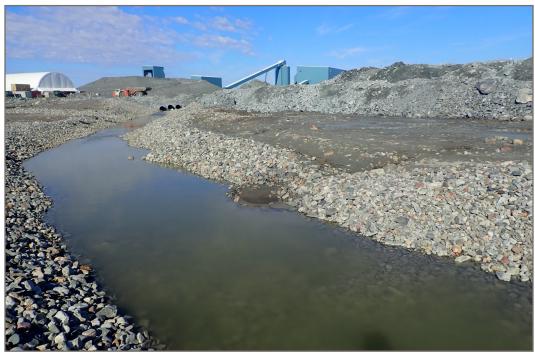
Photo 3: Channel 1—Downstream of crusher ramp, crest subsidence and erosion into channel.

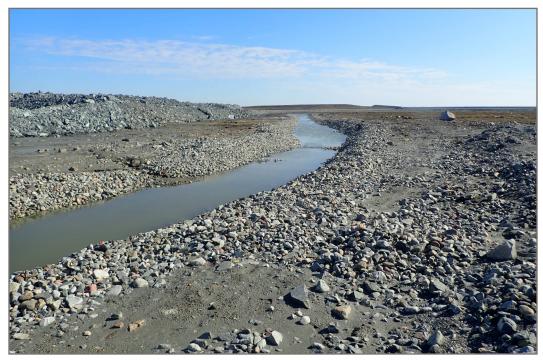
Photo 4: Channel 1—Lower reach to Lake H9, adjacent to ore stockpiles on left.

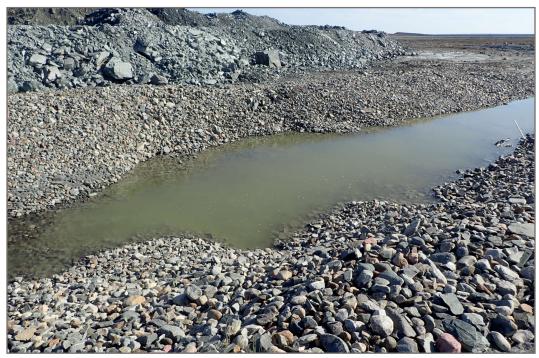
Photo 5: Channel 1—Subsidence of channel base and slopes.

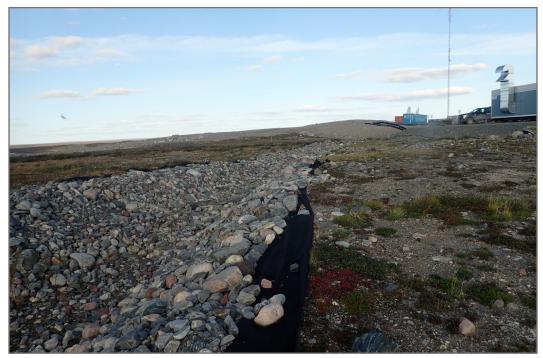
Photo 7: Channel 2—Upper reach, site camp to the right, looking east.

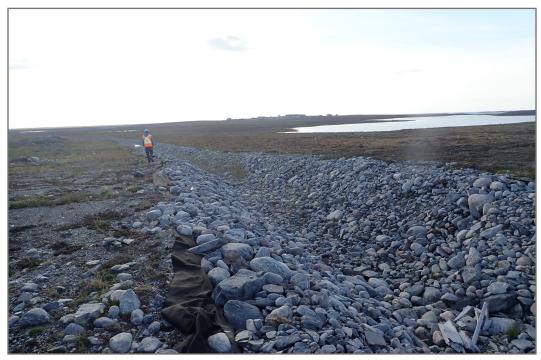
Photo 8: Channel 2—In good condition.

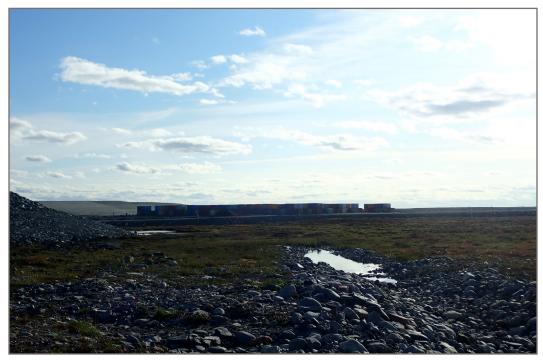
Photo 10: Channel 2—Lower reach, water pooling around discharge.

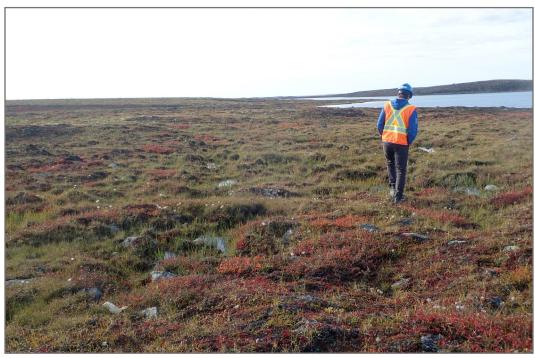
Photo 11: Channel 2—Discharge water potentially able to flow towards Lake G2 due to wet conditions, looking north.

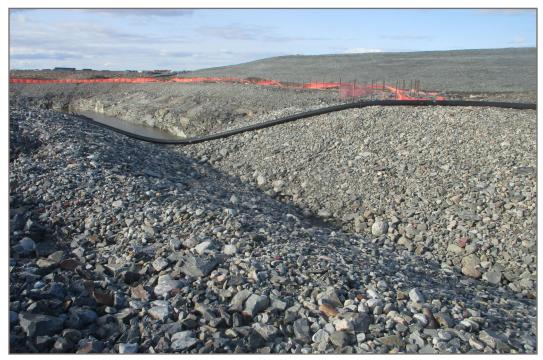
Photo 12: Channel 3—Discharge into CP3.

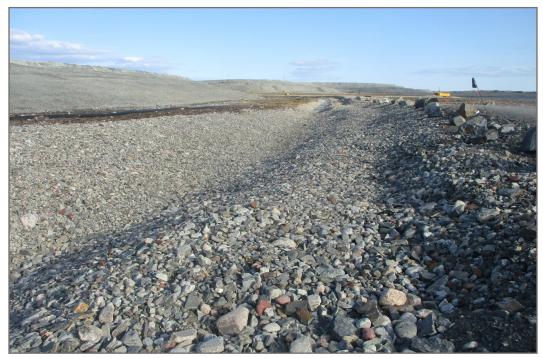
Photo 13: Channel 3—Lower reach, TSF adjacent on left of photo.

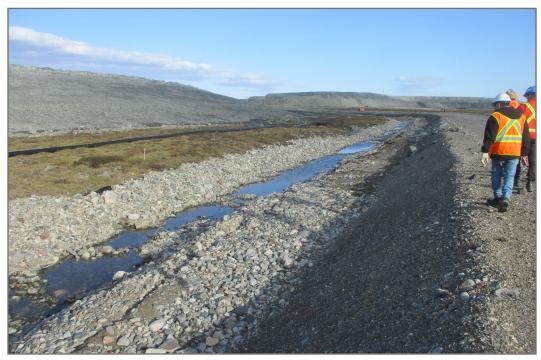
Photo 14: Channel 3—Undulating settlement along base of channel causing ponding.

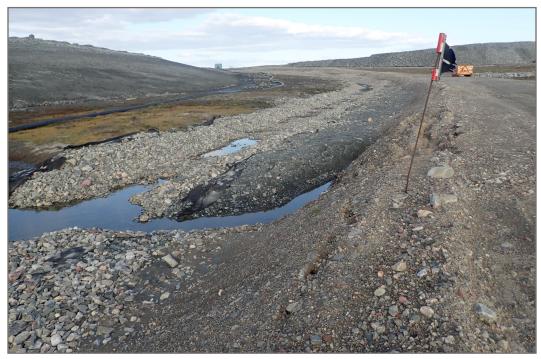
Photo 16: Channel 3—Significant subsidence across channel alignment and subsequent cracking along road side slope, looking northwest.

Photo 17: Channel 3—Same location as Photo 16, looking southeast.

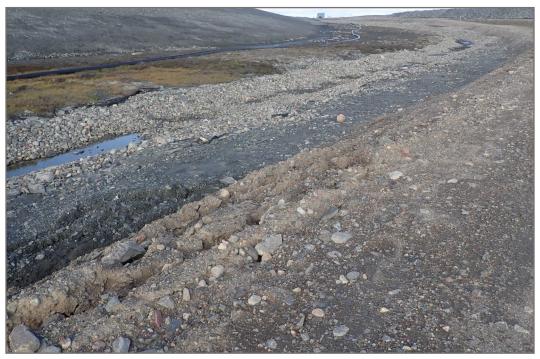
Photo 19: Channel 3—Upper reach, looking east.

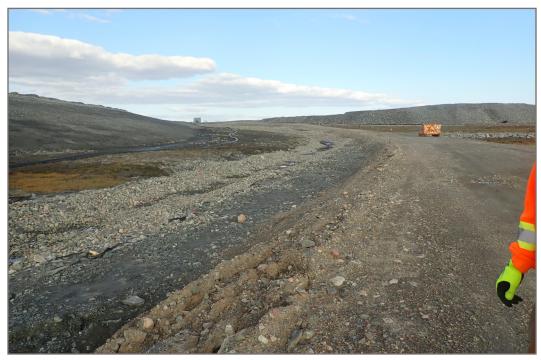
Photo 20: Channel 3—Cracking along road side berm.

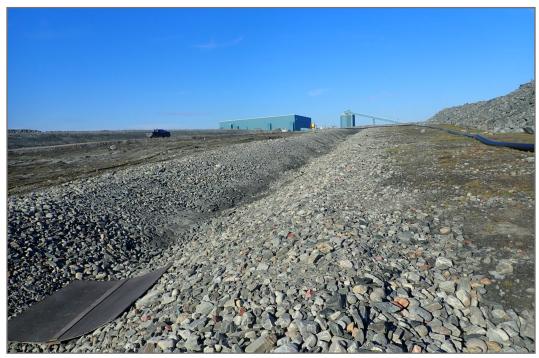
Channel 4 was constructed to divert runoff from the catchment area from WRSF1 into Pond CP4. The as-built side slopes range from 3.5H:1.0V to 1.8H:1.0V with the base of the channel varying from 0.8 m to 3.3 m wide. Channel 4 is shown in Photos 21 to 32, Appendix H. No water was flowing in the channel at the time of the inspection; however, there were localized areas of shallow ponded water due to an uneven base of the channel. It appears there has been some thaw subsidence in the base of the channel. There are also some subsidence areas where the channel ties into the native subgrade, east of the channel.

Photo 21: Channel 4 - Upper reach, below landfill.

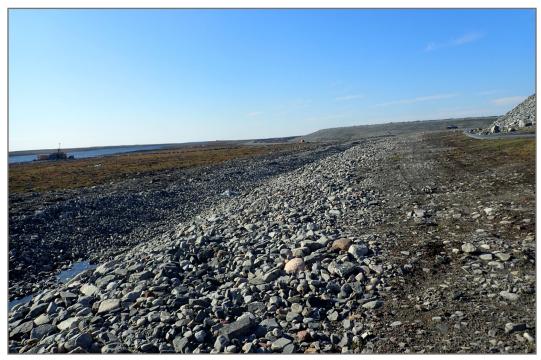
Photo 22: Channel 4—TSF in background, looking northwest.

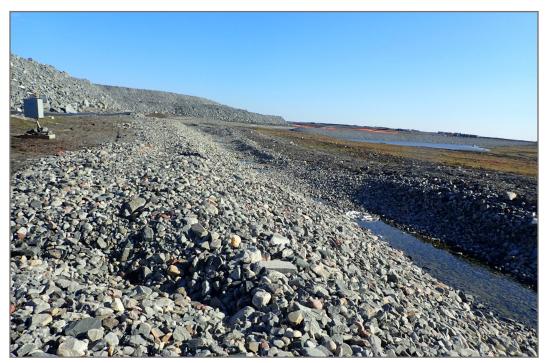
Photo 23: Channel 4 - Settlement in base of channel resulting in minor ponding.

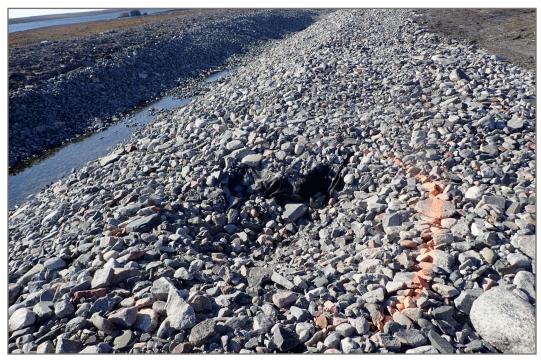
Photo 24: Channel 4 - Minor subsidence between original ground and channel rip rap.

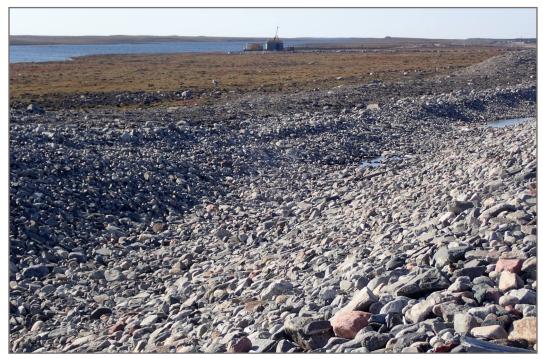
Photo 25: Channel 4 - Subsidence in upstream slope (east slope) of channel.

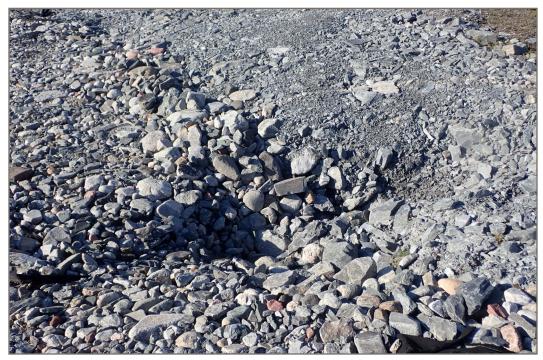
Photo 26: Channel 4 - Subsidence between overburden and rip rap.

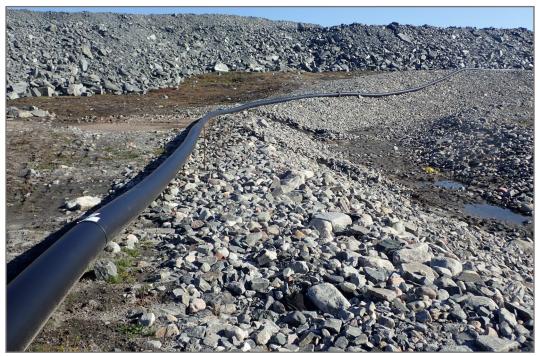
Photo 27: Channel 4 - Low point along upstream of channel crest with preferential flow paths into channel.

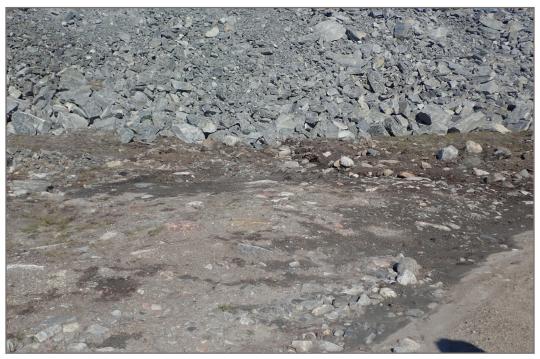
Photo 31: Channel 4—Surface flow path from toe of WRSF1 towards channel.

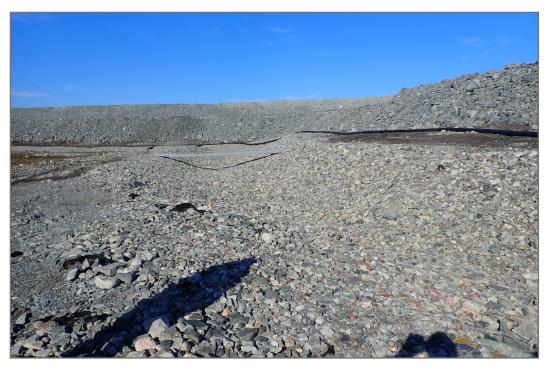
Photo 32: Channel 4—Lower reach, adjacent to WRSF1.

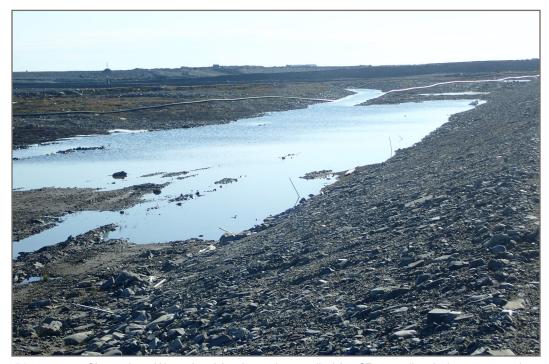
Channel 5 was inspected by walking along its length. Channel 5 is shown in Photos 33 to 36, Appendix H. Overall Channel 5 appeared stable, with no significant geotechnical concerns identified along most of the channel. There was significant subsidence observed adjacent to a former pond at the north end of the channel, with slumping channel slopes. The slumping area is not restricting flow in the channel. Water was ponded within the portions of the channel.

Photo 34: Channel 5—Water level in channel controlled by CP5, pooling in low area against Berm3, looking east. Berm 5 on the right of the photo.

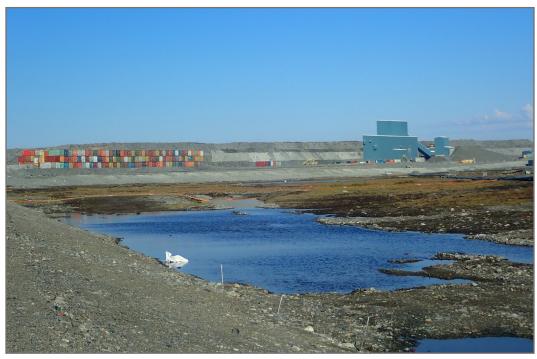
Photo 35: Channel 5—Pooling against Berm3, looking northwest.

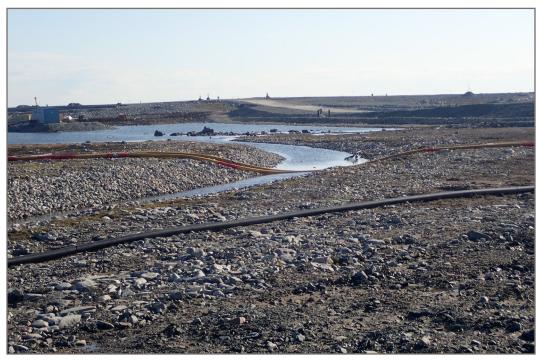
Photo 36: Channel 5—Lower reach, outlet into CP5, looking northeast.

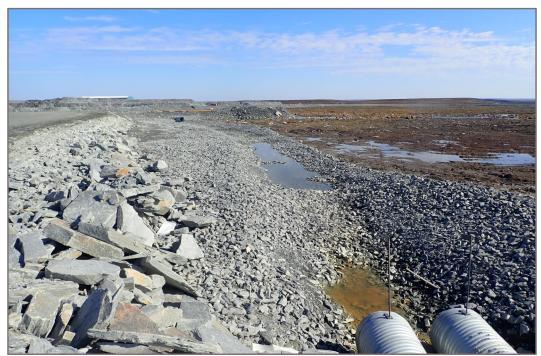
Channel 7 was inspected by walking along its length. The channel is shown in Photos 37 to 39, Appendix H. There is ponded water in portions of the channel, due to some subsidence in the channel base. No significant geotechnical concerns were identified along the channel.

Photo 37: Channel 7—Upper reach, minor subsidence and pooling at bottom of channel, looking north.

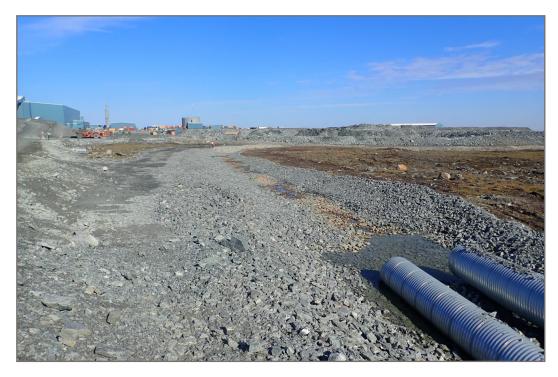
Photo 38: Channel 7—Lower reach, in good condition.

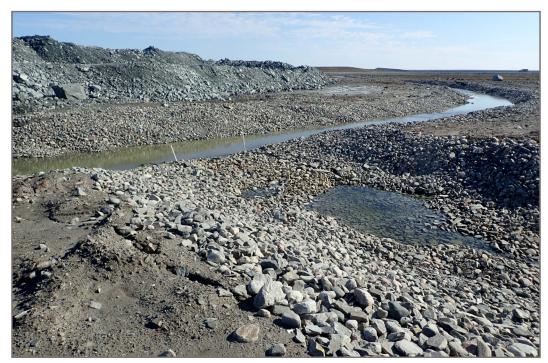
Photo 39: Channel 7—Outlet into Channel 1, ore stockpile in background.

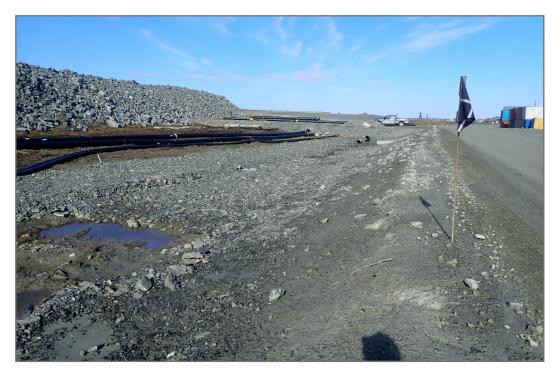
Photo 40: Channel 8—East of WRSF1.
