Appendix 6: 2021 Annual Geotechnical Inspection Report

2021 Annual Geotechnical Inspection Meliadine Gold Project, Rankin Inlet, Nunavut

Agnico Eagle Mines Limited

MARCH 17, 2022 ISSUED FOR USE

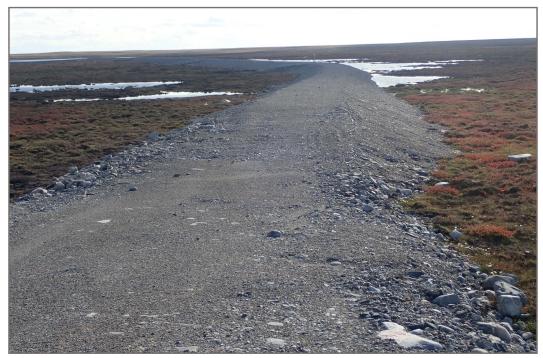
Berm 2 was constructed to reduce the amount of non-contact water entering the TSF and Collection Pond CP3 catchment areas as shown in Photos 41 to 44, Appendix H. Berm 2 was predominately constructed of 50 mm minus screened esker material with a till zone approximately 2 m wide. At the time of the inspection Berm 2 was retaining water in a low area along the berm. The water was up to approximately 0.6 m deep. Minor surface erosion was observed along the lower slope of the berm indicating that the water may have been 0.5 m higher sometime prior to the inspection. There was minimal water on the downslope side of the berm indicating that the berm is functioning

Photo 41: Berm 2— Esker and till berm upslope of TSF

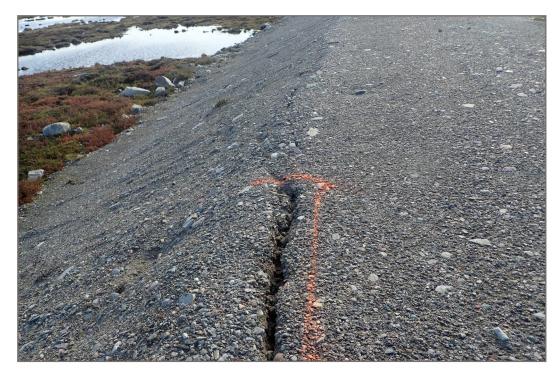
Photo 42: Berm 2—Cracking on upstream slope.

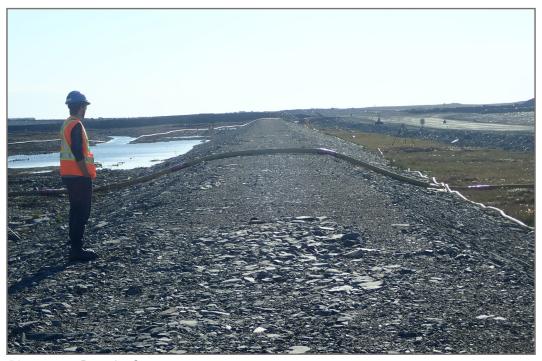
Berm 3 adjacent to Channel 5 was inspected by walking along the crest and slopes and examining the condition of the berm for visual signs of deformation and instability, cracking, or uneven surfaces. A selection of photographs from the inspection are included in Appendix H (Photos 45 to 48). Minor cracking was observed in a location where there was a small amount of ponded water. Overall, Berm 3 appeared stable with no significant geotechnical concerns identified.

Photo 45: Berm 3—Crest

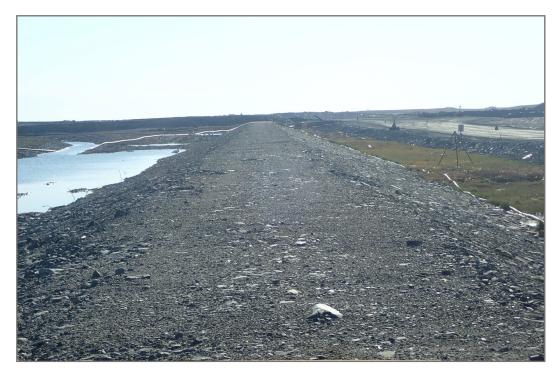
Photo 46: Berm 3 Crest, Channel 3 on the left.

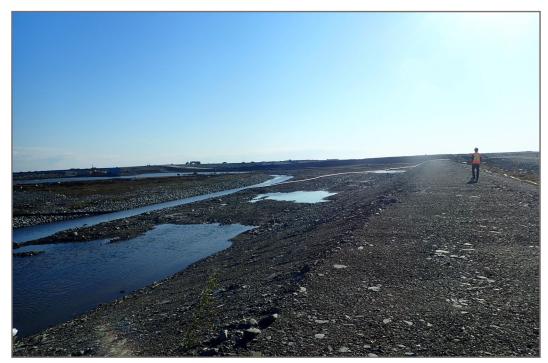
Photo 47: Berm 3, Channel 5 and CP5 on the left. Upstream slope of berm.

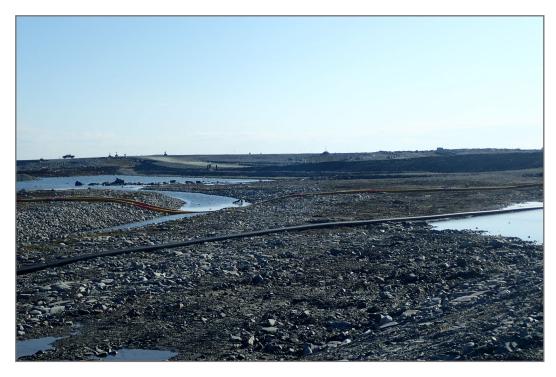
Photo 48: Berm 3—Channel 5 inlet to CP5.

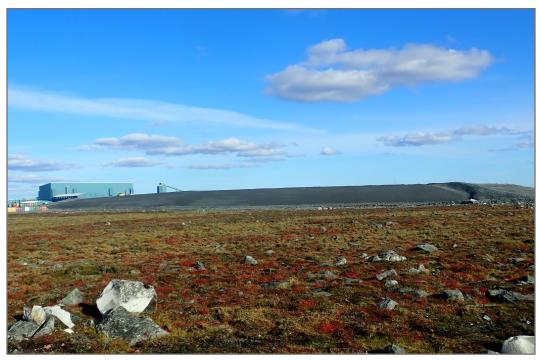
Photo 1: TSF - North side of Cell 1

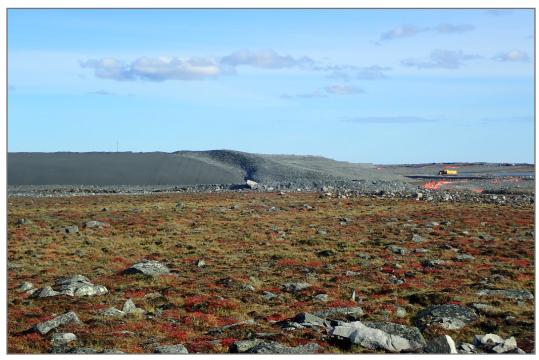
Photo 2: TSF—North side of Cell 1—Rockfill slope covering west side of TSF

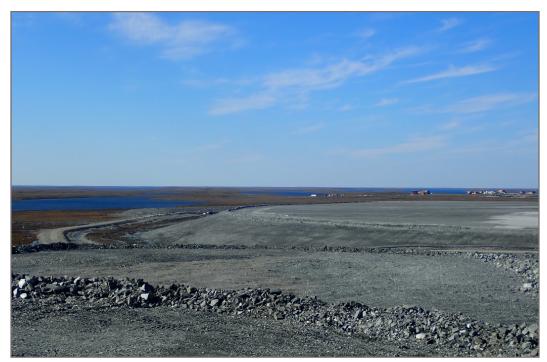
Photo 3: TSF - South slope, Channel 3 on left of photo.

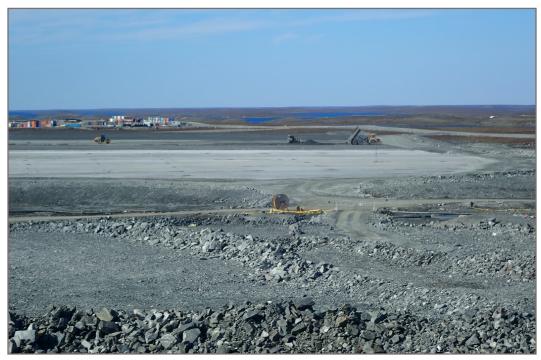
Photo 4: TSF - Placing tailings. White precipitate on some previously placed tailings.

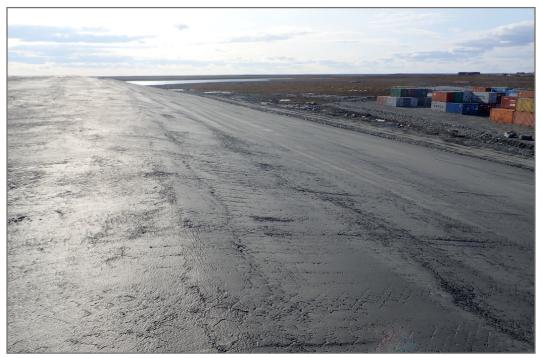
Photo 7: TSF - Slope between Cell 1 and future Cell 2.

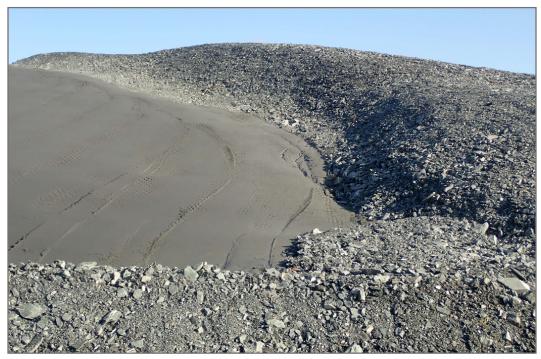
Photo 9: TSF - contact between rockfill cover and tailings at the northwest corner of Cell 1.

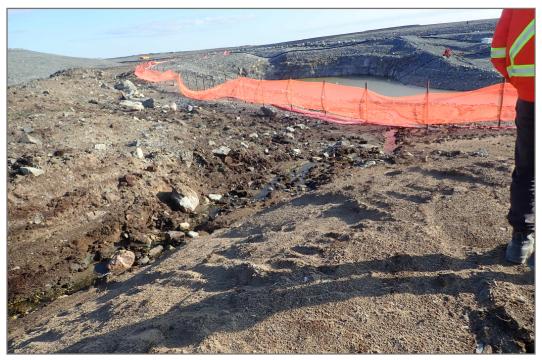
Photo 10: TSF - Drainage from Cell 1 directed to CP3

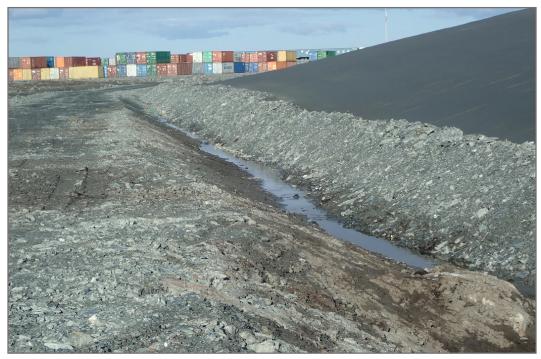
Photo 11: TSF - Channel at north edge of Cell 1.

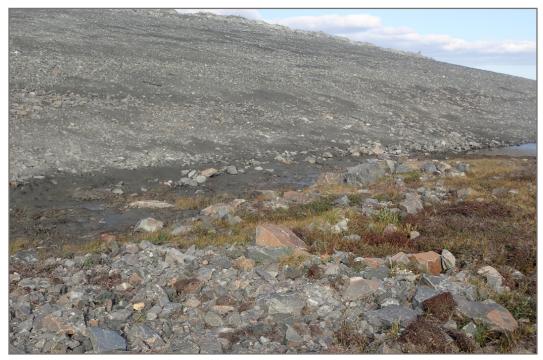
Photo 12: TSF - West slope of TSF. Sediment at toe of TSF slope.

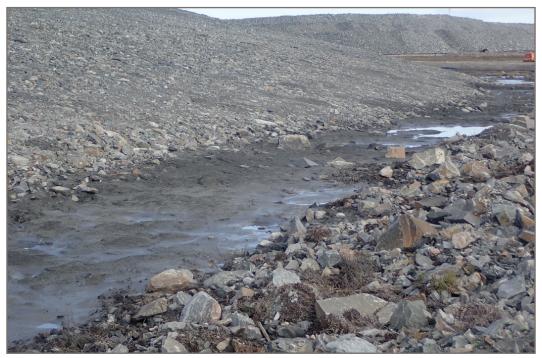
Photo 13: TSF - West slope. Sediment at toe of slope.

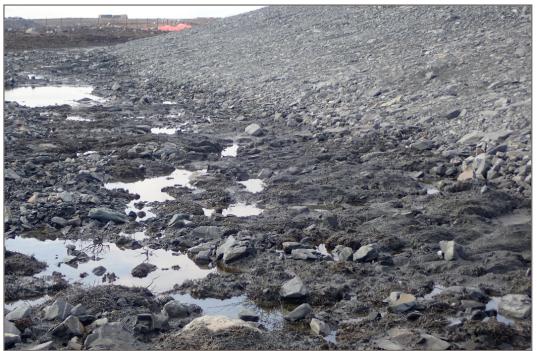
Photo 14: TSF - Sediment at toe of slope.

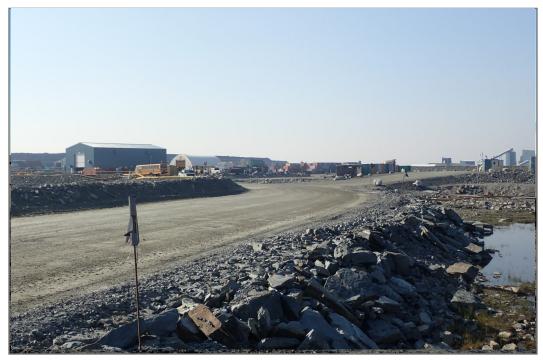
Photo 2: Site Roads—Road adjacent to SP1, looking northwest.

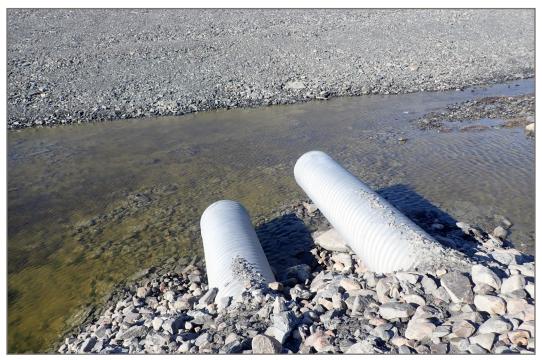
Photo 9: Site Roads—Culvert #18 Inlet.

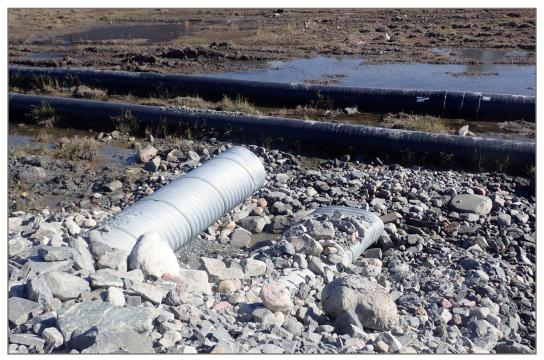
Photo 10: Site Roads—Culvert #18 Outlet. Lower pipe crushed.

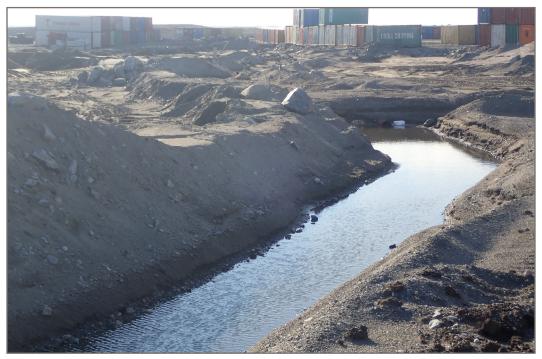
Photo 5: Meliadine Esker—Water management channel through esker deposit.

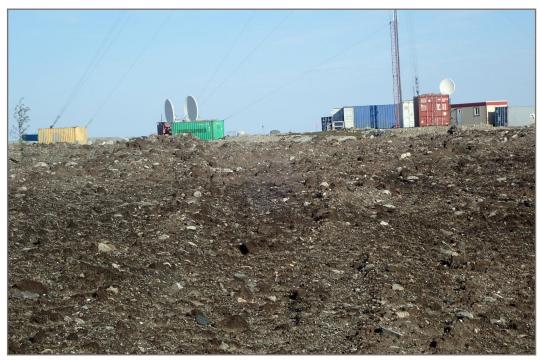
Photo 6: Meliadine Esker—Reclaimed area from esker excavation.

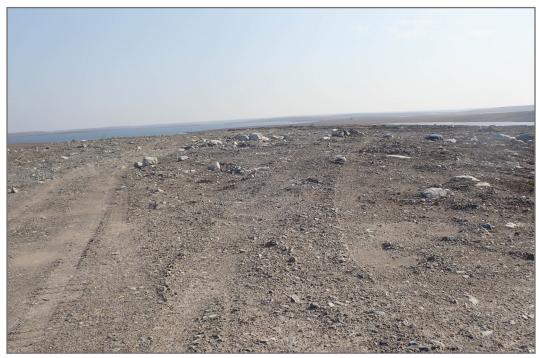
Photo 7: Wesmeg Esker—Looking southeast.

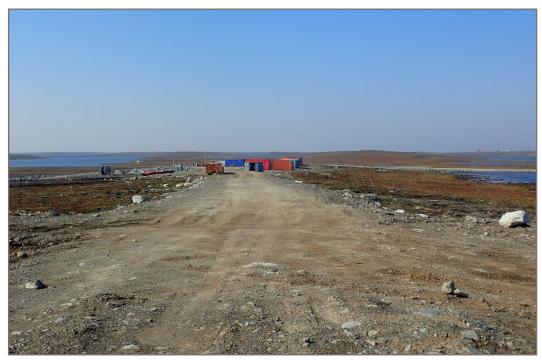
Photo 8: Wesmeg Esker—Access, looking norhtwest.

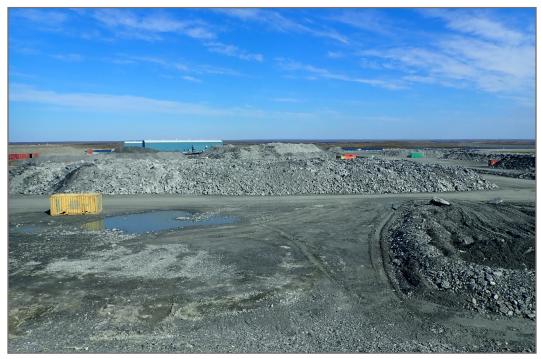
Photo 1: Ore Stockpile Area—Viewed from crusher ramp.

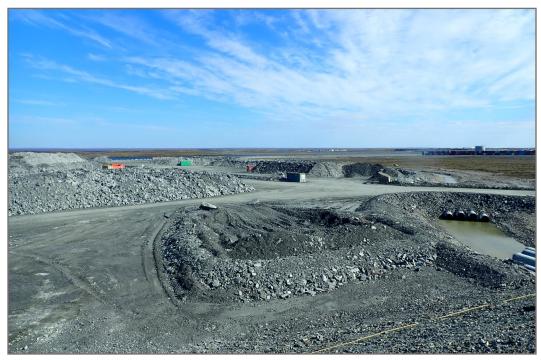
Photo 2: Ore Stockpile Area—Viewed from crusher ramp.

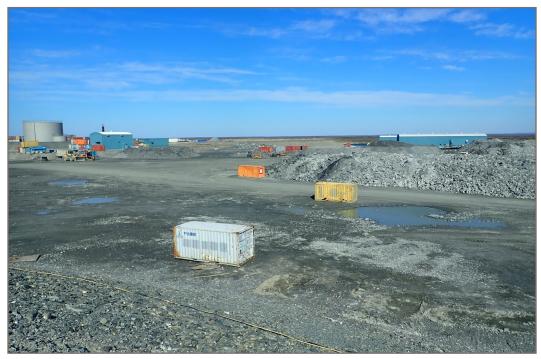
Photo 3: Ore Stockpile Area—Viewed from crusher ramp.

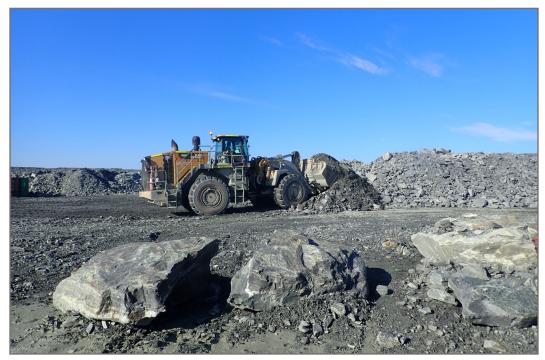
Photo 4: Ore Stockpile—Loader

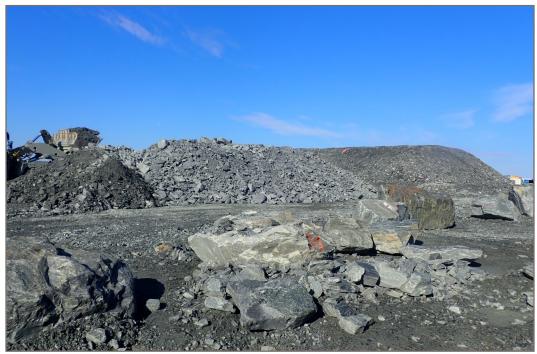
Photo 5: Ore Stockpile.

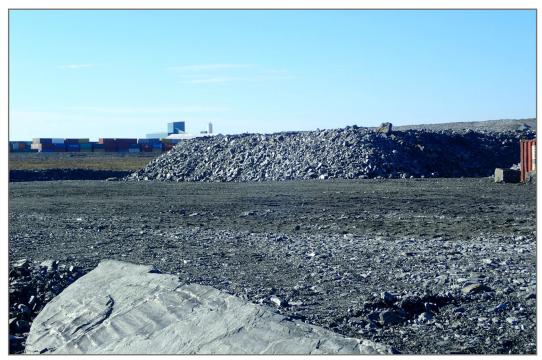
Photo 6: Ore Stockpile.

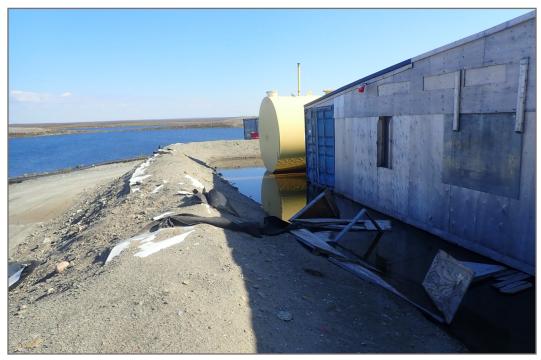
Photo 2: Exploration Camp Fuel Storage

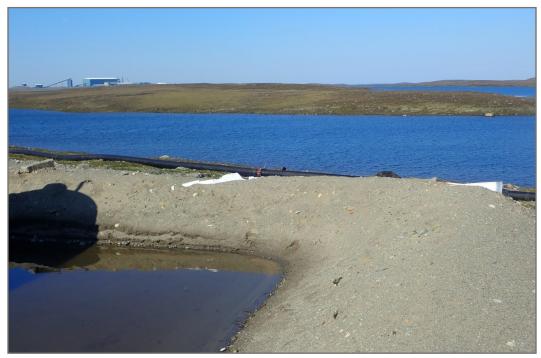
Photo 3: Exploration Camp Fuel Storage

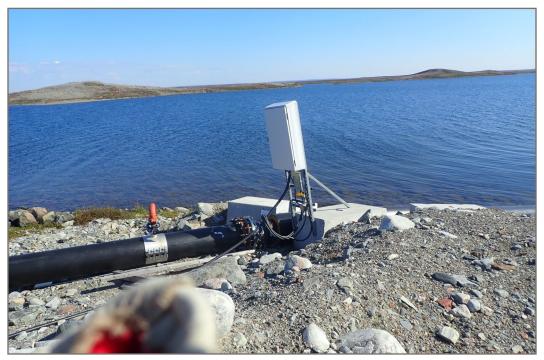
Photo 4: Exploration Camp—Diffuser line

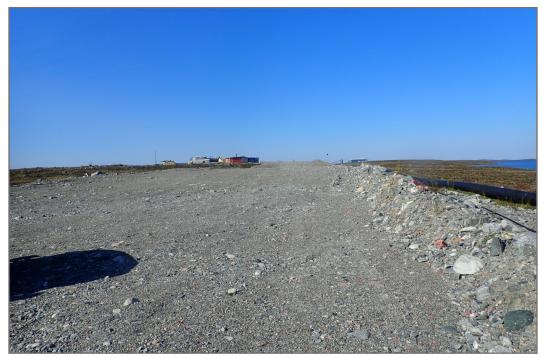
Photo 5: Exploration Camp—Road to diffuser access.

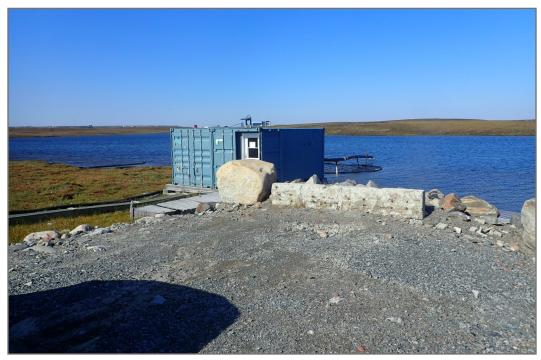
Photo 6: Exploration Camp—Freshwater Intake.

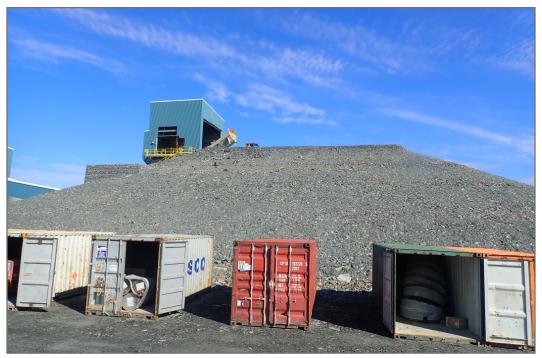
Photo 1: Crusher Pad- West Slope

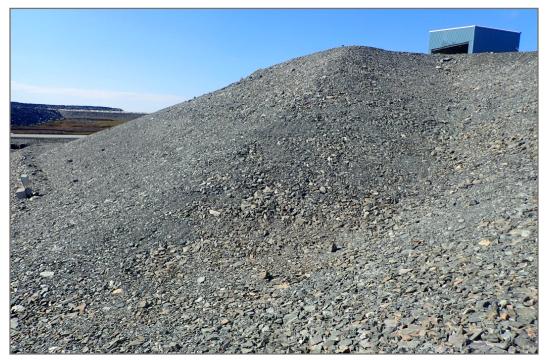
Photo 2: Crusher Pad —South slope

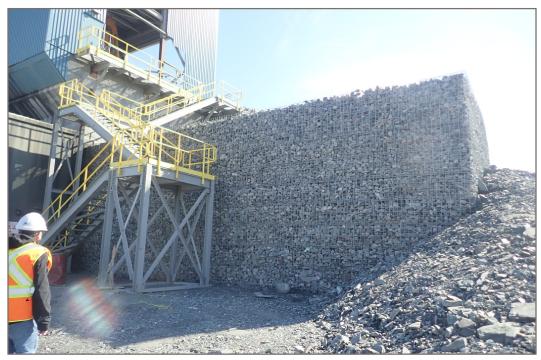
Photo 3: Crusher Pad—MSE Wall on the northwest corner.

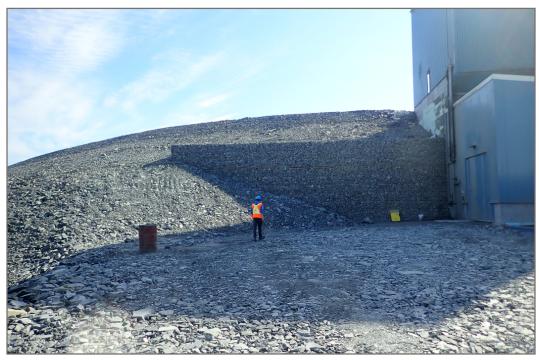
Photo 4: Crusher Pad—MSE Wall on the east corner.

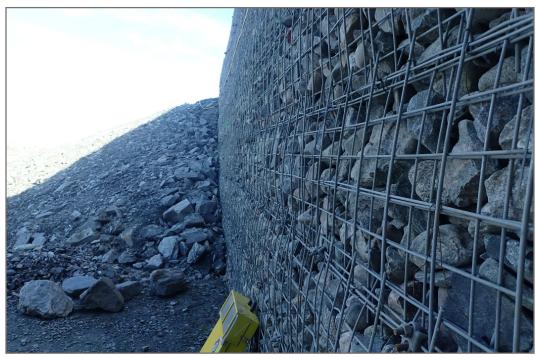
Photo 5: Crusher Pad—MSE wall, north east side. Slight bulge to gabion baskets

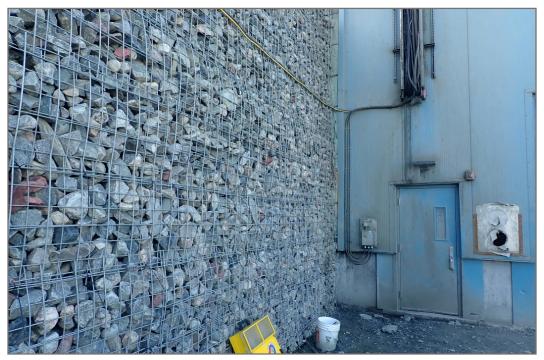
Photo 6: Crusher Pad—MSE wall, north east side. Slight inward slope to wall.

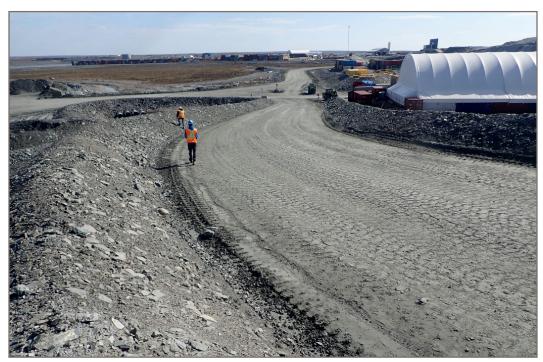
Photo 7: Crusher Pad—Ramp

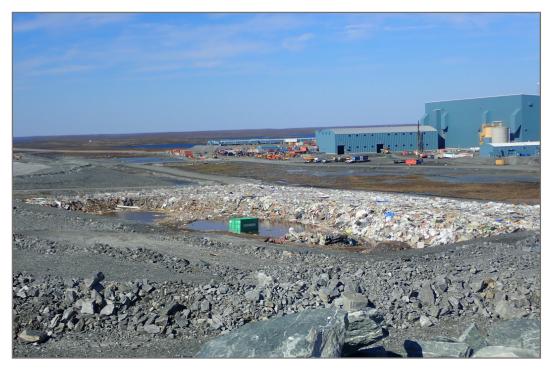
Photo 8: Landfill- WRSF1 Landfill

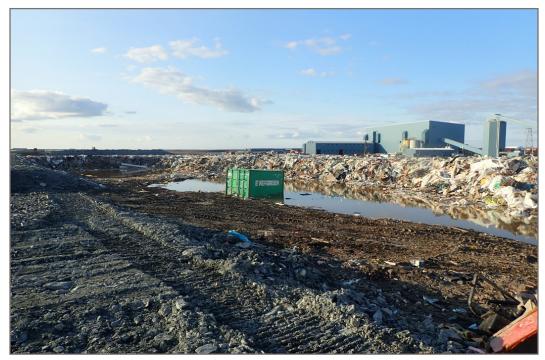
Photo 9: Landfill-WRSF1 Landfill-Ponded water.

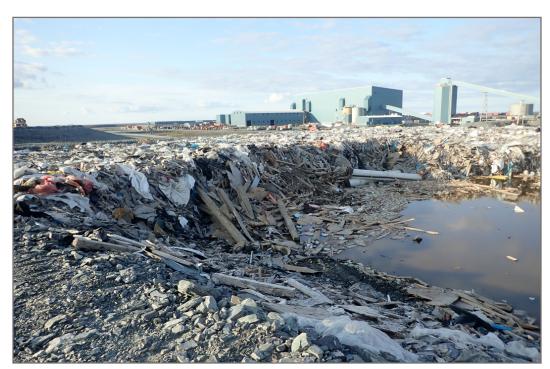
Photo 10: Landfill-WRSF3 Landfill-Sorting debris, removing wood waste

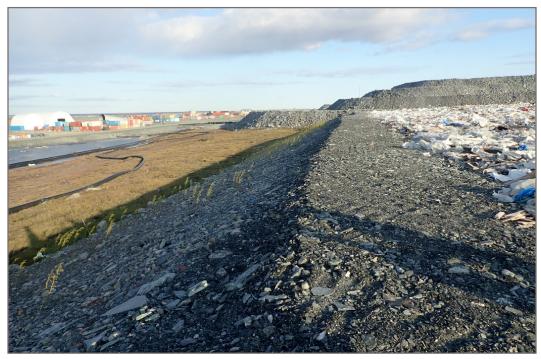
Photo 11: Landfill- WRSF3 Landfill—East berm—some revegetation.

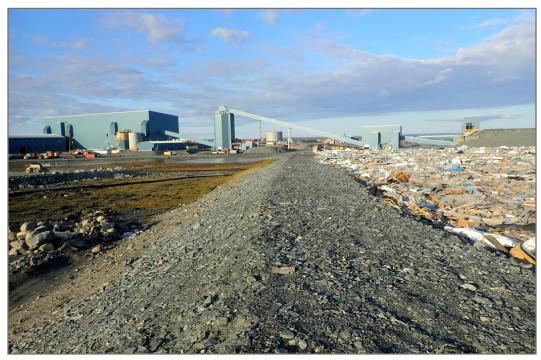
Photo 12: Landfill- WRSF3 Landfill—East berm—some revegetation.

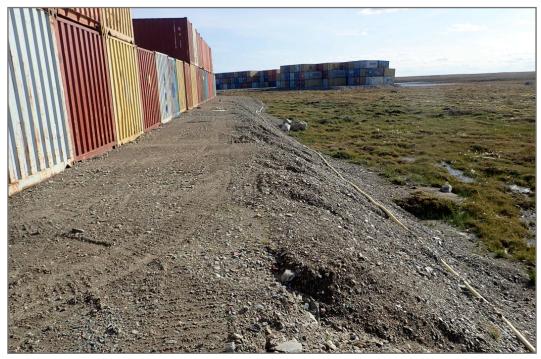
Photo 13: Emulsion Plant—north side of pad, erosion in pad slope.

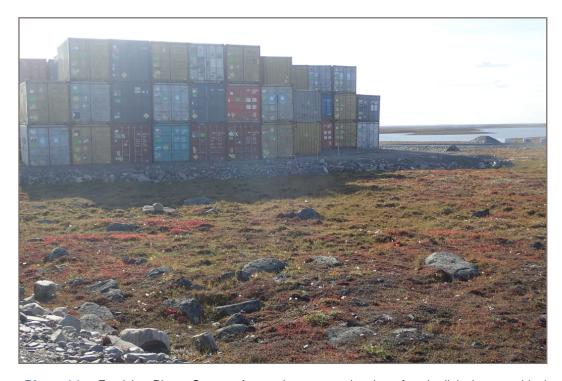
Photo 14: Emulsion Plant—Storage Area—slope on north edge of pad, slight lean to shipping containers.

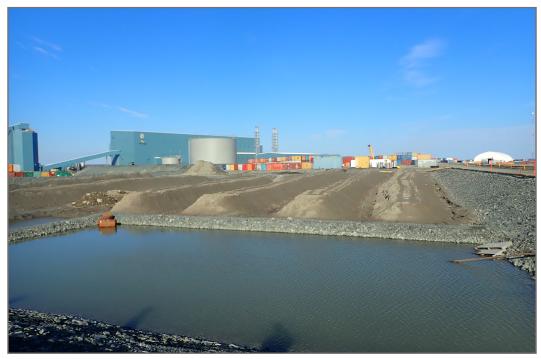
A lined landfarm was constructed south east of the process plant. Windrows of soil 1.0 m to 1.2 m have been placed in the landfarm as shown in Photos 15 to 19, Appendix L.

Photo 15: Landfarm– Windrows of contaminated soil. Water collection pond.

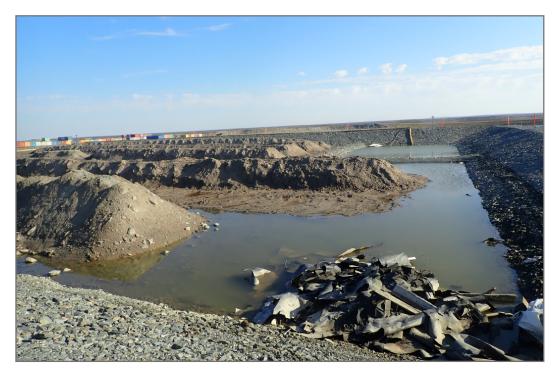
Photo 16: Landfarm ponded water at south end of facility.

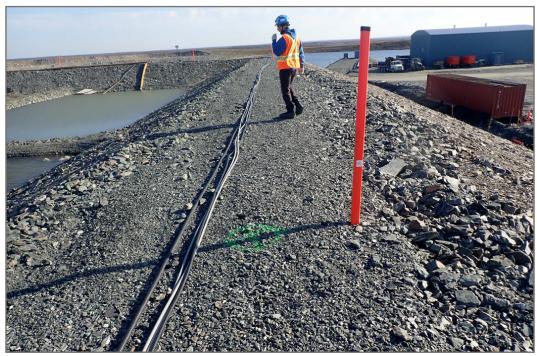
Photo 17: Landfarm—South Berm

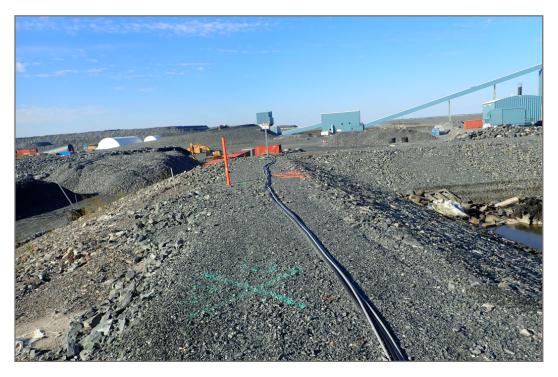
Photo 18: Landfarm South Berm.

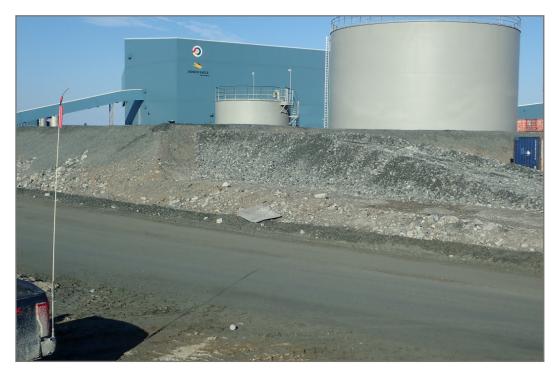
The Industrial Fuel Storage Tanks are located east of the process plant as shown in Photos 20 to 25, Appendix L. Two tanks are in the facility. The facility is lined with a geomembrane liner for secondary containment.

Photo 20: Industrial Fuel Storage Tanks.

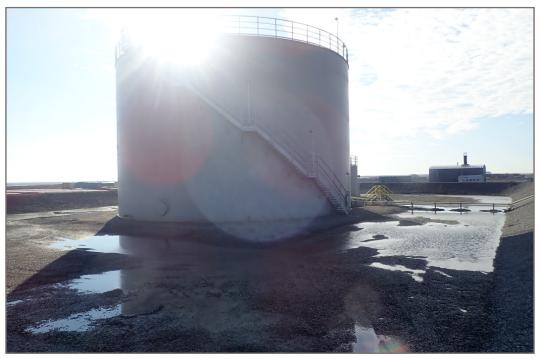
Photo 21: Industrial Fuel Storage Tanks. Ponded water in tankfarm.

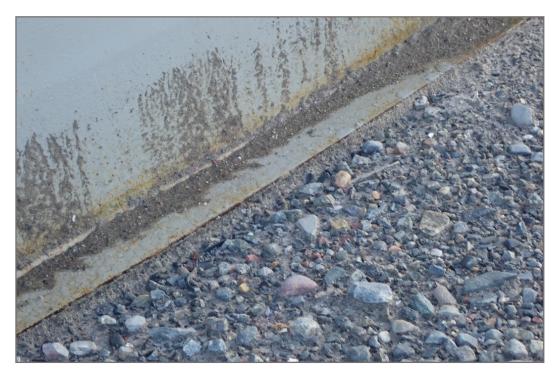
Photo 24: Industrial Fuel Storage Tanks. Small amount of erosion on tank pedestals. Fill generally still under tanks.

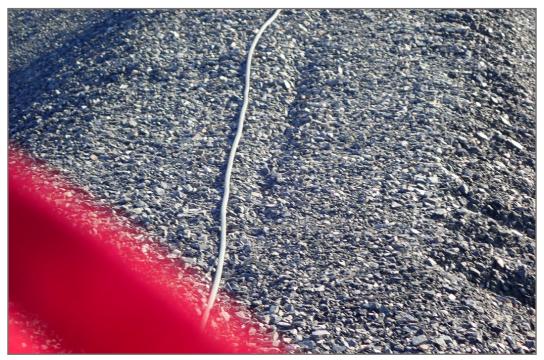
Photo 25: Industrial Fuel Storage Tanks. Exposed grounding cable.

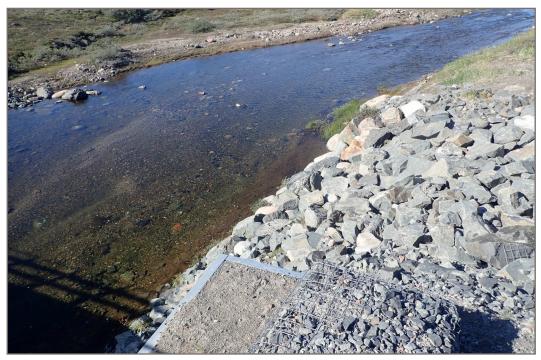
Photo 4: Char River Bridge—South Abutment

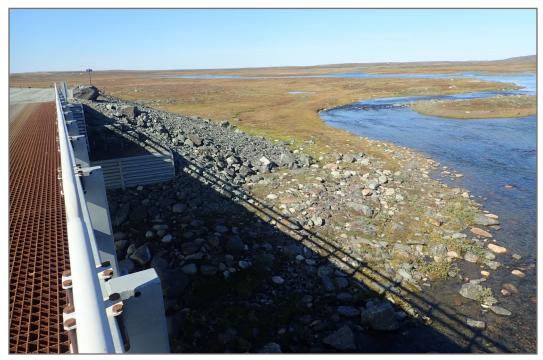
Photo 10: Meliadine River Bridge South Abutment

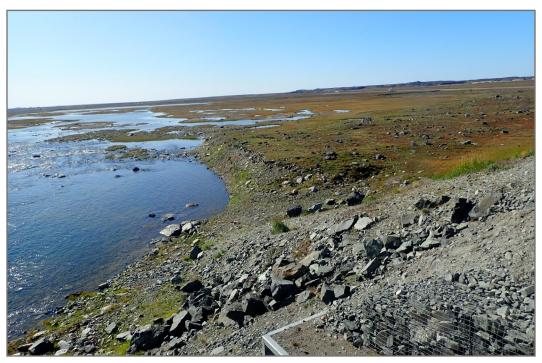
Photo 12: Meliadine River Bridge—Shoreline downstream of bridge—erodible sand and gravel deposit.

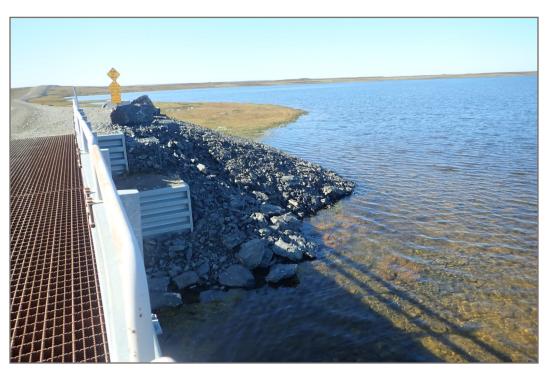
Photo 18: M-5 Bridge—South Abutment.

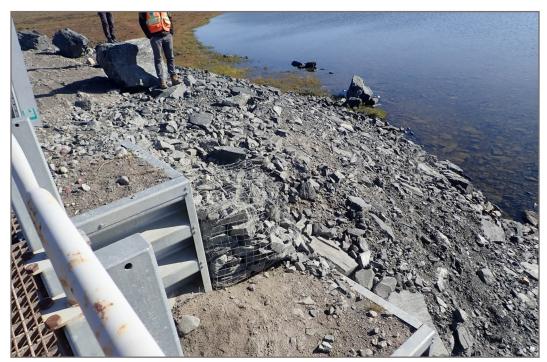
Photo 19: M-5 Bridge—Gabion North Abutment

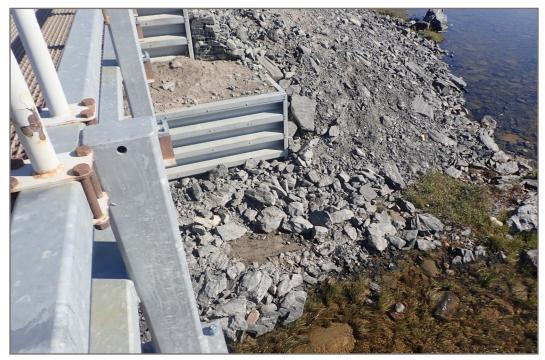
Photo 20: M-5 Bridge—Geotextile exposed at north abutment .

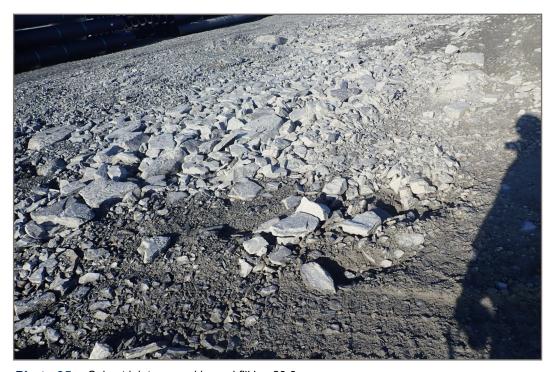
Photo 35: Culvert inlet covered by rockfill km 29.6

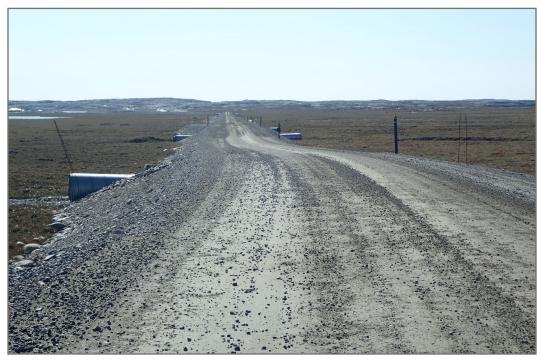
Photo 6: Overview of Bypass Road from KM 5.5 to KM 4.0.

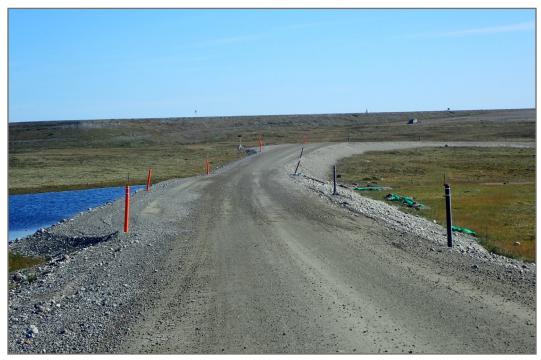
Photo 12: Low area in road northwest of C10, Filled in 2021.

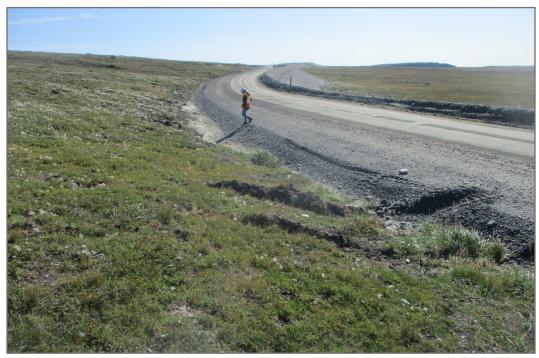
Photo 13: Water collection point between road and hill side near KM 2.35, overtopped road during 2021 freshet.

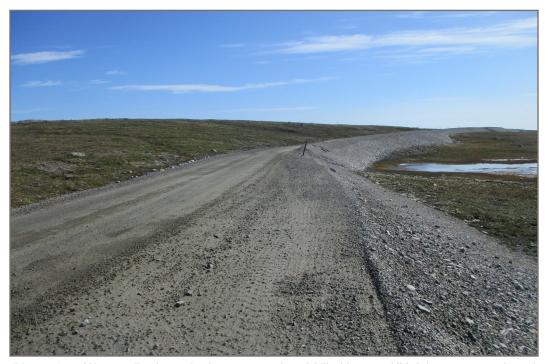
Photo 14: Water collection point between road and hill side near KM 2.35, overtopped road during 2021 freshet.

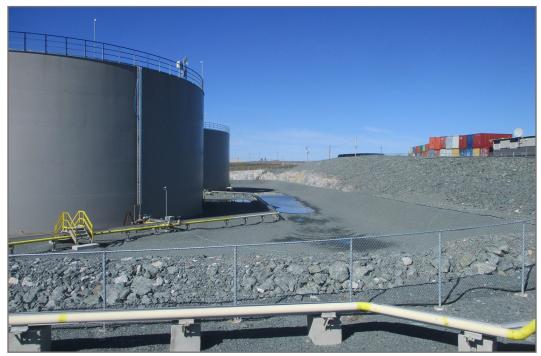
The Itivia fuel farm consists of a 20,000,000 L and a 13,500,000 L fuel storage tanks as shown in Photos 15 through 21, Appendix P. The fuel is hauled to the mine site on an as needed basis. The tanks are contained within a geomembrane lined containment facility. The geomembrane liner is covered with a layer of geotextile and 20 mm crushed rock. The following observations were made during the inspection.

Photo 15: ITIVIA Tankfarm—North of tanks.

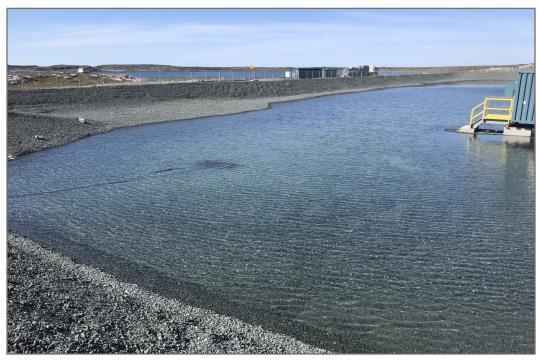
Photo 16: ITIVIA Tankfarm—Ponded water in facility.

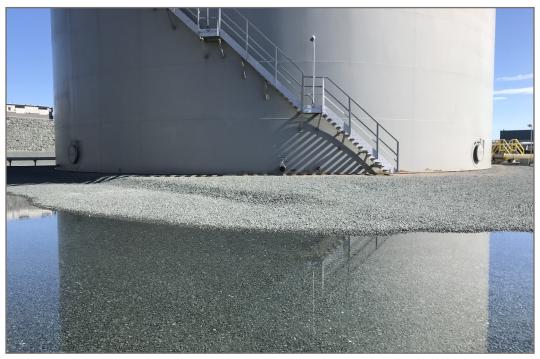
Photo 19: ITIVIA Tankfarm—Small pedestal width beyond tank base

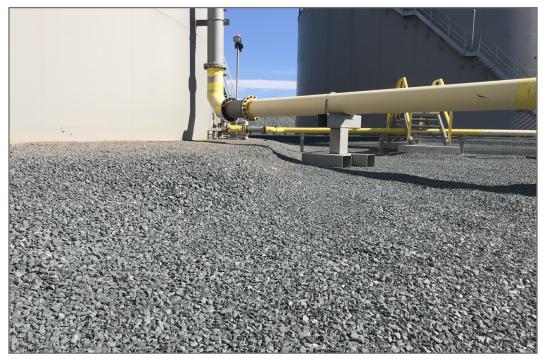
Photo 21: ITIVIA Tankfarm—Airspace below pipe support.

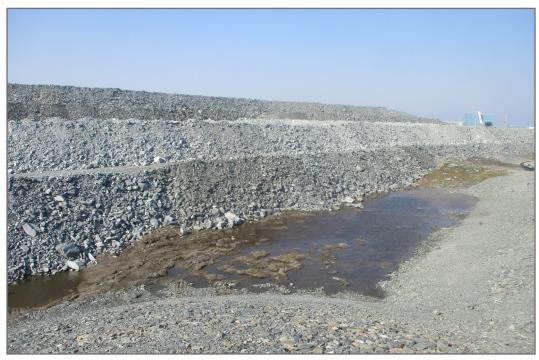
Photo 2: WRSF1—Viewed from Paste Plant Ramp—Low point along toe of WRSF.

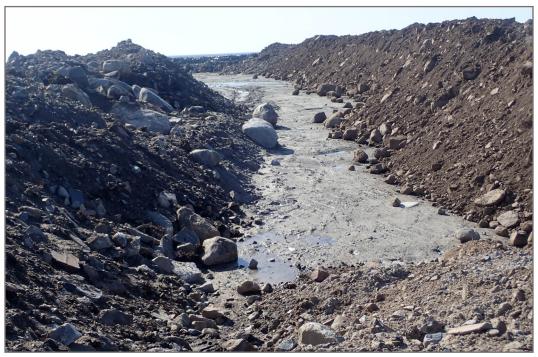
Photo 10: WRSF1—Recent overburden placement outside of WRSF overburden limits.

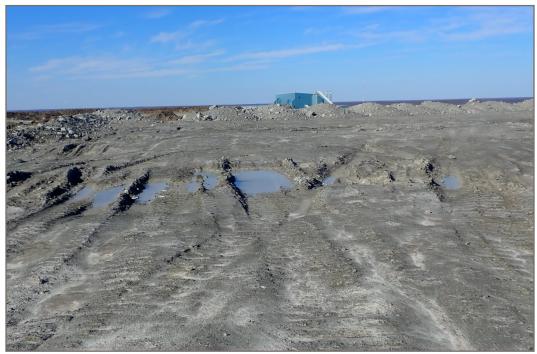
Photo 11: WRSF1—Condition of winter placement overburden on top bench.

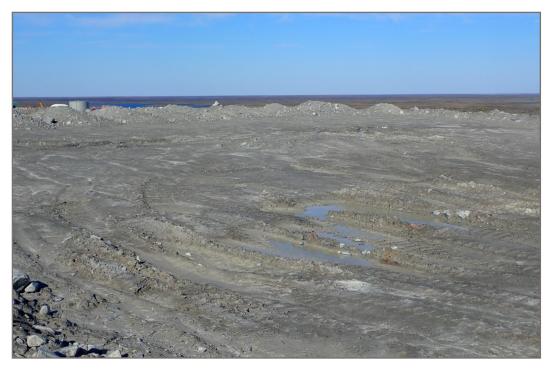
Photo 12: WRSF1—Condition of winter placement overburden on top bench.

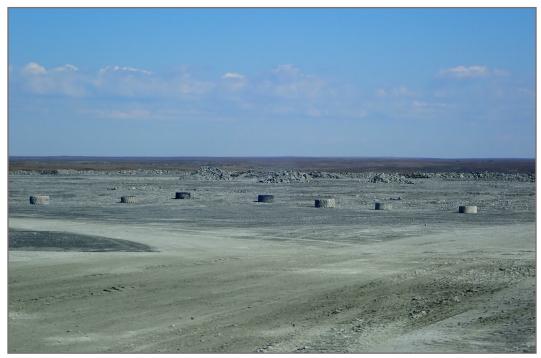
Photo 1: WRSF3 - Access to WRSF. Marginalized ore temporarily stored on surface.

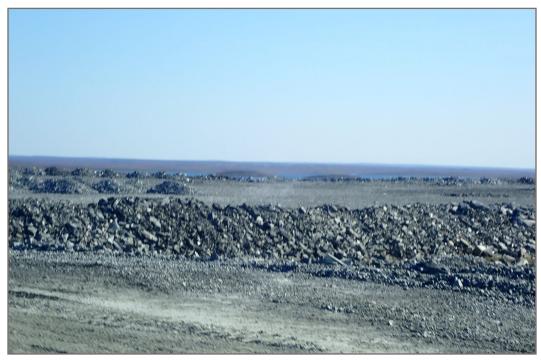
Photo 2: WRSF3 - Waste rock stored in WRSF3

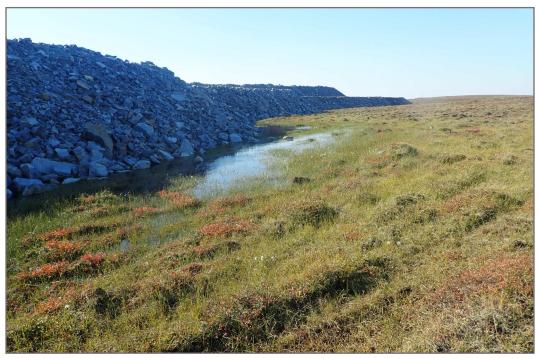
Photo 3: WRSF3—Ponding at the toe on east side of WRSF.

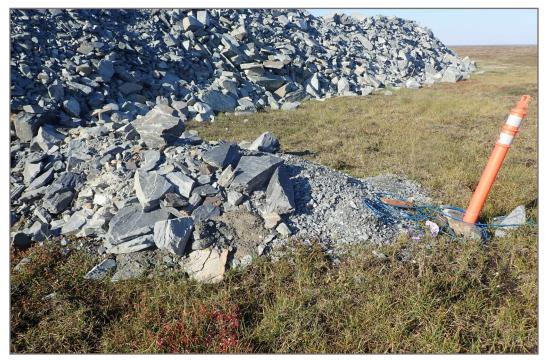
Photo 4: WRSF3—Horizontal GTC at east side of WRSF.

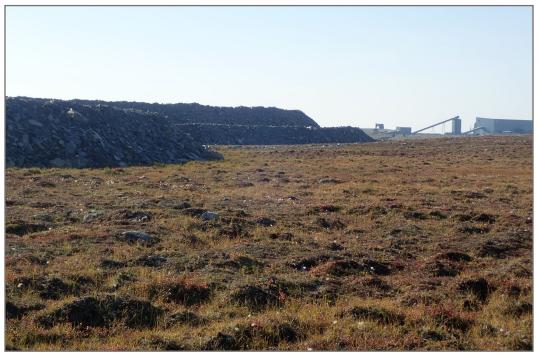
Photo 5: WRSF3—Northeast corners.

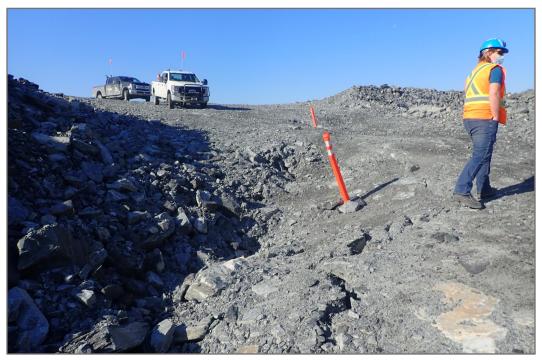
Photo 6: WRSF3—Settlement in access ramp from WRSF3 to CP6.

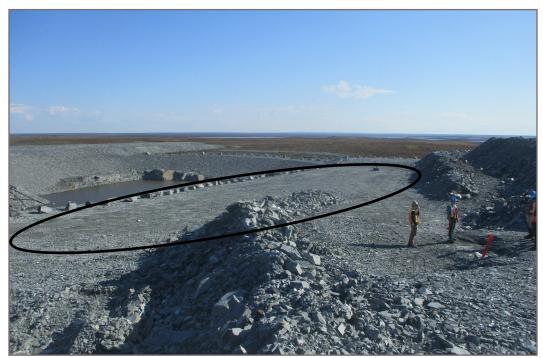
Photo 7: WRSF3—Thermal cover placed in 2021 between WRSF3 and CP6 due to significant settlement and erosion in area.

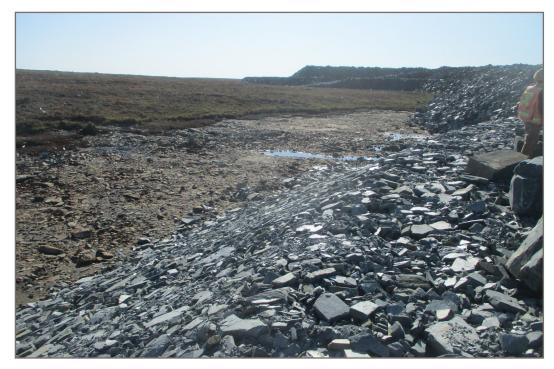
Photo 8: WRSF3—Flow path from northeast corner of WRSF to CP6.
