Appendix 6: 2022 Annual Geotechnical Inspection Report

2022 Annual Geotechnical Inspection Meliadine Gold Project, Rankin Inlet, Nunavut

PRESENTED TO
Agnico Eagle Mines Limited

FEBRUARY 17, 2023
ISSUED FOR USE
FILE: 704-ENG.EARC03140-31
AGNICO EAGLE DOCUMENT NUMBER: 65-600-230-TCR-001

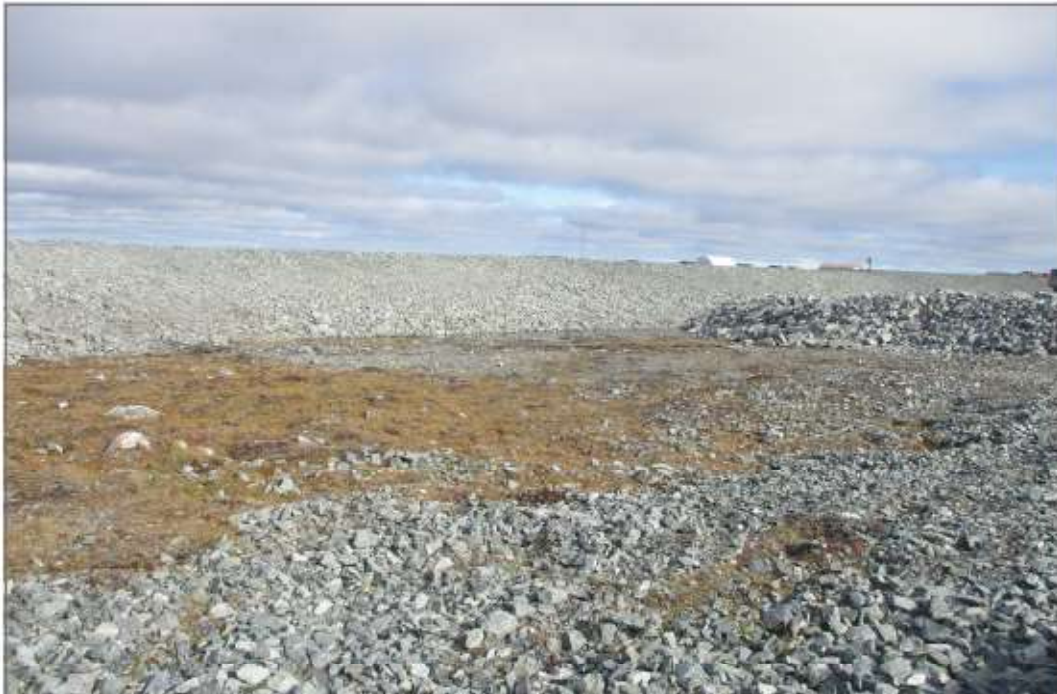
Photo 6: Pond CP2—Ponding against upstream of CP2 berm on original ground.

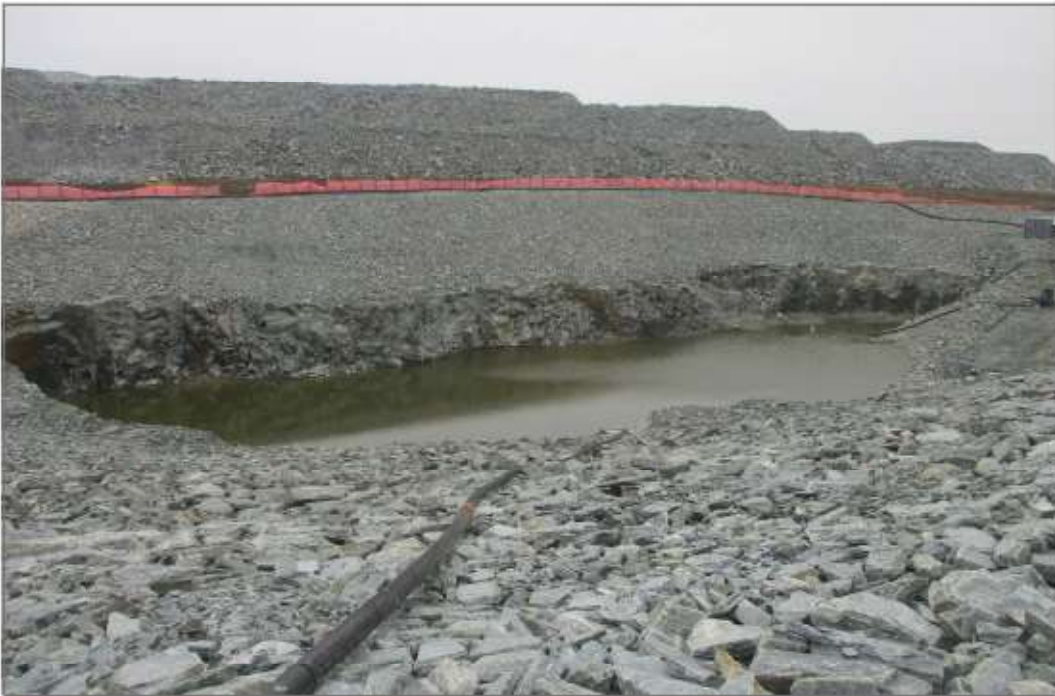
Photo 2: Pond CP4—Looking southeast, WRSF1 in the background.

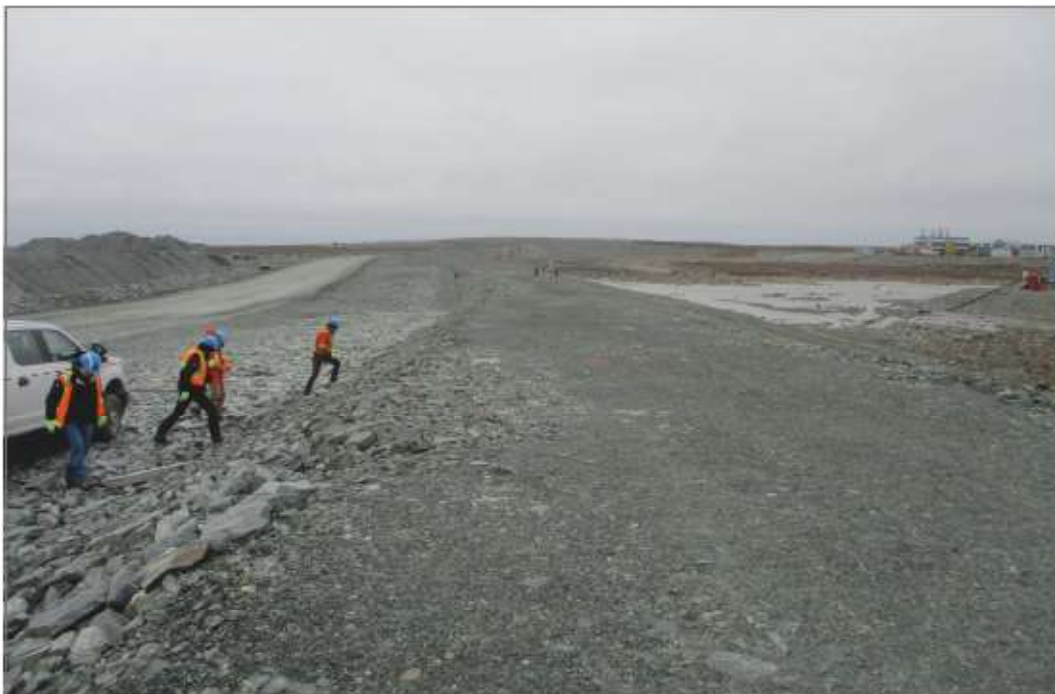
Photo 4: D-CP5 Dike - looking towards the southwest, centerline and downstream.

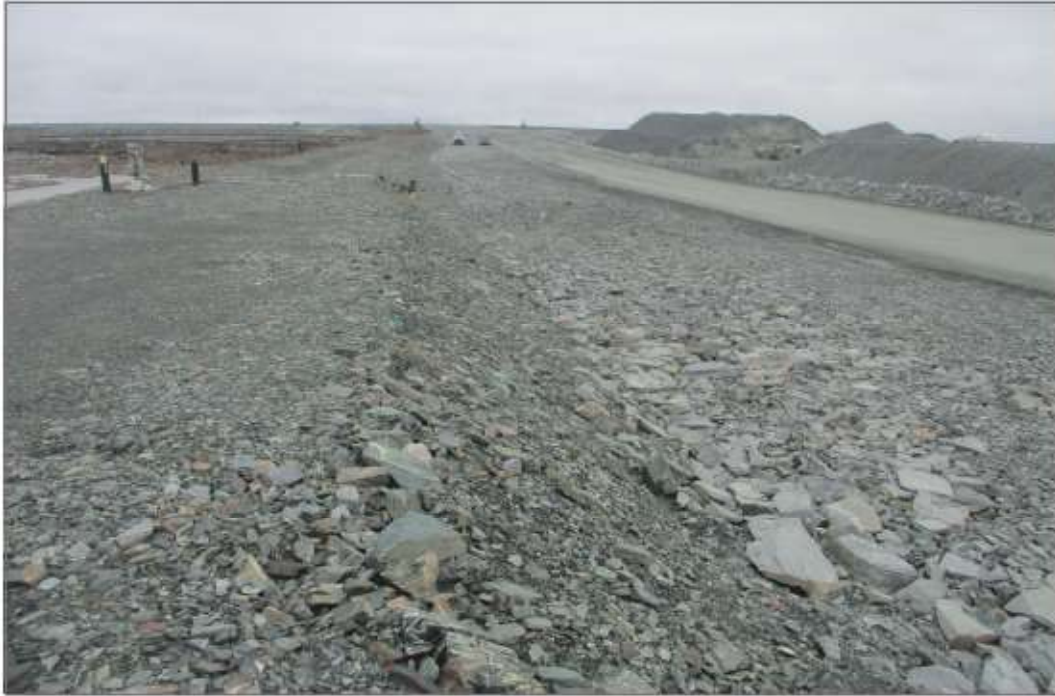
Photo 7: D-CP5 downstream crest, looking northeast.

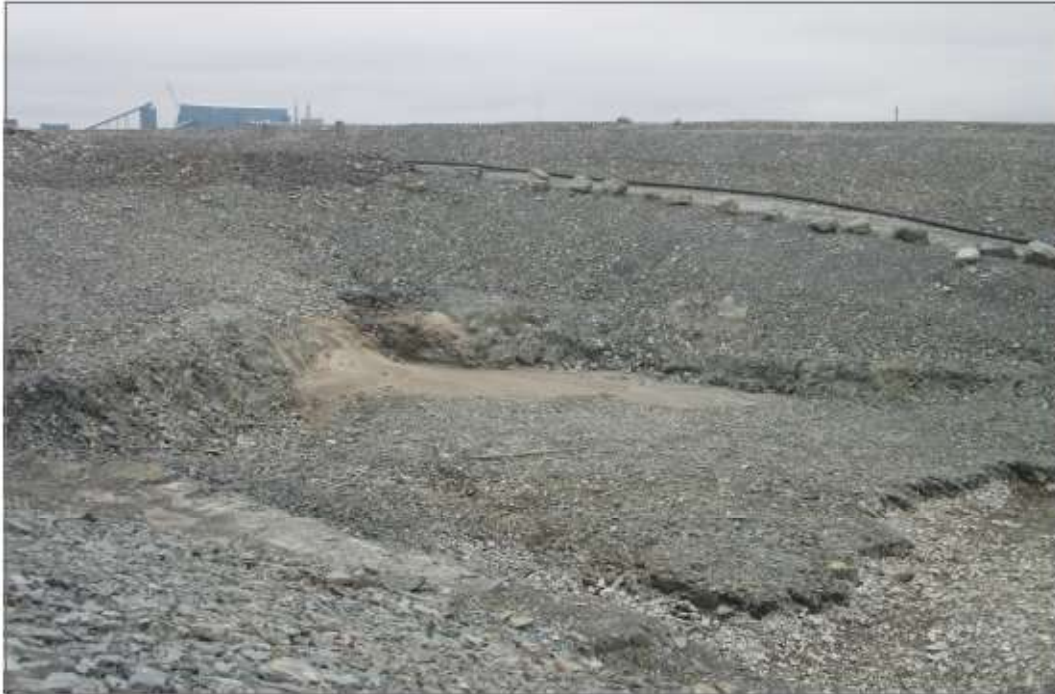
Photo 3: Pond CP6 - Significant sedimentation from water inflow at northwest corner.

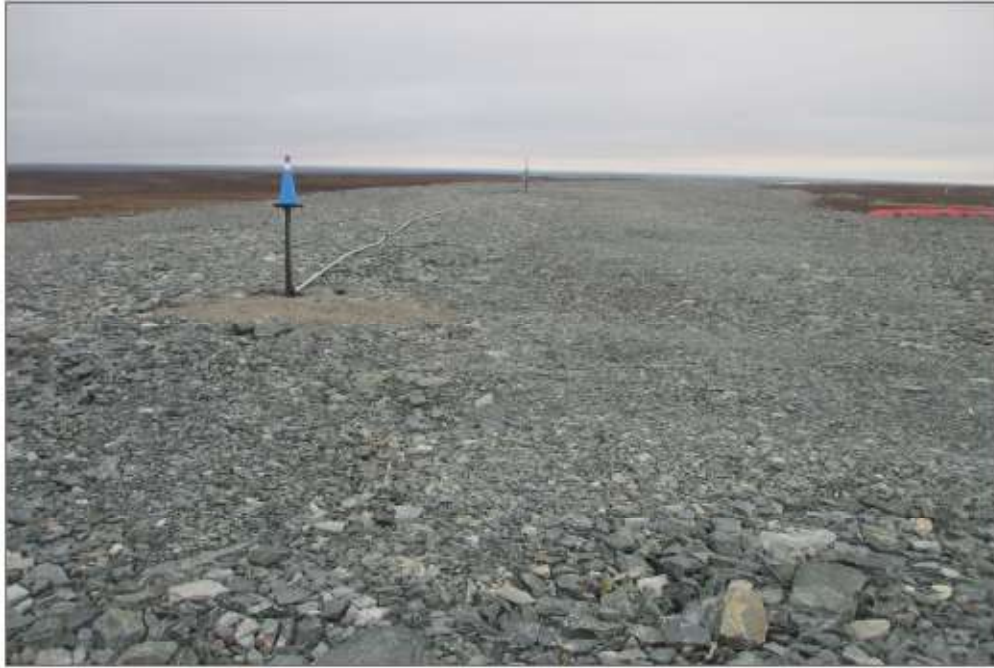
Photo 7: Pond CP6 - Berm CP6 crest. Minimal settlement.

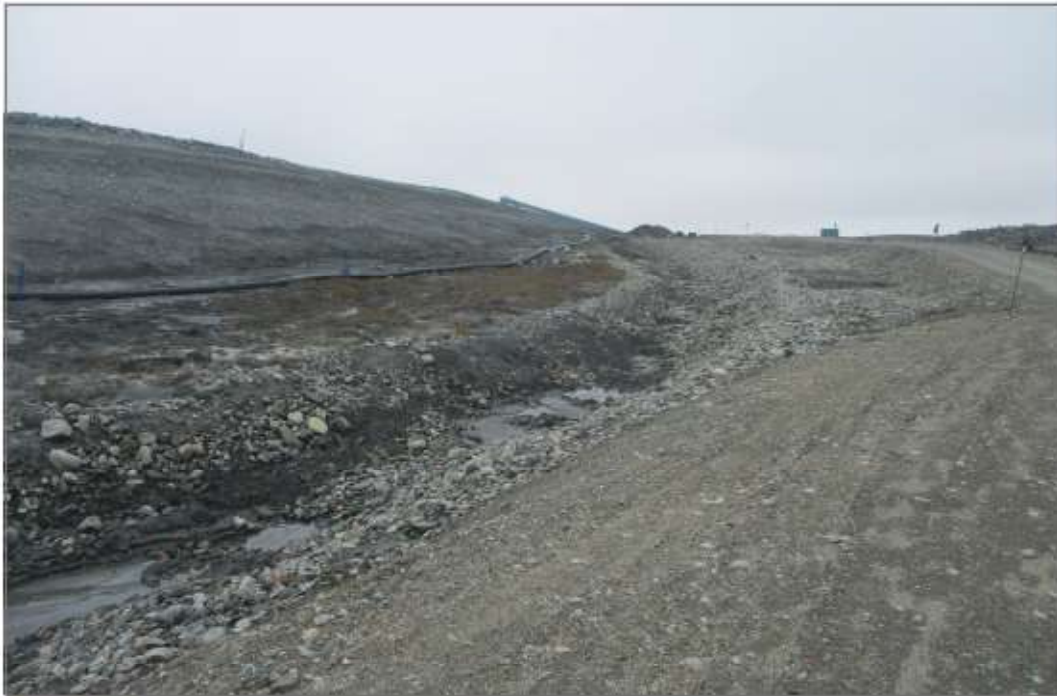
Photo 22: Channel 3—Upper reach, looking east.

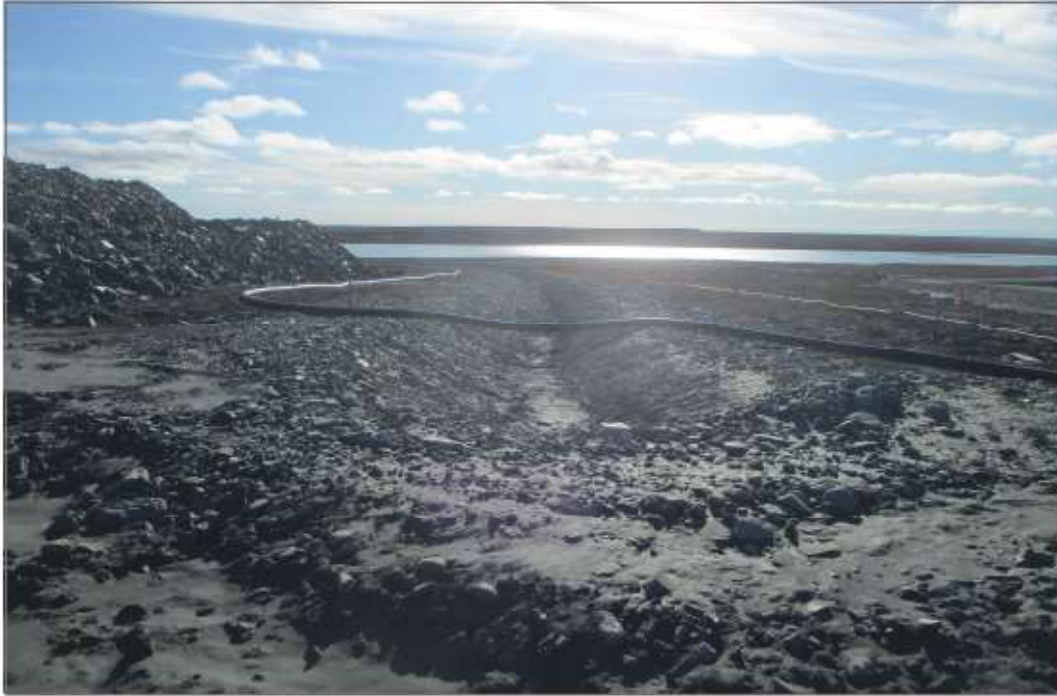
Photo 23: Channel 4 - Upper reach, below landfill.

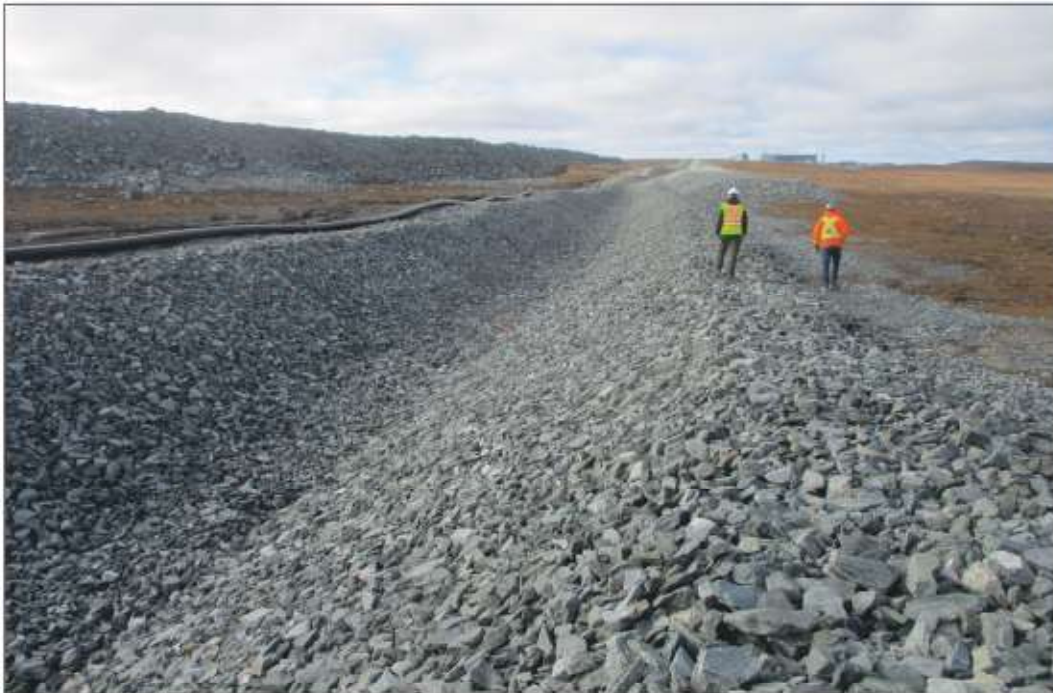
Photo 38: Channel 9—Lower reach, east of WRSF3.

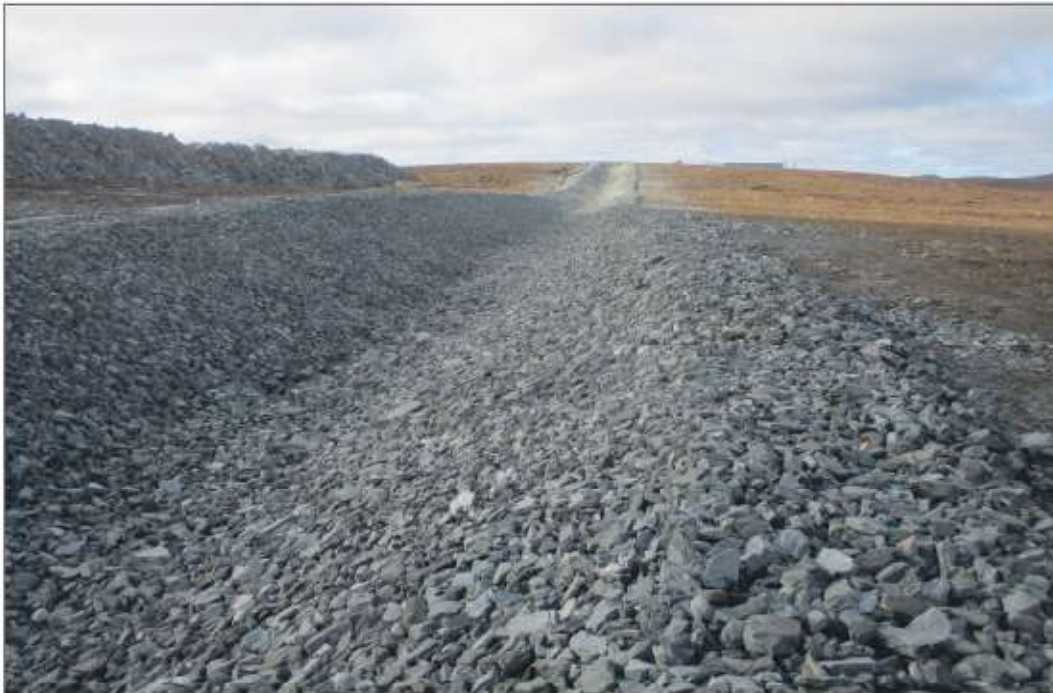
Photo 40: Channel 9—Upper reach, east of WRSF3.

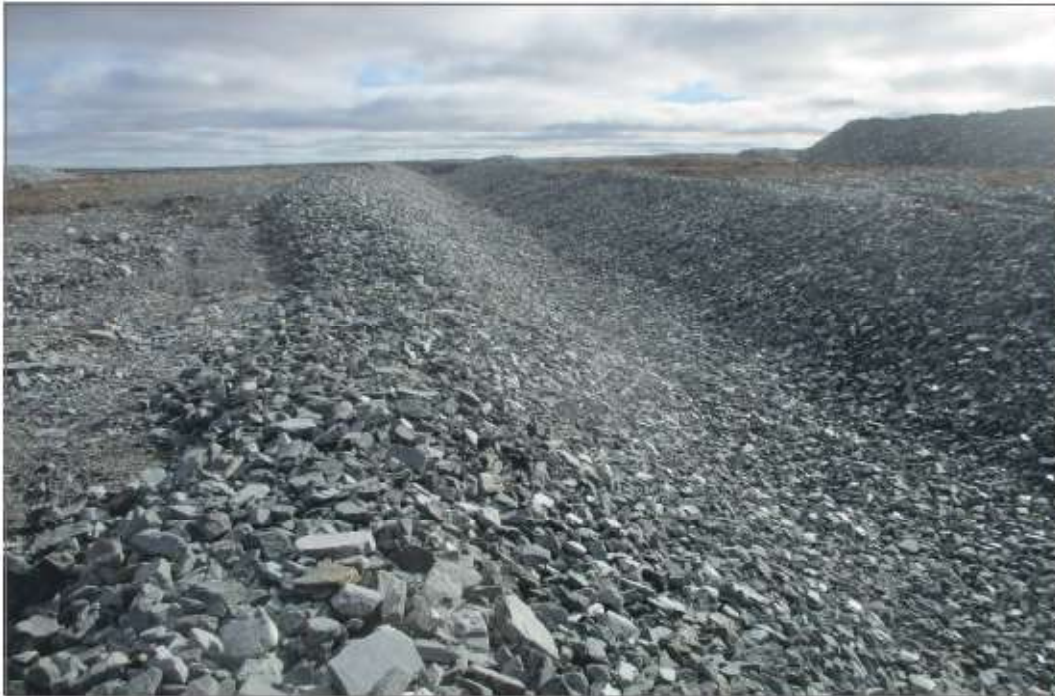
Photo 43: Channel 10—Lower reach, facing south.

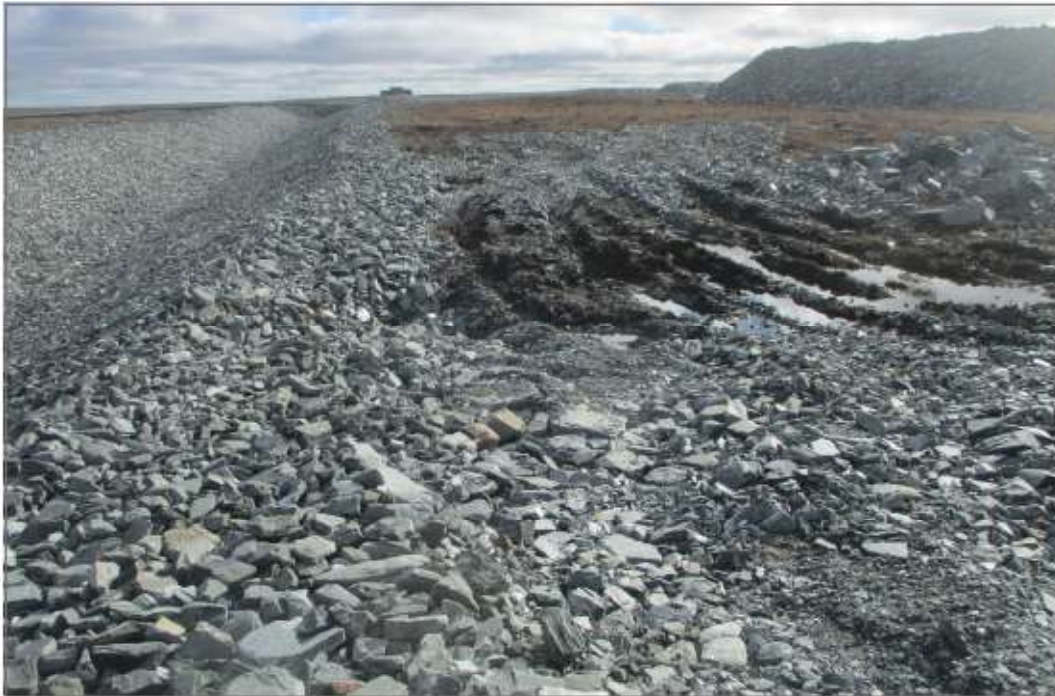
Photo 45: Channel 10—Disturbance to upstream original ground and thaw subsidence.

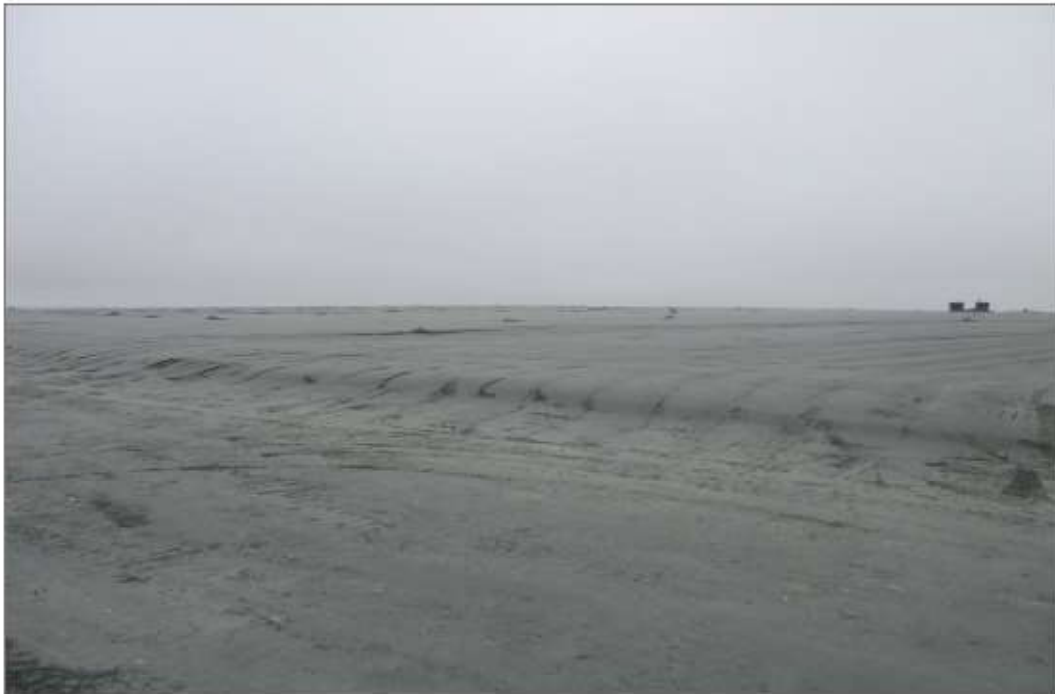
Photo 8: TSF - Placed tailings.

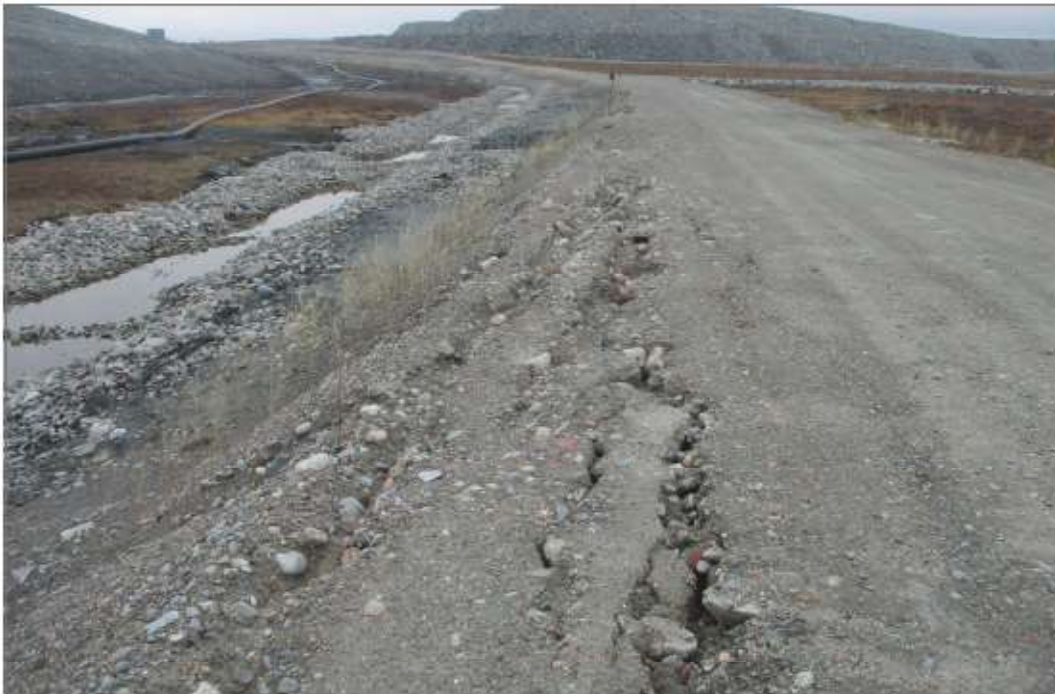
Photo 6: CP3 access road.

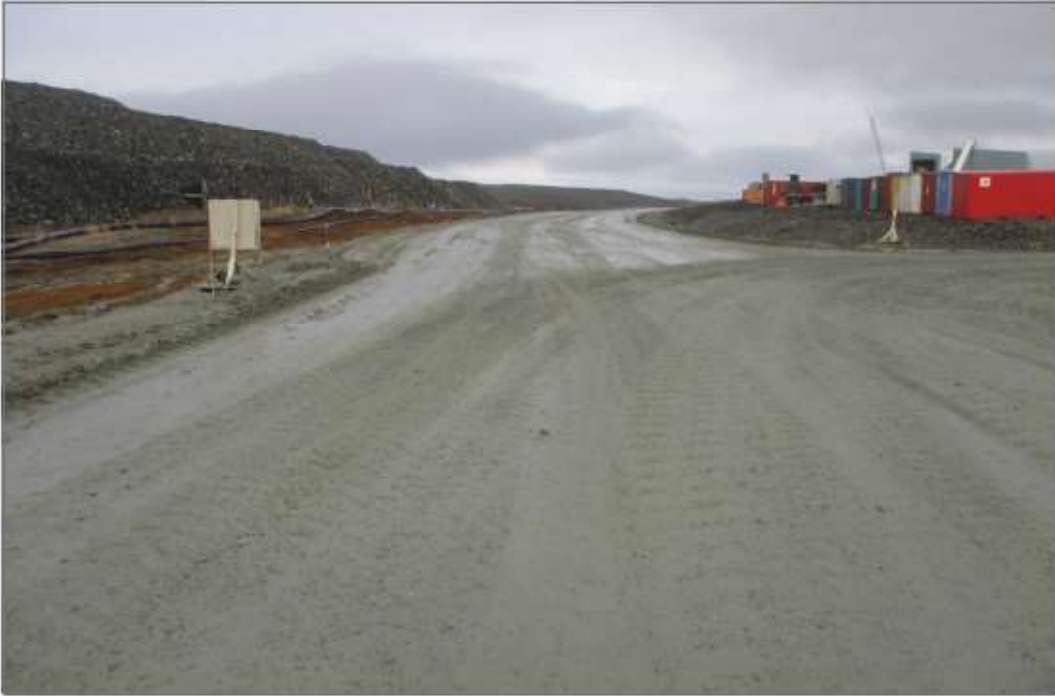
Photo 7: Site Roads—WRSF1 haul road, looking north.

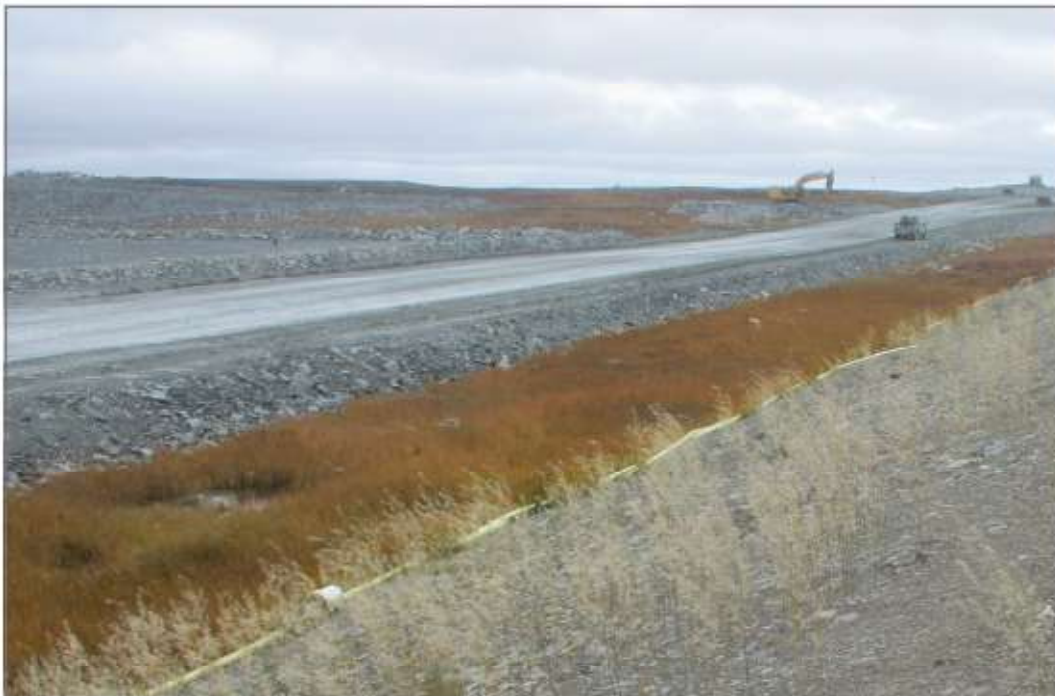
Photo 12: Site Roads—Haul road between Tiri1 and Tiri2 pits, adjacent Berm 3.

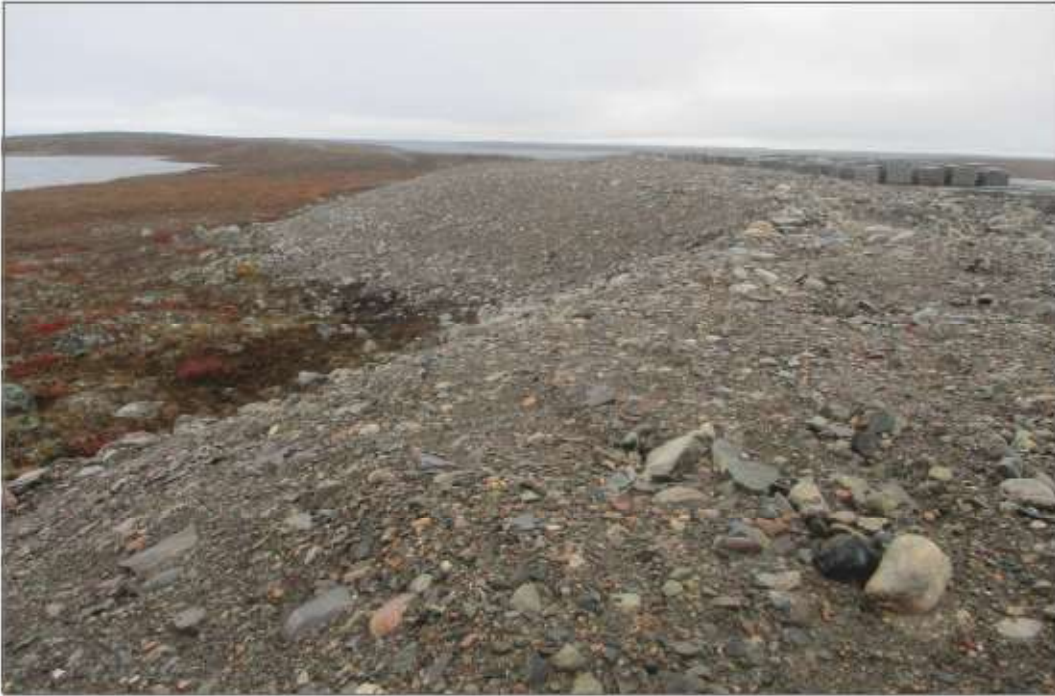
Photo 1: North Esker—Looking north.

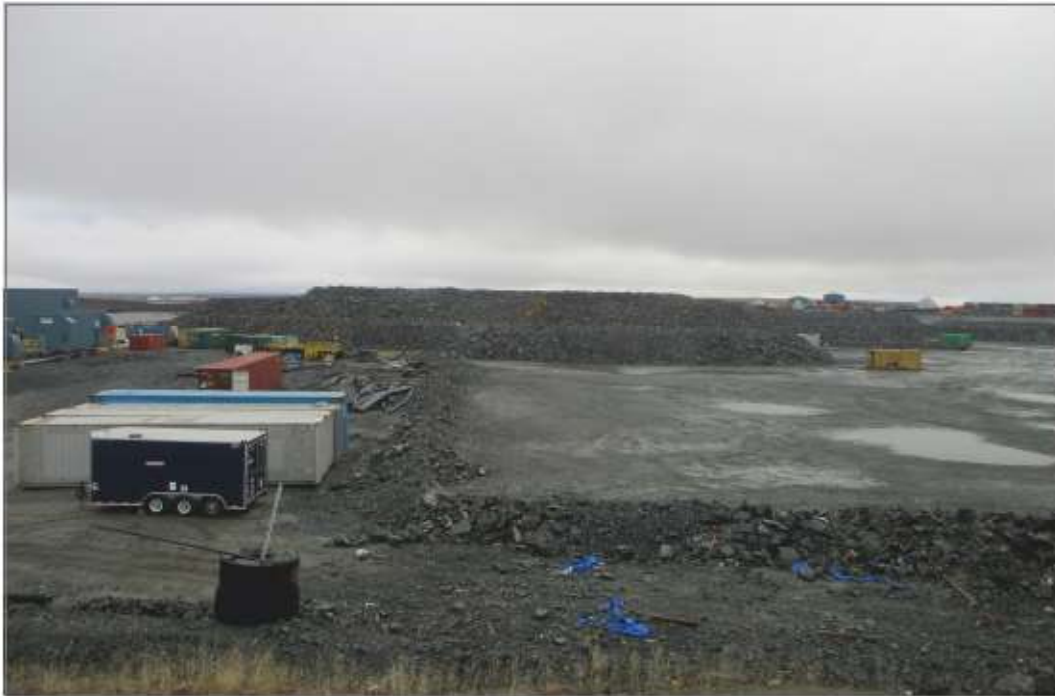
Photo 3: Ore Stockpile Area—Viewed from Landfarm.

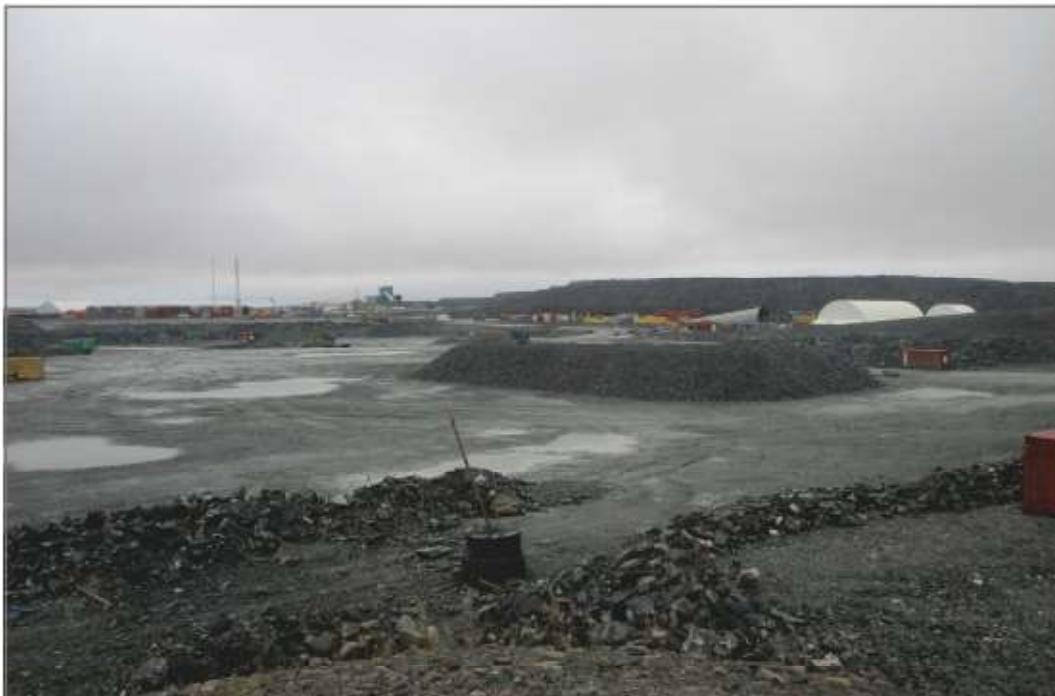
Photo 4: Ore Stockpile—Viewed from Landfarm.

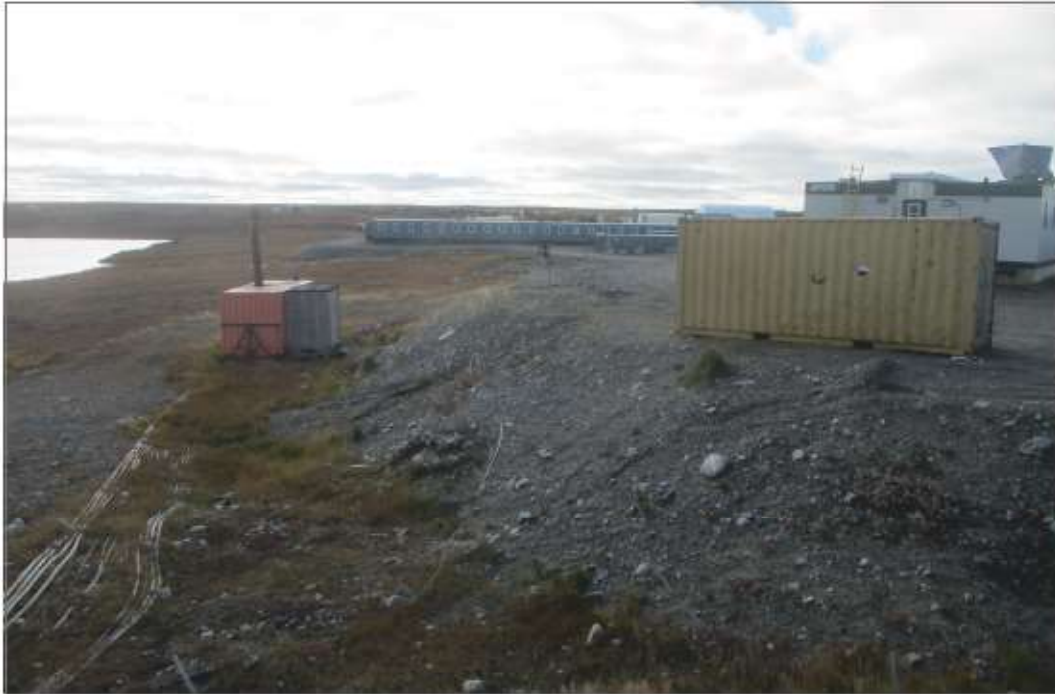
Photo 1: Exploration Camp—East side of camp pad.

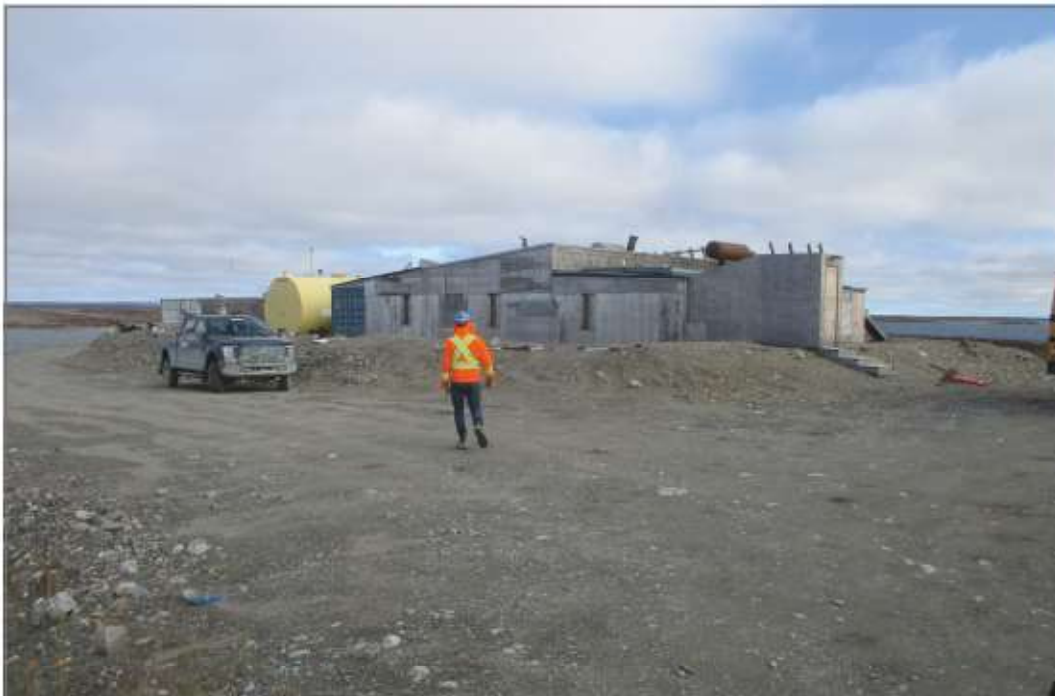
Photo 2: Exploration Camp—Fuel Storage

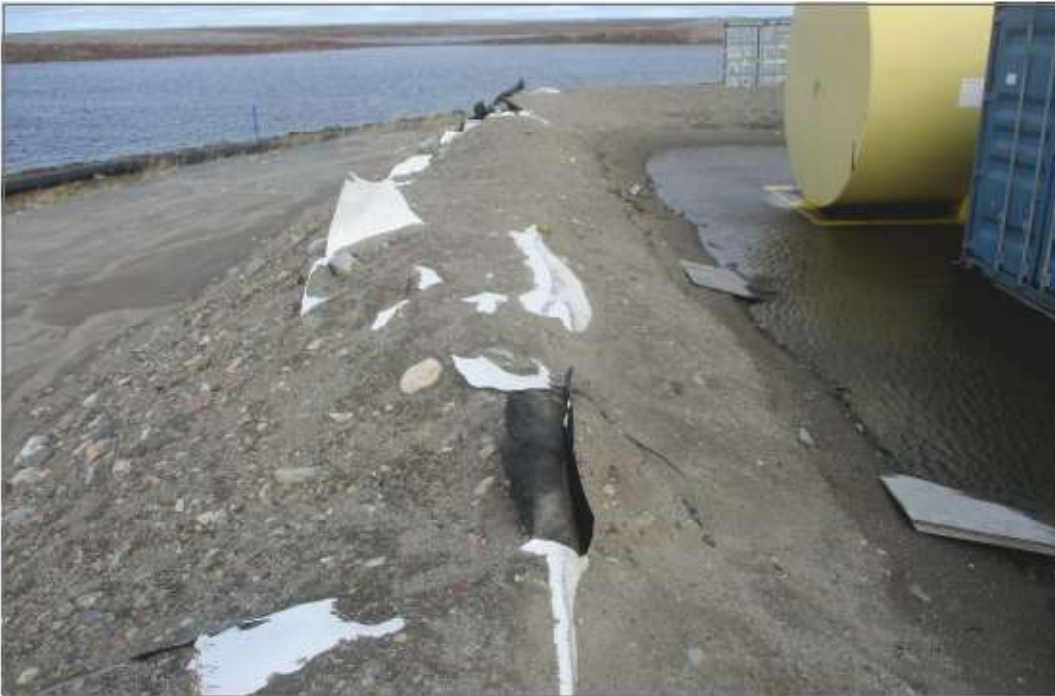
Photo 3: Exploration Camp—Fuel Storage

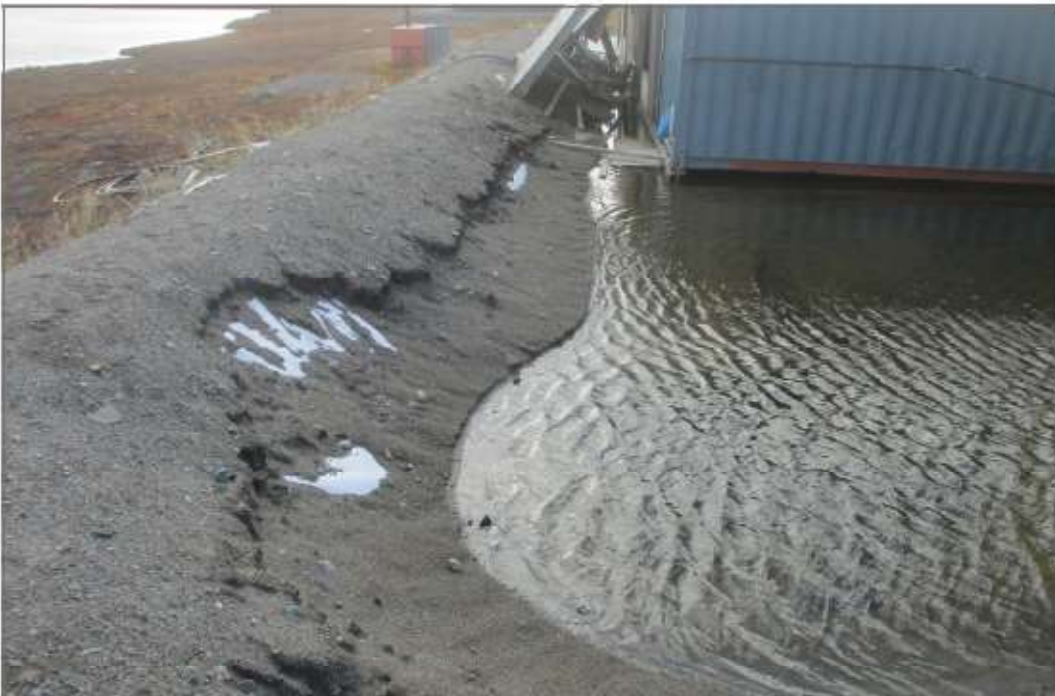
Photo 4: Exploration Camp Fuel Storage

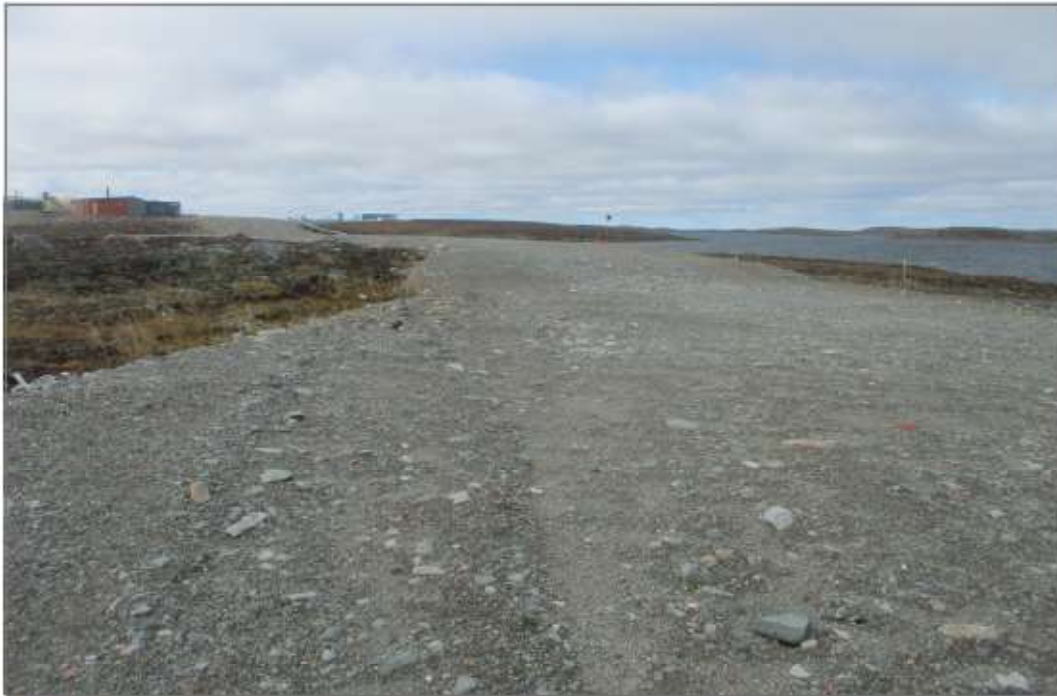
Photo 6: Exploration Camp—Diffuser line road access

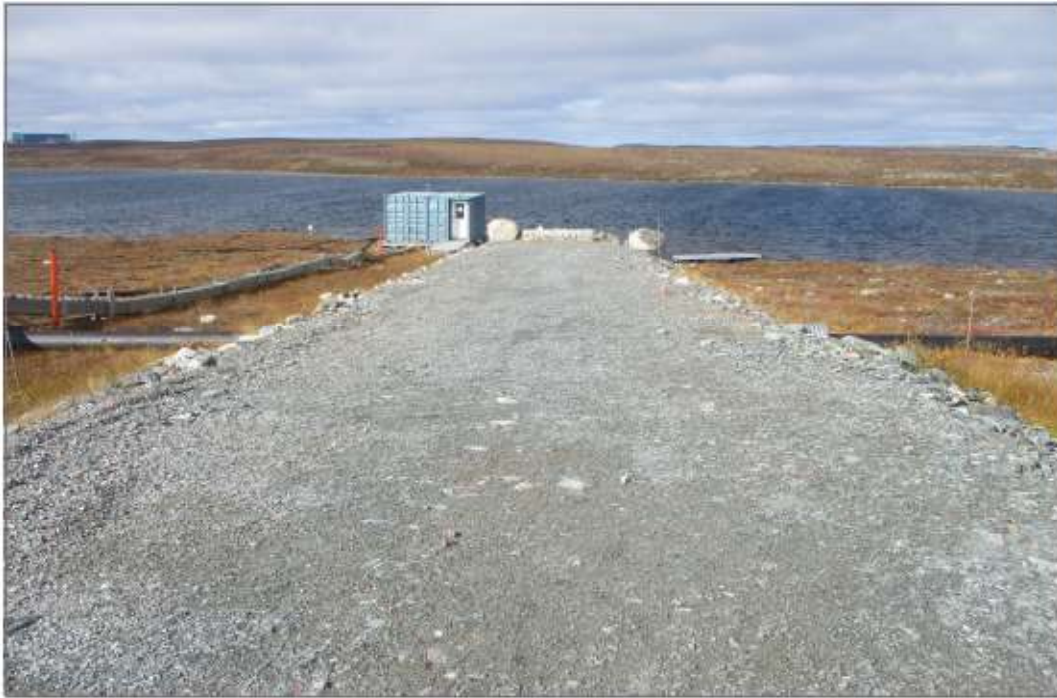
Photo 7: Exploration Camp—Freshwater Intake

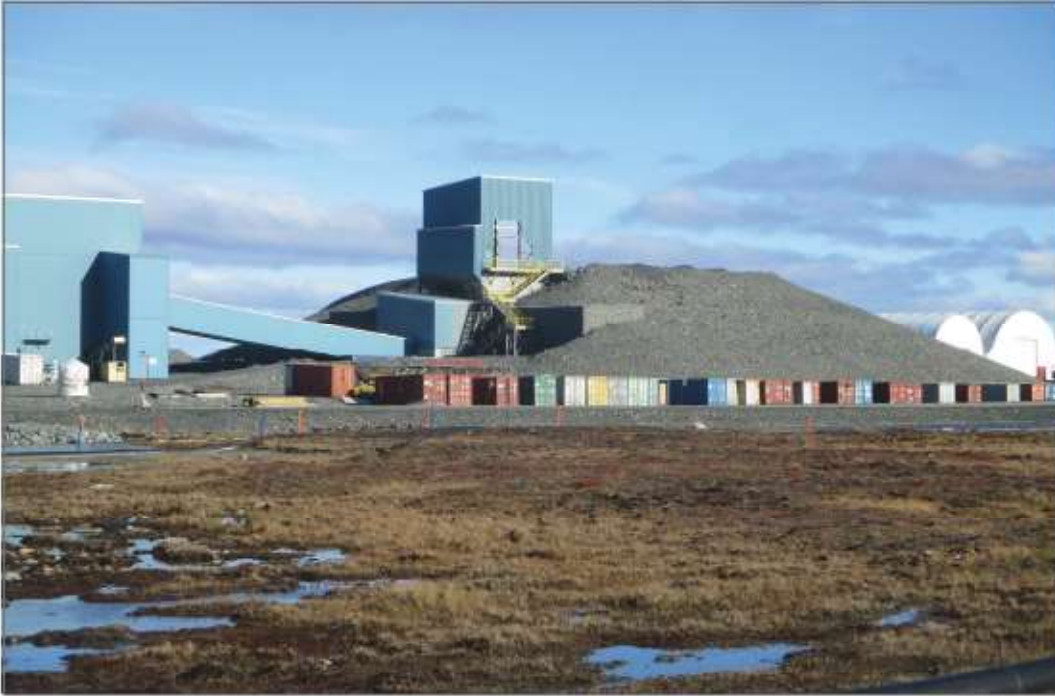
Photo 1: Crusher Pad—Overview from west direction.

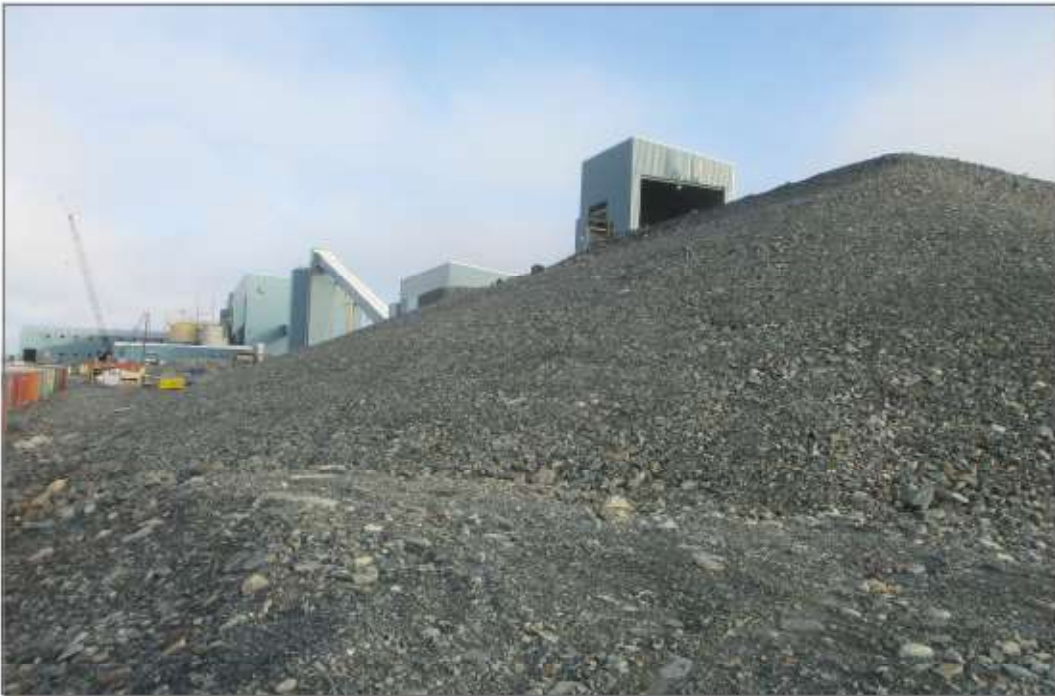
Photo 2: Crusher Pad —West slope.

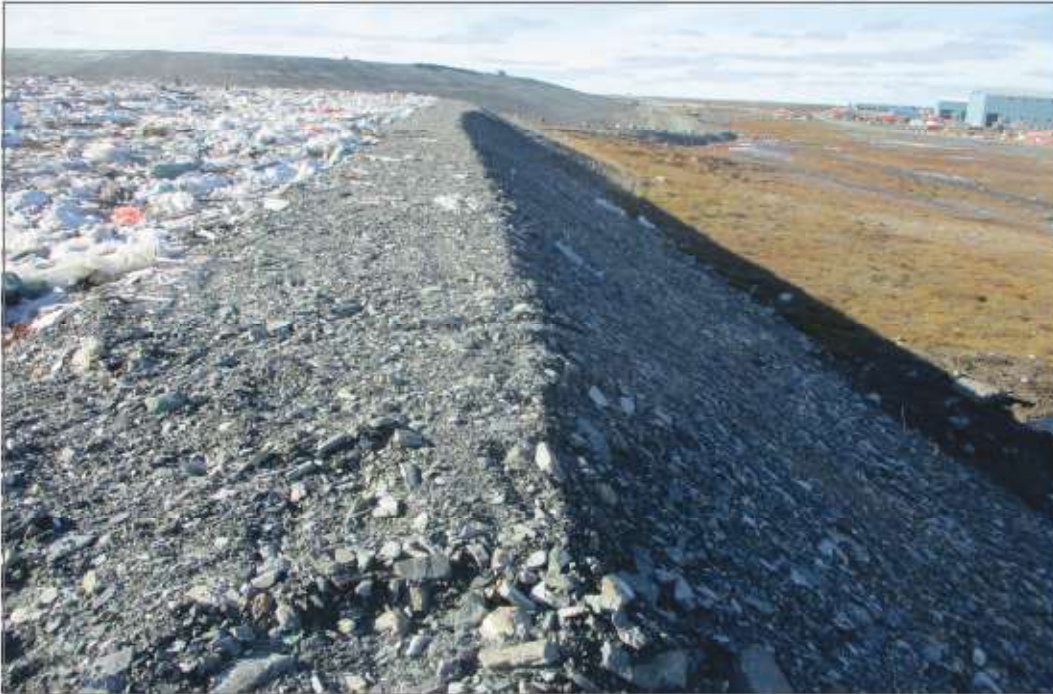
Photo 13: Landfill - WRSF1 Landfill—Northeast berm—some revegetation.

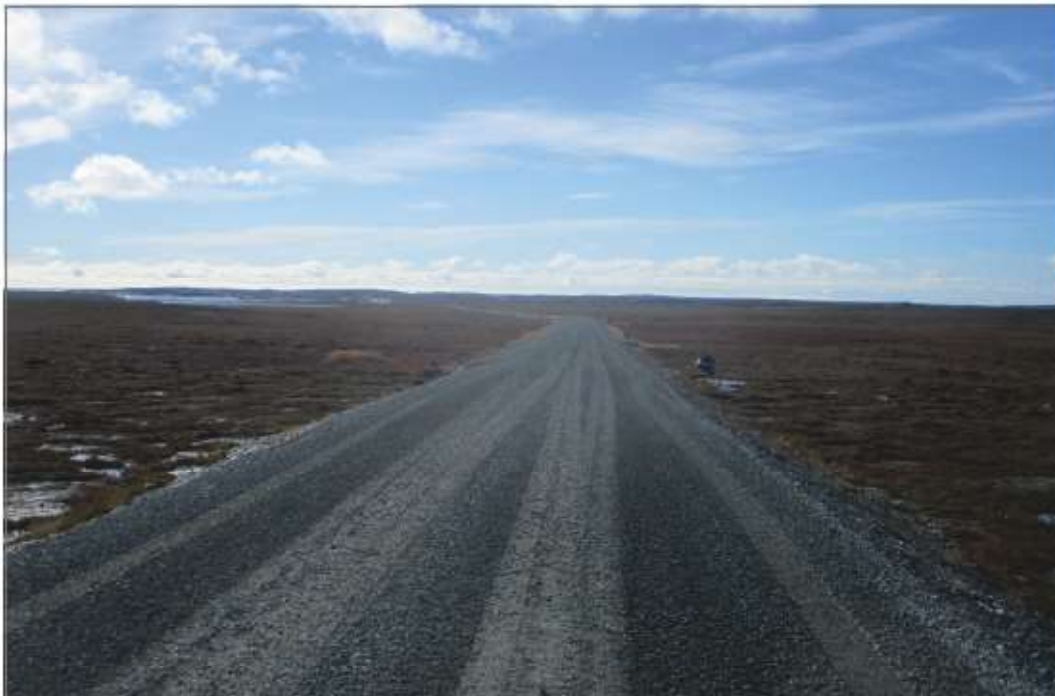
Photo 2: Overview of Bypass Road from KM 5.1 South

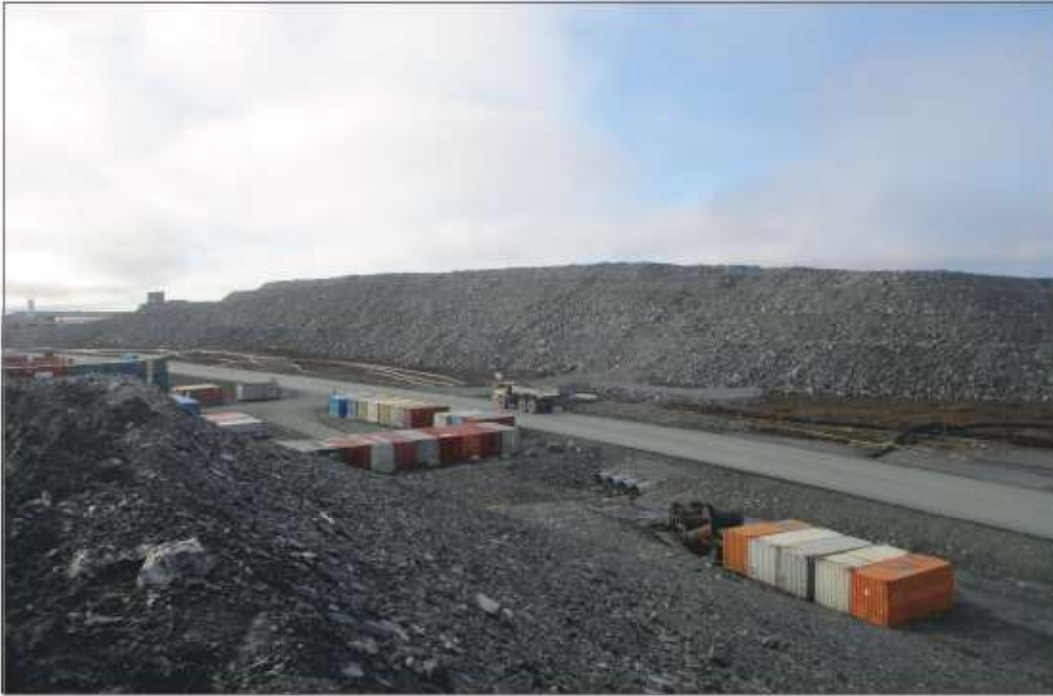
Photo 1: WRSF1—Viewed from Crusher Ramp—Waste Rock in WRSF1 in distance.

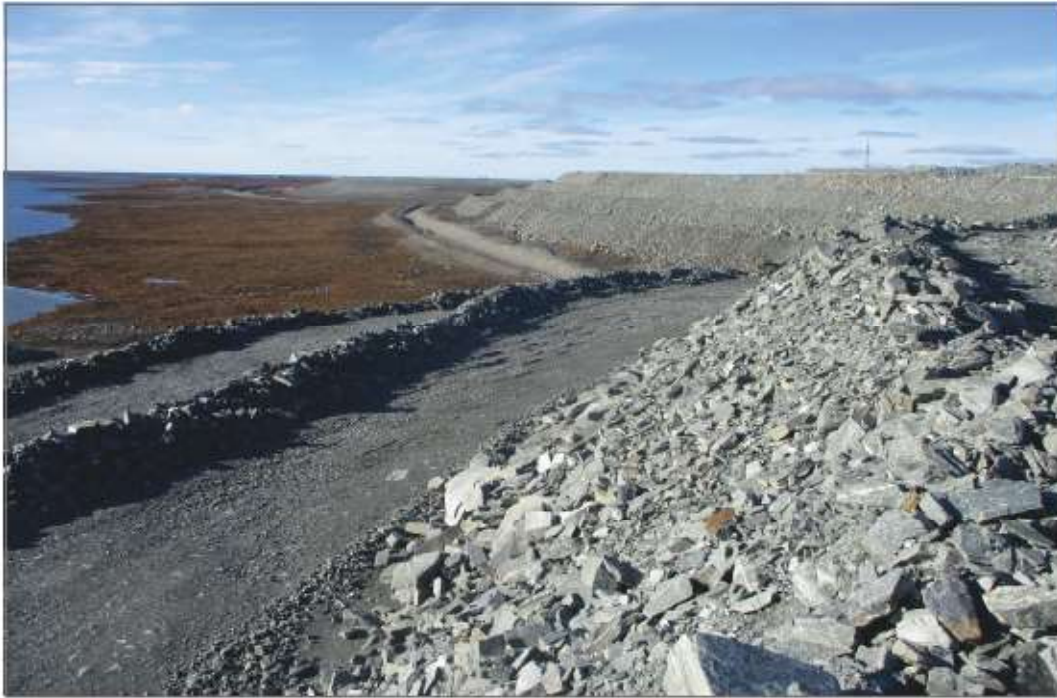
Photo 3: WRSF1—West side of WRSF, TSF in distance.
