Appendix 6: 2022 Annual Geotechnical Inspection Report

2022 Annual Geotechnical Inspection Meliadine Gold Project, Rankin Inlet, Nunavut

PRESENTED TO
Agnico Eagle Mines Limited

FEBRUARY 17, 2023
ISSUED FOR USE
FILE: 704-ENG.EARC03140-31
AGNICO EAGLE DOCUMENT NUMBER: 65-600-230-TCR-001

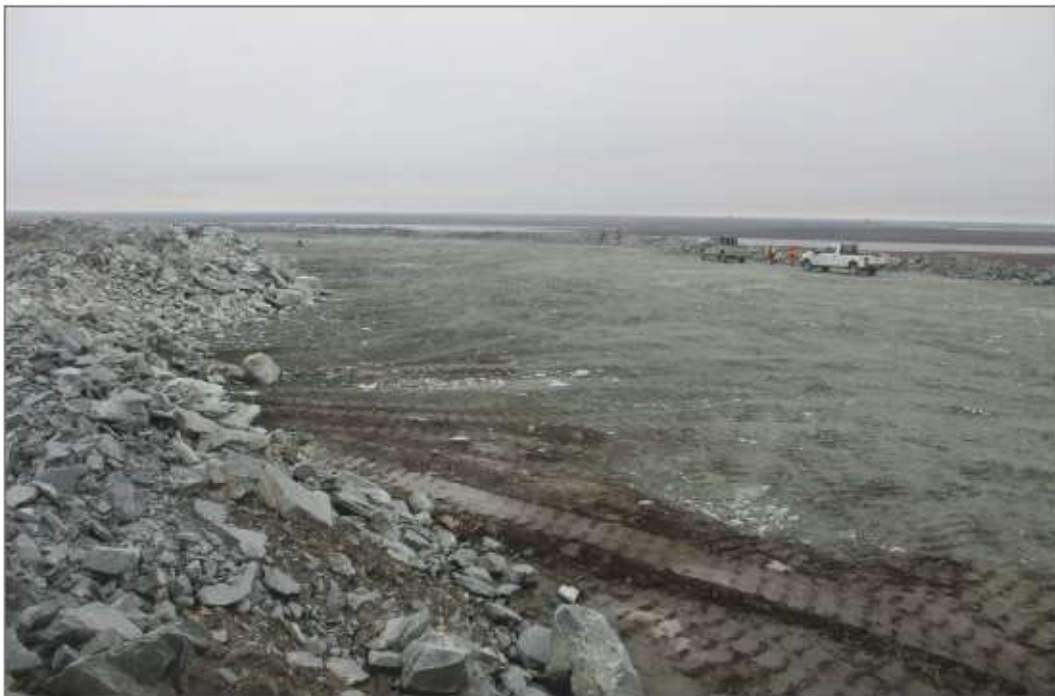
Photo 6: WRSF1—West side of WRSF looking southwest, surface of bench.

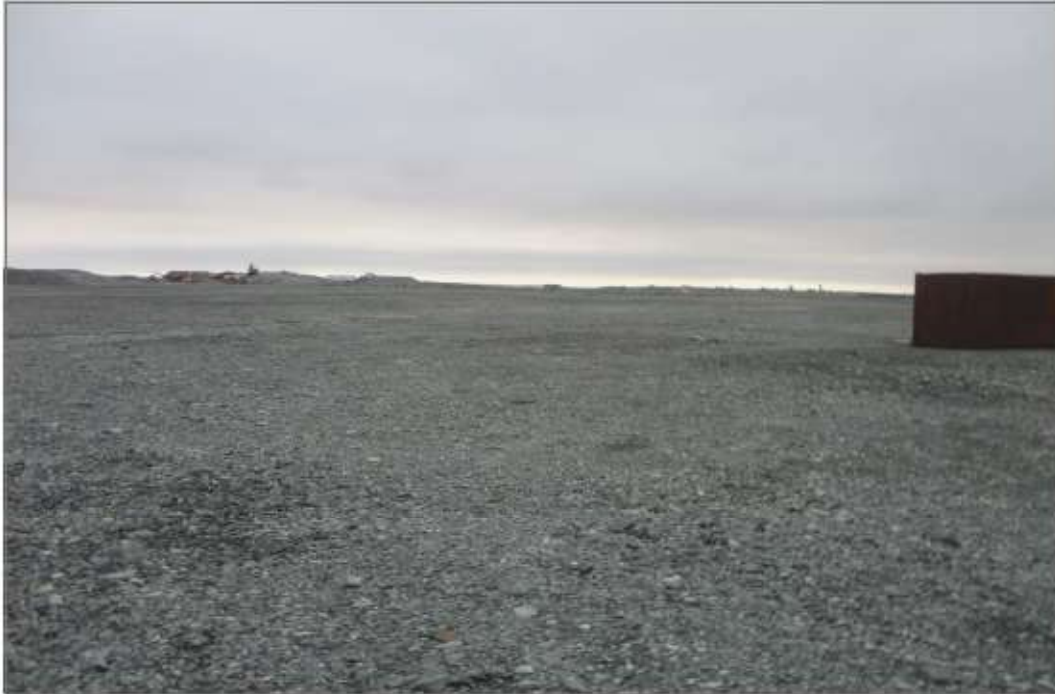
Photo 1: WRSF3 - Access to WRSF. Temporary crusher stockpiles and burnable waste station.

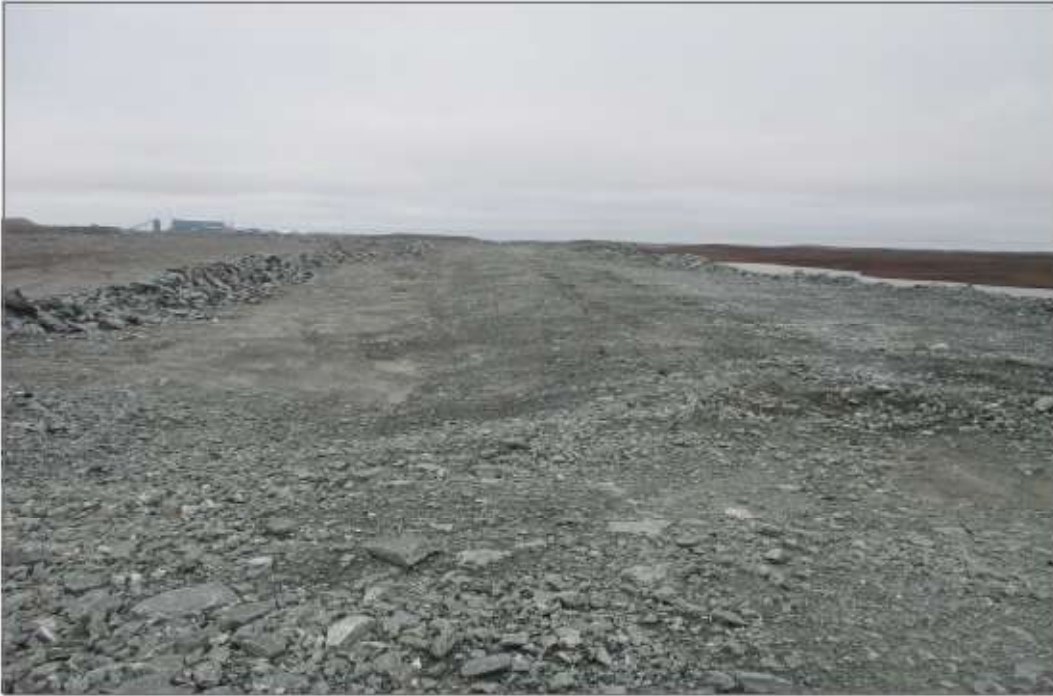
Photo 5: WRSF3—Northeast waste rock surface of expansion.
