Report: 2016 Annual Geotechnical Inspection

2016 Annual Geotechnical Inspection Meadowbank Gold Mine, Nunavut

Agnico-Eagle Mines Limited
Meadowbank Division
PO Box 540
Baker Lake, Nunavut X0C 0A0

Report Number: Doc 1549 1662181 Rev0

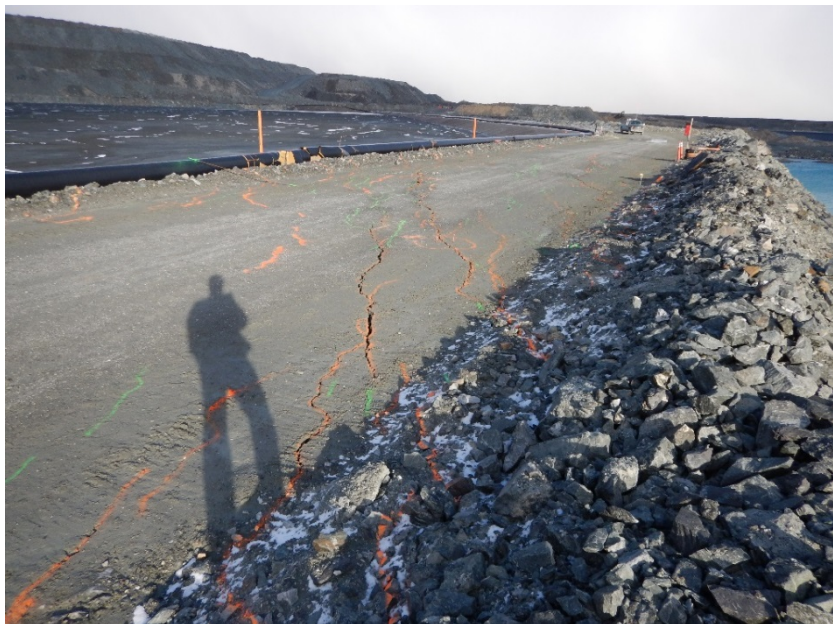
Photograph B7-9 Stormwater Dike

- Several tension cracks associated with movement were observed on the crest from Sta. 10+500 to 10+750. These movements appeared in August 2016 shortly after water from the South Cell reached this sector and stabilized, then stopped shortly after a rockfill buttress was constructed at the toe on the downstream side in September 2016. The observed movements are happening in a sector where the dike was built on frozen soft sediment and were probably caused by the water thawing this soft layer. The MDRB recommended that more instruments be installed, that a better understanding of the foundation be obtained through a geotechnical investigation, and that design criteria be established for the mitigation measure put in place.

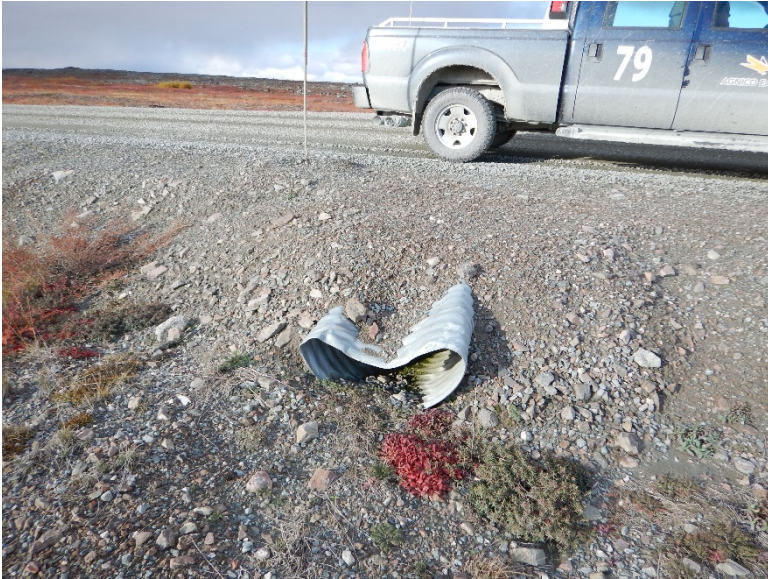
Photograph D1-7: R-00A km 2+550

Description: View of culvert inlet. The inlet is partially collapsed. No sign of flow.

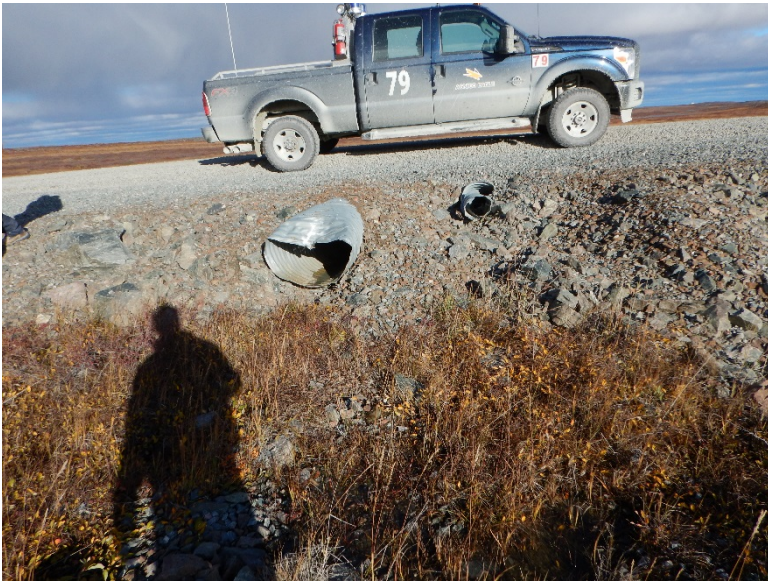
Photograph D1-9: PC-14 km 4+260

Description: View of the culverts inlet. Culverts is too damaged to be functional.

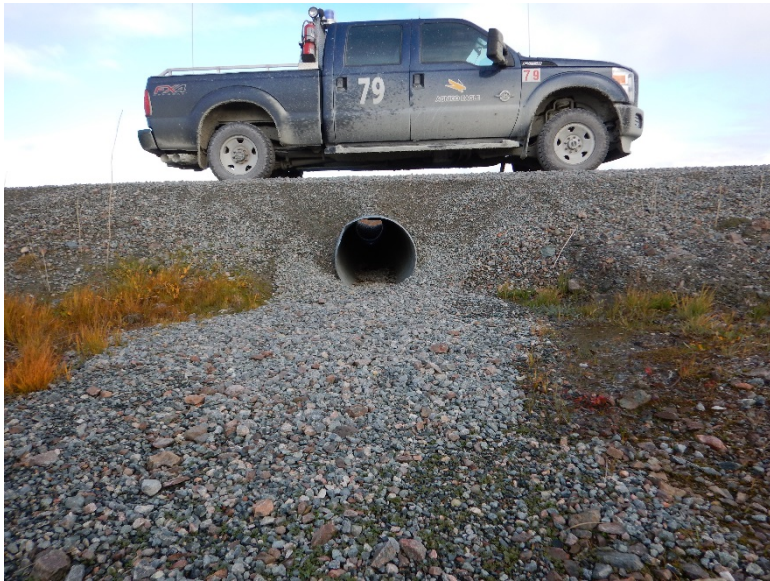
Photograph D1-11: unnamed km 5+700

Description: View of the culvert inlet. Good condition, inlet is short in length as the road rolling surface is at the edge of the inlet.

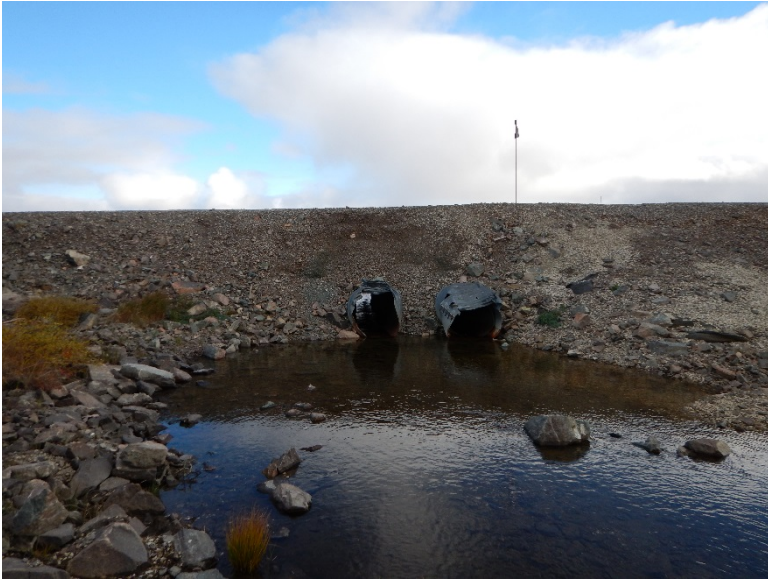
Photograph D1-15: PC-17 km 8+850

Description: View of the culverts inlet. Good condition.

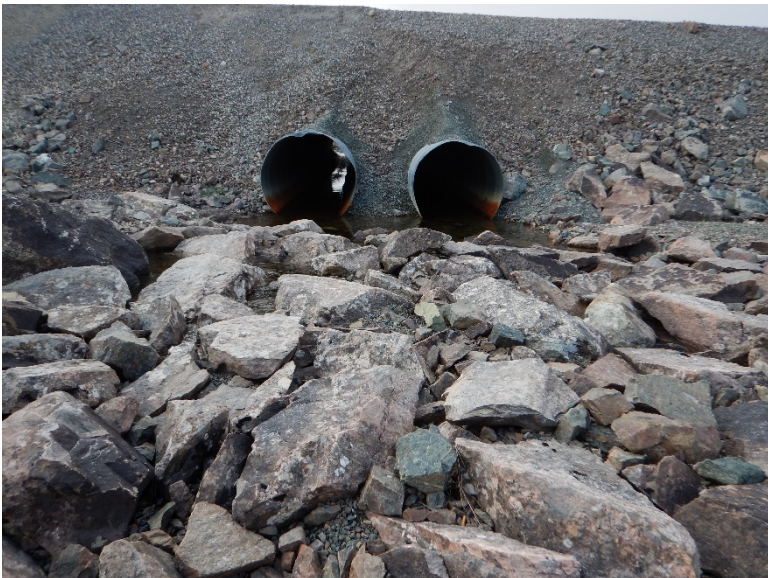
Photograph D1-16: PC-17 km 8+850

Description: View of the culverts outlet (right side of the picture). Good condition.

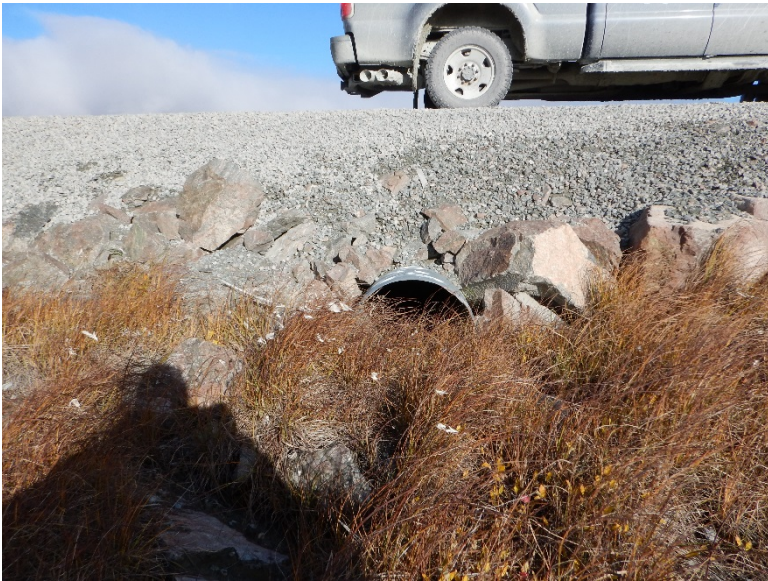
Photograph D1-17: PC-1 km 9+952

Description: View of the culvert inlet. In good condition.

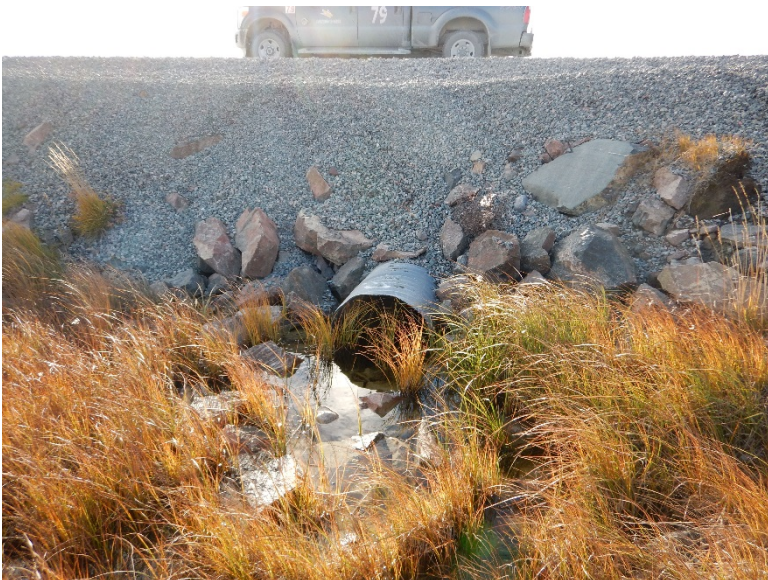
Photograph D1-18: PC-1 km 9+952

Description: View of the culvert outlet. In good condition.

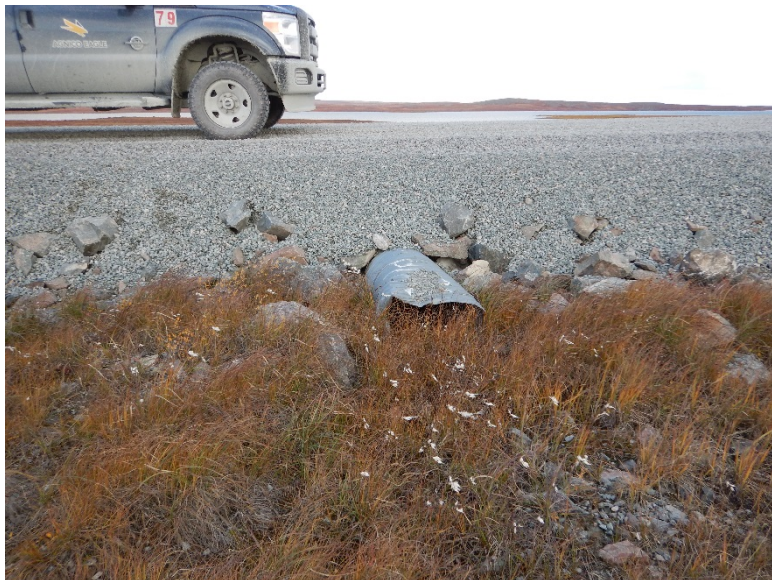
Photograph D1-23: PC-13 km 12+745

Description: View of the culvert inlet. In good condition.

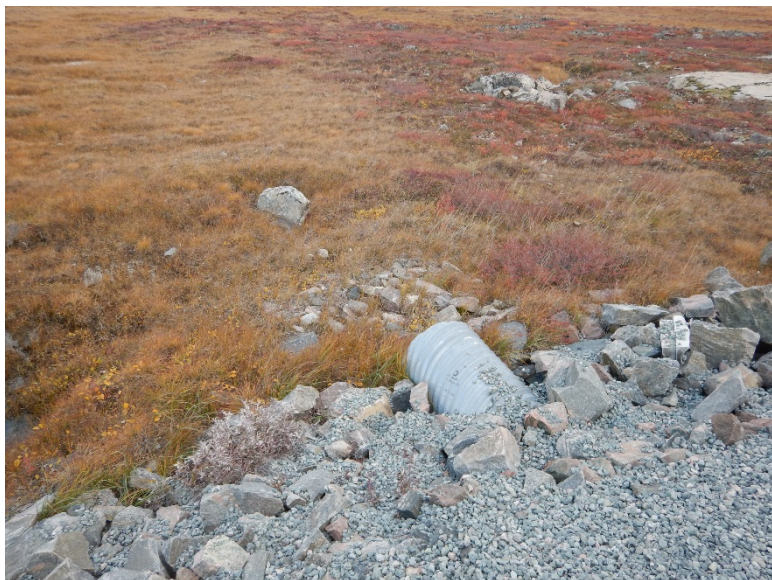
Photograph D1-24: PC-13 km 12+745

Description: View of the culvert outlet. In good condition.

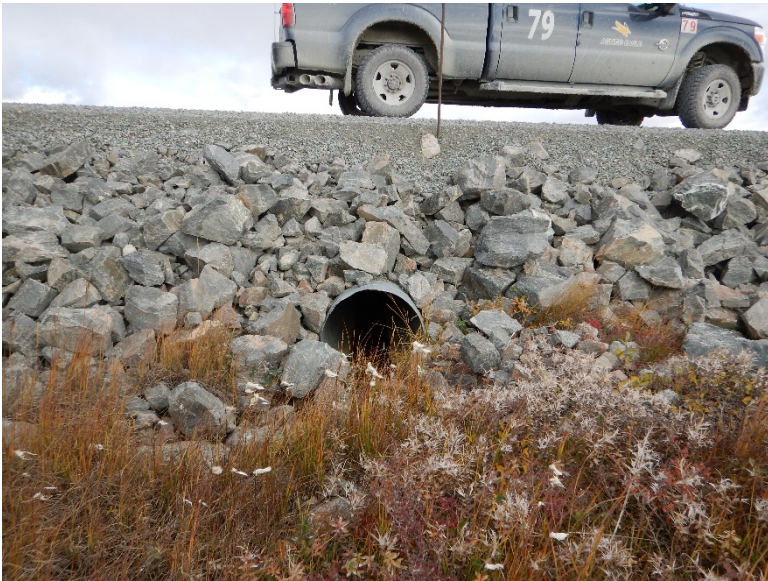
Photograph D1-25: PC-2 km 13+405

Description: View of the culvert inlet. In good condition.

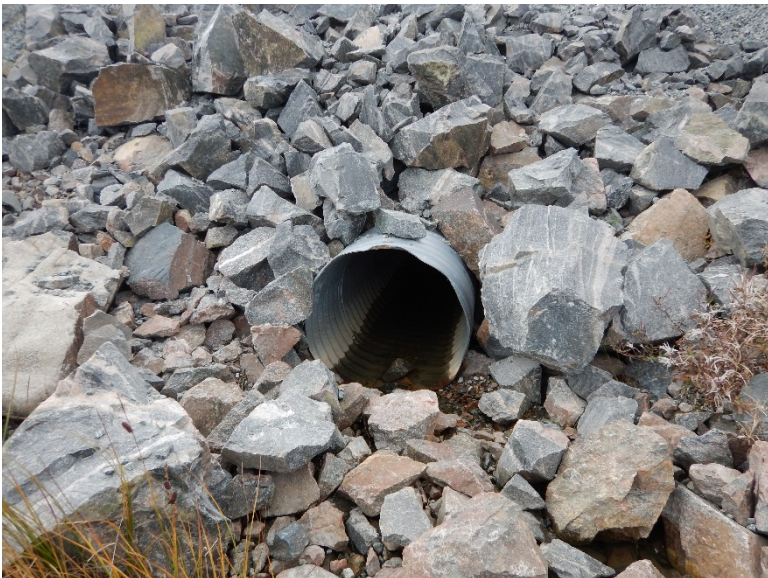
Photograph D1-26: PC-2 km 13+405

Description: View of the culvert outlet. In good condition.

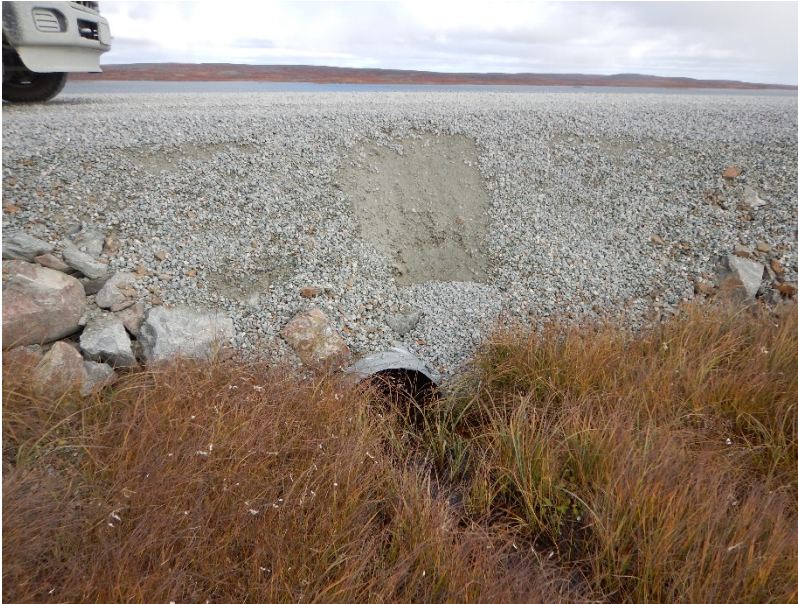
Photograph D1-27: PC-3 km 13+685

Description: View of the culvert inlet. In good condition.

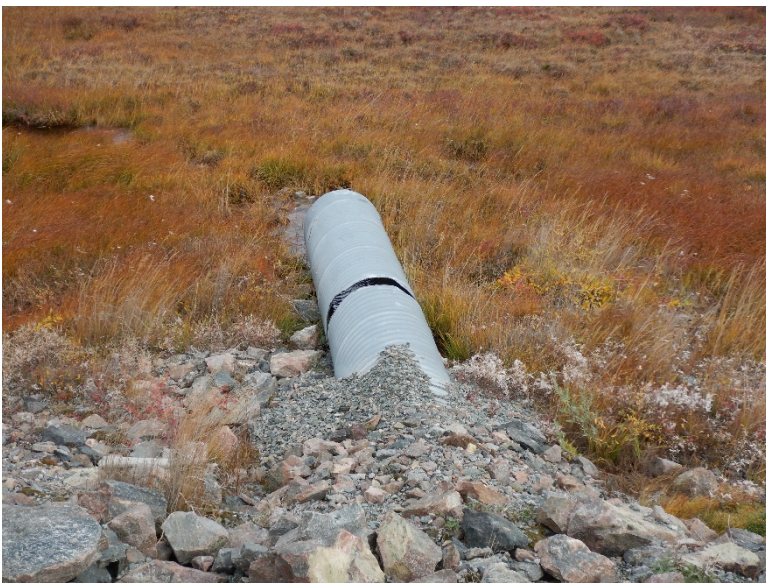
Photograph D1-28: PC-3 km 13+685

Description: View of the culvert outlet. In good condition.

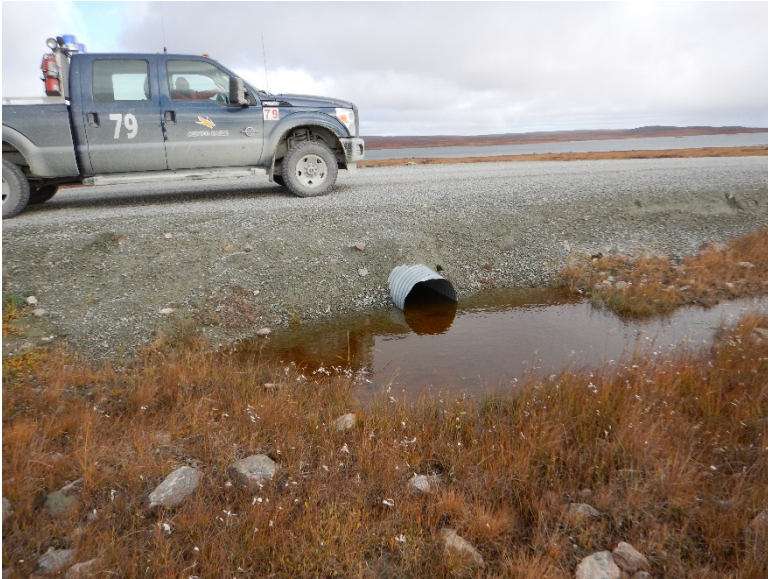
Photograph D1-29: unnamed km 13+950

Description: View of the culvert inlet. In good condition.

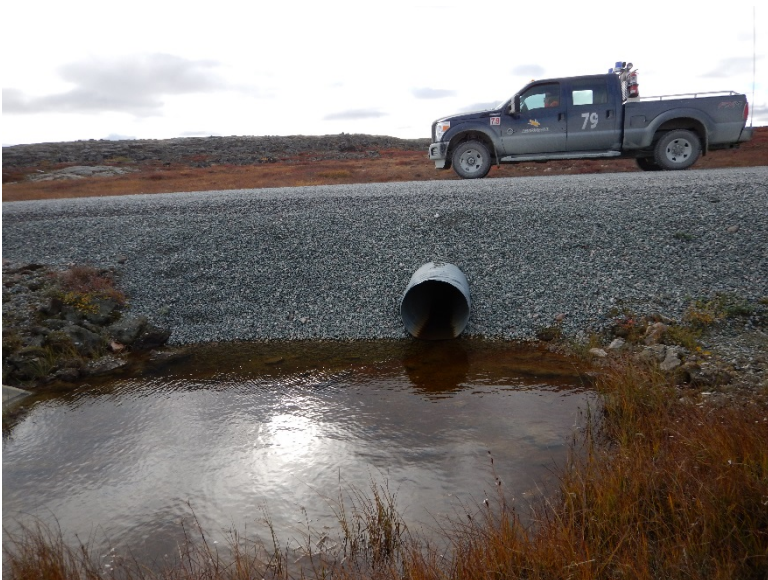
Photograph D1-30: unnamed km 13+950

Description: View of the culvert outlet. The outlet is in good condition.

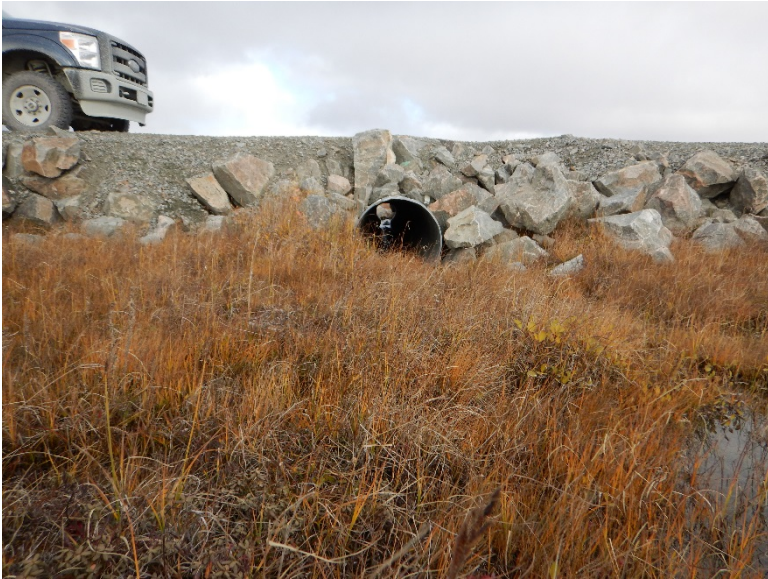
Photograph D1-31: PC-4 km 14+910

Description: View of the culvert inlet. In good condition.

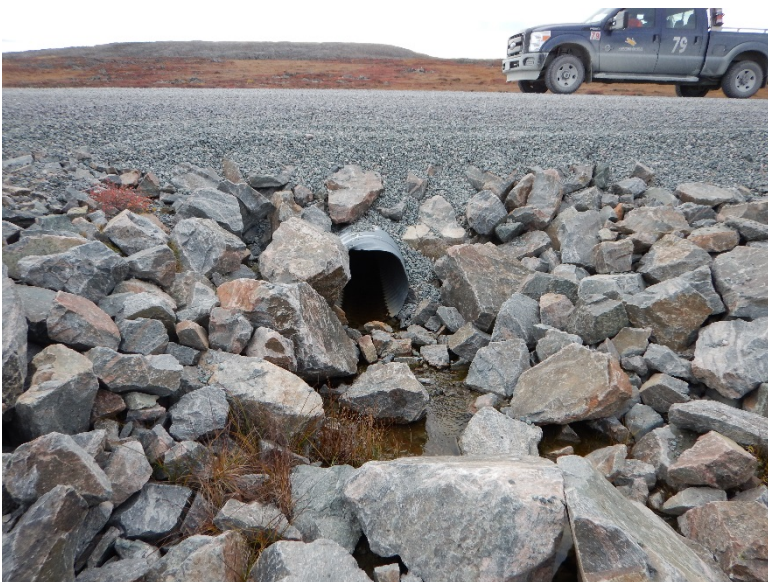
Photograph D1-32: PC-4 km 14+910

Description: View of the culvert outlet. In good condition. Large boulders around the outlet.

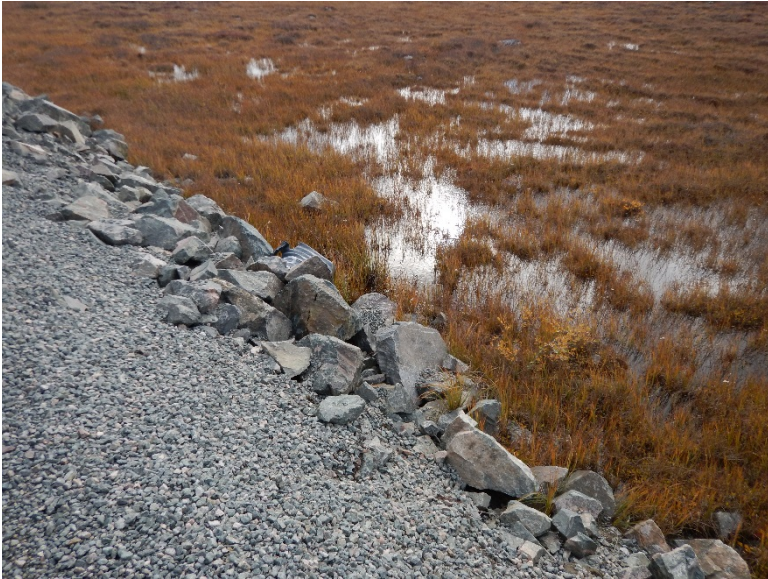
Photograph D1-35: PC-5 km 18+280

Description: View of the culvert inlet. In good condition.

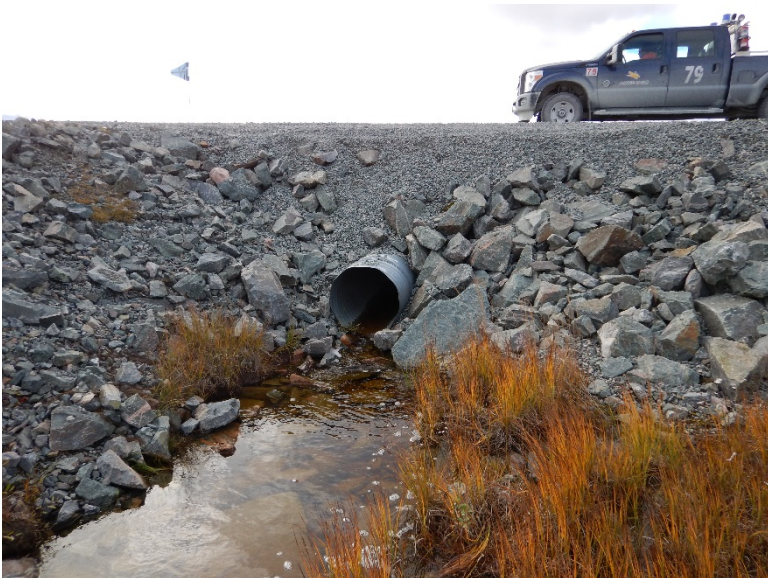
Photograph D1-36: PC-5 km 18+280

Description: View of the culvert outlet. In good condition.

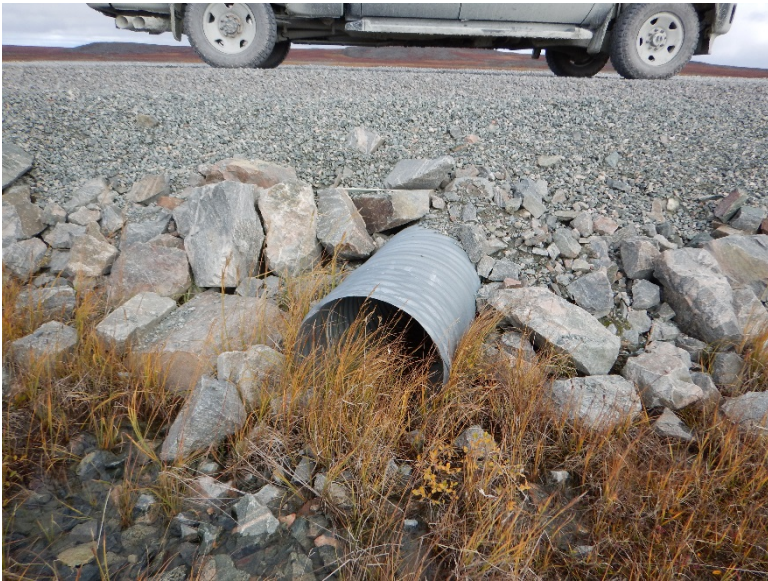
Photograph D1-37: PC-6 km 18+900

Description: View of culvert inlet. In good condition.

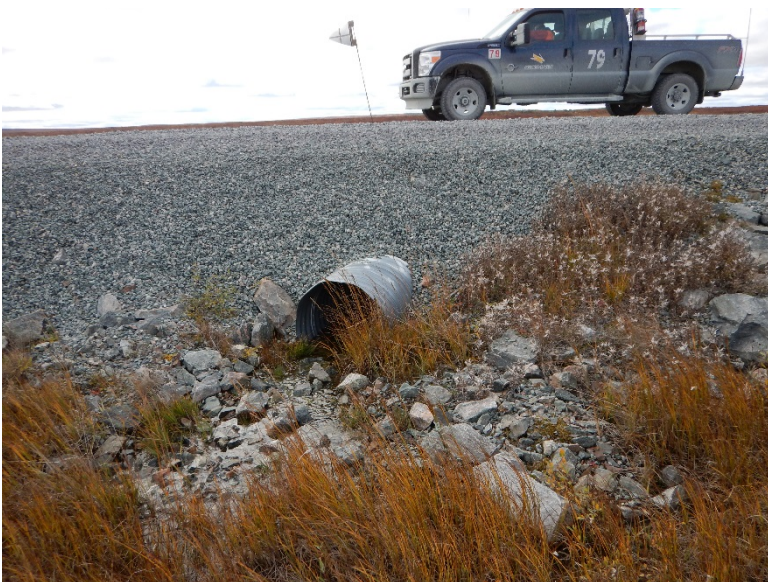
Photograph D1-38: PC-6 km 18+900

Description: View of culvert outlet. In good condition.

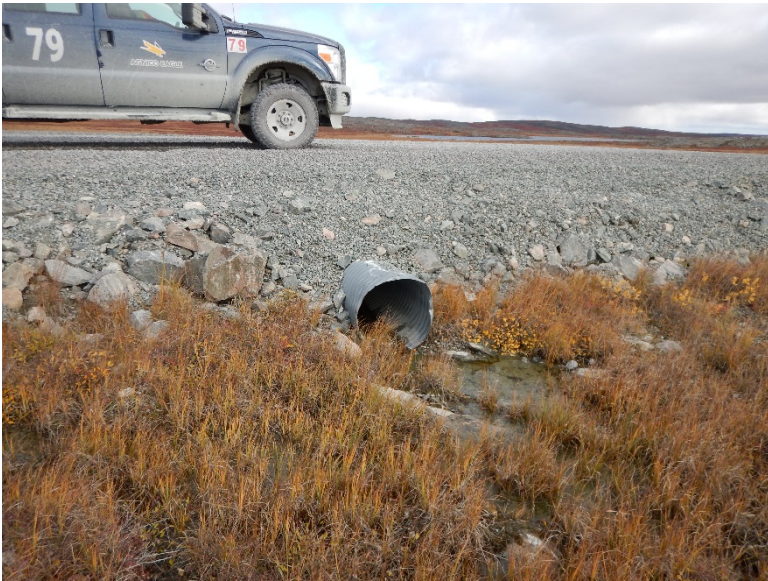
Photograph D1-41: PC-7 km 20+250

Description: View of the culvert inlet. In good condition.

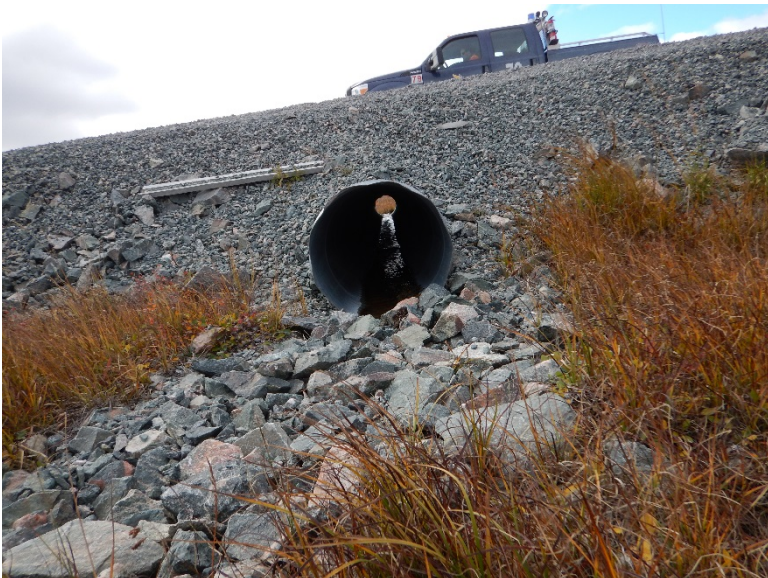
Photograph D1-42: PC-7 km 20+250

Description: View of the culvert outlet. In good condition.

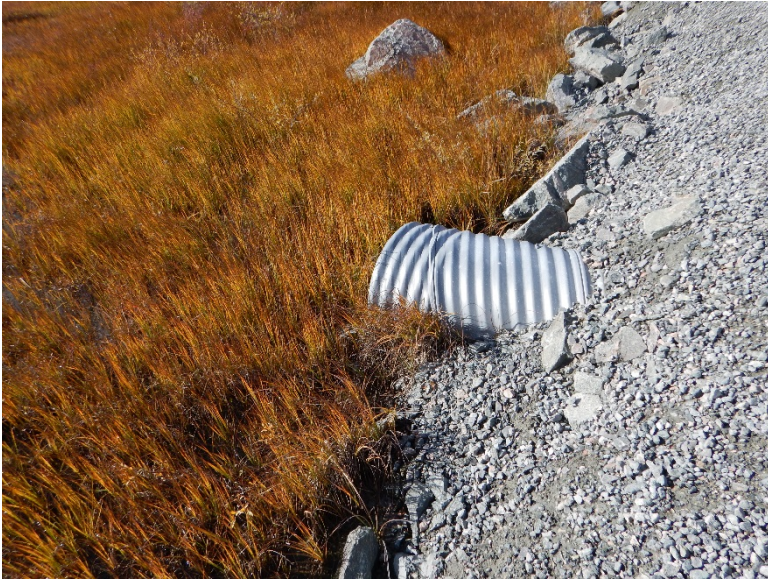
Photograph D1-45: PC-8 km 29+420

Description: View of the culvert inlet. In good condition.

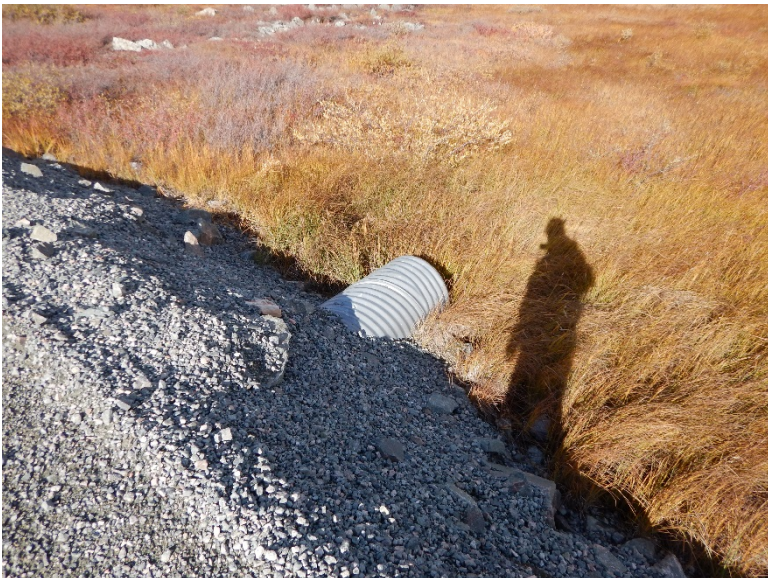
Photograph D1-46: PC-8 km 29+420

Description: View of the culvert outlet. In good condition.

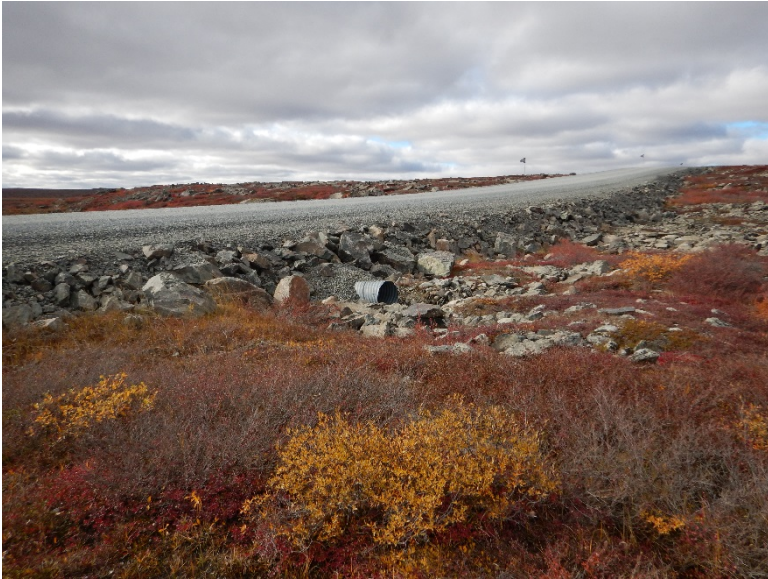
Photograph D1-47: PC-9 km 35+690

Description: View of the culvert inlet. In good condition.

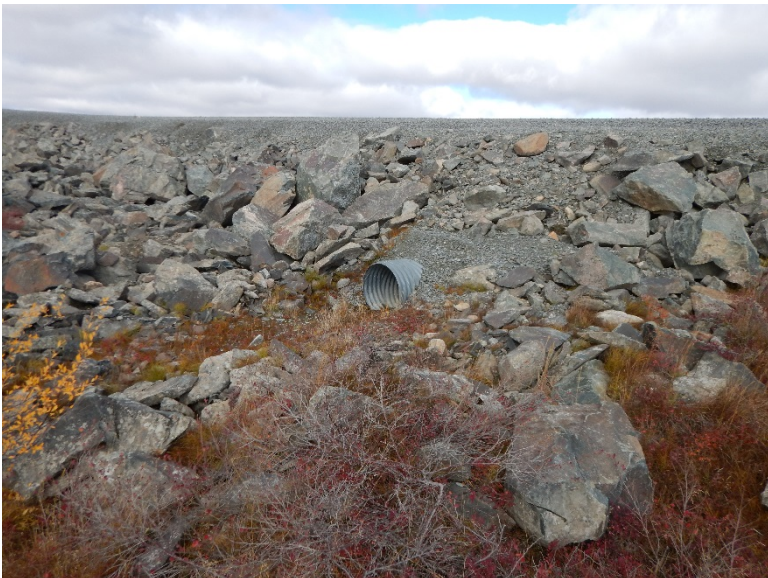
Photograph D1-48: PC-9 km 35+690

Description: View of the culvert outlet. In good condition.

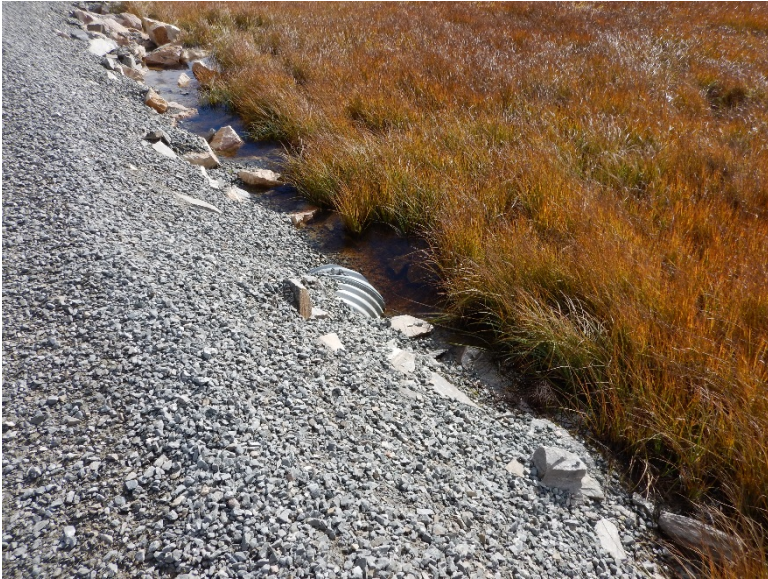
Photograph D1-49: PC-10 km 36+865

Description: View of the culvert inlet. In good condition.

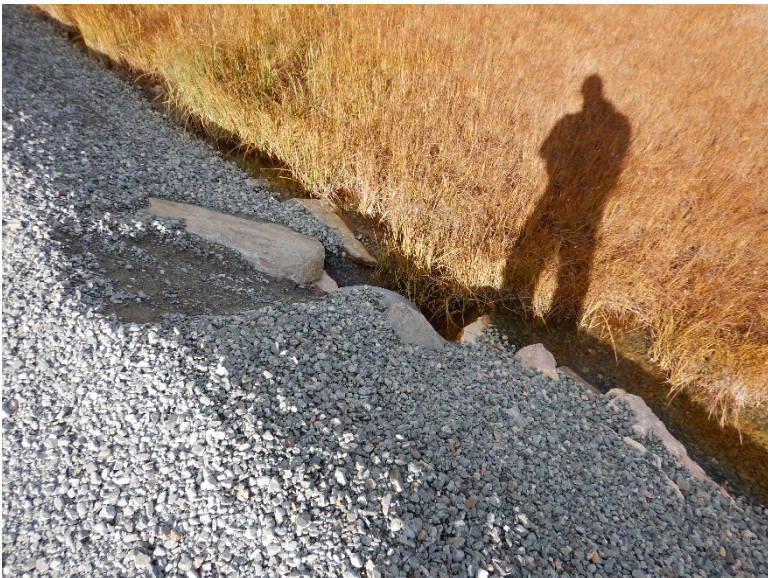
Photograph D1-50: PC-10 km 36+865

Description: View of the culvert outlet. In good condition.

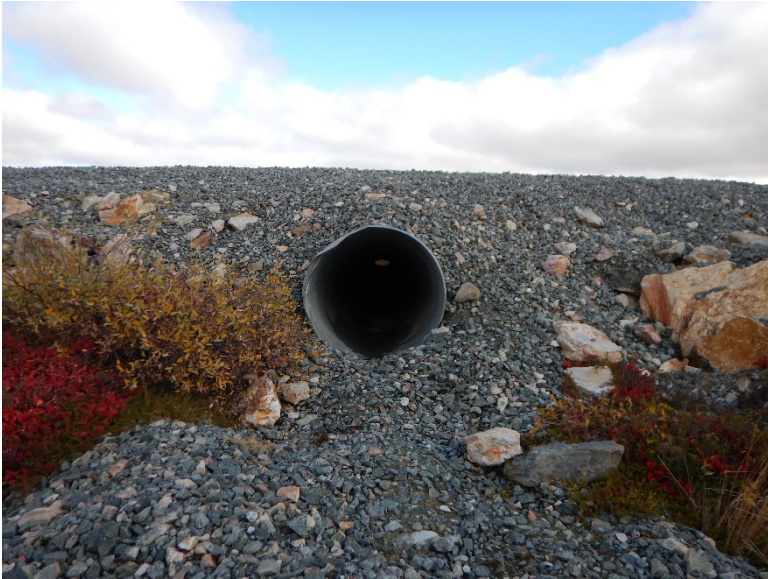
Photograph D1-51: PC-11 km 39+552

Description: View of the culvert inlet. In good condition.

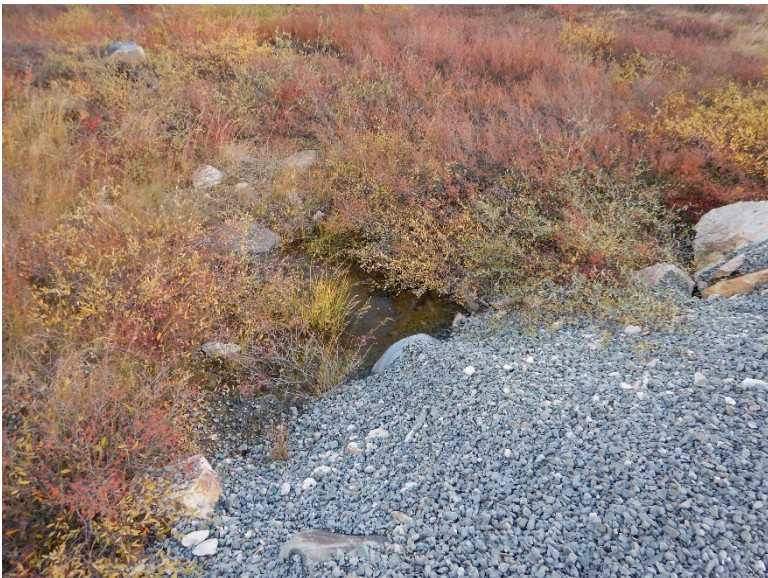
Photograph D1-52: PC-11 km 39+552

Description: View of the culvert outlet. In good condition, almost submerged.

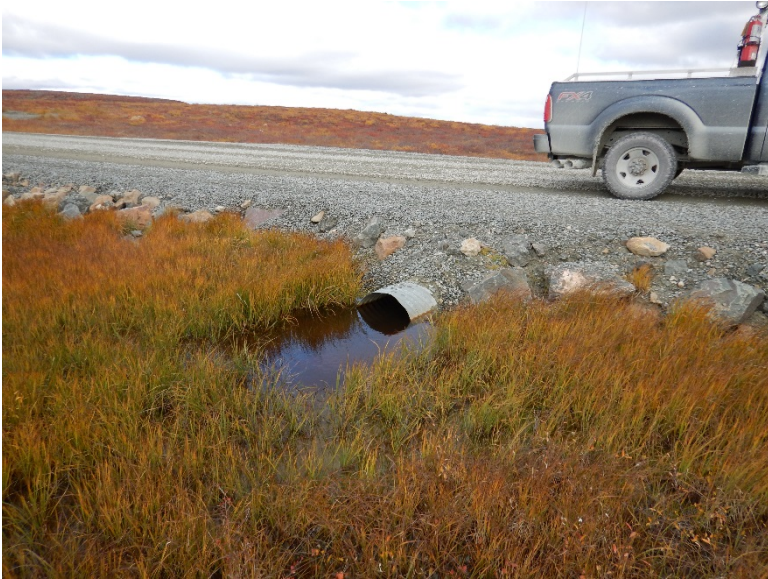
Photograph D1-53: PC-12 km 41+300

Description: View of the culvert inlet. In good condition, almost submerged.

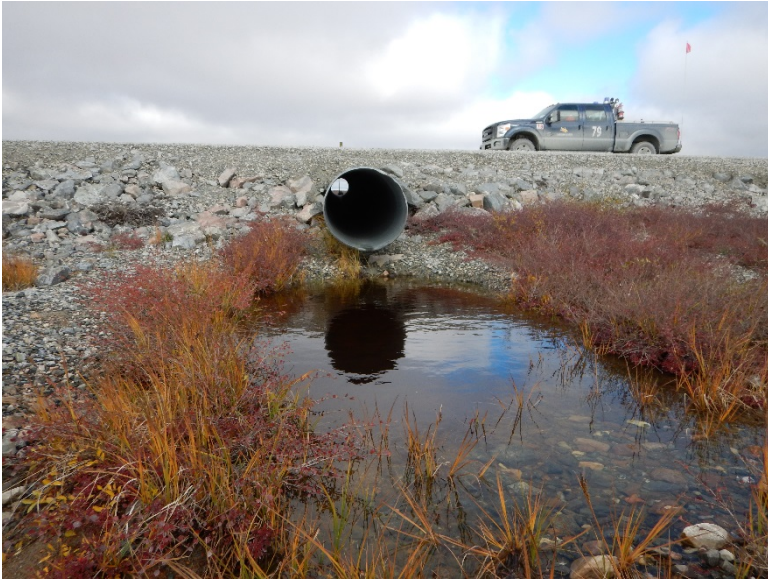
Photograph D1-61: R-18B km 80+950

Description: View of the culverts inlet. In good condition, installed above the ground surface.

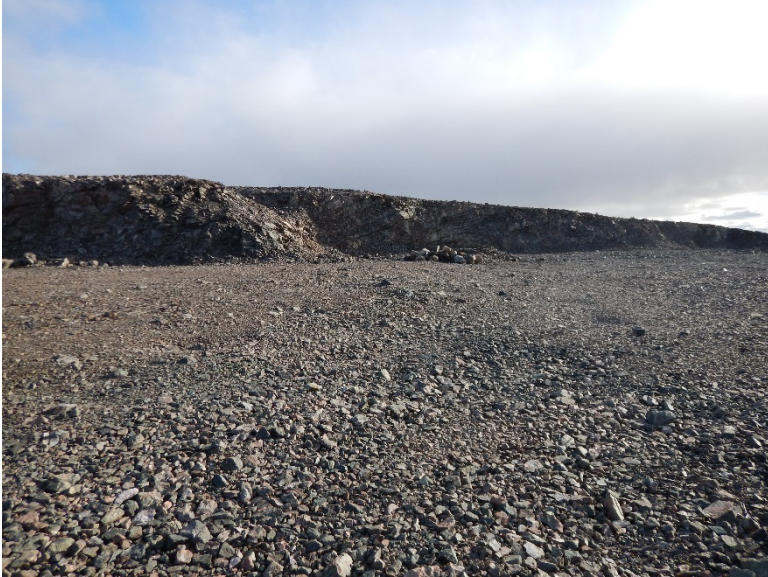
Photograph E1-1: Quarry 1 – km 5+200

Description: View of south walls.

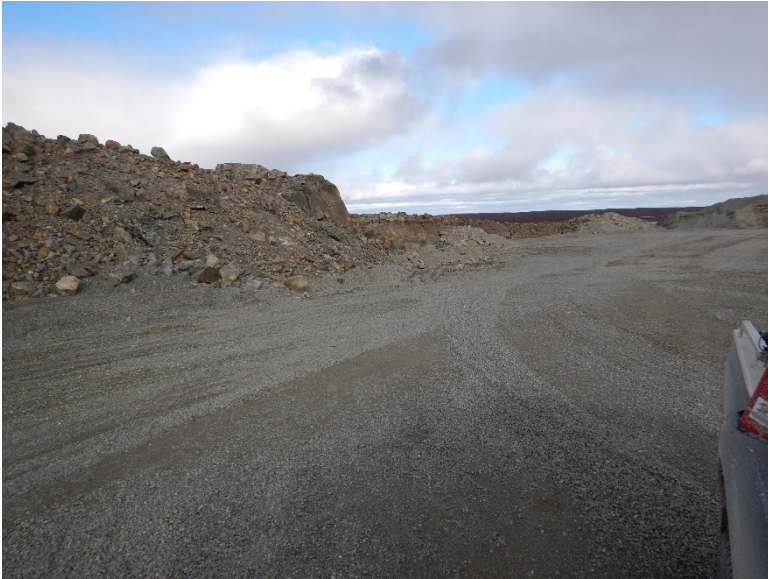
Photograph E1-3: Quarry 2 – km 13+250

Description: View of north and east walls.

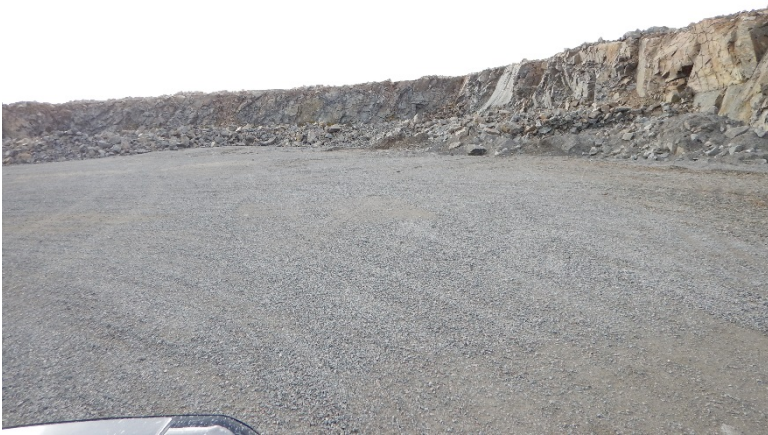
Photograph E1-5: Quarry 2 – km 13+250

Description: View of west and south walls.

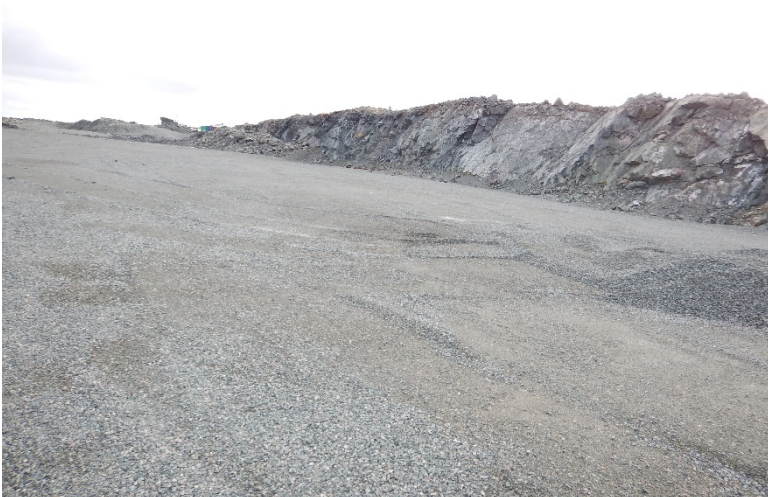
Photograph E1-6: Quarry 3 – km 23+700

Description: View of west wall. Presence of loose rock along steep wall.

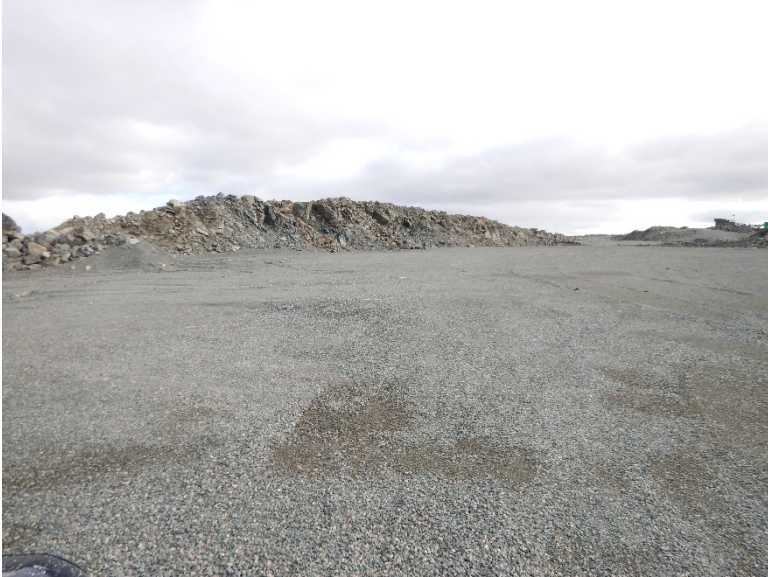
Photograph E1-7: Quarry 3 – km 23+700

Description: View of east wall.

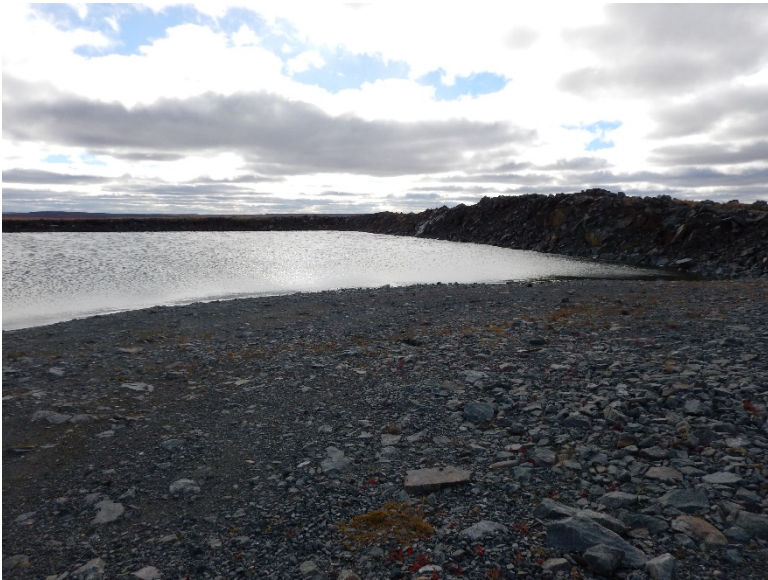
Photograph E1-9: Quarry 4 – km 31+300

Description: View of the west and south walls of Quarry 4. The quarry is flooded.

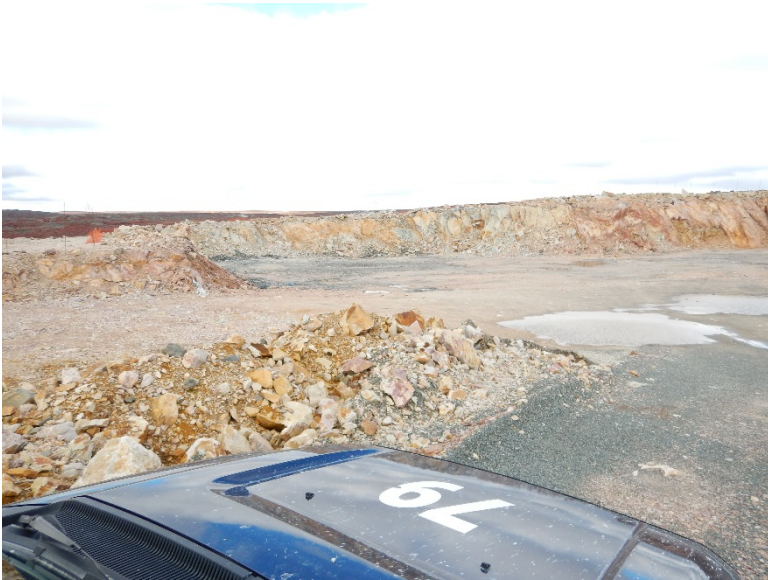
Photograph E1-11: Quarry 5 – km 34+650

Description: View of north and west walls. Minor accumulation of water.

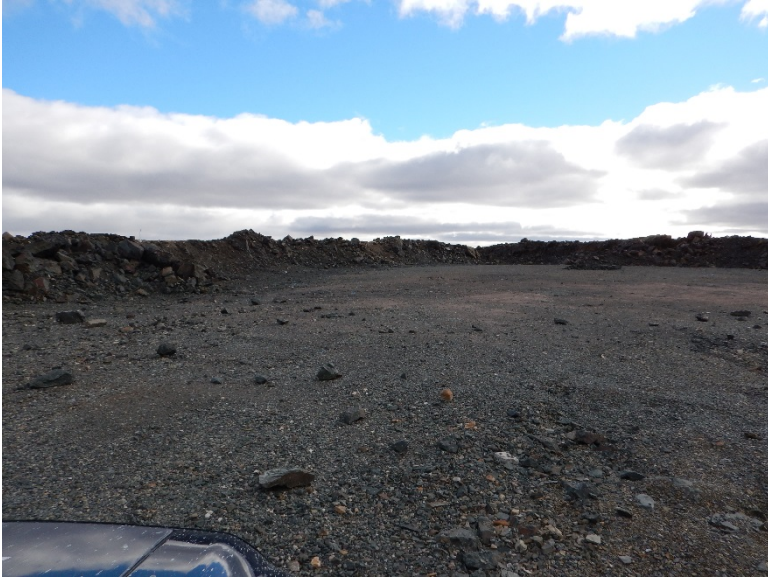
Photograph E1-13: Quarry 6 – km 36+470

Description: View of south and east walls.

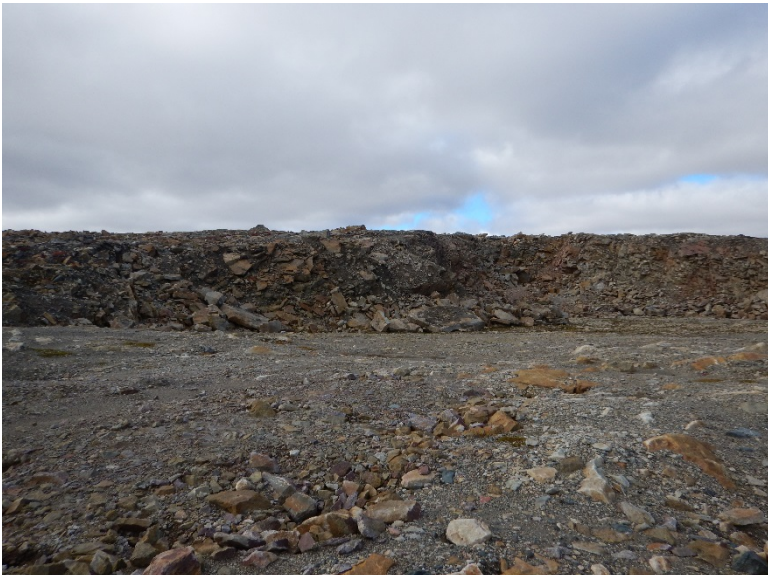
Photograph E1-14: Quarry 7 – km 39+800

Description: View of west wall. Presence of loose blocks.

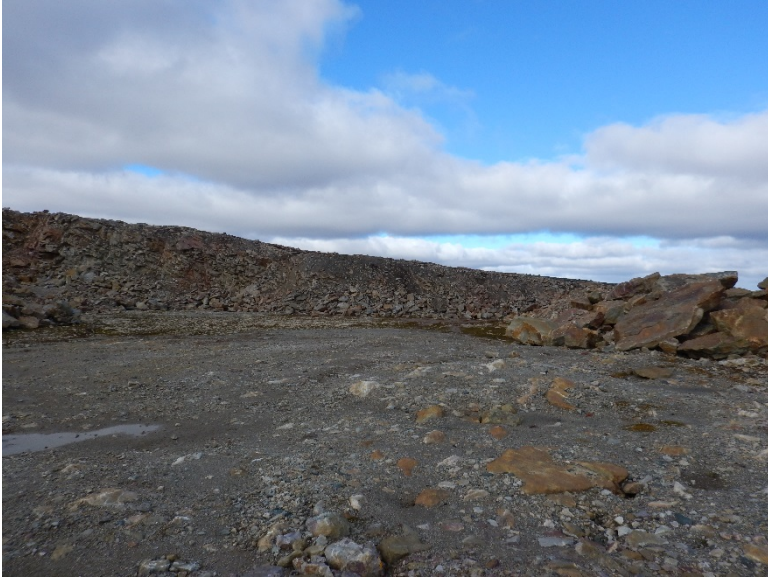
Photograph E1-15: Quarry 7 – km 39+800

Description: View of north wall. Loose blocks were removed.

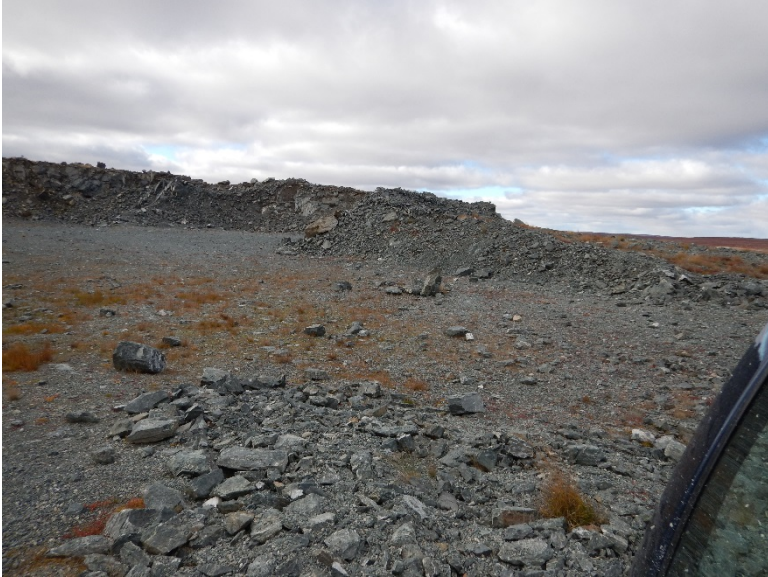
Photograph E1-17: Quarry 8 – km 42+950

Description: View of north and west walls.

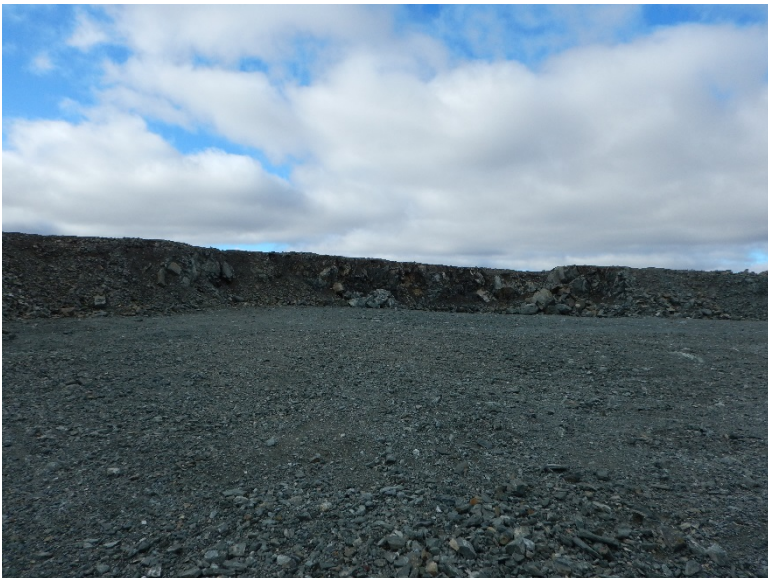
Photograph E1-18: Quarry 9 – km 44+600

Description: View of west and south walls. Presence of loose blocks at the base of the wall.

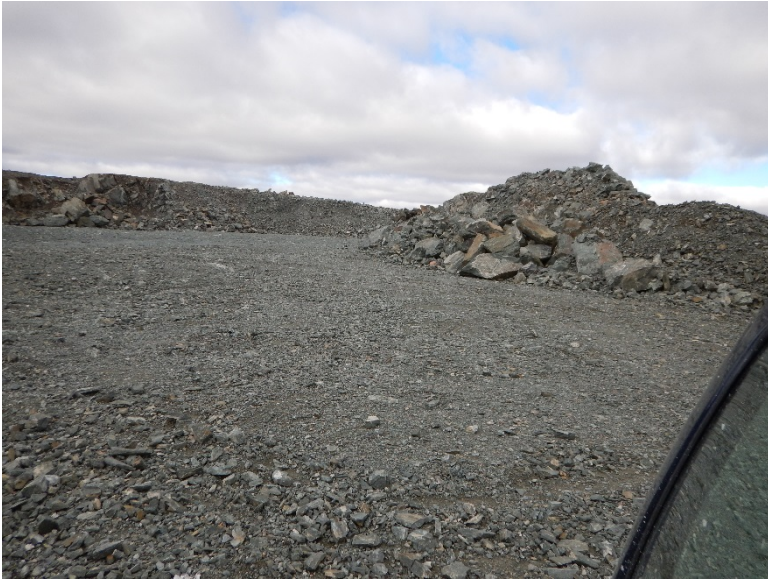
Photograph E1-19: Quarry 9 – km 44+600

Description: View of north and east walls. View of a pile of loose material.

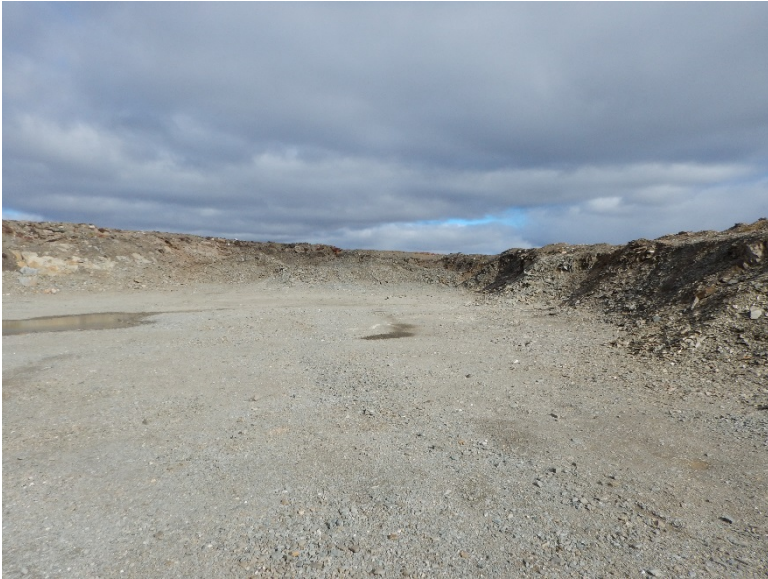
Photograph E1-21: Quarry 10 – km 48+900

Description: Overview of the quarry looking north at the east, west and north walls.
