Report: 2016 Annual Geotechnical Inspection

2016 Annual Geotechnical Inspection Meadowbank Gold Mine, Nunavut

Agnico-Eagle Mines Limited
Meadowbank Division
PO Box 540
Baker Lake, Nunavut X0C 0A0

Report Number: Doc 1549 1662181 Rev0

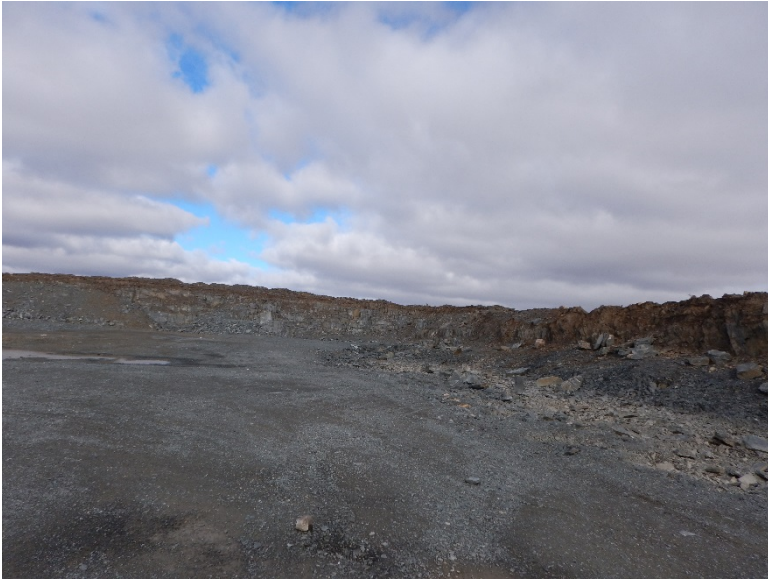
Photograph E1-23: Quarry 11 – km 53+500

Description: Overview of Quarry 11 looking at the north and east walls.

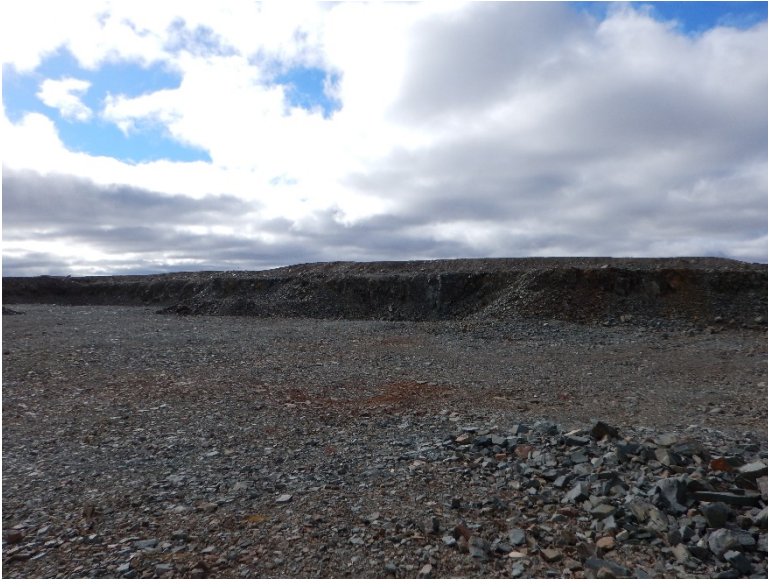
Photograph E1-25: Quarry 12 – km 58+300

Description: View of the west wall.

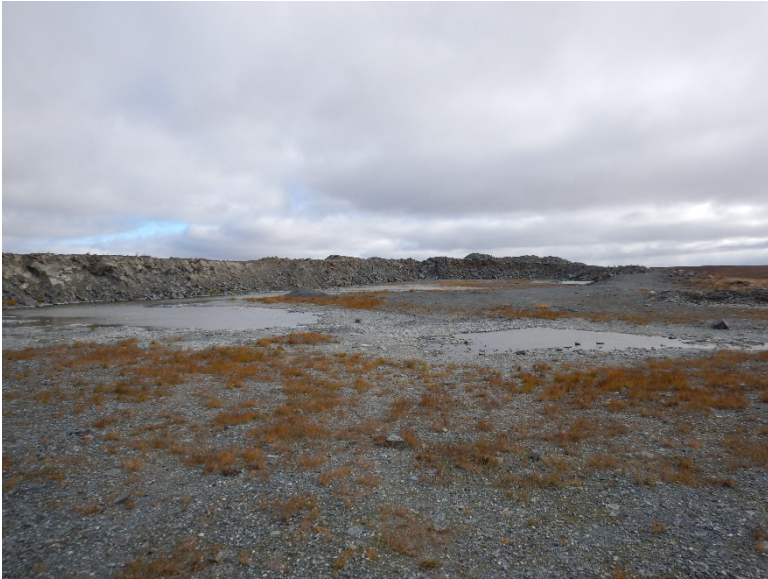
Photograph E1-27: Quarry 13 – km 62+350

Description: Looking at the south and east walls. Accumulation of water inside the quarry.

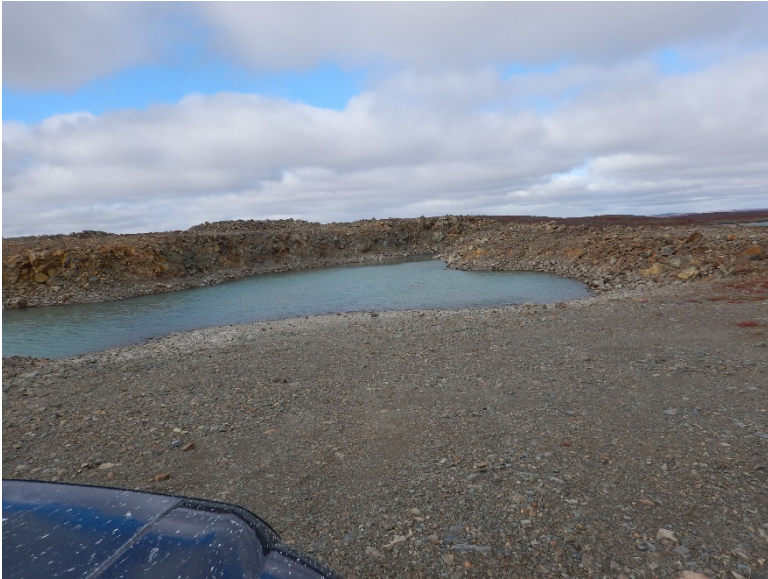
Photograph E1-29: Quarry 14 – km 65+700

Description: View of north and west walls. Quarry flooded.

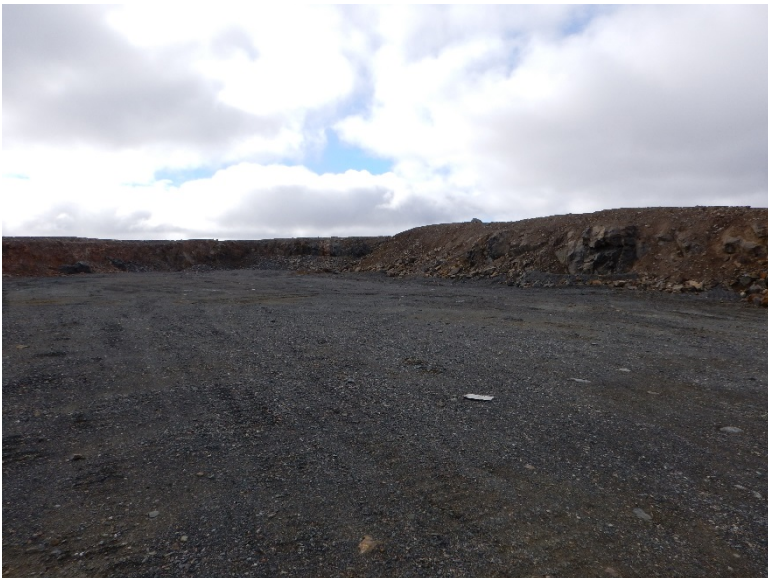
Photograph E1-32: Quarry 16 – km 70+400

Description: View of the south and west walls. Presence of loose rocks on steep wall.

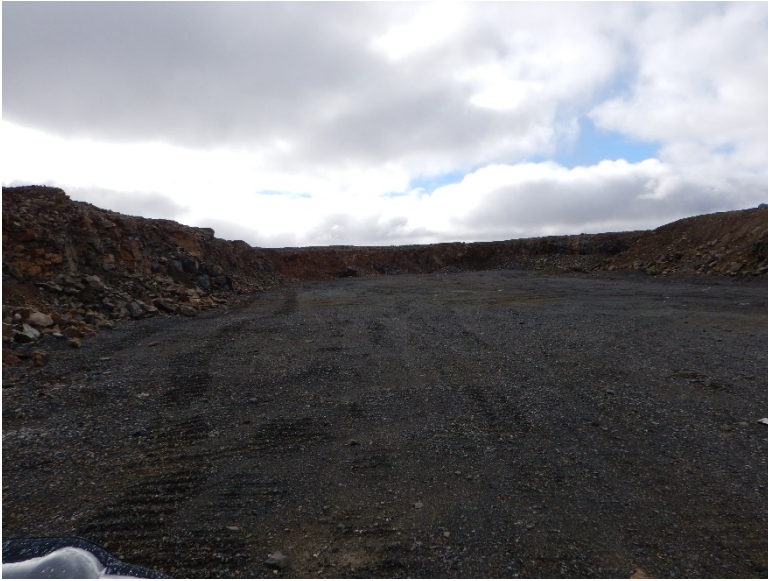
Photograph E1-33: Quarry 16 – km 70+400

Description: View of the east and south walls. Presence of loose rocks on steep wall.

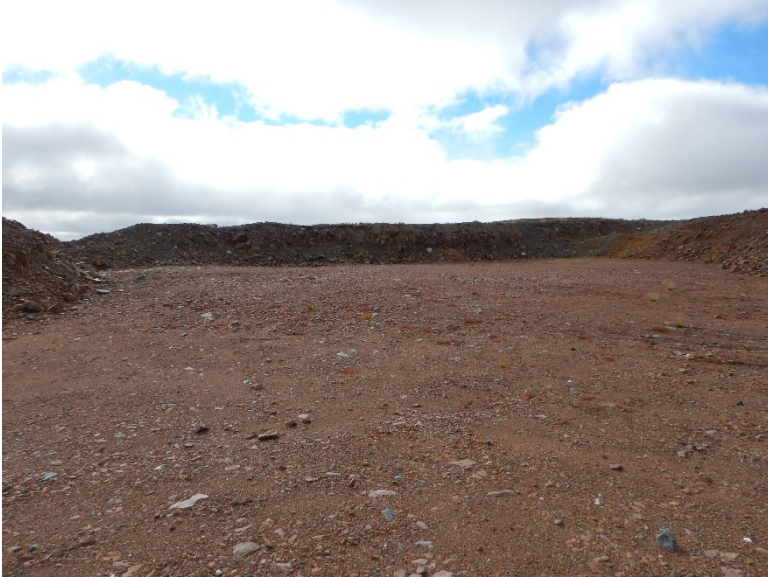
Photograph E1-35: Quarry 17 – km 72+800

Description: Looking at the north wall.

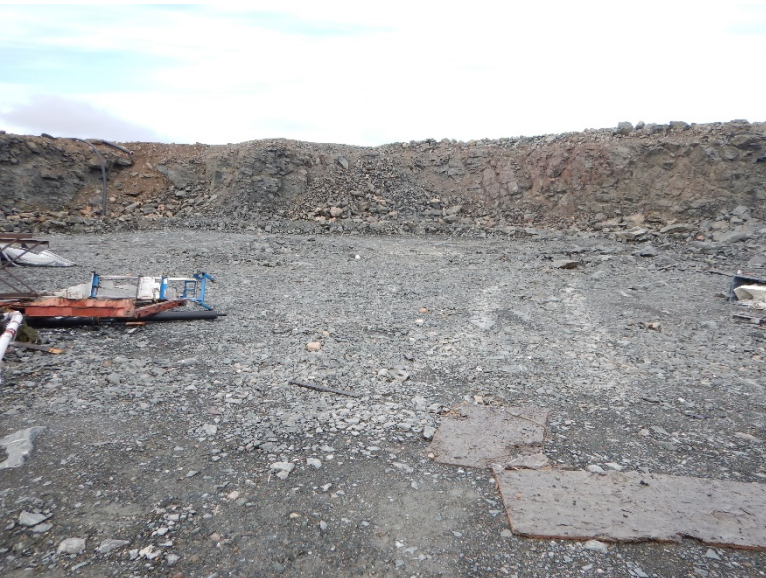
Photograph E1-48: Quarry 23 (Airstrip Quarry)

Description: Looking at the north and west walls. Presence of loose rocks along steep wall.

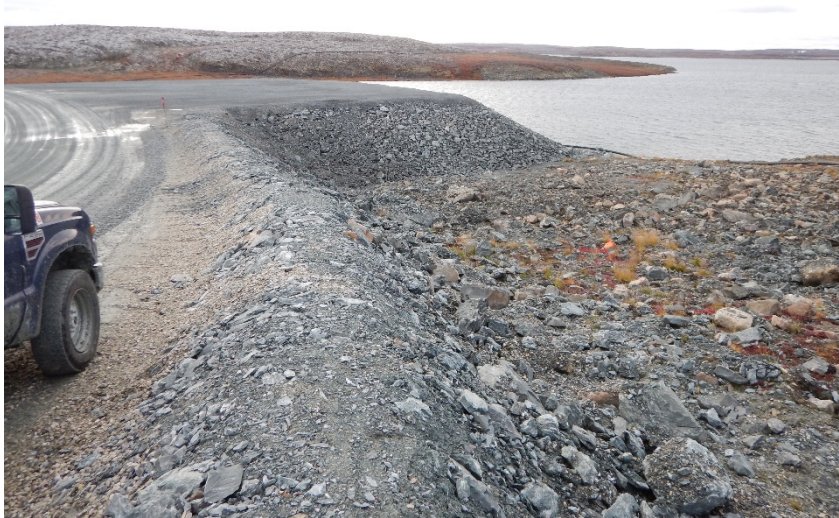
Photograph G8-1 Airstrip

Description: Looking west at the extremity of the airstrip located within Third Portage Lake.

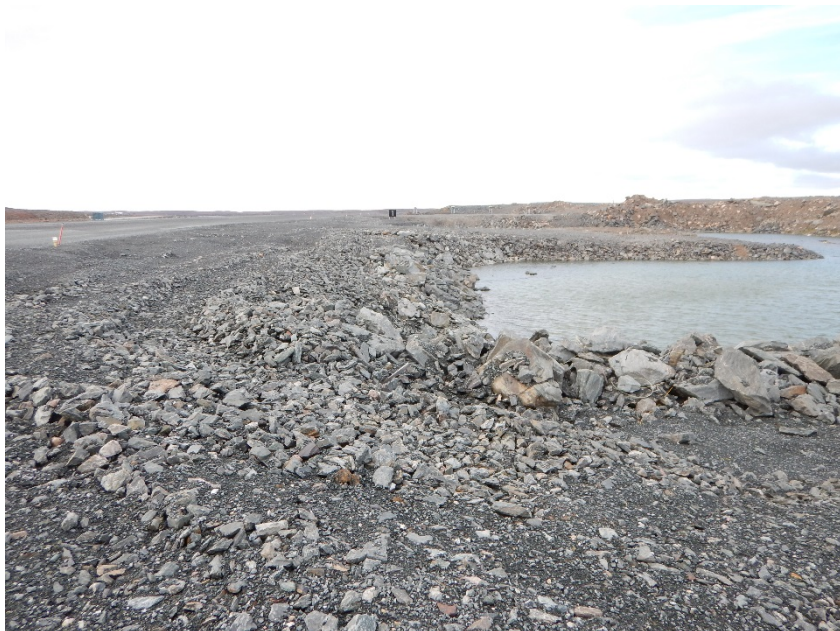
Photograph G8-3 Airstrip

Description: From the northwest side of the airstrip looking west.

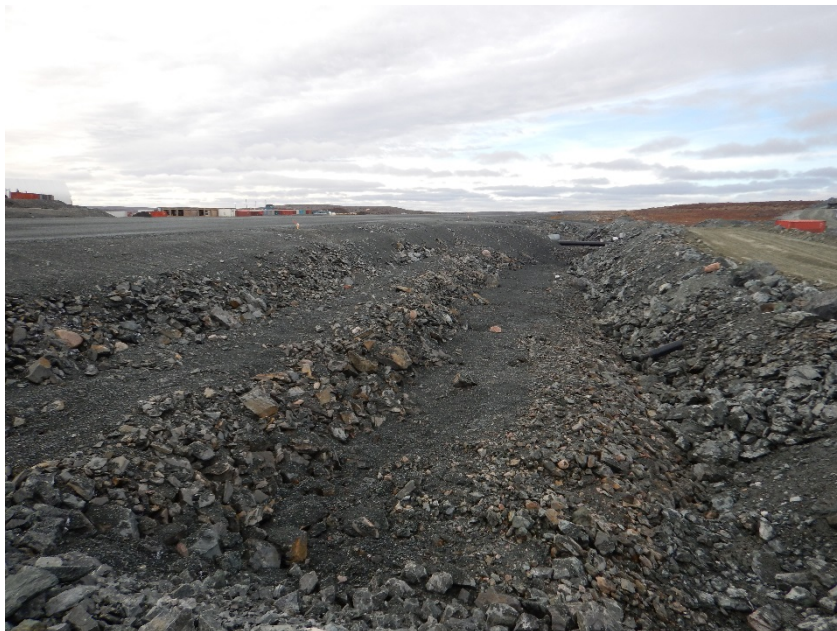
Photograph G8-5 Airstrip

Description: From the northeast side of the airstrip looking northwest.

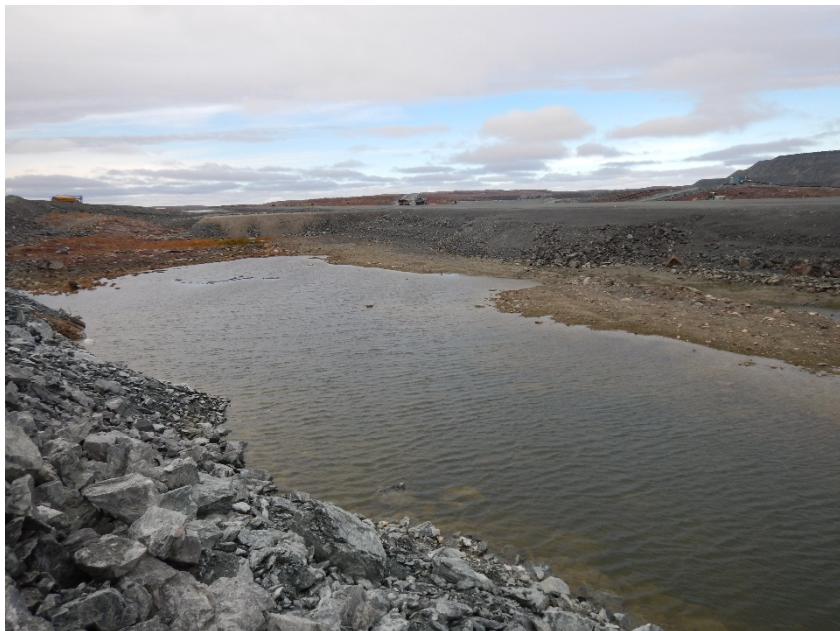
Photograph G8-7 Airstrip

Description: From the southeast side of the airstrip looking northwest.
