APPENDIX 6 2023 ANNUAL GEOTECHNICAL INSPECTION REPORT

2023 Annual Geotechnical Inspection Meliadine Gold Mine, Nunavut, Canada

PRESENTED TO
Agnico Eagle Mines Limited

JANUARY 31, 2024
ISSUED FOR USE
FILE: 704-ENG.EARC03140-33
AGNICO EAGLE DOCUMENT NUMBER: 65-600-230-TCR-001

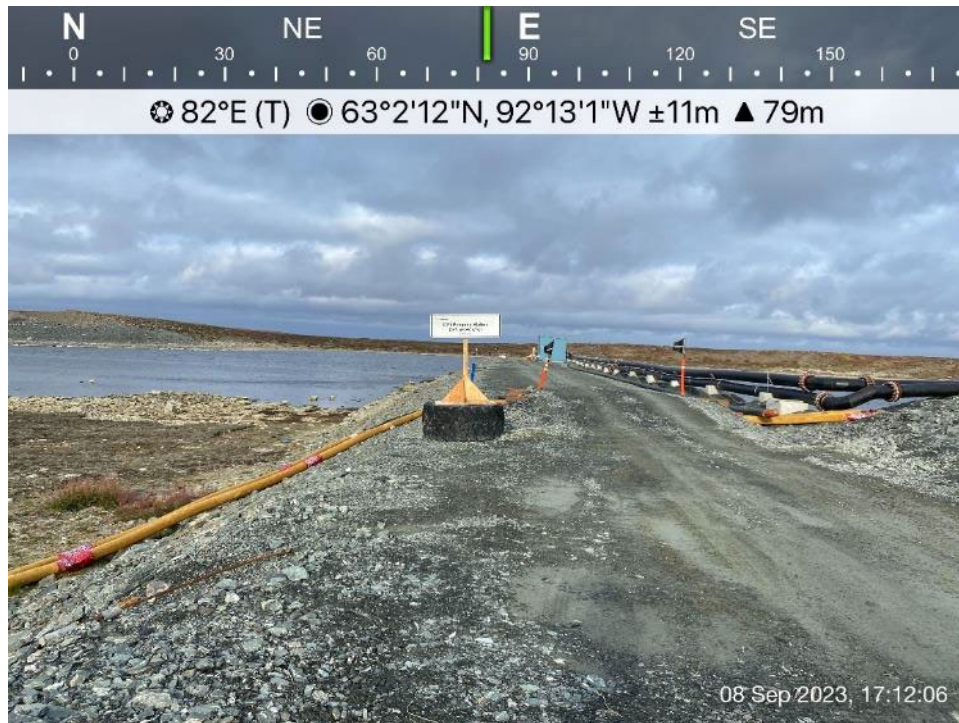
D-CP1 - Photo 16: Dike D-CP1: Jetty 1.

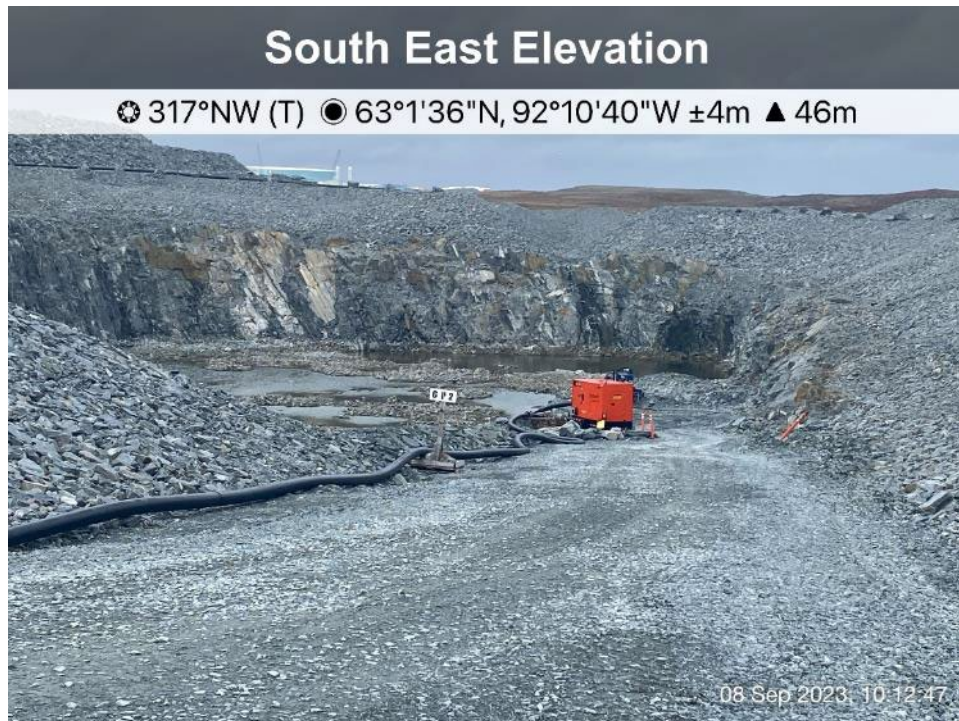
CP2 - Photo 1:

CP2 - Pumping system, bedrock slopes with fractured rock, no stability concern.

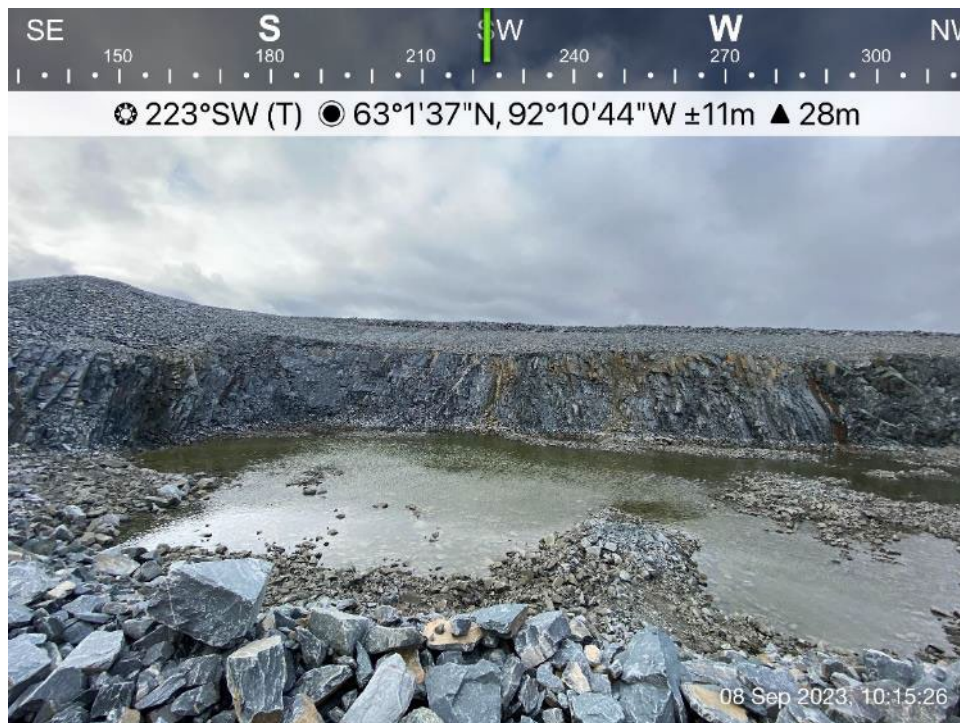
CP2 - Photo 2:

CP2 - small amount of water stored in CP2.

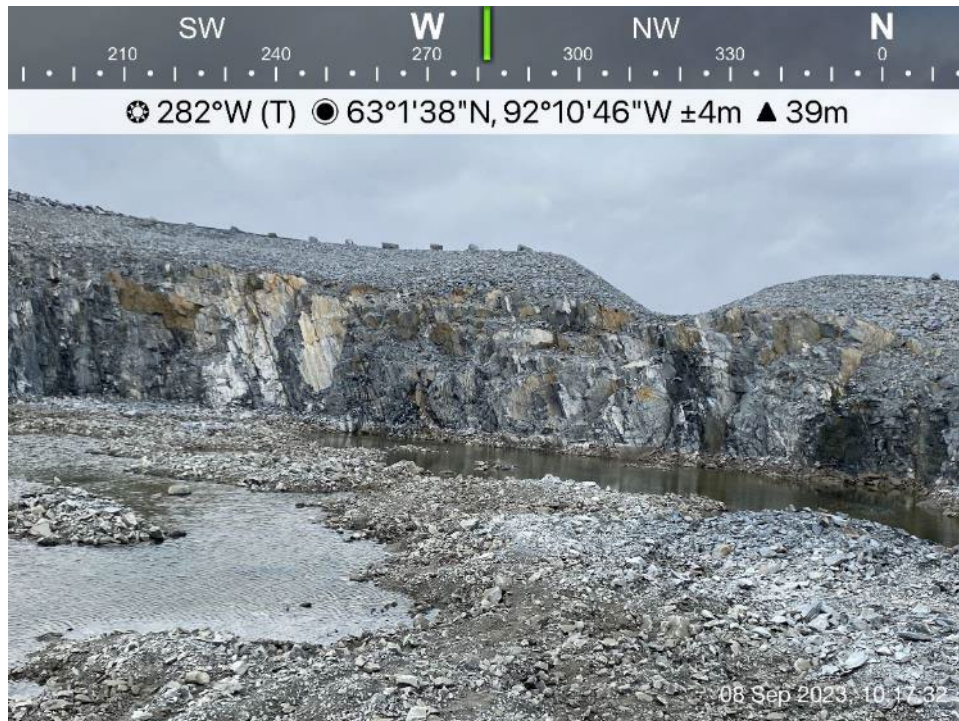
CP2 - Photo 3:

CP2 - minor water flow into CP2 from the outlet of Channel 9.

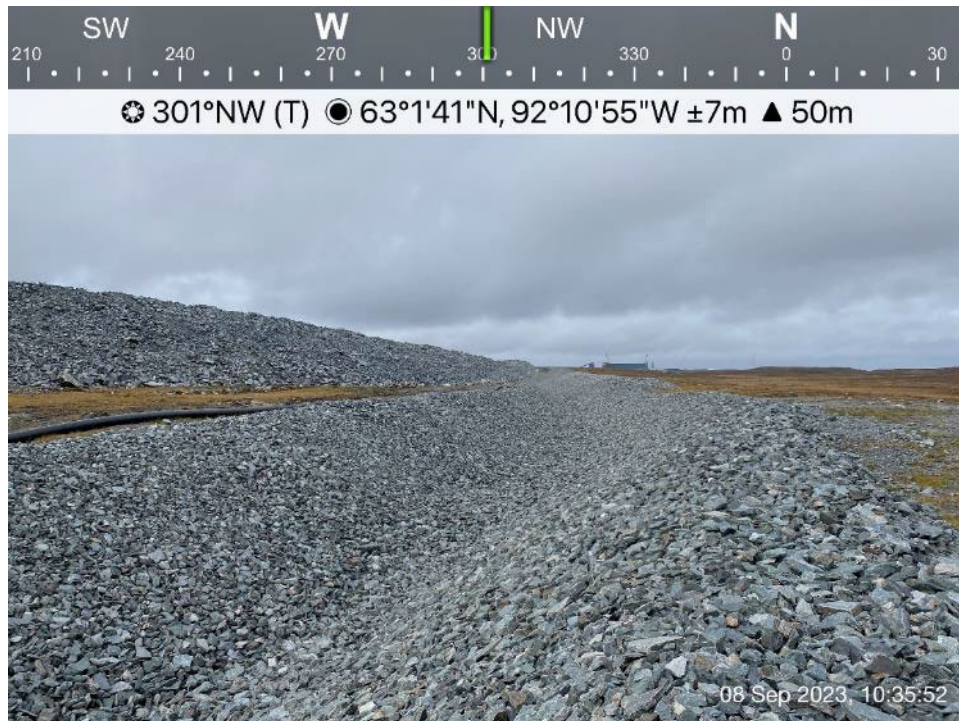
Channel 9 - Photo 9:

Channel 9 - view of Channel 9, looking at northwest, performing well, no stability concern.

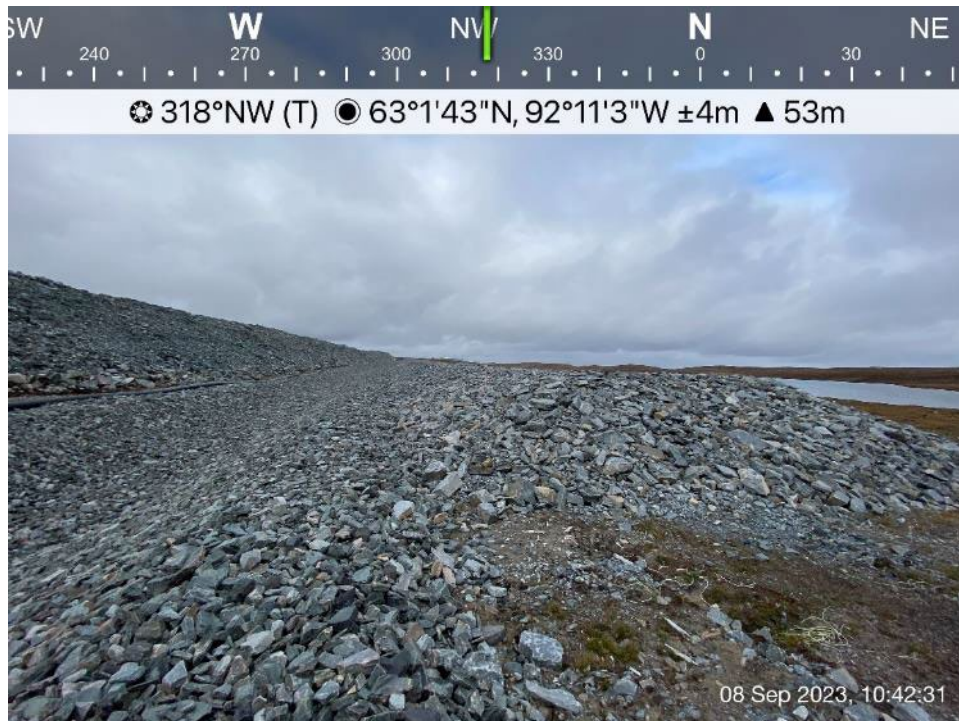
Channel 9 - Photo 10:

Channel 9 - view of Channel 9 Berm, looking at northwest, performing well, no stability concern.

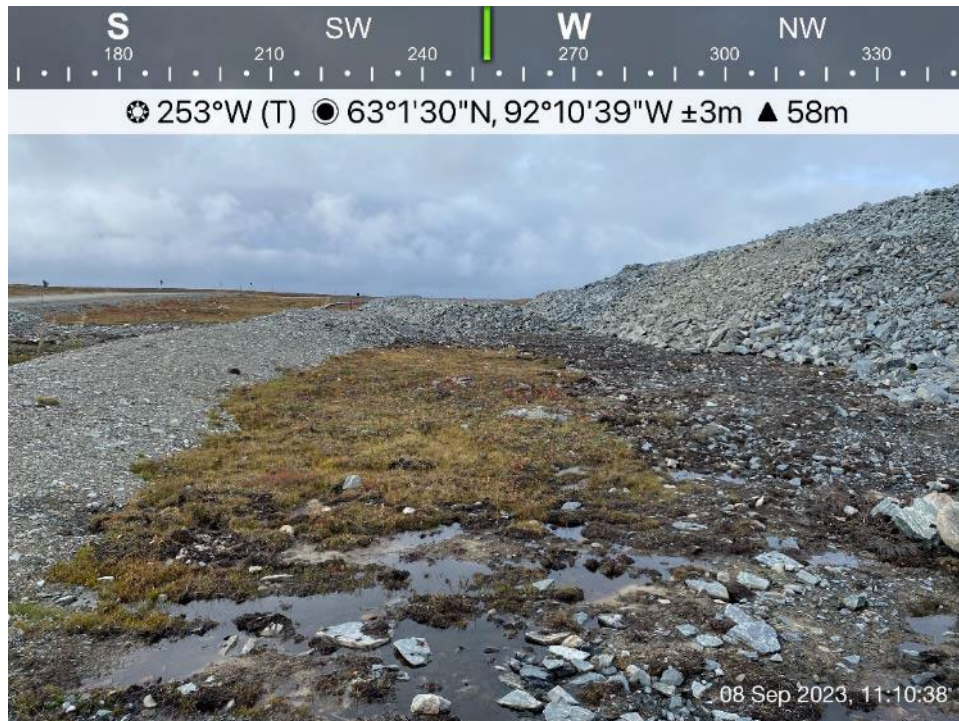
Channel 10 - Photo 15:

Channel 10 - minor ponded water observed between the channel and WRSF3.

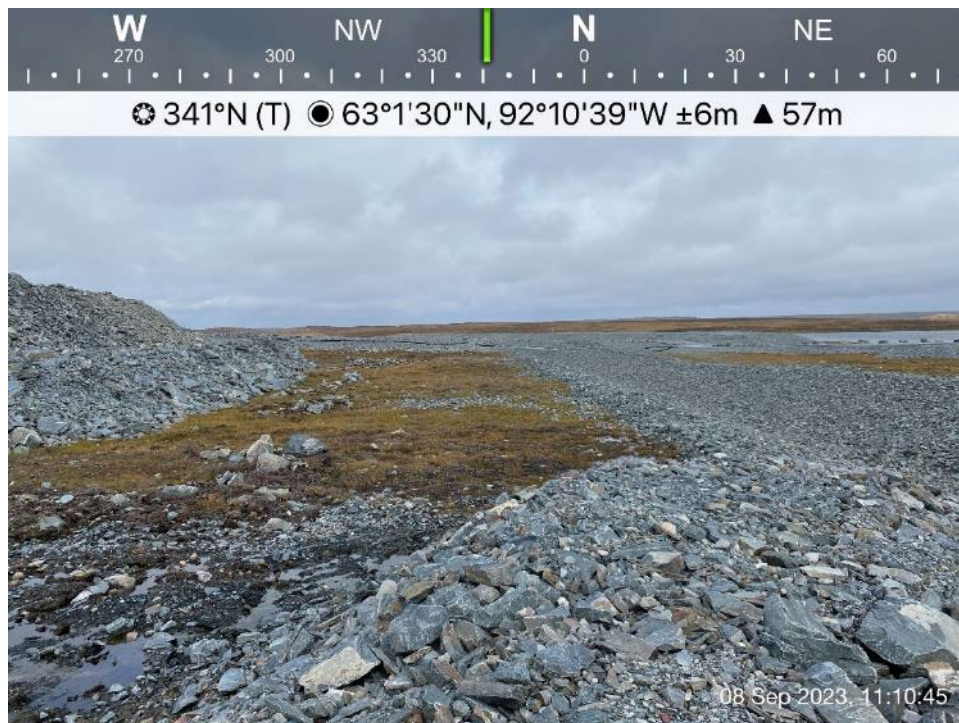
Channel 10 - Photo 16:

Channel 10 - minor ponded water observed between the channel and WRSF3.

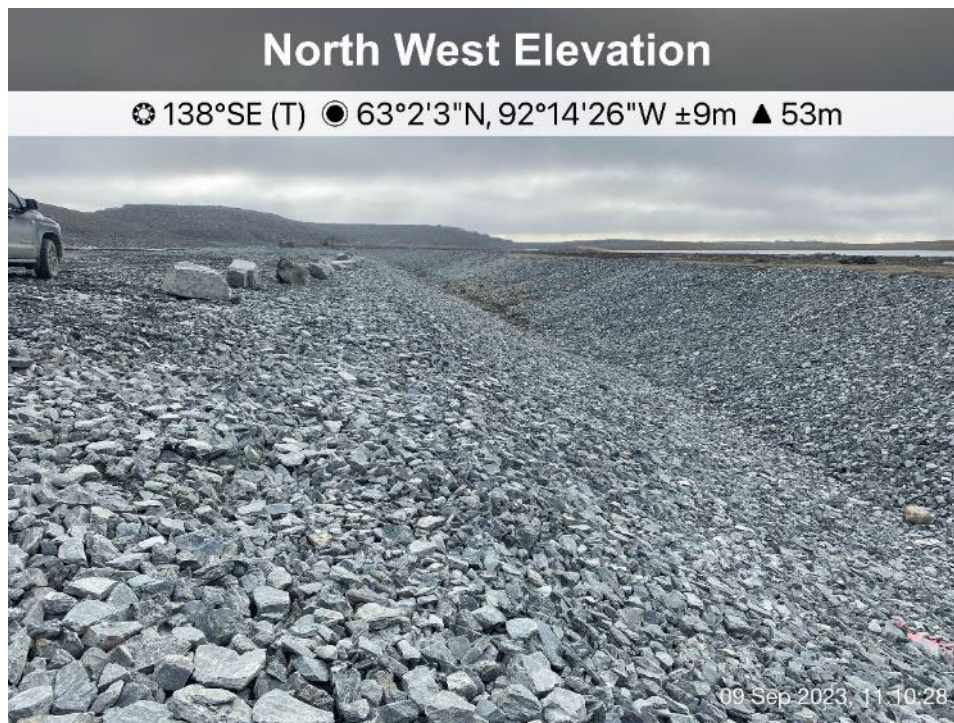
Channel 3 - Photo 8: Channel 3 - view of reconstructed Channel 3.

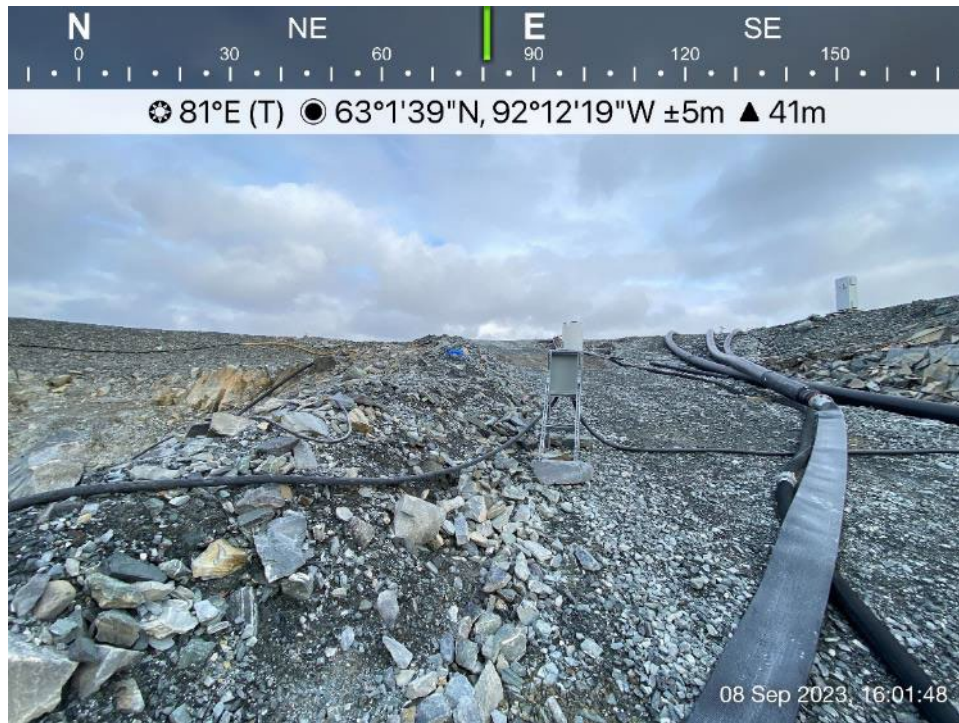
SP1 - Photo 5: SP1 Saline Pond - access ramp and pipelines.

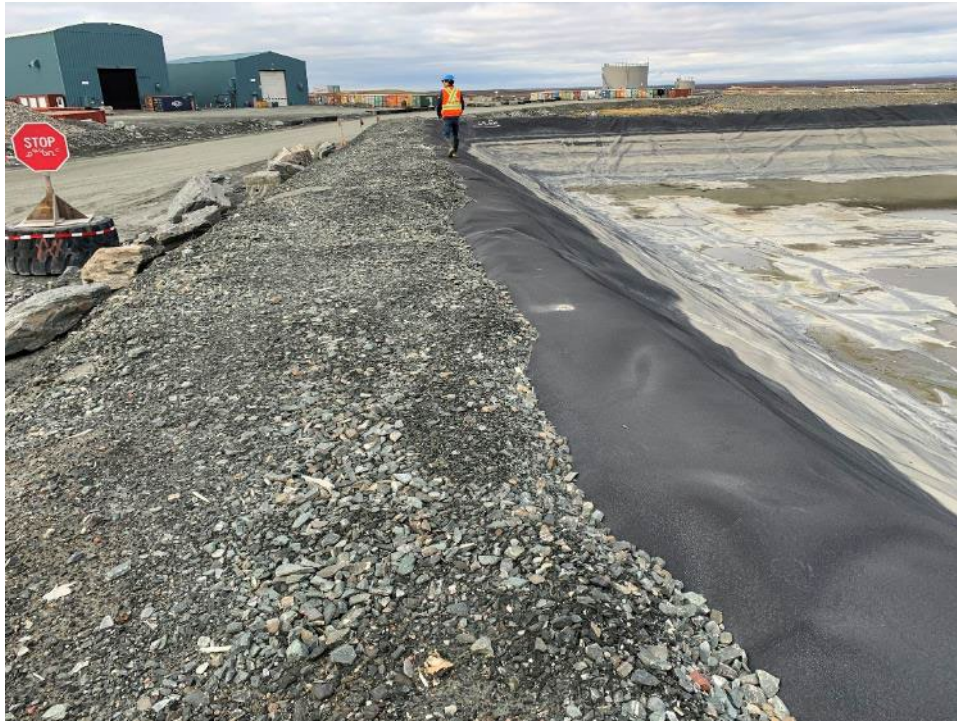
SP3 - Photo 2: SP3 Saline Pond - Perimeter berm.

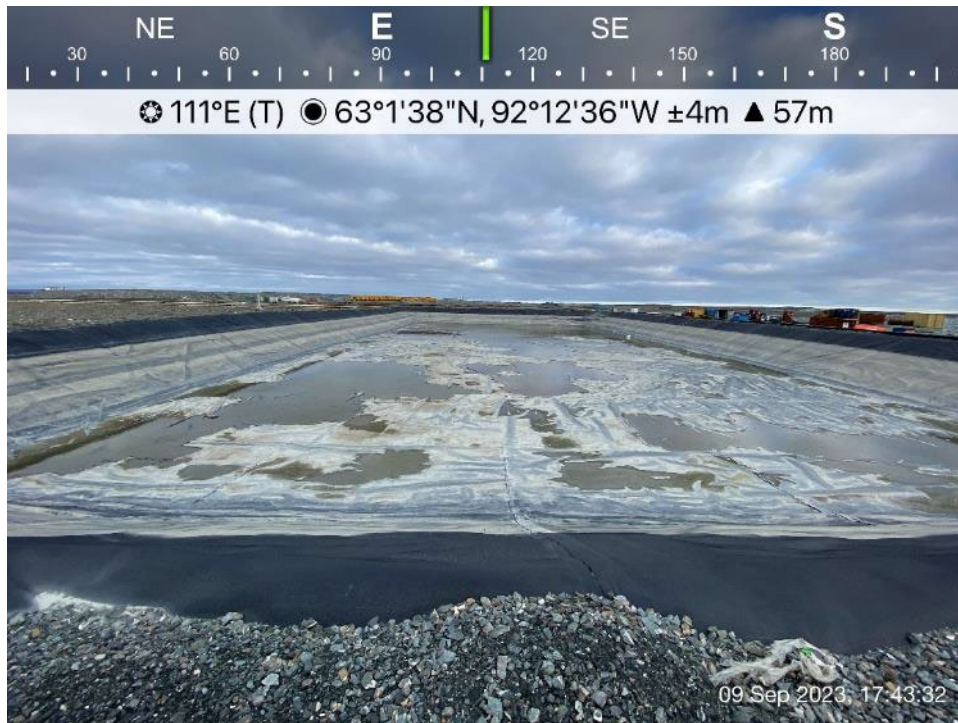
SP3 - Photo 3: SP3 Saline Pond - Looking east, overview of SP3.

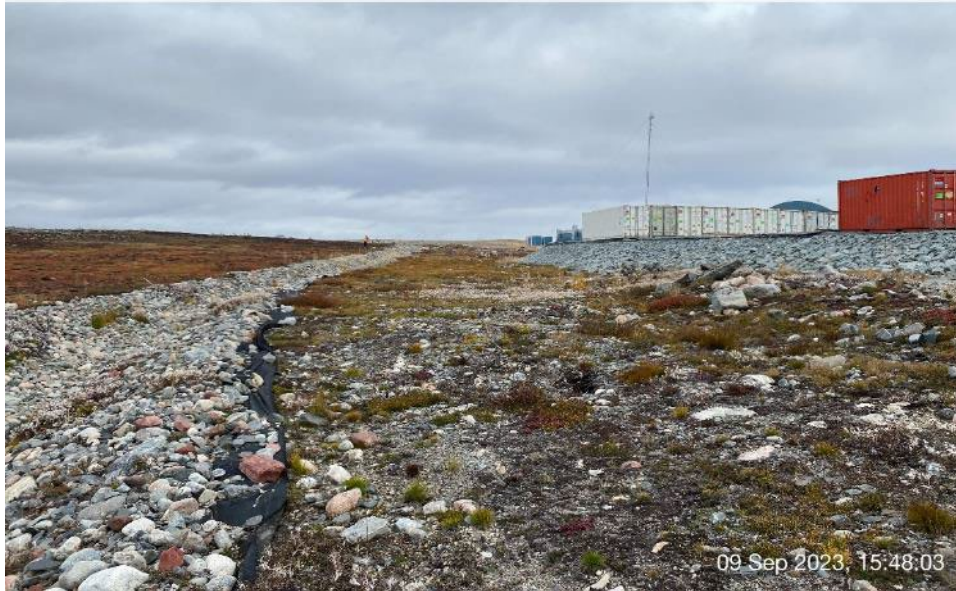
Channel 2 - Photo 7: Channel 2 -Middle section, industrial pad on the right.

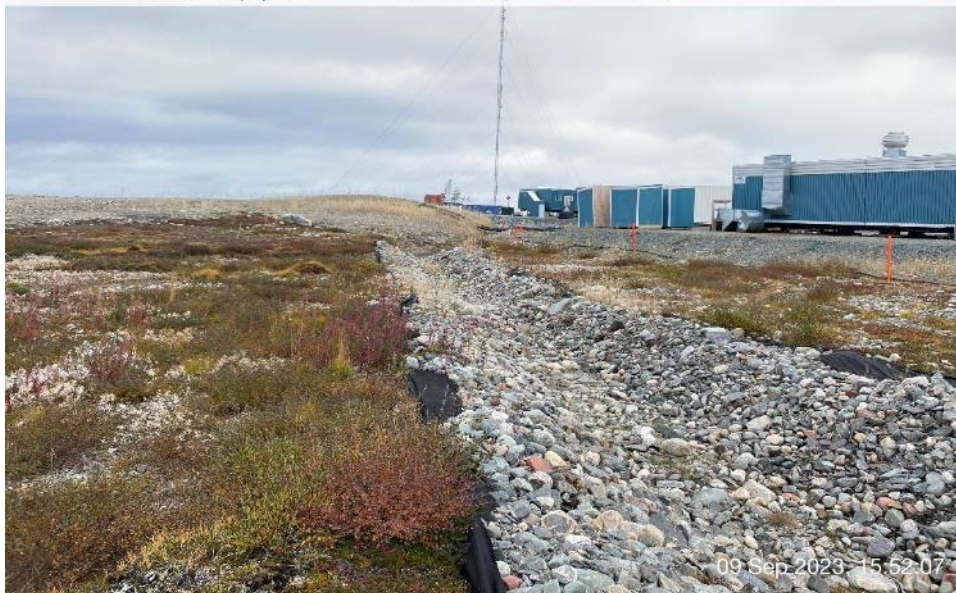
Channel 2 - Photo 8: Channel 2 -Upper reach, camp pad on the right.

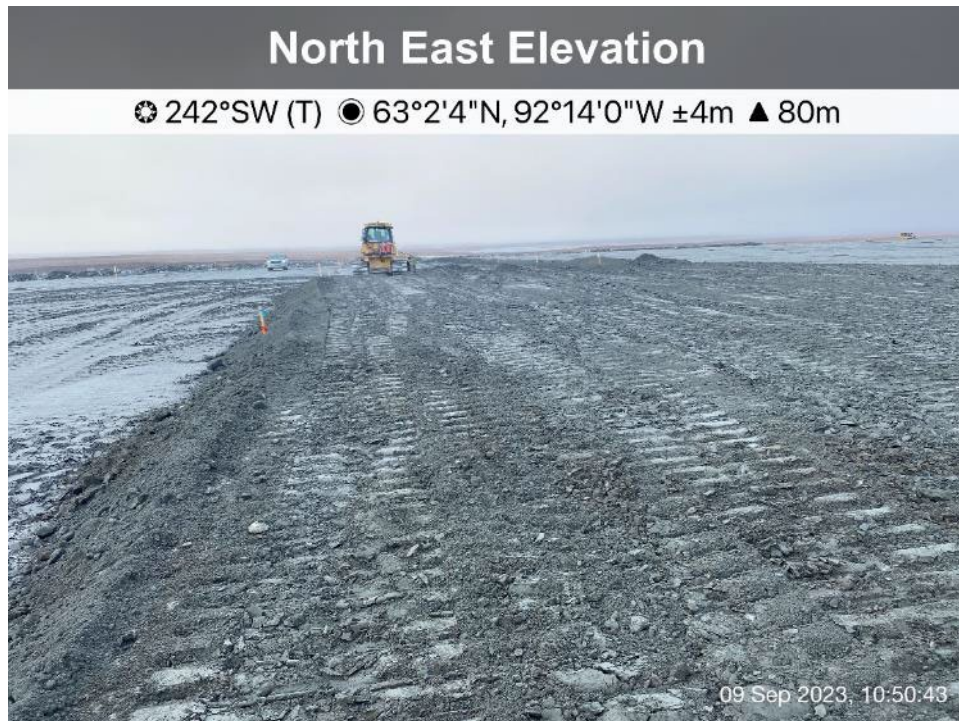
TSF - Photo 9: TSF - Spreading tailings following 0.3 m thick lift control.

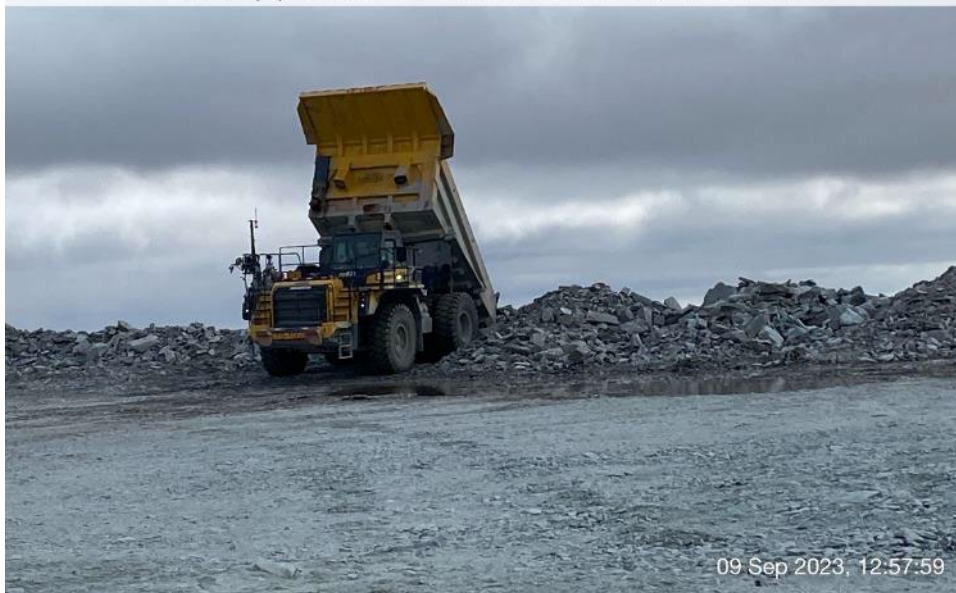
WRSF1 - Photo 2: WRSF 1 - Bench 102 m top, looking south east.

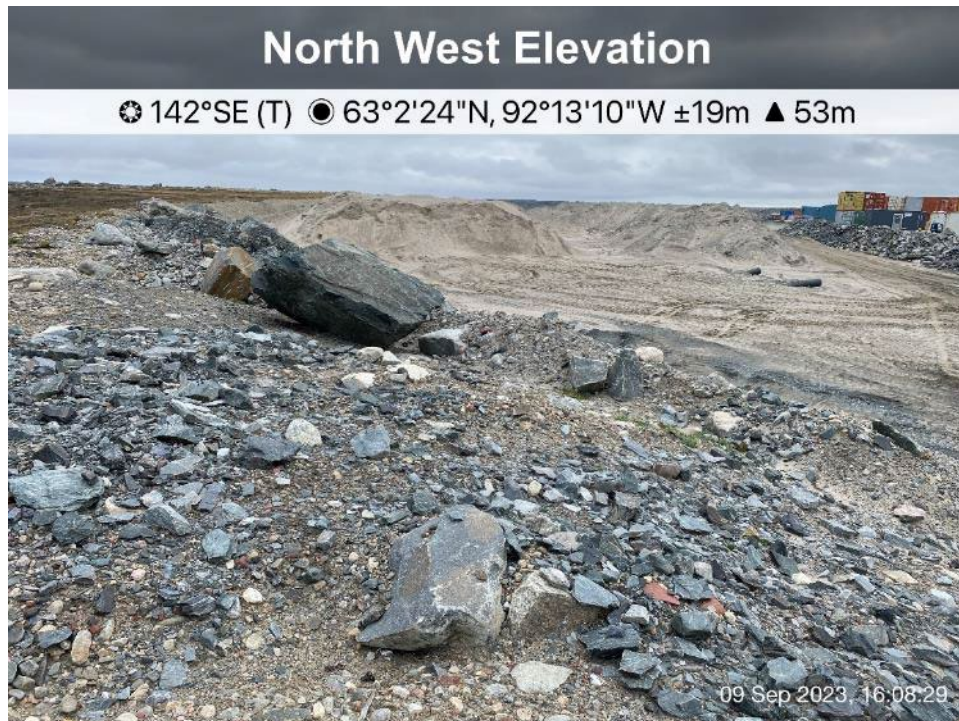
Mel Esker - Photo 1: Borrow Source - Meliadine esker borrow source, looking southeast.

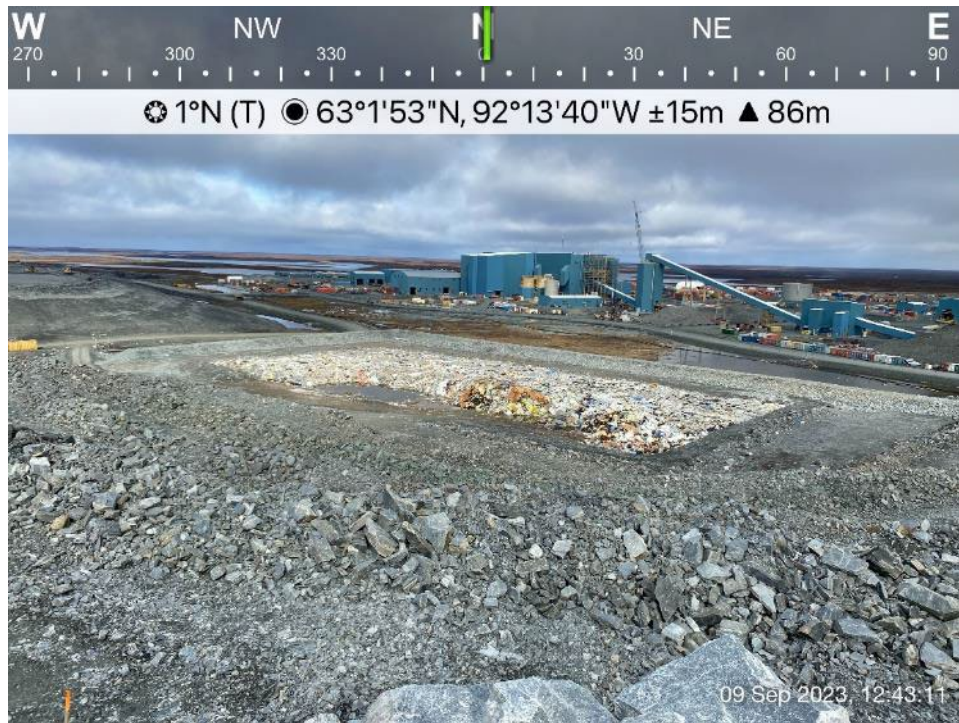
Landfill - Photo 9: WRSF1 Landfill - Overview of landfill from WRSF1, looking north.

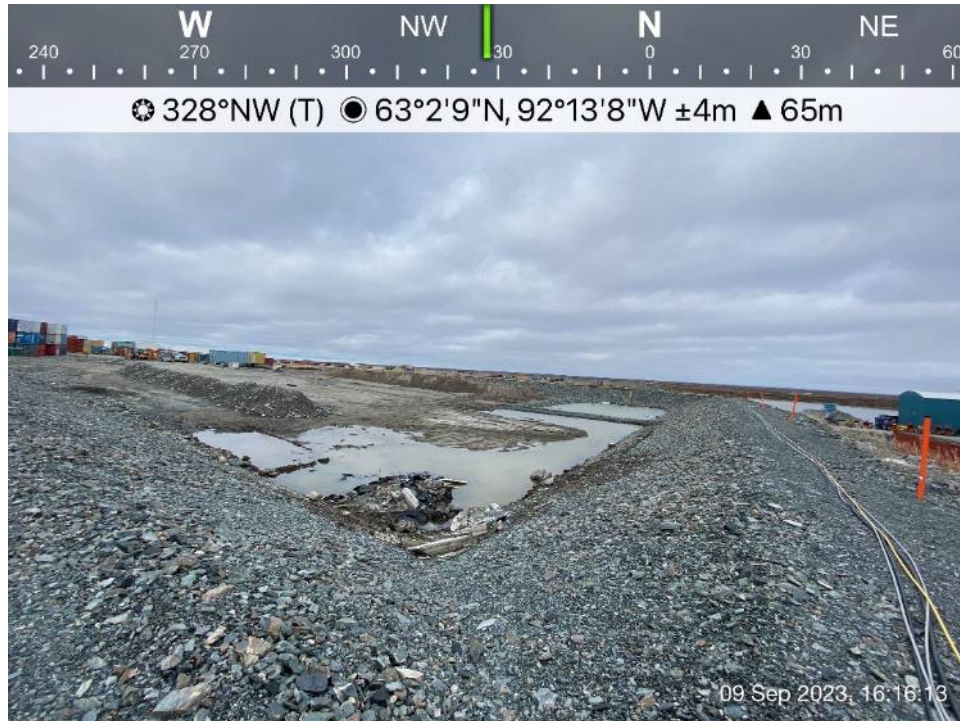
Landfarm - Photo 19: Landfarm - Overview of landfarm, looking northwest

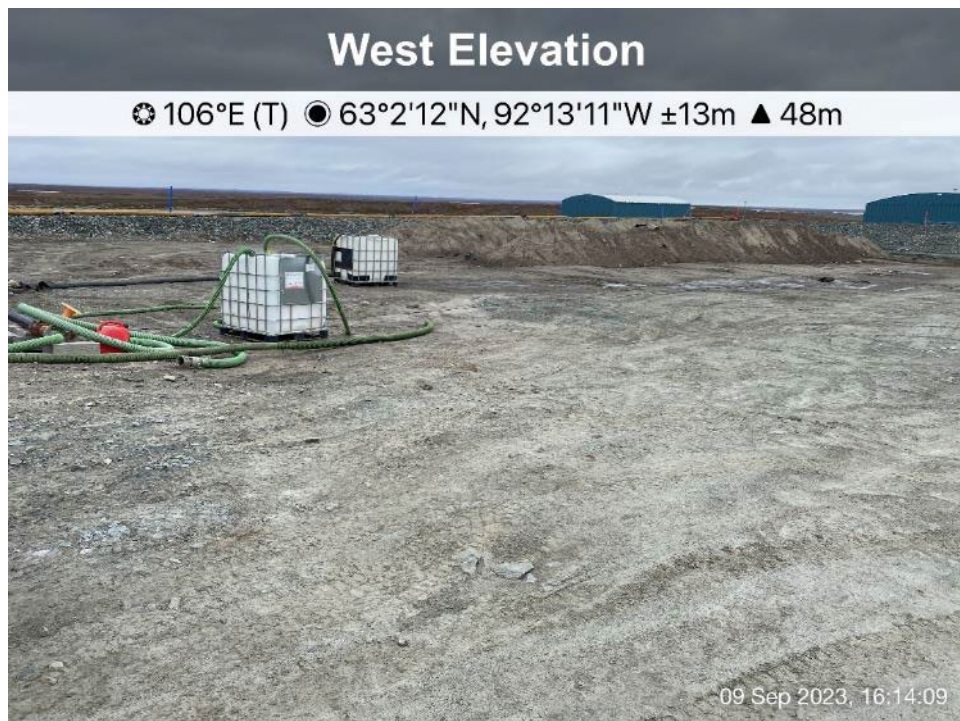
Landfarm - Photo 20: Landfarm - Contaminated soil -1

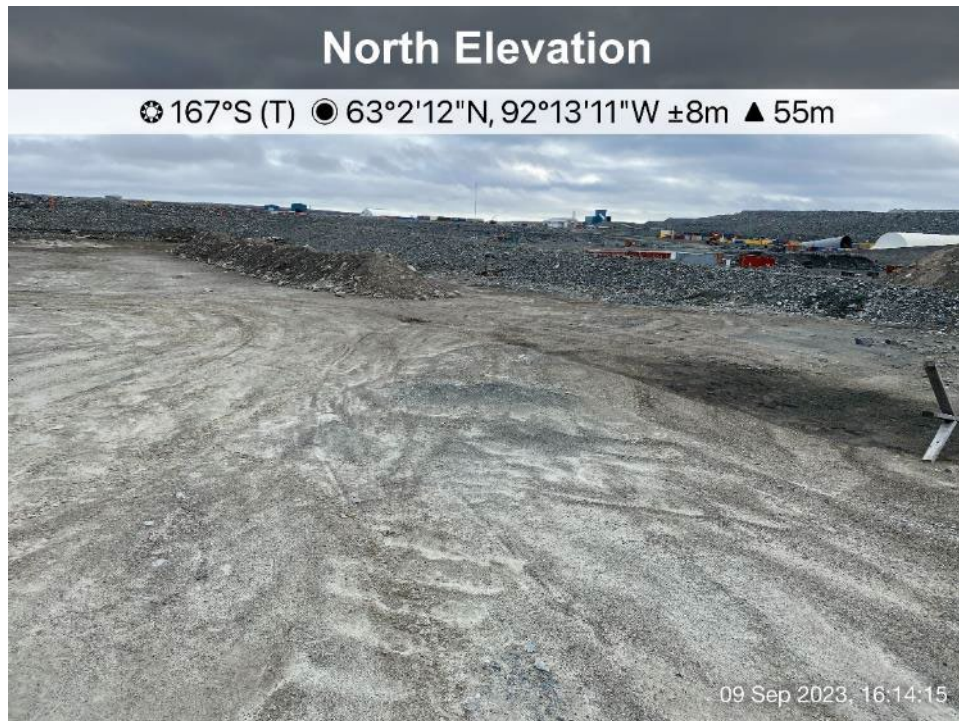
Landfarm - Photo 21: Landfarm - Contaminated soil -2

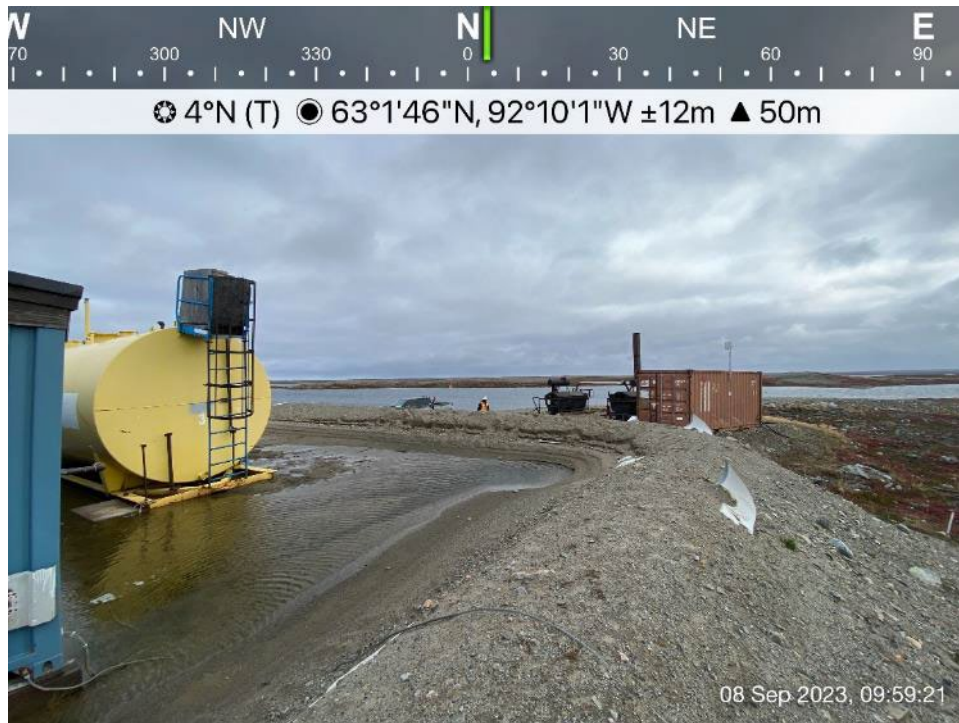
Exploration Camp - Photo 5: Exploration Camp - Fuel storage, looking north.

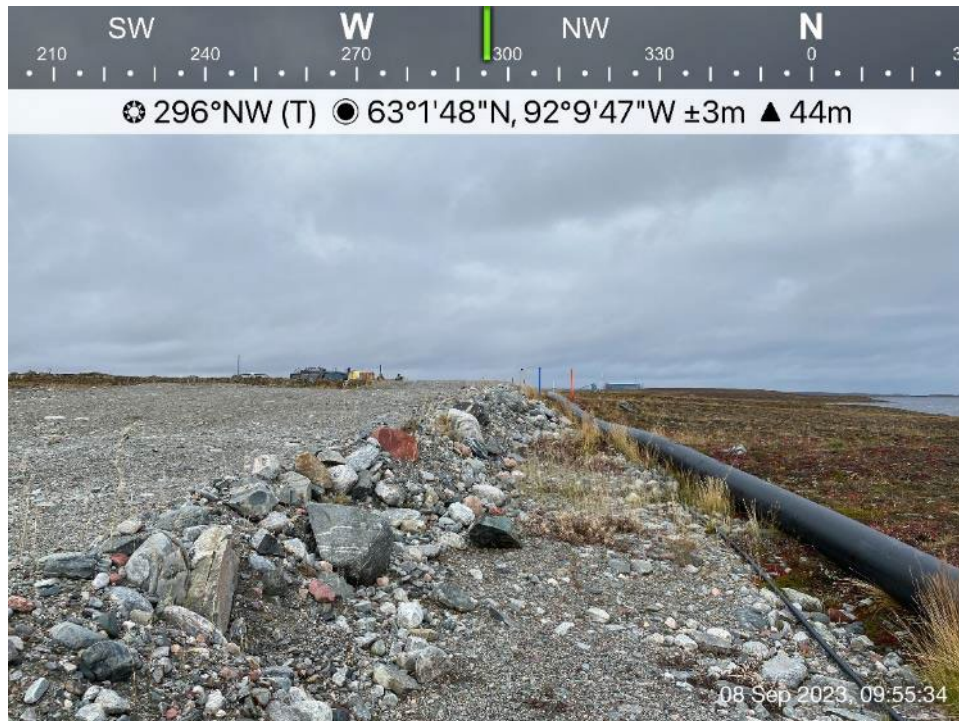
Exploration Camp - Photo 7: Exploration Camp - diffuer access road, looking northwest.

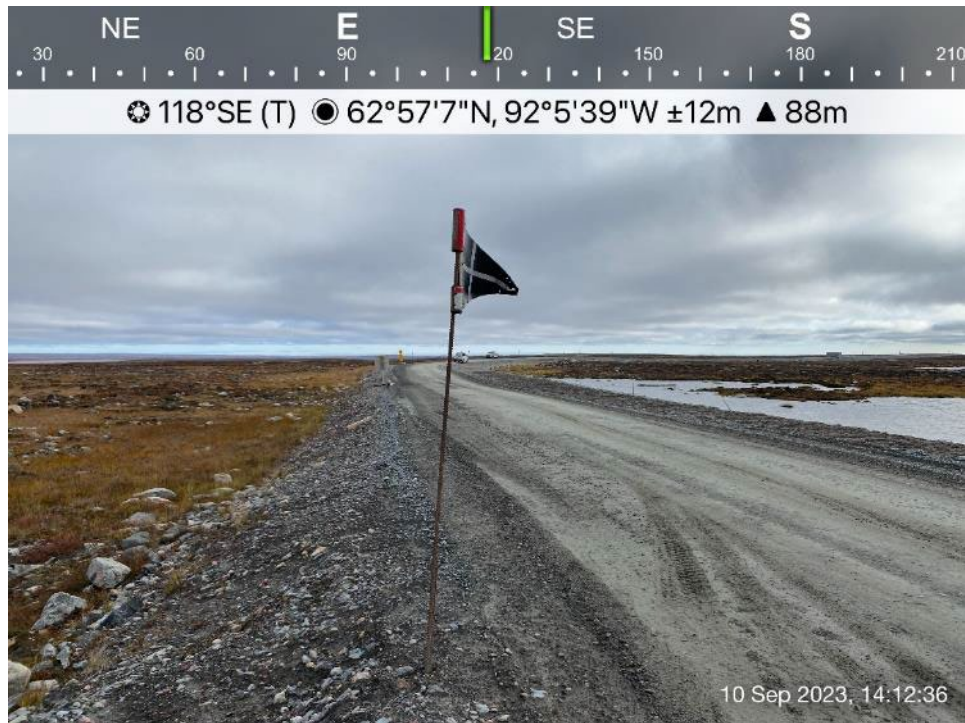
AWAR Road/Culvert - Photo 48: KM 19 - No culvert installed, ponded water upstream, no sign of overflow.

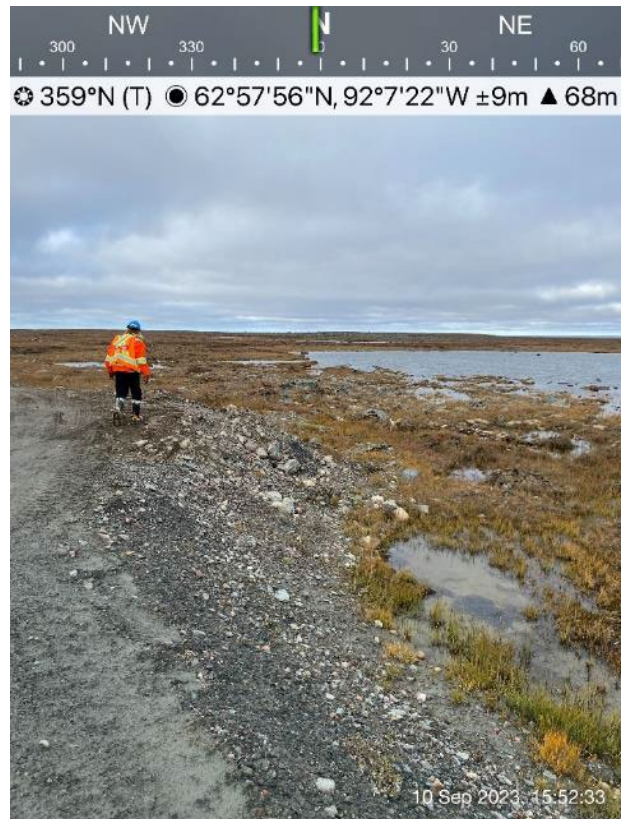
AWAR Road/Culvert
- Photo 51:

KM 21.7 - Culverts were buried during the waterline construction, ponded water observed, poor drainage

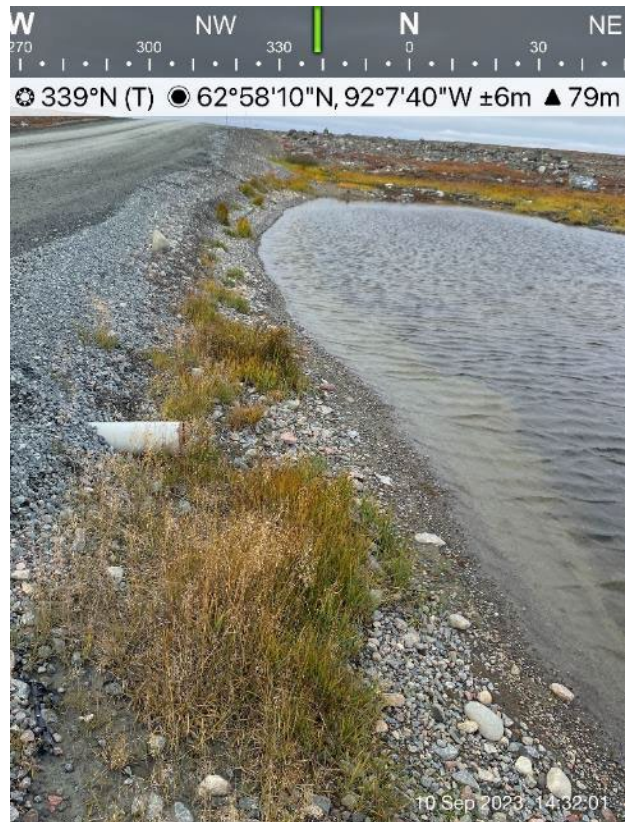
AWAR Road/Culvert - Photo 53:

Culvert KM 22.3 - steel pipe as culvert, outlet was buried during the waterline project construction.

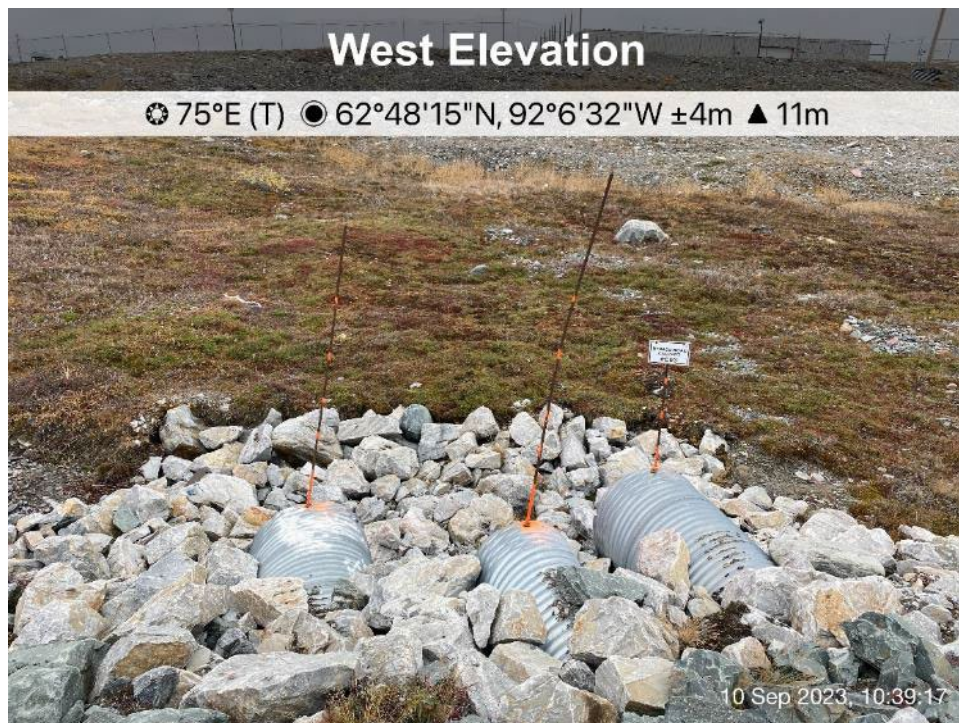
Itivia Bypass Road/Culvert - Photo 6: Culvert C03 inlet.

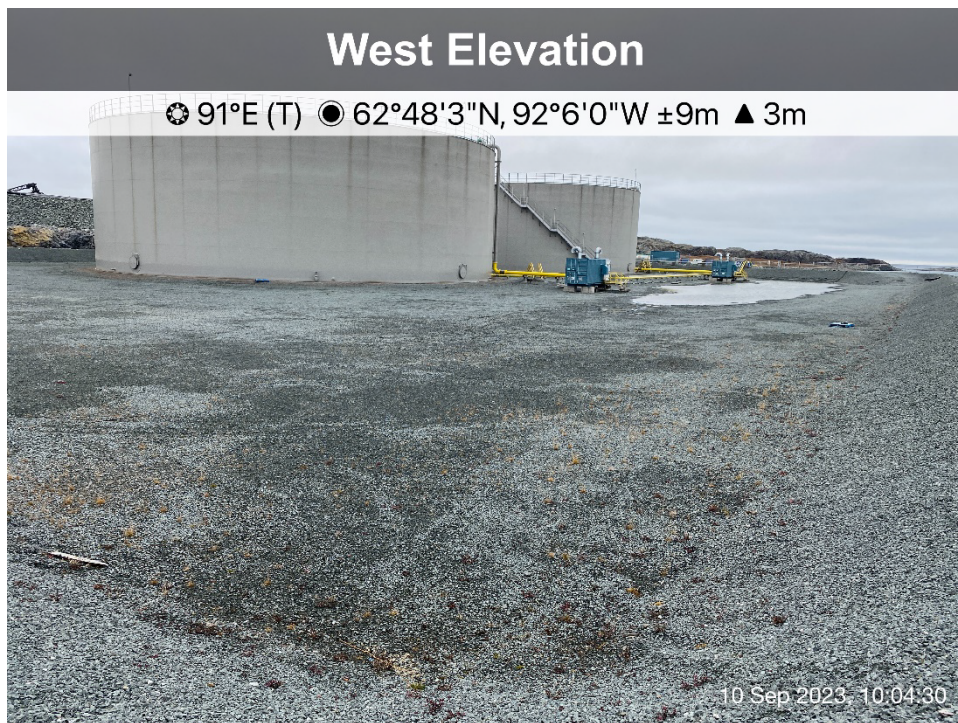
Itivia Fuel Tankfarm - Photo 57:

Tankfarm overview, looking east

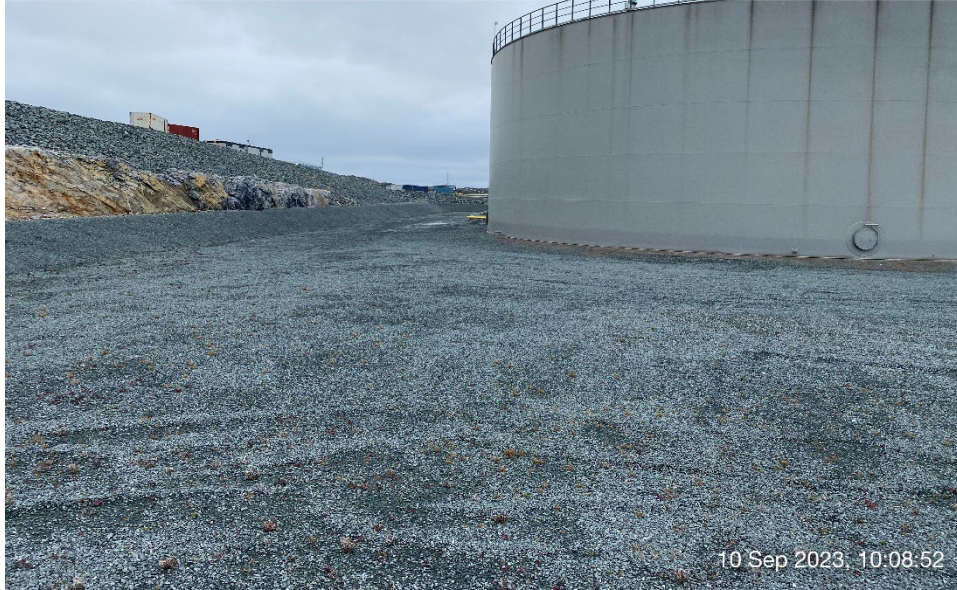
Itivia Fuel Tankfarm - Photo 58:

Tankfarm side berm and foundation

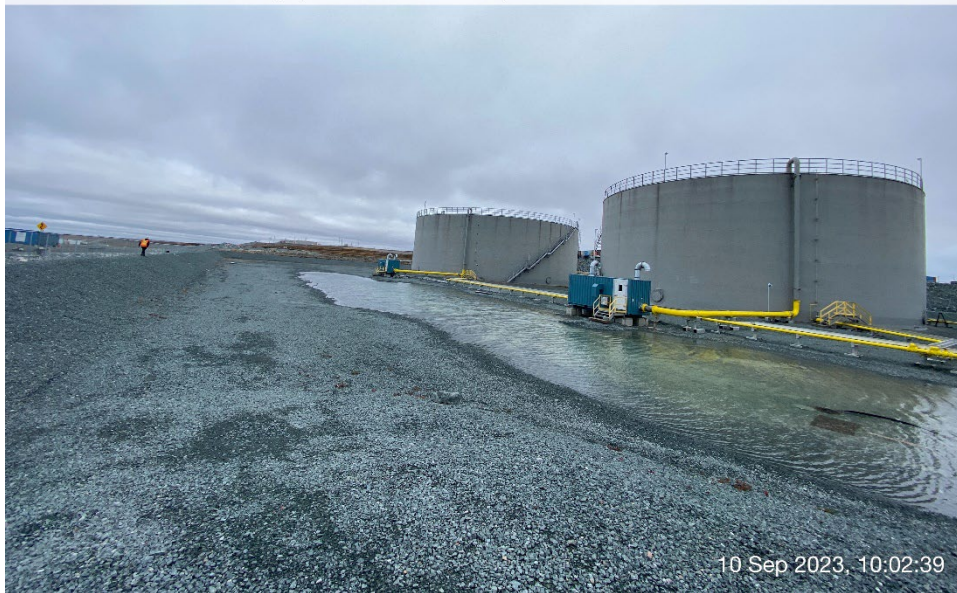
Itivia Fuel Tankfarm - Photo 59:

Tankfarm side berm and water ponding
