APPENDIX 14 2023 REPORTABLE SPILLS

Re: Follow-up Report Spill #2023-009 – Release of 5 L of Sewage at the Meliadine Gold Project

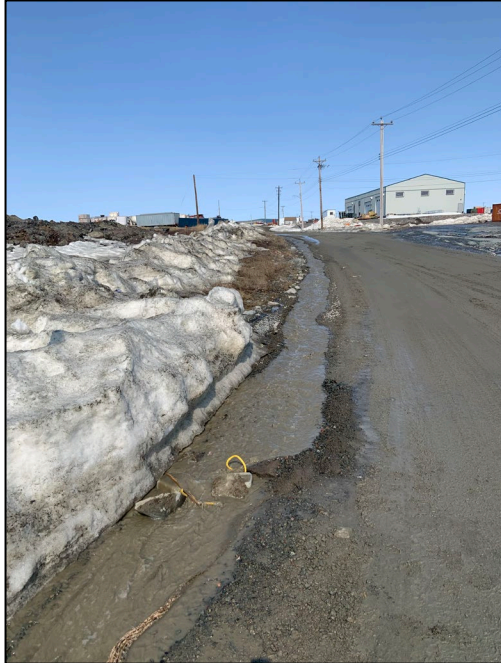
Photo 1 – Upstream east of Itivia site.

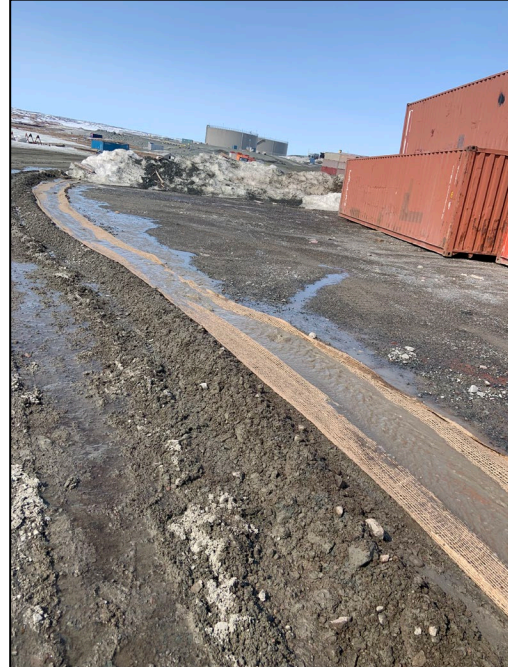
Photo 2 – Upstream east entering Itivia site.

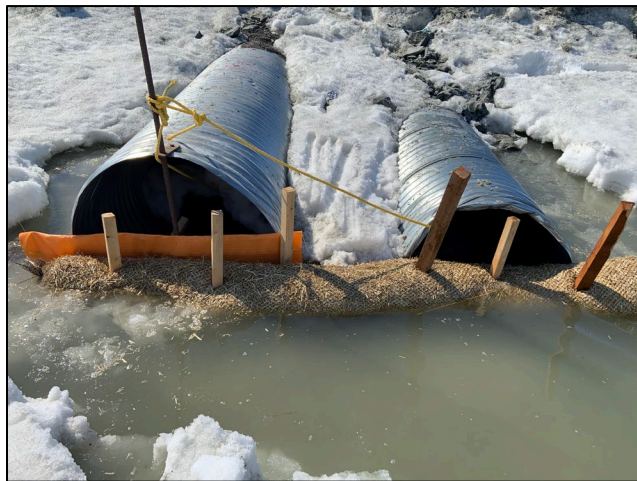
Photo 3 – Upstream of MEL-SR-1.

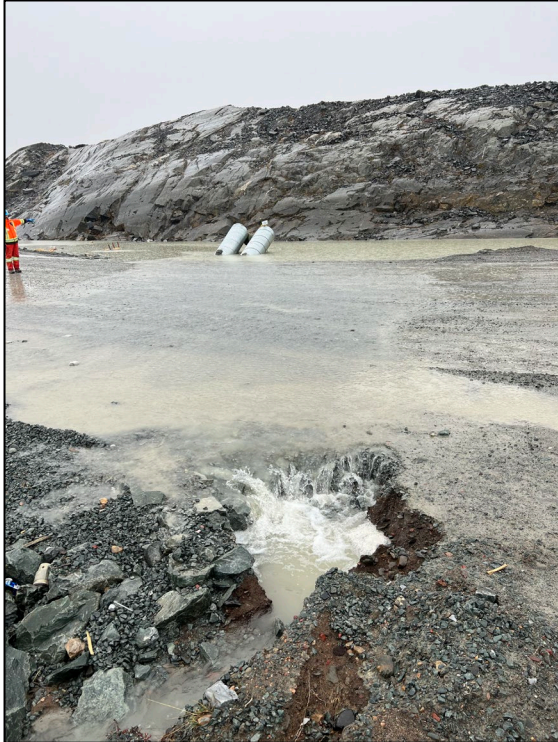
Photo 1 – Situation upon arrival.

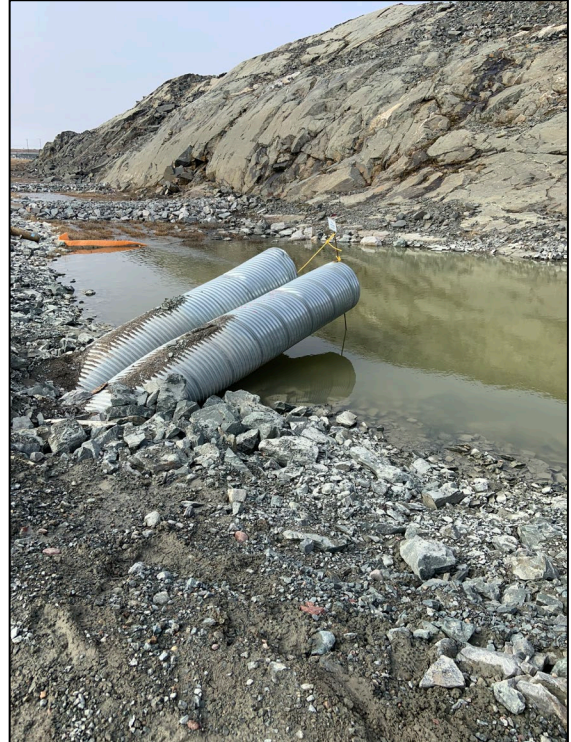
Photo 2 – 1h after response.

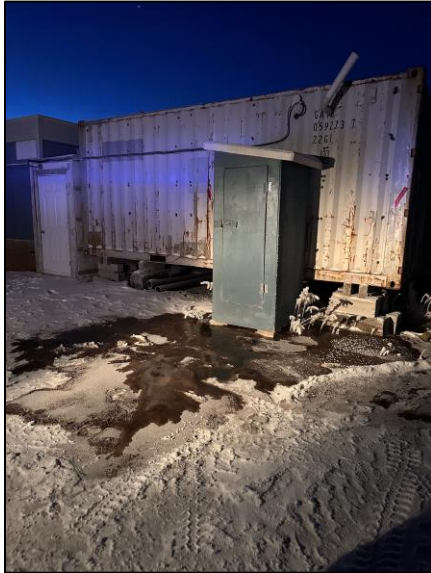
On November 6th, 2023, at approximately 06:30, an estimated 50 L of sewage was spilled onto the ground at the Orbit Garant holding tank. The facility was serviced but its valve was inadvertently left partially open, allowing for sewage to leak from the valve into the enclosure. No water bodies were impacted by this spill. The closest water body (Lake H5A) is approximately 650 m northeast, as seen in Figure 1.

Photos 1 & 2: Sewage spill location.
