Meadowbank Thermal Monitoring Report 2023

MEADOWBANK PROJECT

Thermal Monitoring Report

Prepared by:
Agnico Eagle Mines Limited – Meadowbank Division

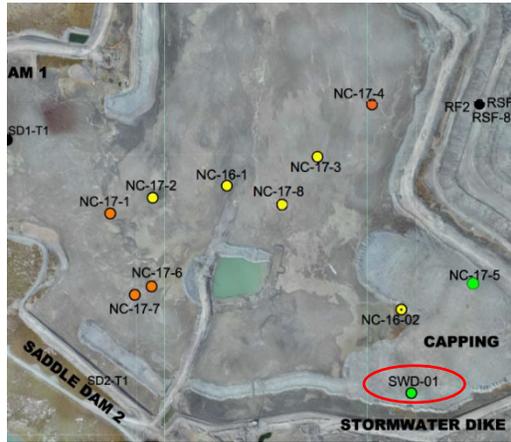
SWD-01 shows a stable unfrozen condition in the foundation below the frozen tailings and capping.

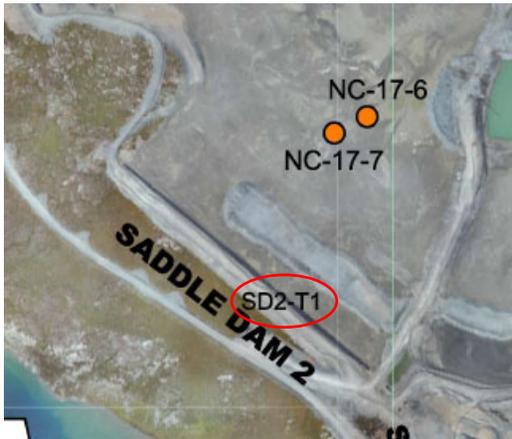
SD2-1

This instrument is along the liner.
