2024 Annual Geotechnical Inspection – Doris Tailings Impoundment Area

Hope Bay Mine, Nunavut, Canada
Agnico Eagle Mines Limited

SRK Consulting (Canada) Inc. ■ CAPR003066 ■ March 2025

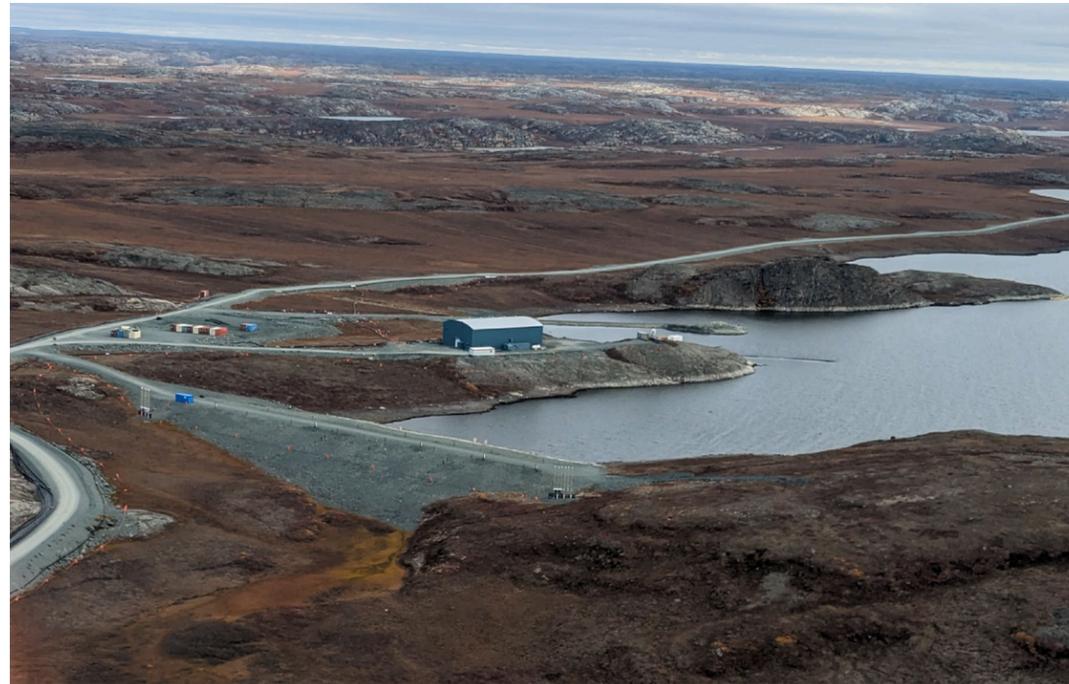
Photo 1: North Dam Overview from the Helicopter (Looking Southeast).

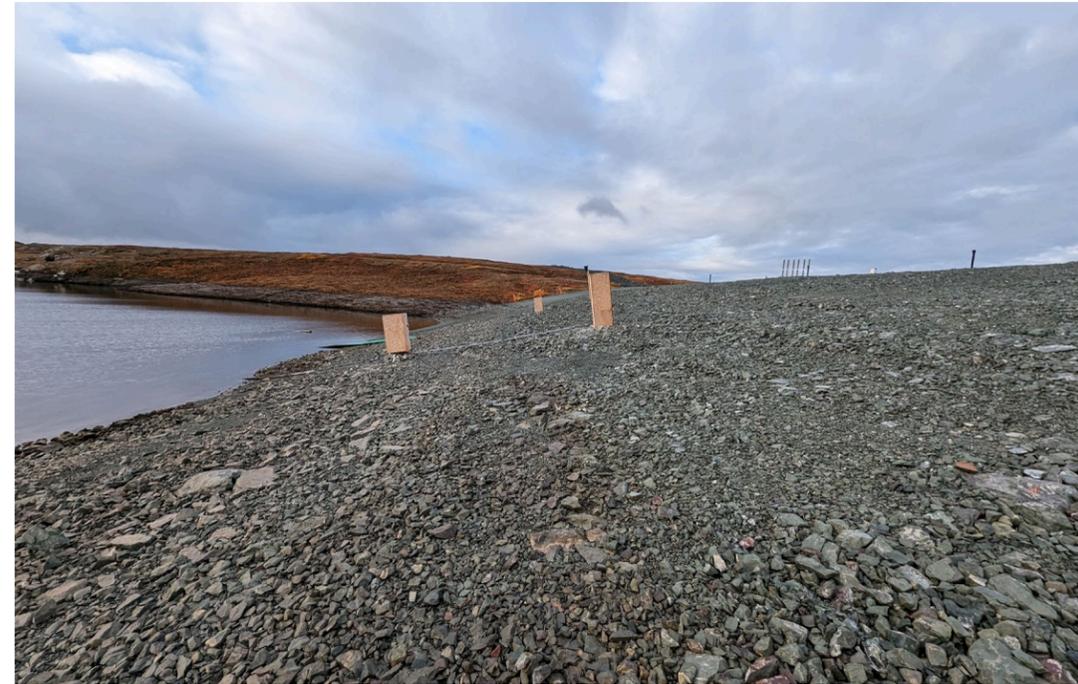
Photo 2: North Dam Upstream Face (Looking Southwest).

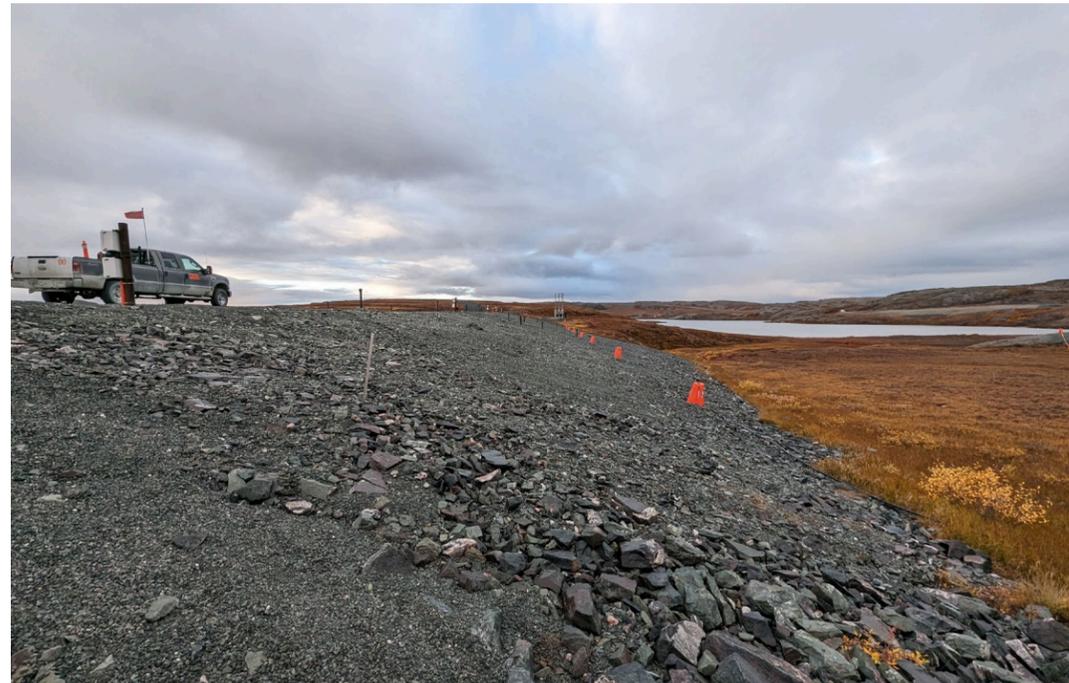
Photo 3: North Dam Downstream Face (Looking Southwest).

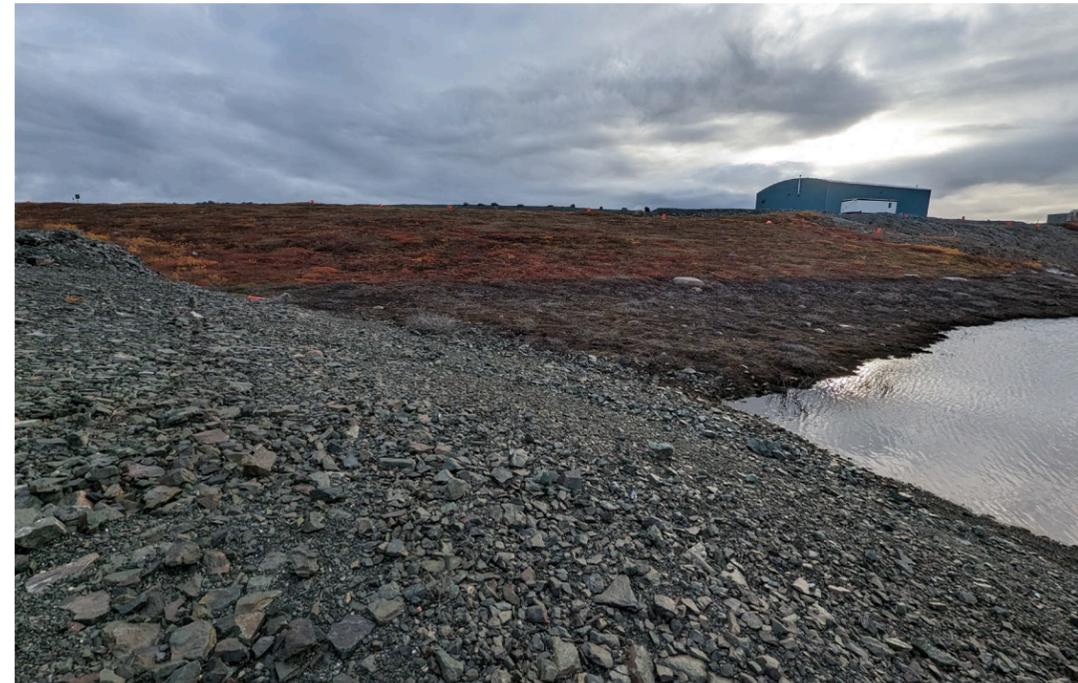
Photo 4: North Dam Upstream Toe Tundra Die-Back (Looking Southeast).

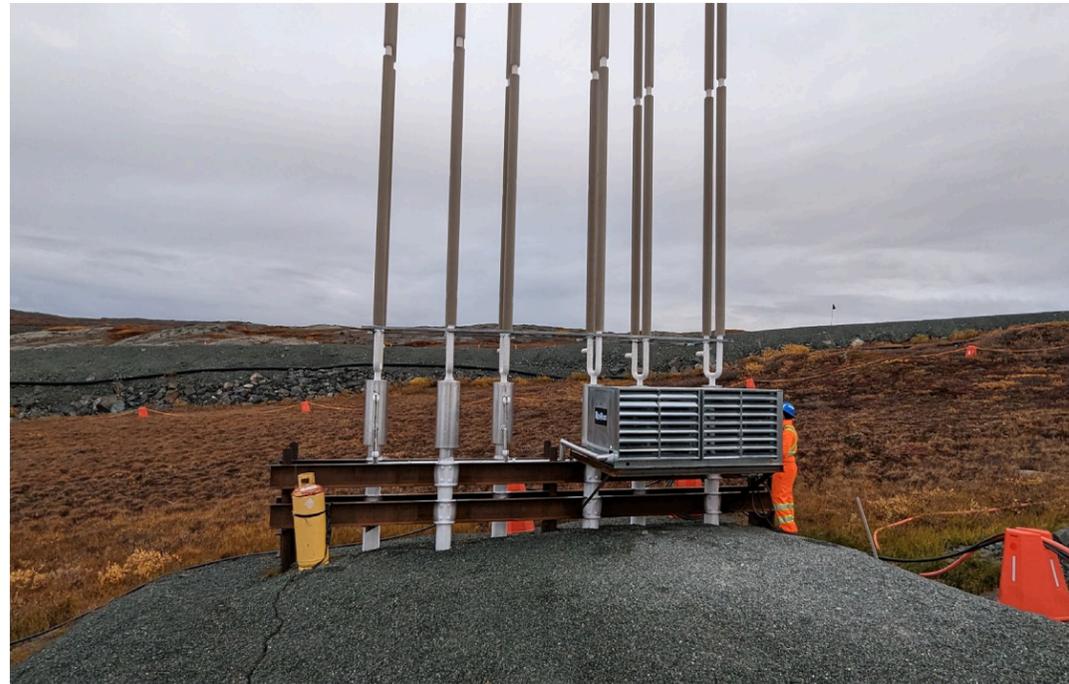
Photo 5: North Dam Northeastern Thermosyphon (Looking Northwest).

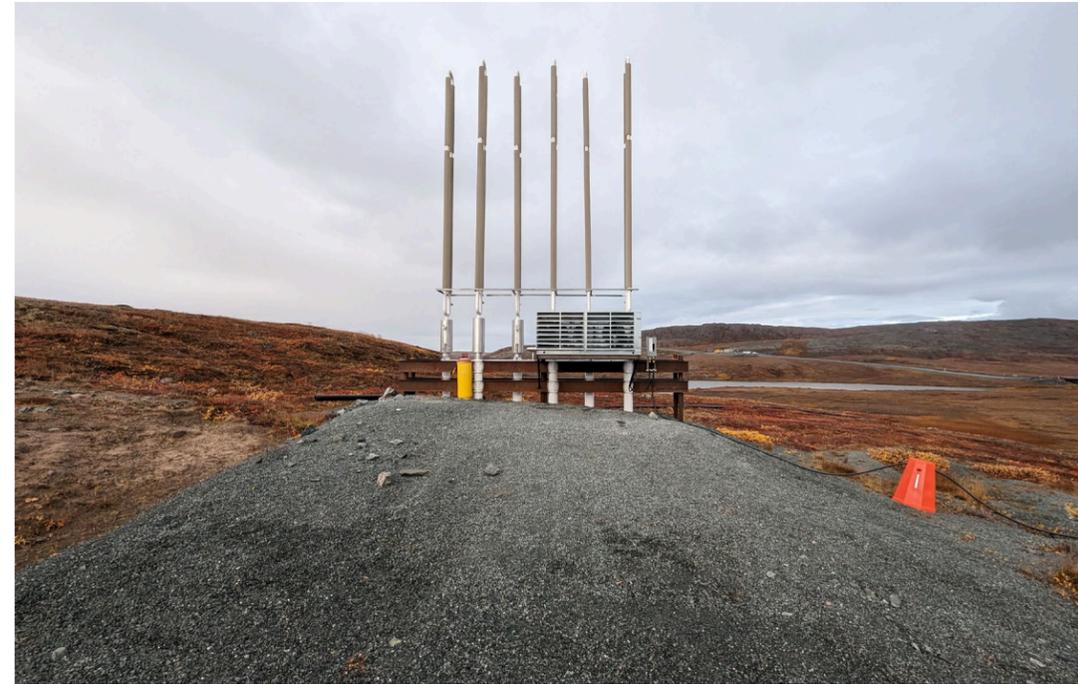
Photo 6: North Dam Southwestern Thermosyphon (Looking Southwest).

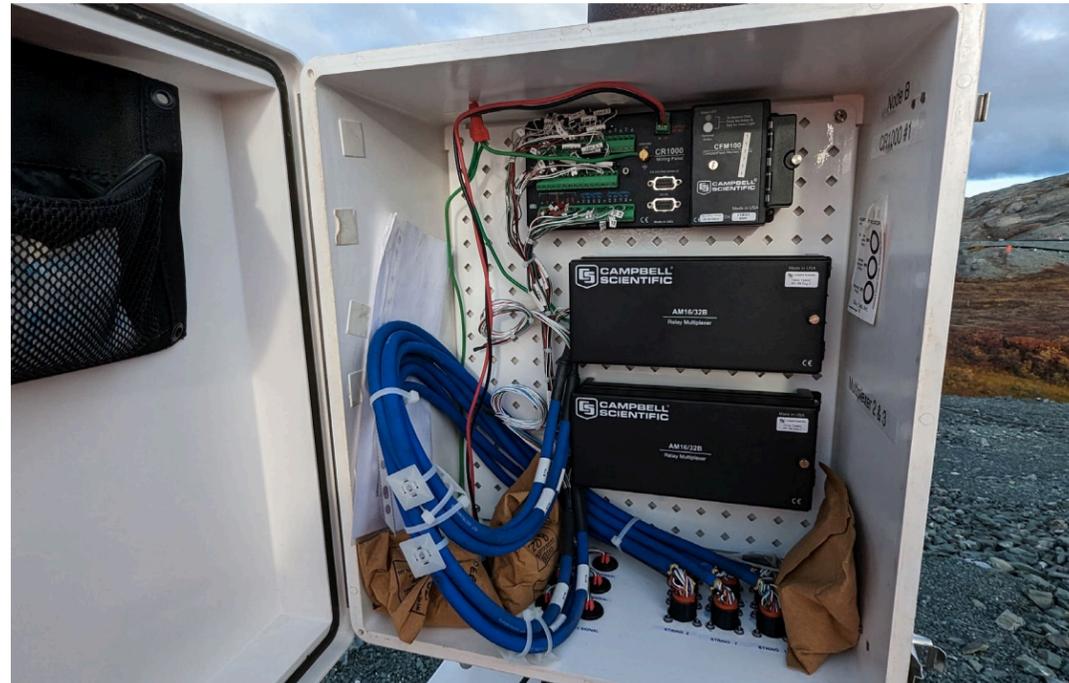
Photo 7: North Dam Instrumentation Inspection (Looking Northwest).

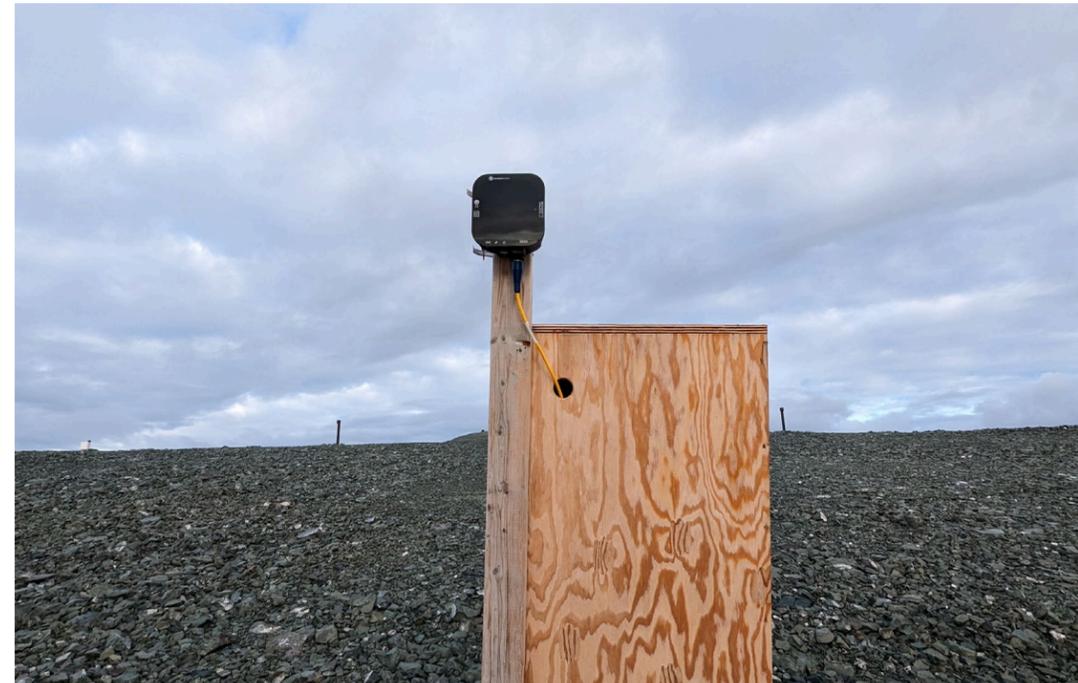
Photo 8: North Dam Instrumentation Inspection (Looking Northwest).

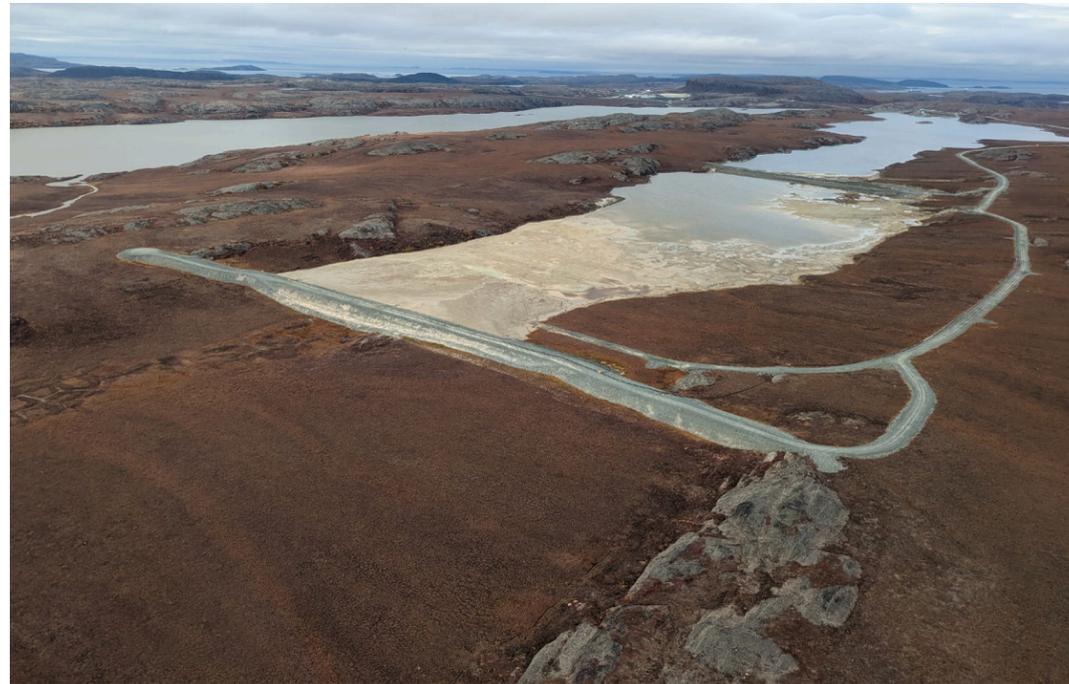
Photo 9: South Dam Overview from the helicopter (Looking Northwest).

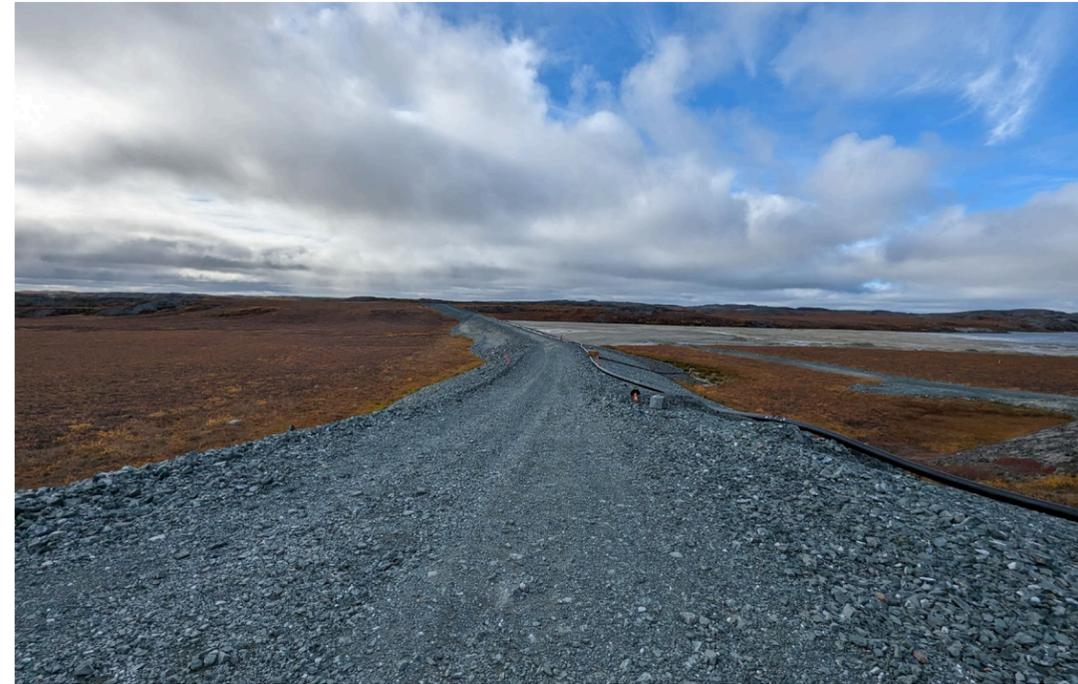
Photo 10: South Dam Crest (Looking West).

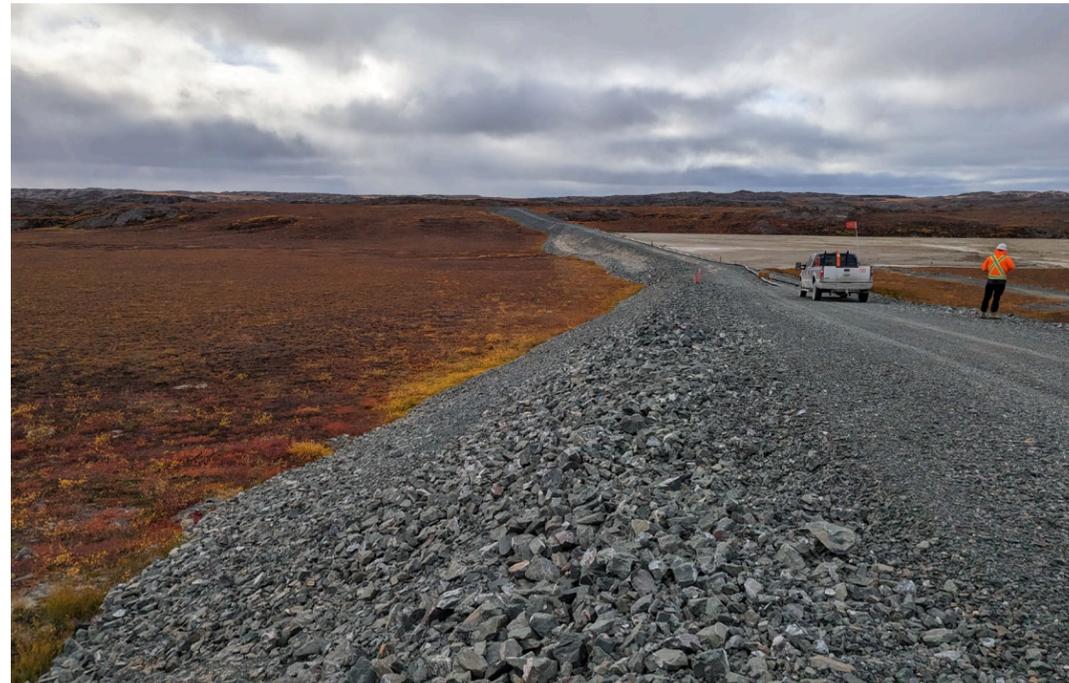
Photo 11: North Dam Downstream Face (Looking Northwest).

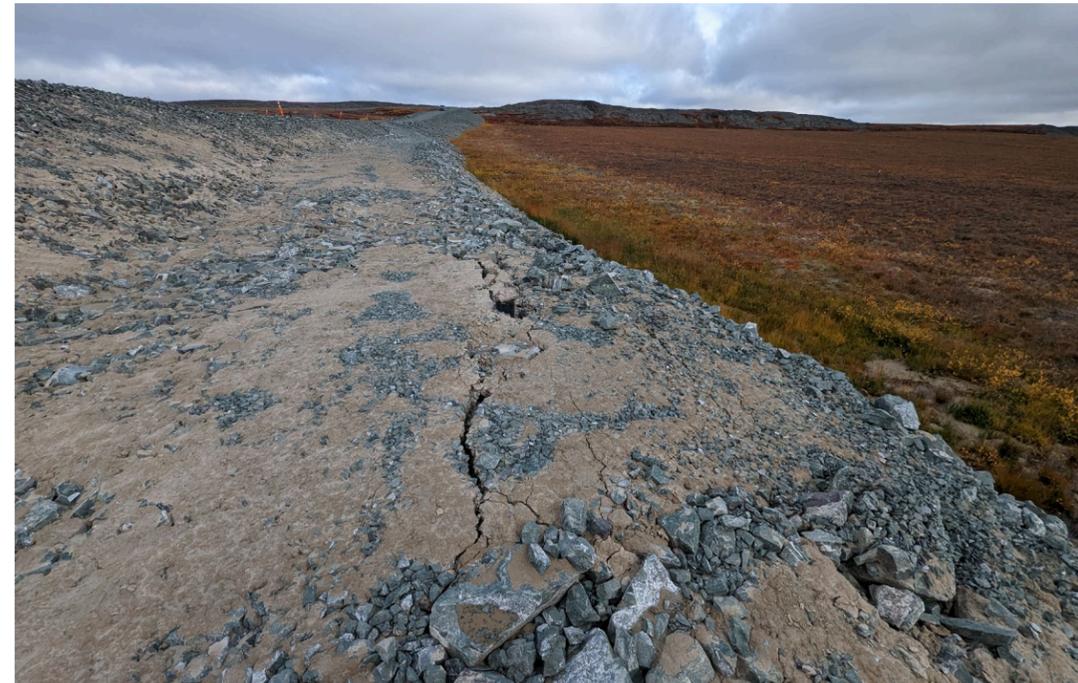
Photo 12: South Dam Downstream Toe Berm (Looking Southeast).

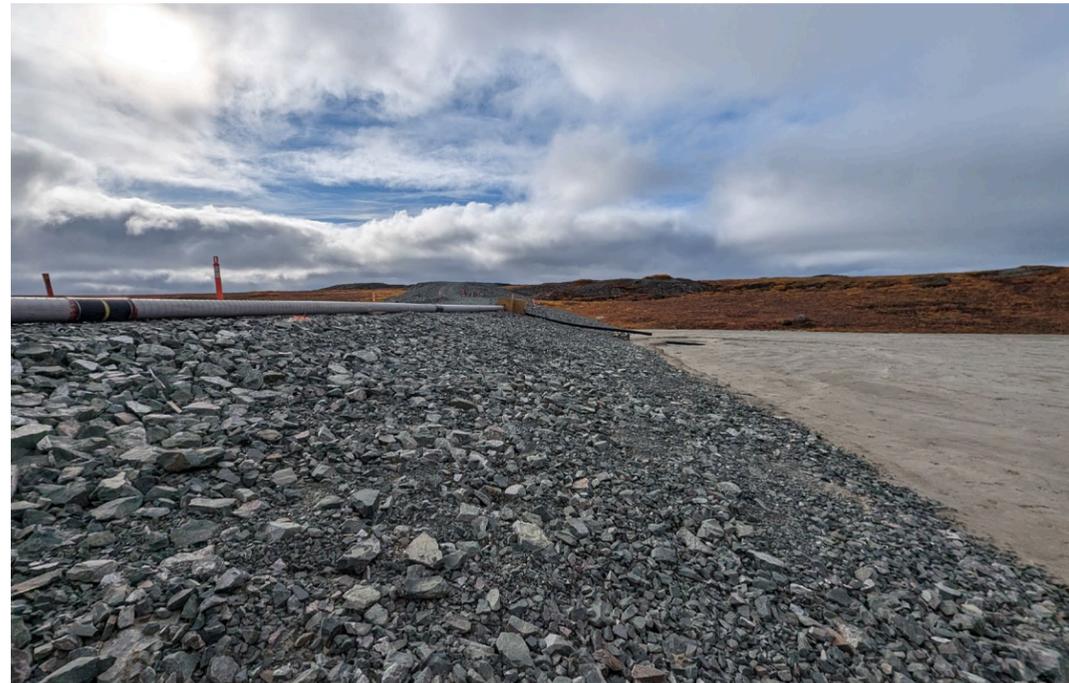
Photo 15: South Dam Upstream Face (Looking Southwest).

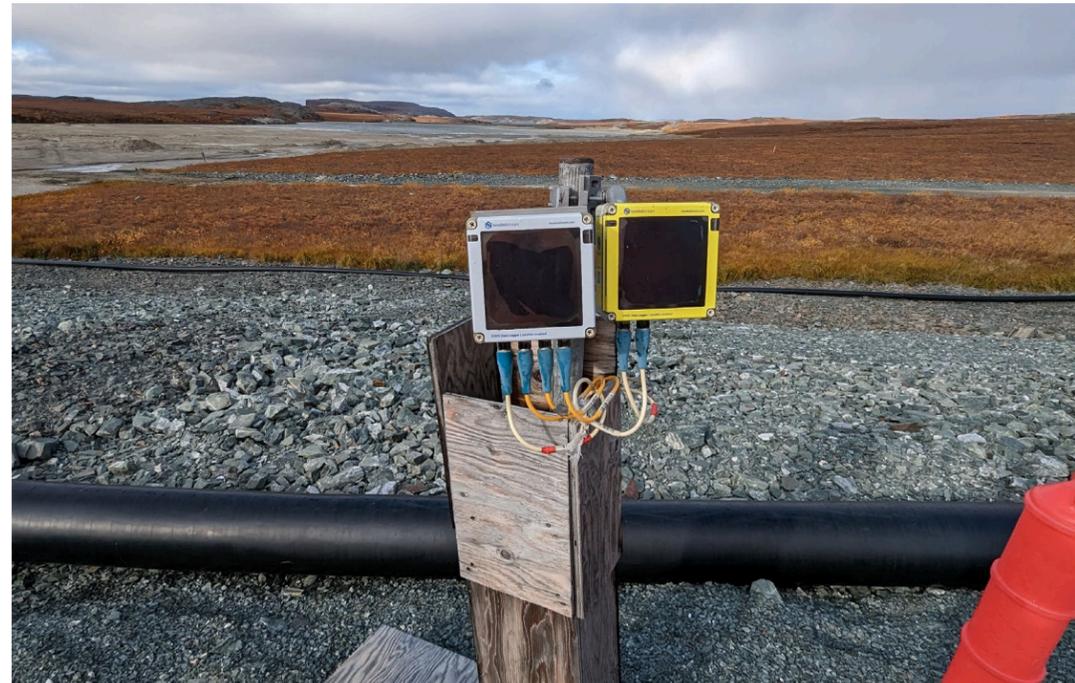
Photo 16: South Dam Instrumentation Inspection (Looking Southeast).

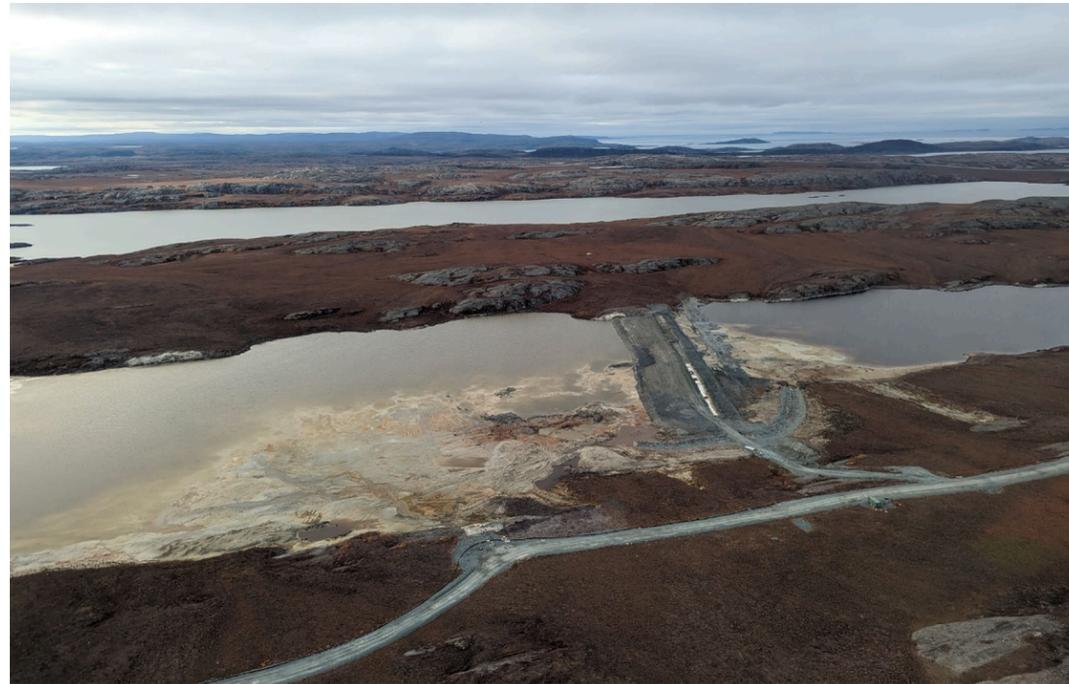
Photo 17: Interim Dike Overview from the helicopter (Looking Southeast).

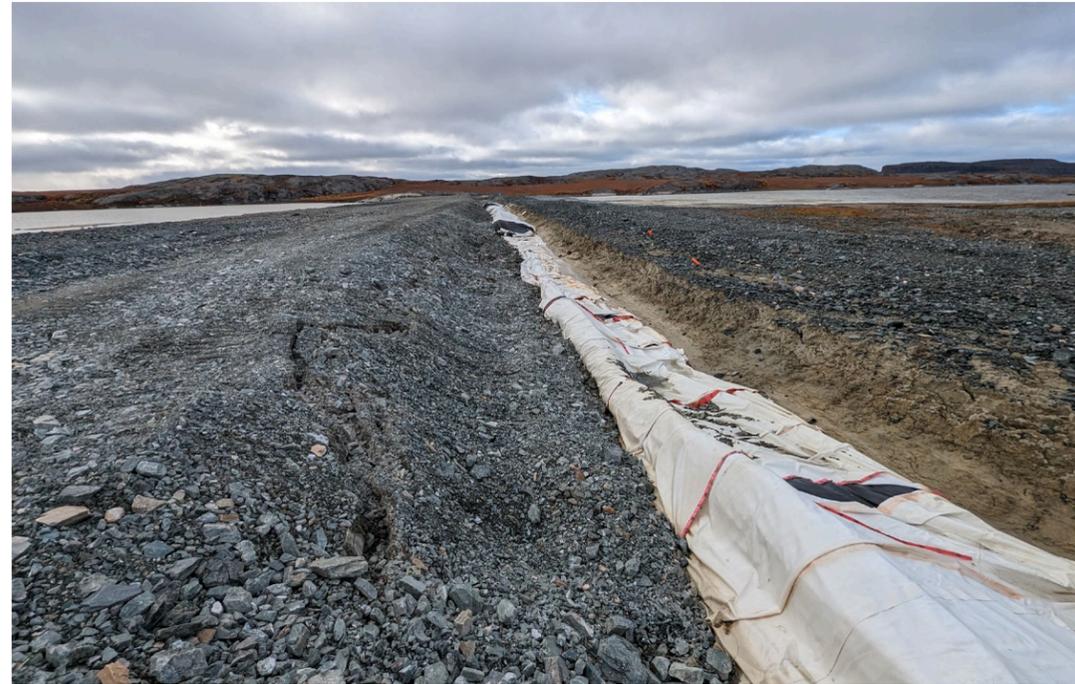
Photo 18: Interim Dike Overview and Former Aquadam Location (Looking West).

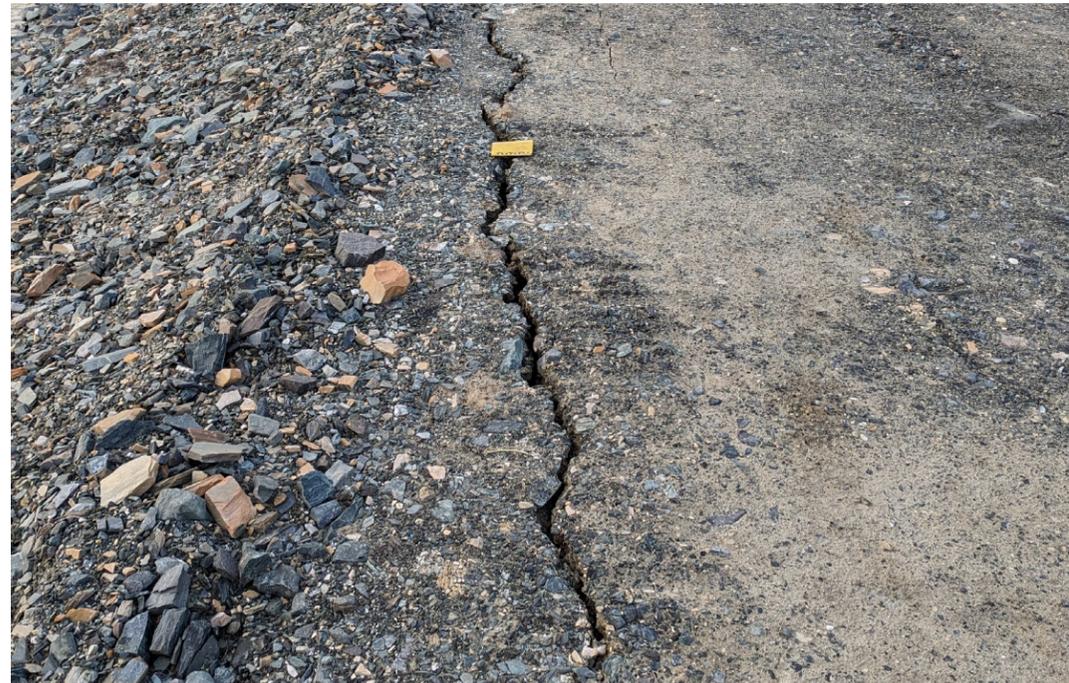
Photo 19: Interim Dike Crest (Cracking) (Looking West).

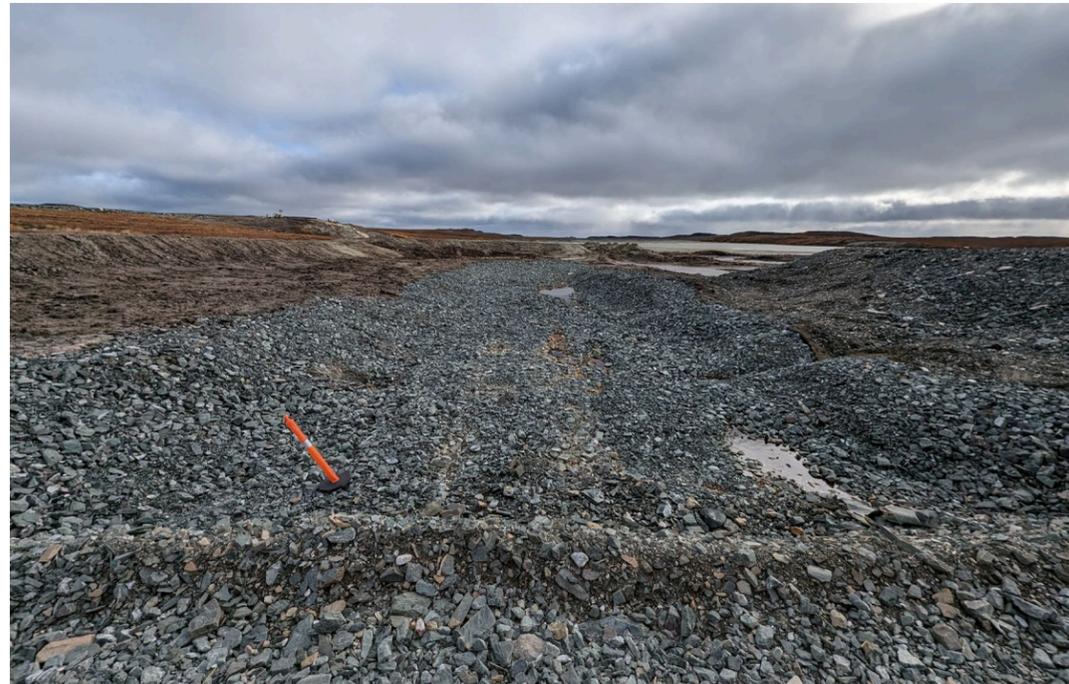
Photo 21: Interim Dike Spillway (Looking South).

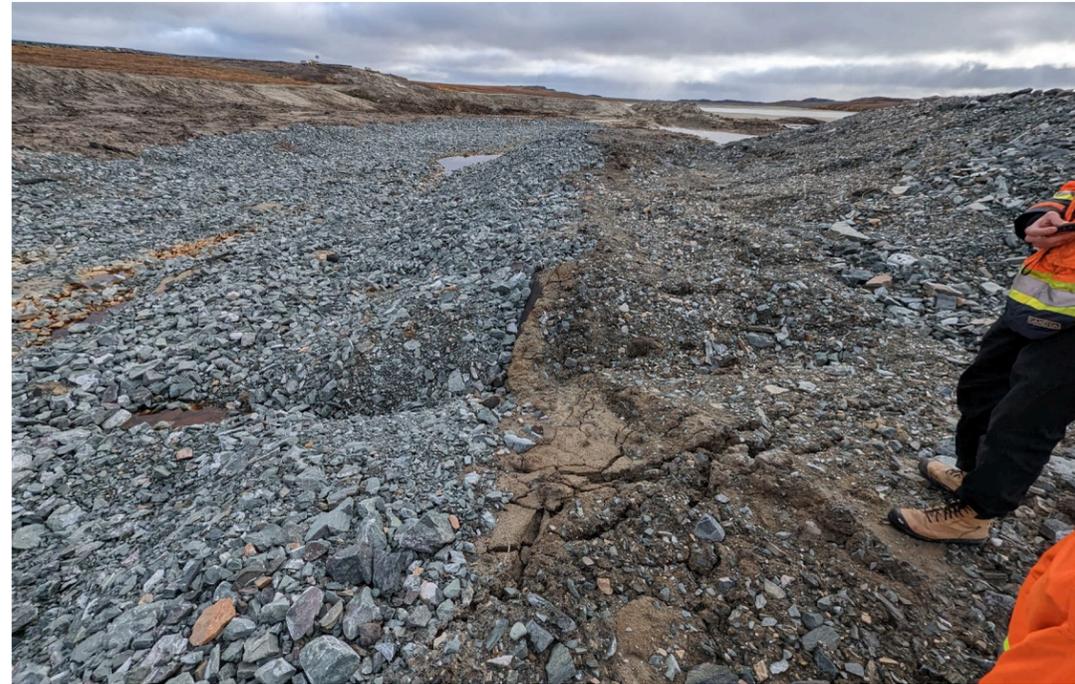
Photo 22: Interim Dike Spillway (Looking South).

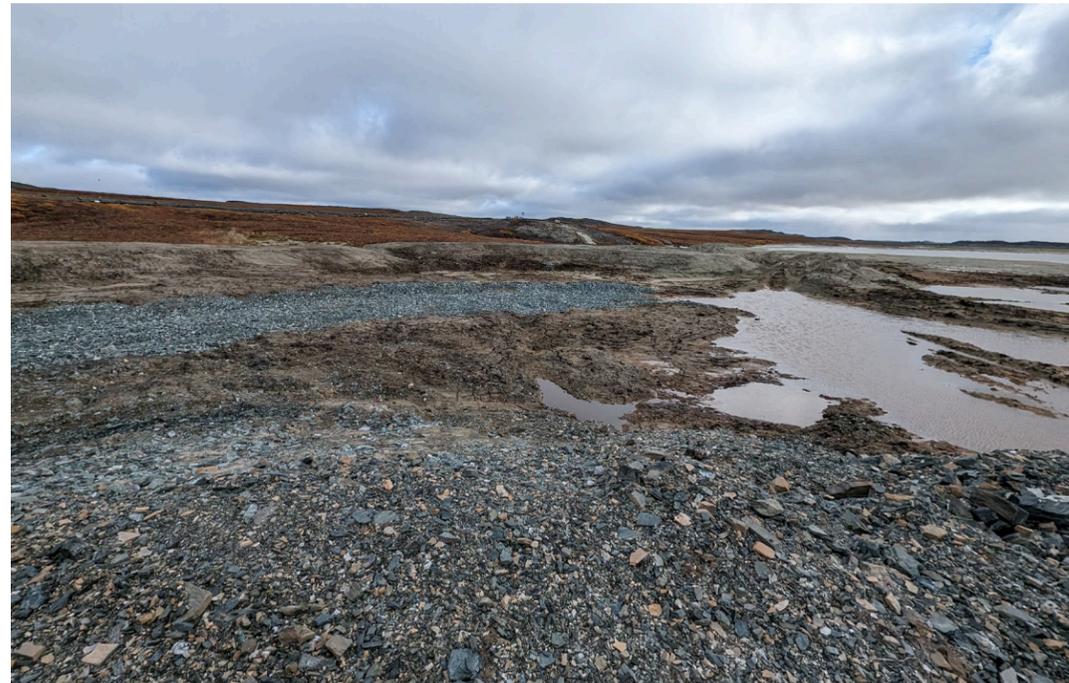
Photo 23: Interim Dike Spillway (Looking Southeast).

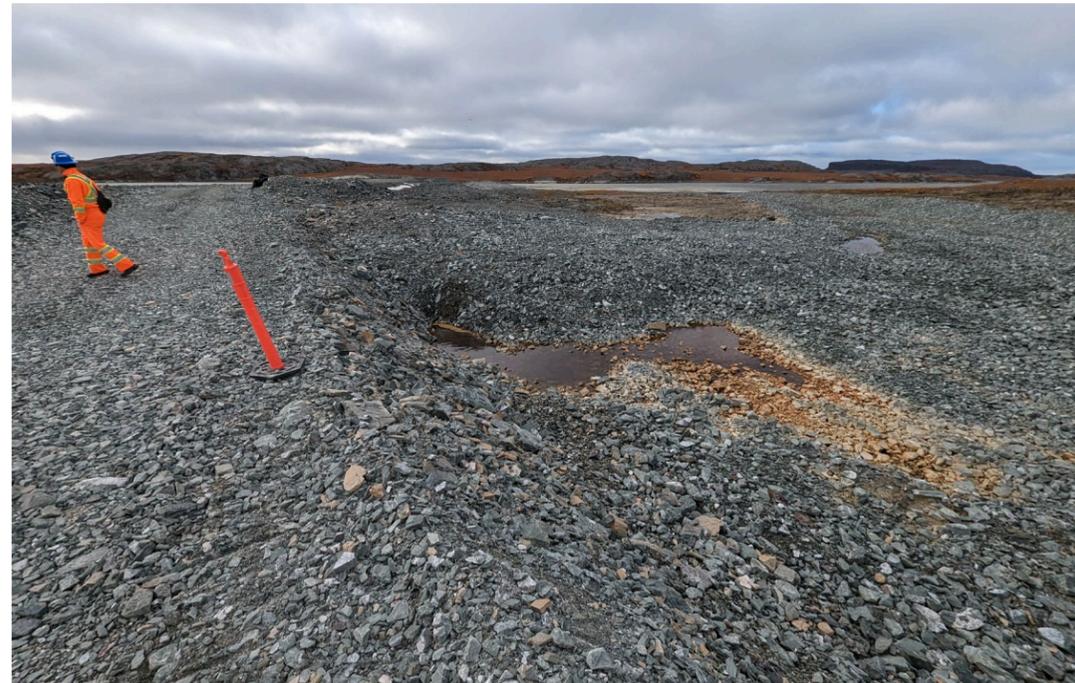
Photo 24: Interim Dike Spillway (Looking Northwest).

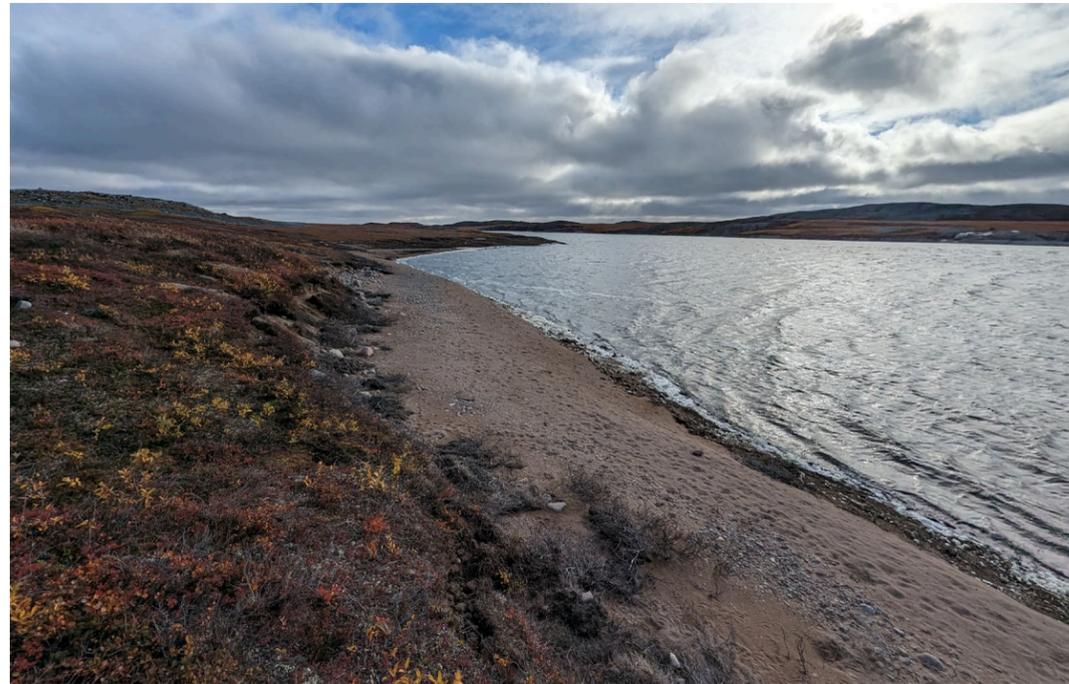
Photo 25: TIA Shoreline Overview (Looking South).

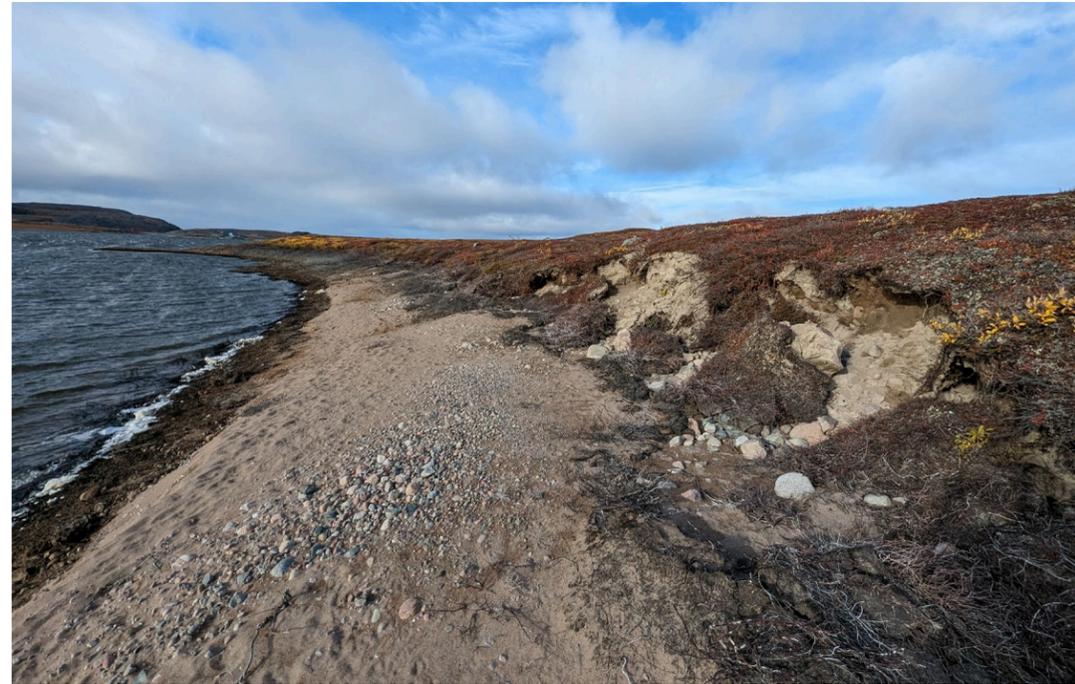
Photo 26: TIA Shoreline Erosion (Looking Southeast).

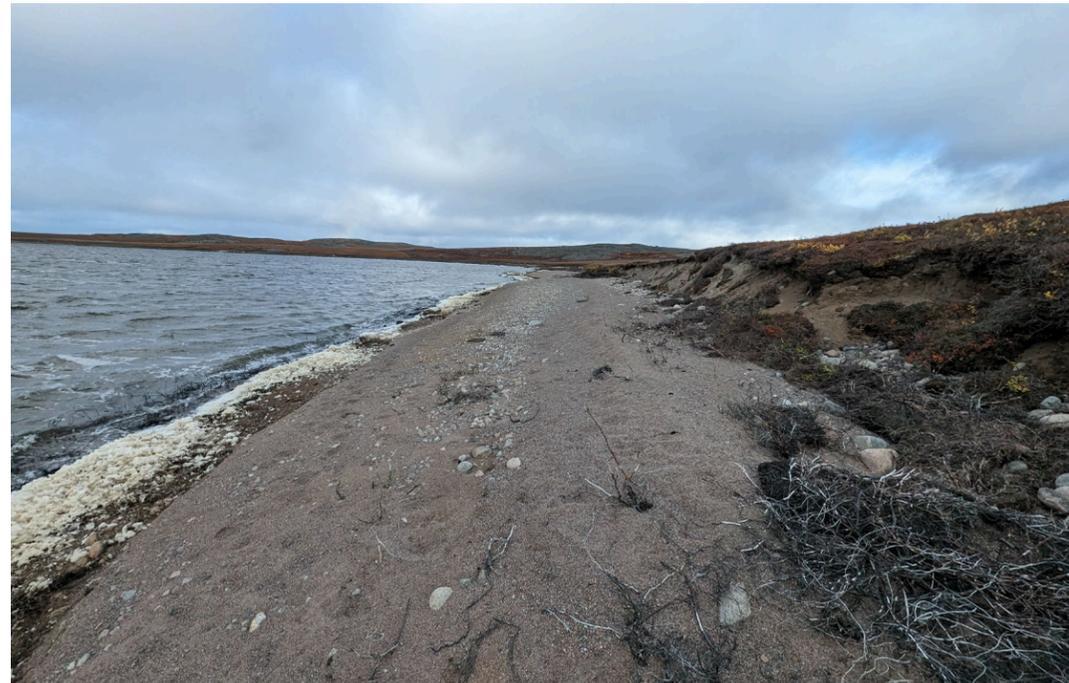
Photo 27: TIA Shoreline Overview (Looking Northeast).

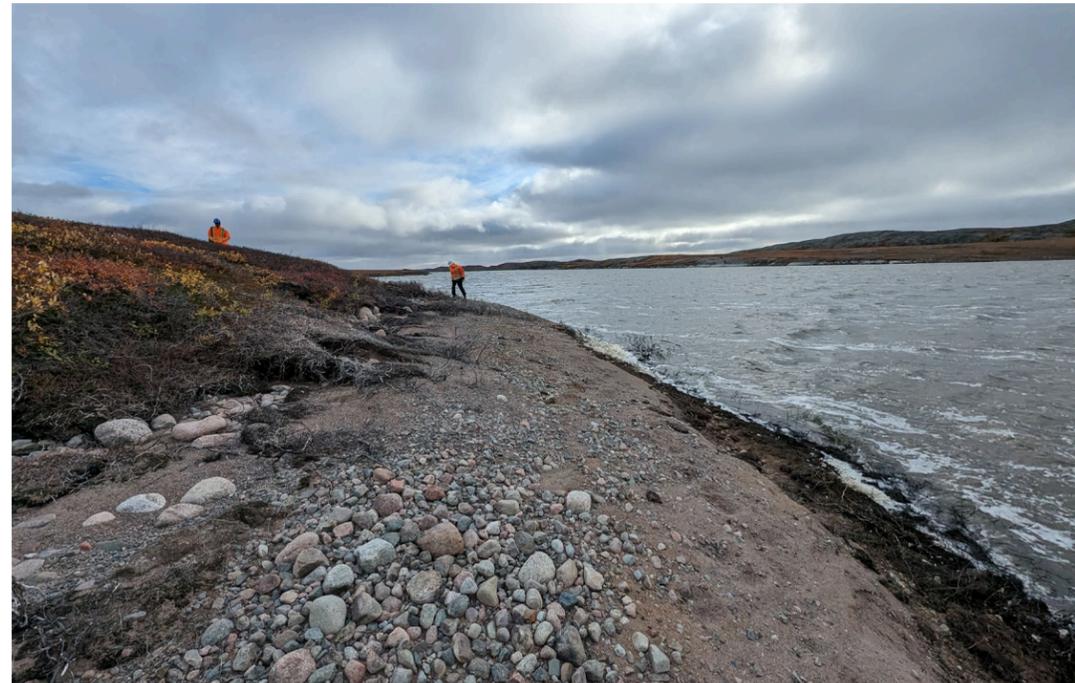
Photo 28: TIA Shoreline Overview (Looking Southwest).

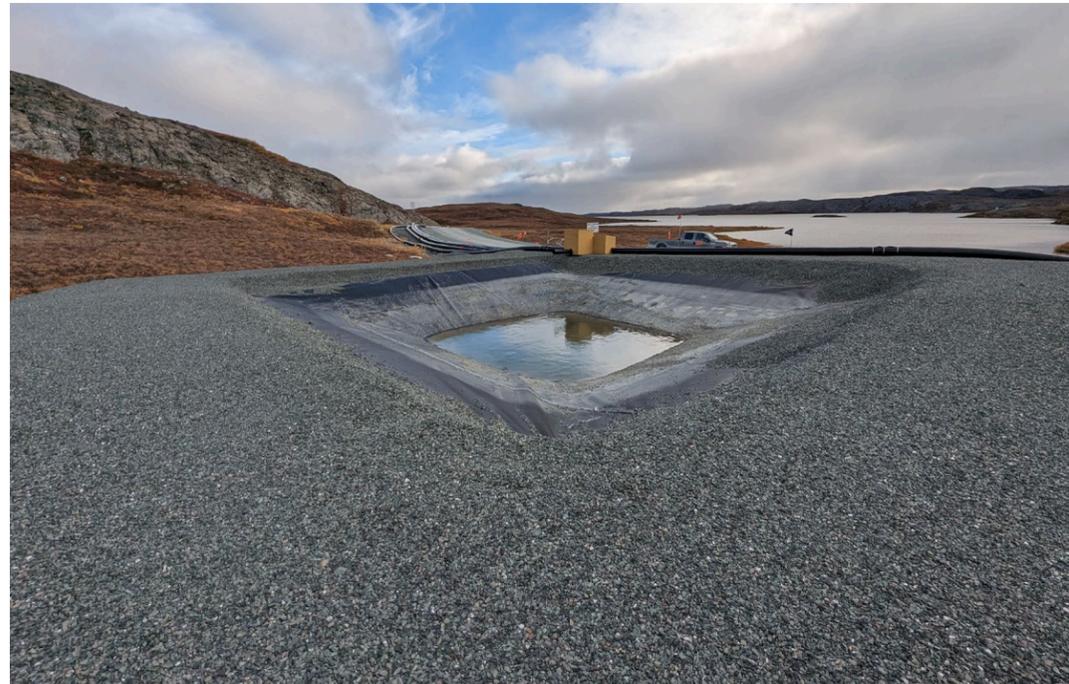
Photo 29: Eastern Emergency Dump Catch Basin (Looking Southeast).

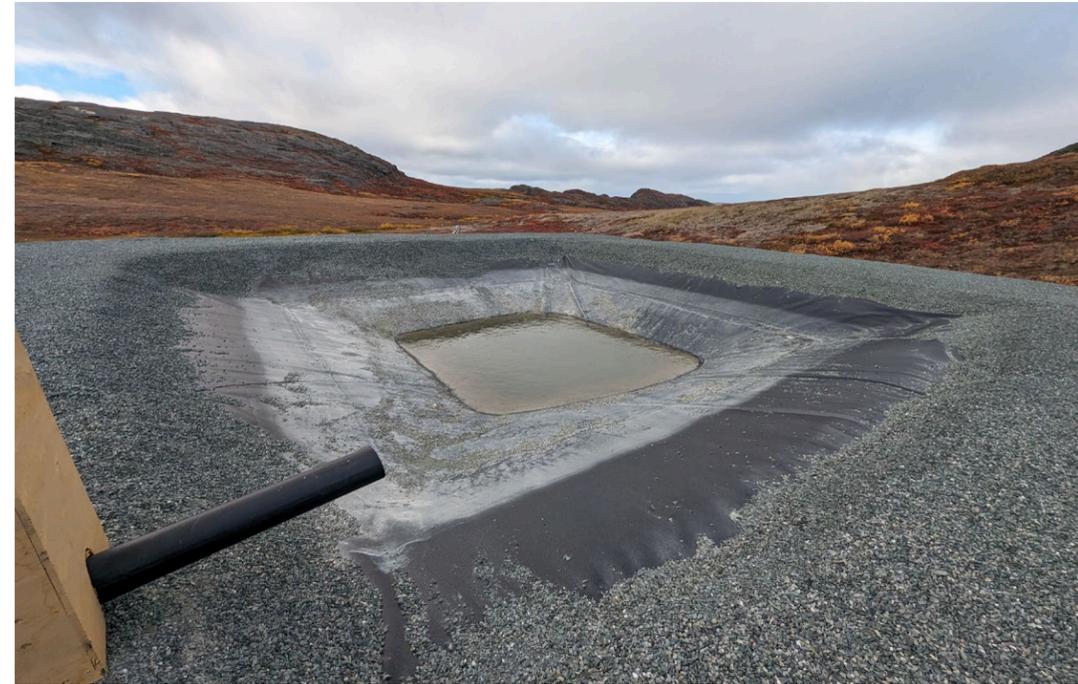
Photo 30: Eastern Emergency Dump Catch Basin (Looking Northeast).

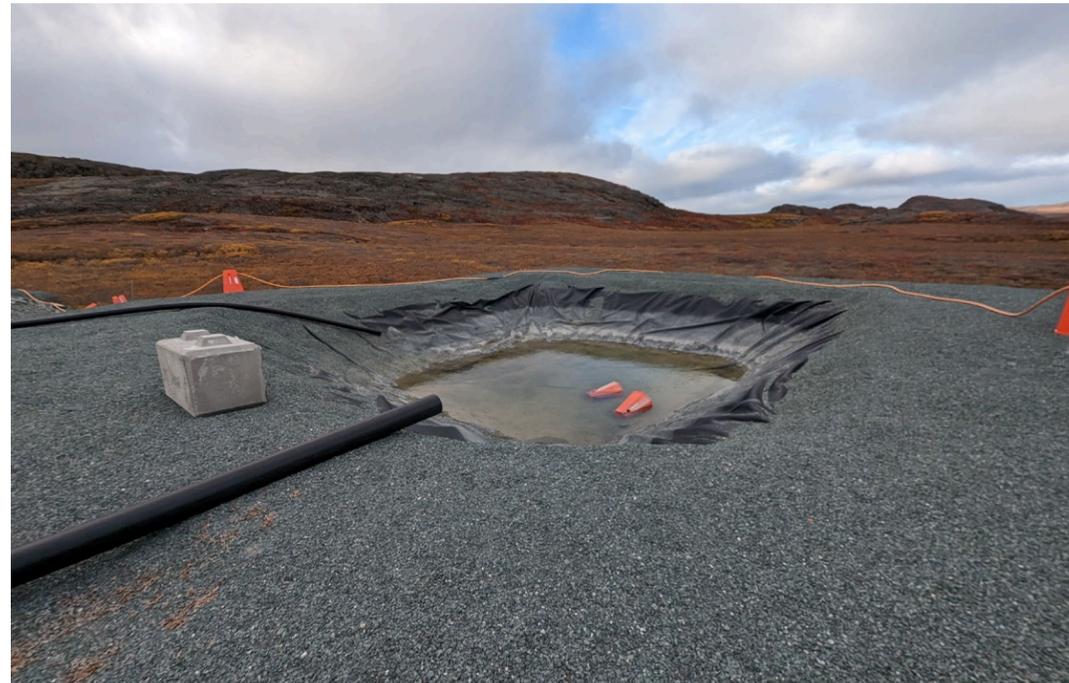
Photo 31: Western Emergency Dump Catch Basin (Looking Northwest).

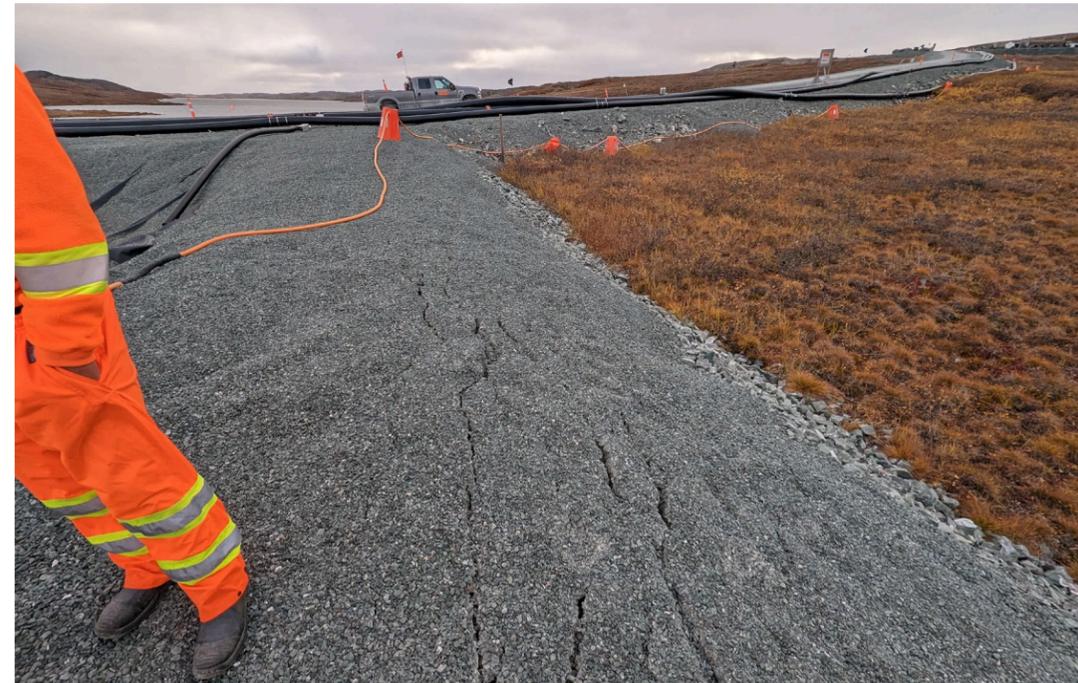
Photo 32: Western Emergency Dump Catch Basin Western Slope (Looking Southwest).

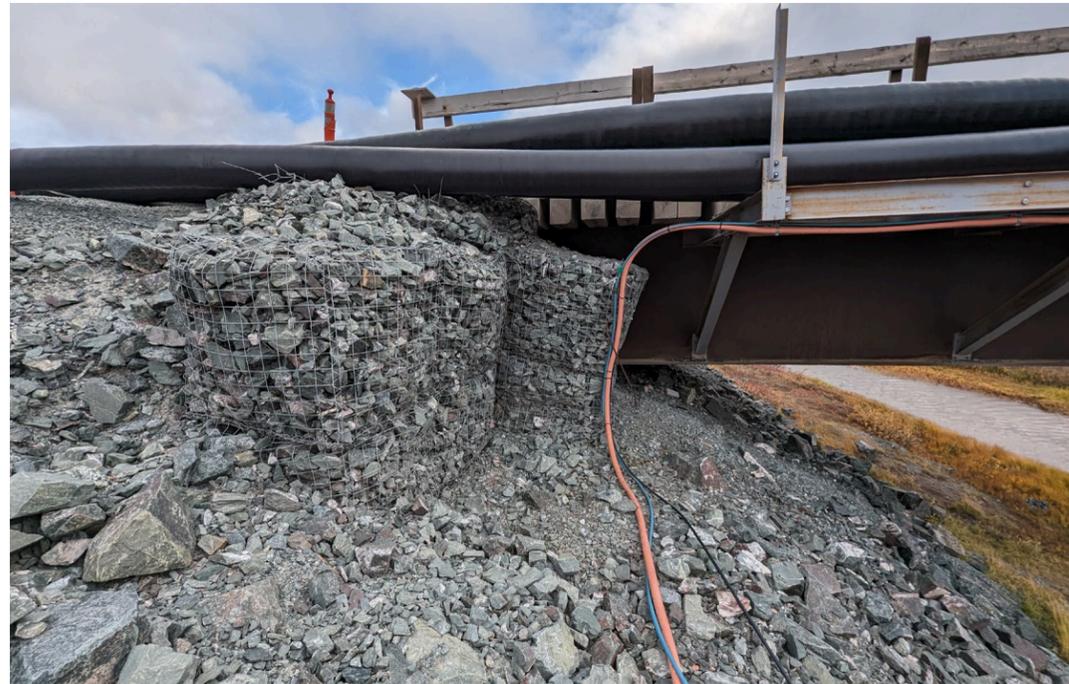
Photo 33: Eastern Side of Doris Bridge, Northern Gabion (Looking South).

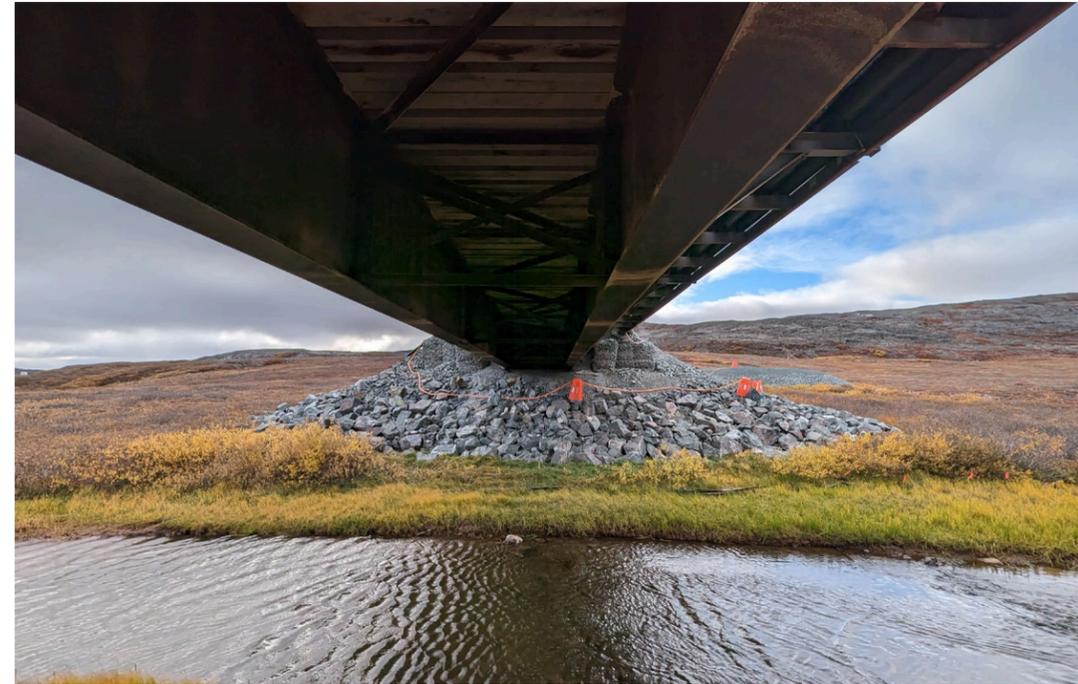
Photo 34: Doris Bridge Overview Below the Deck (Looking West).
