2024 Annual Geotechnical Inspection – Doris Tailings Impoundment Area

Hope Bay Mine, Nunavut, Canada
Agnico Eagle Mines Limited

SRK Consulting (Canada) Inc. ■ CAPR003066 ■ March 2025

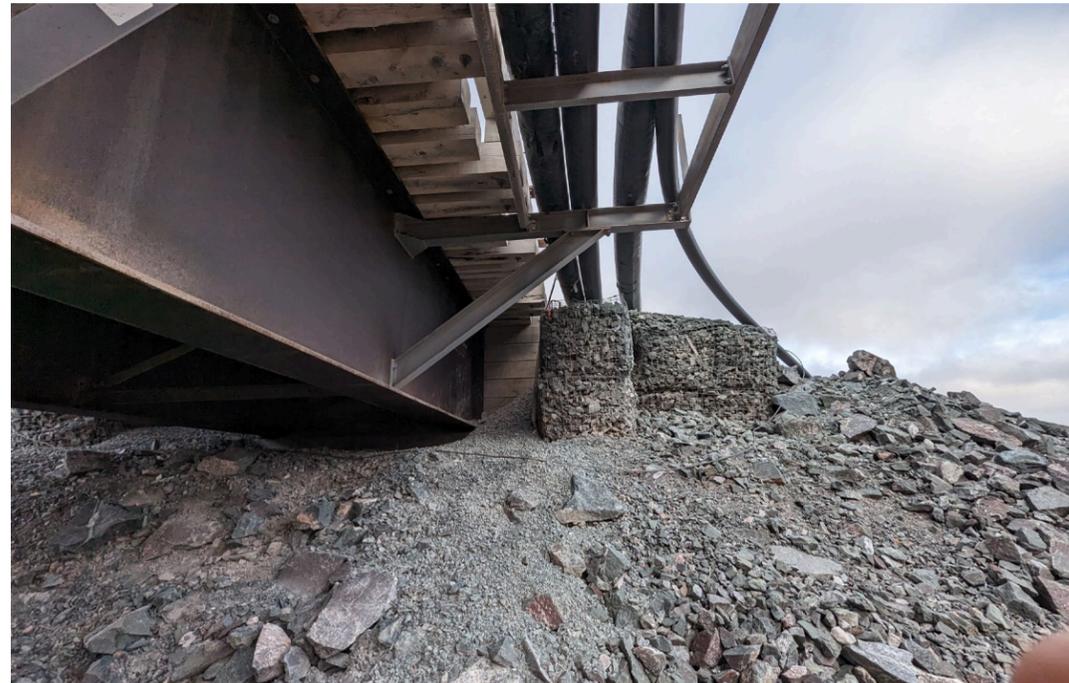
Photo 35: Eastern Side of Doris Bridge, Southern Gabion (Looking East).

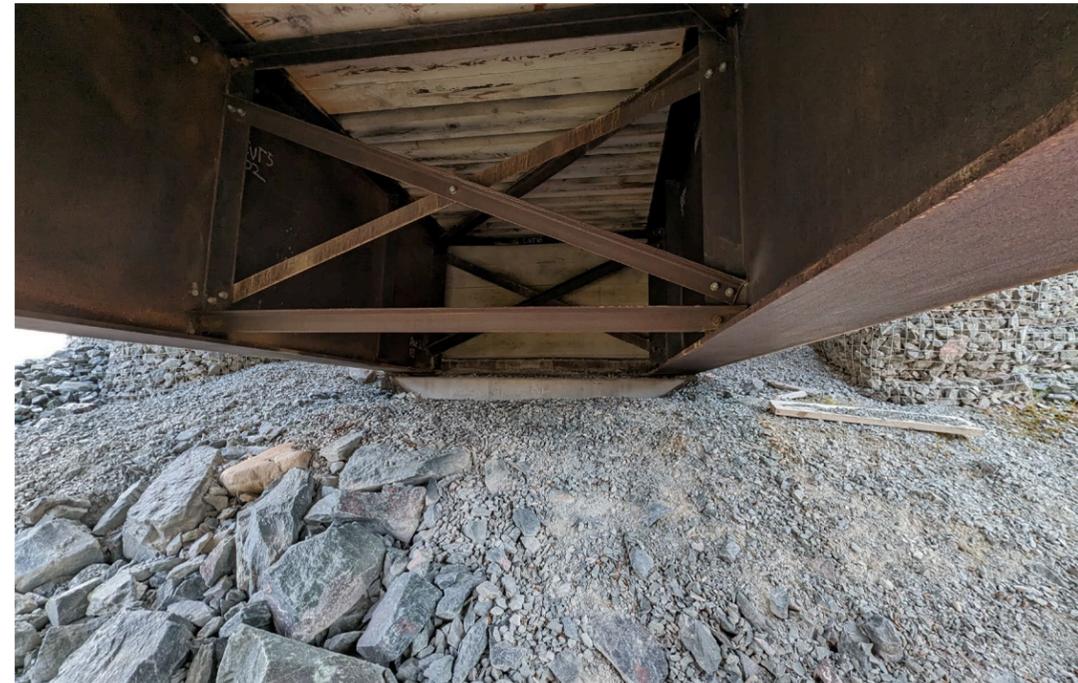
Photo 36: Western Side of Doris Bridge, Abutment Overview (Looking West).

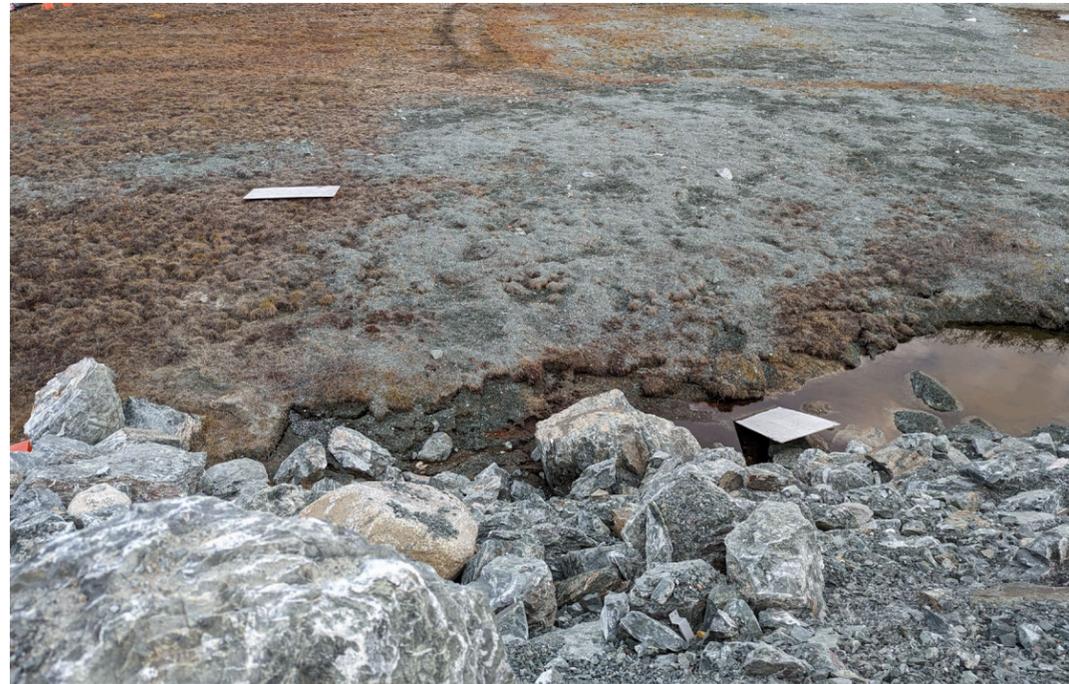
Photo 37: ROQ below the WTP slope (Looking Southeast).

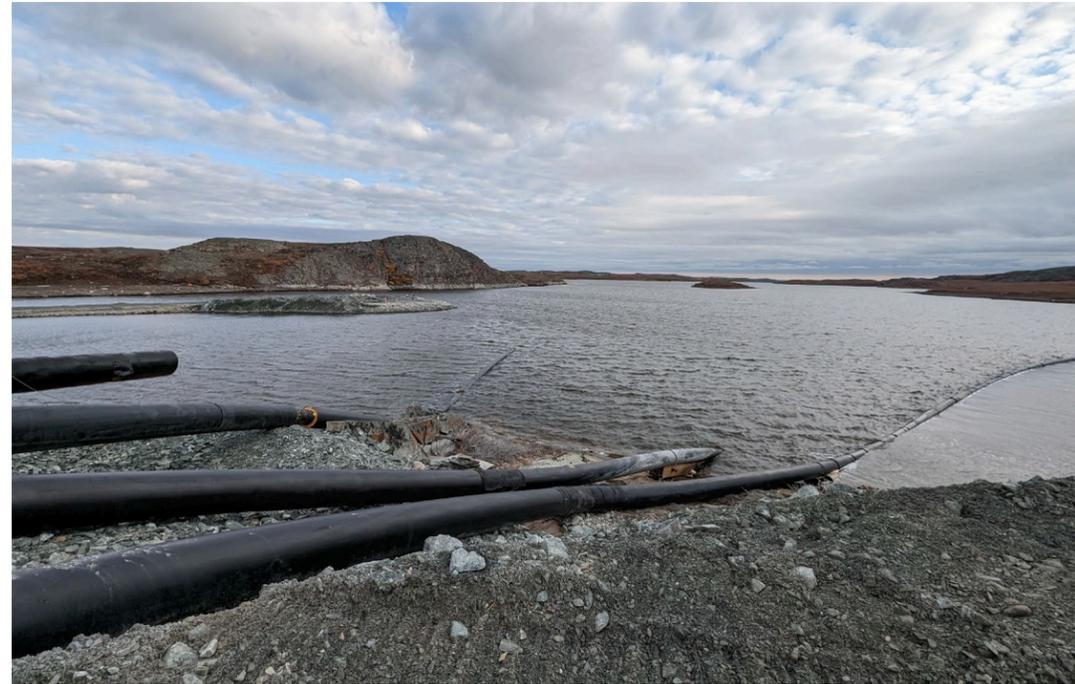
Photo 38: Partially Dismantled Pipelines (Looking Southeast).

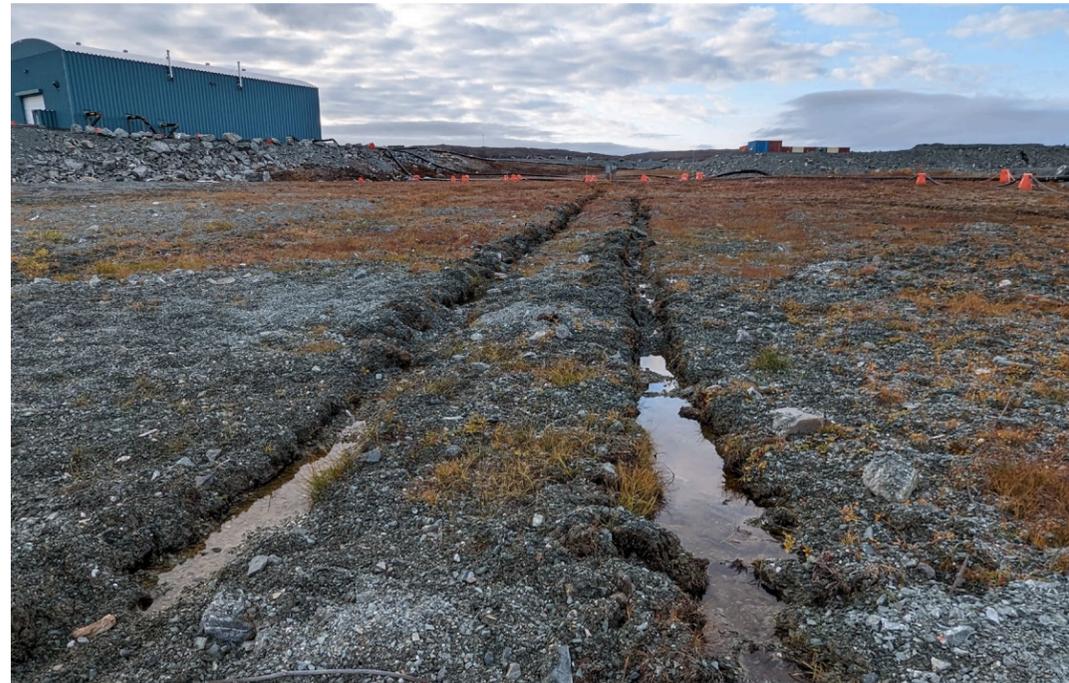
Photo 39: Disturbance in Tundra (Dozer Tracks) (Looking Northwest).

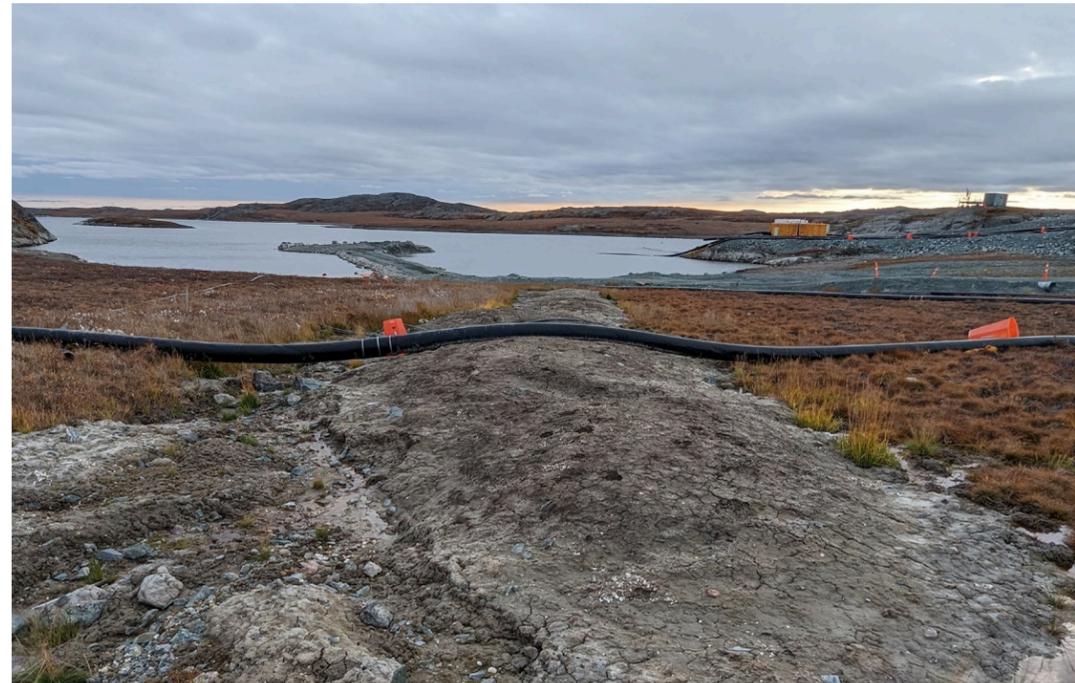
Photo 40: Presence of Waste Material (Looking South).
