## **APPENDIX 6      2024 ANNUAL GEOTECHNICAL INSPECTION REPORT**

## 2024 Annual Geotechnical Inspection Meliadine Gold Mine, Nunavut, Canada

PRESENTED TO  
**Agnico Eagle Mines Limited**

MARCH 11, 2025  
ISSUED FOR USE-REVISION 1  
FILE: 704-ENG.EARC03140-39  
AGNICO EAGLE DOCUMENT NUMBER: 65-600-230-TCR-002

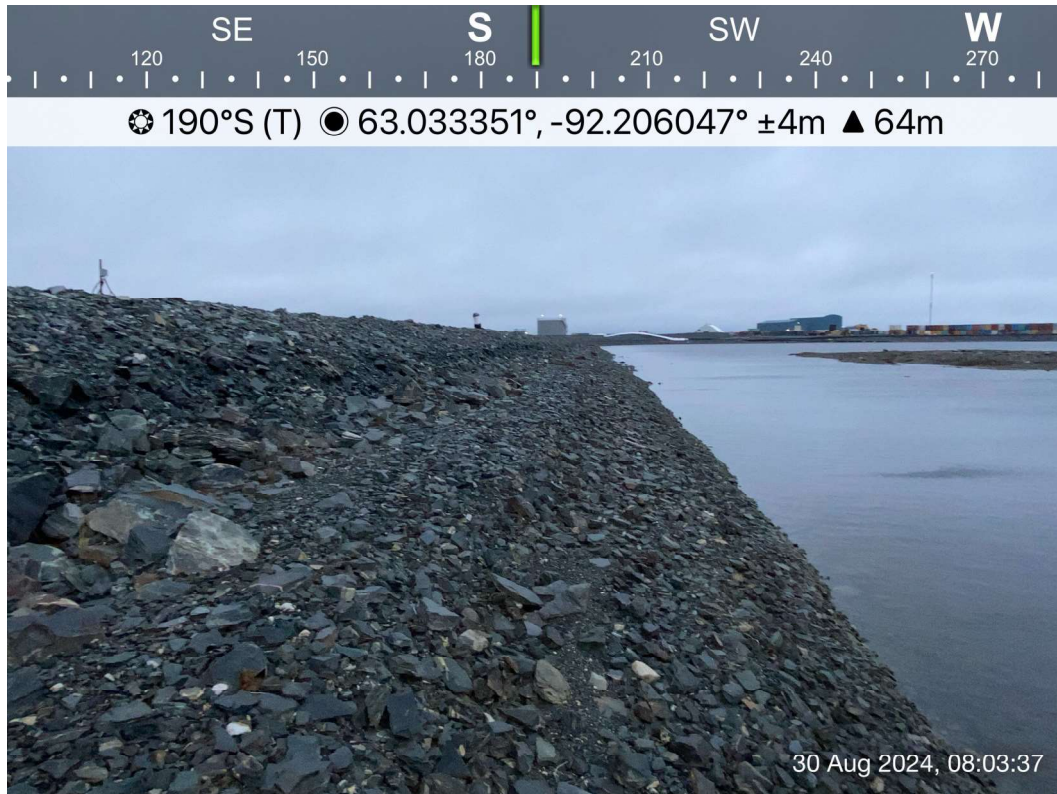
CP1, Dike D-CP1, downstream seepage collection ditches, sump, and Jetty1 are performing adequately. Some erosion was observed on the upstream shell of Dike D-CP1 and occurred during a high-water event between 2019 and 2020. No noticeable change on the upstream shell erosion has been observed since 2021. Ongoing surveying of the erosion should be performed to determine if remedial measures are required.

**D-CP1 - Photo 1:** Dike D-CP1: Upstream face– some wave erosion evident from 2019/2020 high water level event, no change from previous years. Facing south.

It is recommended that effective snow removal or snow fencing be applied to help mitigate the warming trend of the dike's foundation. Consideration should be given to refill and regrade the slope of the CP1 jetty where the erosion was observed.

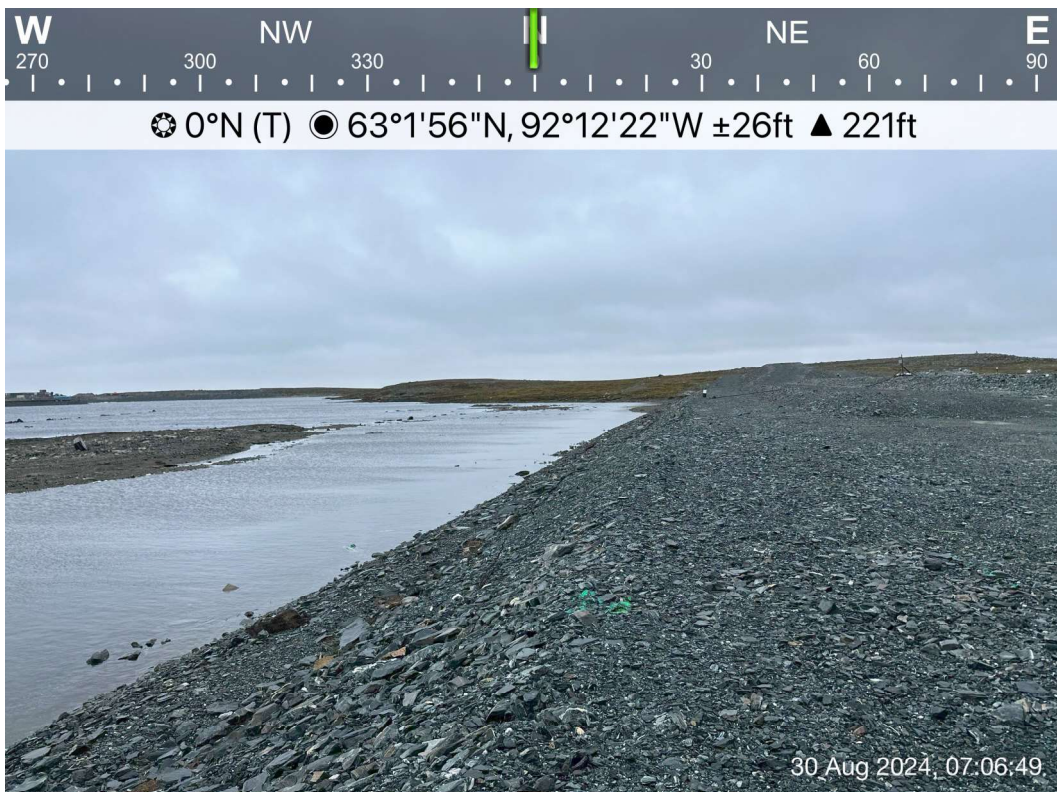
**D-CP1 - Photo 2:** Dike D-CP1: Upstream face– some wave erosion evident from 2019/2020 high water level event, no change from previous years. Facing north.

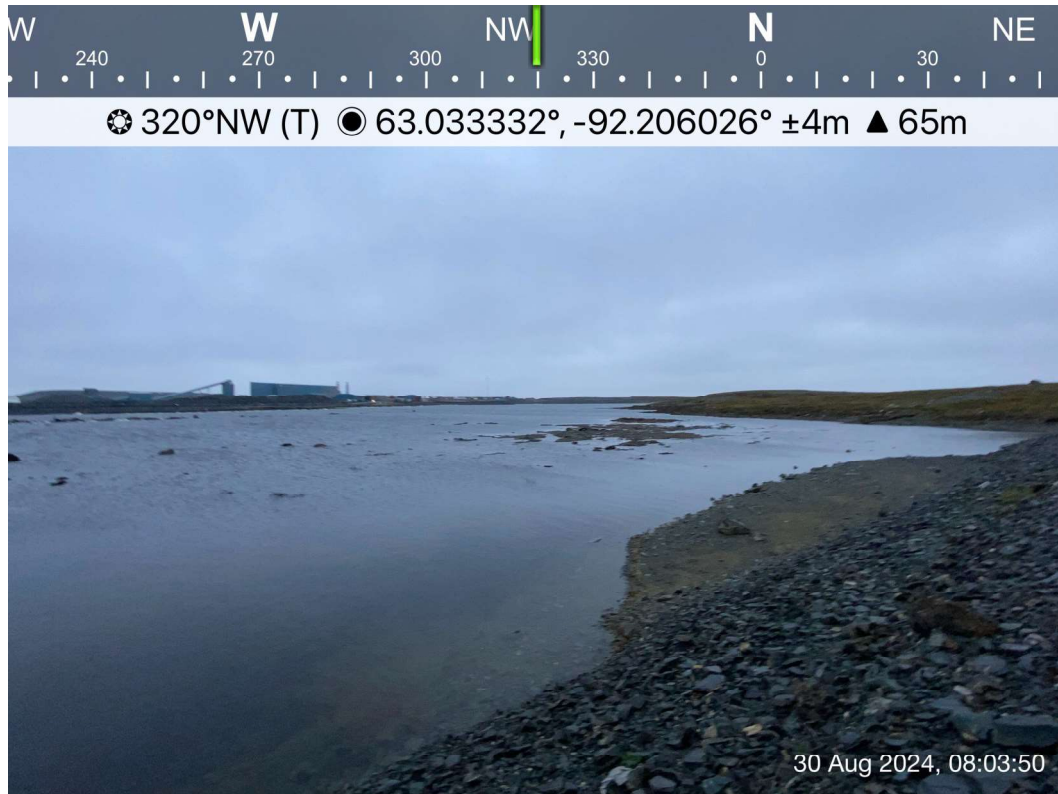
**D-CP1 - Photo 3:** CP1: Upstream view of CP1—water level well managed. Facing northwest.

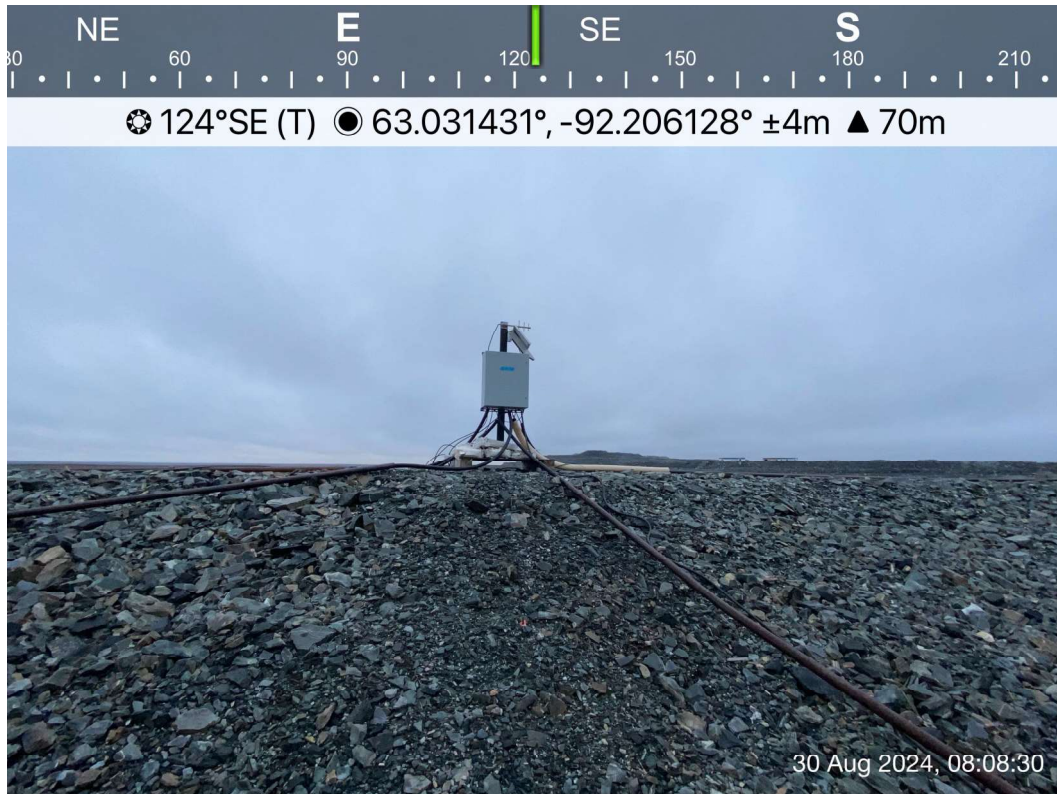
**D-CP1 - Photo 4:** Dike D-CP1: Dike crest view—downstream on left, upstream on right. Facing south.

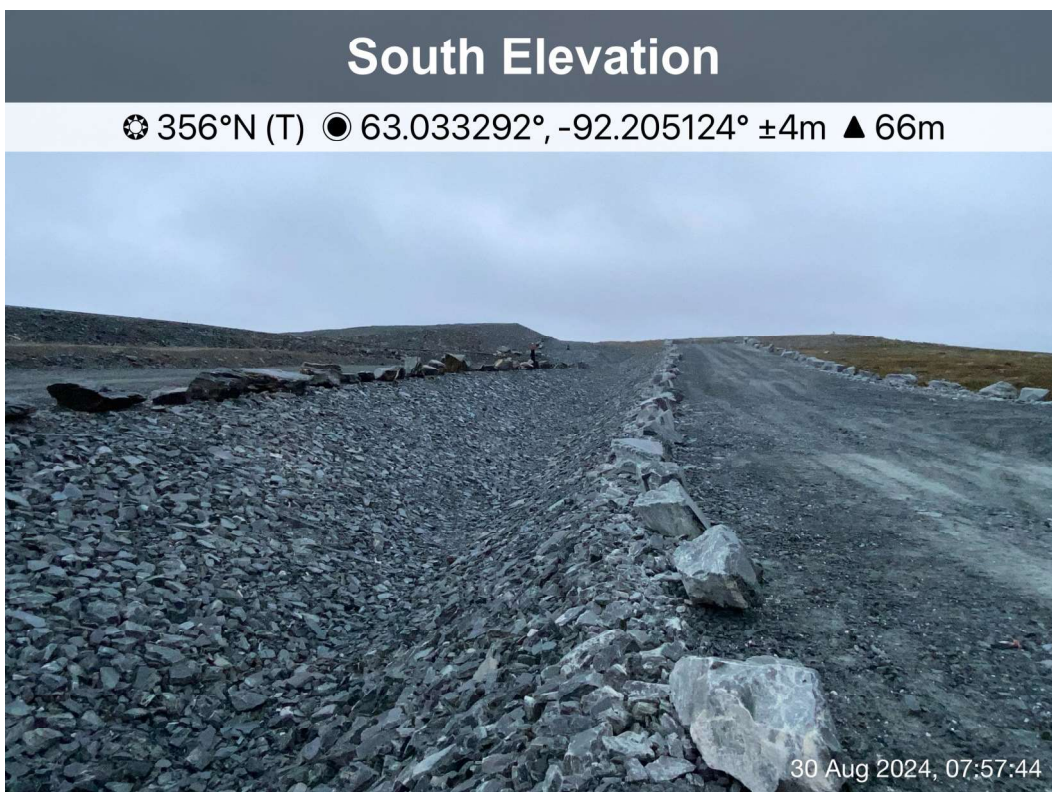
**D-CP1 - Photo 7:** Dike D-CP1: Dike downstream toe berm view. Facing south.

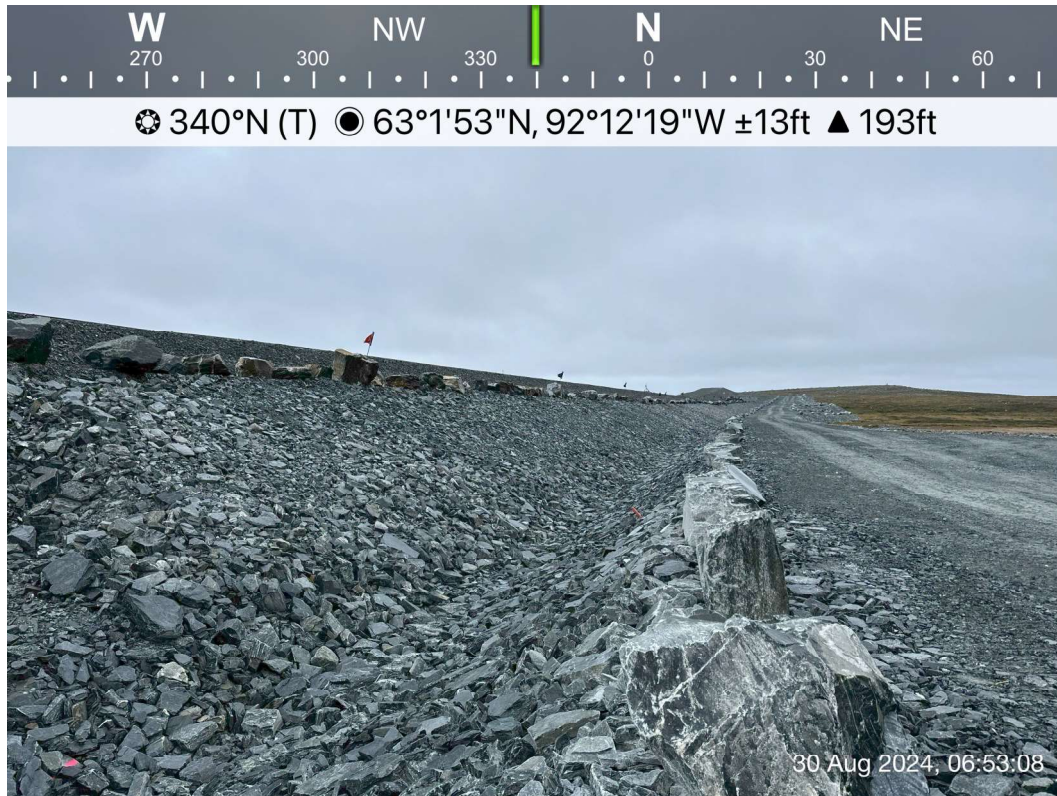
**D-CP1 - Photo 8:** Dike D-CP1: Dike downstream runoff/seepage collection north channel. Facing north.

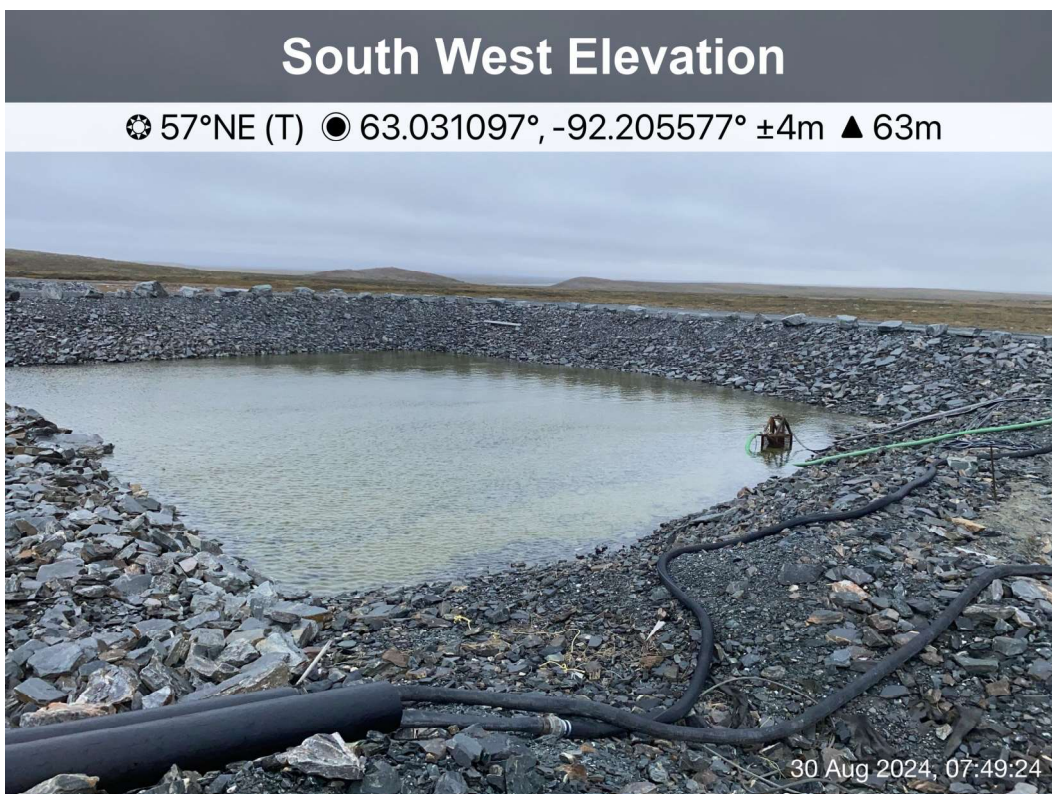
**D-CP1 - Photo 11:** Dike D-CP1: Dike downstream collection sump. Facing north.

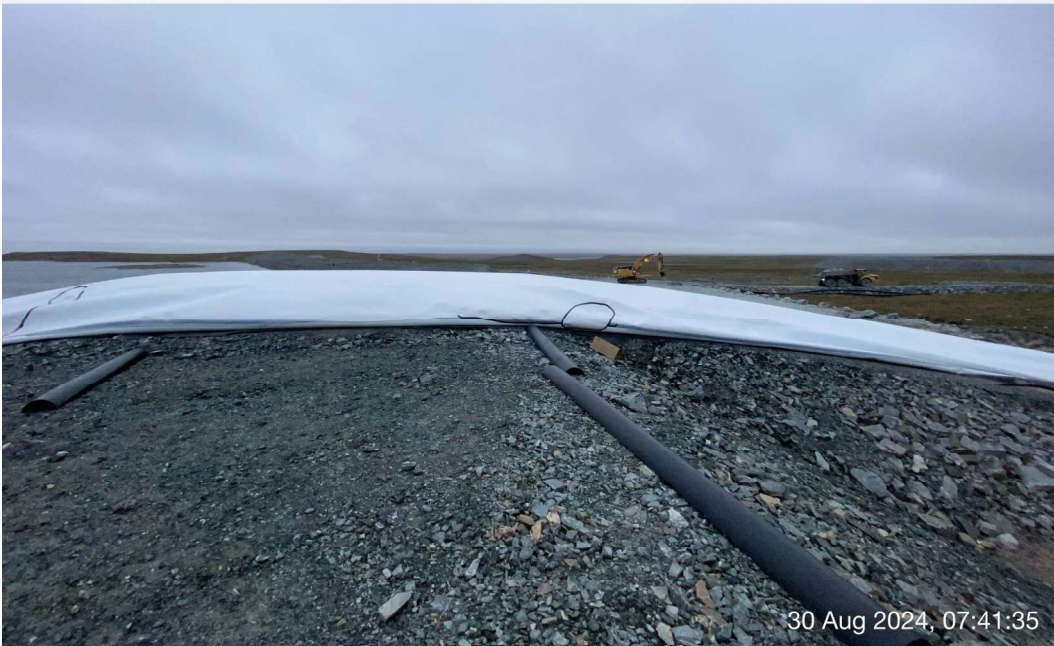
**D-CP1 - Photo 13:** Dike D-CP1: Downstream ROM cover. Facing southeast.

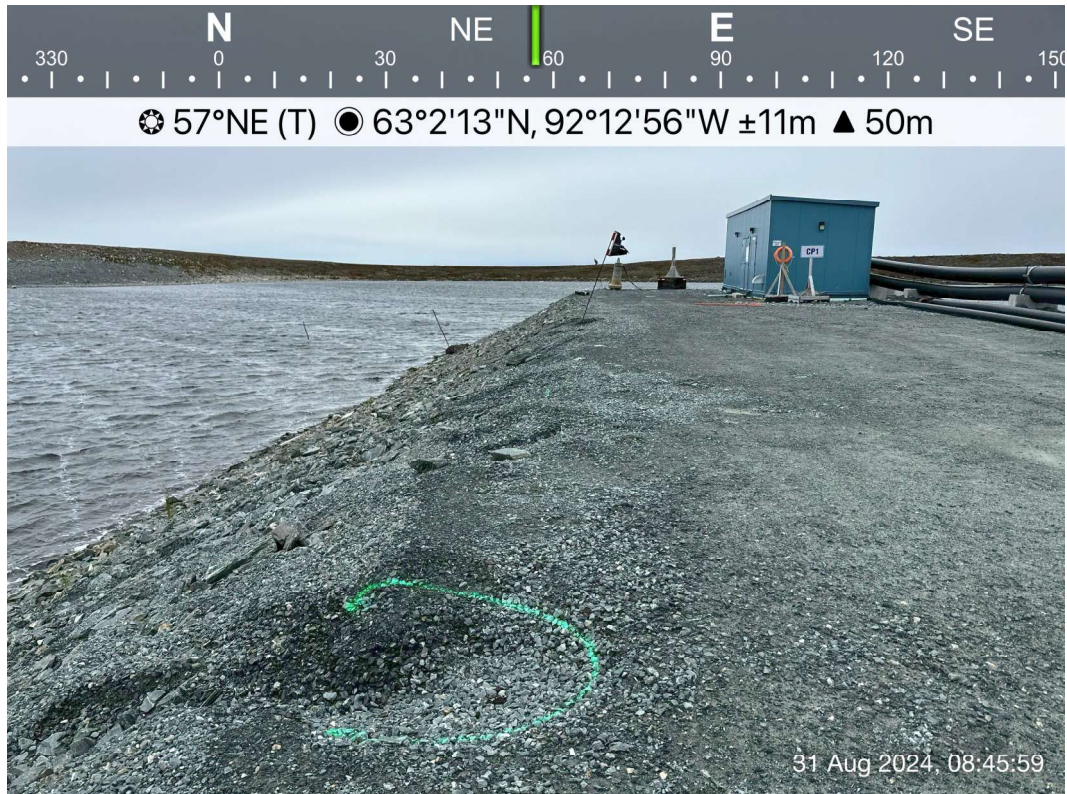
**D-CP1 - Photo 14:** Dike D-CP1: Pipelines crossing at Station 1+250 of Dike D-CP1. Facing northeast.

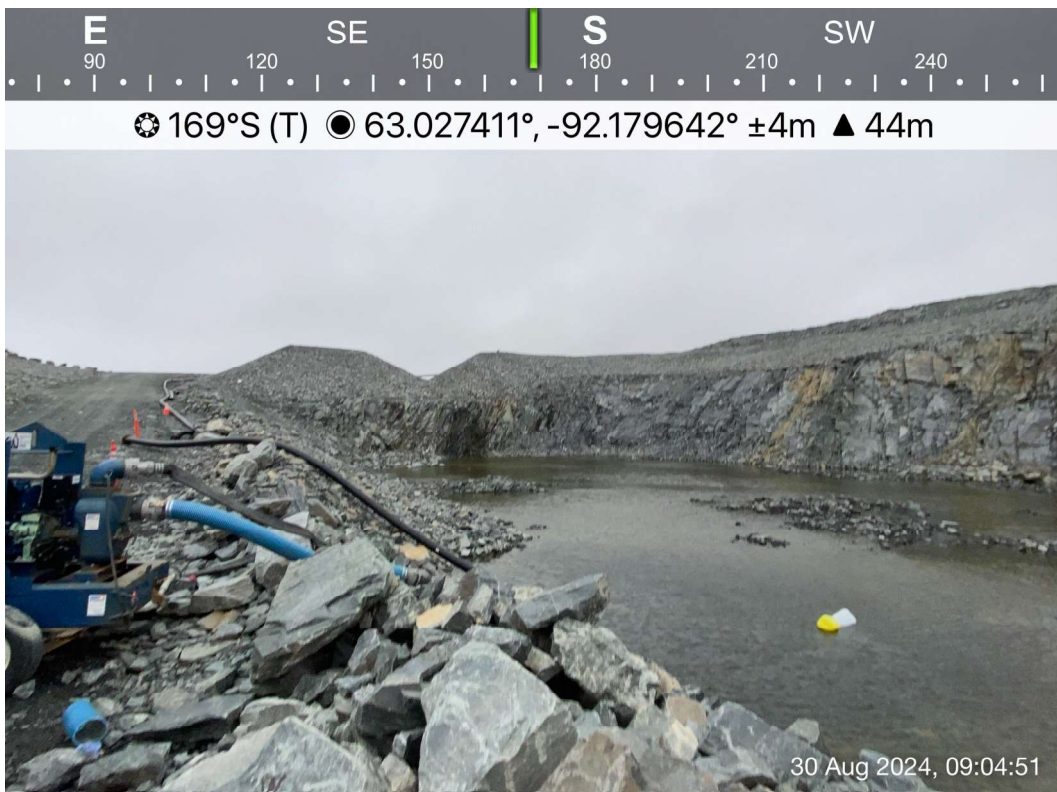
**CP2 - Photo 2:** CP2 - Small amount of water stored in CP2. Facing south.

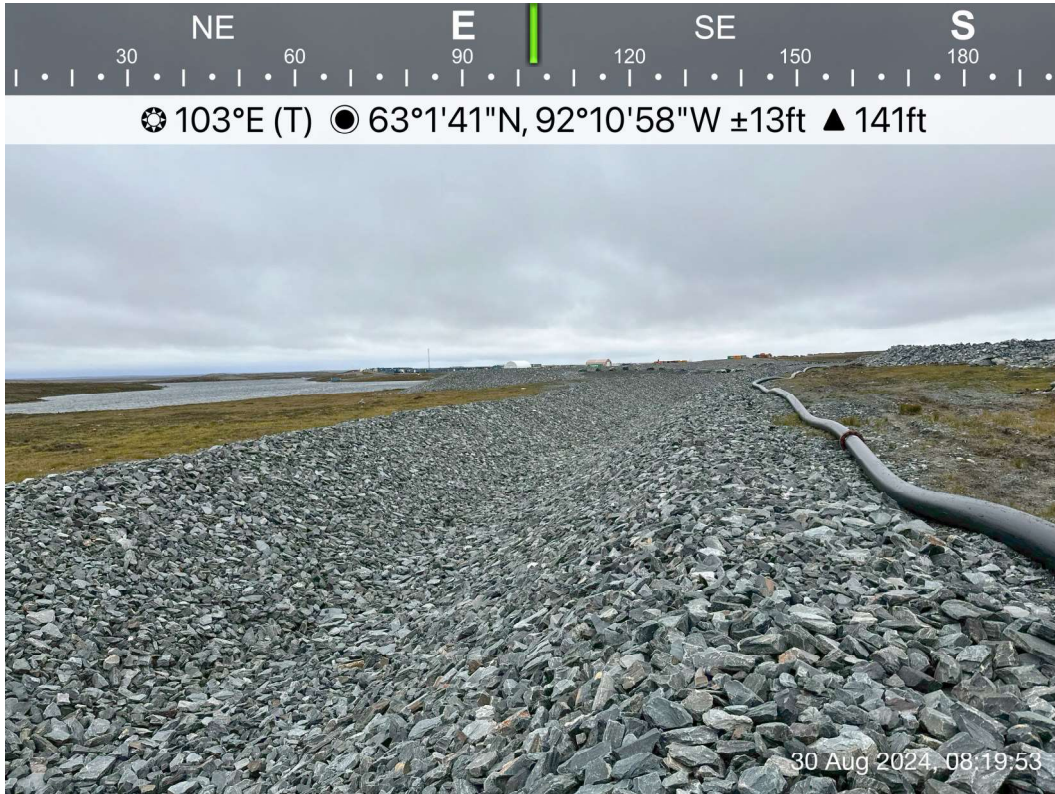
**Channel 9 -  
Photo 7:**

Channel 9 - View of Channel 9, performing well, no stability concerns. Facing east.

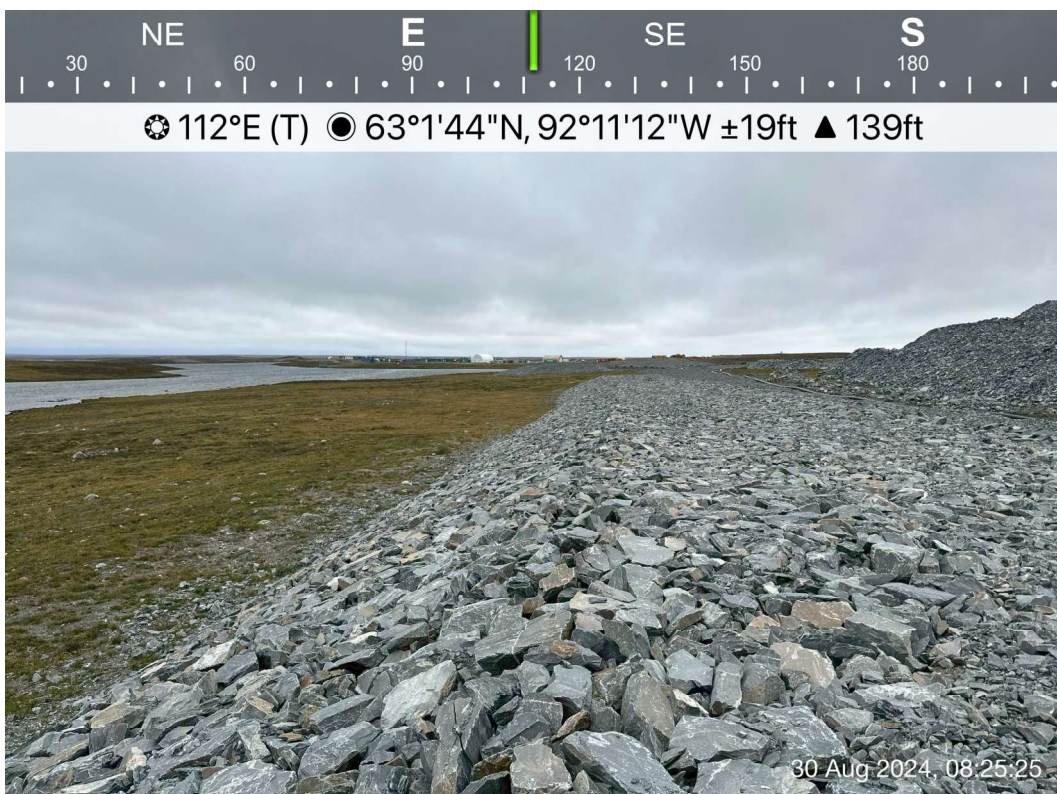
**Channel 9 Berm - Photo 10:** Channel 9 Berm: View of crest and downstream slope, performing well, no stability concern. Facing east.

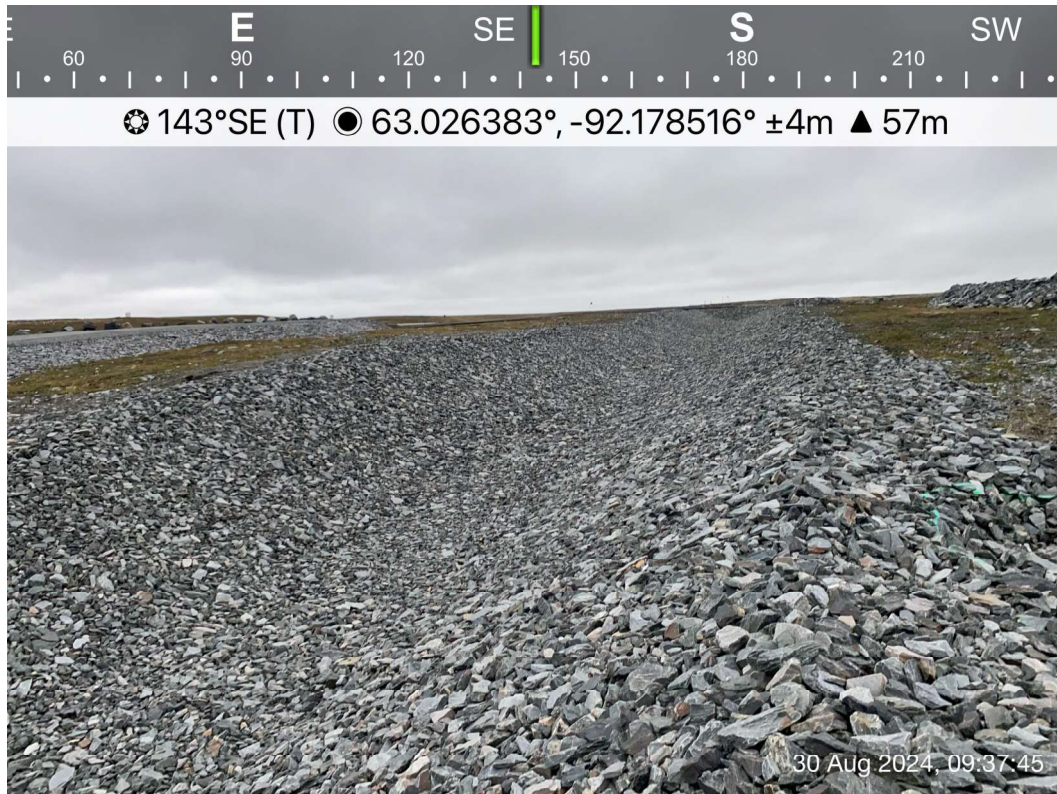
**Channel 10 -  
Photo 13:**

Channel 10—View of Channel 10, no stability concerns. Facing Southeast.

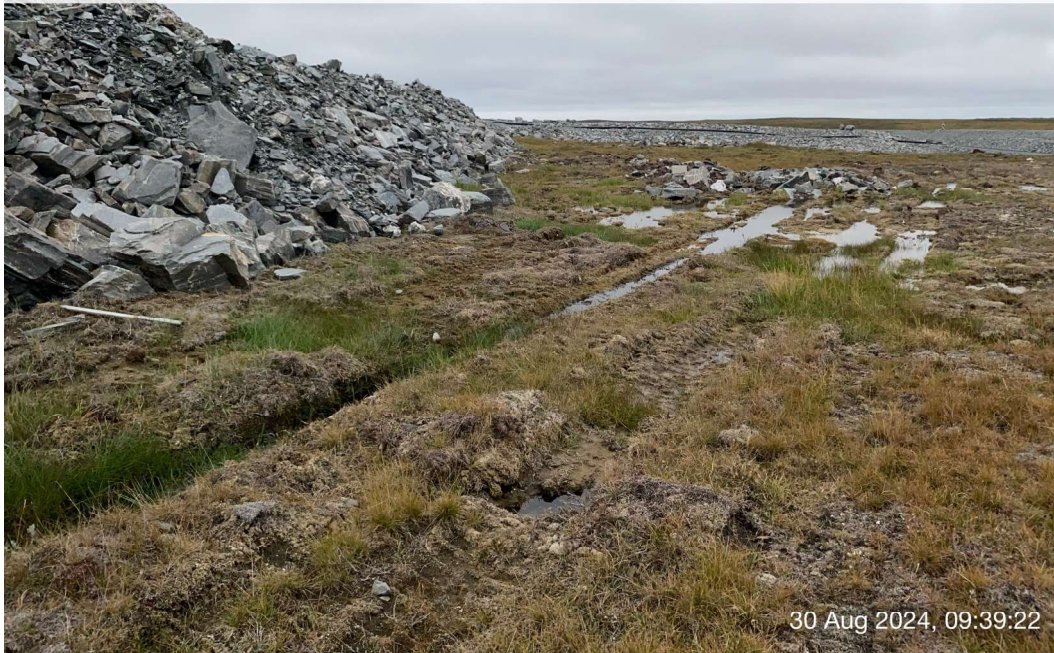
**Channel 10 -  
Photo 15:**

Channel 10 - Rutting from traffic and ponded water observed between Channel 10 and WRSF3. Facing northwest.

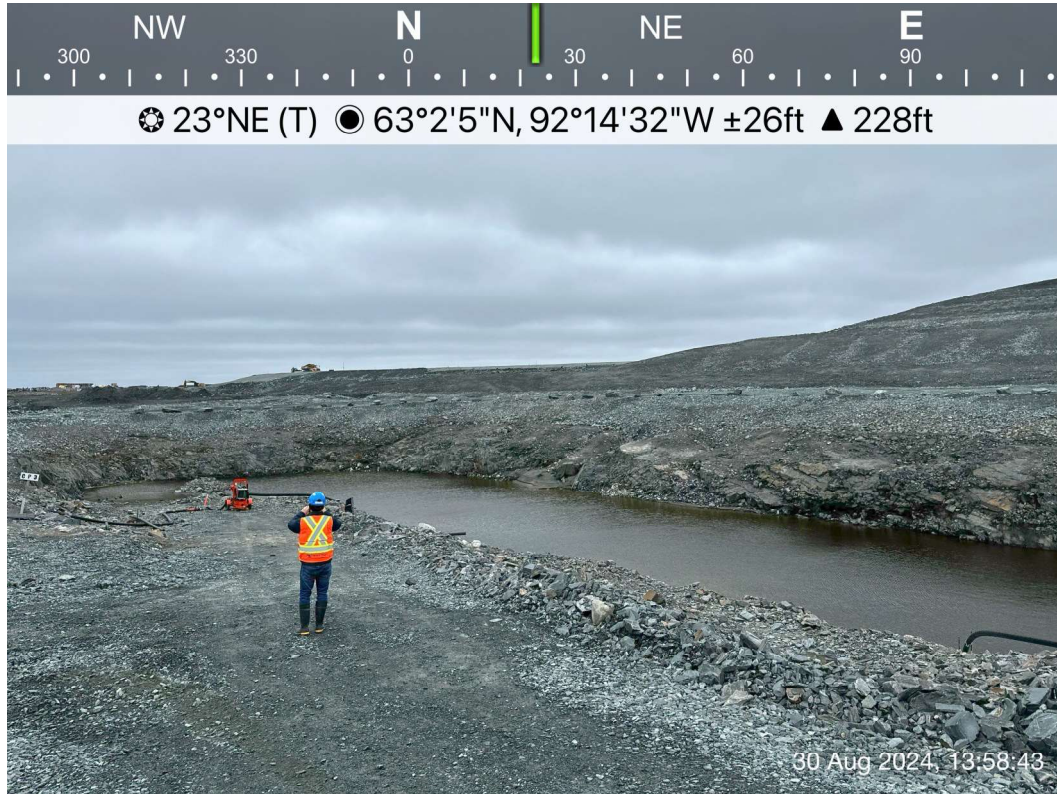
**CP3 - Photo 1:** CP3 - Small amount of water stored in CP3, bedrock slopes with fractured rock, no stability concern.

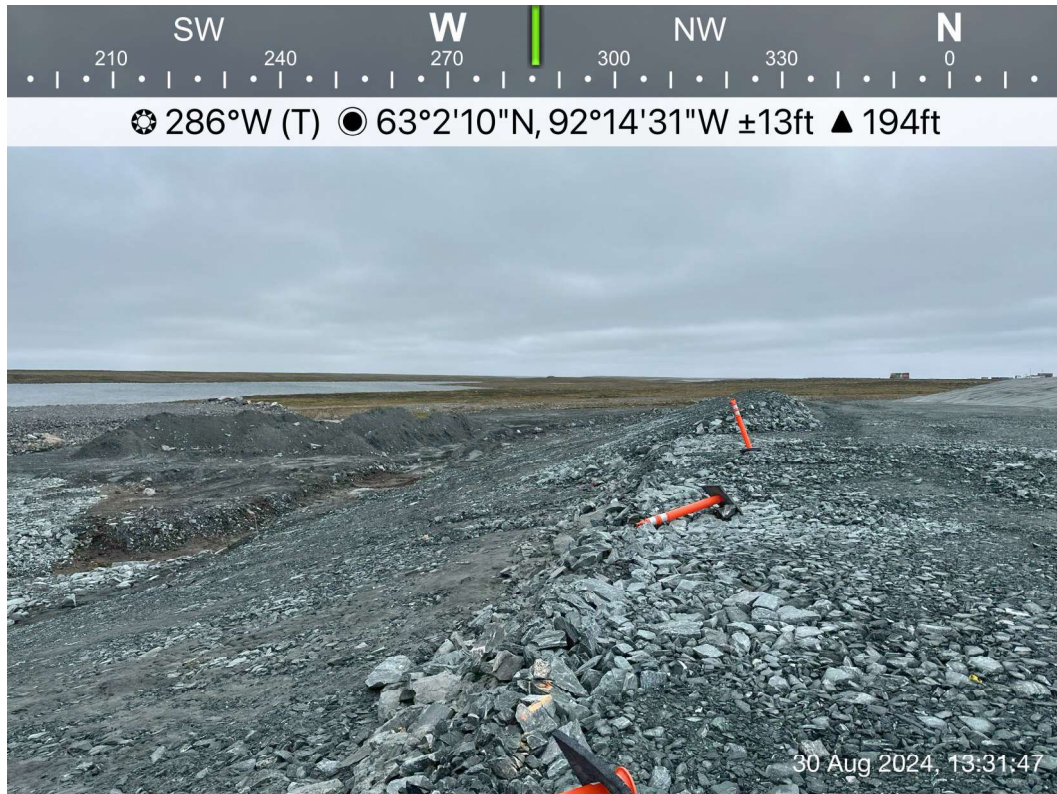
**CP3 - Photo 3:** CP3 - Snow stockpile between TSF and CP3 Thermal Berm. Facing west.

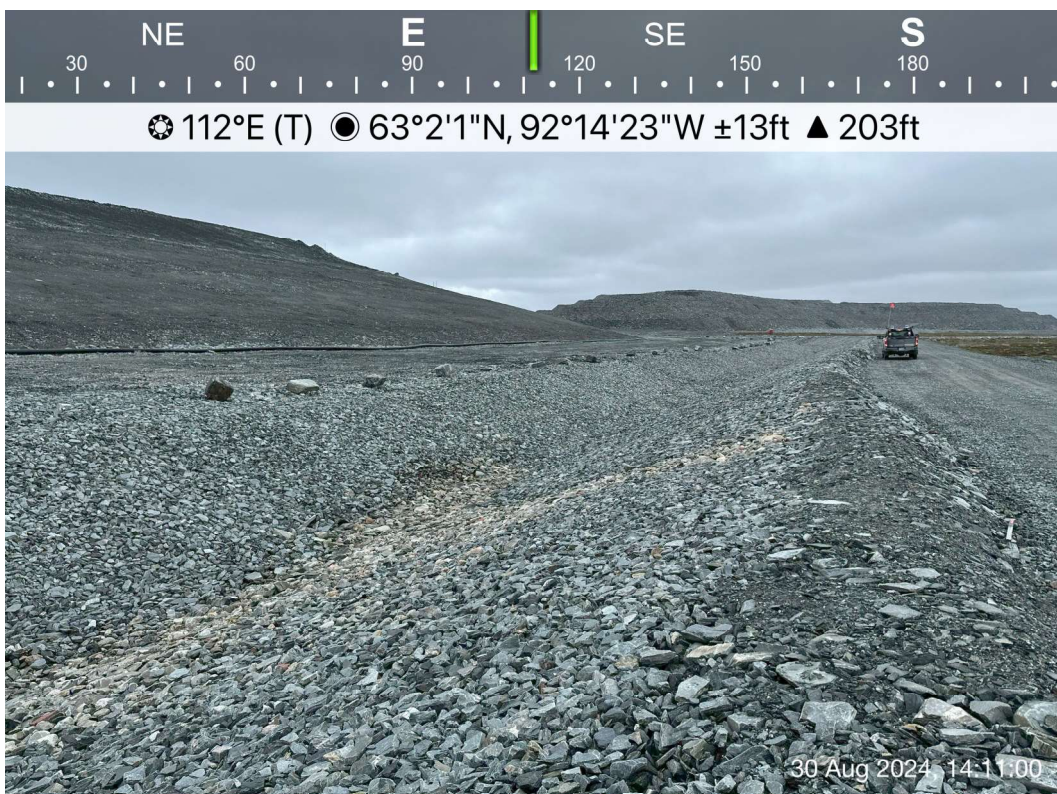
**Channel 3 - Photo 6:** Channel 3 - View of Channel 3. Facing East.

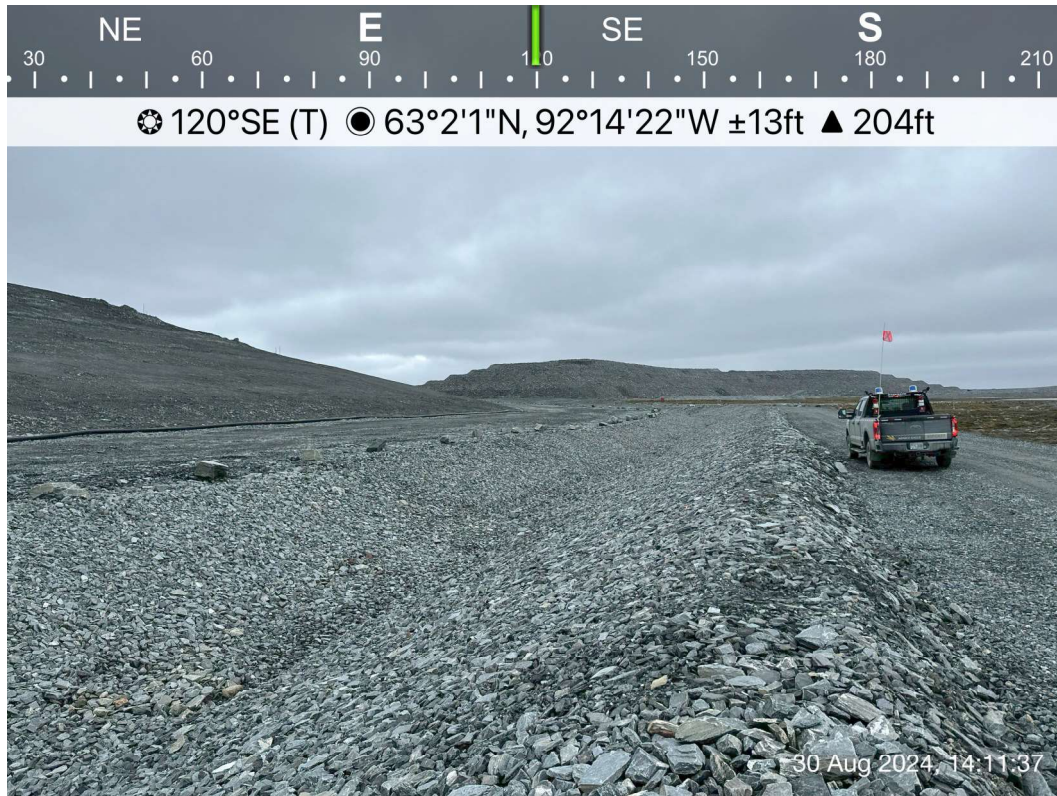
**Channel 3 -  
Photo 7:**

Channel 3 - View of middle section. Facing southeast.

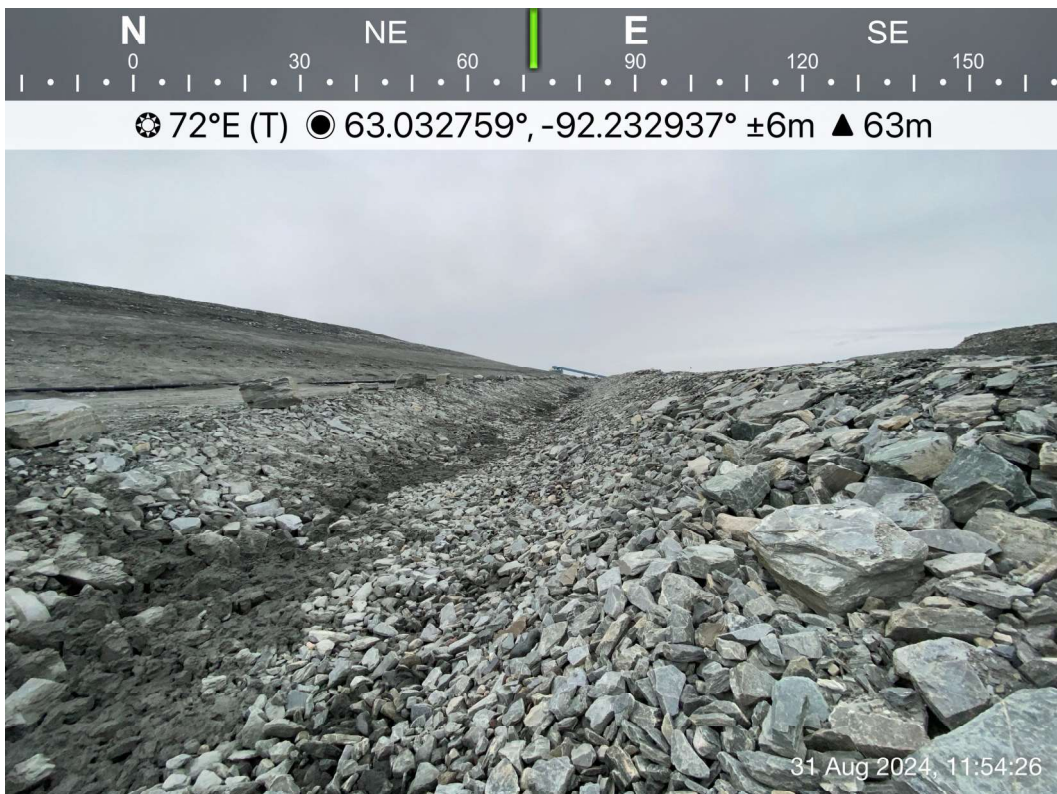
**Channel 3 -  
Photo 8:**

Channel 3 - View of east end section of Channel 3. Facing east.

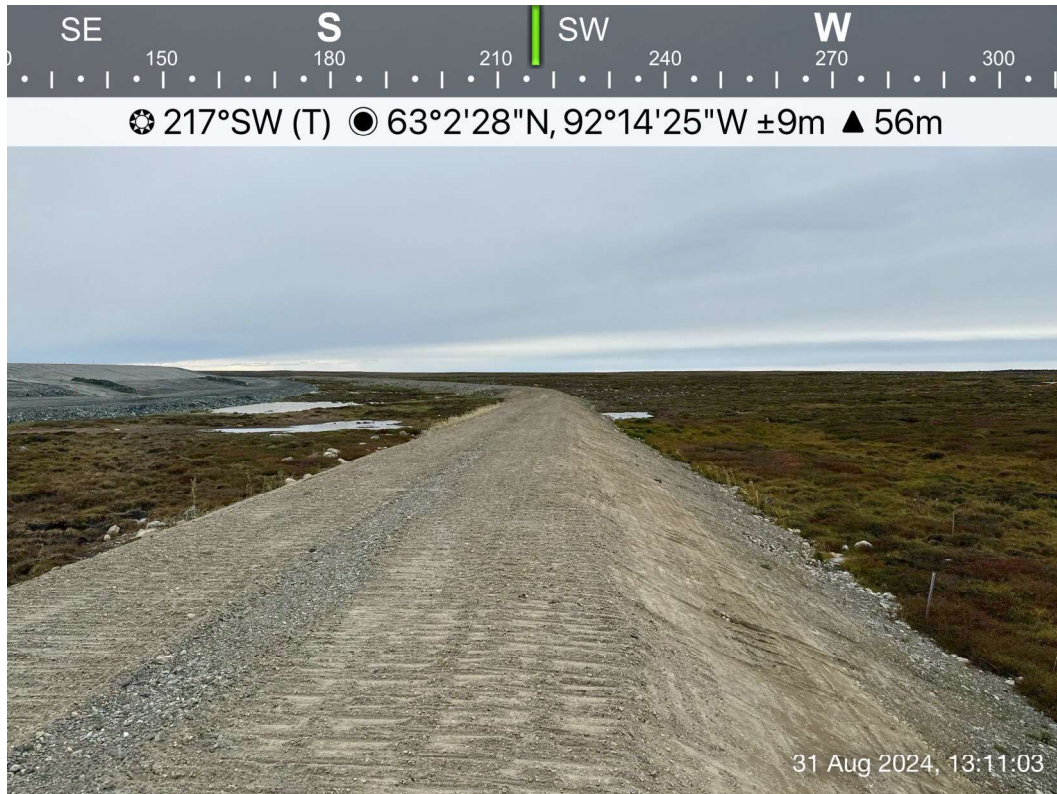
**Berm 2 - Photo 9:** Berm 2 - Berm 2 north portion, slope and crest, performing well, no stability concern. Facing southwest.

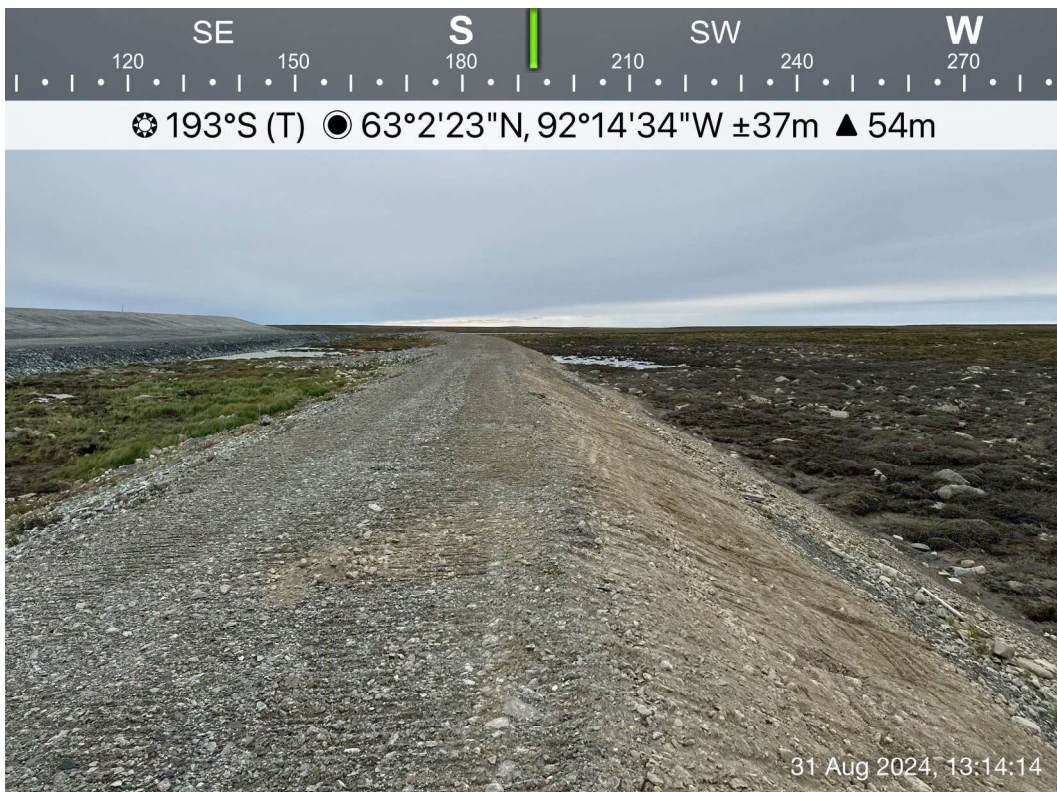
**Berm 2 - Photo 10:** Berm 2 - Berm 2 middle portion, slope and crest, performing well, no stability concern, ponded water on both sides. Facing south.

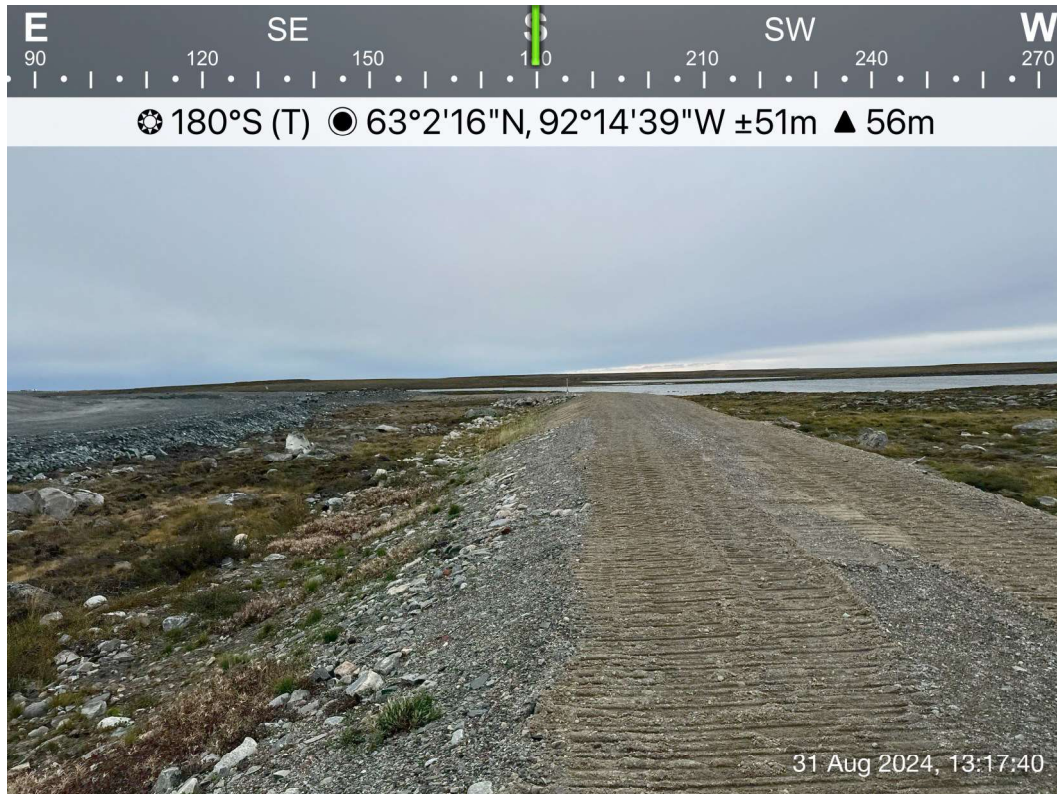
**Berm 2 -  
Photo 11:**

Berm 2 - Berm 2 south portion, slope and crest, performing well, no stability concern. Facing south.

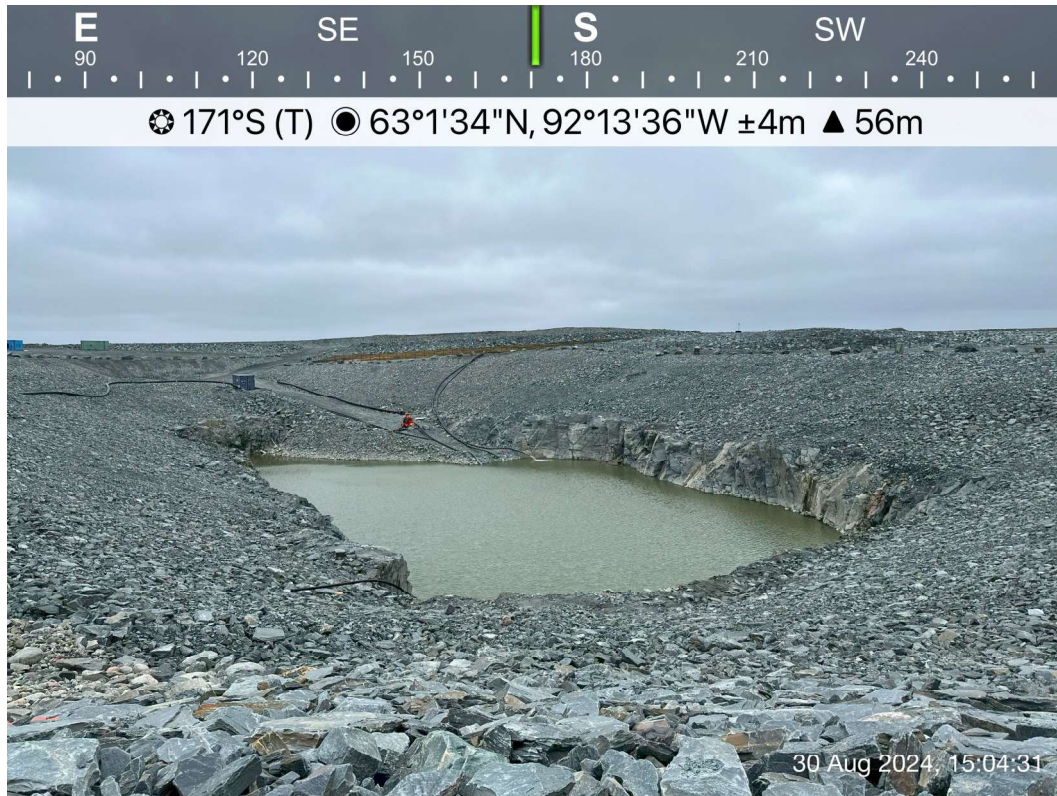
**CP4 - Photo 1:** CP4 - View of CP4. Facing south.

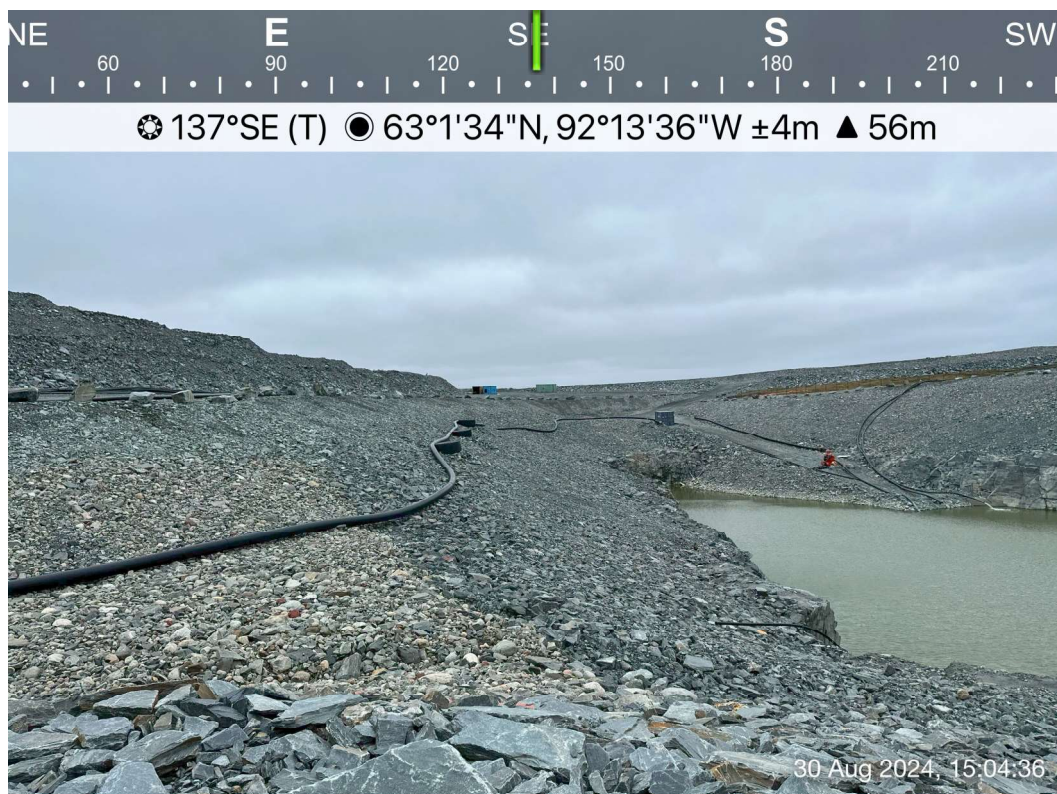
**CP4 - Photo 2:** CP4 - View of northeast slope. Facing southeast.

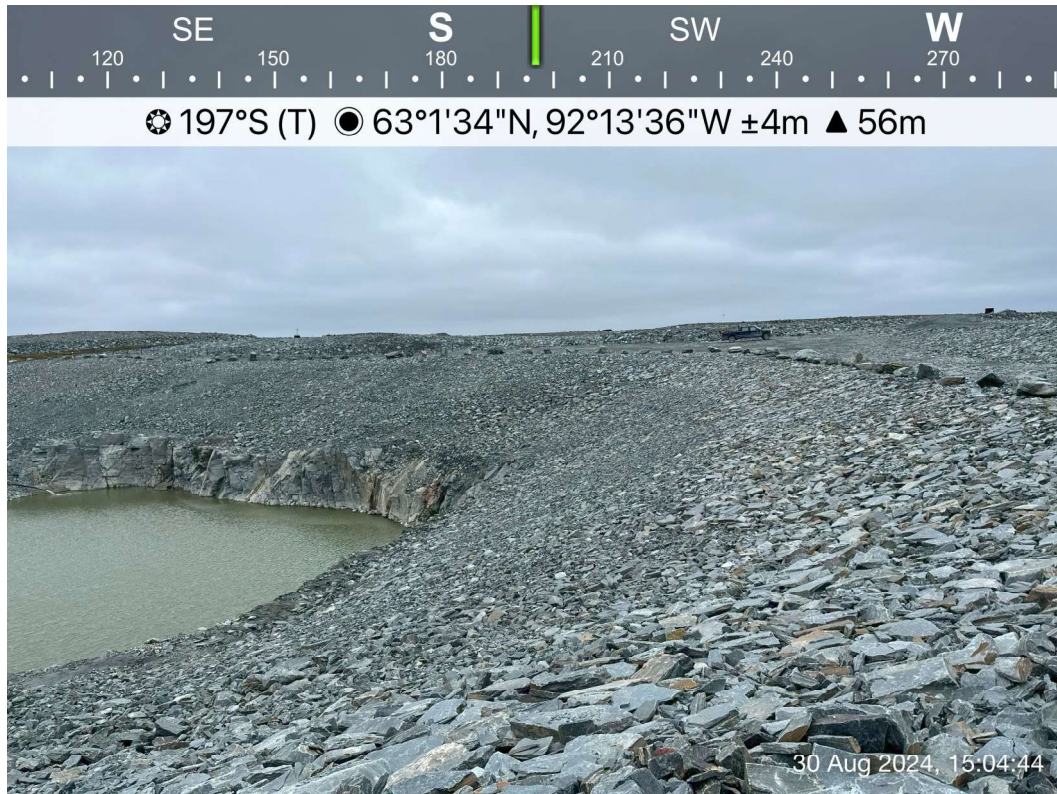
**CP4 - Photo 3:** CP4 - View of northwest slope. Facing south.

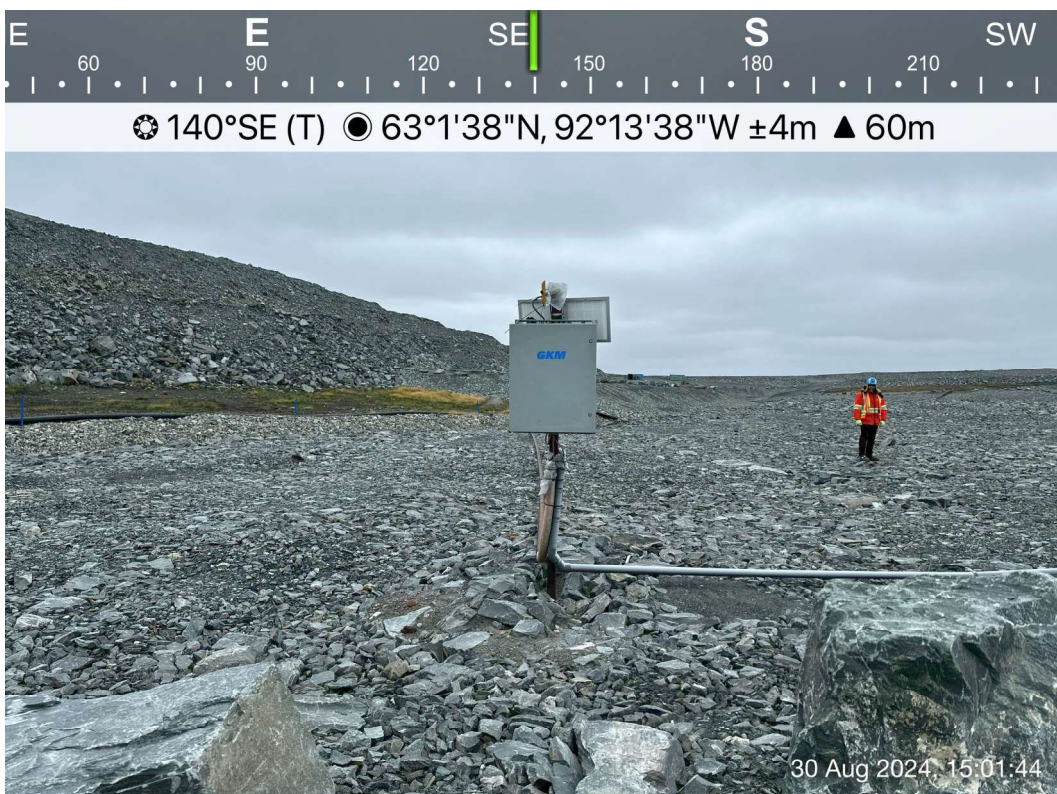
**CP4 Thermal Berm Photo 4:** CP4 Thermal Berm - GTC data collection system. Facing southeast.

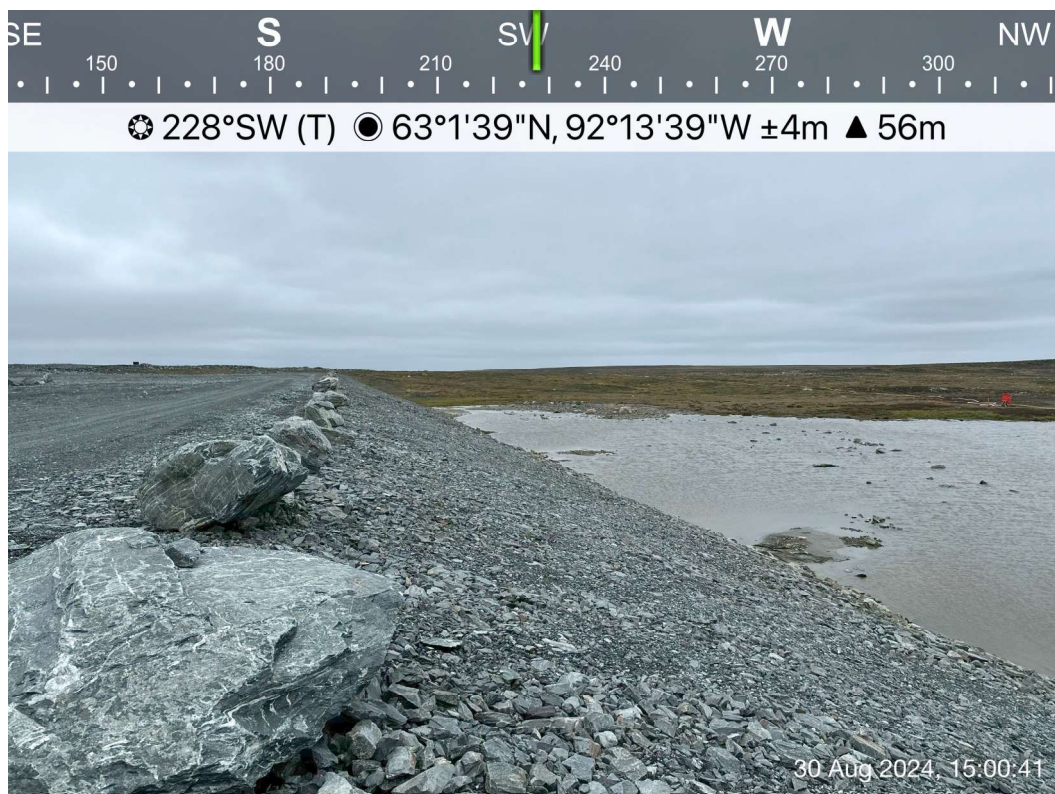
**CP4 Thermal  
Berm Photo 6:**

CP4 Thermal Berm - View of downstream side slope. Facing southwest.
