## **APPENDIX 6      2024 ANNUAL GEOTECHNICAL INSPECTION REPORT**

## 2024 Annual Geotechnical Inspection Meliadine Gold Mine, Nunavut, Canada

PRESENTED TO  
**Agnico Eagle Mines Limited**

MARCH 11, 2025  
ISSUED FOR USE-REVISION 1  
FILE: 704-ENG.EARC03140-39  
AGNICO EAGLE DOCUMENT NUMBER: 65-600-230-TCR-002

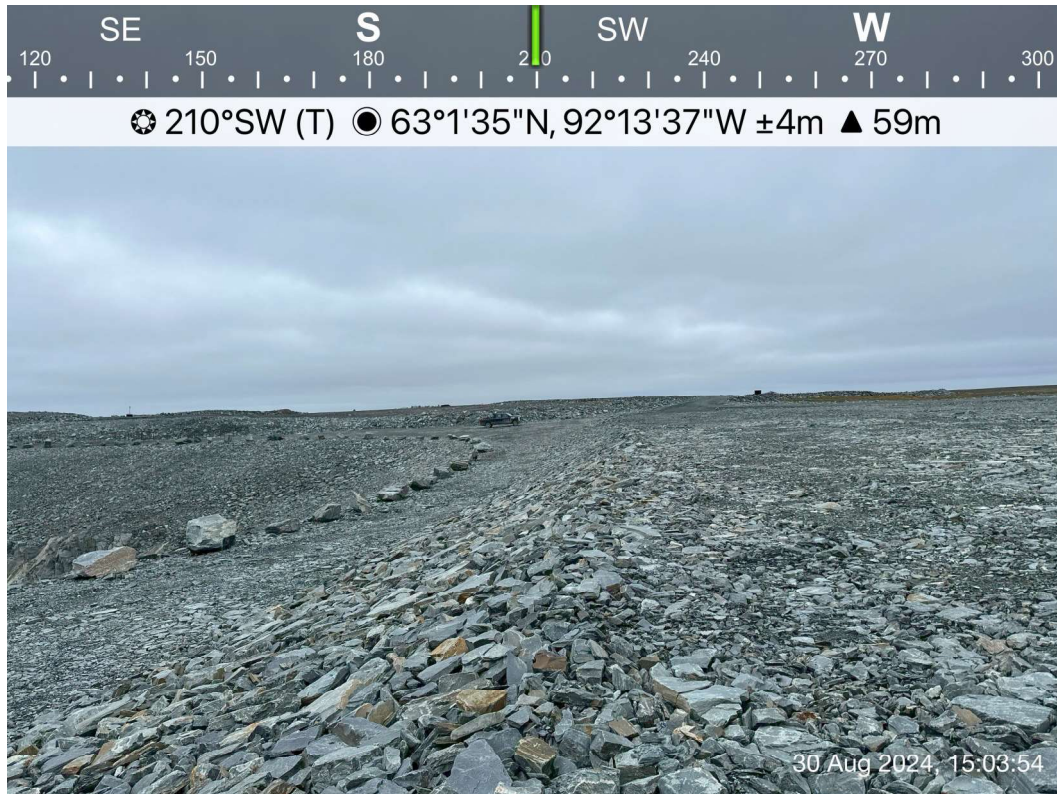
**CP4 Thermal  
Berm - Photo 7:**

CP4 Thermal Berm - View of upstream side slope. Facing southwest.

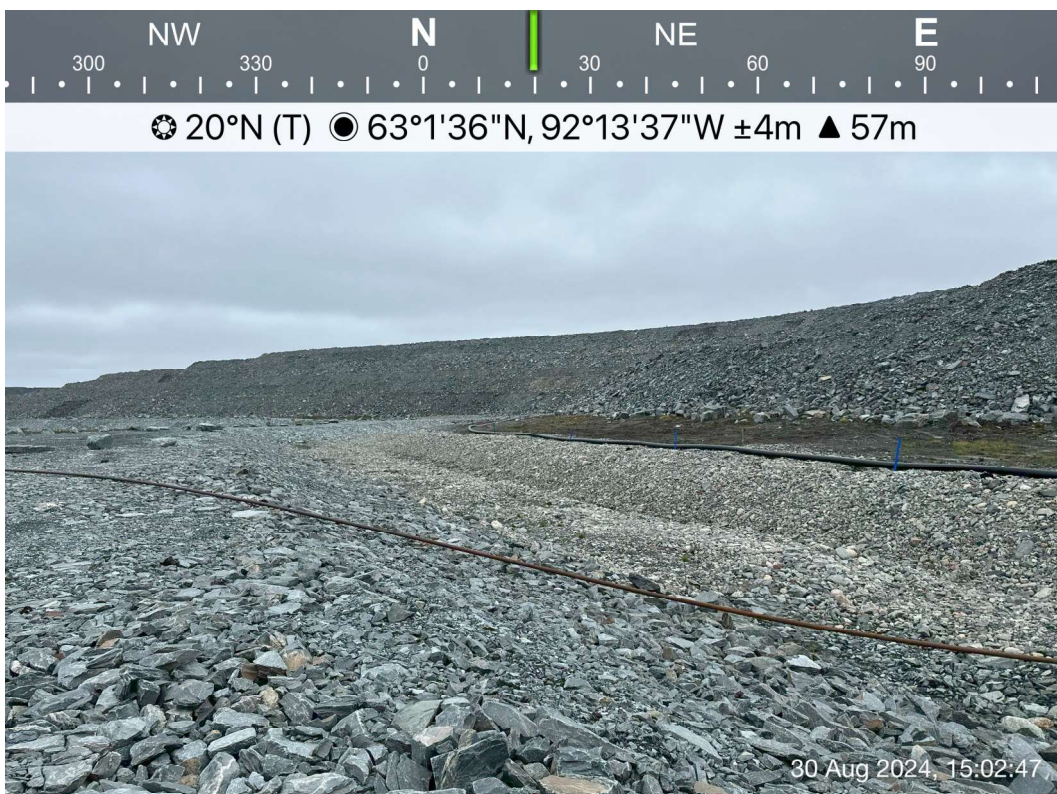
**CP4 Thermal  
Berm Photo 8:**

CP4 Thermal Berm - Upstream side slope of CP4 Thermal Berm and south end of Channel 4. Facing north.

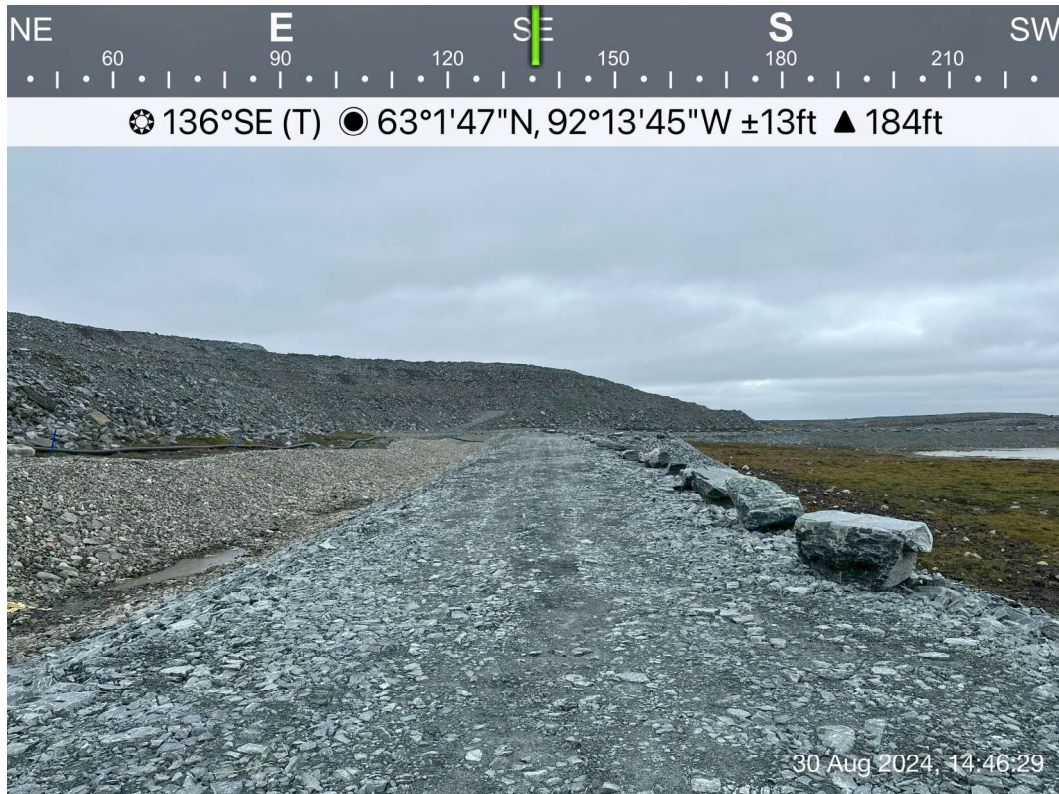
**Channel 4 -  
Photo 11:**

Channel 4 - Channel 4 and recently placed ROM cover to mitigate surface erosion downstream of the channel. Facing southeast.

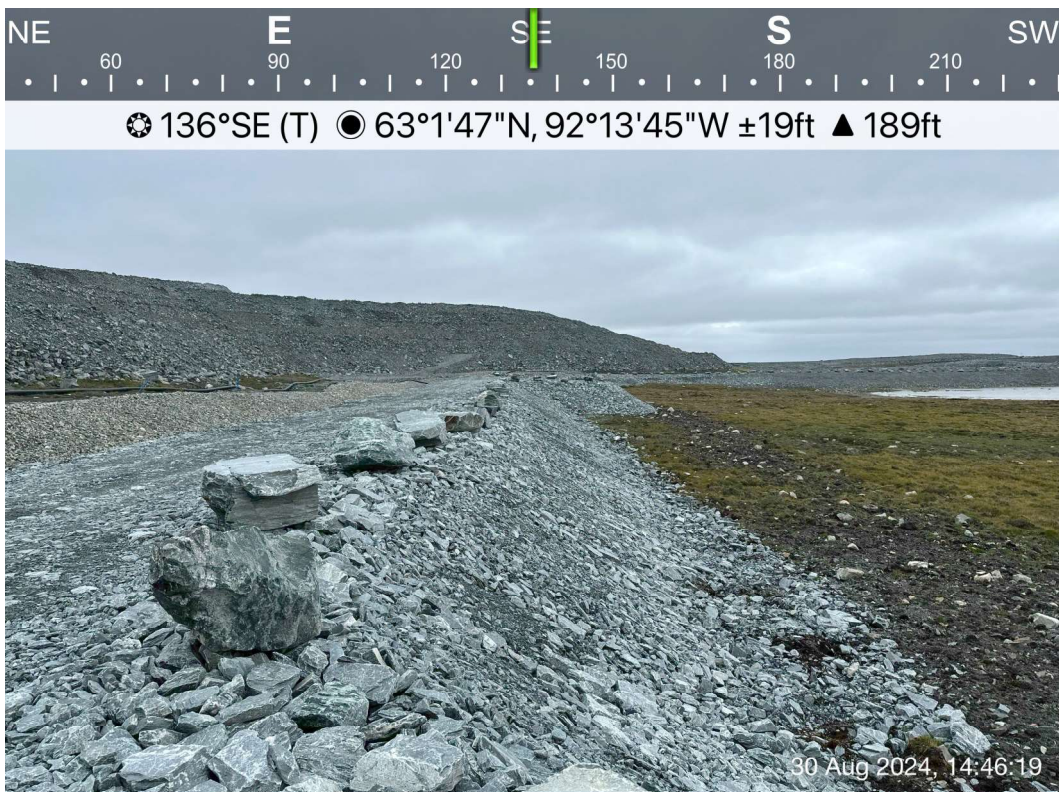
**Channel 4 -  
Photo 12:**

Channel 4 - View downstream of Channel 4, performing well, no stability or seepage concerns. Facing southeast.

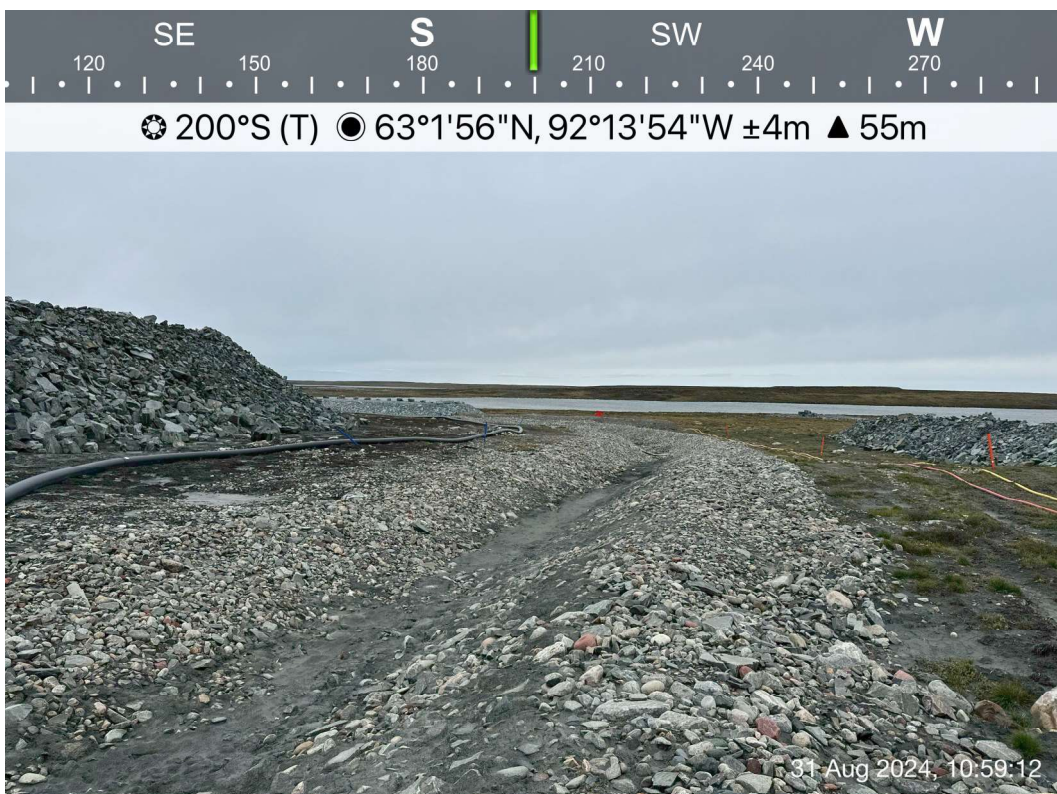
**Channel 4 -  
Photo 14:**

Channel 4 - Upper portion, performing well, no stability concerns. Facing south.

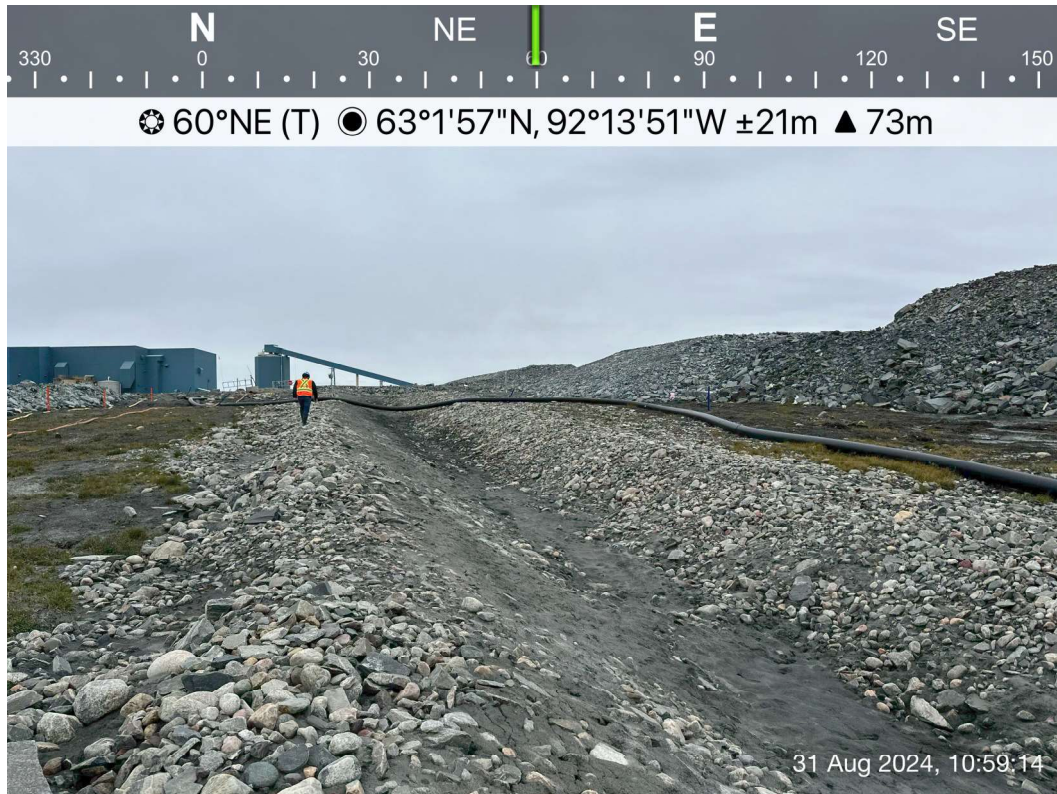
**Channel 4 -  
Photo 15:**

Channel 4 - Upper portion, performing well, no stability concerns. Facing northeast.

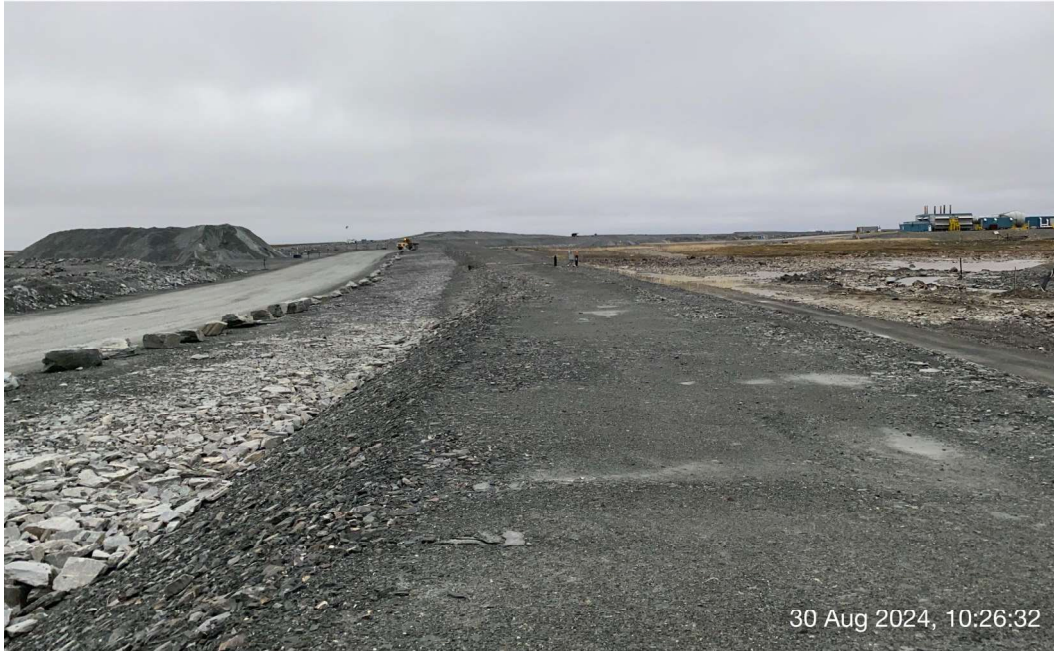
**D-CP5 - Photo 1:** Dike D-CP5 - Dike downstream side slope. Facing southwest.

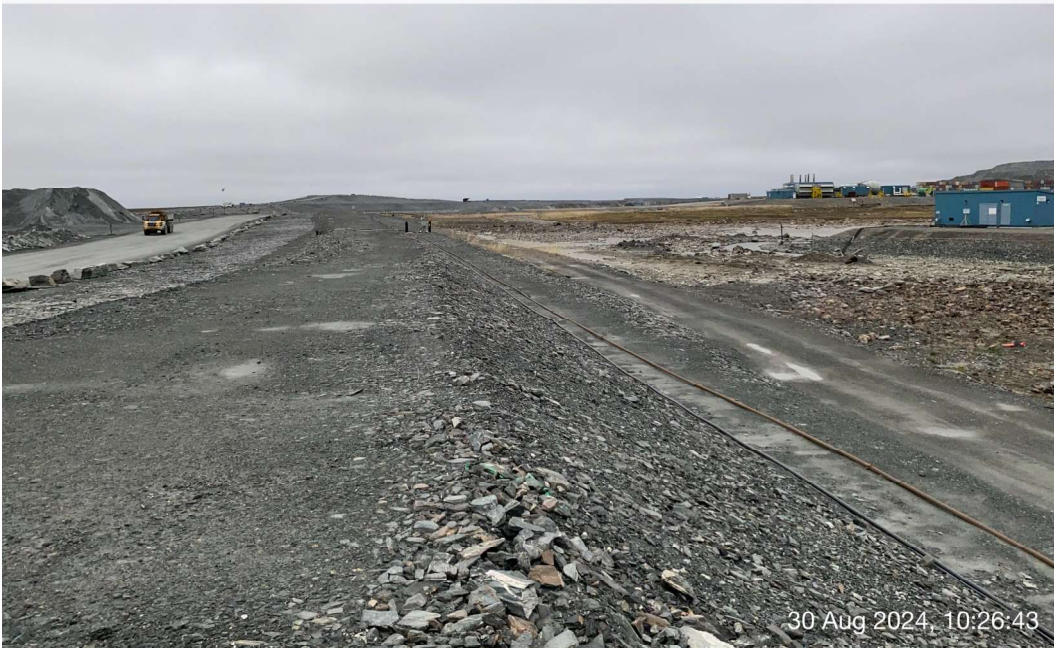
**D-CP5 - Photo 2:** Dike D-CP5 - Dike upstream side slope. Facing west.

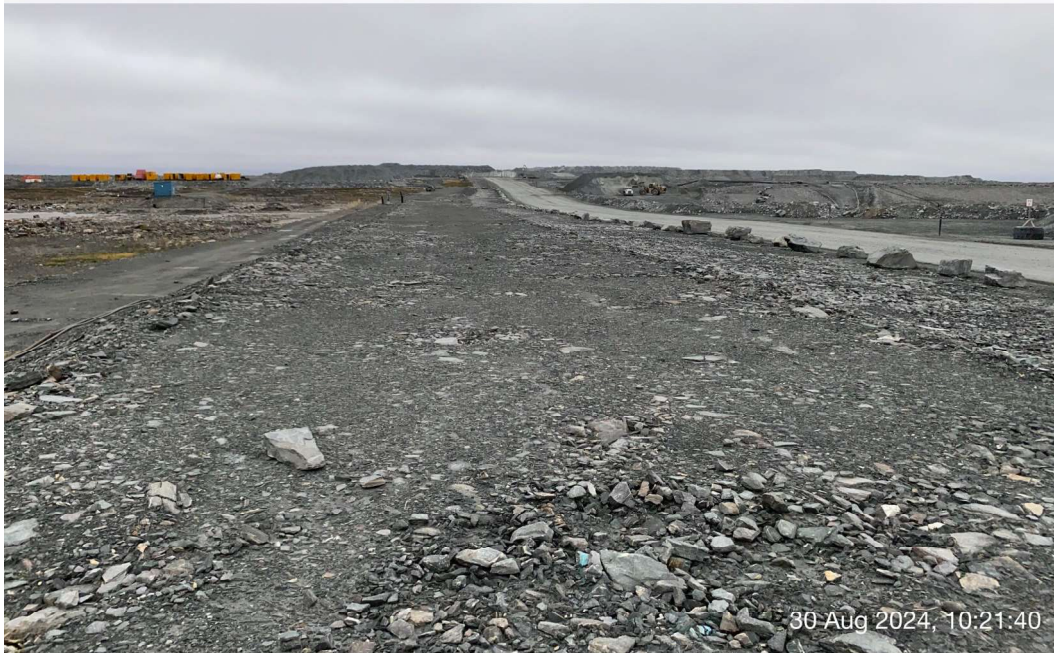
**D-CP5 - Photo 3:** Dike D-CP5 - Dike crest. Looking northeast.

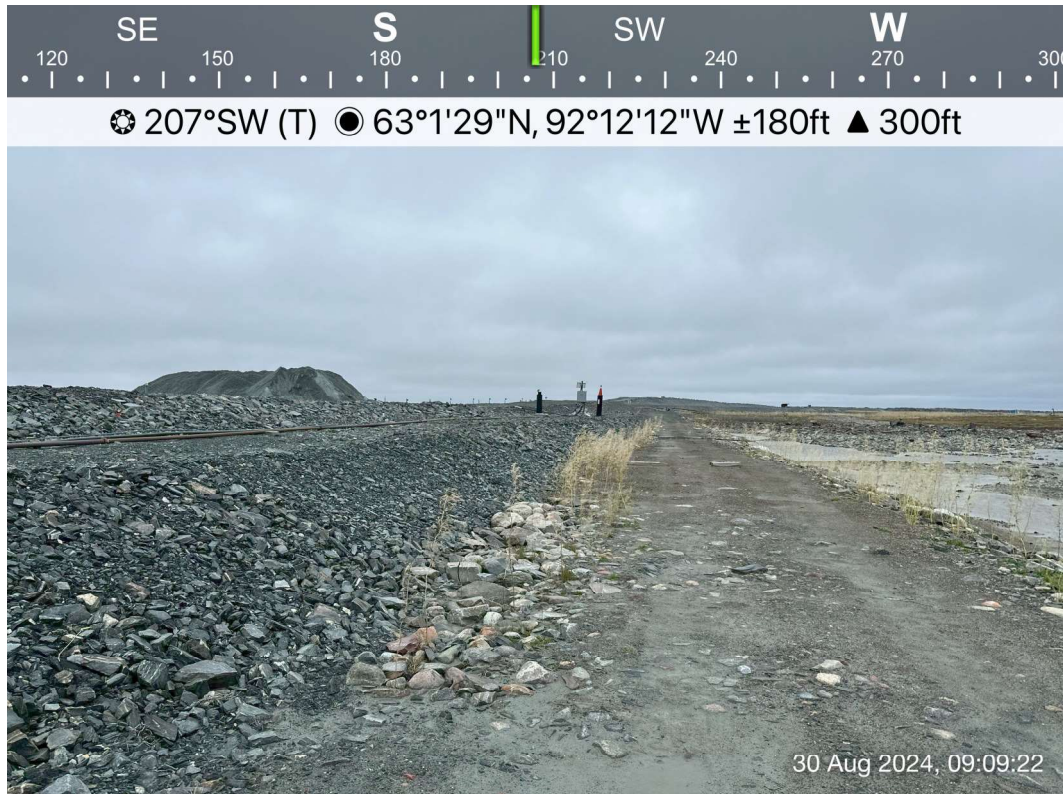
**D-CP5 - Photo 5:** Dike D-CP5: View of upstream side of dike. Facing southwest.

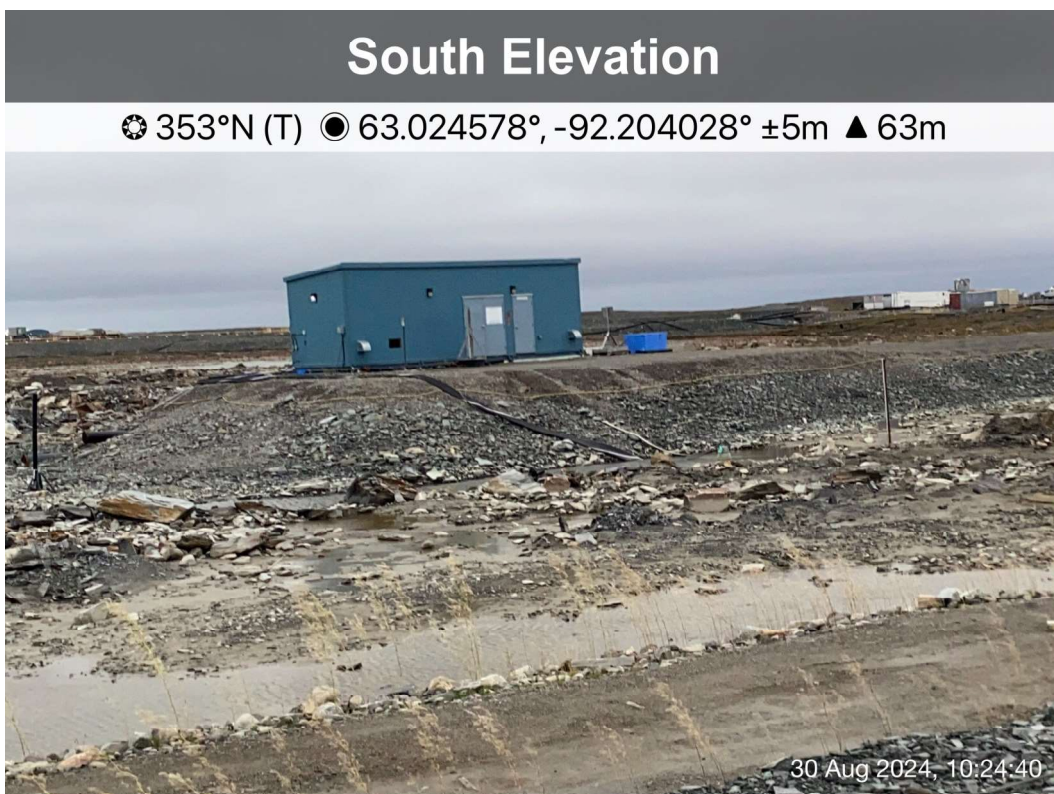
**CP5 Jetty - Photo 6:** CP5 Jetty: View of CP5 Jetty and pumping house. Facing North.

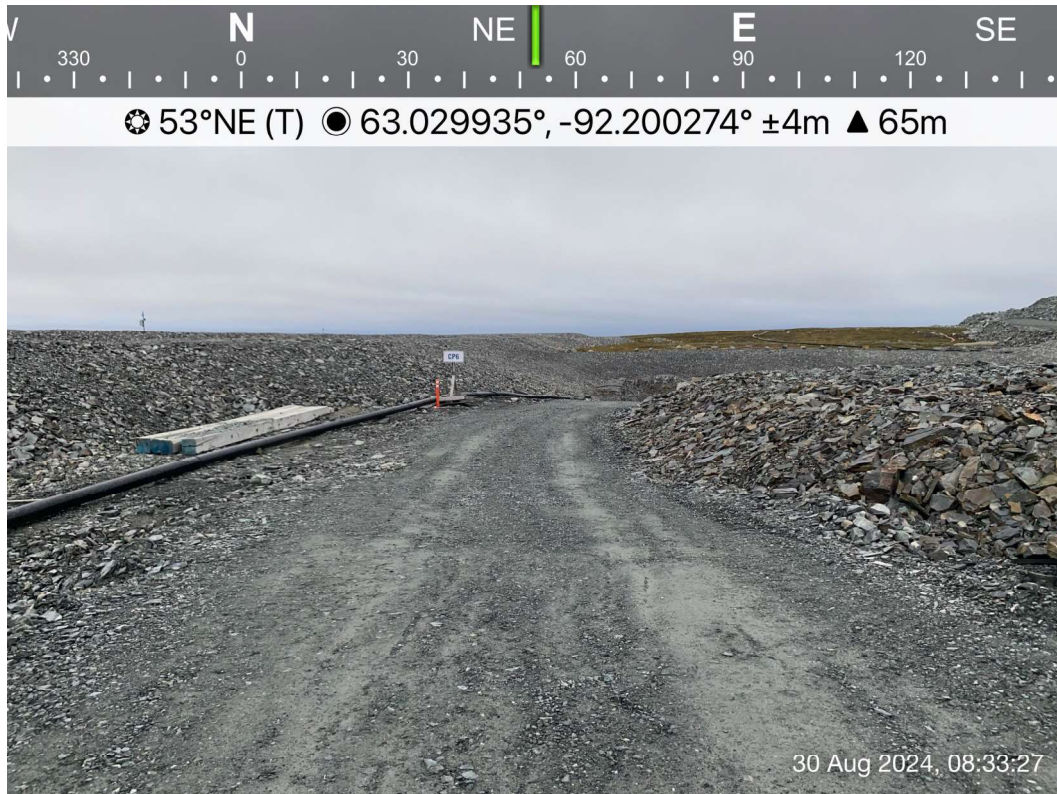
**CP6 - Photo 1:** CP6 - View of ramp entering CP6. Facing northeast.

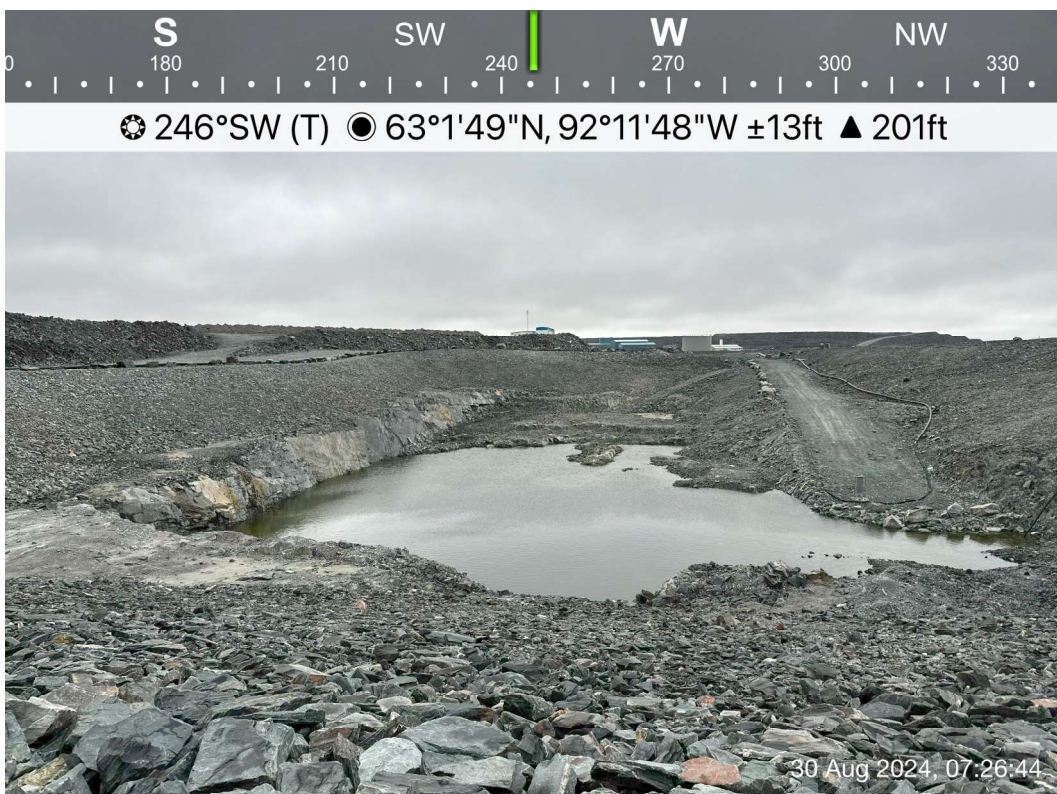
**CP6 - Photo 2:** CP6 - Overview of CP6. Facing southwest.

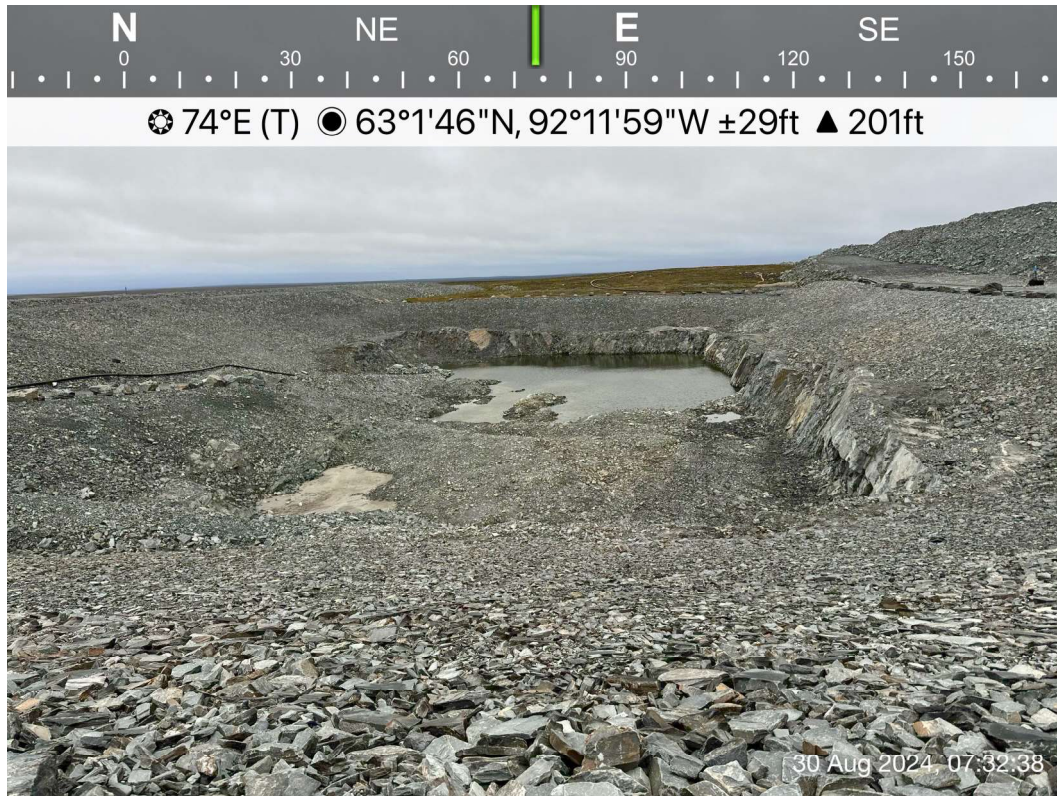
**CP6 - Photo 3:** CP6 - Overview of CP6. Facing east.

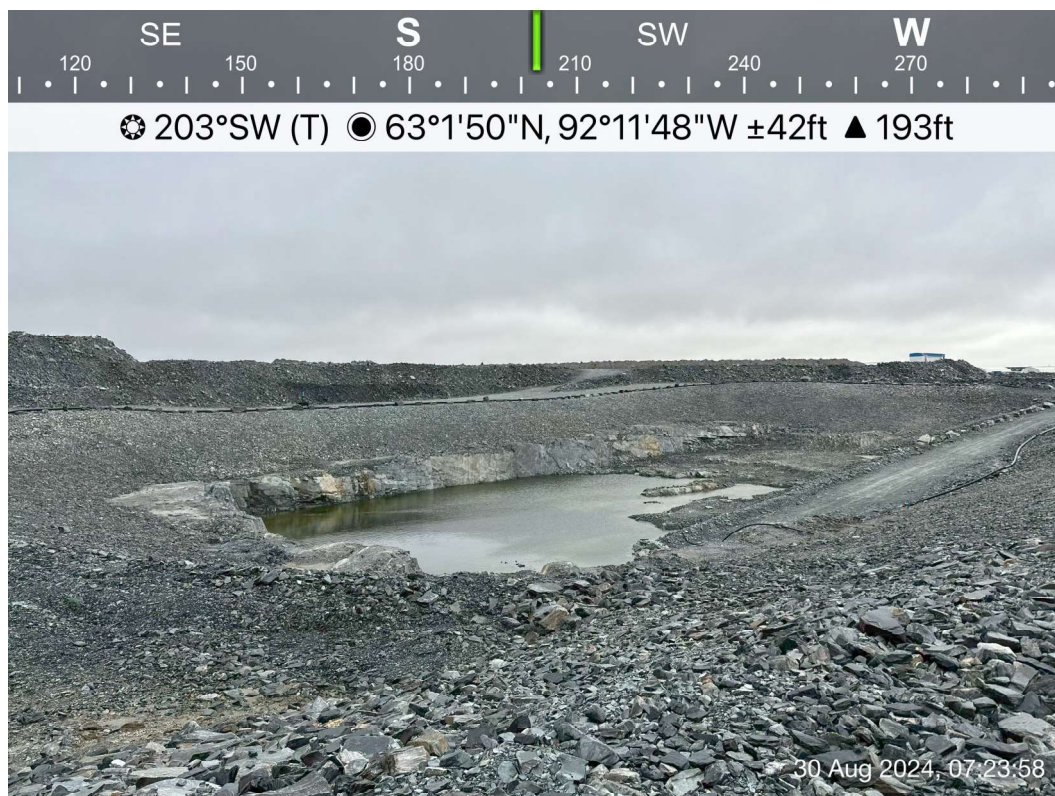
**CP6 - Photo 4:** CP6 - CP6 overview, minor water stored in CP6. Facing southwest.

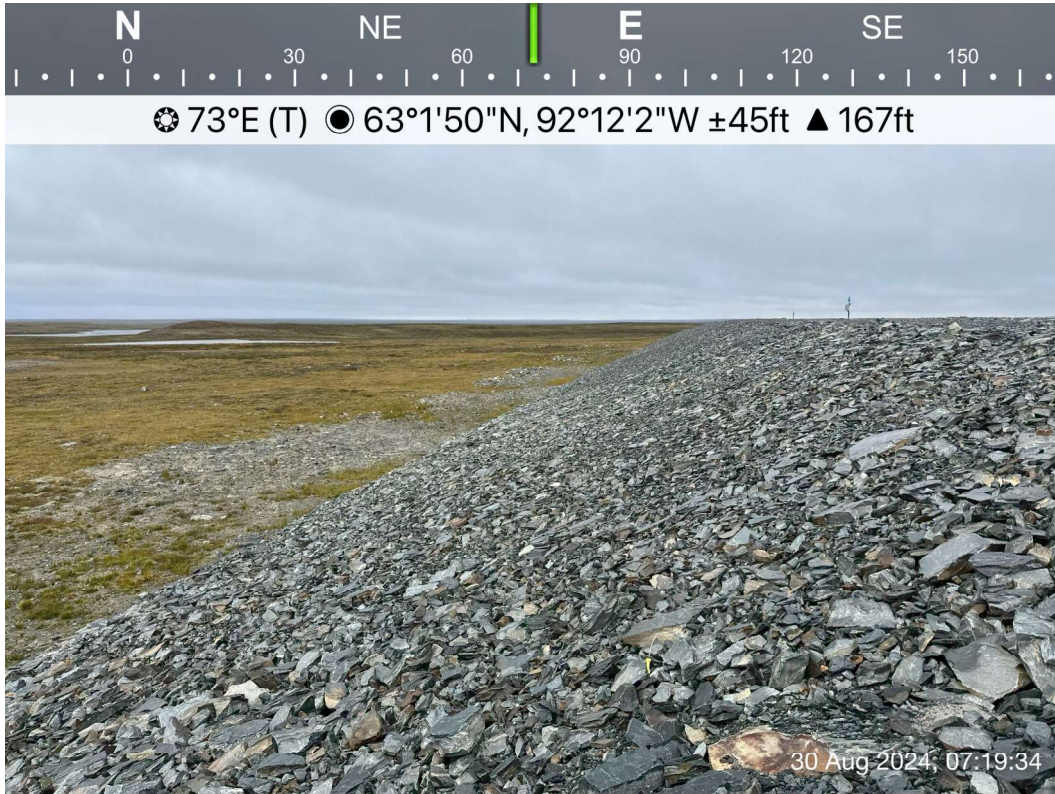
**CP6 Thermal Berm - Photo 7:** CP6 Thermal Berm - View of downstream and crest of berm, performing well, no stability concerns. Facing east.

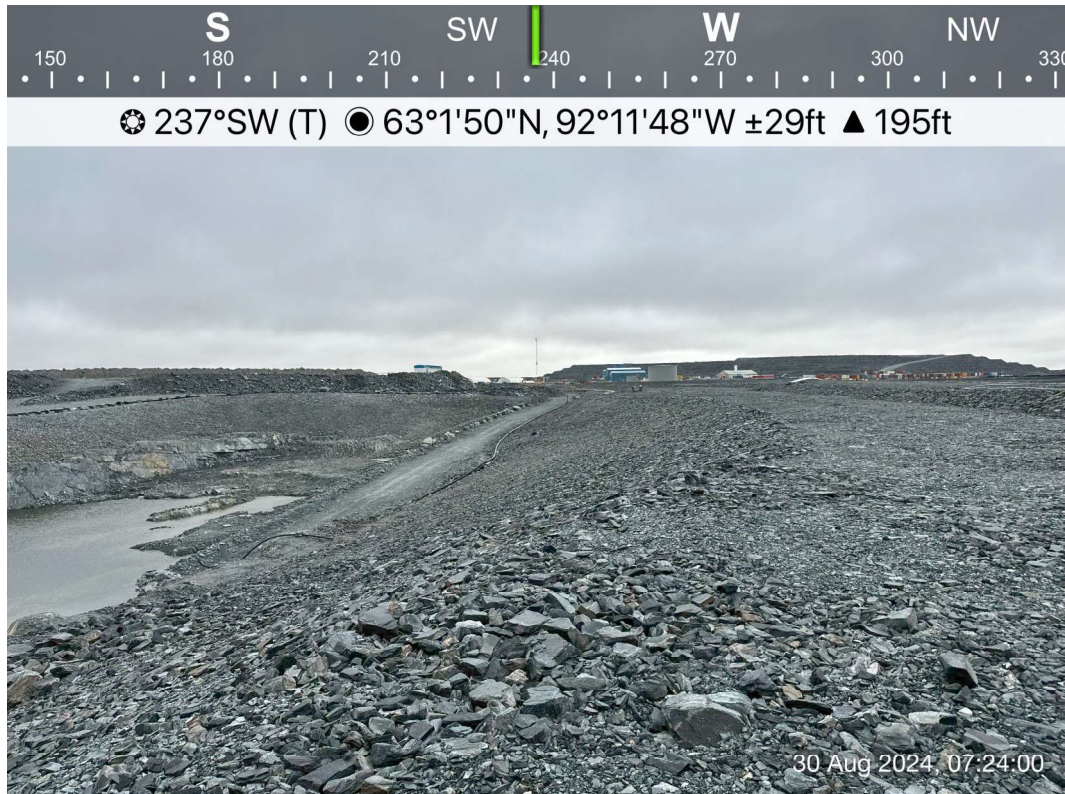
**CP6 Thermal Berm - Photo 9:** CP6 Thermal Berm - Upstream slope and crest of thermal berm. Facing southwest.

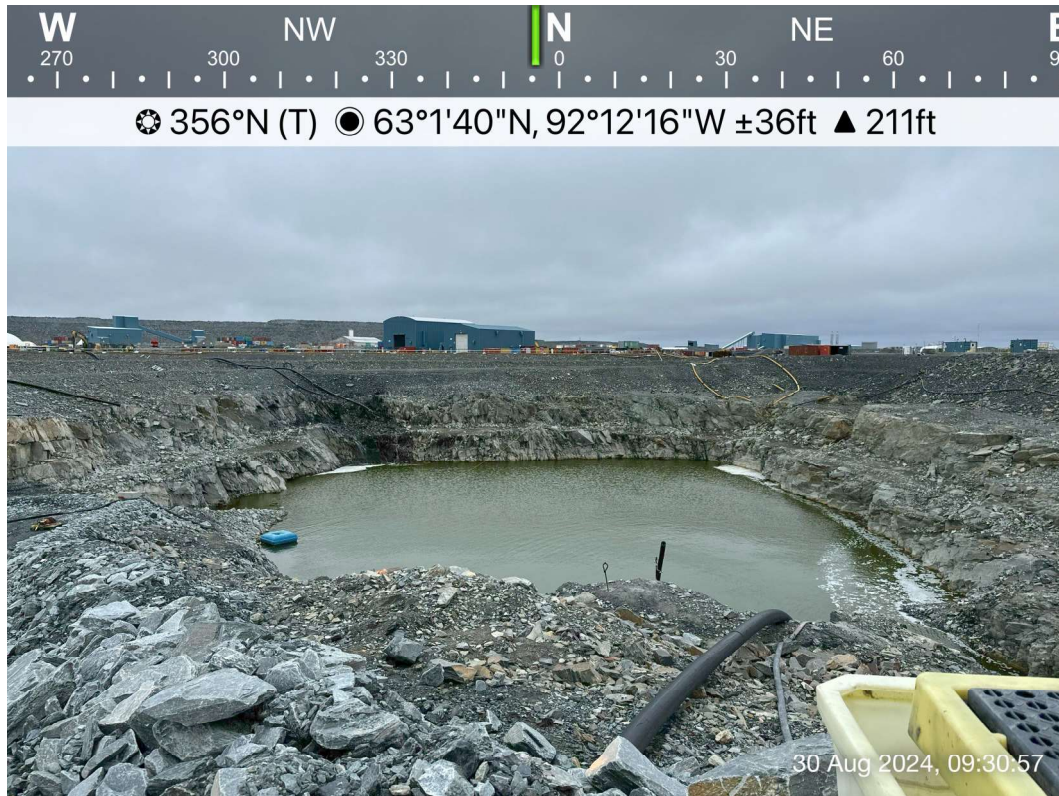
**SP1 - Photo 1:** SP1 Saline Pond - Overview of SP1, pond in bedrock, ROM covered overburden slopes. Facing North.

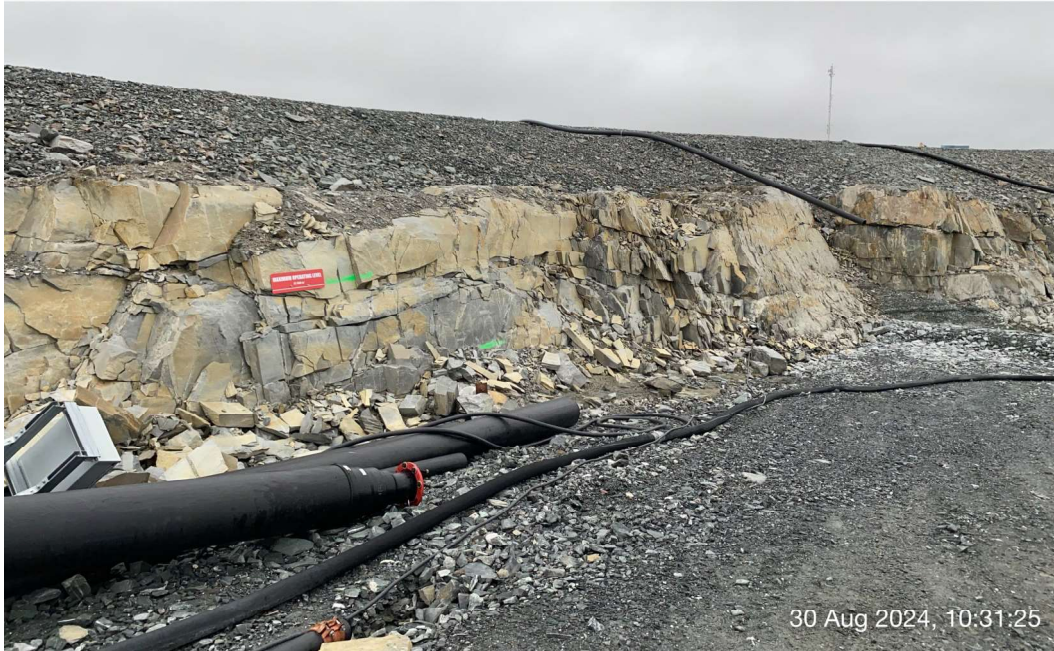
**SP1 - Photo 3:** SP1 Saline Pond - Perimeter berm side slope and bedrock side wall. Facing southwest.

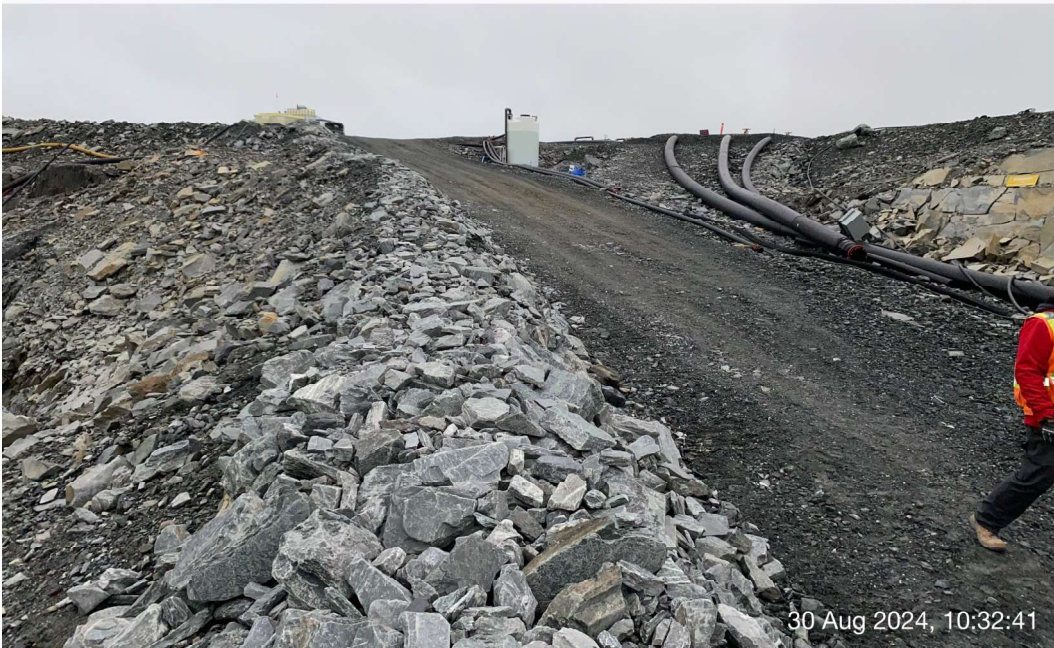
**SP1 - Photo 4:** SP1 Saline Pond - Access ramp, pipelines and safety berms. Facing east.

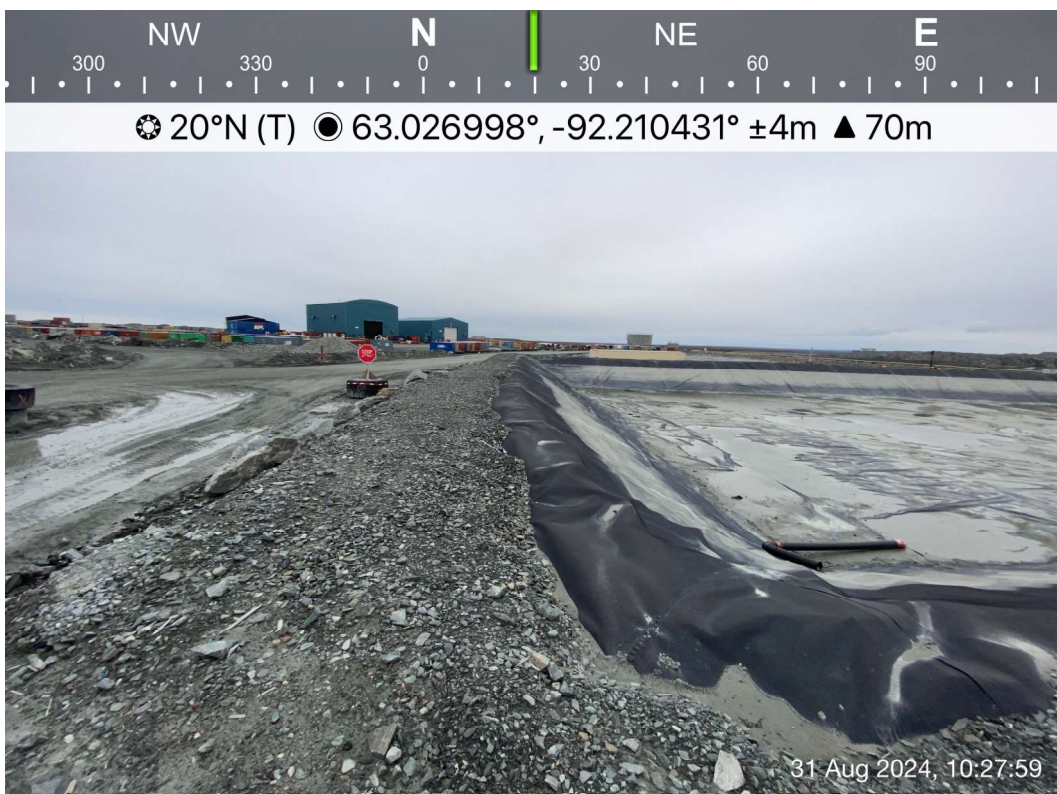
**SP3 - Photo 8:** SP3 Saline Pond - View of perimeter berm. Facing north.

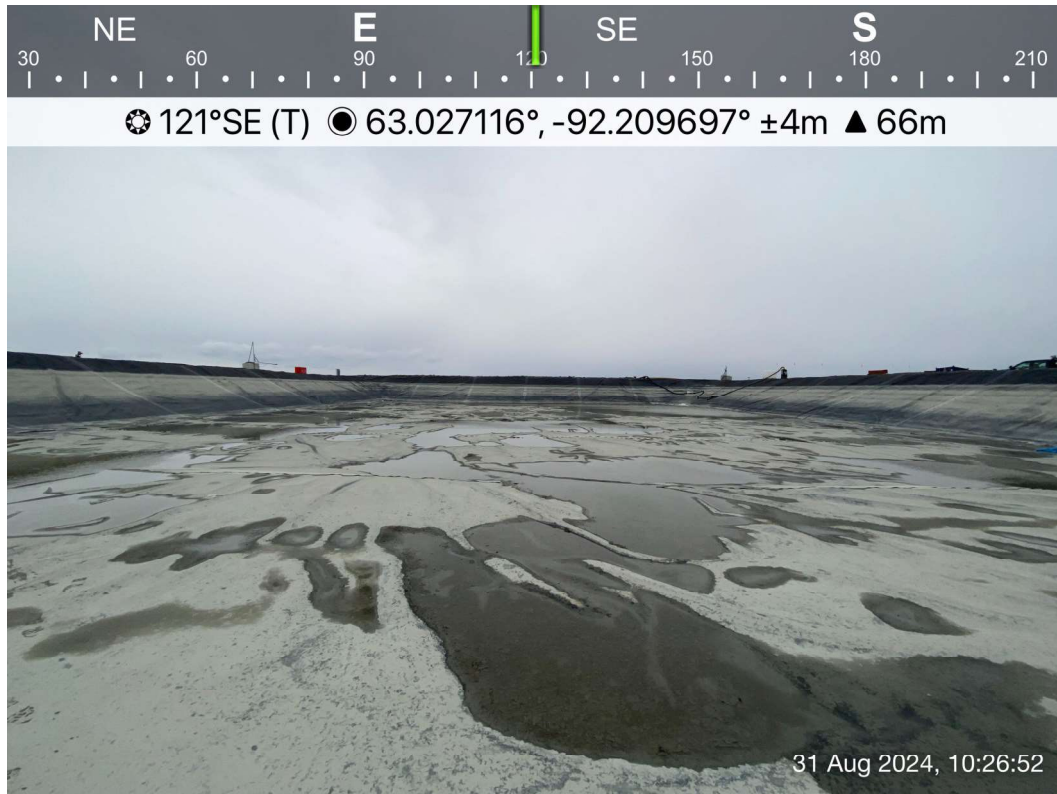
**SP3 - Photo 9:** SP3 Saline Pond - Overview of SP3, ponded water at base of pond. Facing southeast.

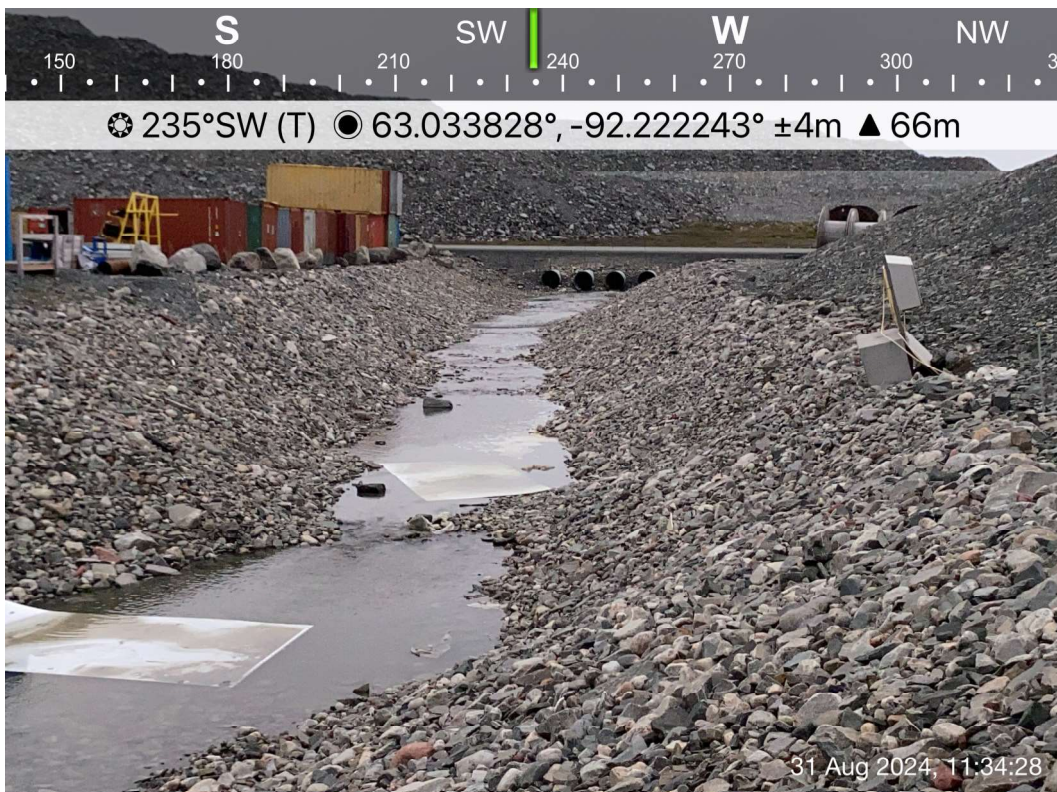
**Channel 1 -  
Photo 2:**

Channel 1 - Upper section, south of the crusher ramp. Facing southwest.

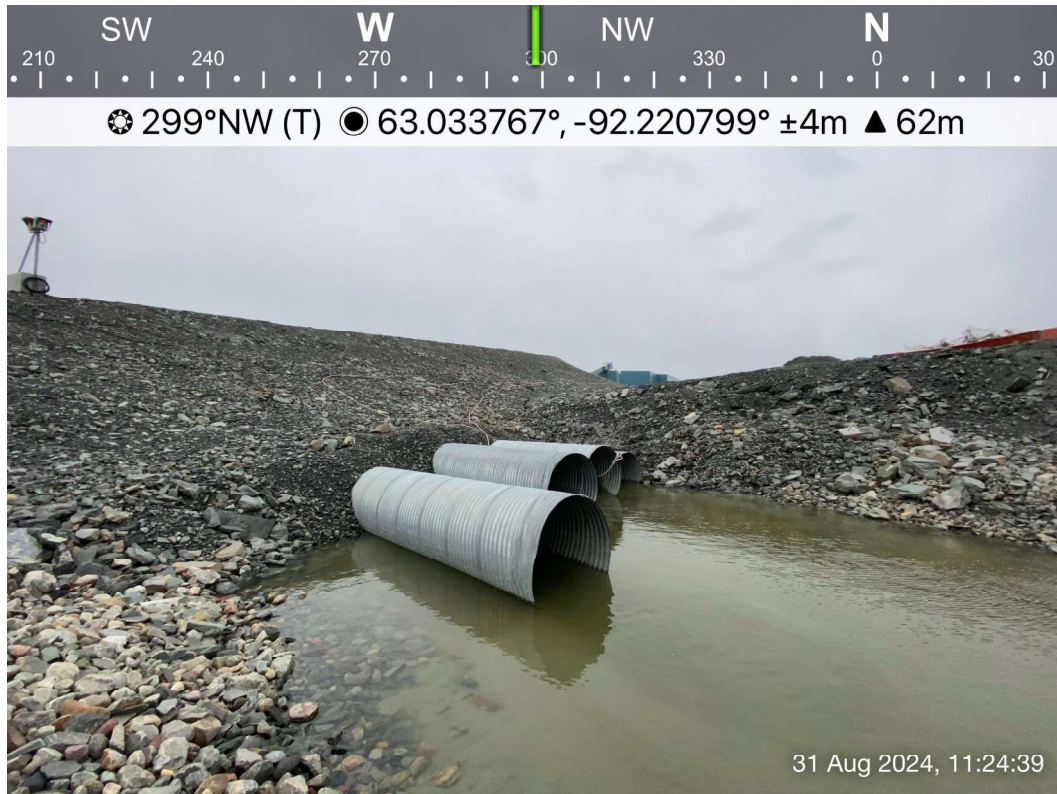
**Channel 1 -  
Photo 3:**

Channel 1 - Section between crusher ramp and ore pad access. Facing northwest.

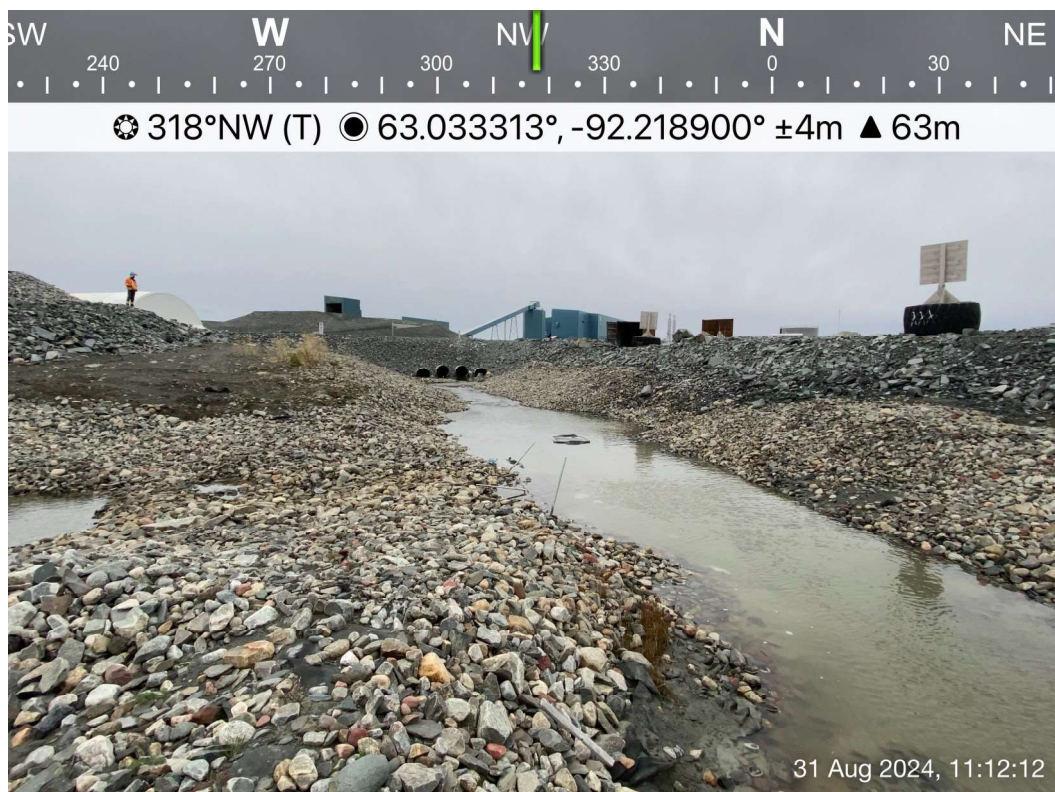
**Channel 1 -  
Photo 4:**

Channel 1 - Lower reach, adjacent to ore stockpiles on right. Facing northwest.

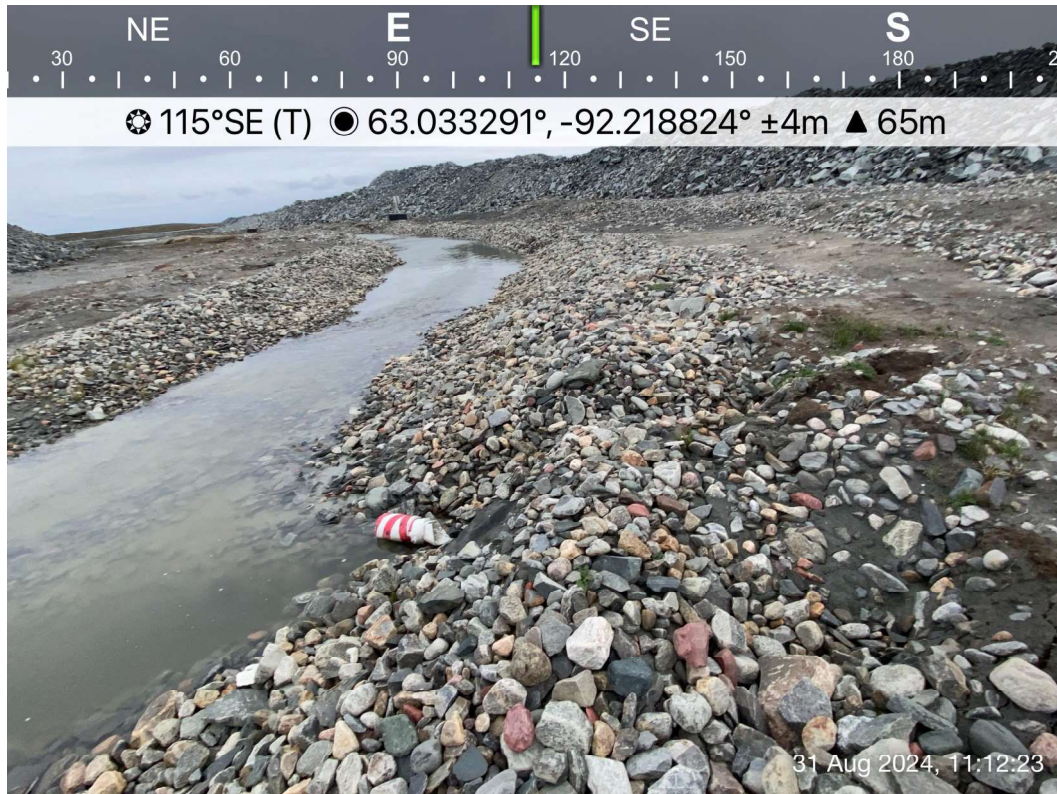
**Channel 1 -  
Photo 5:**

Channel 1 - Lower reach to Lake H9. Facing southeast.

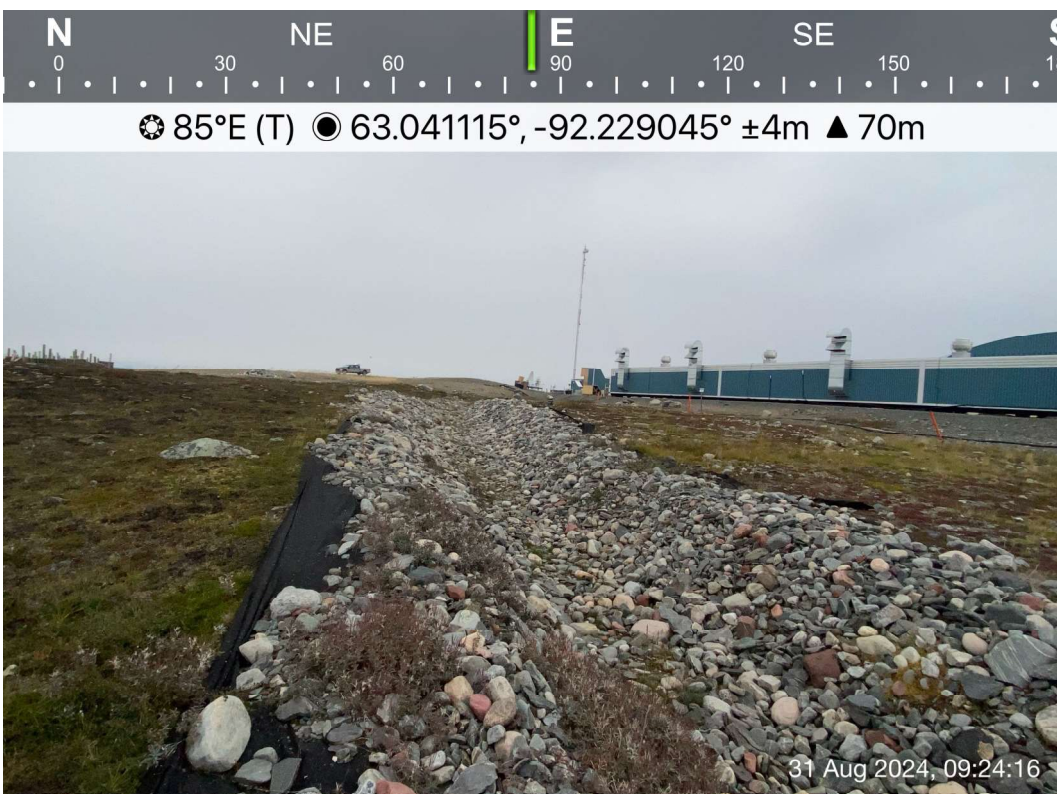
**Channel 2 -  
Photo 8:**

Channel 2 - Upper reach, camp pad on the right. Facing east.
