## **APPENDIX 6      2024 ANNUAL GEOTECHNICAL INSPECTION REPORT**

## 2024 Annual Geotechnical Inspection Meliadine Gold Mine, Nunavut, Canada

PRESENTED TO  
**Agnico Eagle Mines Limited**

MARCH 11, 2025  
ISSUED FOR USE-REVISION 1  
FILE: 704-ENG.EARC03140-39  
AGNICO EAGLE DOCUMENT NUMBER: 65-600-230-TCR-002

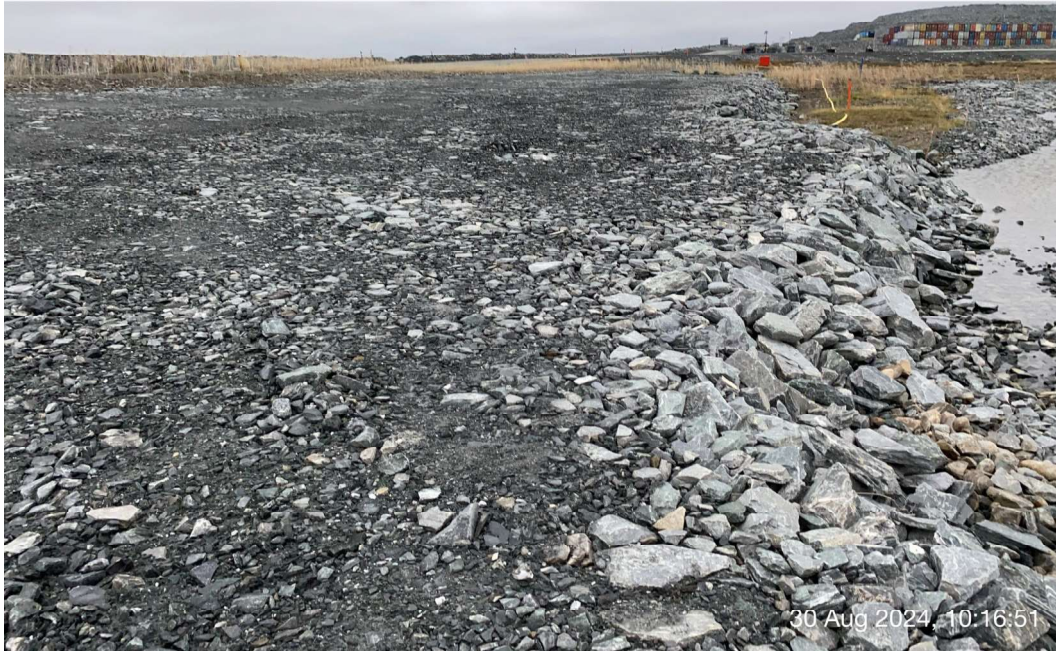
**Channel 5 -  
Photo 13:**

Channel 5 - Upper section of Channel 5, ROM cover placement between Berm 3 and Channel 5. Facing southwest.

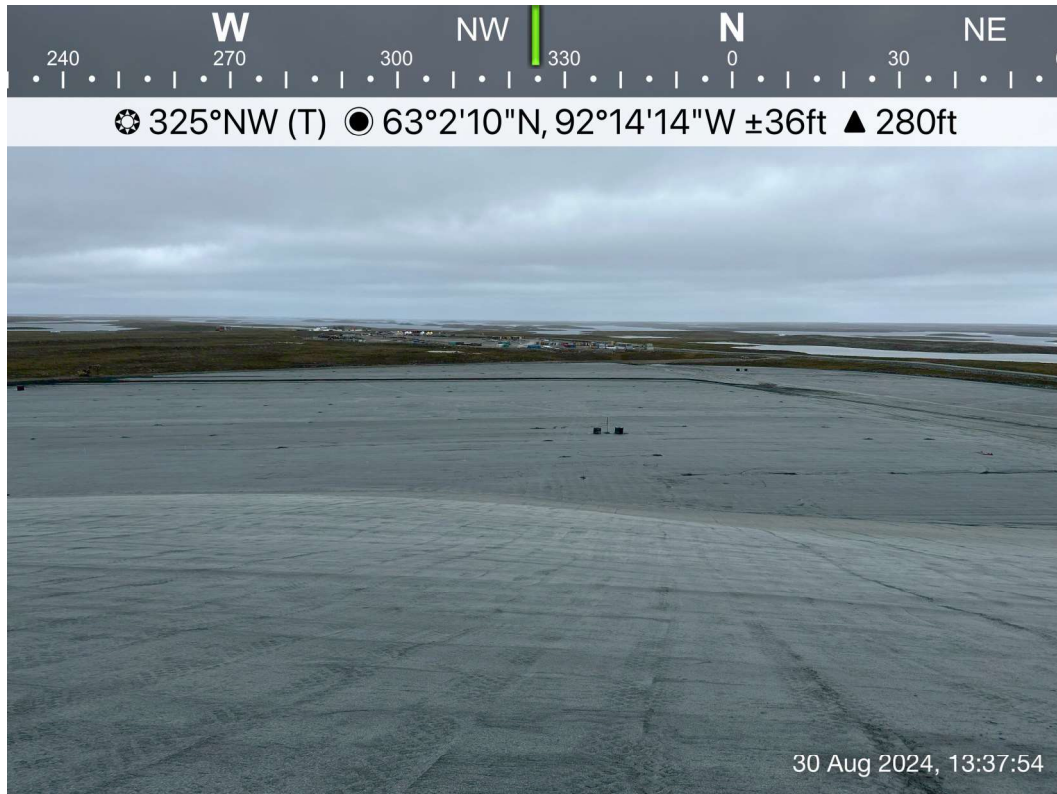
**TSF - Photo 1:** TSF - Overview of north slope of TSF Cell 1 and TSF Cell 2. Facing northwest.

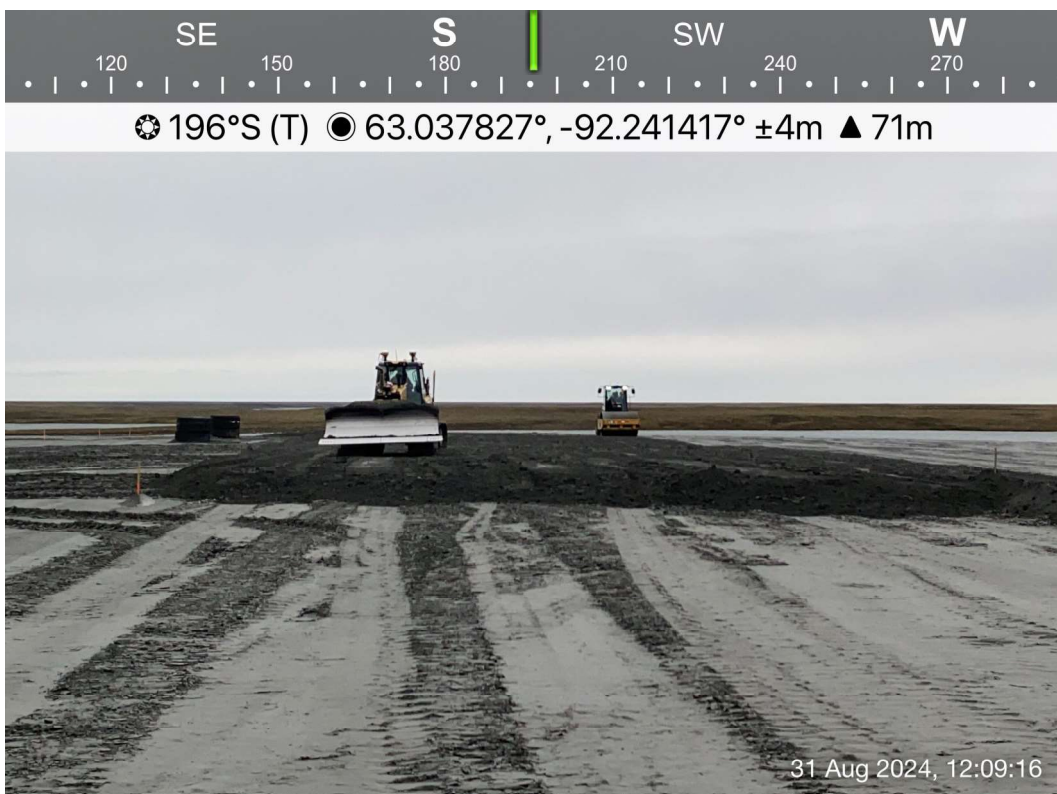
**TSF - Photo 4:** TSF - Placement and compaction of tailings in Cell 2. Facing south.

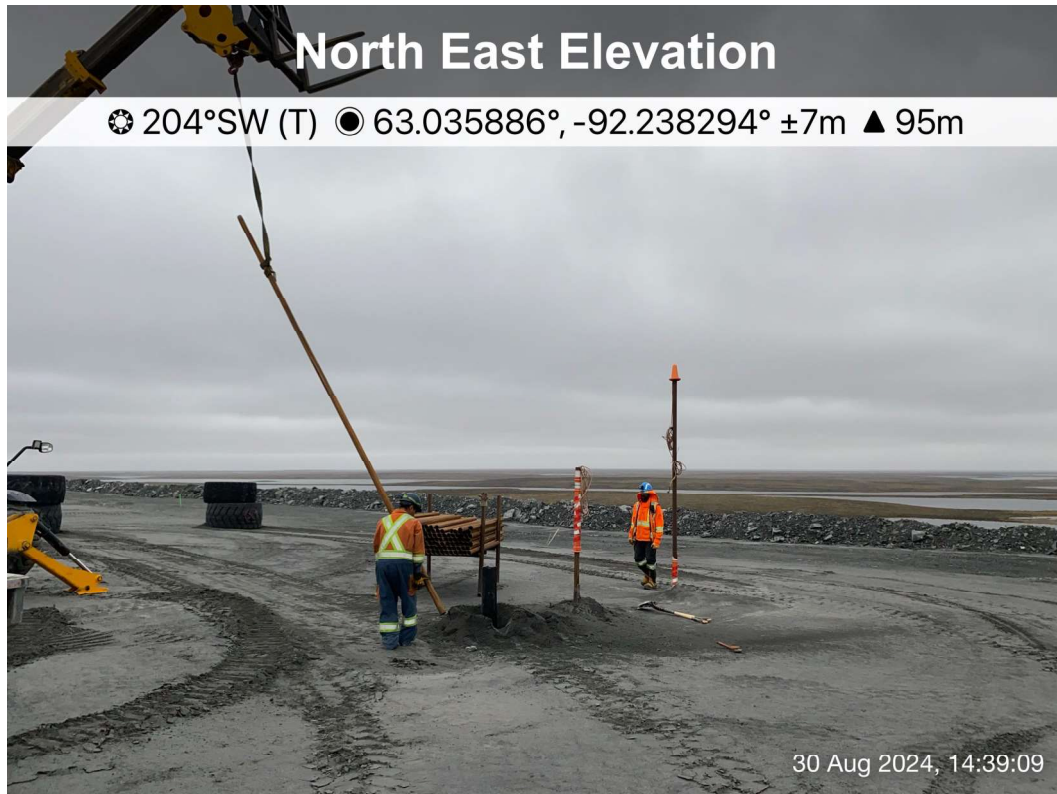
**TSF - Photo 5:** TSF - GTC installation at northwest corner of Cell 1. Facing southwest.

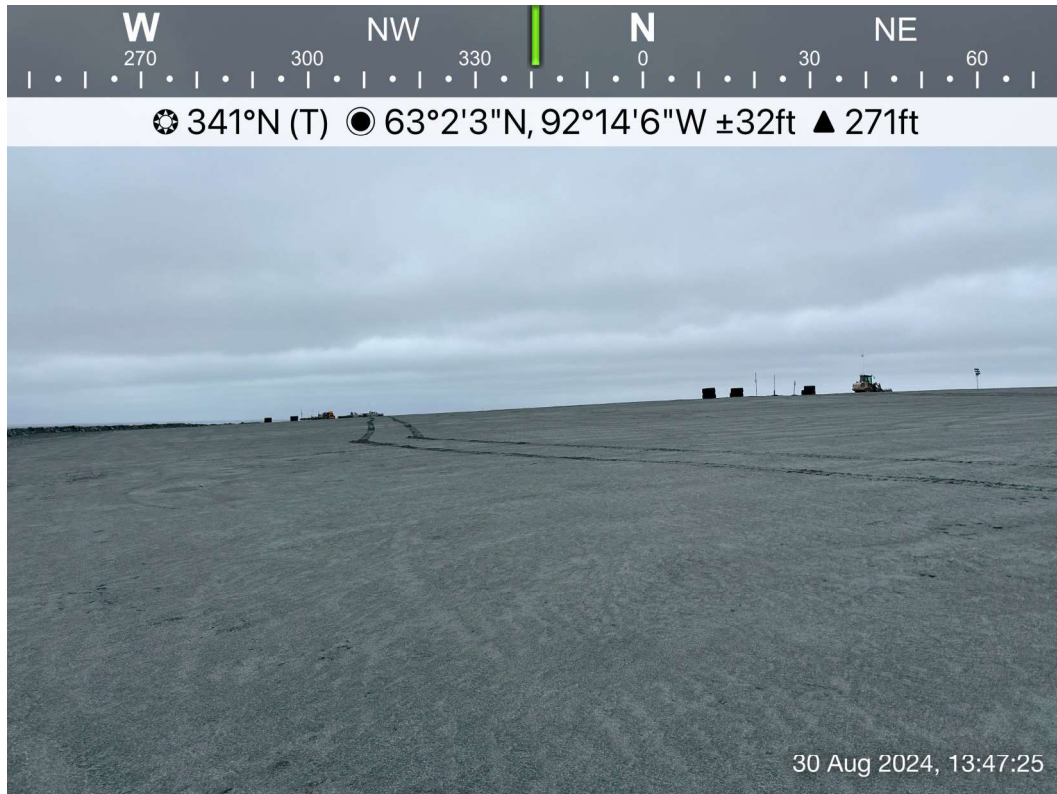
**TSF - Photo 7:** TSF - Crest of TSF Cell 1. Facing north.

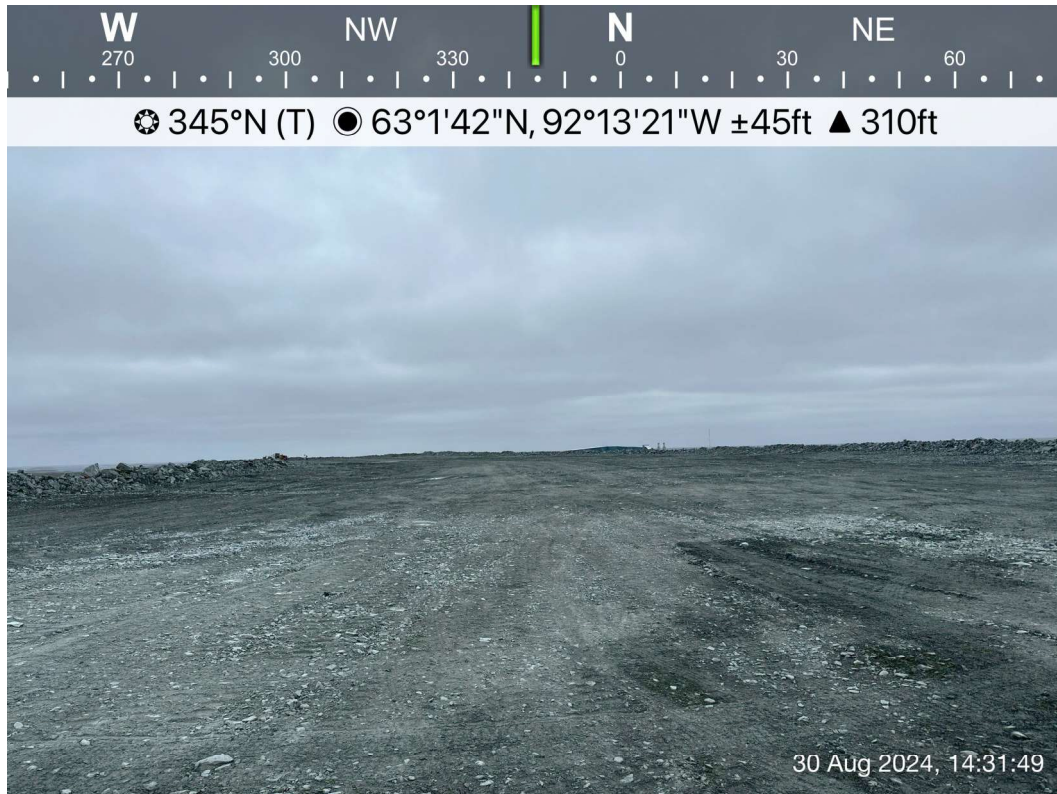
**WRSF1 - Photo 1:** WRSF1 - Crest of WRSF1 from bench 107 m. Facing north.

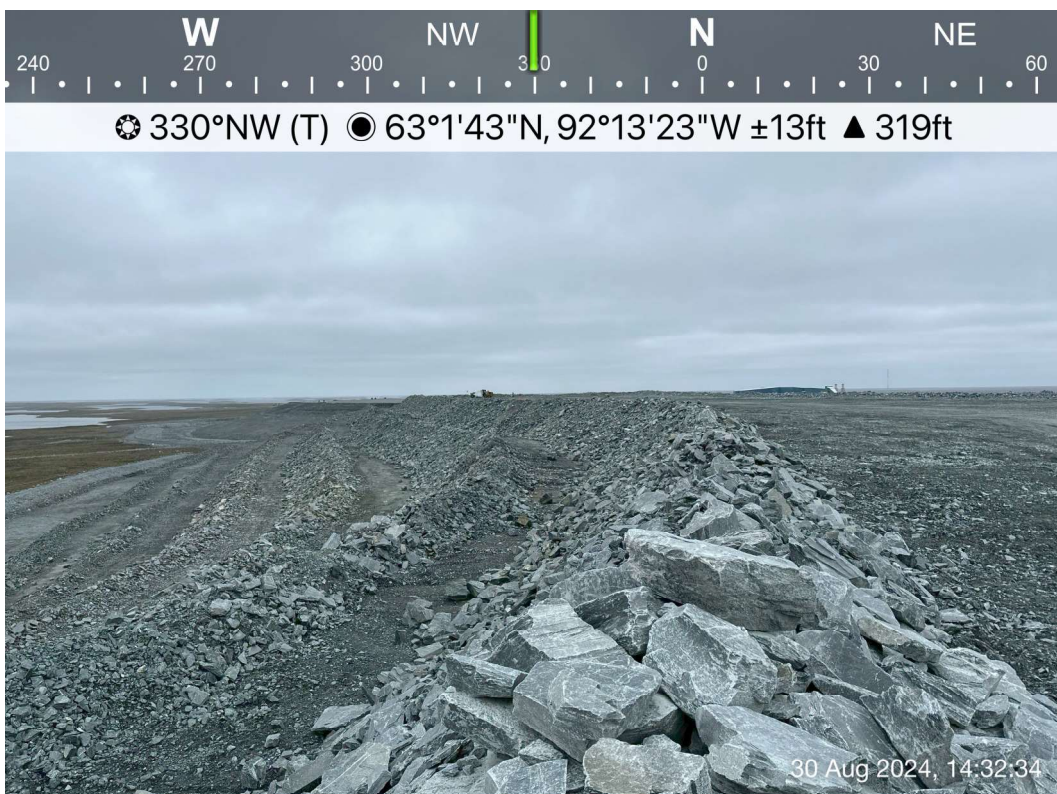
**WRSF1 - Photo 2:** WRSF1 - West side benches and slopes, Channel 3 and 4 in the background. Facing northwest.

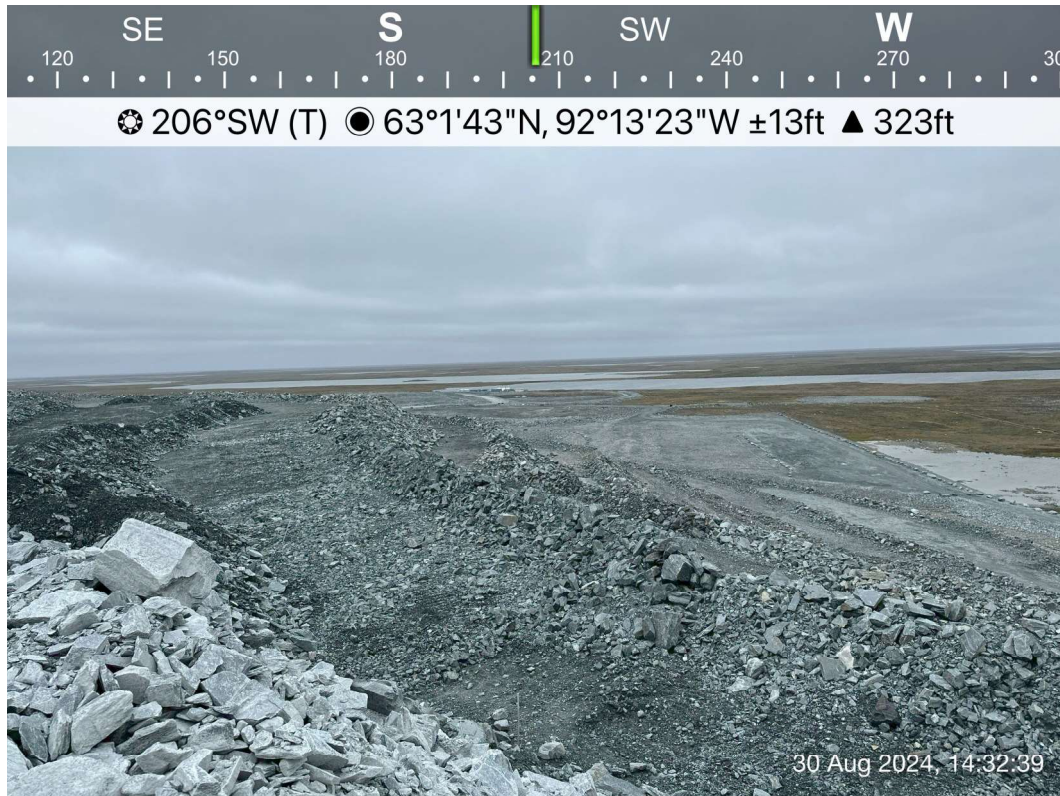
**WRSF1 - Photo 3:** WRSF1 - West side benches and slopes, CP4 and CP4 Thermal Berm in the background. Facing southwest.

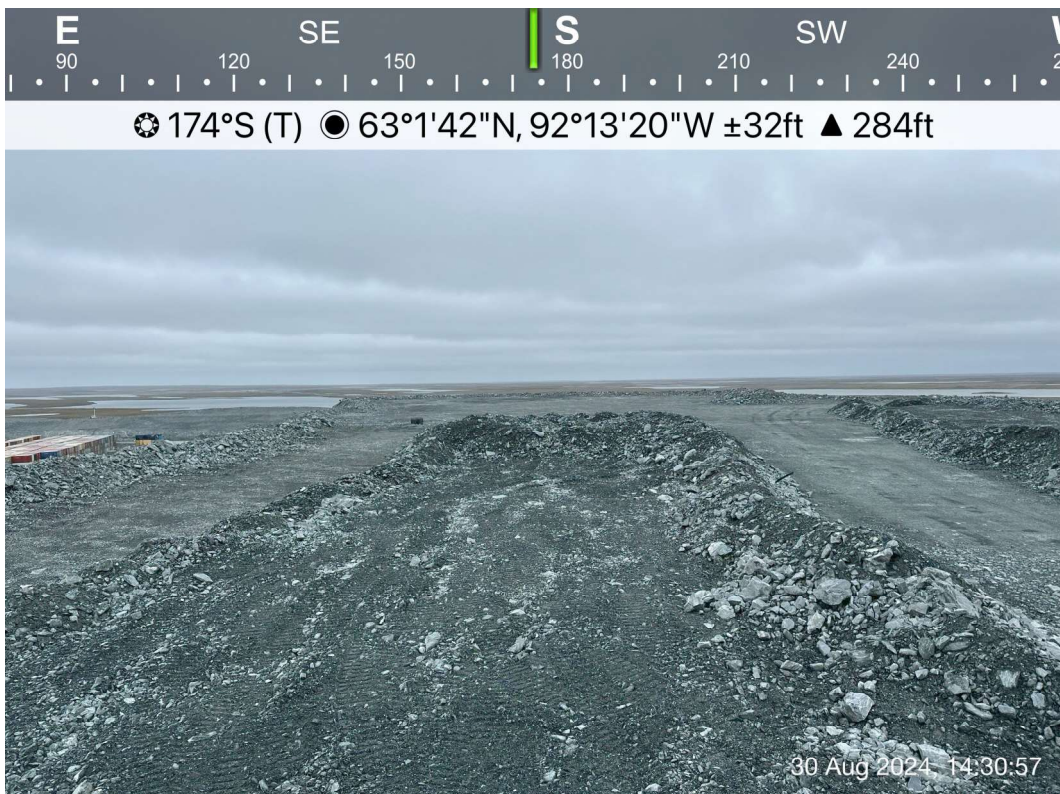
**WRSF1 - Photo 4:** WRSF1 - Free dumps spread on bench 97 m. Facing south.

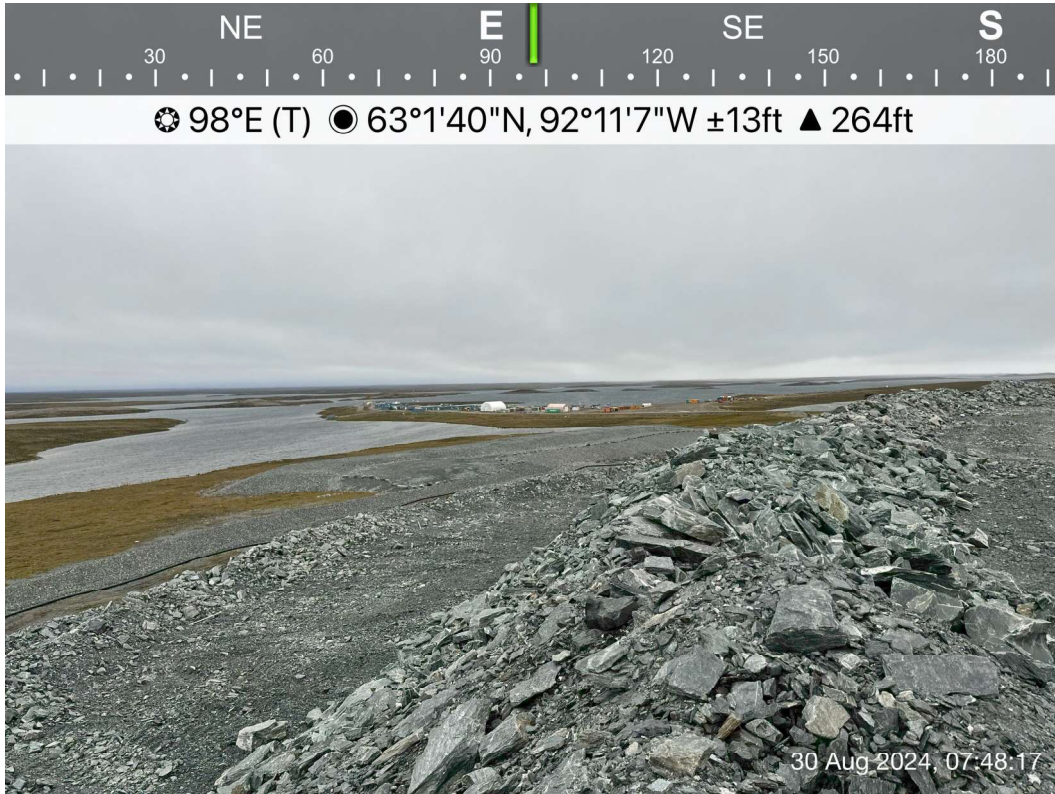
**WRSF3 - Photo 3:** WRSF3 - East side benches and slopes, Channel 9, CP2 and CP2 Thermal Berm in the background. Facing east.

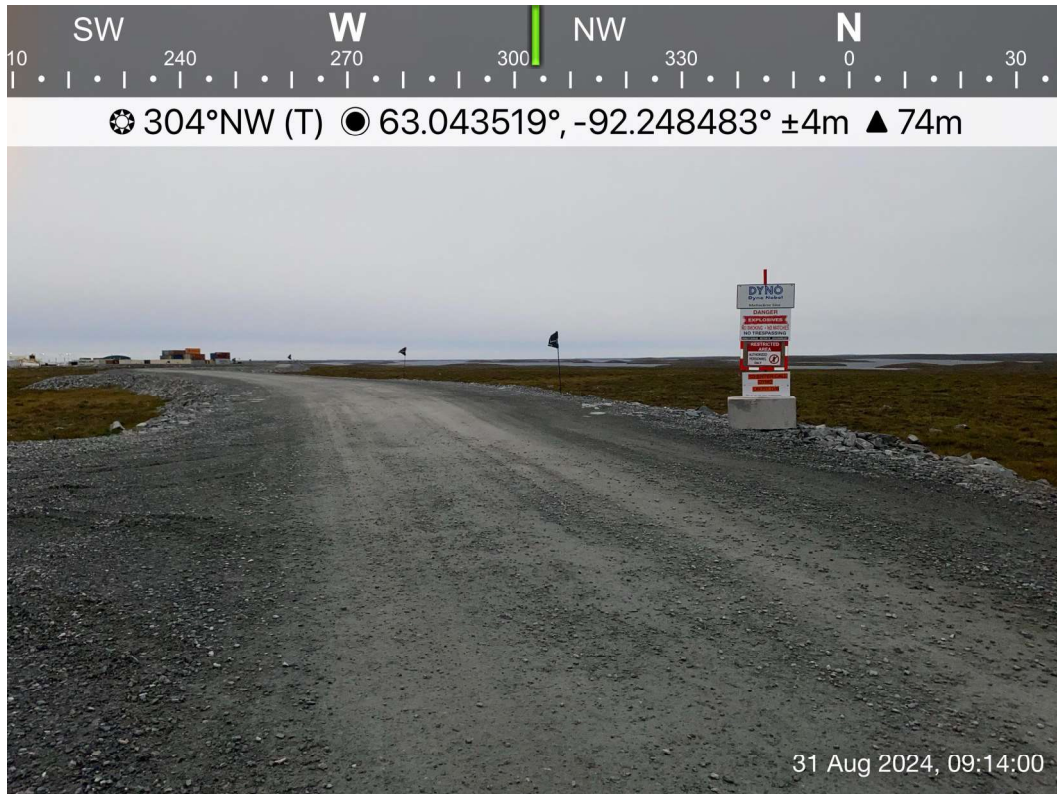
**Site Road -  
Photo 1:**

Site Road - Road to Emulsion AN Pad and storage area. Facing northwest.

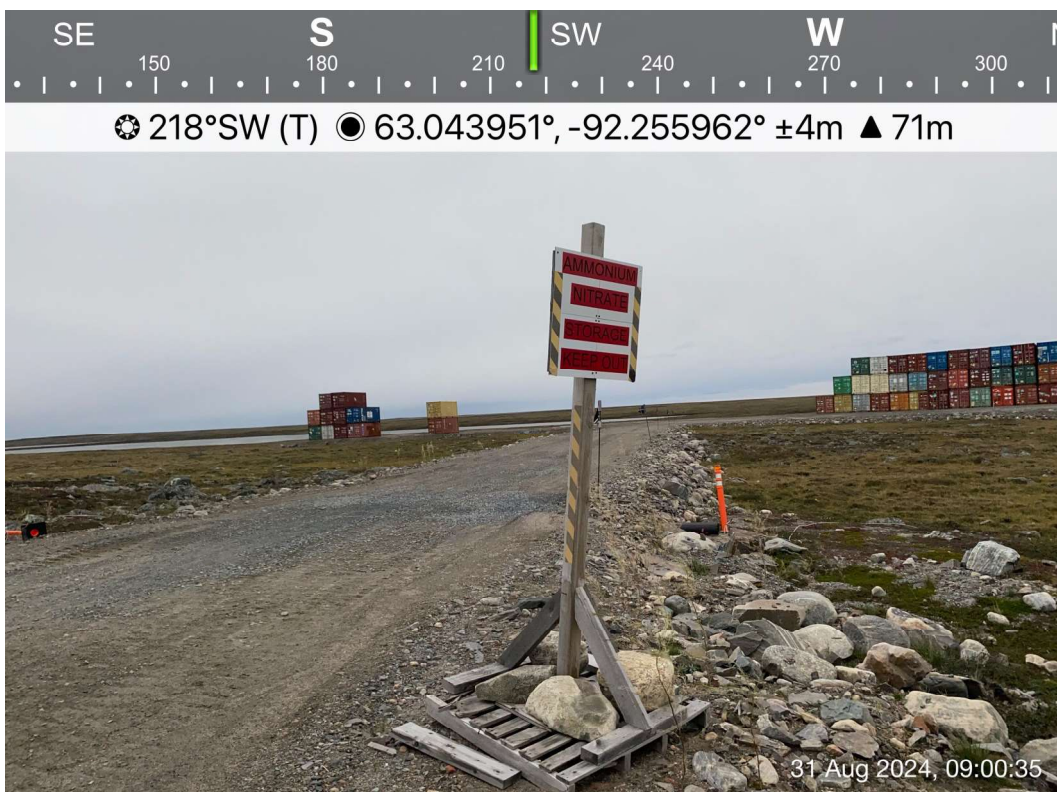
**Site Road -  
Photo 2:**

Site Road - Road to Emulsion AN Pad. Facing southwest.

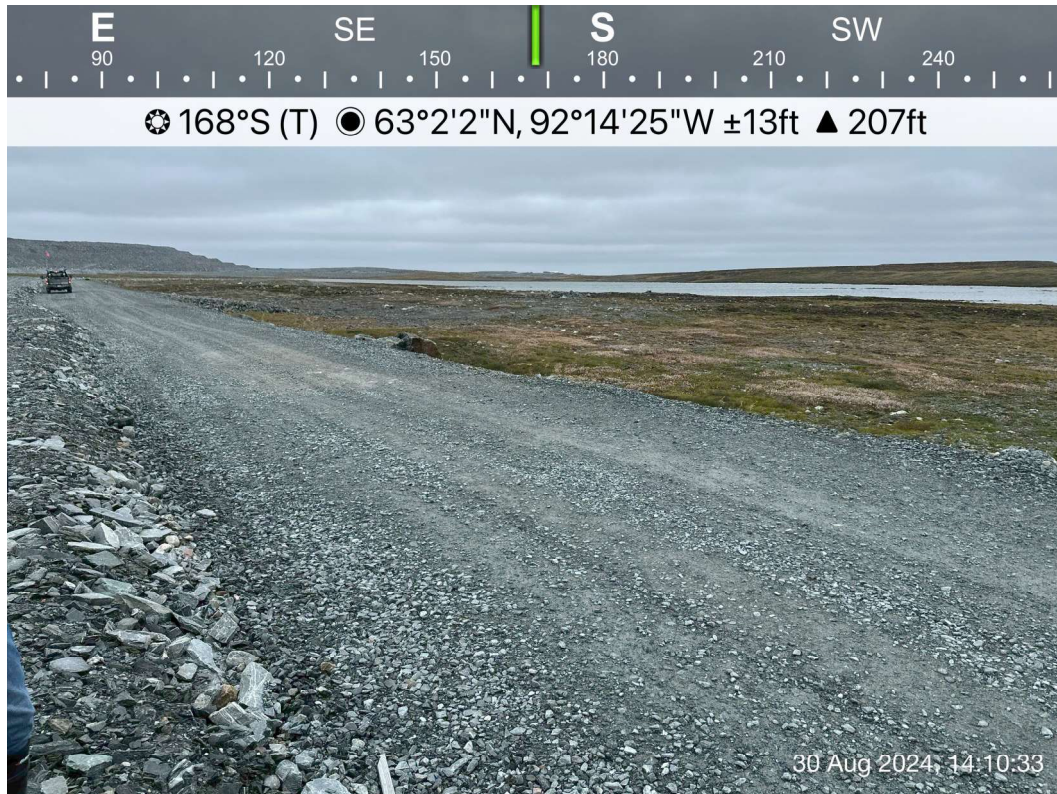
**Site Road -  
Photo 3:**

Site Road - CP3 access road. Facing south.

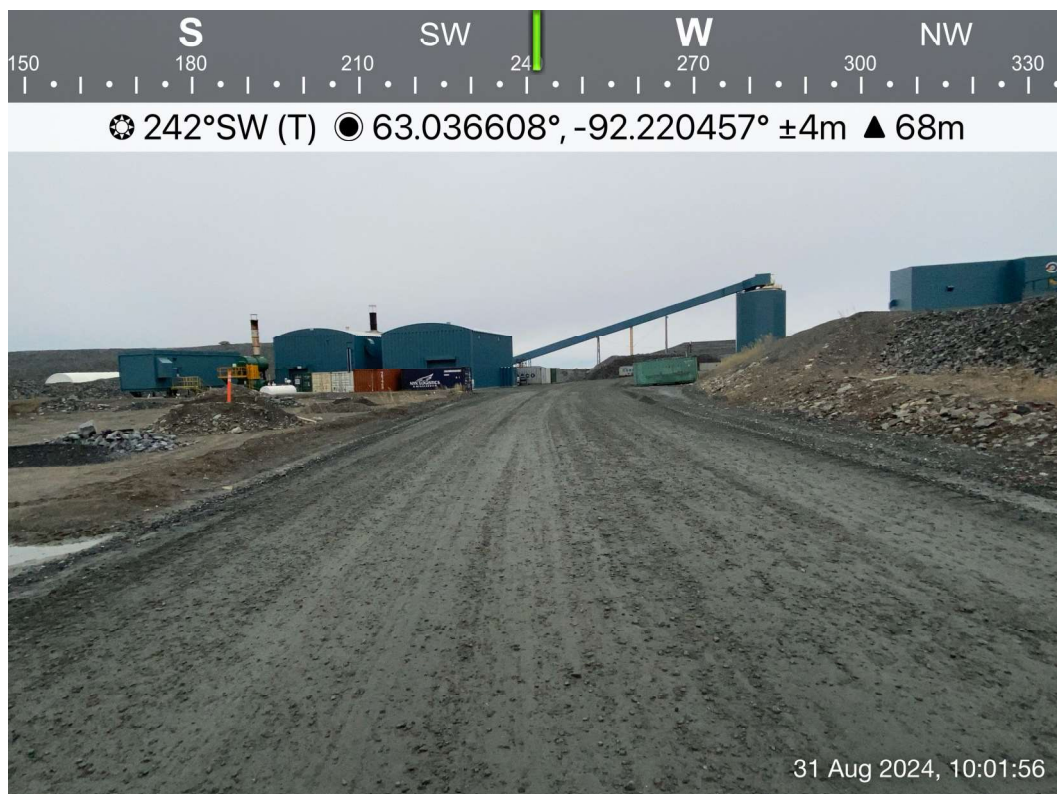
**Site Road -  
Photo 4:**

Site Road - Landfarm access road. Facing southwest.

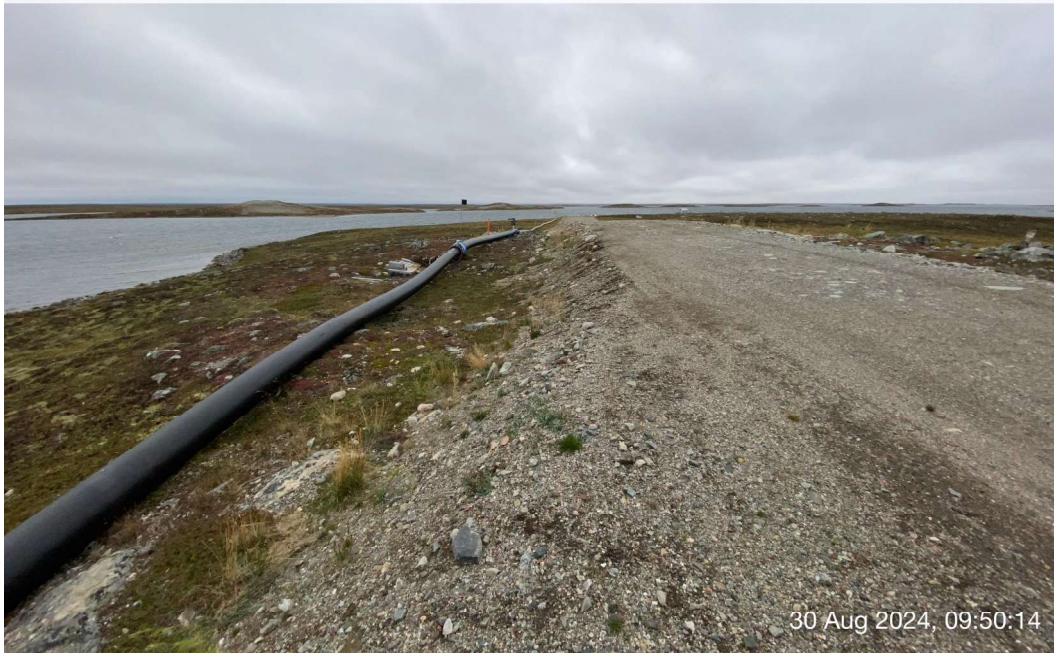
**Site Road -  
Photo 5:**

Site Road - Exploration camp diffuser access road. Facing east.

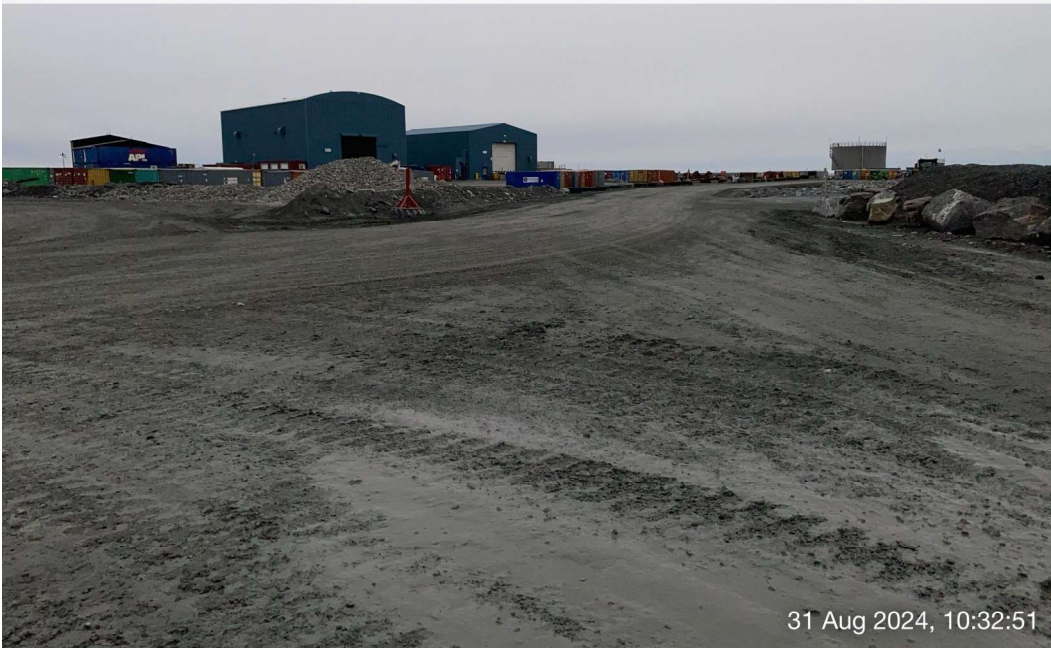
**Site Road -  
Photo 6:**

Site Road - SP3 access road. Facing northeast.

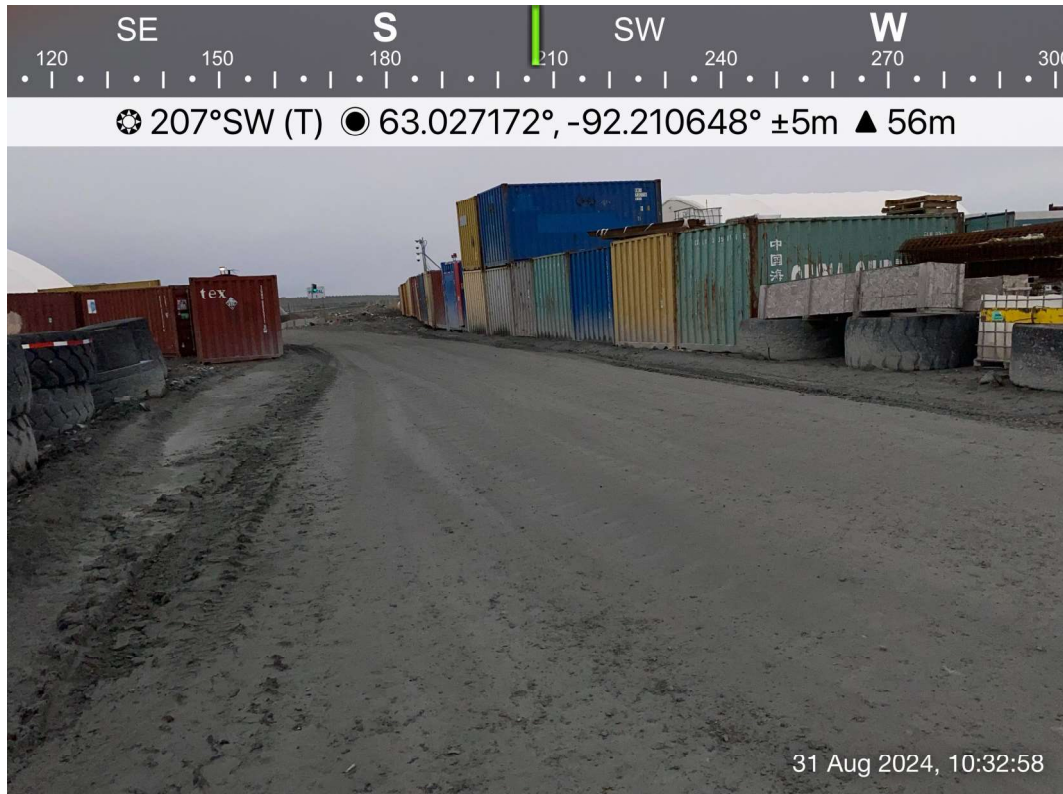
**Site Road -  
Photo 7:**

Site Road - Portal 1 access road. Facing southwest.

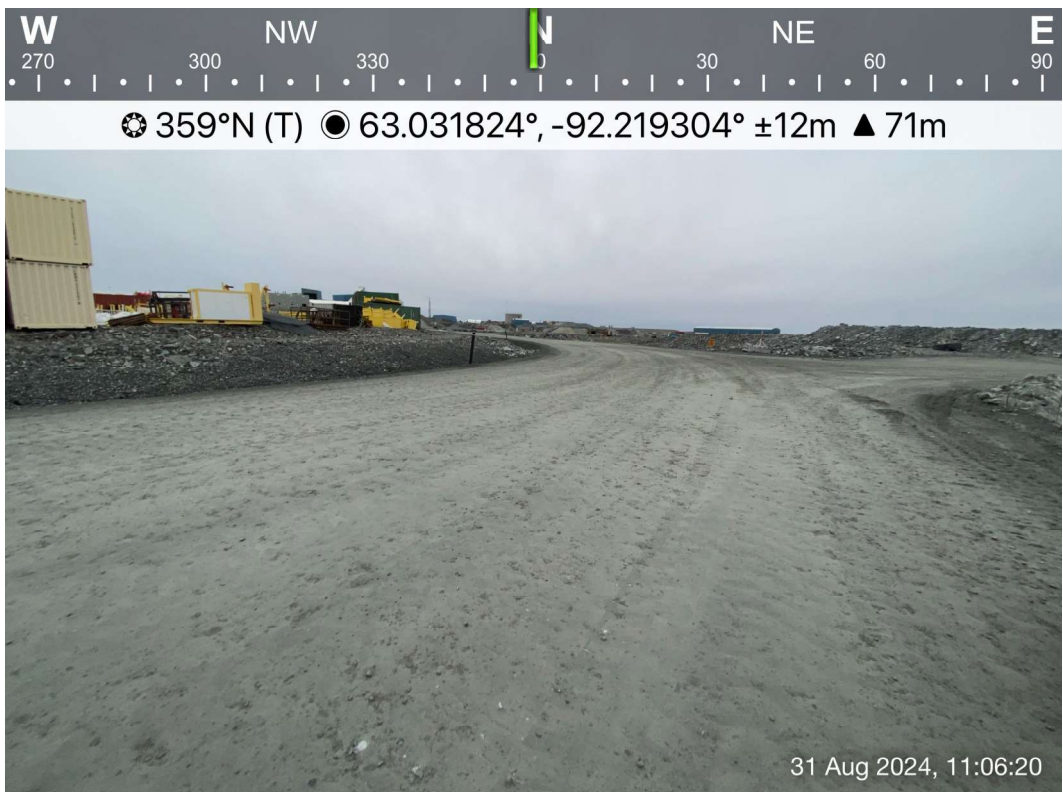
**Site Road -  
Photo 8:**

Site Road - Paste plant access road. Facing north.

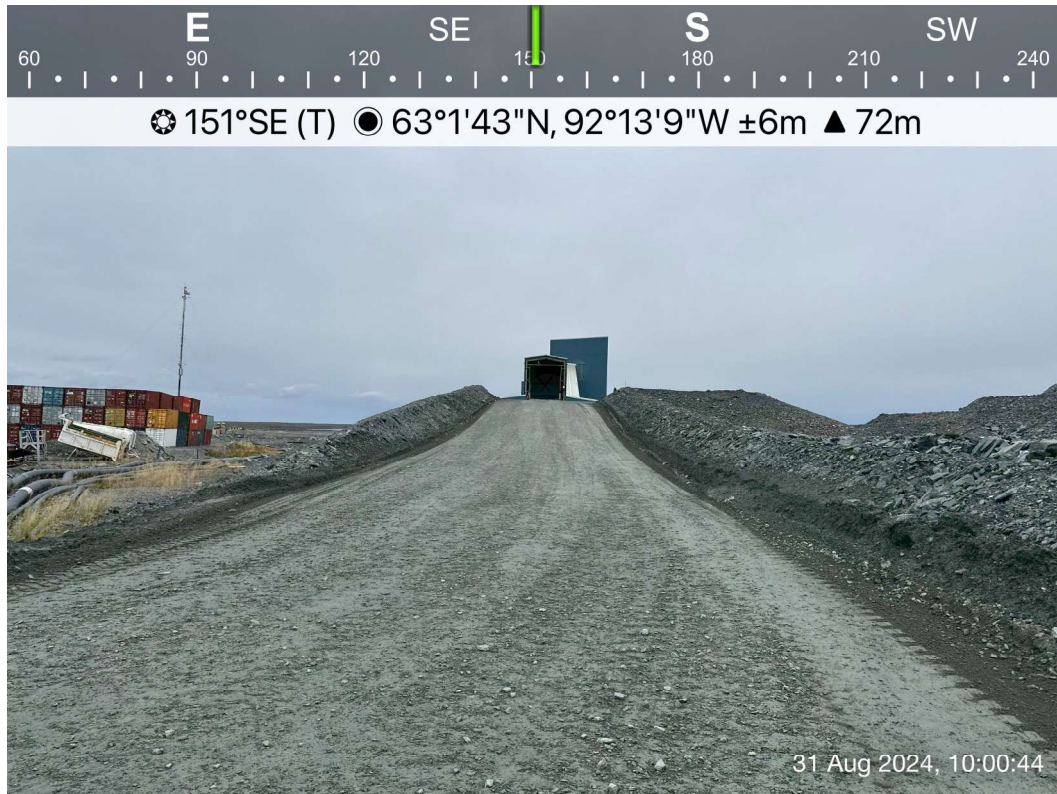
**Site Road -  
Photo 9:**

Site Road - Paste plant ramp. Facing southeast.

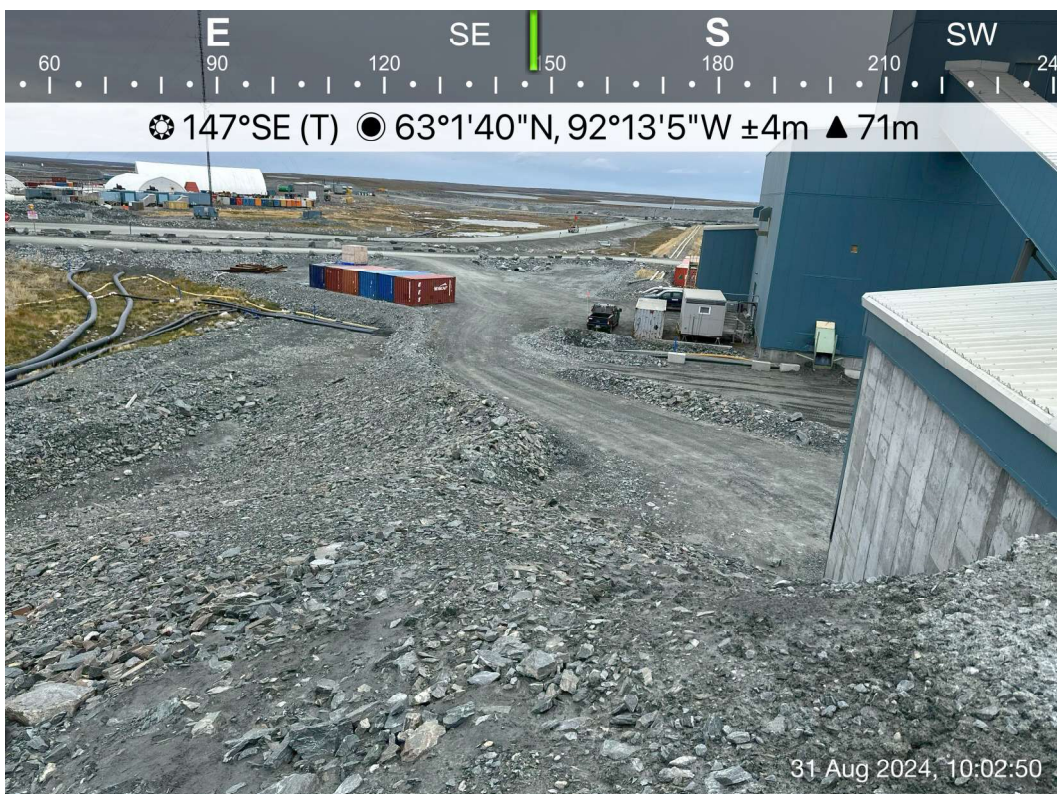
**Site Road -  
Photo 10:**

Site Road - Access road on south side of paste plant. Facing southeast.

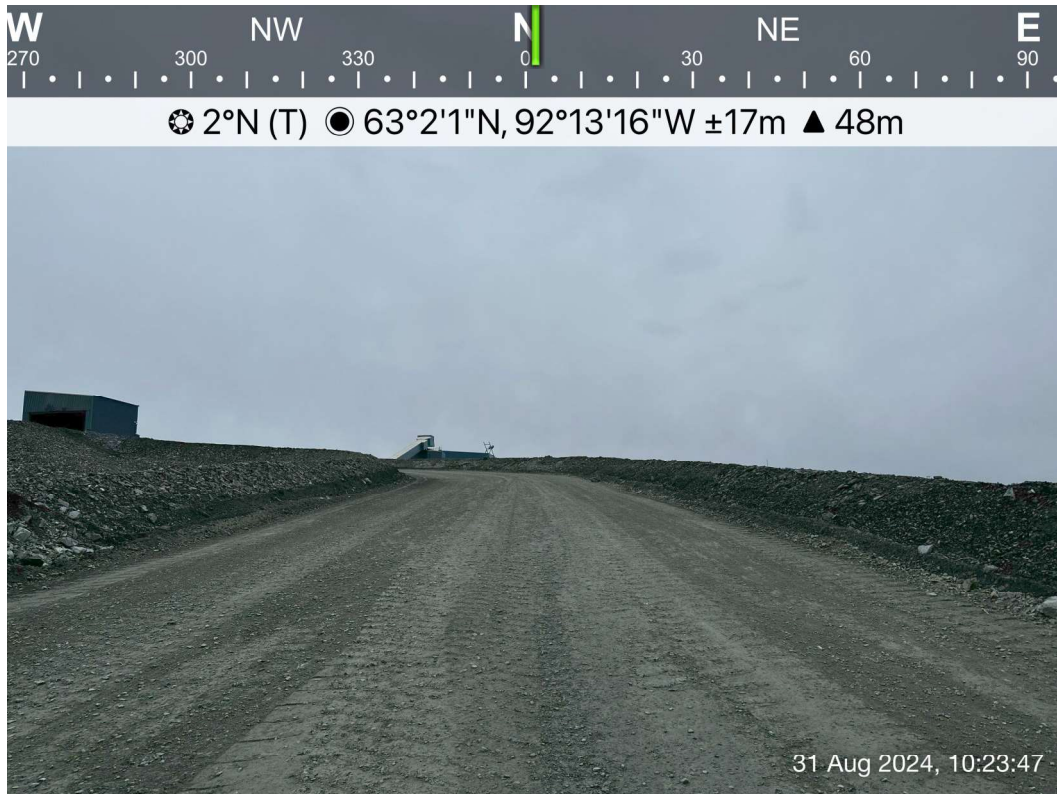
**Site Road -  
Photo 11:**

Site Road - Crusher pad ramp. Facing north.

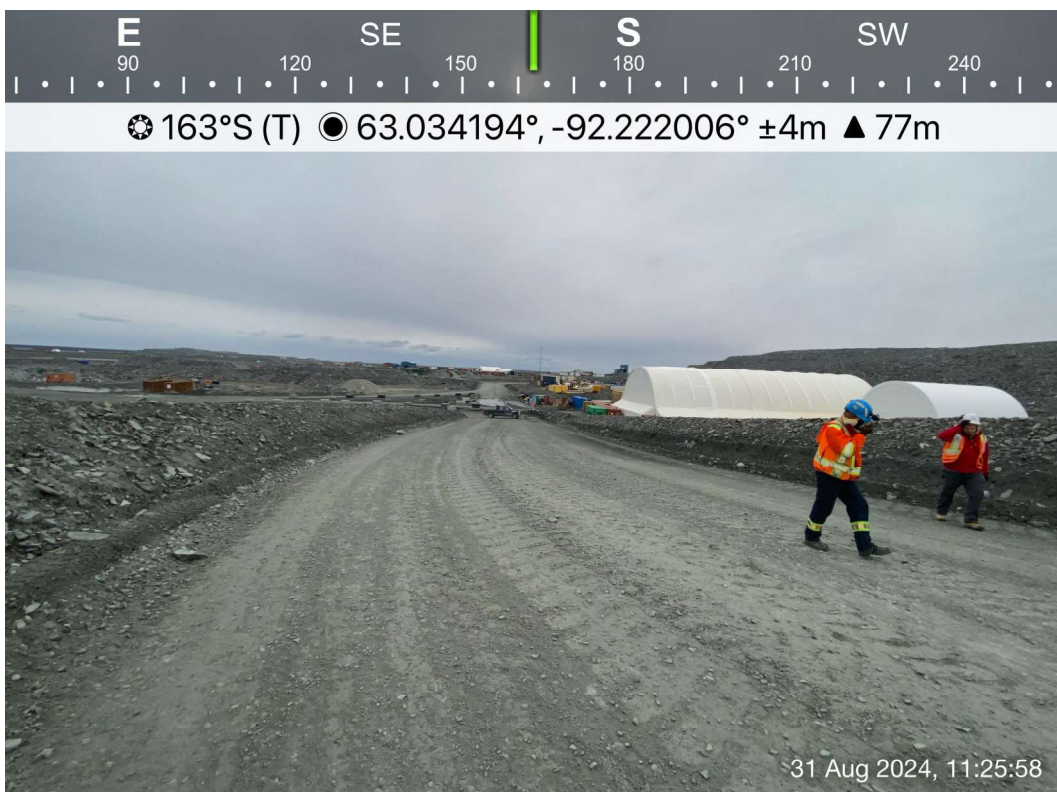
**Site Road -  
Photo 12:**

Site Road - Crusher pad ramp. Facing south.

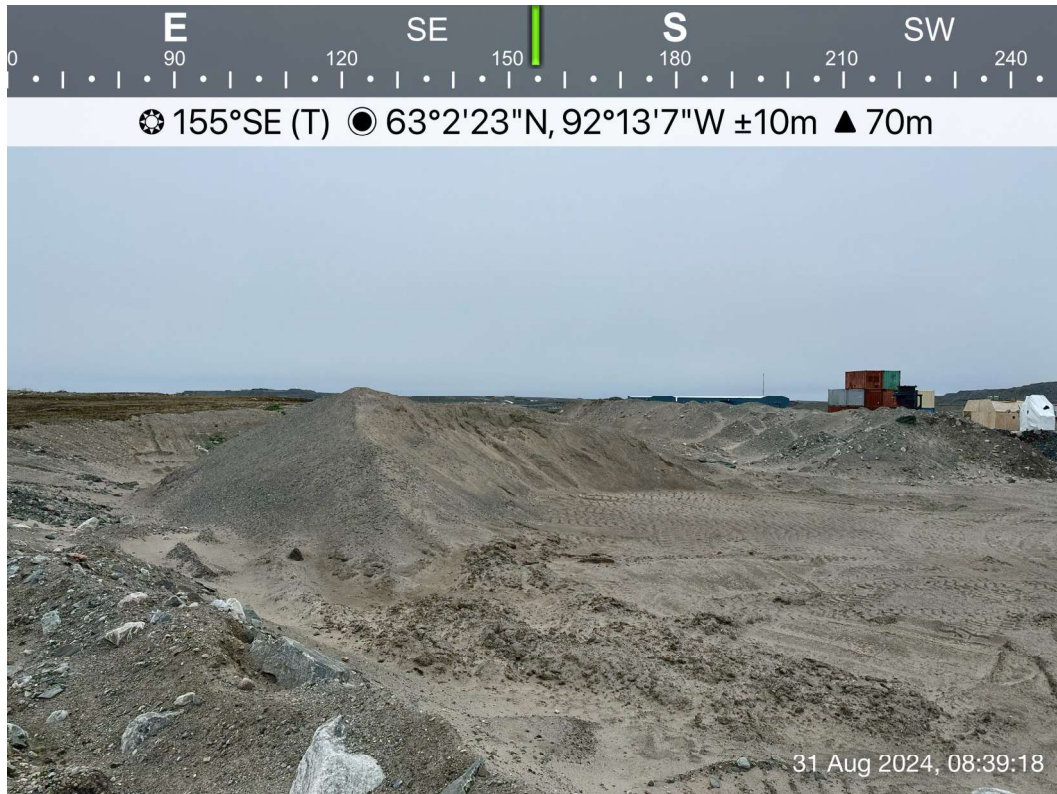
**Meliadine Esker** Borrow Source - Meliadine esker borrow source overview. Facing southeast.  
**Photo 1:**

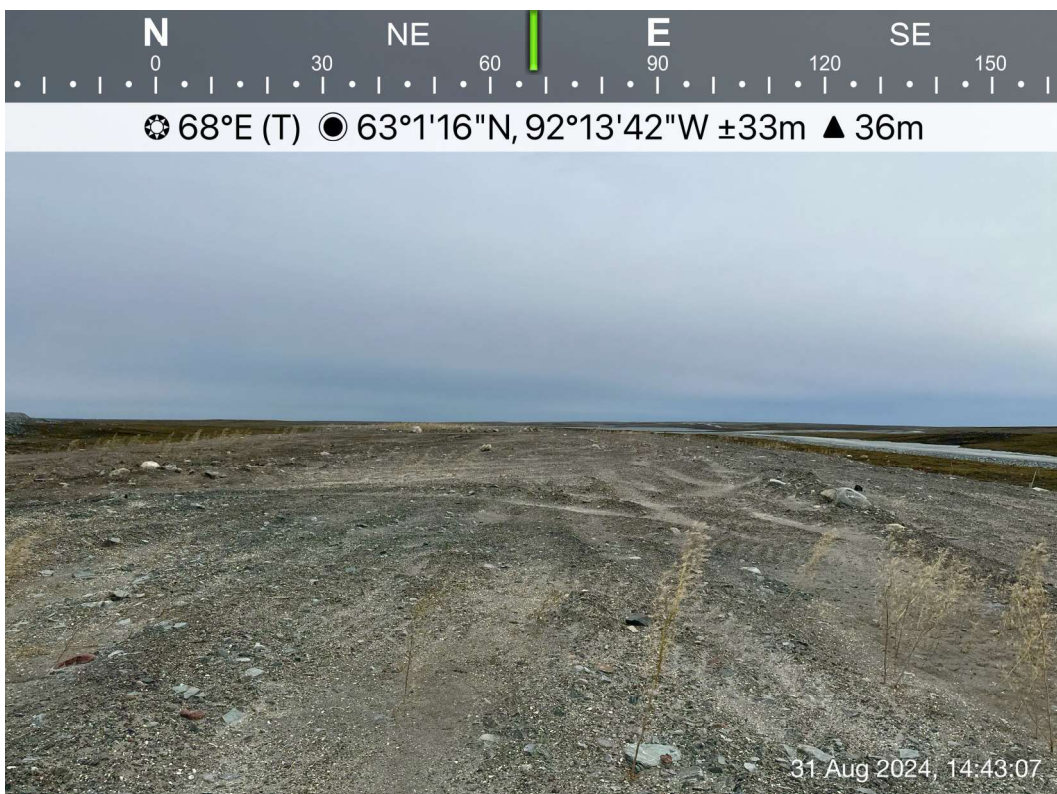
**West Meg Esker** Borrow Source - West Meg esker borrow source overview. Facing east.  
**- Photo 2:**

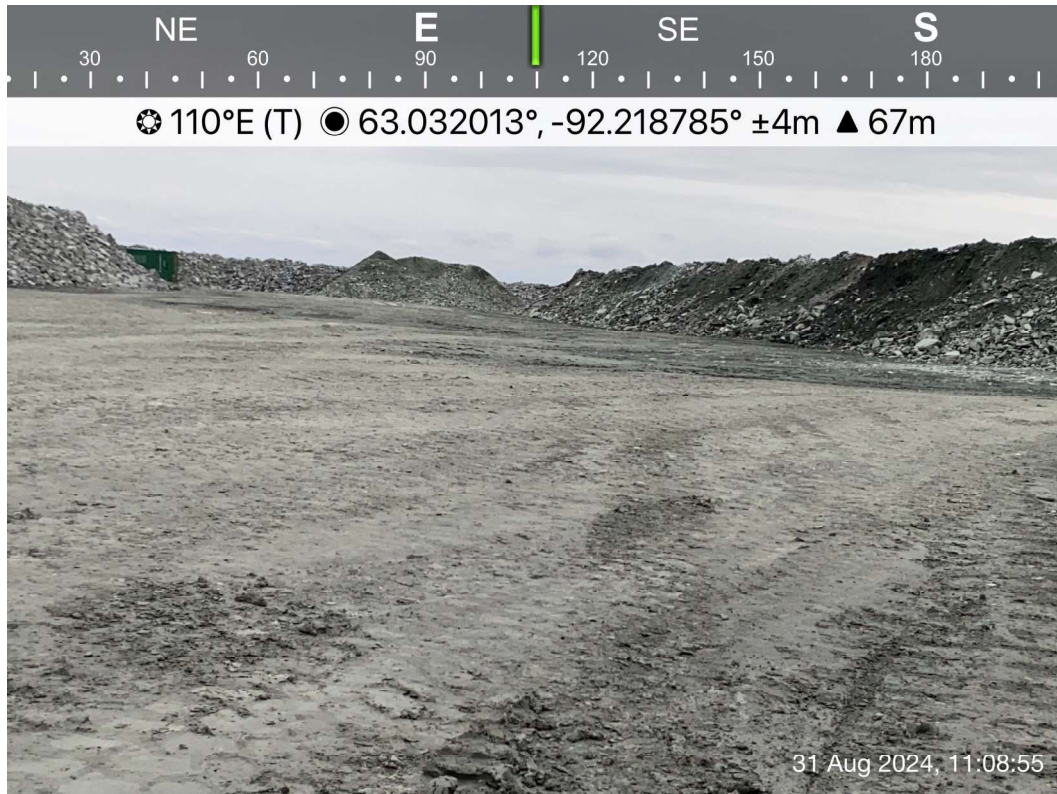
**Ore Stockpile - Photo 1:** Ore Stockpile - Ore stockpile overview. Facing east.

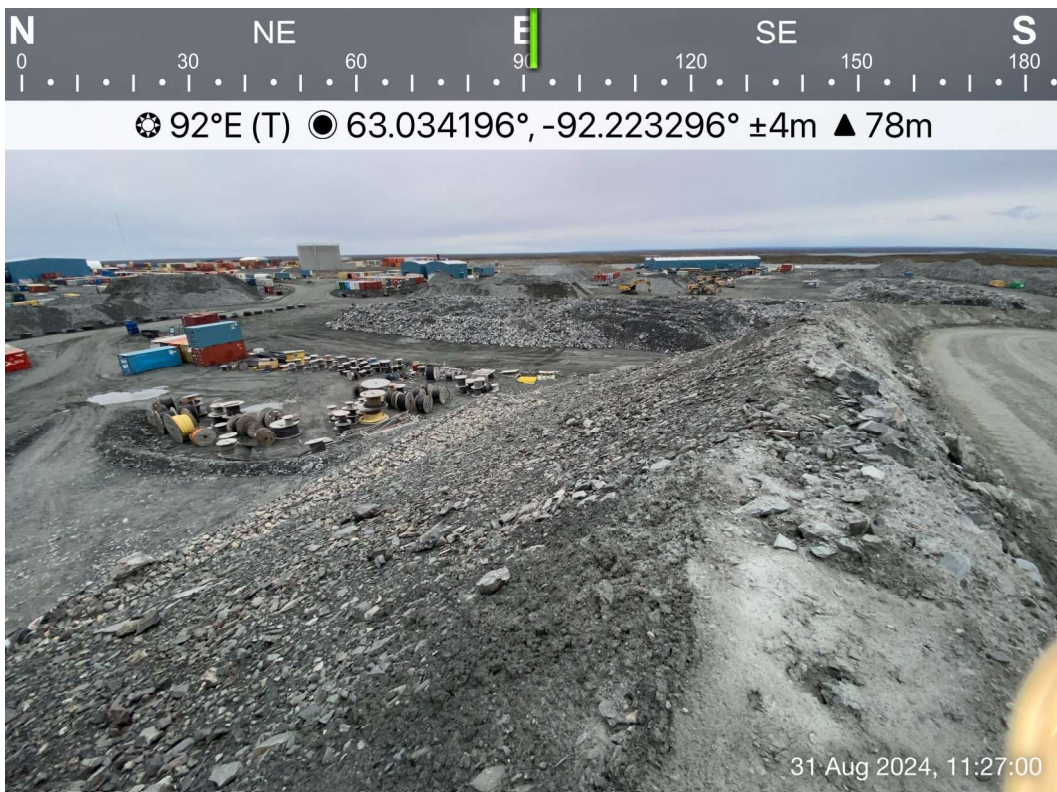
**Ore Stockpile - Photo 2:** Ore Stockpile - View from crusher ramp. Facing east.

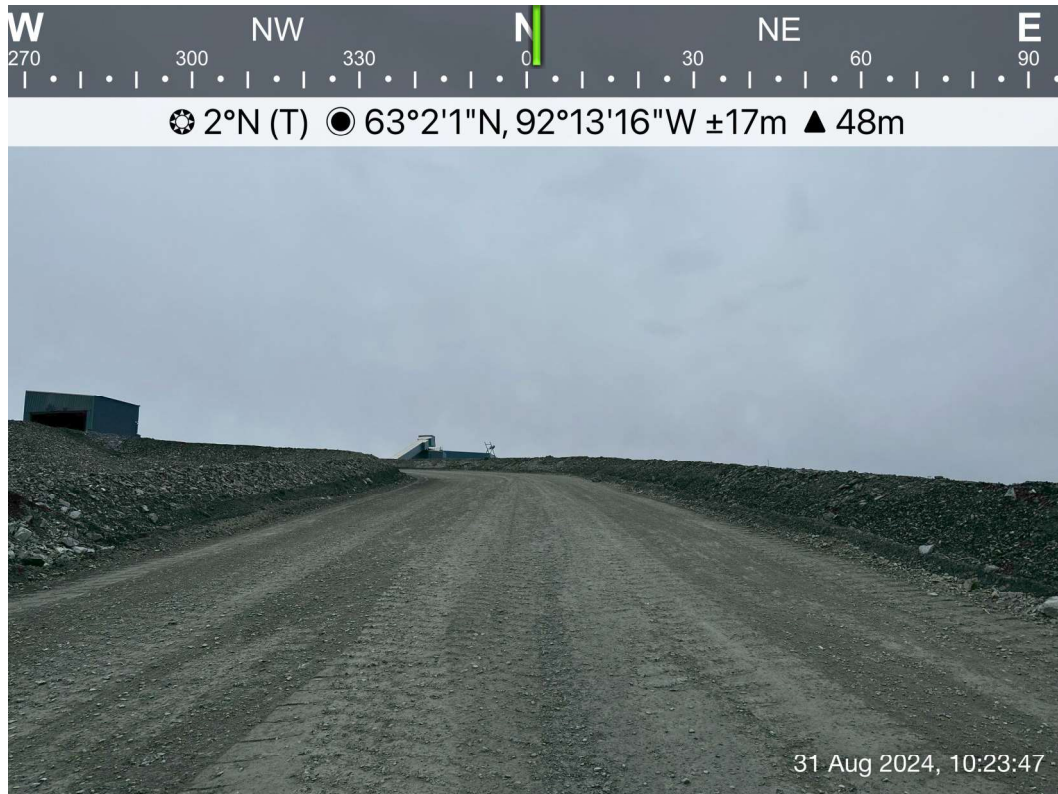
**Crusher Ramp - Photo 1:** Crusher Ramp - Overview of crusher ramp. Facing north.
