## **APPENDIX 6      2024 ANNUAL GEOTECHNICAL INSPECTION REPORT**

## 2024 Annual Geotechnical Inspection Meliadine Gold Mine, Nunavut, Canada

PRESENTED TO  
**Agnico Eagle Mines Limited**

MARCH 11, 2025  
ISSUED FOR USE-REVISION 1  
FILE: 704-ENG.EARC03140-39  
AGNICO EAGLE DOCUMENT NUMBER: 65-600-230-TCR-002

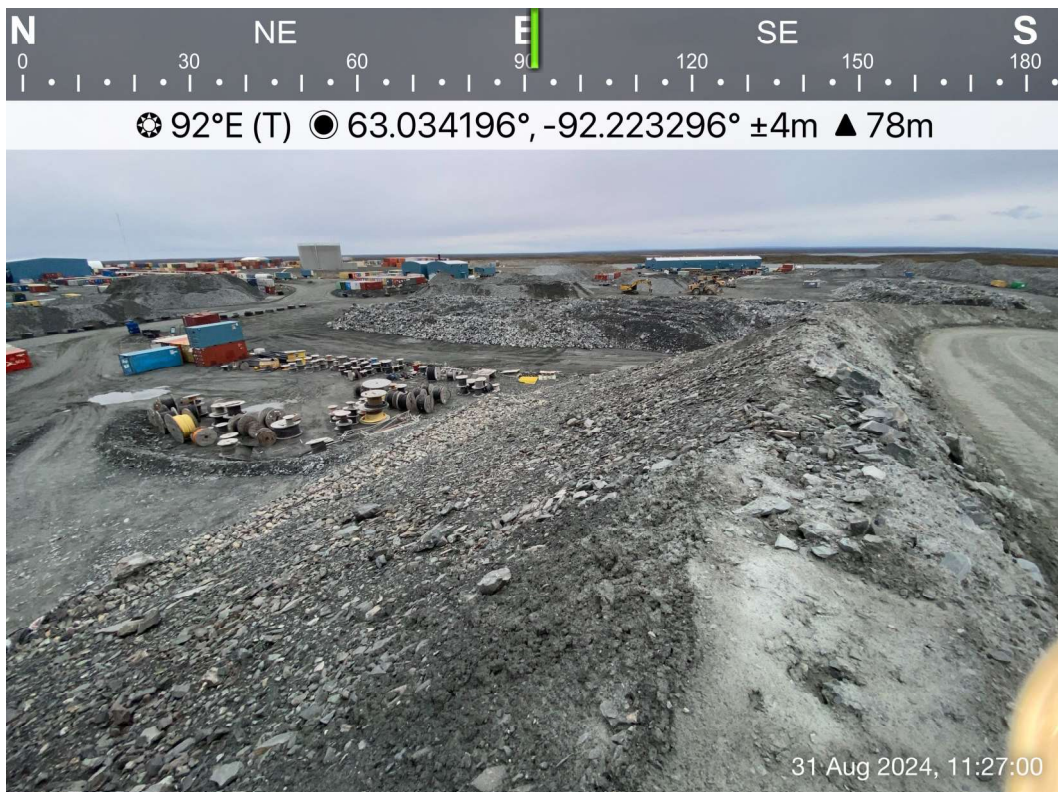
**Crusher Ramp - Photo 2:** Crusher Ramp - Ramp side slope overview. Facing east.

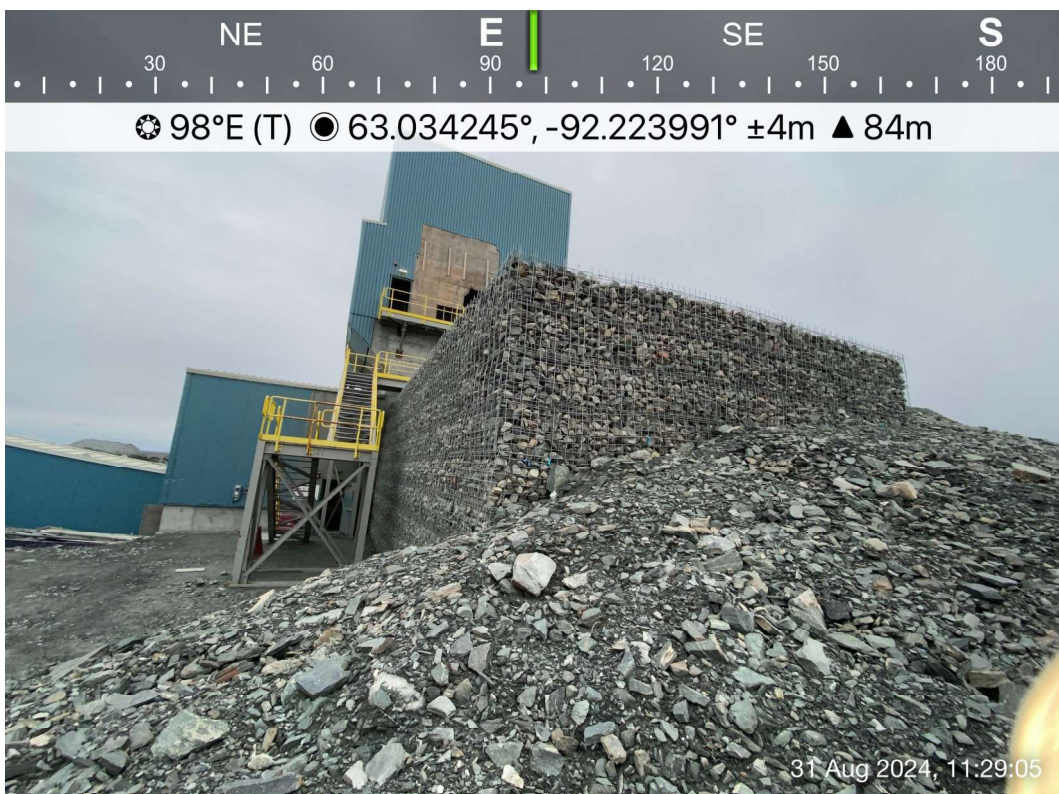
**Crusher Pad - Photo 4:** Crusher Pad - MSE retaining wall on the northwest corner. Facing east.

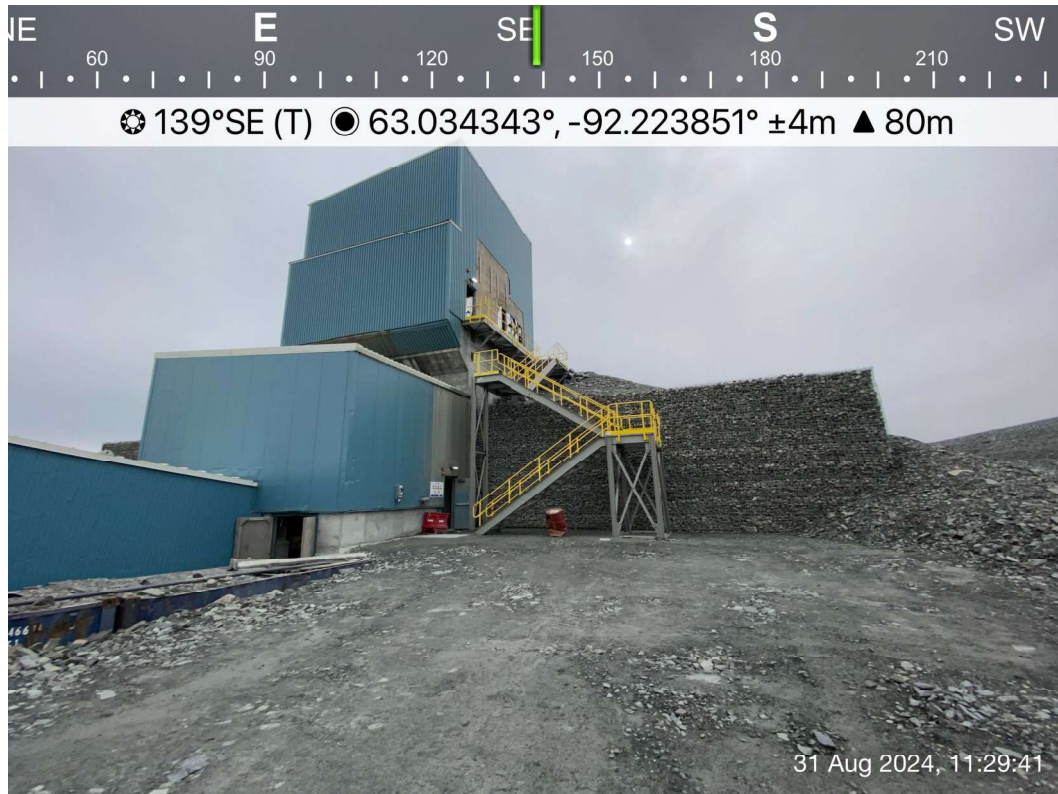
**Crusher Pad -  
Photo 5:**

Crusher Pad - Overview of MSE retaining wall and crusher building, north-west side. Facing southeast.

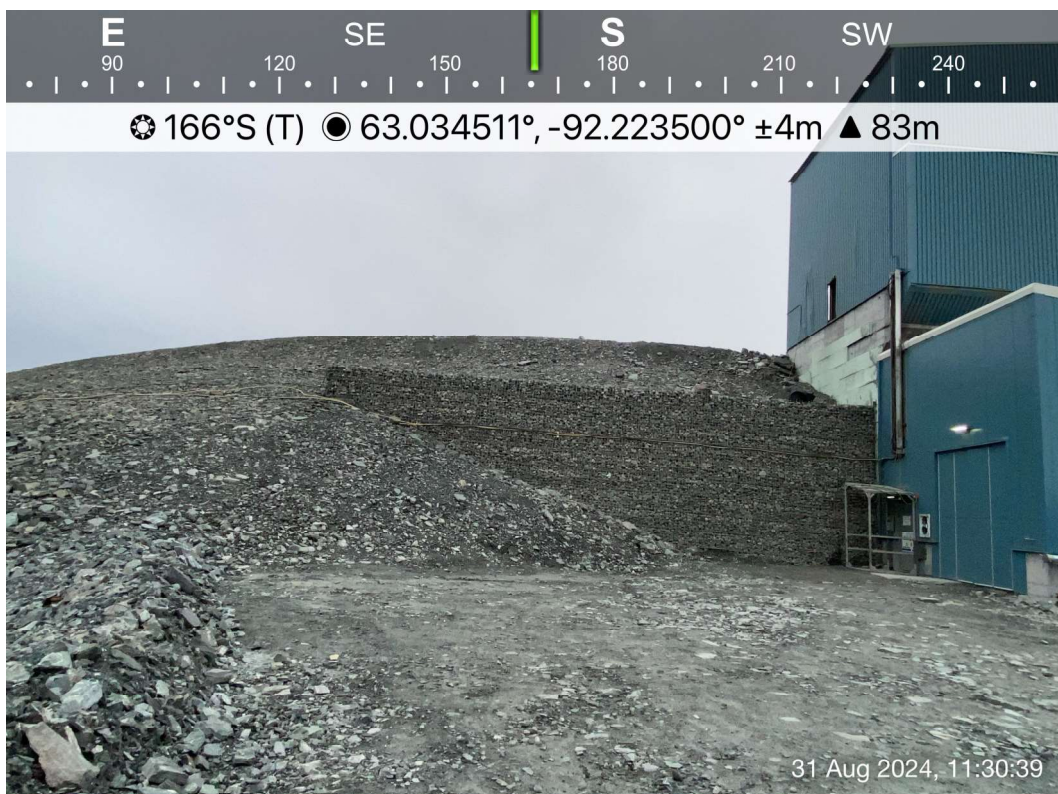
**Crusher Pad -  
Photo 6:**

Crusher Pad - Overview of MSE retaining wall and crusher building, north-east side. Facing south.

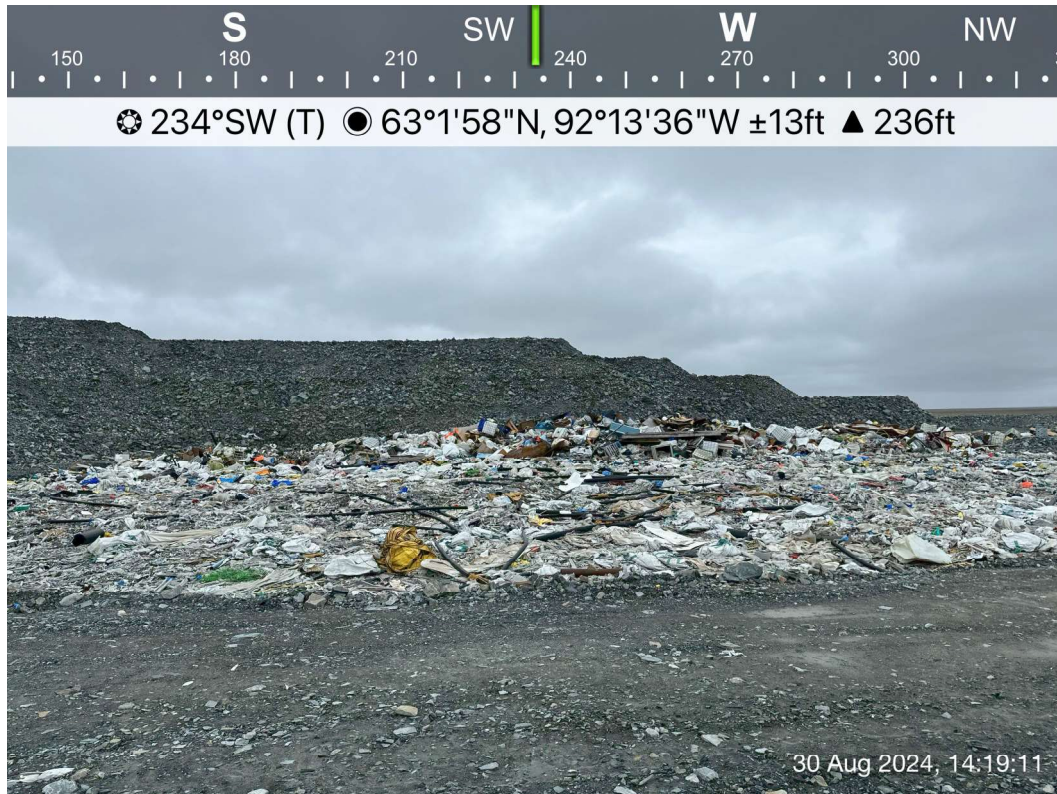
**Landfill - Photo 7:** WRSF1 Landfill - Overview of landfill. Facing southwest.

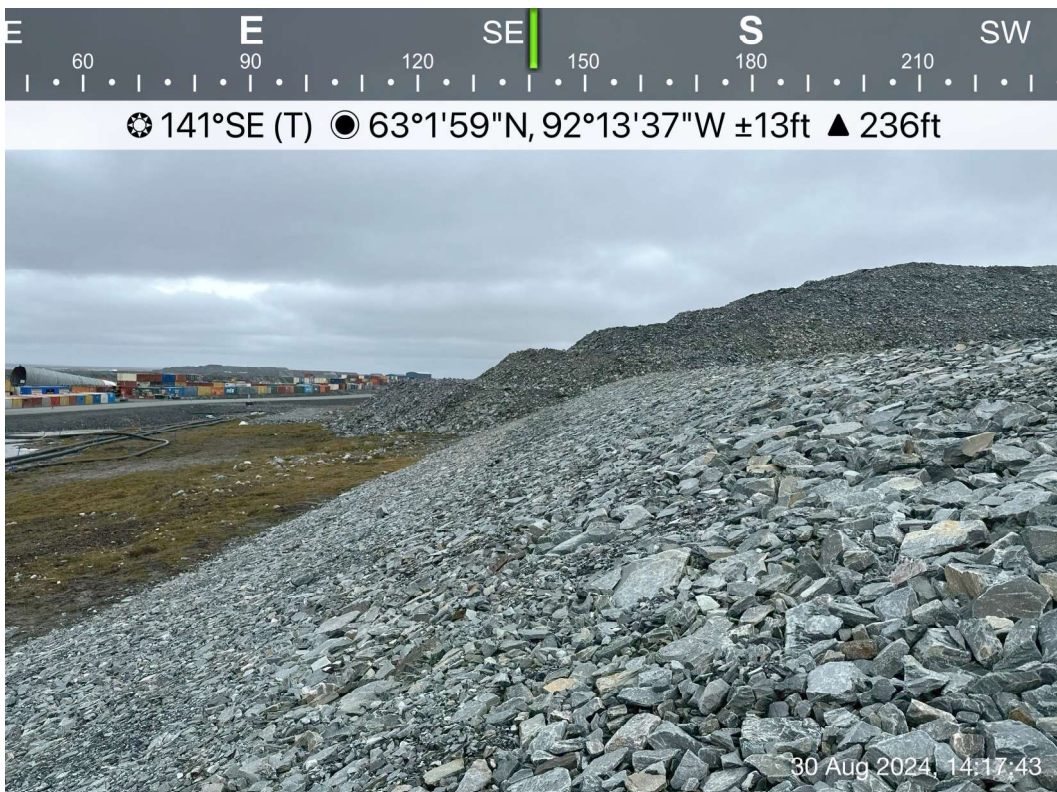
**Landfill - Photo 8:** WRSF1 Landfill - Landfill east side slope overview. Facing southeast.

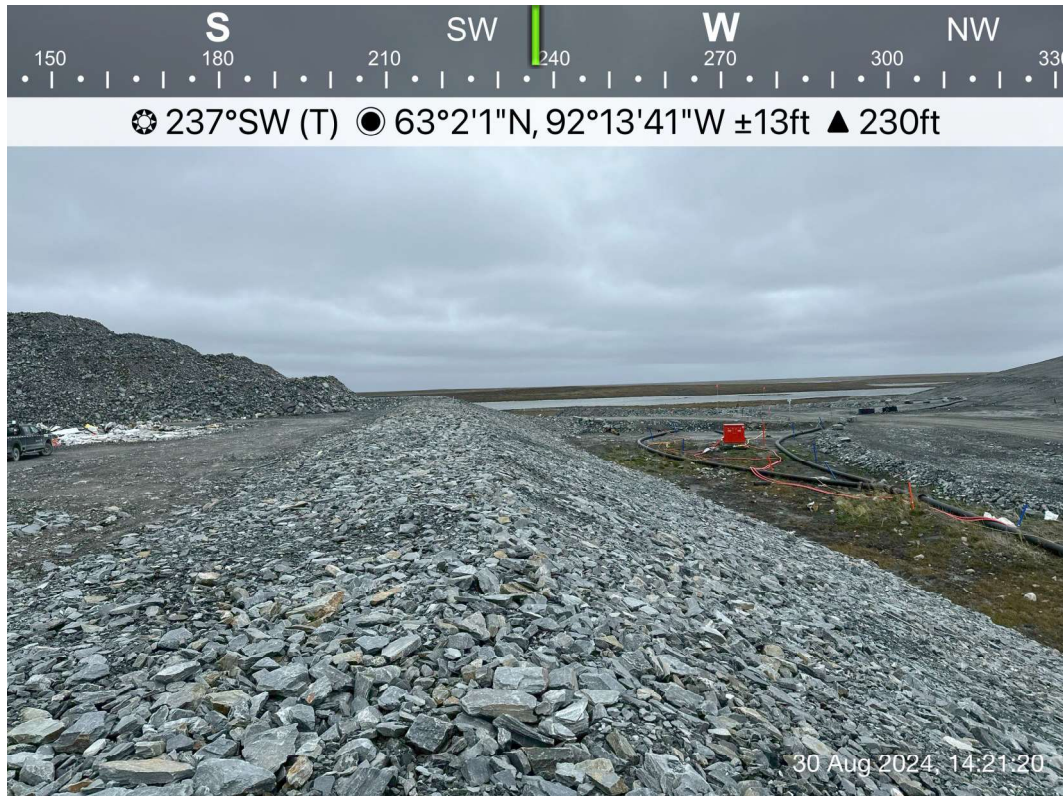
**Landfill - Photo 9:** WRSF1 Landfill - Landfill north side slope. Facing southwest.

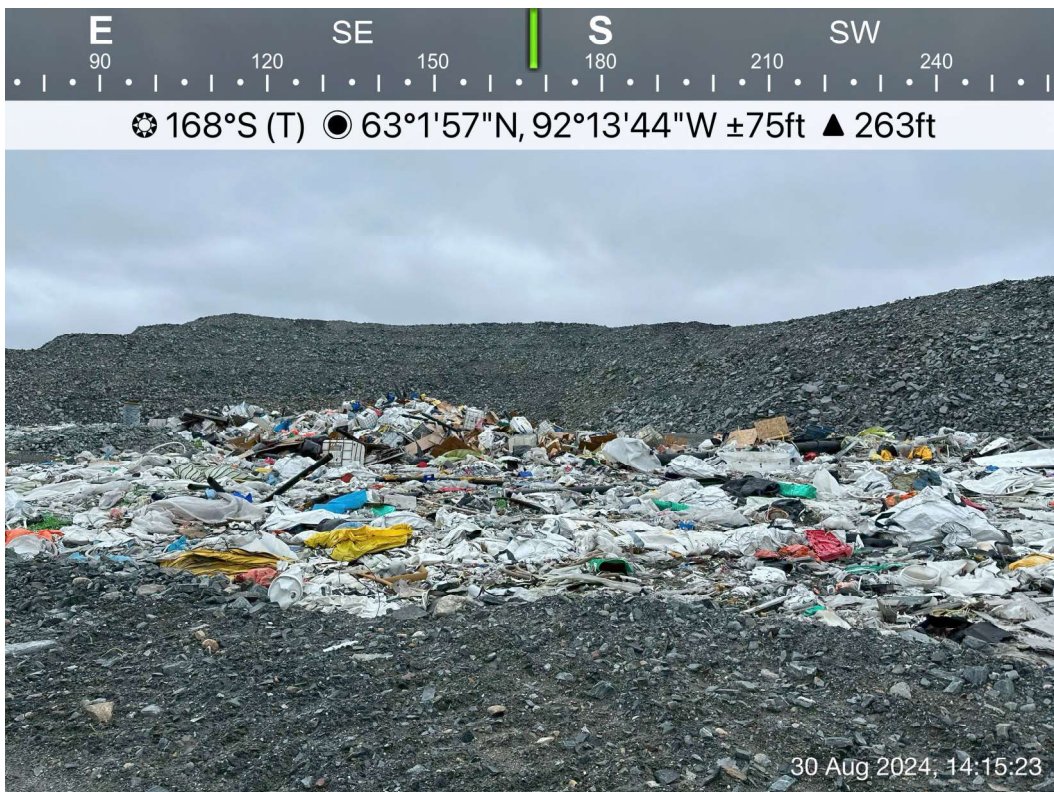
**Landfill - Photo 10:** WRSF1 Landfill - Landfill overview, waste and debris. Facing south.

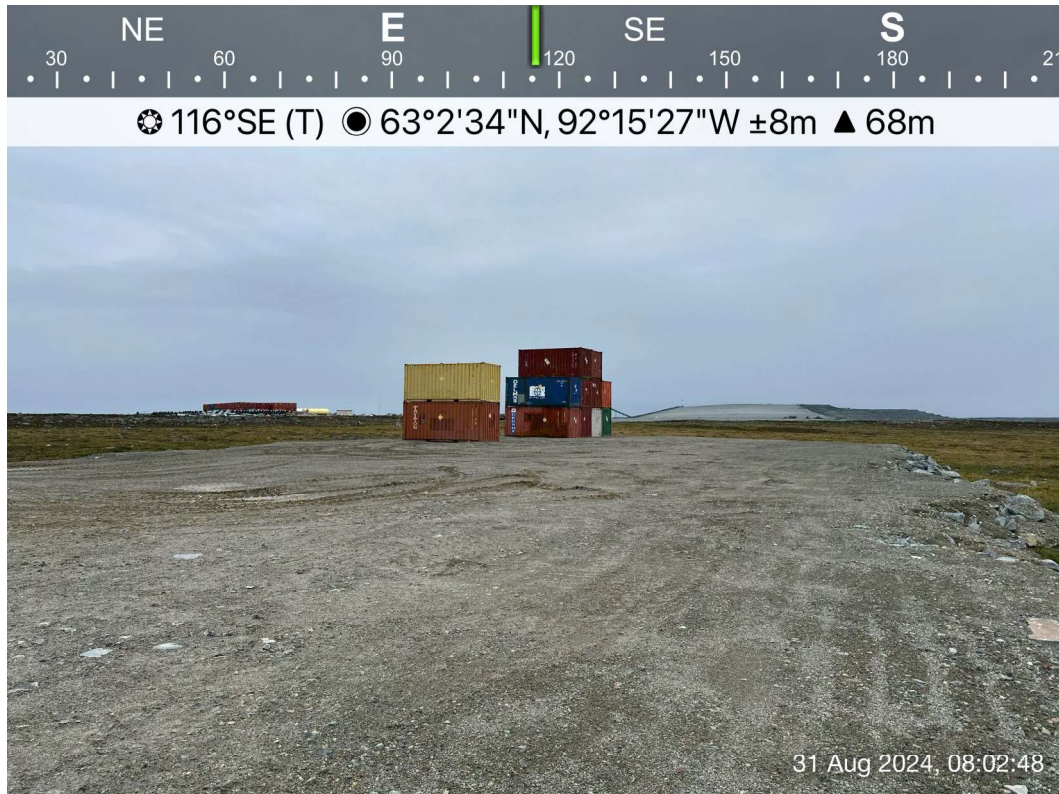
**Emulsion Plant Pad - Photo 11:** Emulsion Plant Pad - Overview of pad. Facing southeast.

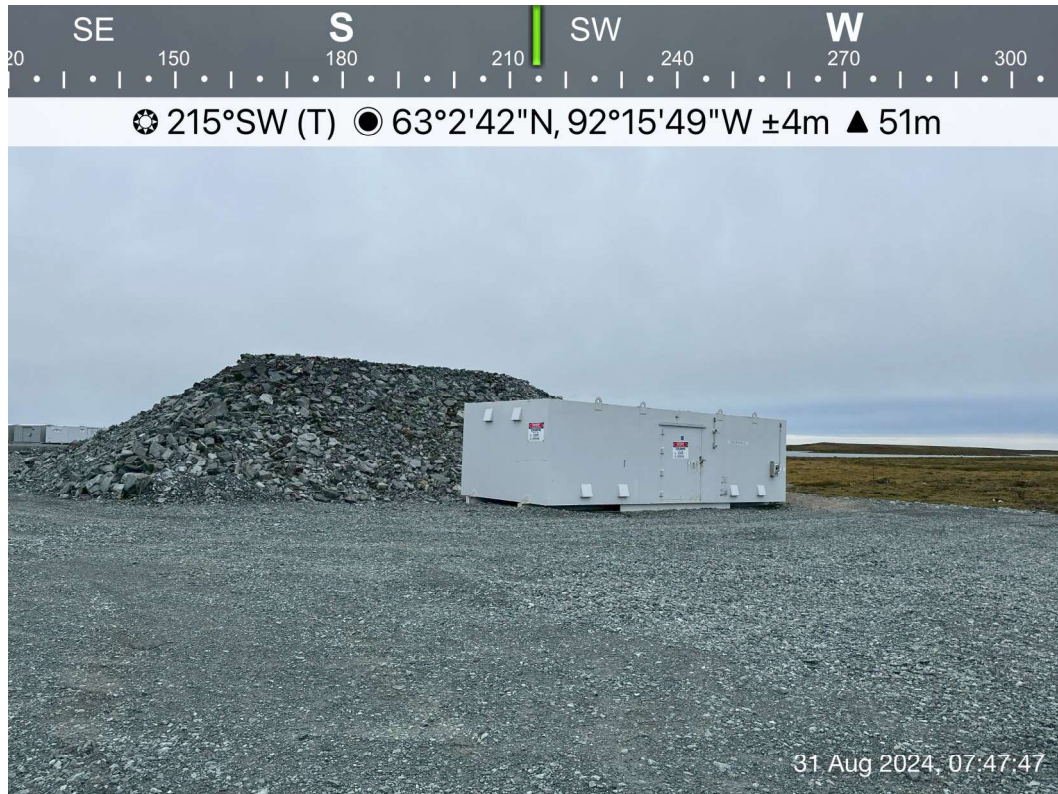
**Emulsion Plant Pad - Photo 13:** Emulsion Storage Pad - Overview of pad and storage. Facing southwest.

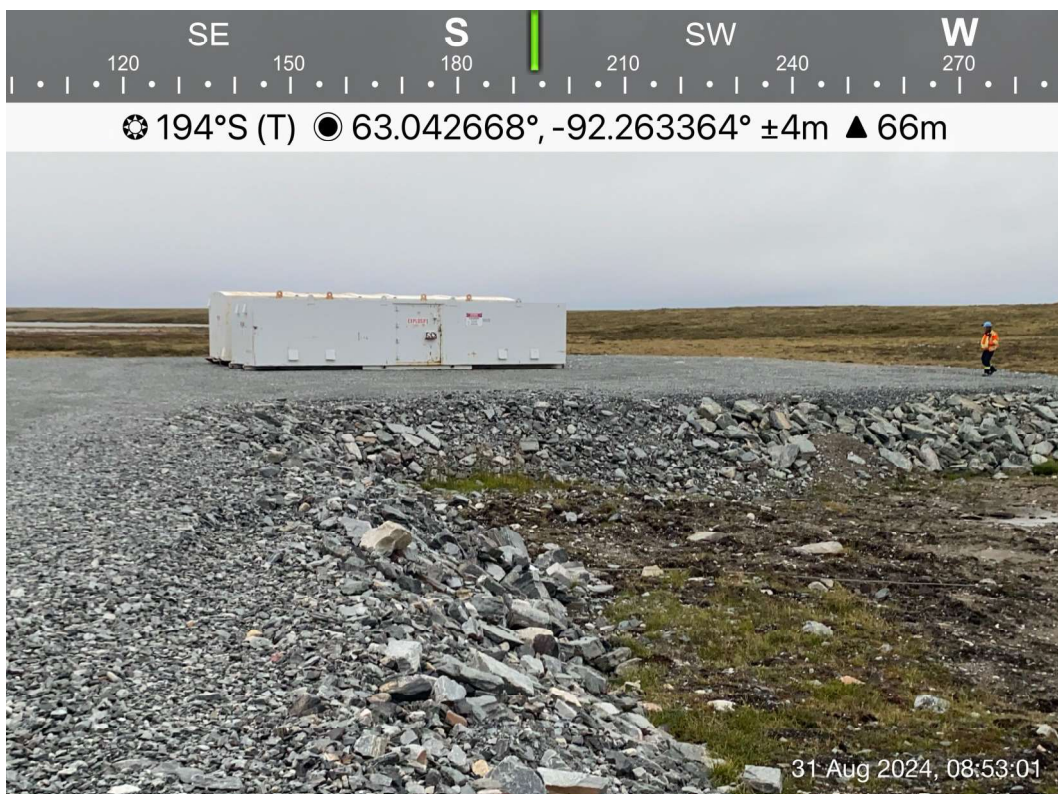
**Emulsion Plant Pad - Photo 14:** Emulsion Storage Pad - Overview of pad and storage. Facing south.

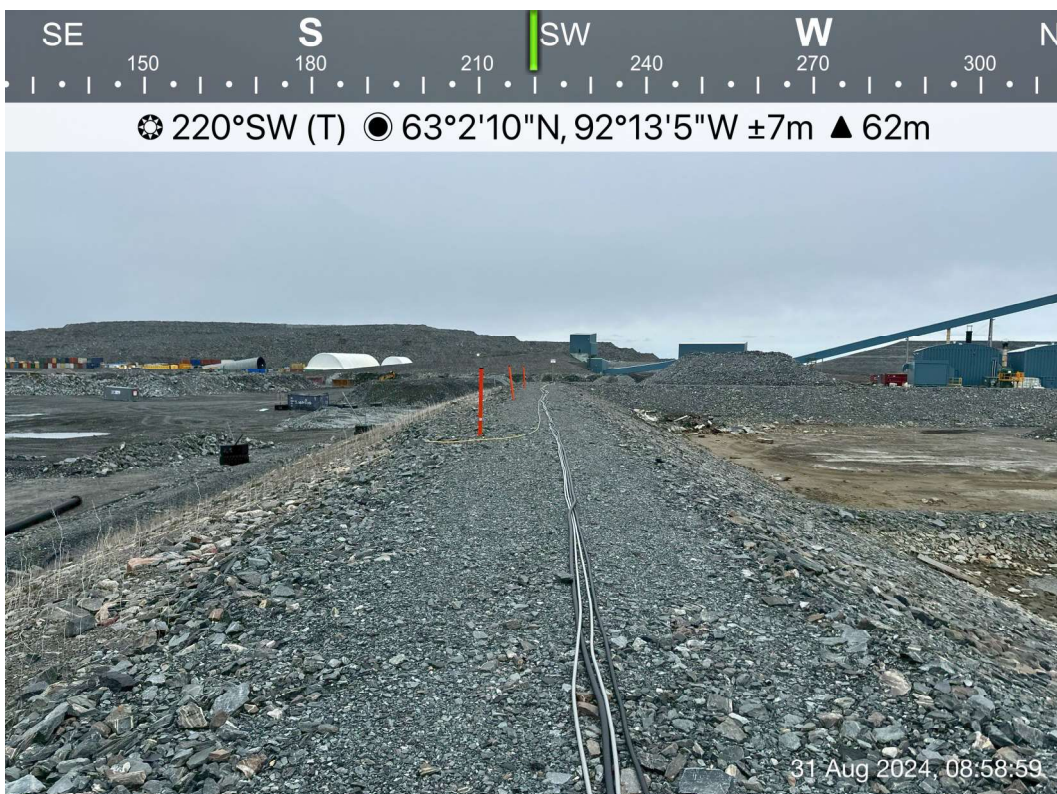
**Landfarm -  
Photo 16:**

Landfarm - Overview of perimeter berm crest. Facing southwest.

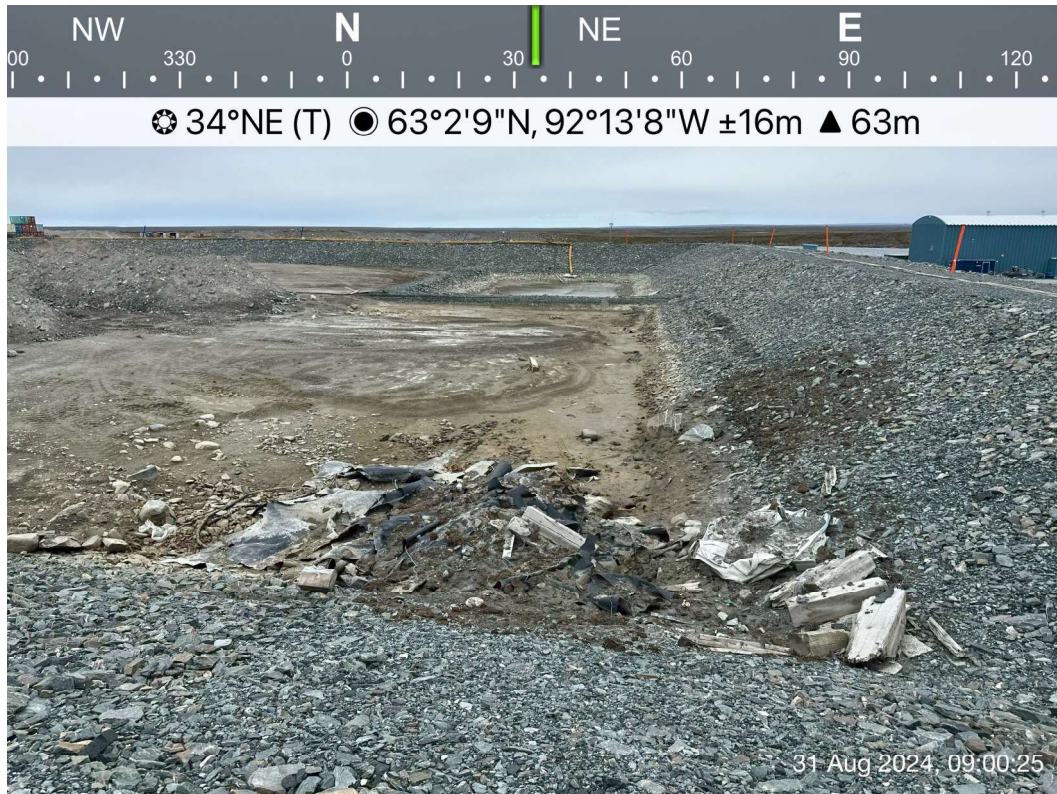
**Landfarm -  
Photo 17:**

Landfarm - Overview of landfarm. Facing northeast.

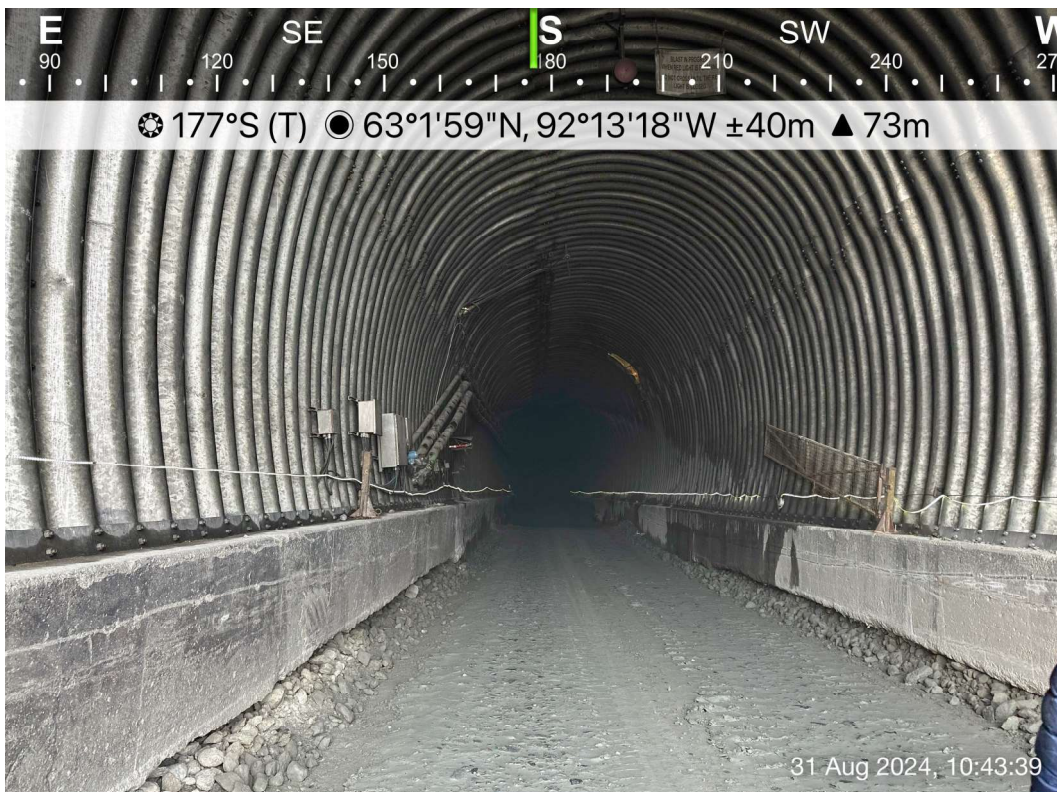
**Portal 2 -  
Photo 29:**

Portal 2 - Overview of Portal 2. Facing southeast.

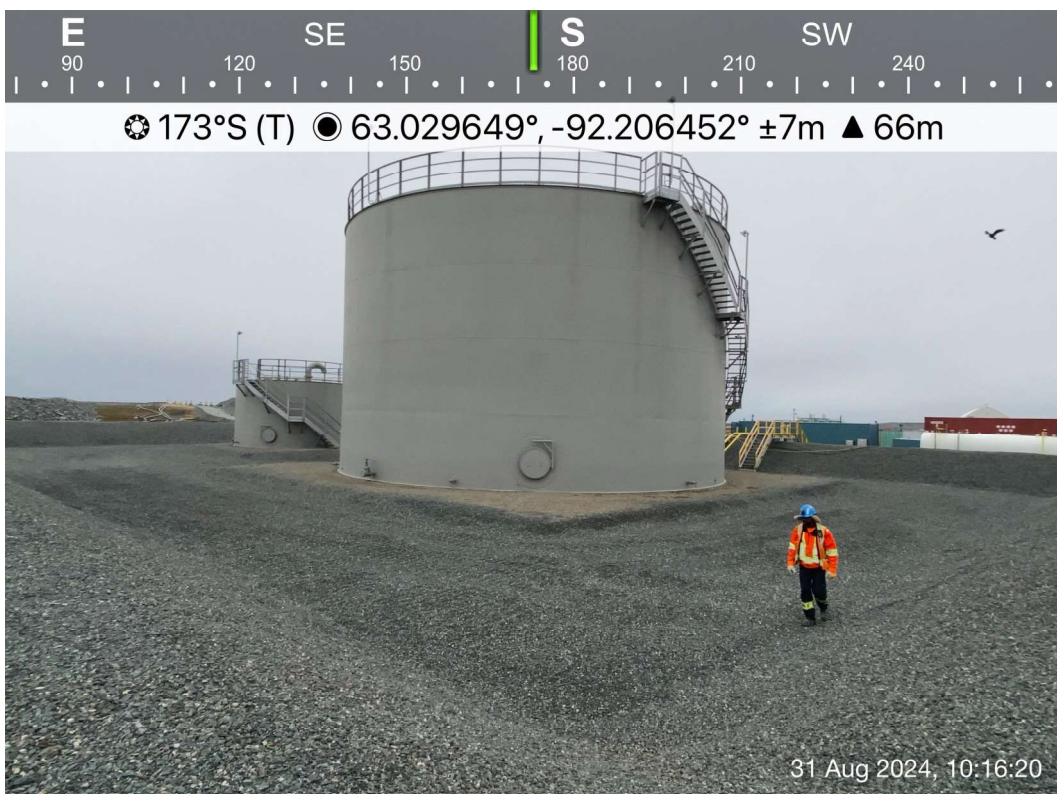
**3M Fuel Tanks - Photo 31:** 3M Fuel Tanks - Overview of 3M fuel tanks. Facing east.

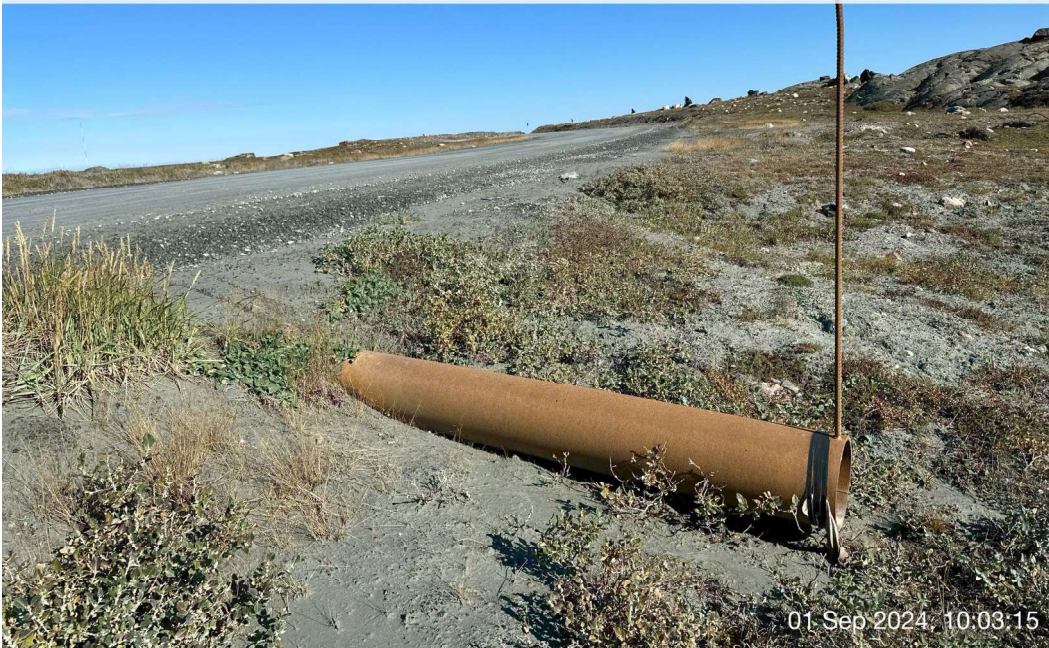
**AWAR Road/  
Culvert - Photo 2:** Culvert KM 4.9 - Outlet.

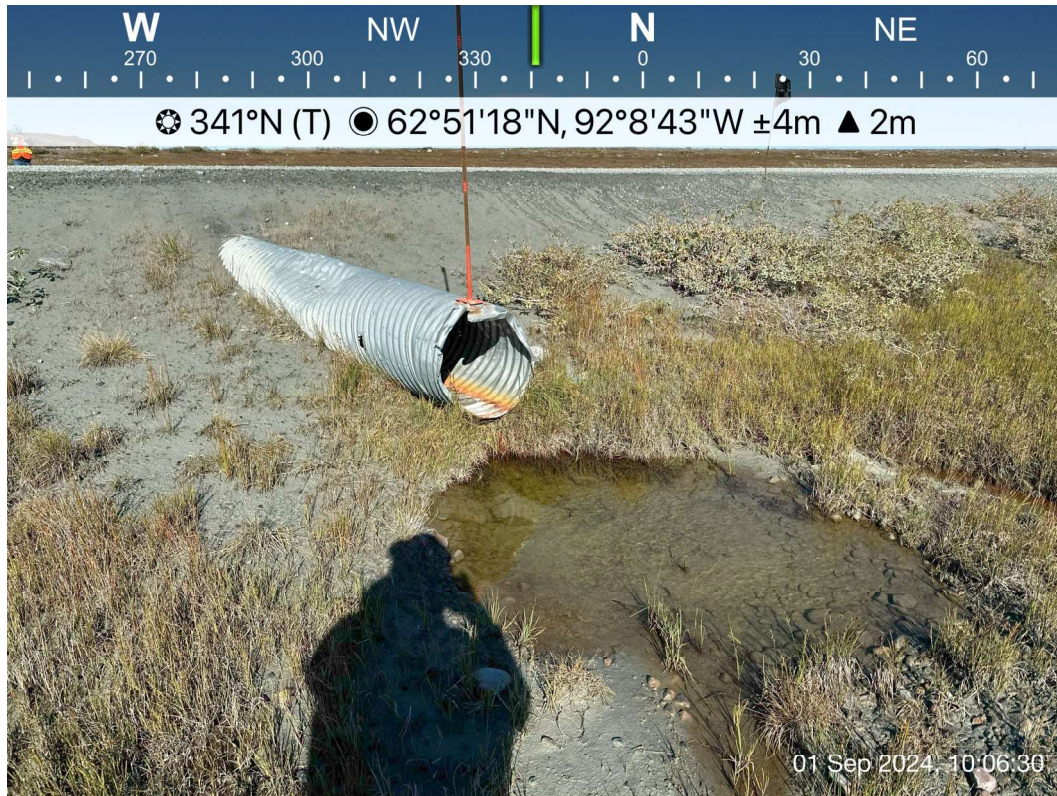
**AWAR Road/  
Culvert - Photo 3:** Culvert KM 5.5 - Inlet.

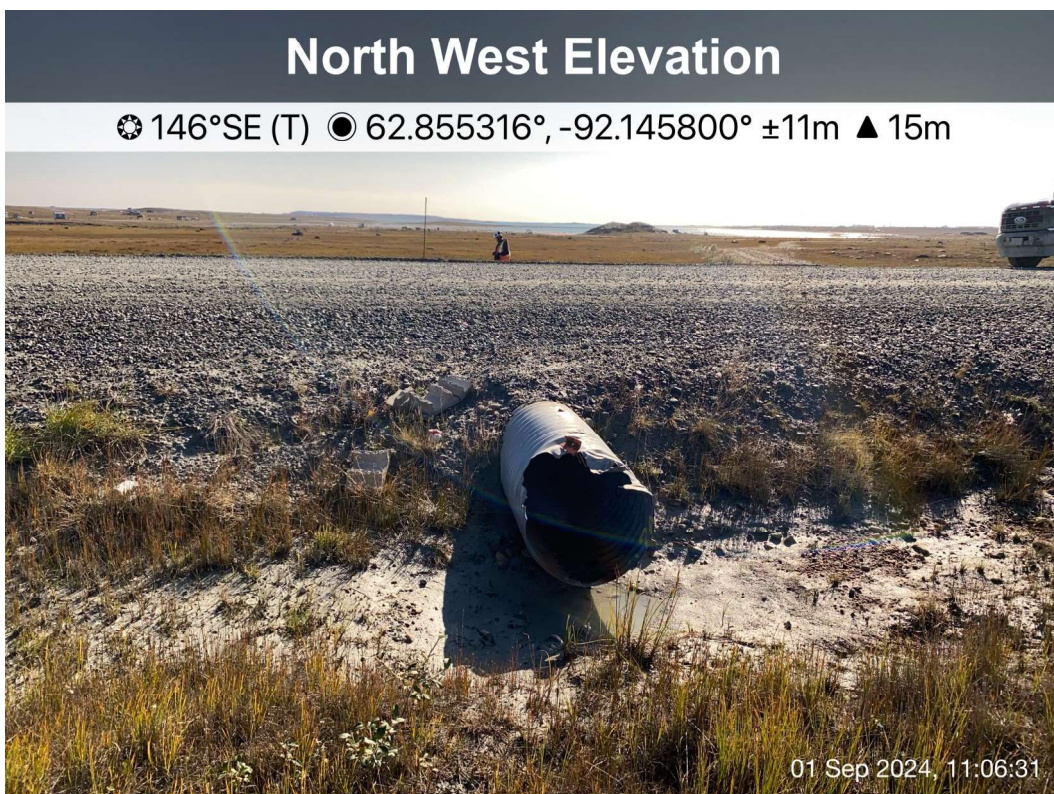
**AWAR Road/  
Culvert - Photo 4:** Culvert KM 5.5 - Outlet.

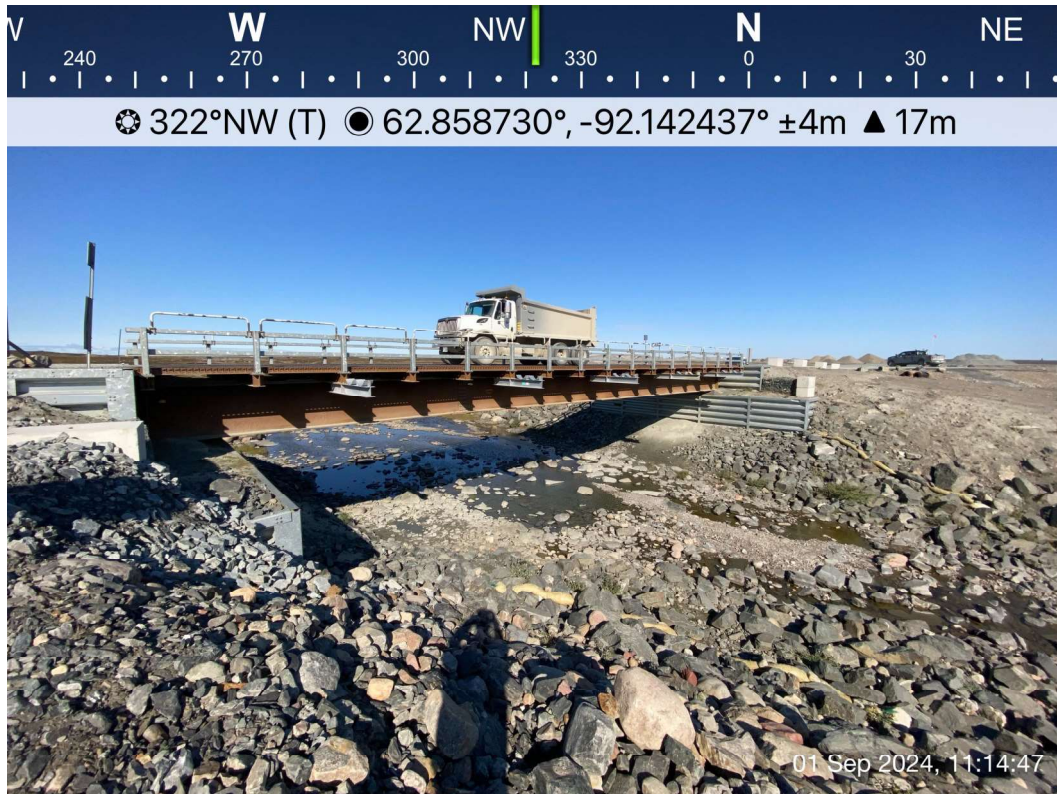
**AWAR Road/  
Culvert - Photo 5:** Char River Bridge KM 6.0 - Overview.

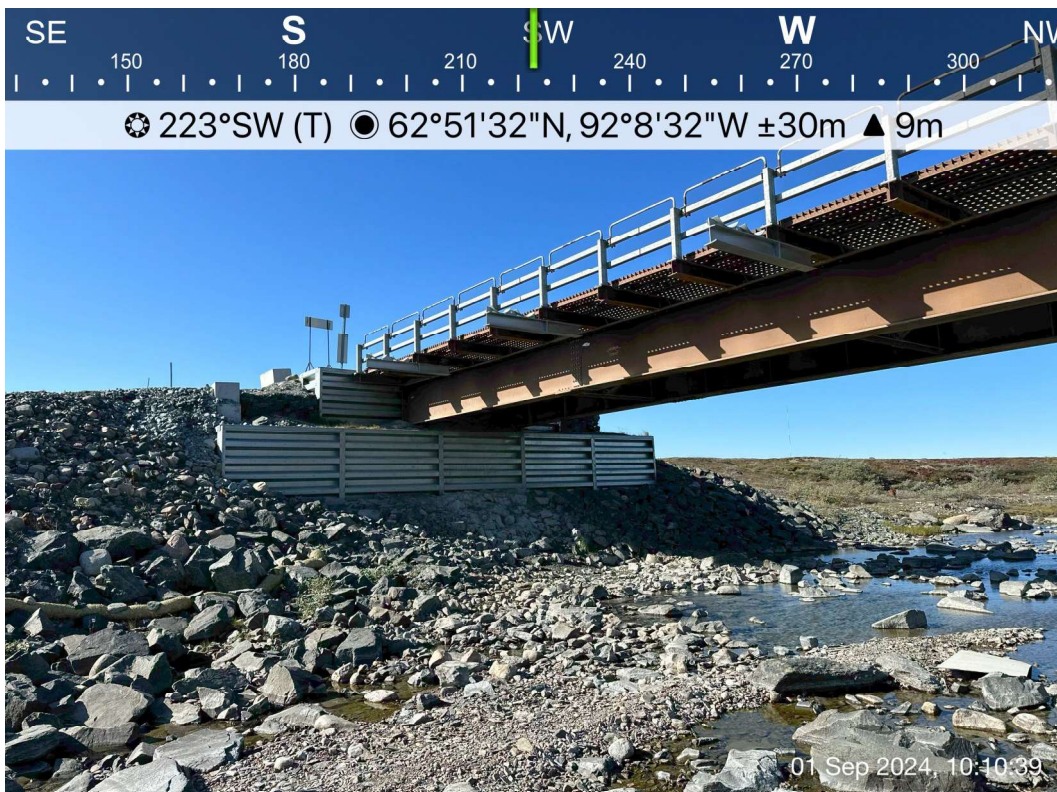
**AWAR Road/  
Culvert - Photo 6:** Char River Bridge KM 6.0 - South Abutment.

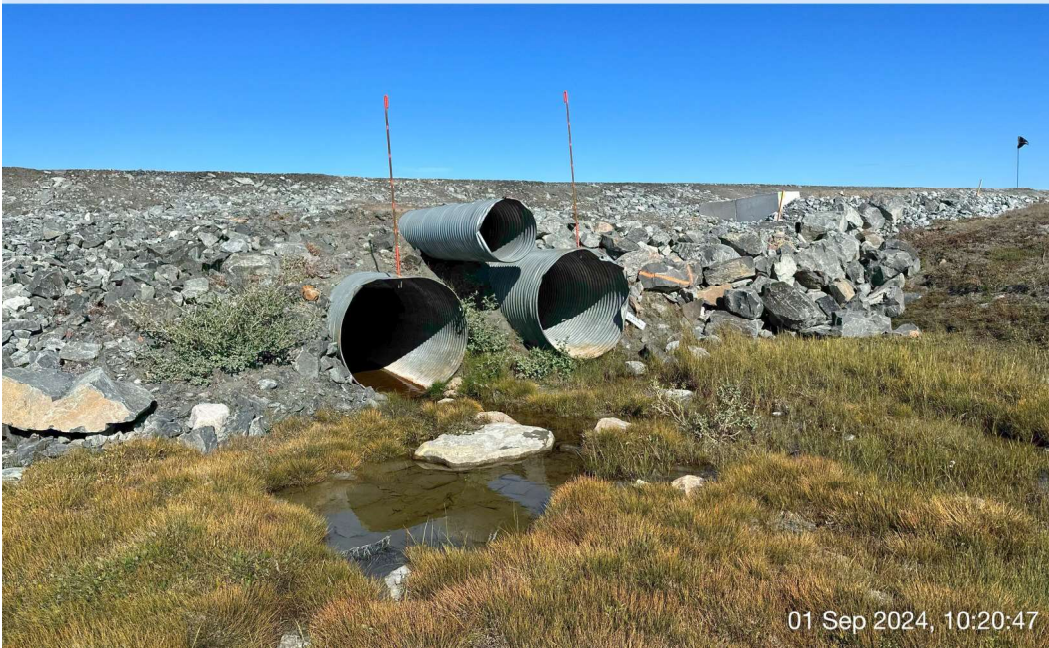
**AWAR Road/  
Culvert - Photo 8:** Culvert KM 6.2 - Inlet.

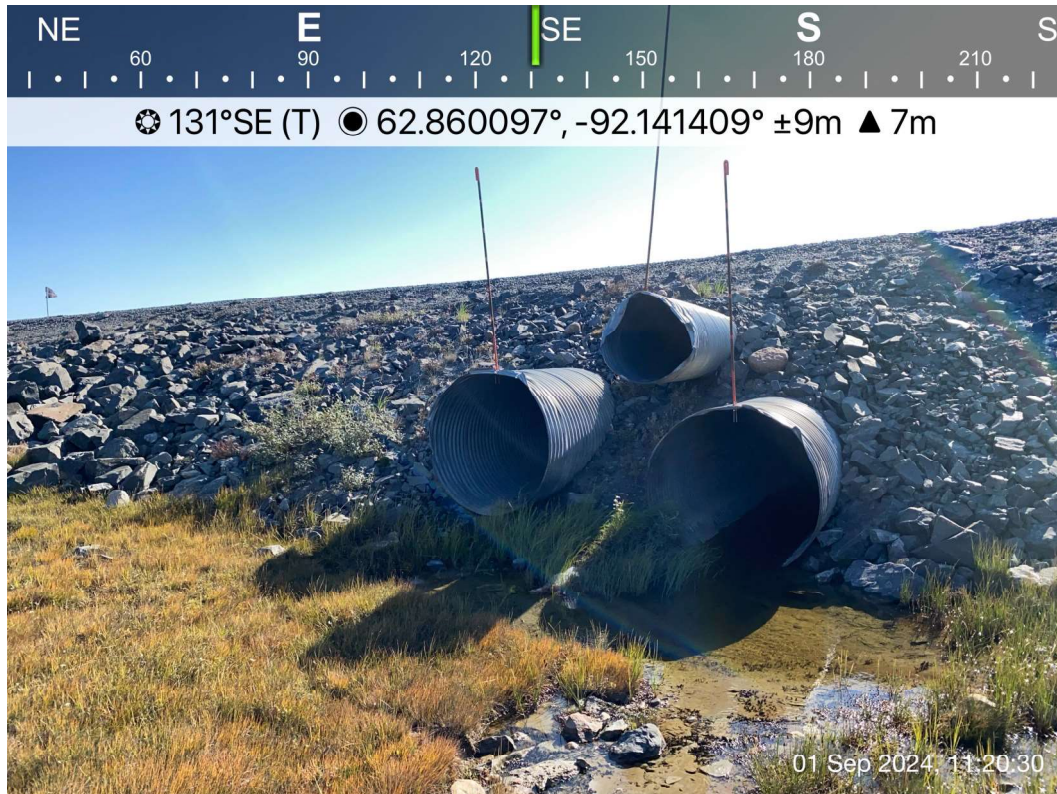
**AWAR Road/** Culvert KM 6.2 - Outlet.  
**Culvert - Photo 9:**

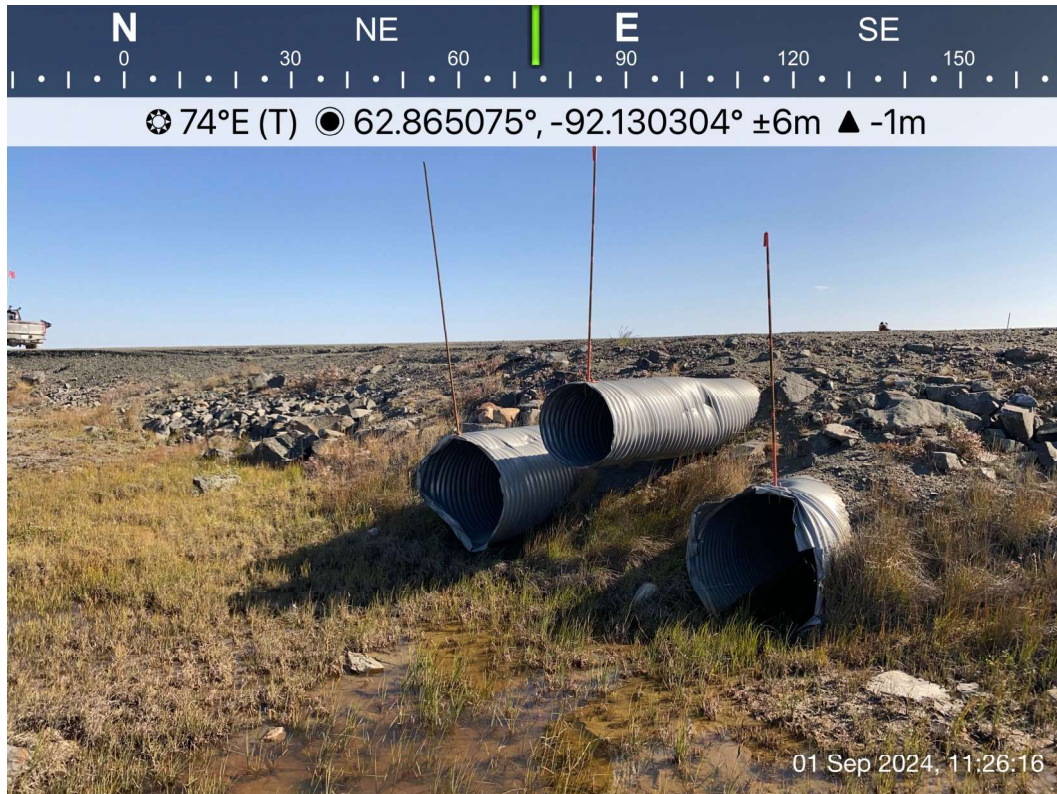
**AWAR Road/  
Culvert - Photo 11:** Culvert KM 7.0 - Outlet.

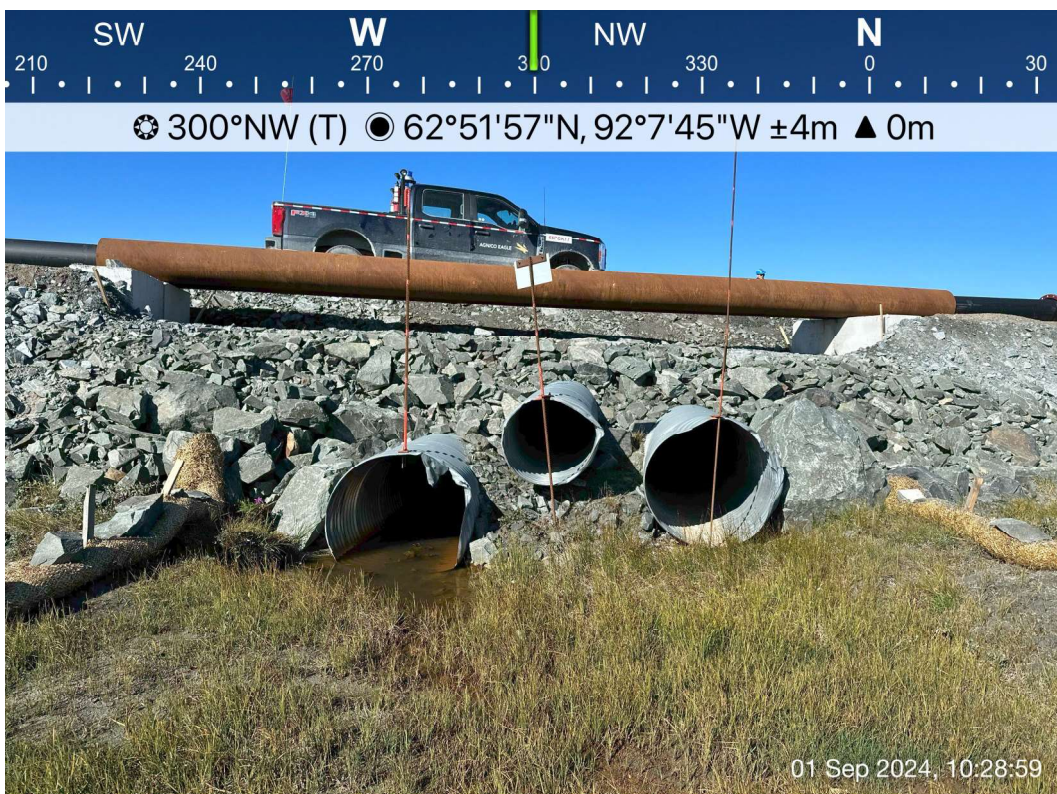
**AWAR Road/  
Culvert - Photo 12:** Culvert KM 7.1 - Inlet.

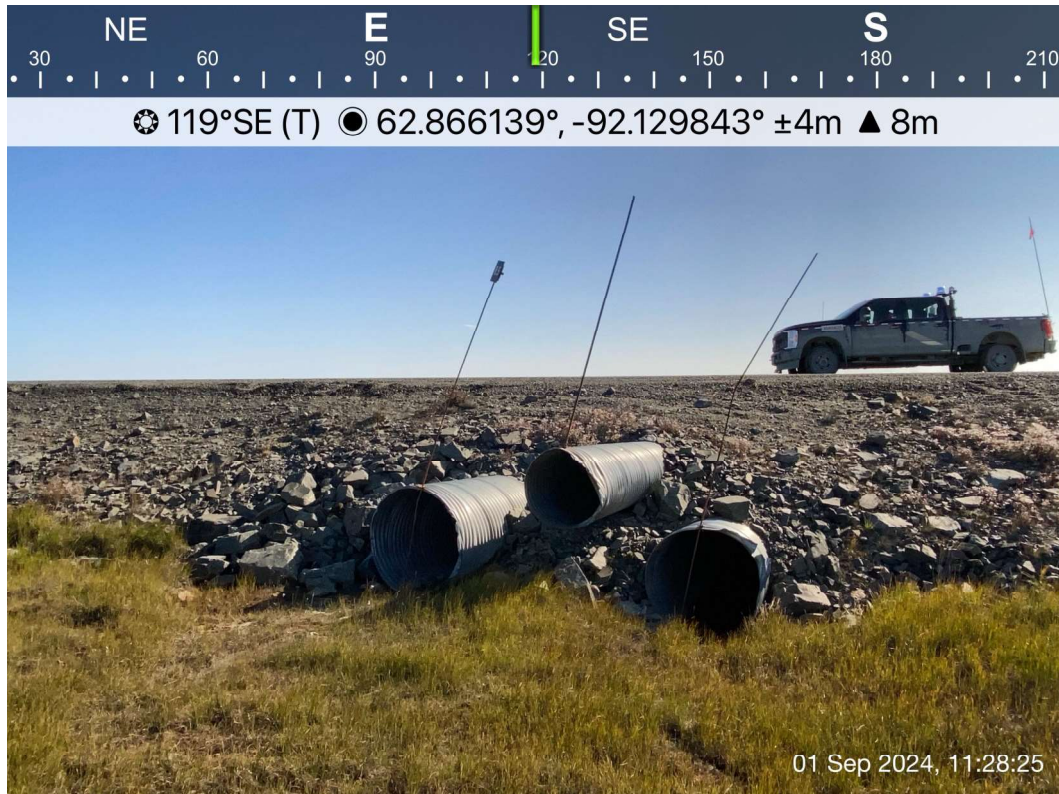
**AWAR Road/  
Culvert - Photo 13:** Culvert KM 7.1 - Outlet.

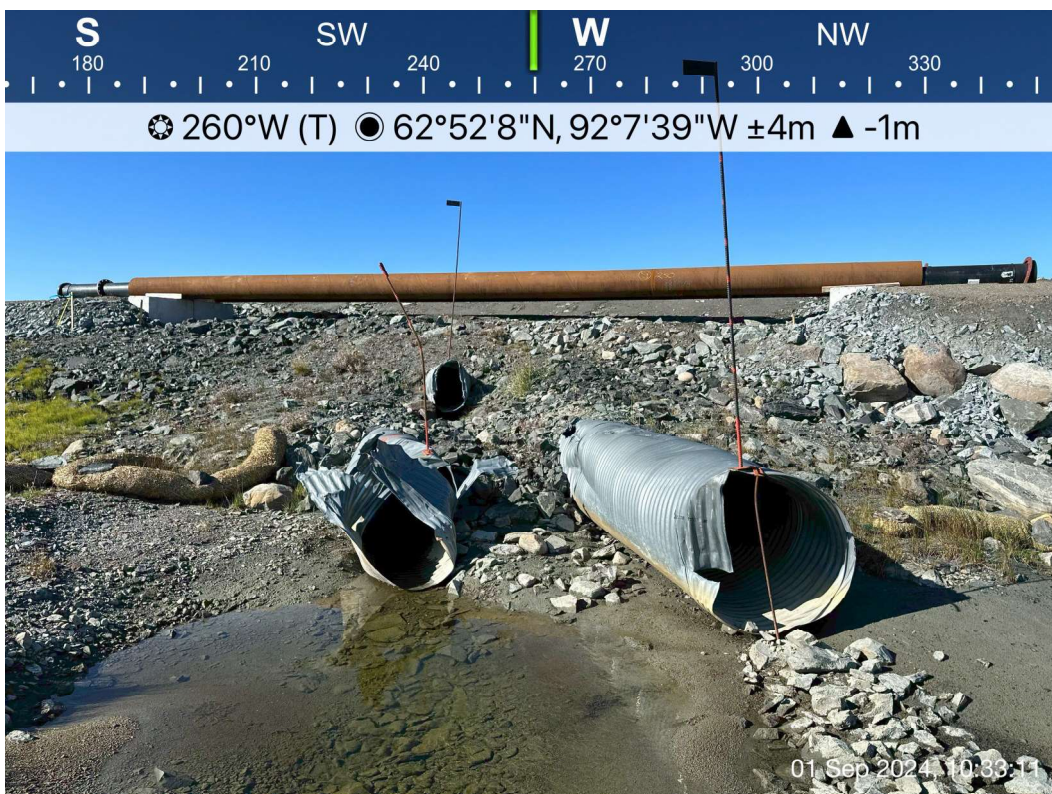
**AWAR Road/  
Culvert - Photo 14:** Culvert KM 7.4 - Inlet.

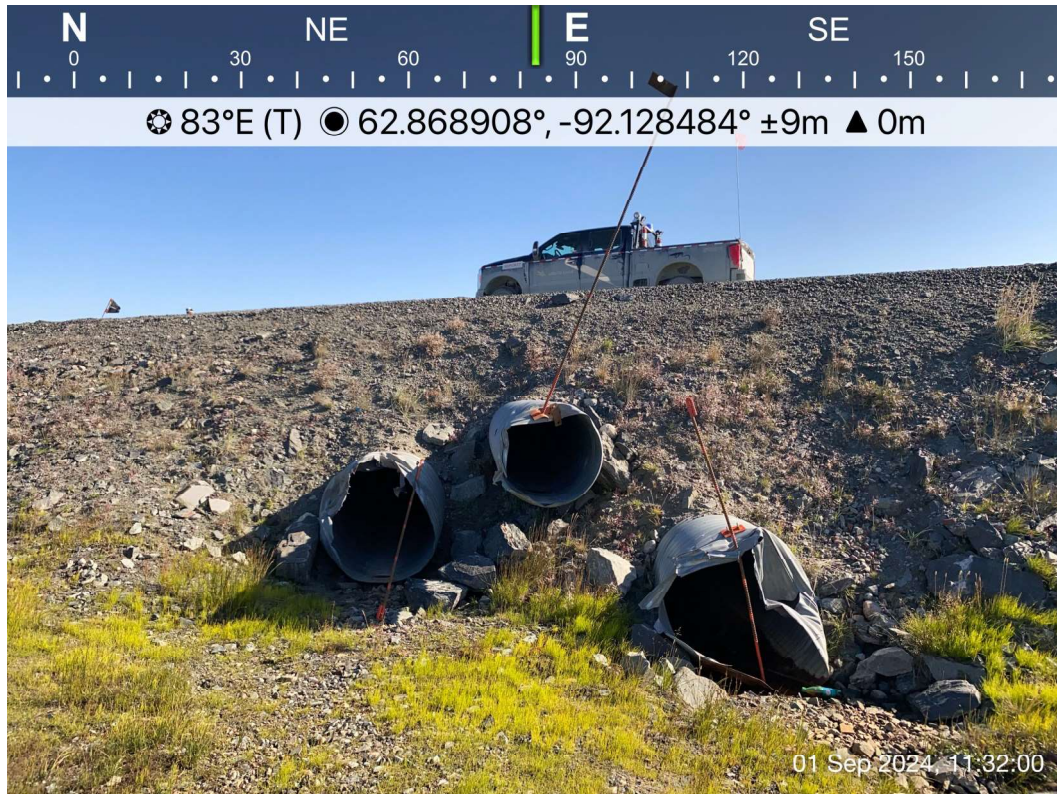
**AWAR Road/  
Culvert - Photo 15:** Culvert KM 7.4 - Outlet.
