## **APPENDIX 6      2024 ANNUAL GEOTECHNICAL INSPECTION REPORT**

## 2024 Annual Geotechnical Inspection Meliadine Gold Mine, Nunavut, Canada

PRESENTED TO  
**Agnico Eagle Mines Limited**

MARCH 11, 2025  
ISSUED FOR USE-REVISION 1  
FILE: 704-ENG.EARC03140-39  
AGNICO EAGLE DOCUMENT NUMBER: 65-600-230-TCR-002

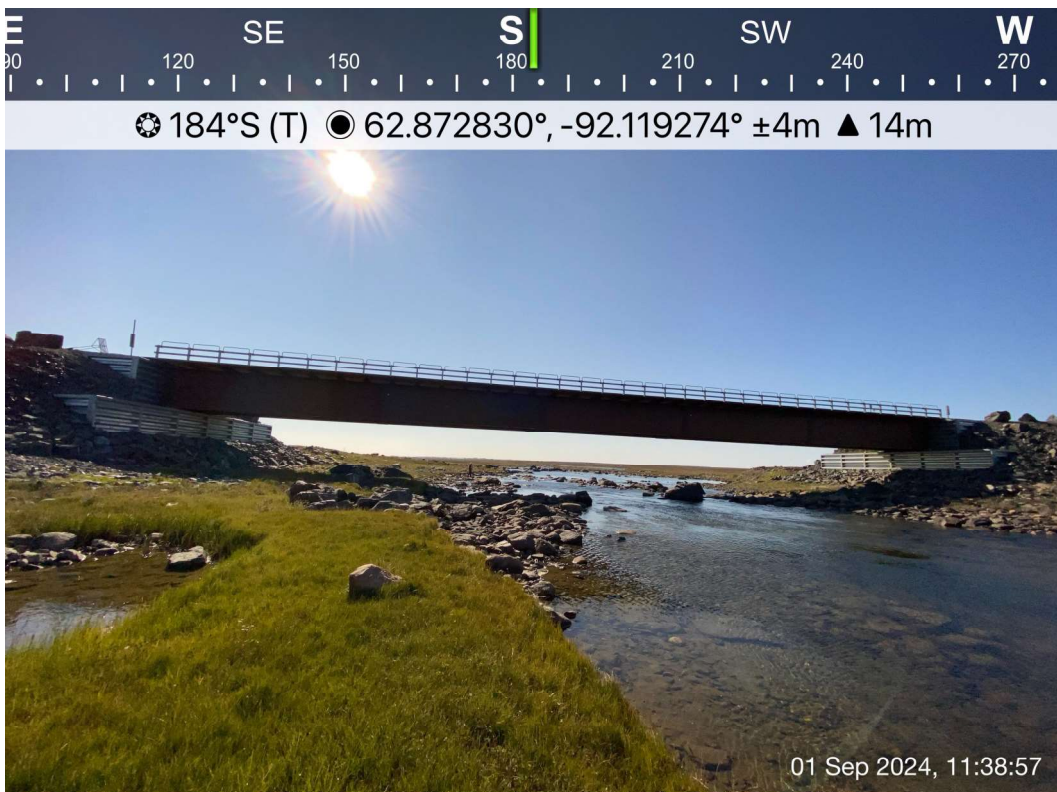
**AWAR Road/  
Culvert - Photo 16:** Meliadine River Bridge KM 8.0.

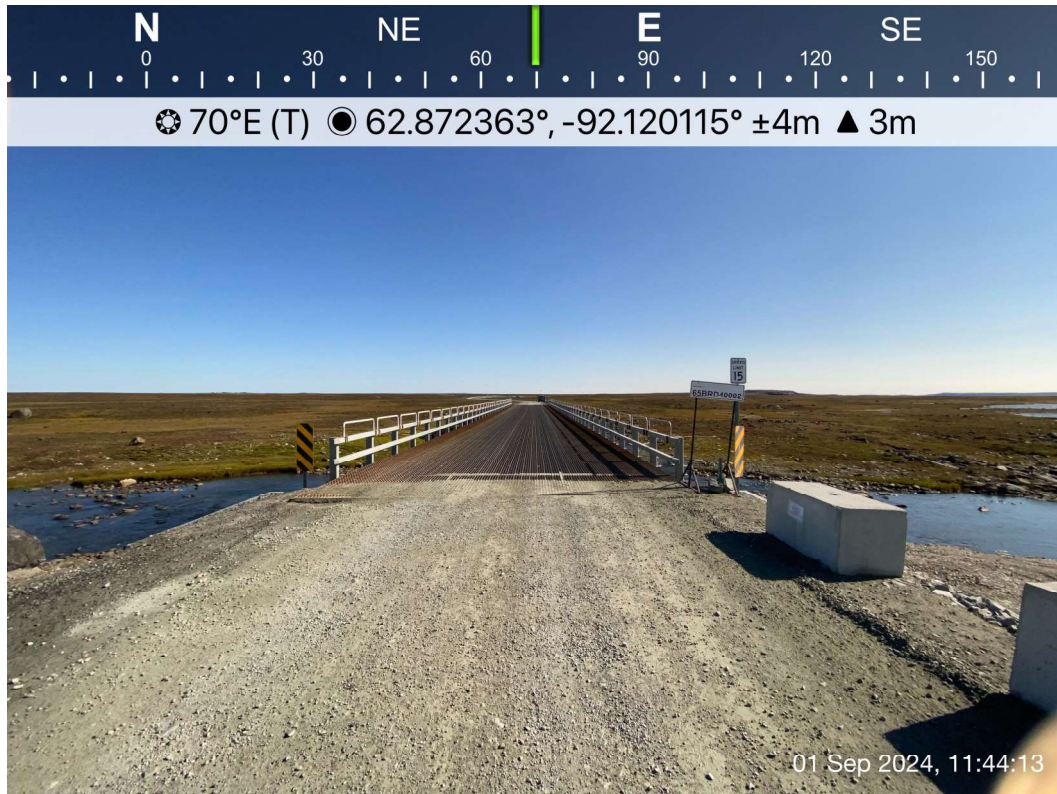
**AWAR Road/  
Culvert - Photo 17:** Meliadine River Bridge KM 8.0.

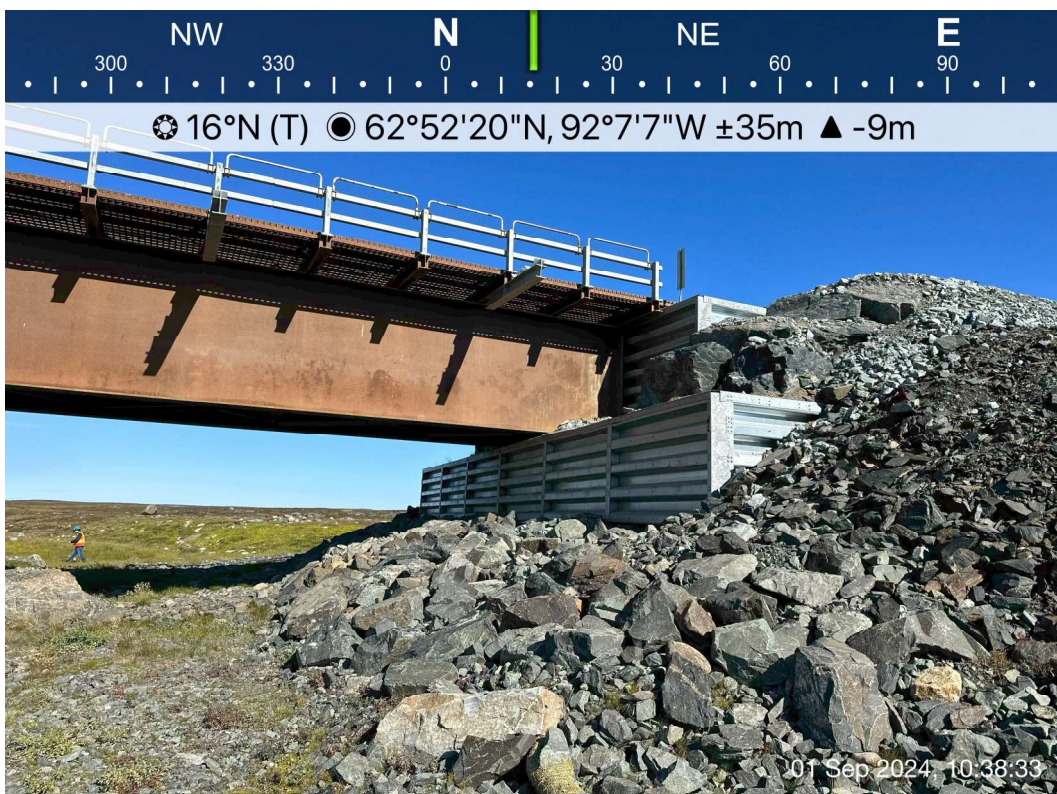
**AWAR Road/  
Culvert - Photo 18:** Meliadine River Bridge KM 8.0 - East abutment.

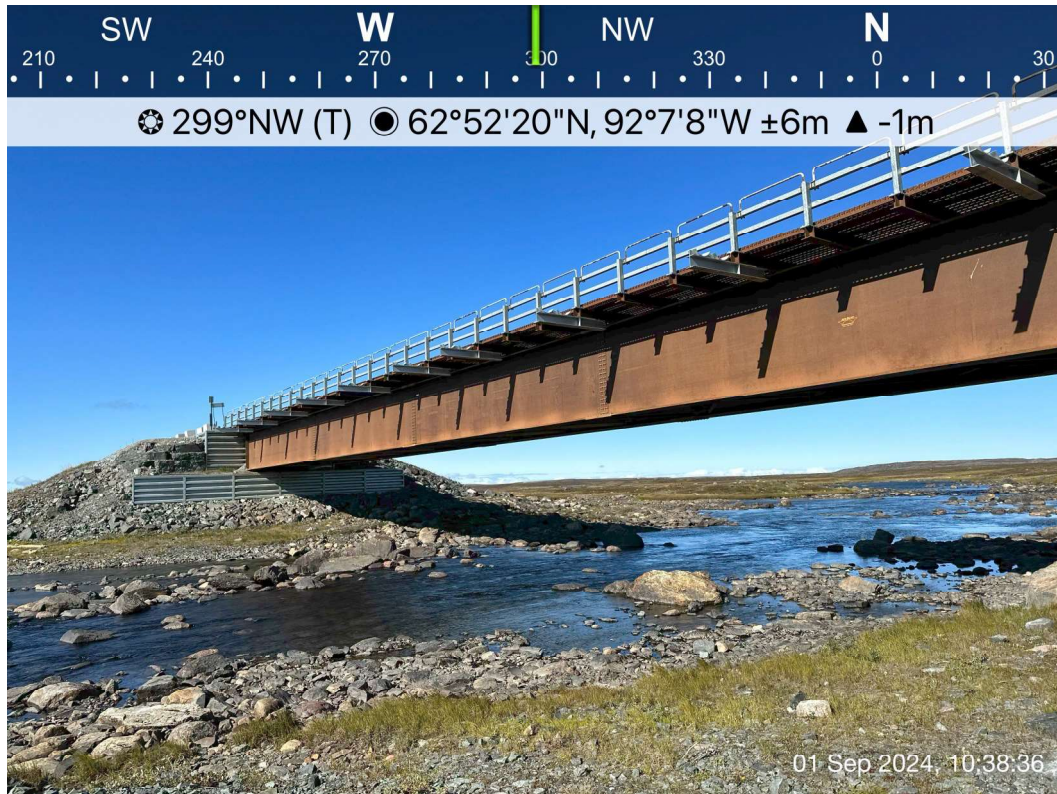
**AWAR Road/  
Culvert - Photo 19:** Meliadine River Bridge KM 8.0 - West abutment.

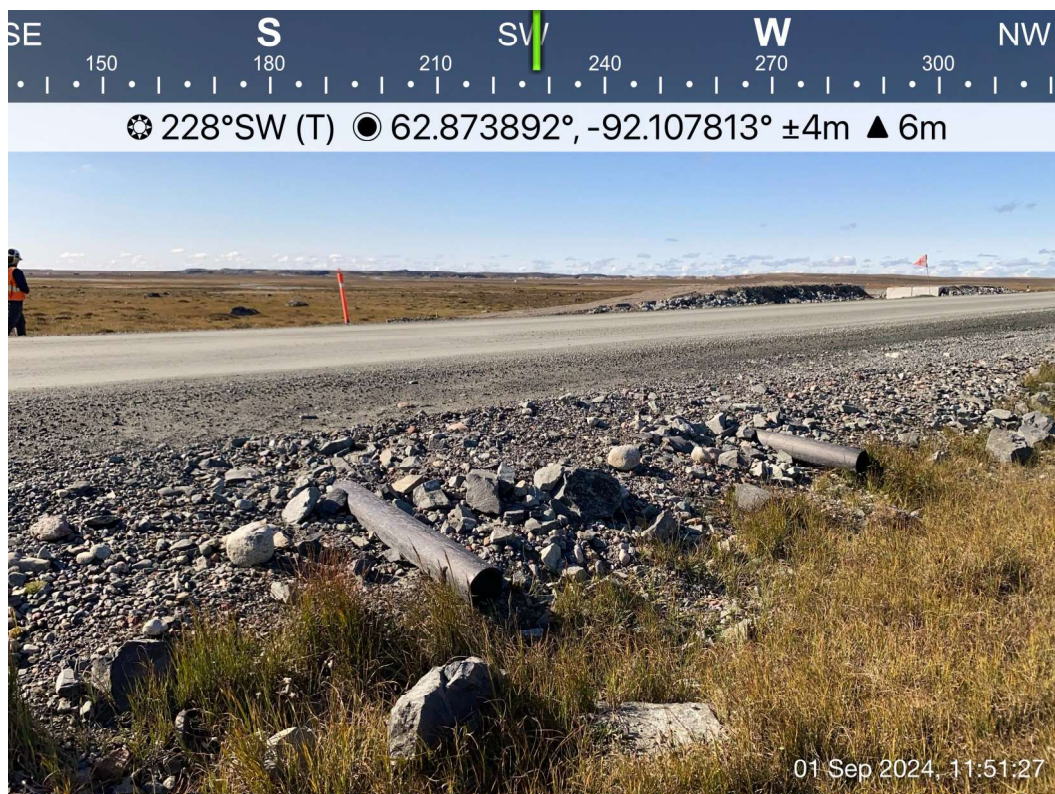
**AWAR Road/  
Culvert - Photo 20:** Culvert KM 8.8 - Inlet.

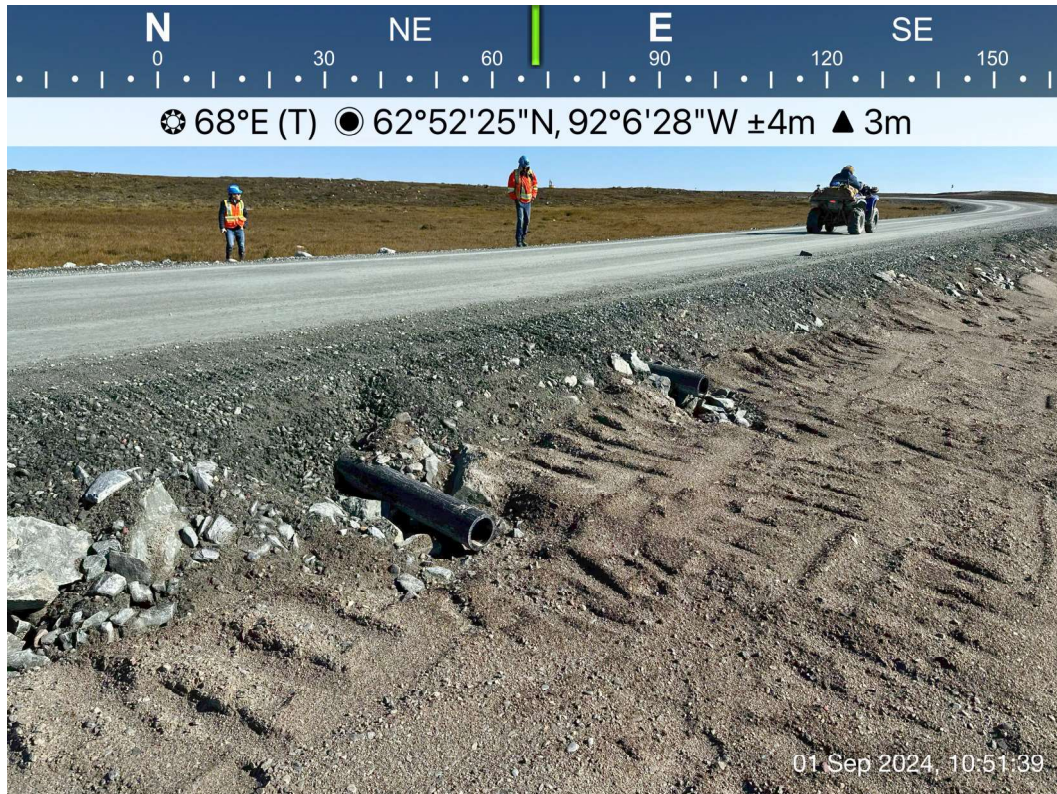
**AWAR Road/  
Culvert - Photo 21:** Culvert KM 8.8 - Outlet.

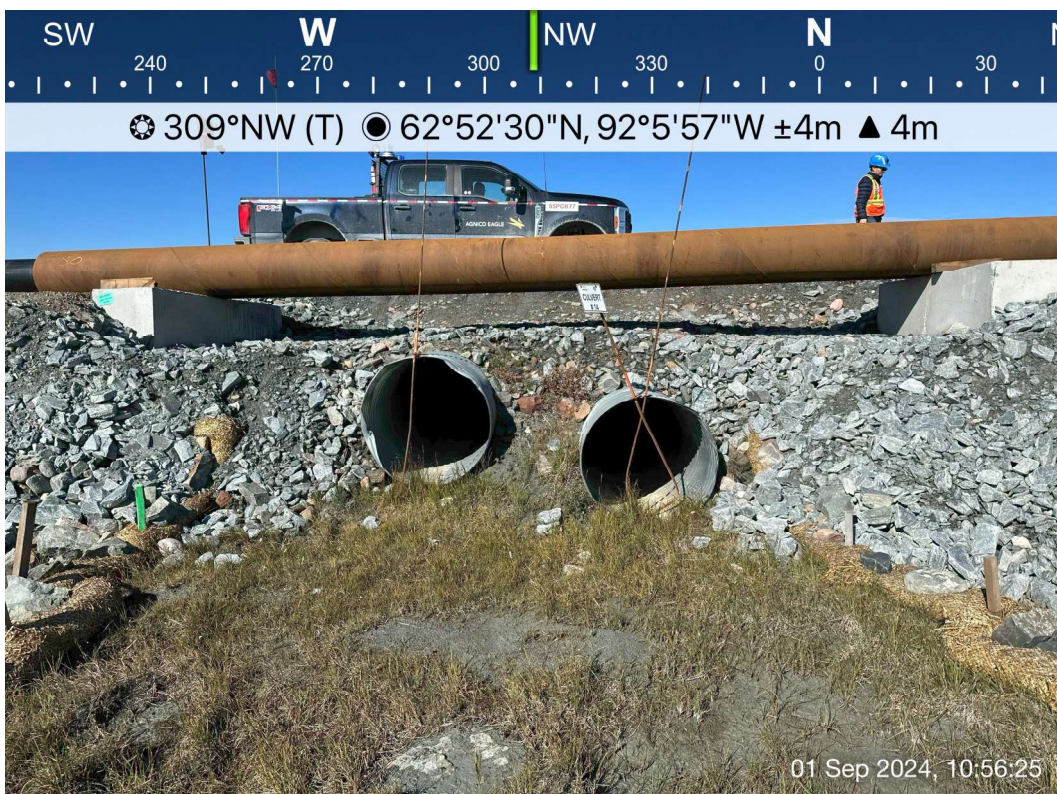
**AWAR Road/  
Culvert - Photo 22:** Culvert KM 9.1 - Inlet.

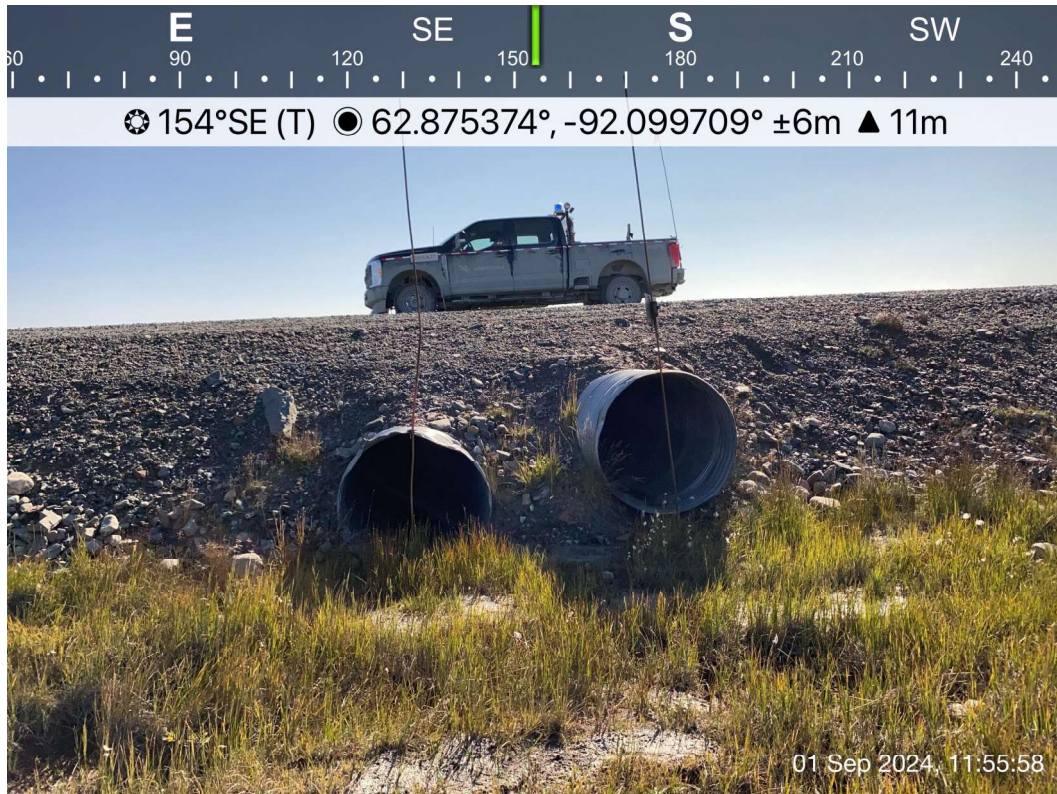
**AWAR Road/  
Culvert - Photo 23:** Culvert KM 9.1 - Outlet.

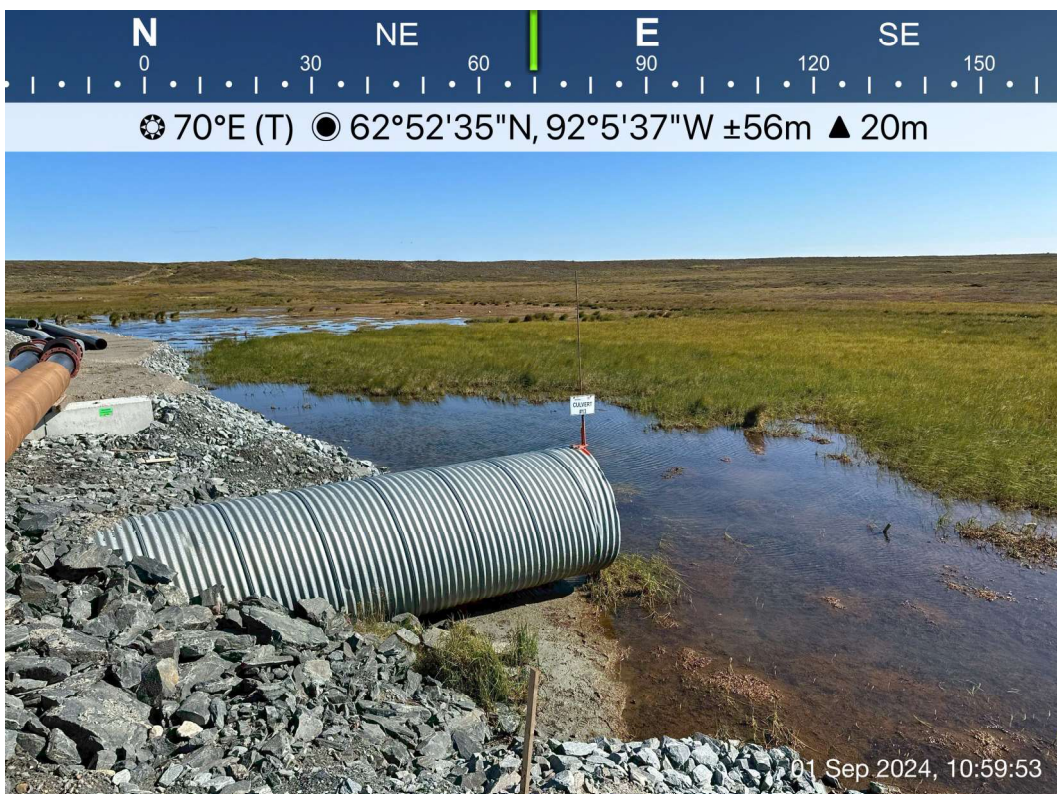
**AWAR Road/  
Culvert - Photo 24:** Culvert KM 9.5 - Inlet.

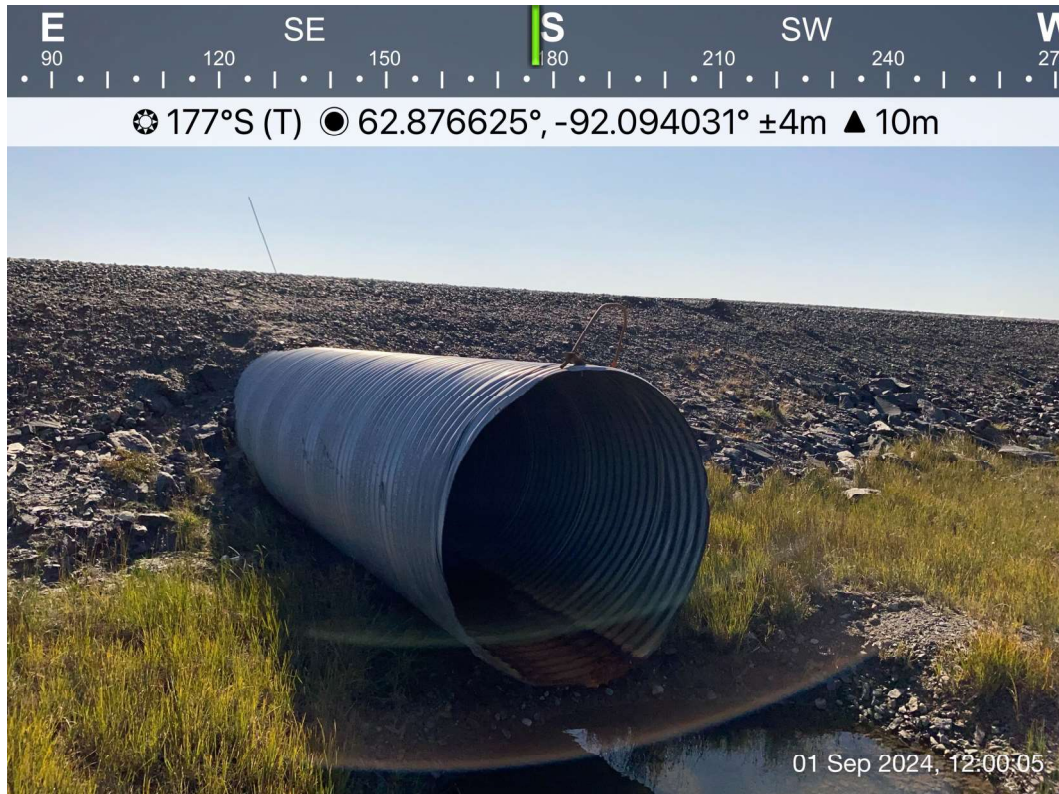
**AWAR Road/  
Culvert - Photo 25:** Culvert KM 9.5 - Outlet.

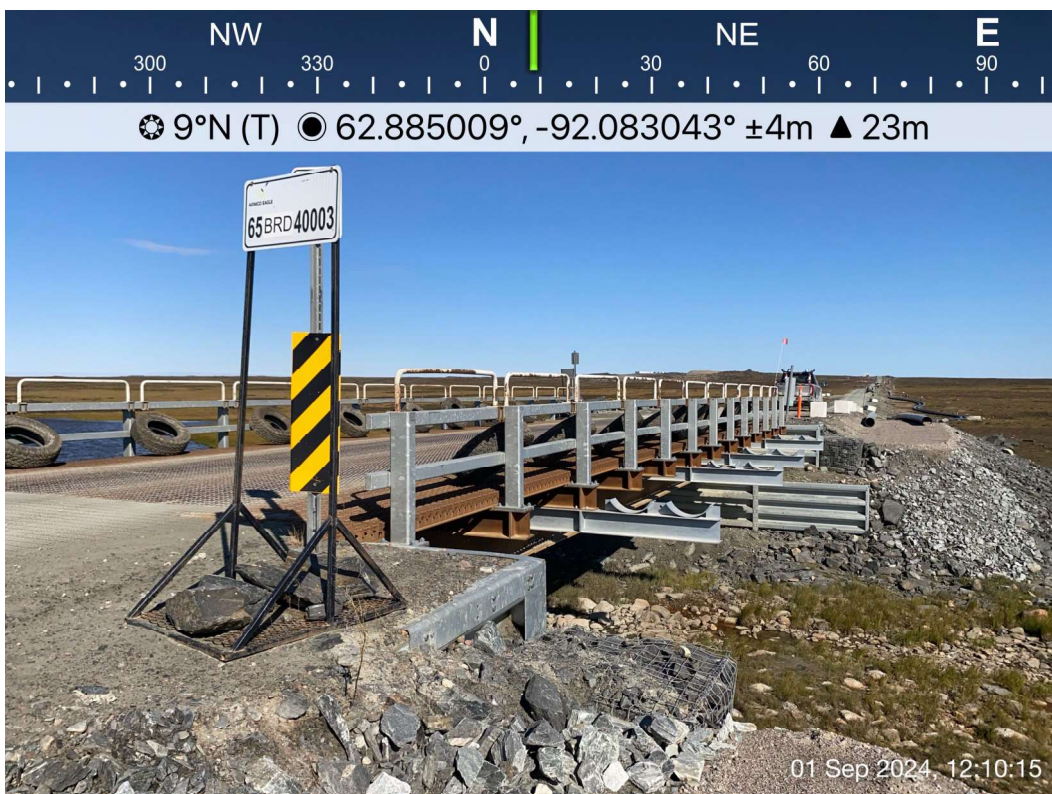
**AWAR Road/  
Culvert - Photo 26:** M-5 Bridge KM 10.5.

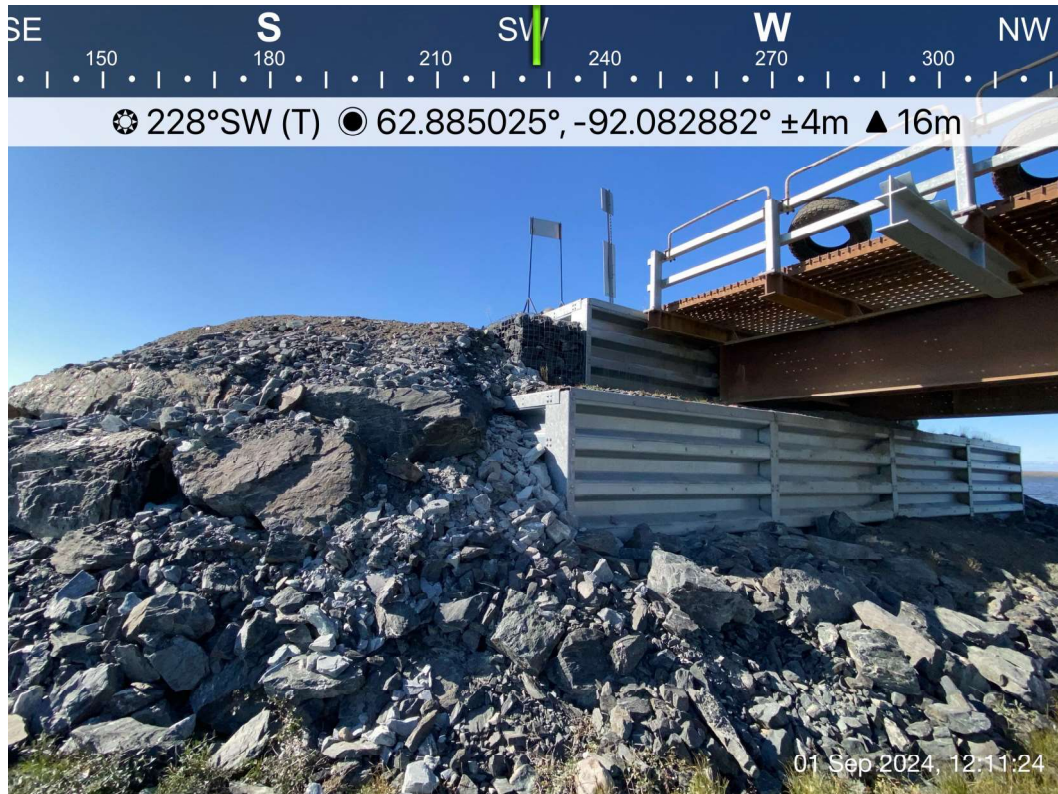
**AWAR Road/  
Culvert - Photo 27:** M-5 Bridge KM 10.5 - South abutment.

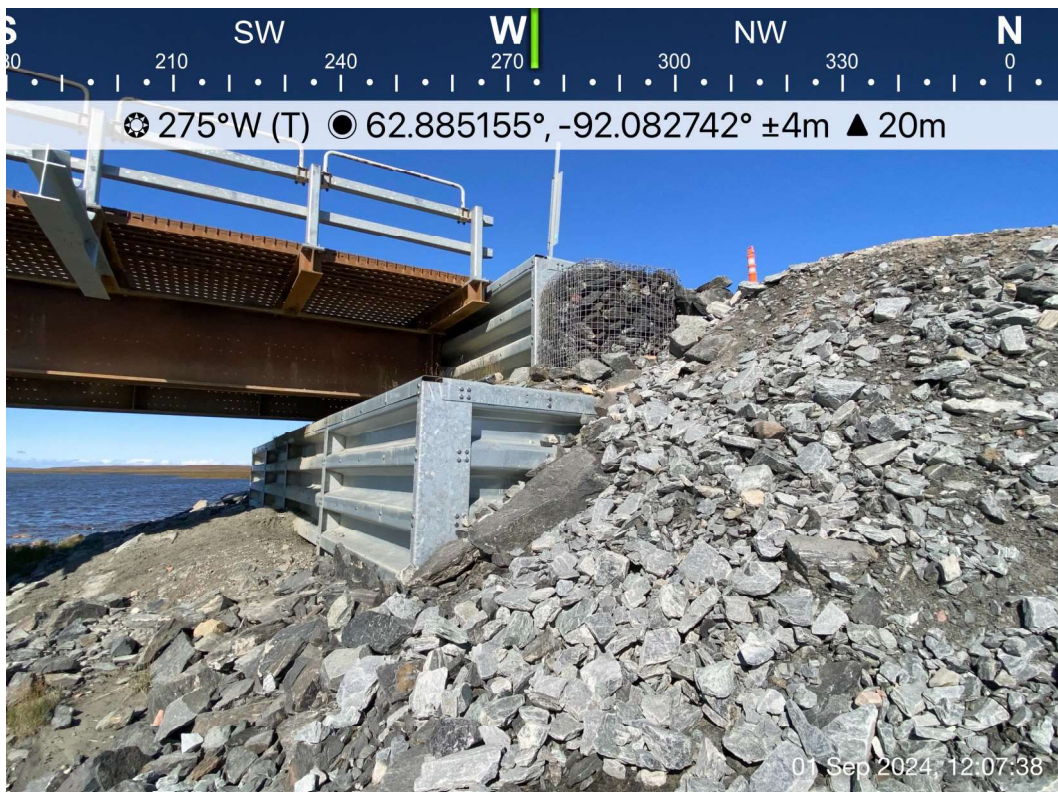
**AWAR Road/  
Culvert - Photo 28:** M-5 Bridge KM 10.5 - North abutment.

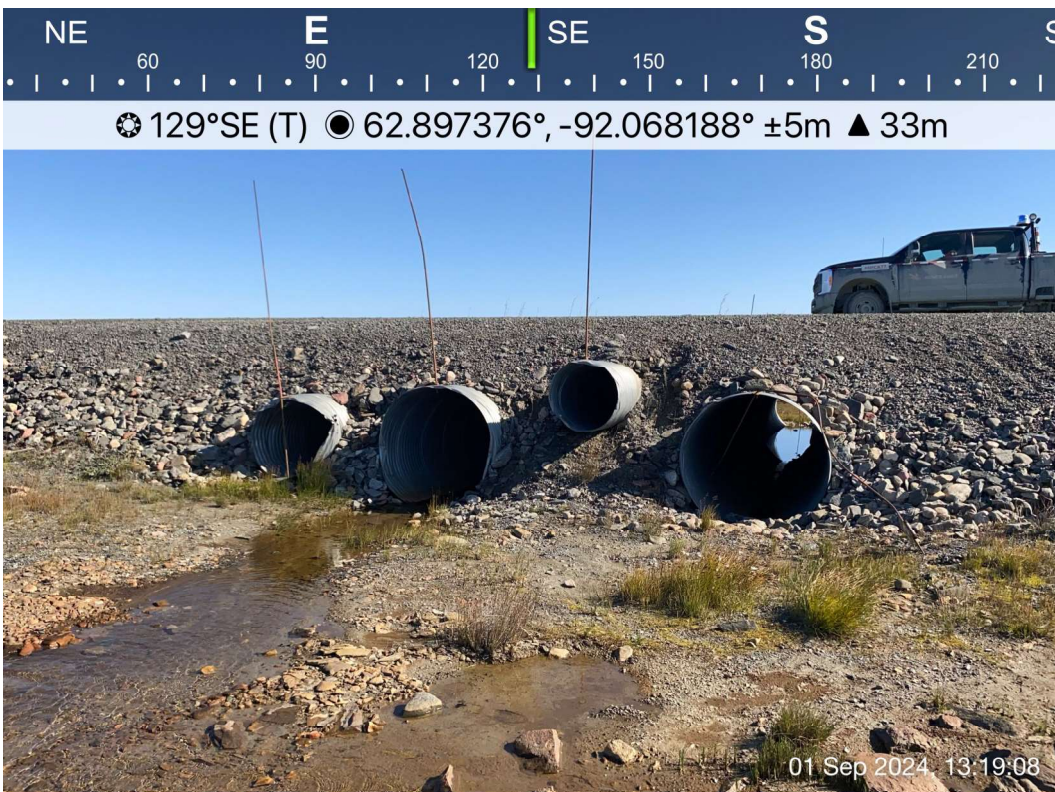
**AWAR Road/  
Culvert - Photo 30:** Culvert KM 12.1 - Outlet.

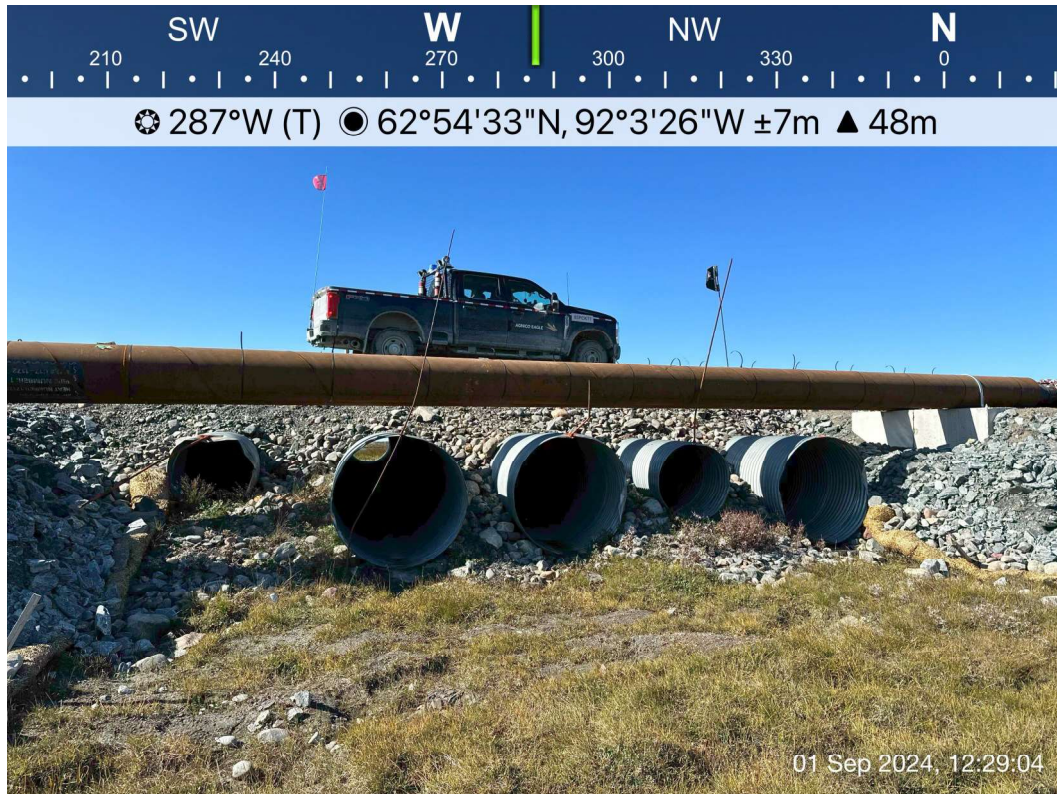
**AWAR Road/  
Culvert - Photo 34:** Culvert KM 13.5 - Outlet.

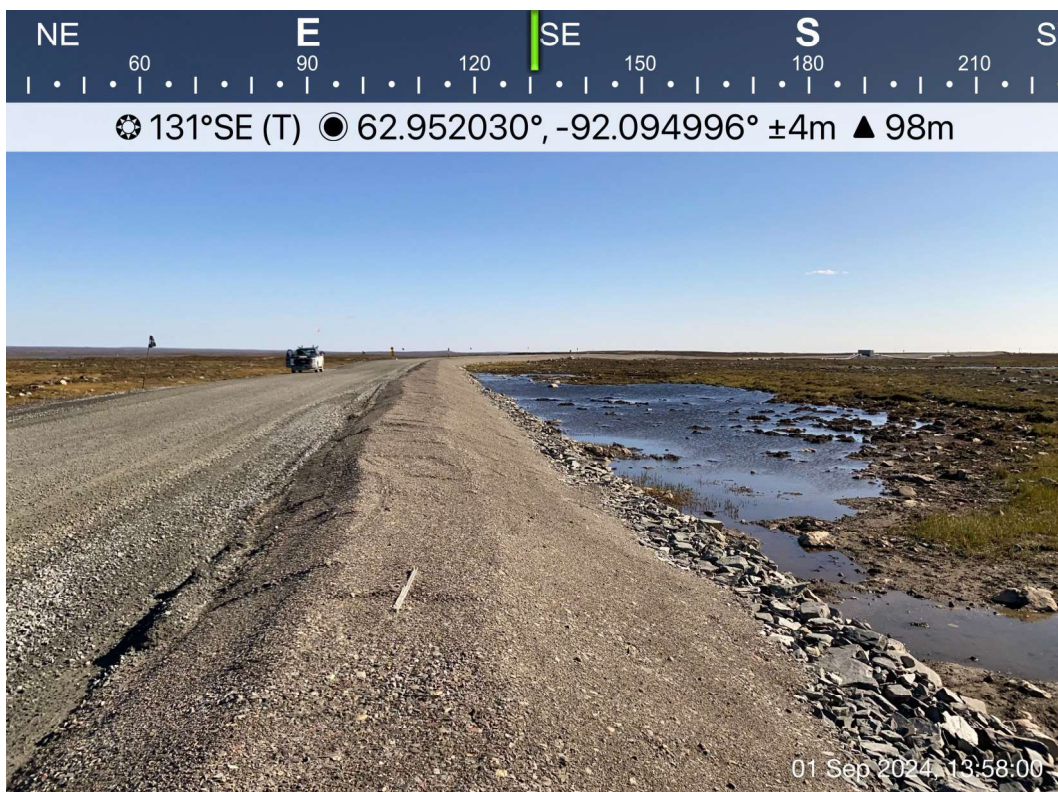
**AWAR Road/  
Culvert - Photo 43:**

KM 21.0 to 21.5 - No culvert installed, ponded water upstream.

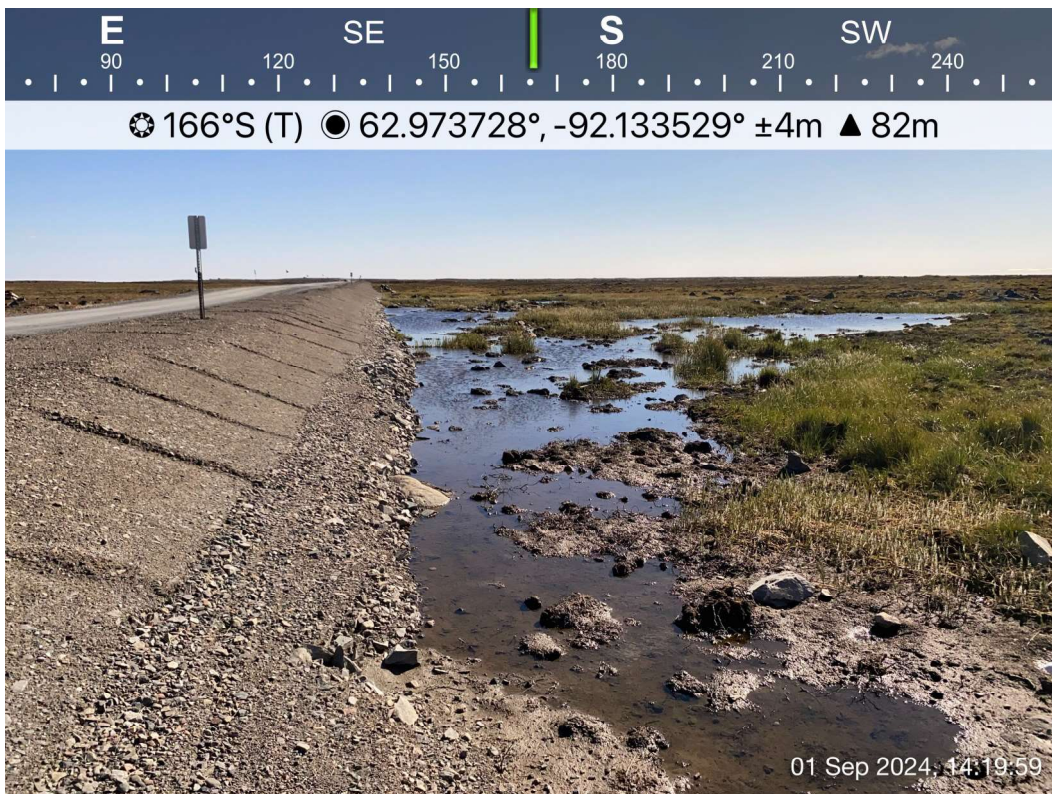
**AWAR Road/  
Culvert - Photo 49:**

KM 22.7 to 23.0 - No culvert installed, ponded water downstream.

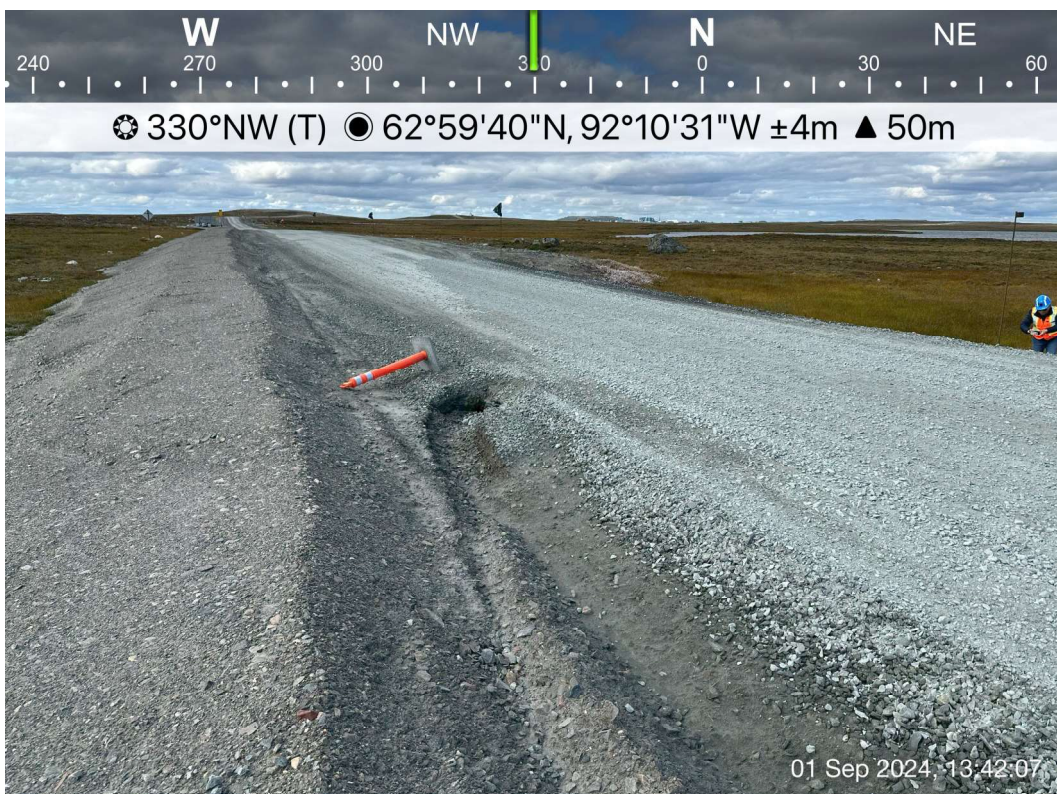
**AWAR Road/  
Culvert - Photo 51:**

KM 25.8 Corrugated HDPE Culvert - Inlet, eroded pipe bedding material.

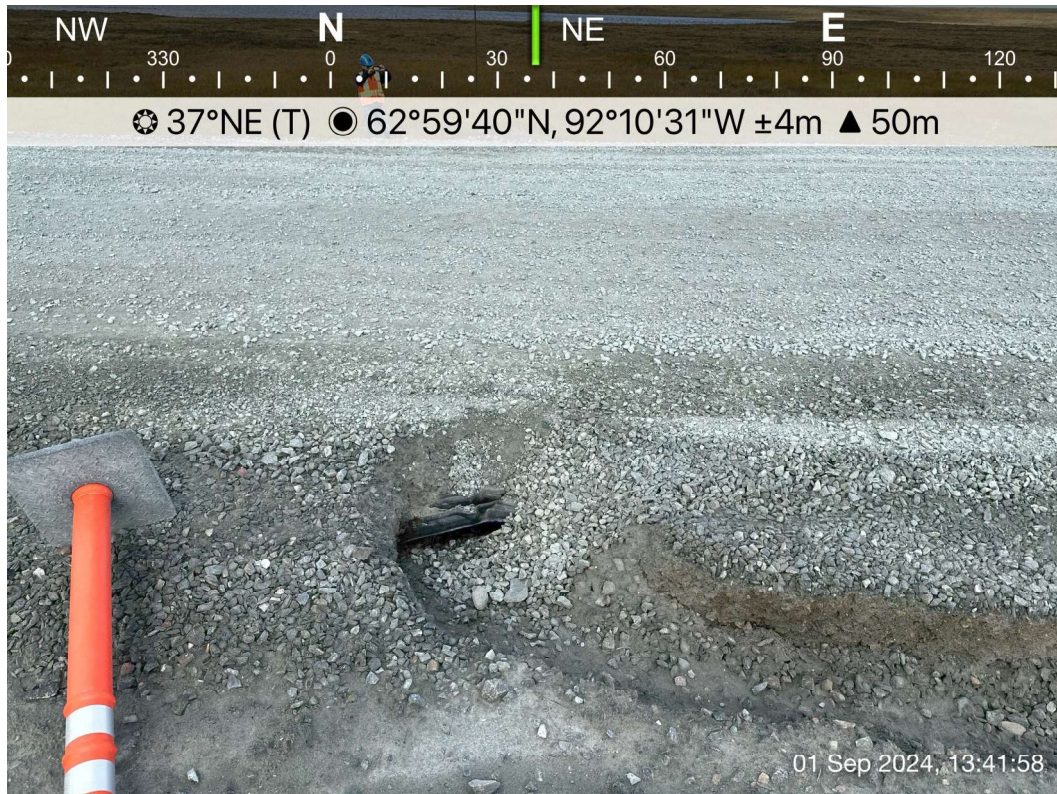
**AWAR Road/  
Culvert - Photo 52:**

KM 25.8 Corrugated HDPE Culvert - Culvert filled with bedding material.

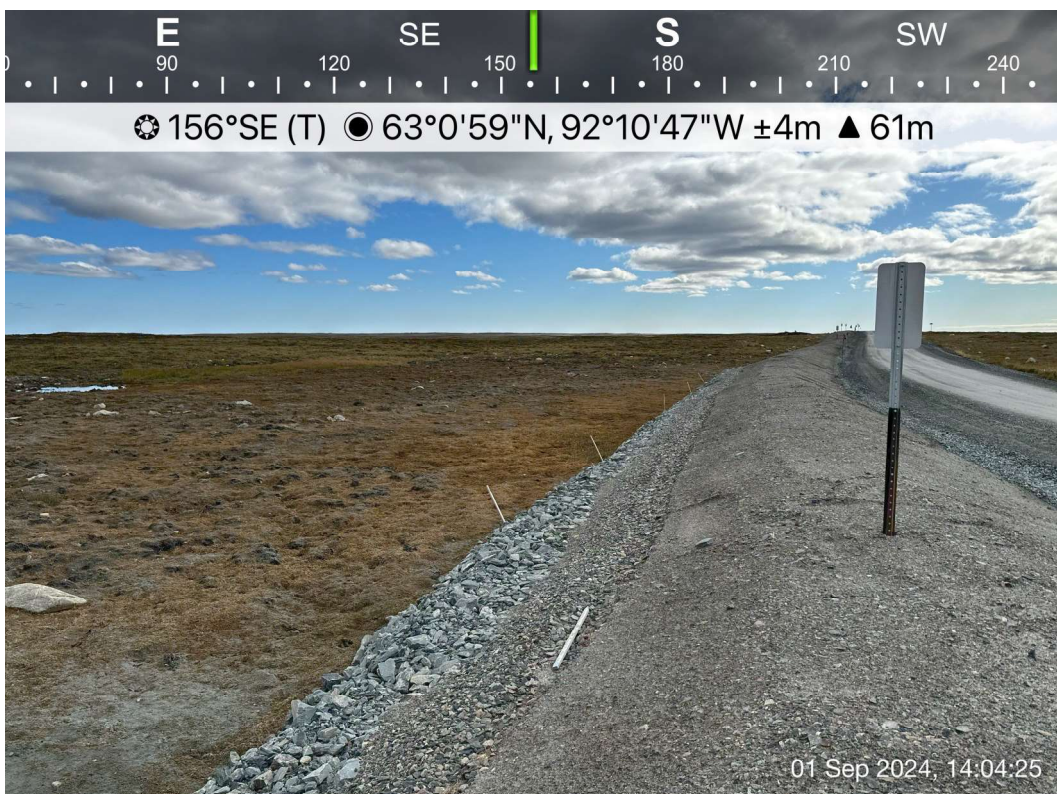
**AWAR Road/  
Culvert - Photo 62:** KM 28.7 - High water mark and erosion on upstream side.

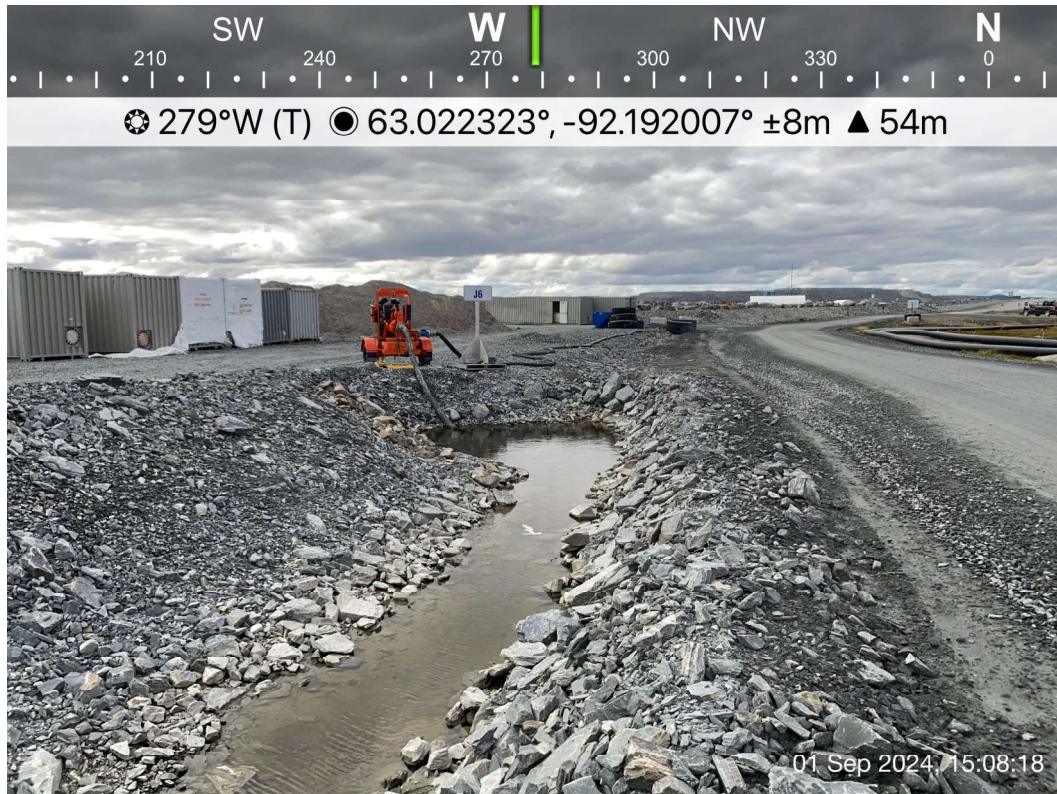
**AWAR Road/  
Culvert - Photo 63:** KM 29.6 - Sump and Pump J6.

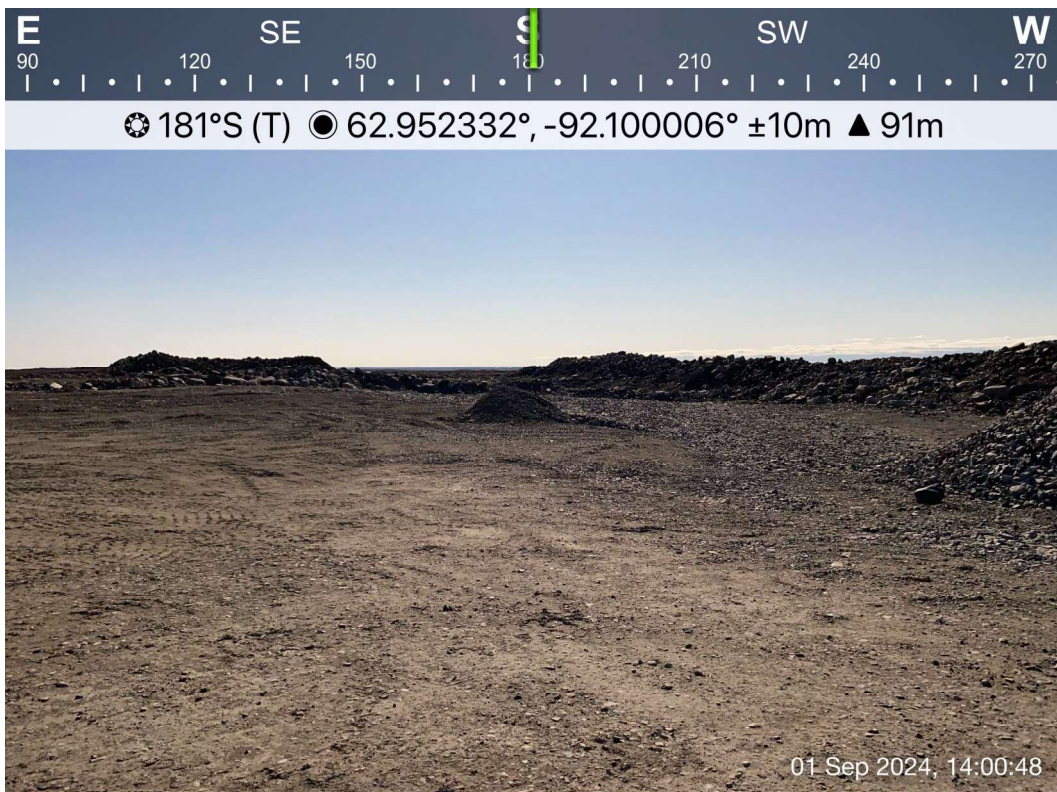
**AWAR Borrow  
Source - Photo 64:** KM 19.4 - Borrow source south of AWAR.

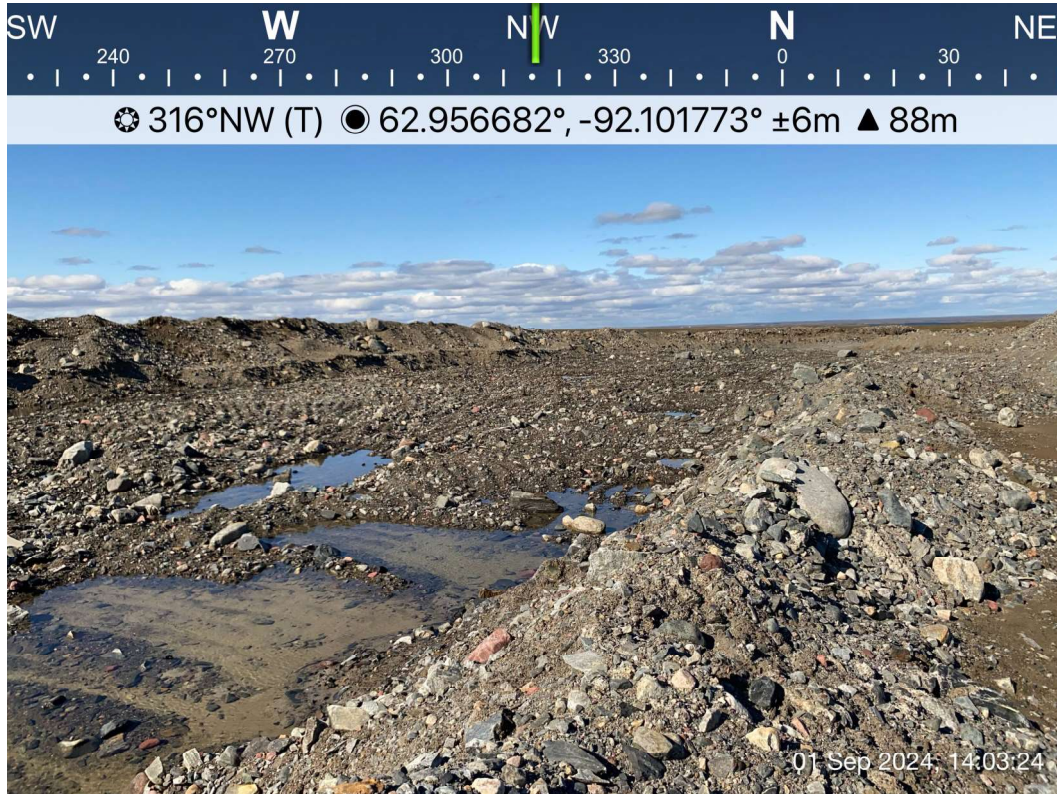
**AWAR Borrow Source - Photo 65:** KM 19.7 - Borrow source north of AWAR.

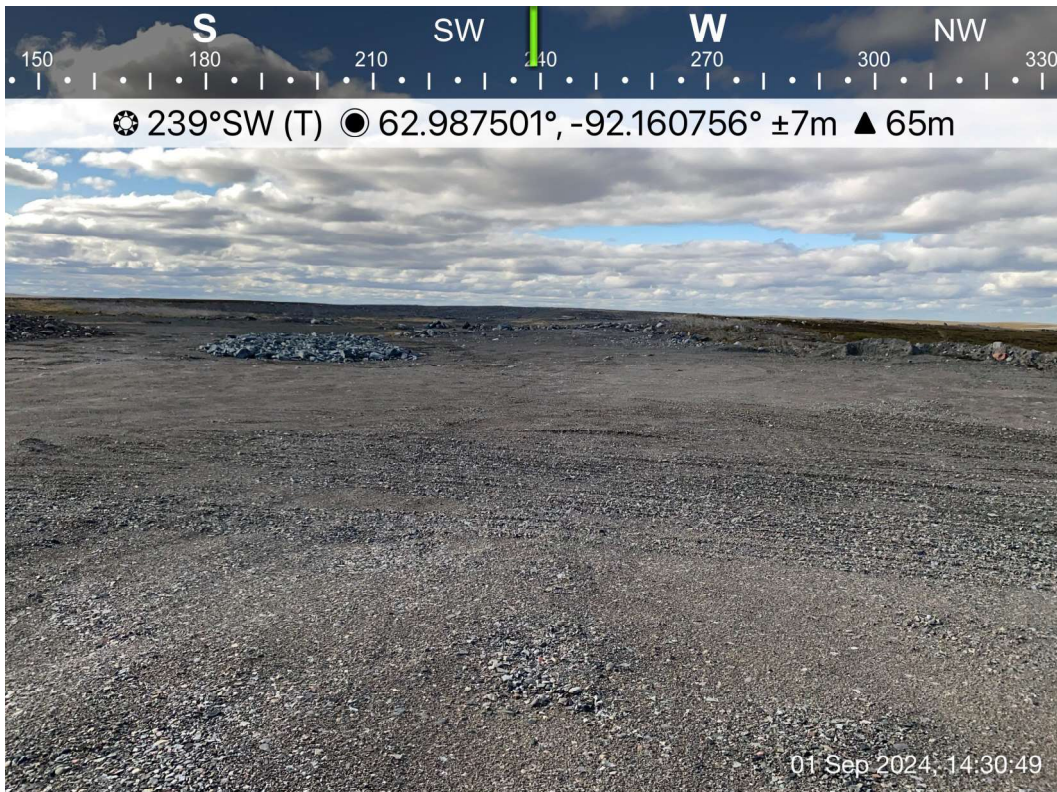
**AWAR Borrow Source - Photo 66:** KM 24.7 - Borrow source south of AWAR.

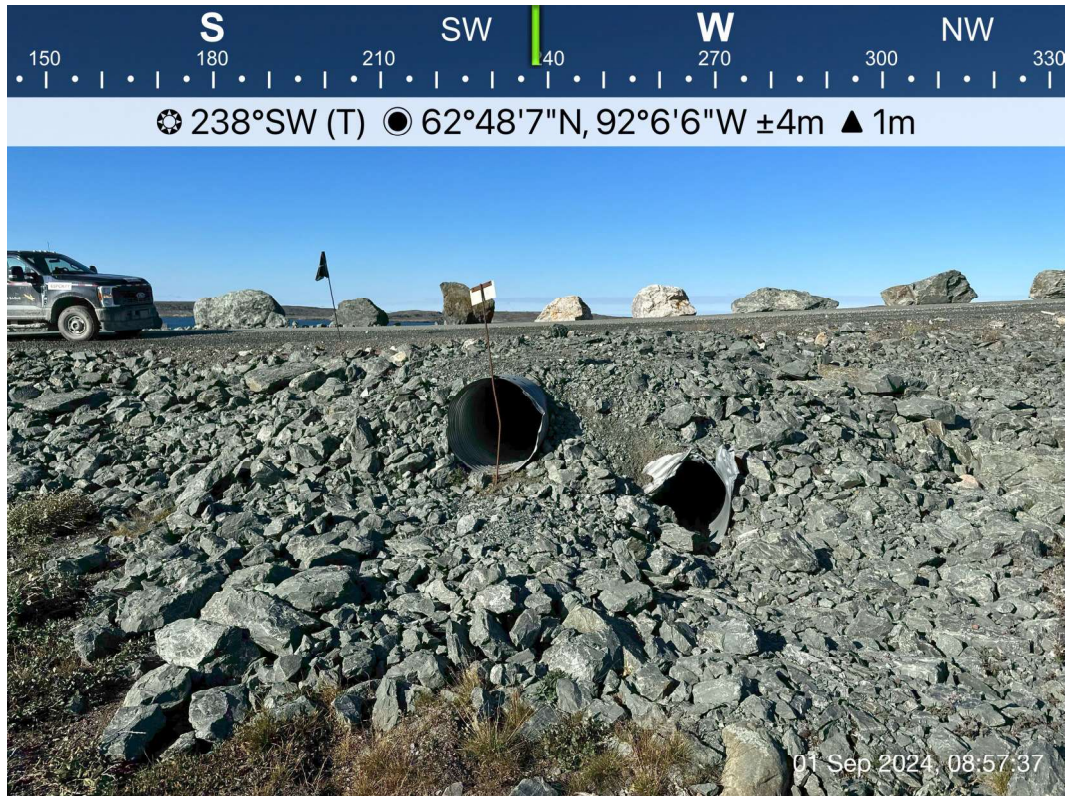
**Itivia Bypass Road/  
Culvert - Photo 1:** Culvert C01 - KM 0.35 - Inlet.

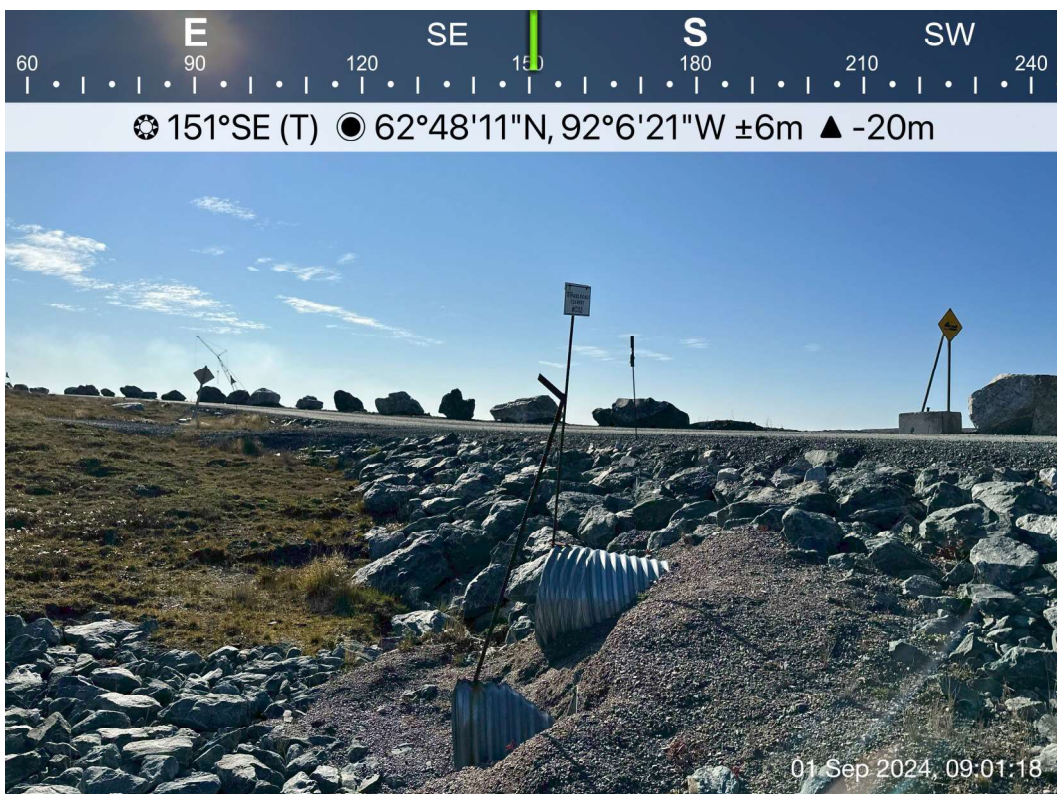
**Itivia Bypass Road/  
Culvert - Photo 4:**

Culvert C02 - KM 0.6 - Inlet.

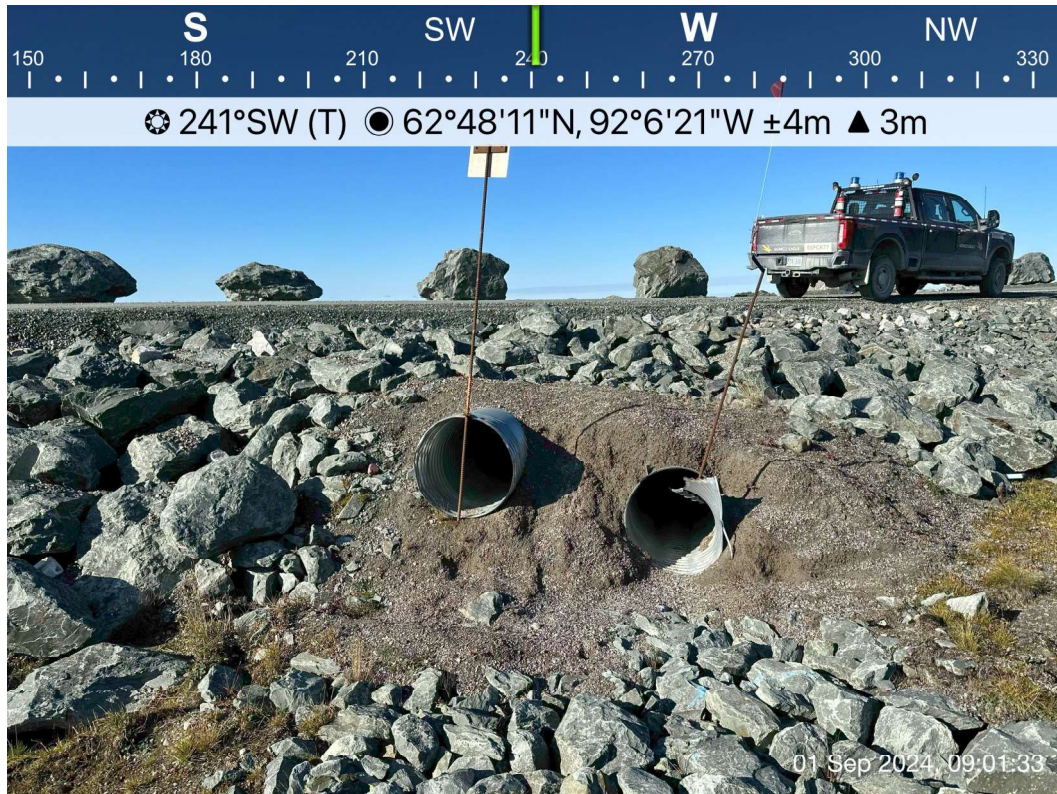
**Itivia Bypass Road/  
Culvert - Photo 5:**

Culvert C02 - KM 0.6 - Inlet.
