## **APPENDIX 6      2024 ANNUAL GEOTECHNICAL INSPECTION REPORT**

## 2024 Annual Geotechnical Inspection Meliadine Gold Mine, Nunavut, Canada

PRESENTED TO  
**Agnico Eagle Mines Limited**

MARCH 11, 2025  
ISSUED FOR USE-REVISION 1  
FILE: 704-ENG.EARC03140-39  
AGNICO EAGLE DOCUMENT NUMBER: 65-600-230-TCR-002

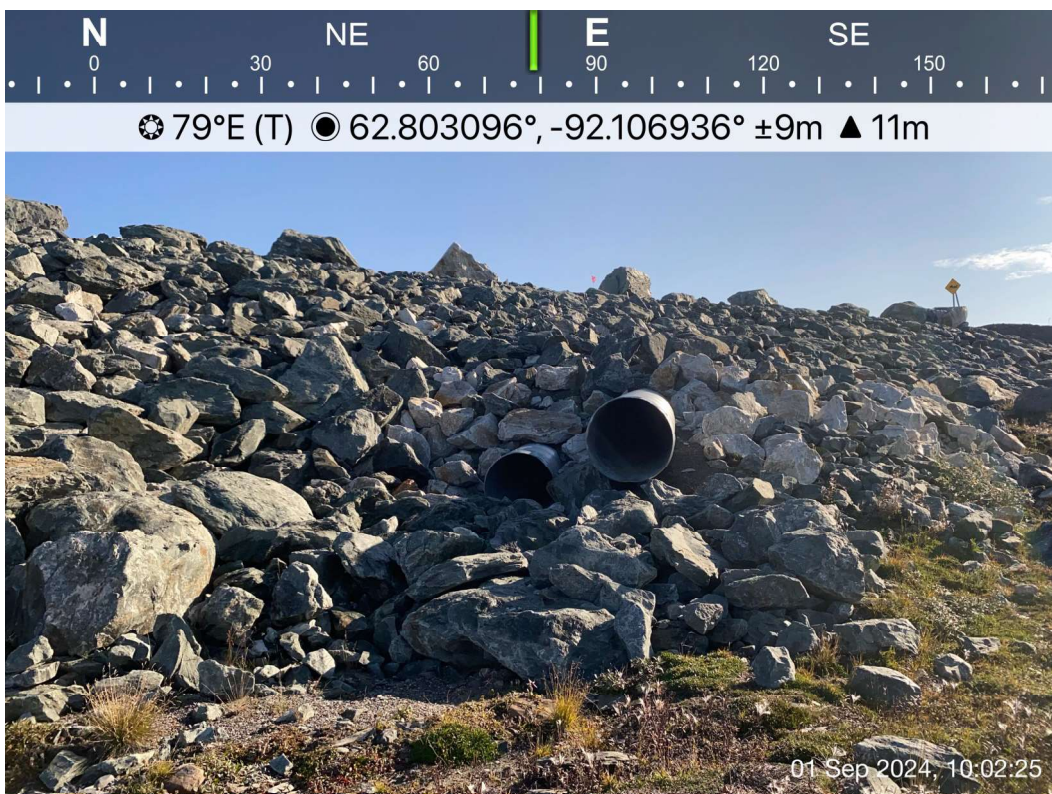
**Itivia Bypass Road/  
Culvert - Photo 6:**

Culvert C02 - KM 0.6 - Outlet.

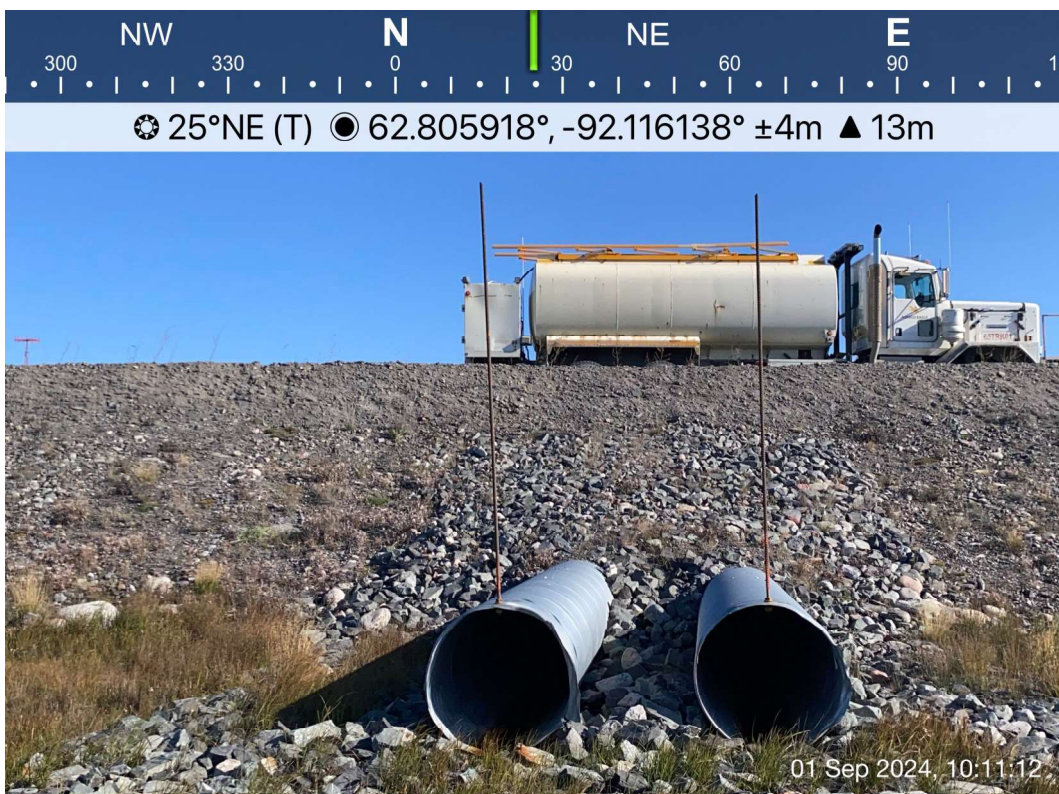
**Itivia Bypass Road/  
Culvert - Photo 12:**

Culvert C04 - KM 1.0 - Outlet.

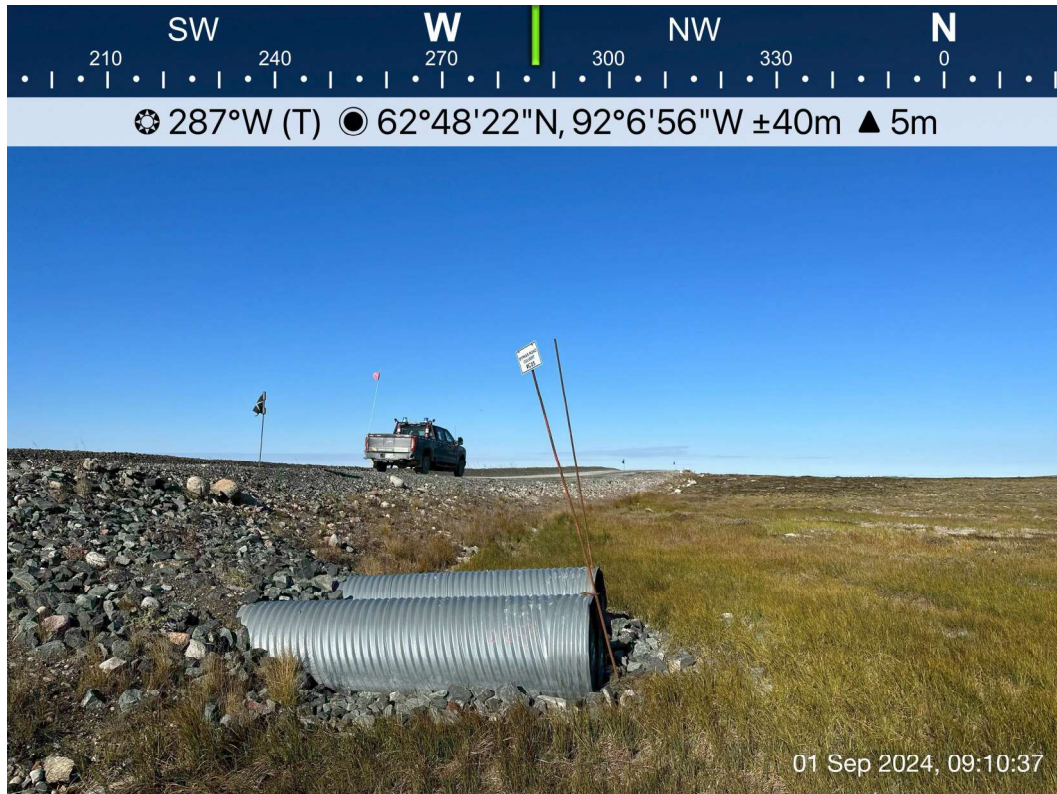
**Itivia Bypass Road/  
Culvert - Photo 13:**

Culvert C05 - KM 1.2 - Inlet.

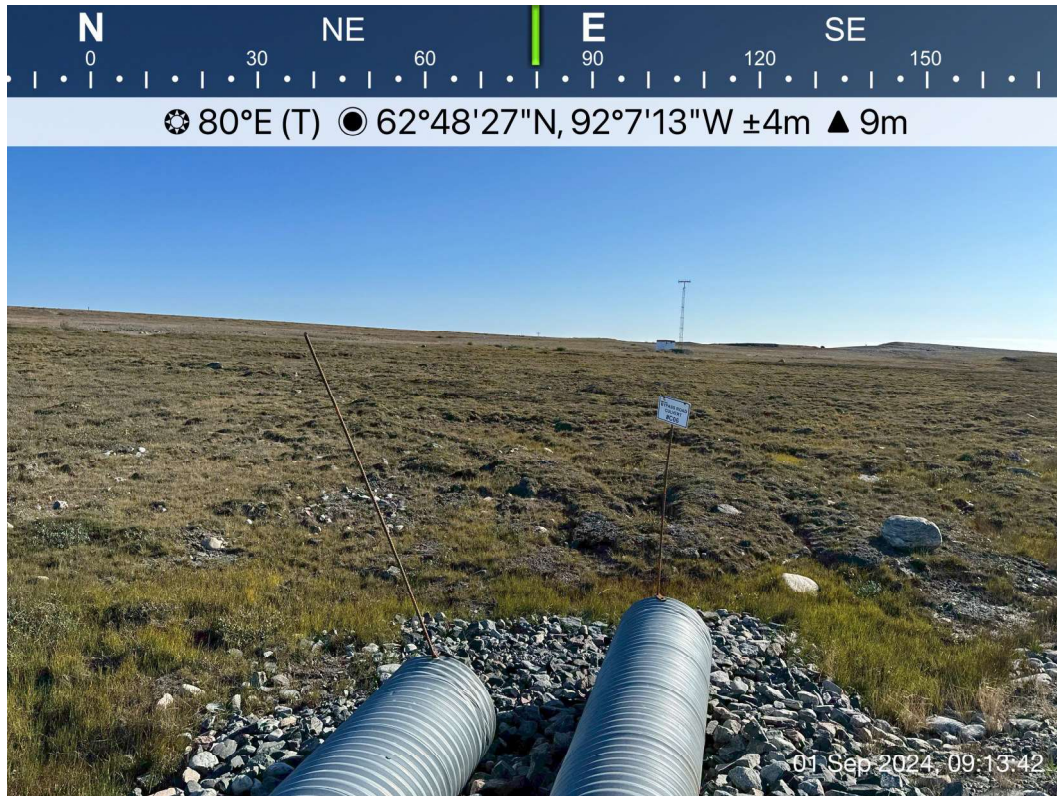
**Itivia Bypass Road/  
Culvert - Photo 15:**

Culvert C06 - KM 1.5 - Inlet.

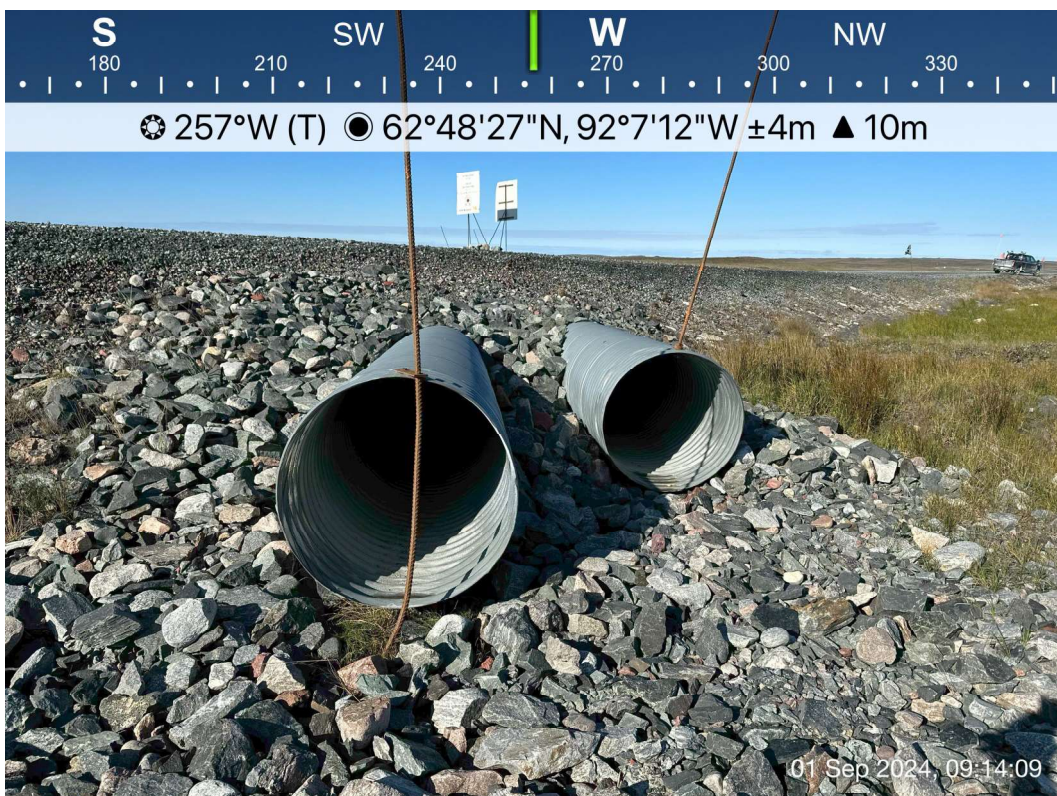
**Itivia Bypass Road/  
Culvert - Photo 16:**

Culvert C06 - KM 1.5 - Inlet.

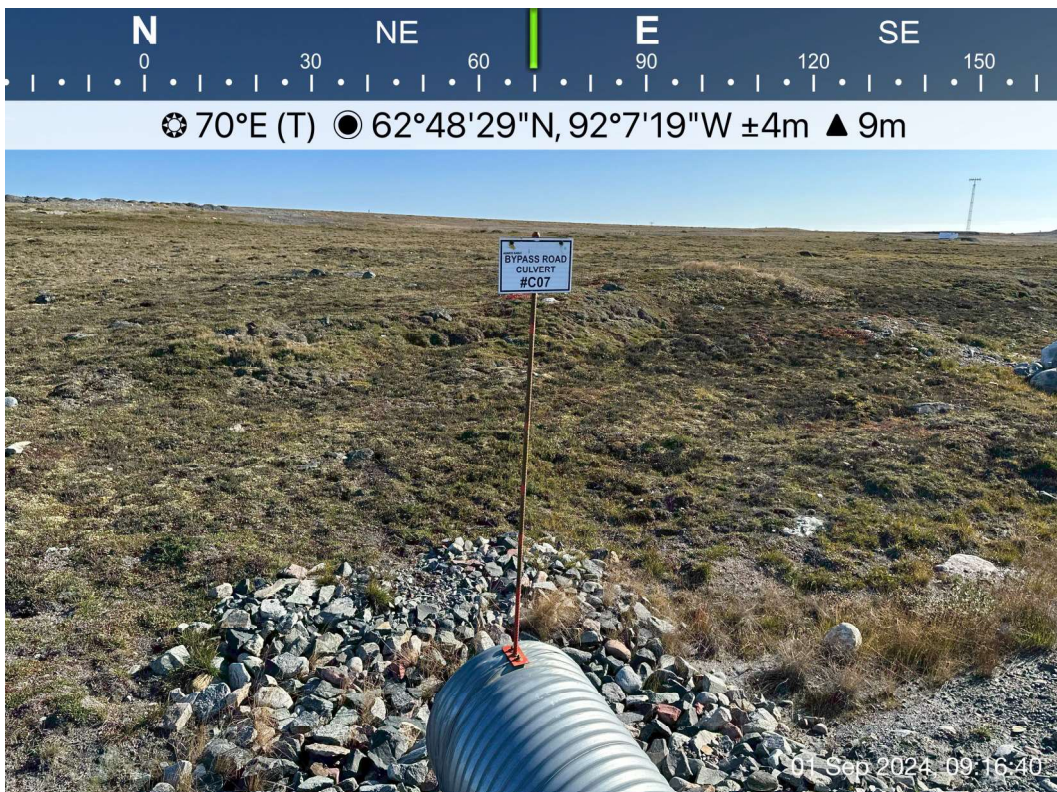
**Itivia Bypass Road/  
Culvert - Photo 18:** Culvert C07 - KM 1.6 - Inlet.

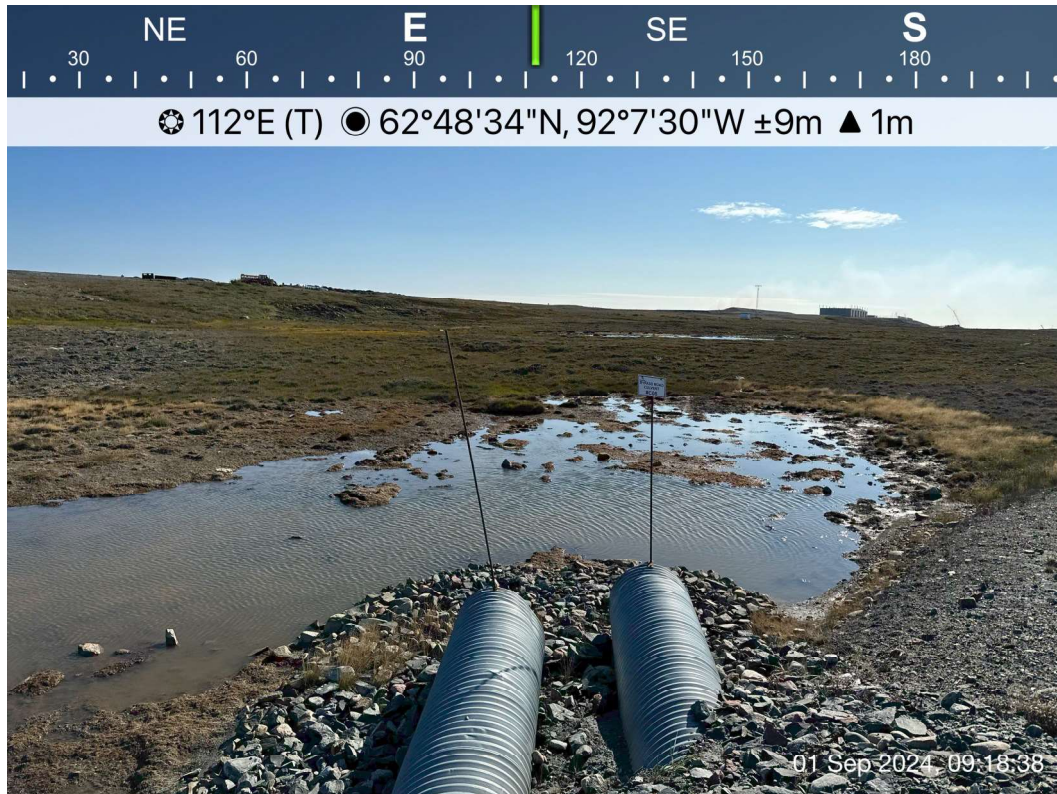
**Itivia Bypass Road/  
Culvert - Photo 21:**

Culvert C08 - KM 1.8 - Inlet.

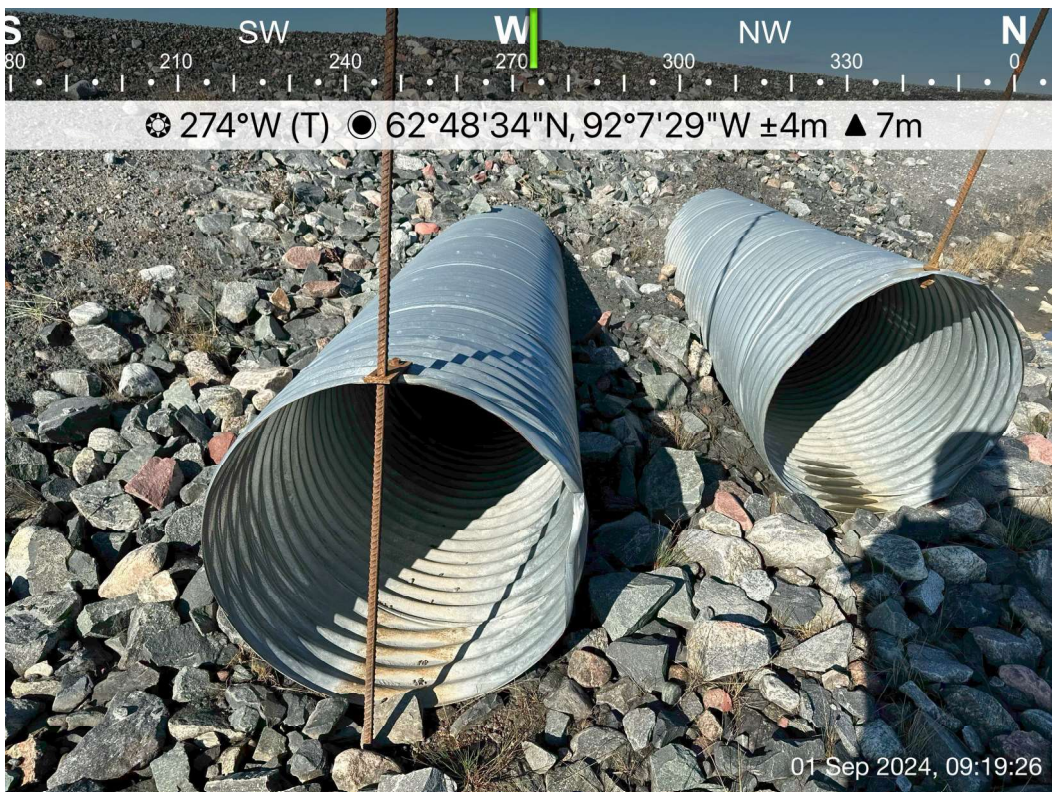
**Itivia Bypass Road/  
Culvert - Photo 22:**

Culvert C08 - KM 1.8 - Inlet.

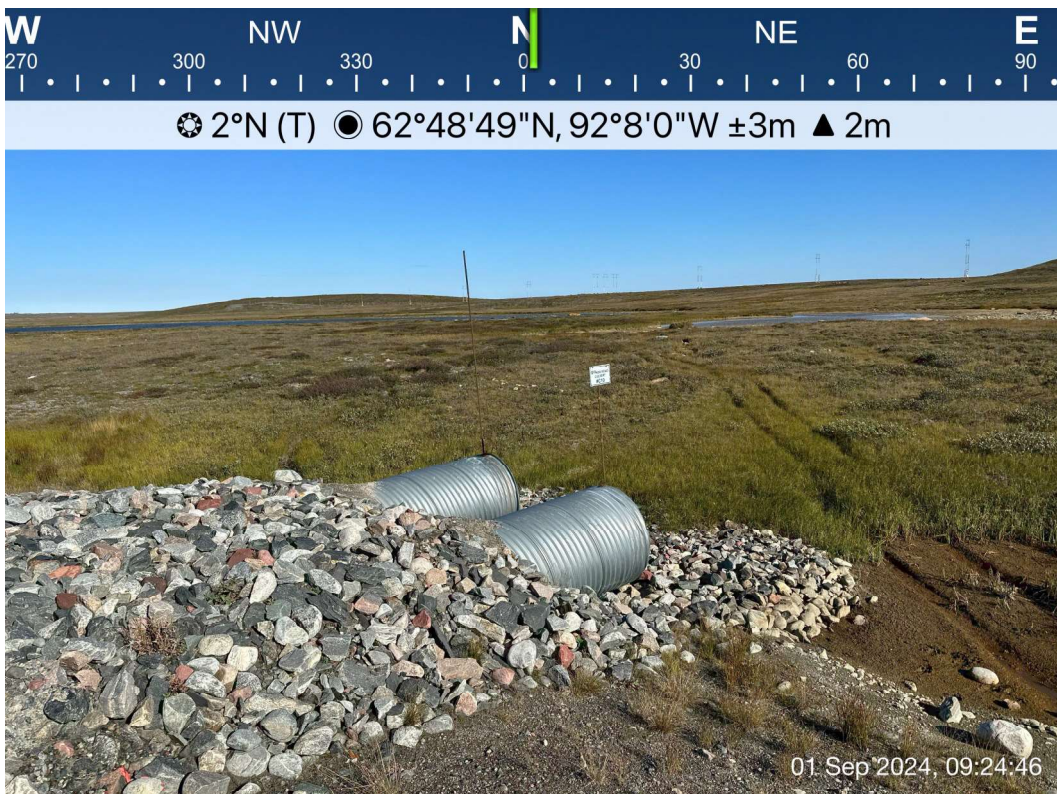
**Itivia Bypass Road/  
Culvert - Photo 24:**

Culvert C10 - KM 2.4 - Inlet.

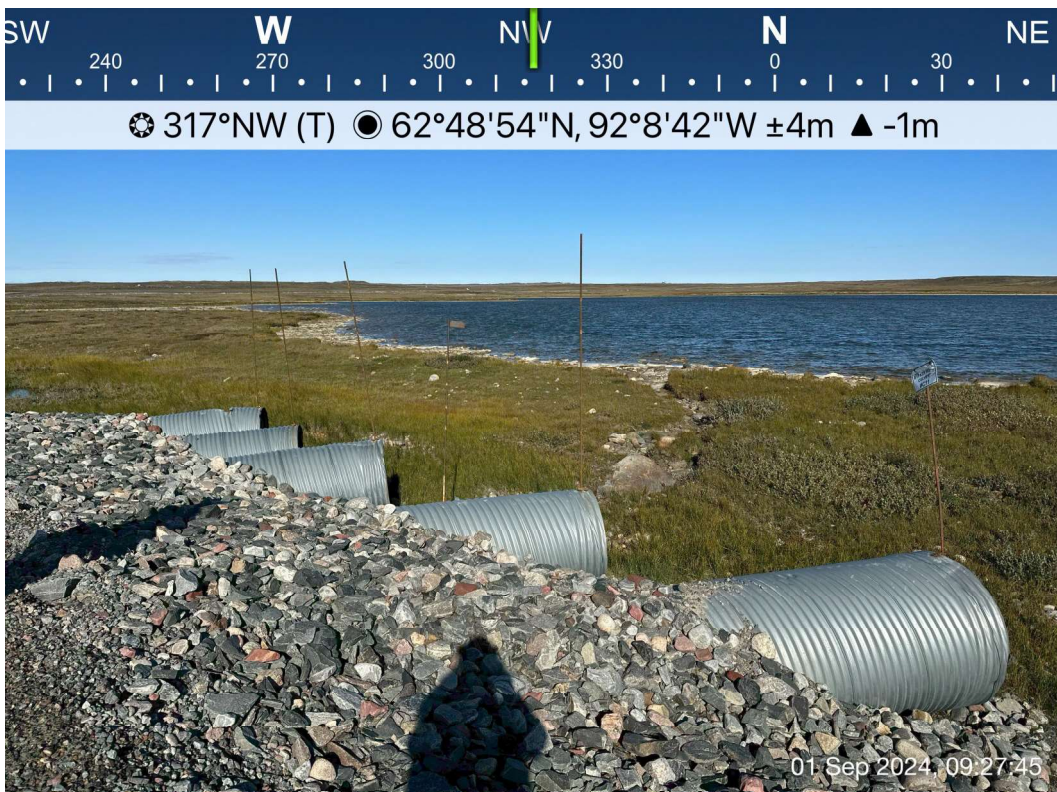
**Itivia Bypass Road/  
Culvert - Photo 26:**

Culvert C11 - KM 3.1 - Inlet.

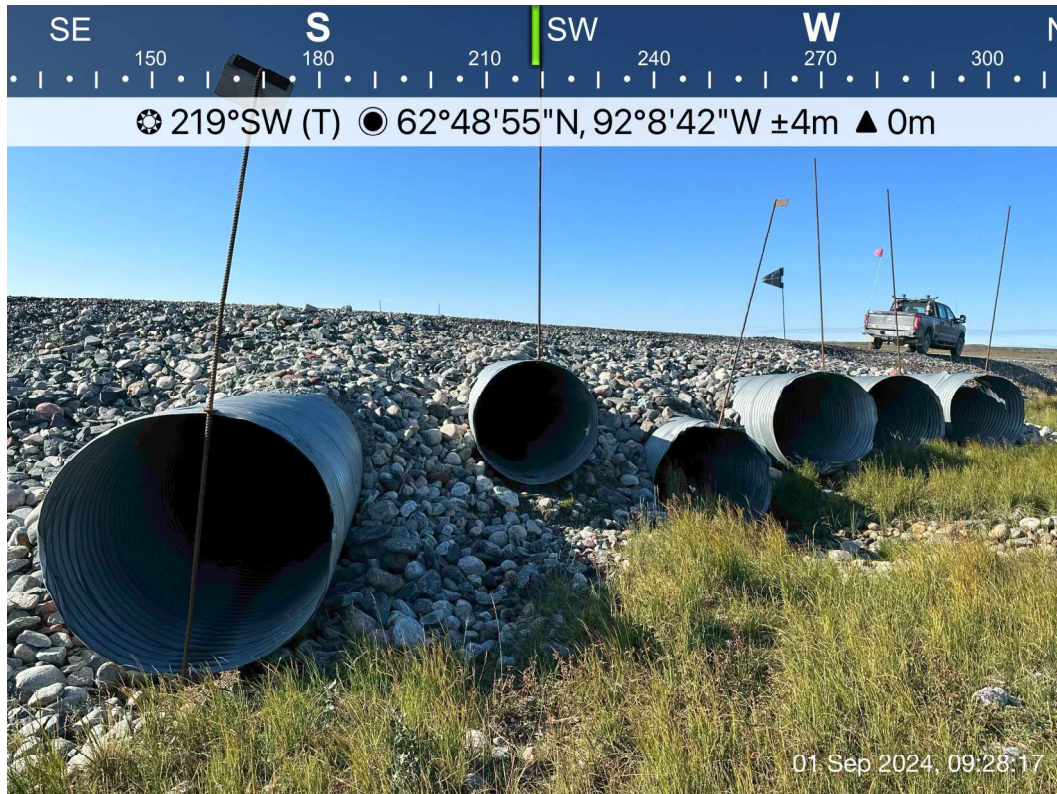
**Itivia Bypass Road/  
Culvert - Photo 27:**

Culvert C11 - KM 3.1 - Inlet.

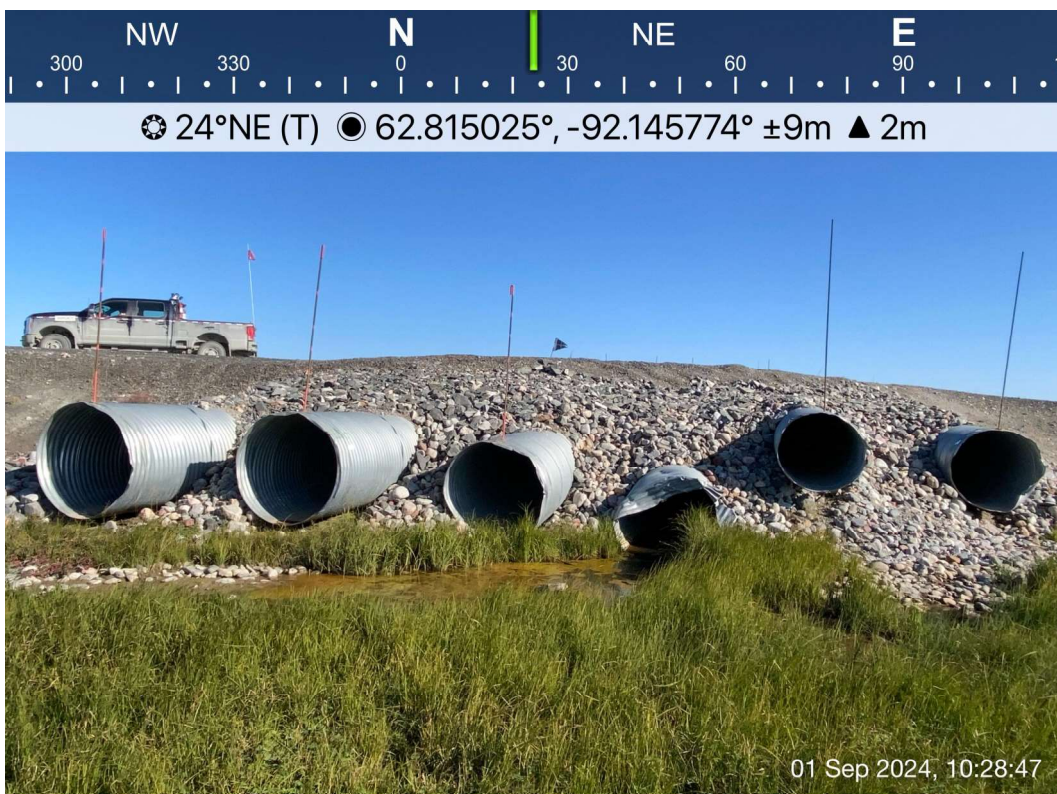
**Itivia Bypass Road/  
Culvert - Photo 28:**

Culvert C11 - KM 3.1 - Outlet.

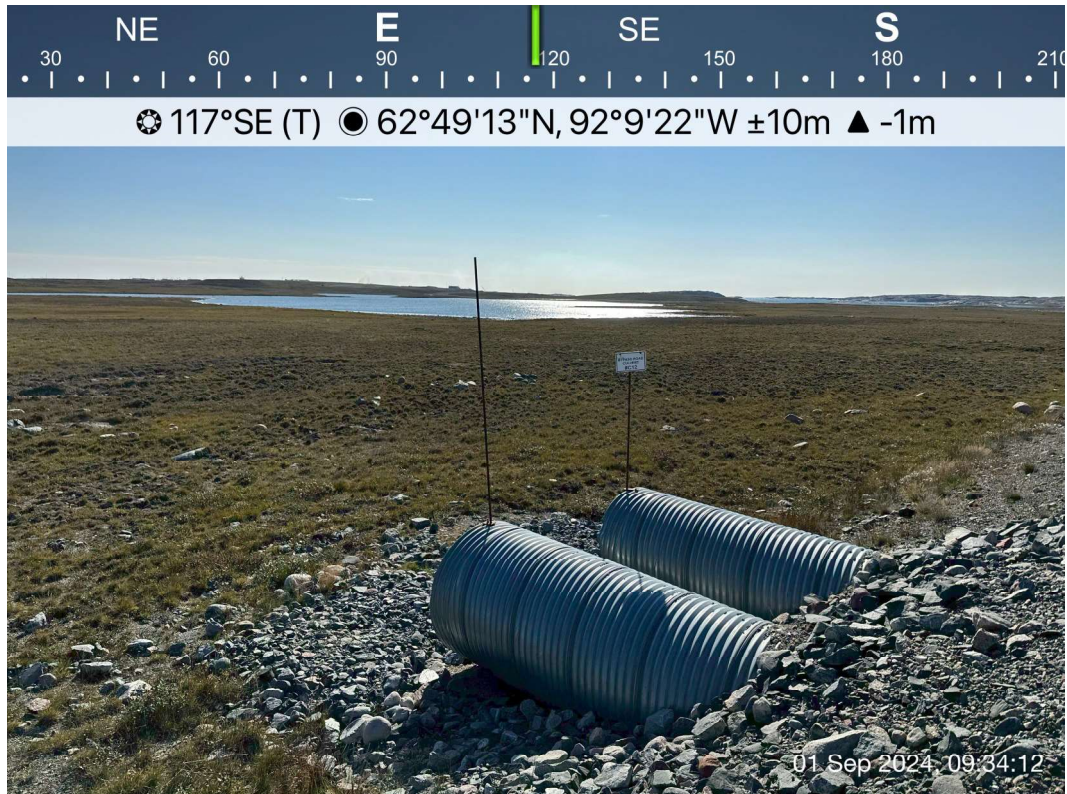
**Itivia Bypass Road/  
Culvert - Photo 29:**

Culvert C12 - KM 4.0 - Inlet.

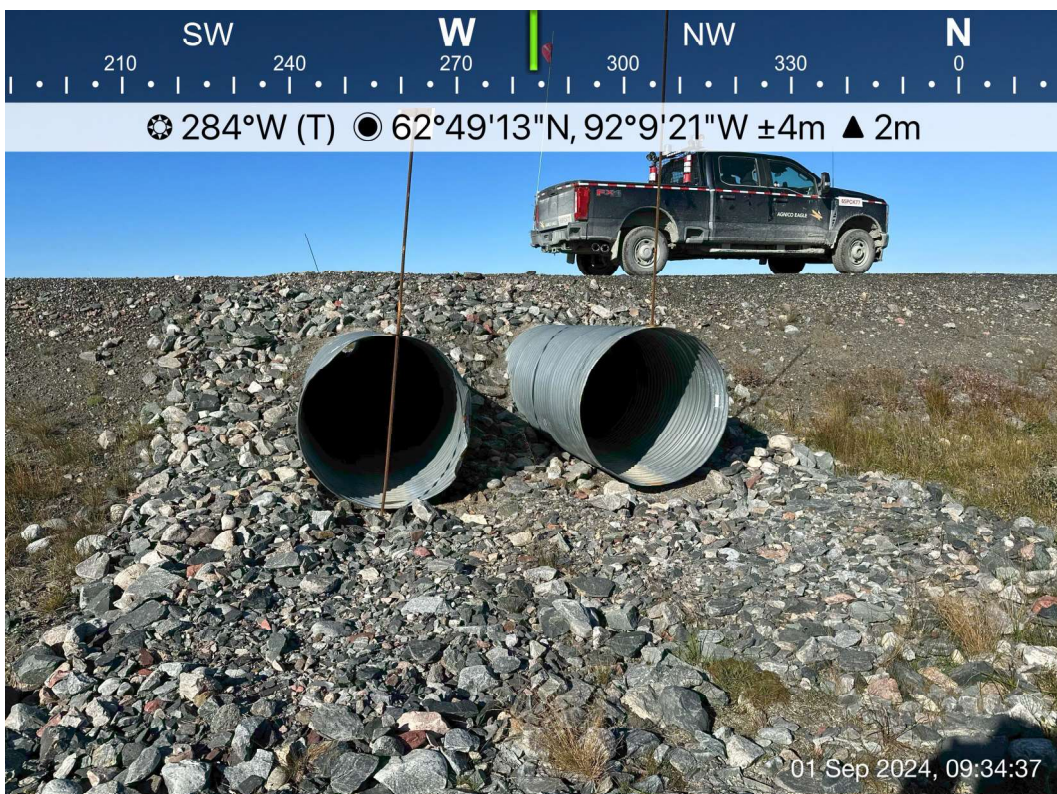
**Itivia Bypass Road/  
Culvert - Photo 30:**

Culvert C12 - KM 4.0 - Outlet.

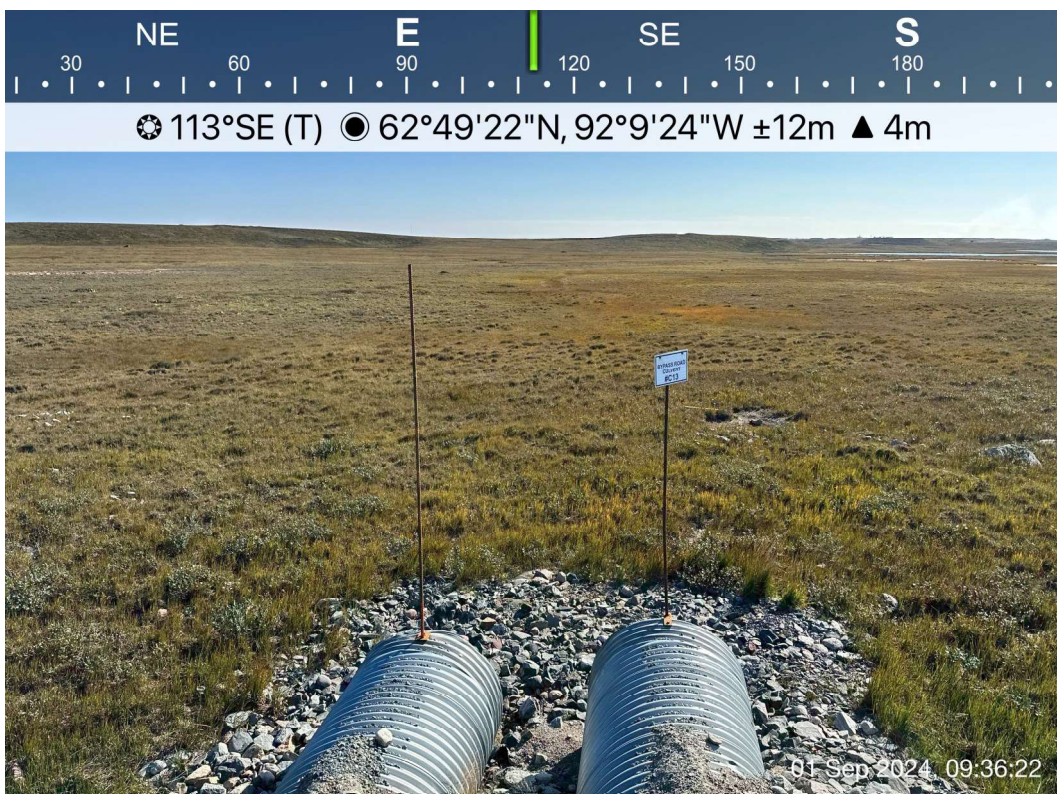
**Itivia Bypass Road/  
Culvert - Photo 32:**

Culvert C13 - KM 4.3 - Inlet.

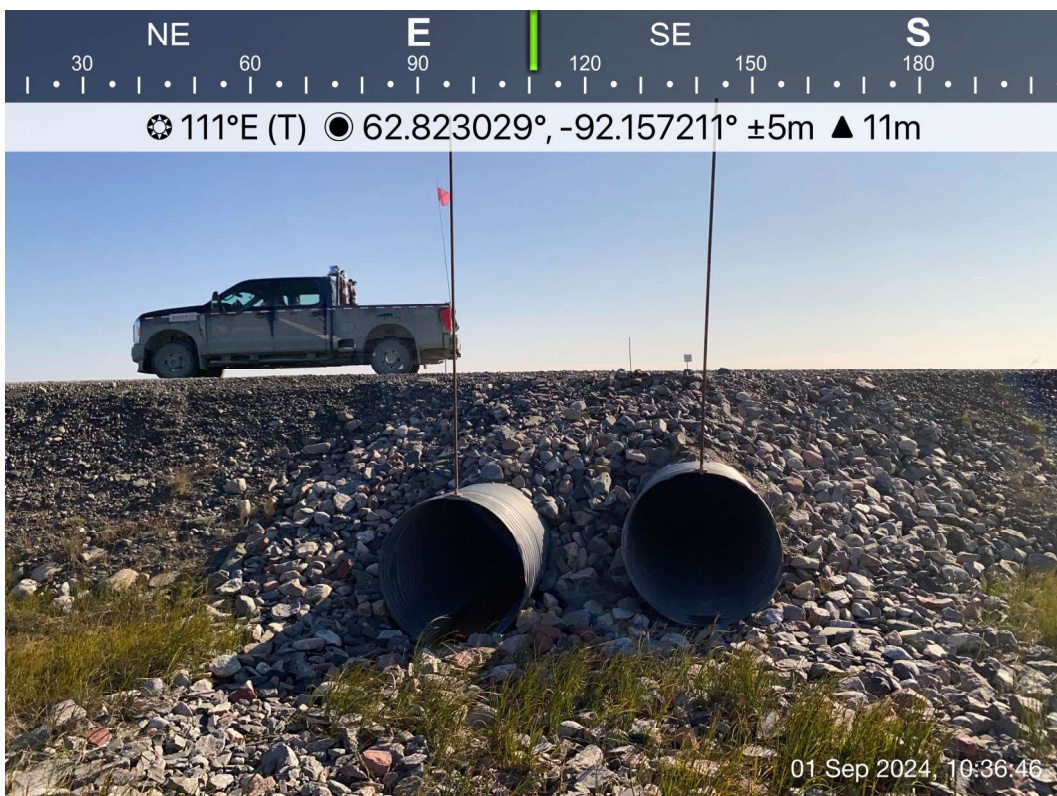
**Itivia Bypass Road/  
Culvert - Photo 33:**

Culvert C13 - KM 4.3 - Inlet.

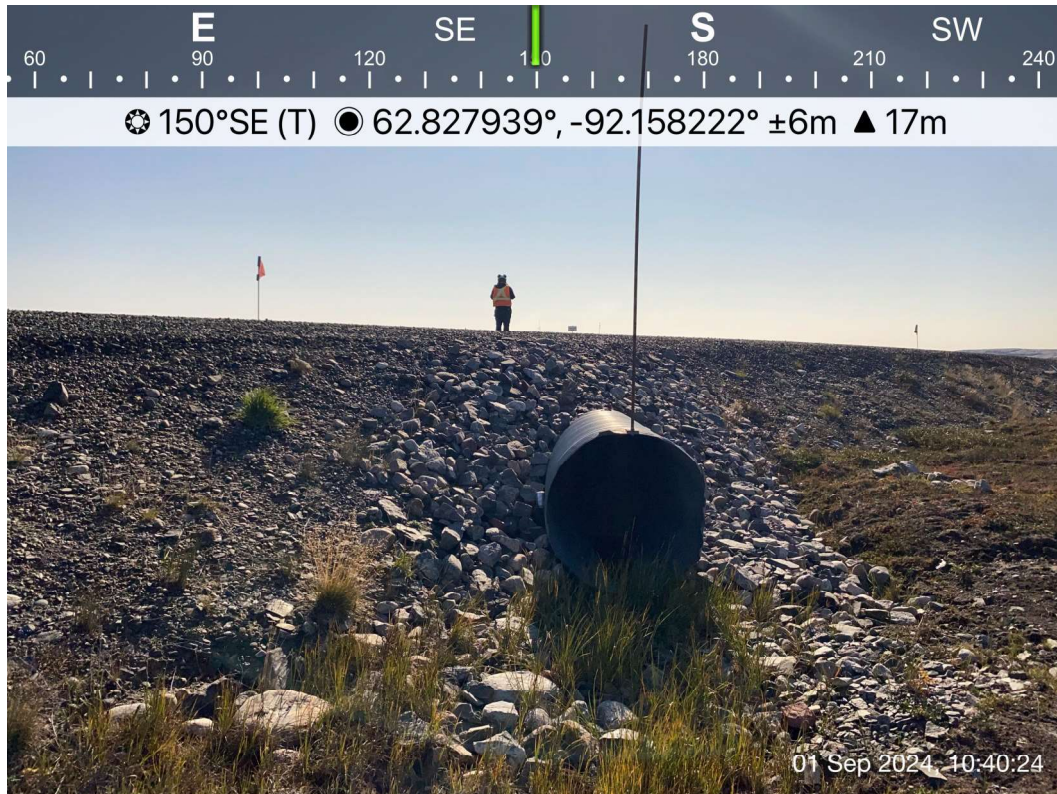
**Itivia Bypass Road/  
Culvert - Photo 36:**

4.8 km	C14 (Design identification C11b-1)	1 x 1,000 mm	Good condition, invert of culvert is dented. Culvert is constructed over riprap and invert is raised above surrounding tundra. Small natural drainage path observed upstream and downstream of culvert. No flow or ponding water observed. Road constructed out of esker material performing adequately.	Itivla Bypass Road Culvert – Photos 35 to 37

Culvert C14 - KM 4.8 - Inlet.

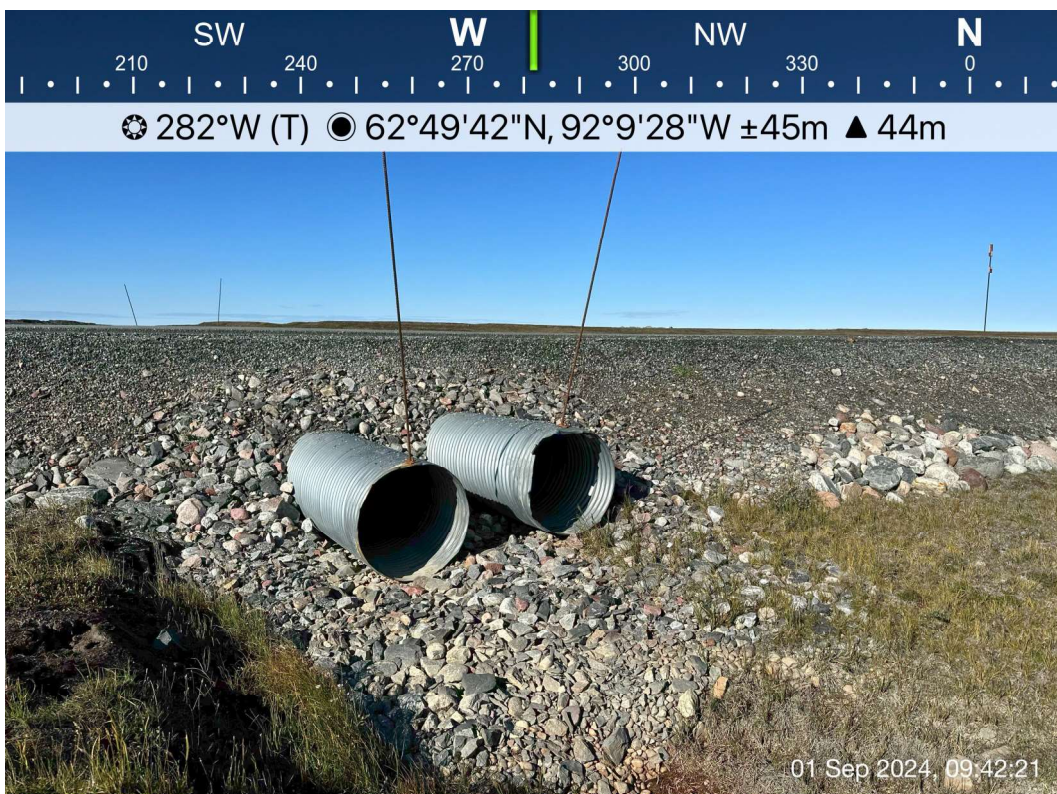
**Itivia Bypass Road/  
Culvert - Photo 37:**

Culvert C14 - KM 4.8 - Outlet.

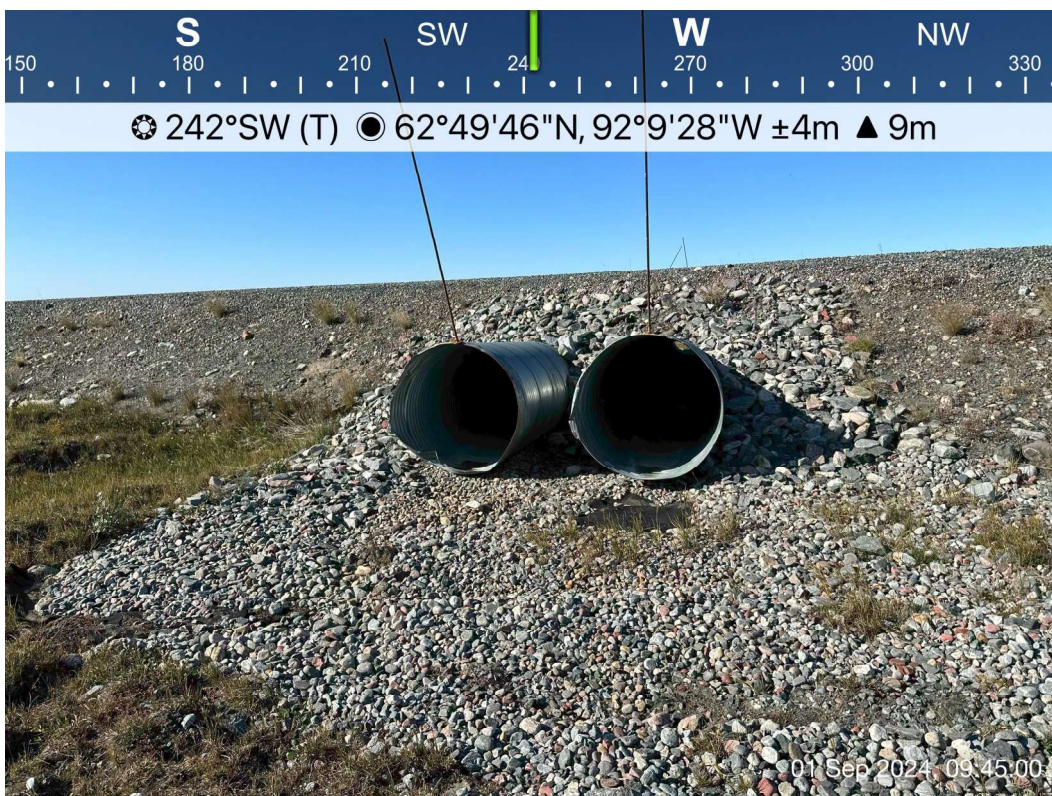
**Itivia Bypass Road/  
Culvert - Photo 39:**

4.9 km	C15 (Design identification C11c)	2 x 1,200 mm	Good condition, culverts are constructed over riprap and inverts are raised above surrounding tundra. No ponded water or flow through culverts. Road constructed out of esker materials. Road fill performing adequately.	Itivla Bypass Road Culvert – Photos 38 and 39

Culvert C15 - KM 4.9 - Outlet.

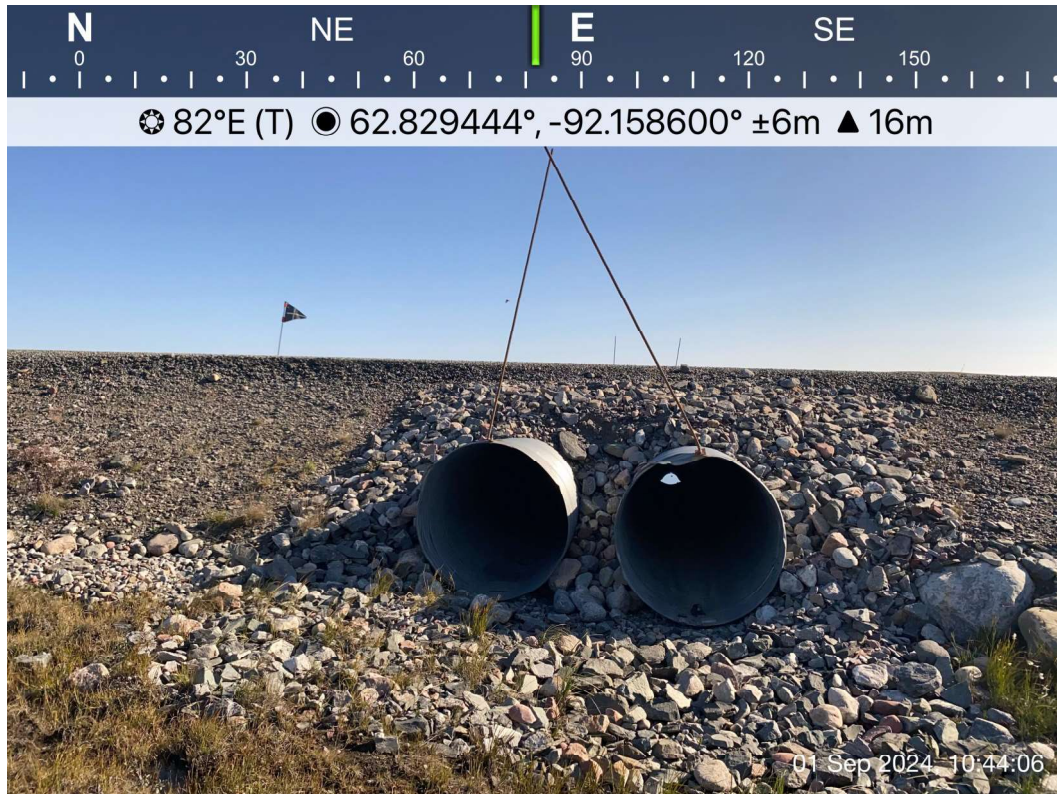
**Itivia Bypass Road/  
Culvert - Photo 40:**

5.0 km	C16 (Design identification C12a)	2 x 1,200 mm	Good condition, culverts are constructed over riprap and upstream inverts raised above surrounding tundra. No ponded water or flow through culverts. Small section of exposed geotextile was observed at the inlet of the northern culvert. Road constructed out of esker materials. Road slopes performing adequately.	Itivla Bypass Road Culvert – Photos 40 and 41

Culvert C16 - KM 5.0 - Inlet.

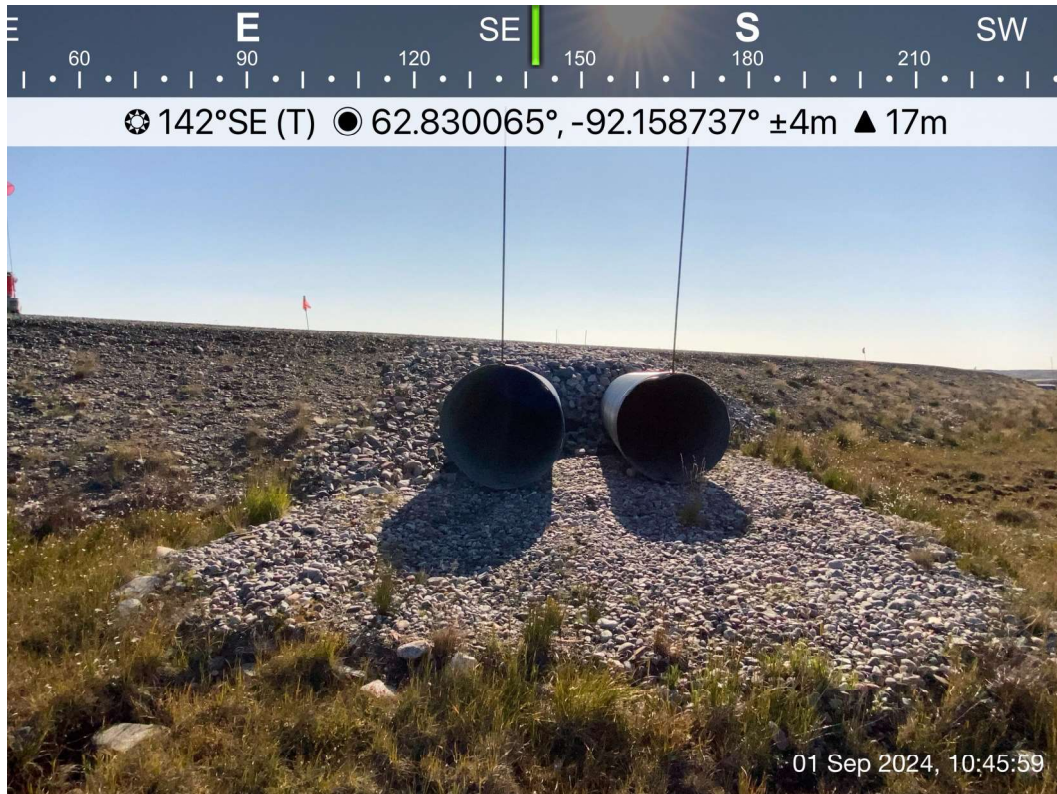
**Itivia Bypass Road/  
Culvert - Photo 42:**

5.1 km	C17 (Design identification C12b)	2 x 1,000 mm	Good condition, culverts are constructed over riprap and inverts are raised above surrounding tundra. No ponded water or flow observed. Road constructed out of esker materials. Riprap placed in local area of culvert. No signs of erosion on roadside slopes indicating previous higher water levels.	Itivla Bypass Road Culvert – Photos 42 and 43

Culvert C17 - KM 5.1 - Inlet.

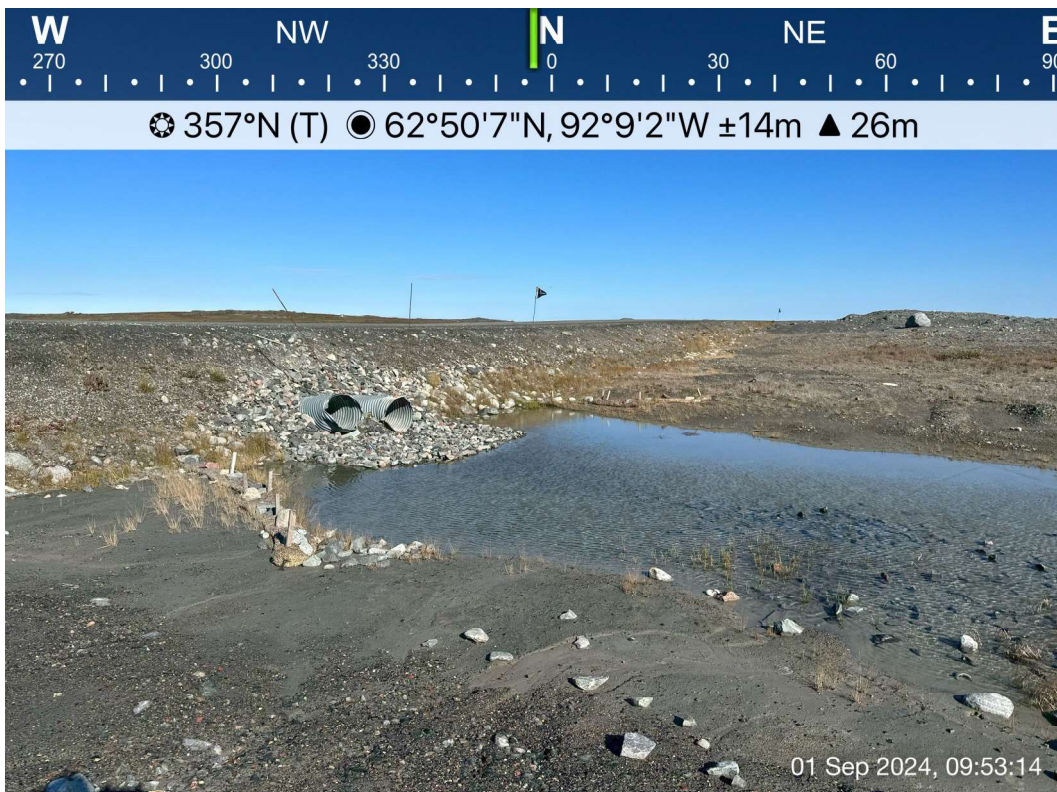
**Itivia Bypass Road/  
Culvert - Photo 43:**

Culvert C17 - KM 5.1 - Outlet.

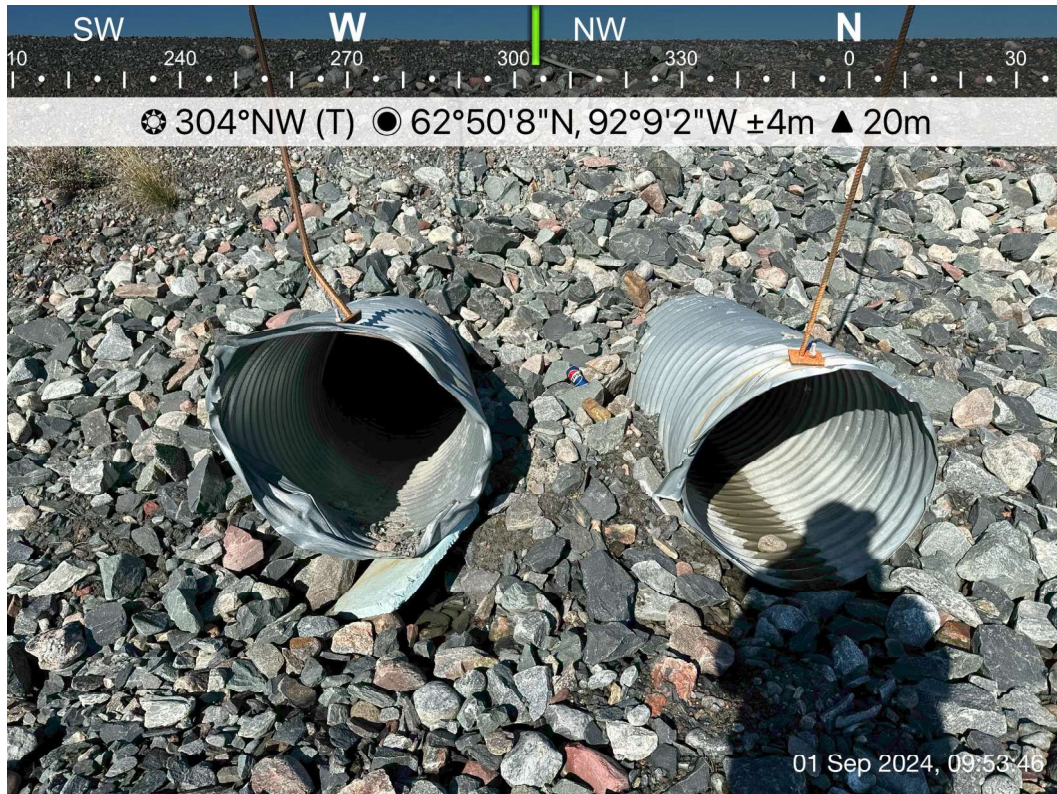
**Itivia Bypass Road/  
Culvert - Photo 44:**

6.2 km	C18 (Design identification C13)	2 x 800 mm	Good condition, culverts are constructed over riprap and inverters are raised above surrounding tundra. Relatively large pond of water upstream and downstream of the culverts; road constructed through natural pond. Culvert inlets and outlets are dented, no flow observed. The west inlet is damaged with the culvert being bent with ¼ of the area. Road constructed out of esker materials.	Itivia Bypass Road Culvert – Photos 44 to 46

Culvert C18 - KM 6.2 - Inlet.

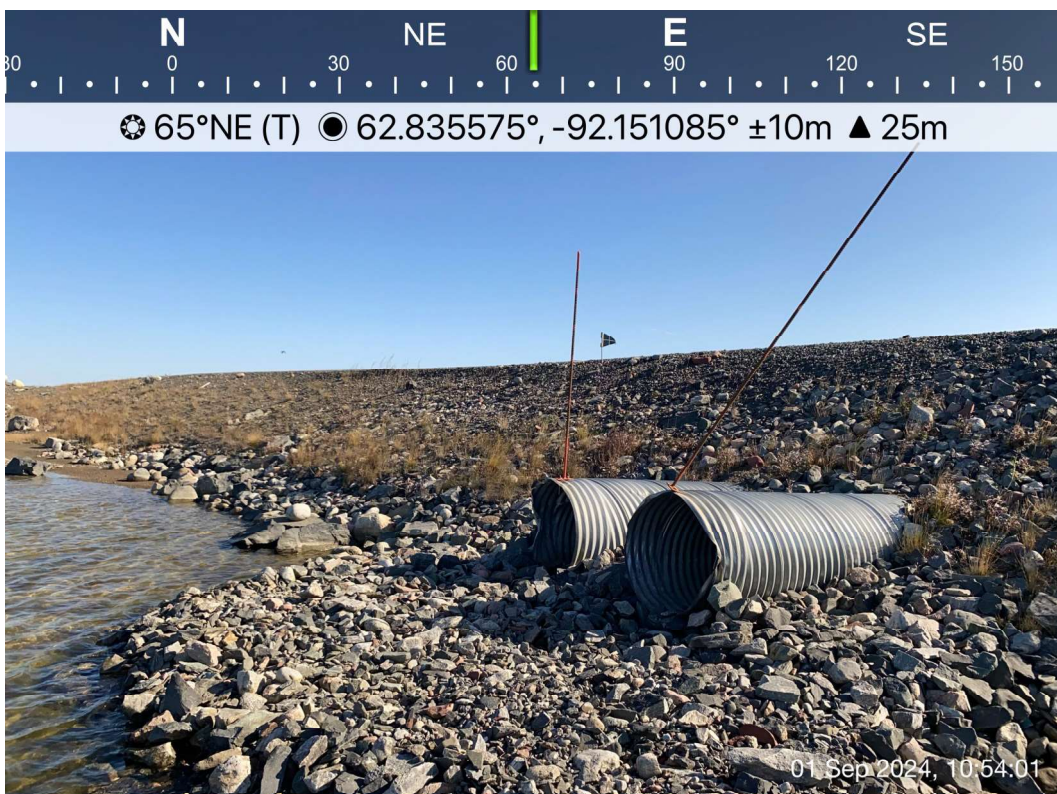
**Itivia Bypass Road/  
Culvert - Photo 45:**

Culvert C18 - KM 6.2 - Inlet.

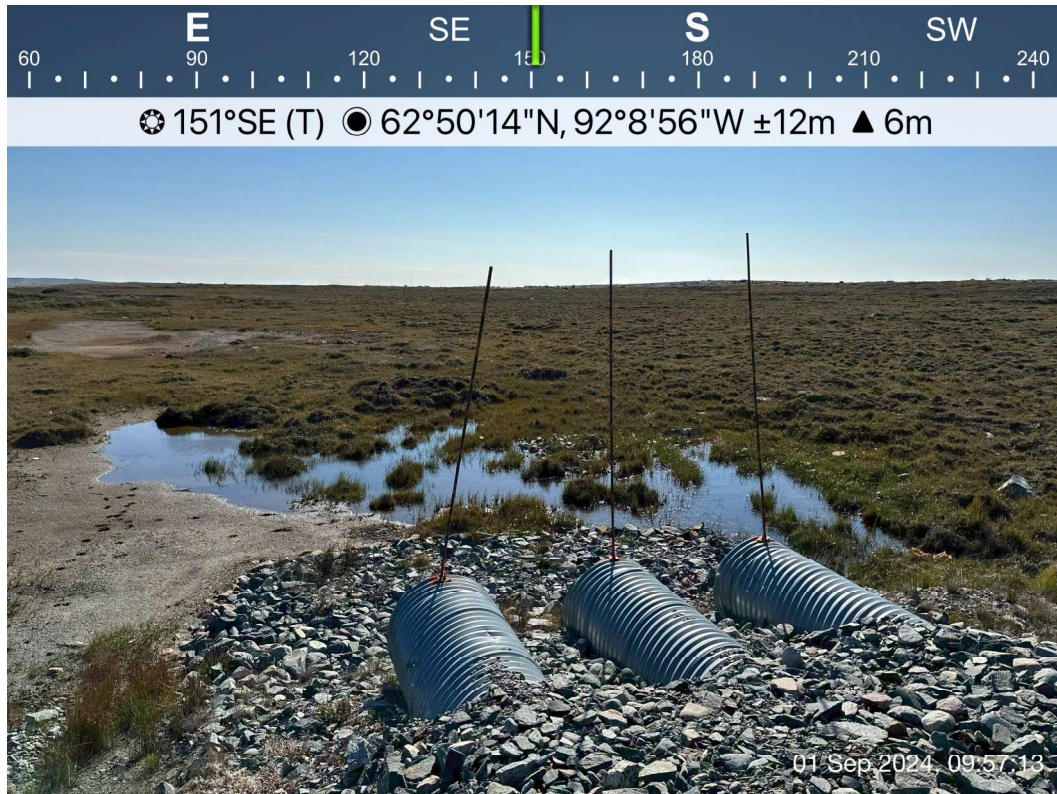
**Itivia Bypass Road/  
Culvert - Photo 46:**

Culvert C18 - KM 6.2 - Outlet.

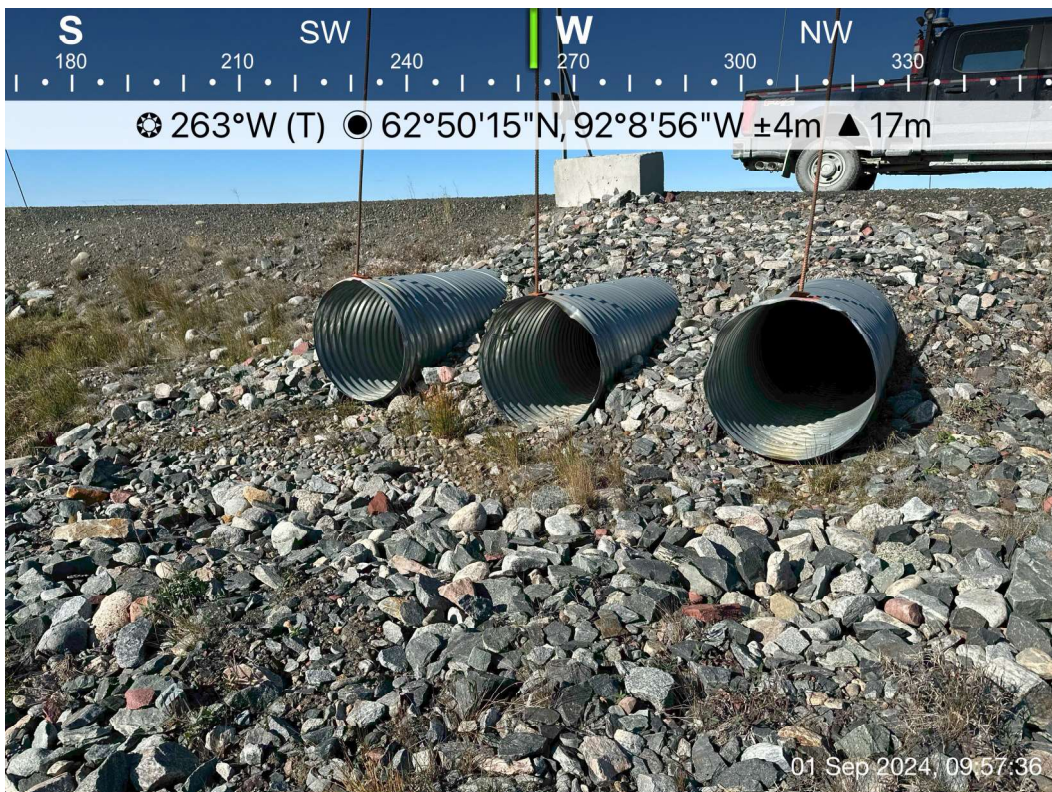
**Itivia Bypass Road/  
Culvert - Photo 47:**

6.3 km	C19 (Design identification C14)	3 x 800 mm	Good condition, culverts are constructed over riprap and inverters are raised above surrounding tundra. Water ponded upstream and downstream of the culverts. No signs of subsidence due to ponded water. No water flow. Road constructed out of esker materials. Left inlet culvert has a dent in the middle, underneath the road fill.	Itivia Bypass Road Culvert – Photos 47 and 48

Culvert C19 - KM 6.3 - Inlet.
