## **APPENDIX 6      2024 ANNUAL GEOTECHNICAL INSPECTION REPORT**

## 2024 Annual Geotechnical Inspection Meliadine Gold Mine, Nunavut, Canada

PRESENTED TO  
**Agnico Eagle Mines Limited**

MARCH 11, 2025  
ISSUED FOR USE-REVISION 1  
FILE: 704-ENG.EARC03140-39  
AGNICO EAGLE DOCUMENT NUMBER: 65-600-230-TCR-002

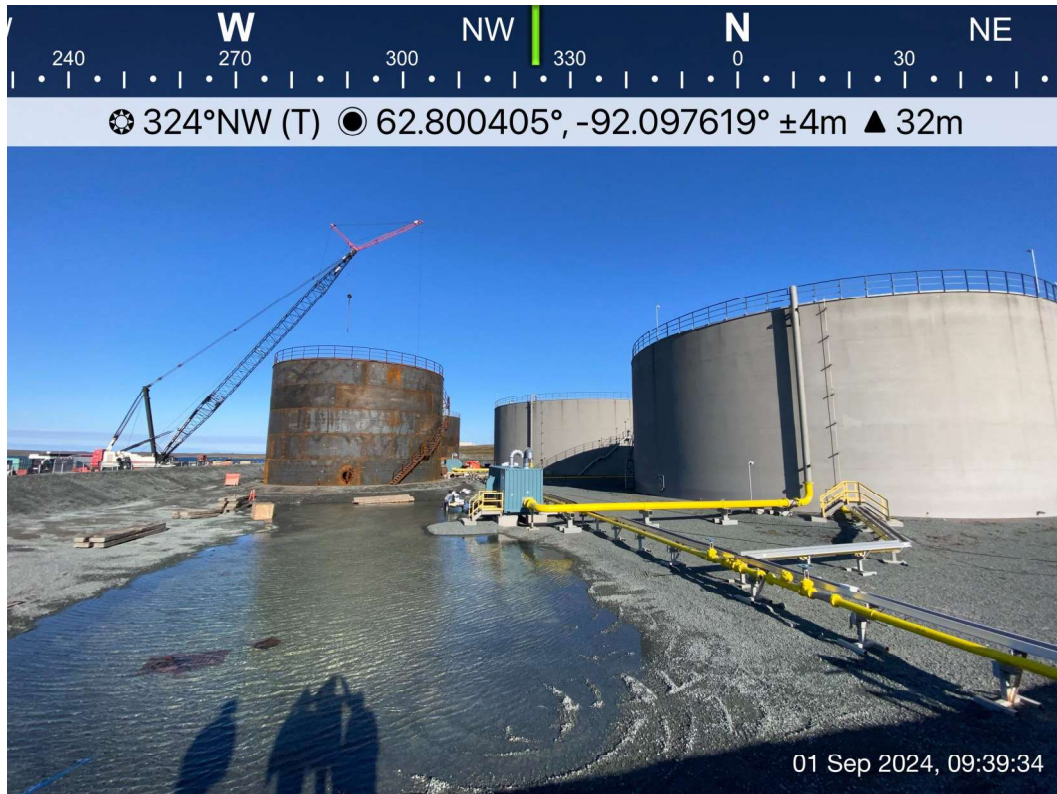
**Itivia Fuel  
Tankfarm - Photo 4:**

Itivia Fuel Tankfarm - Ponding water. Facing west.

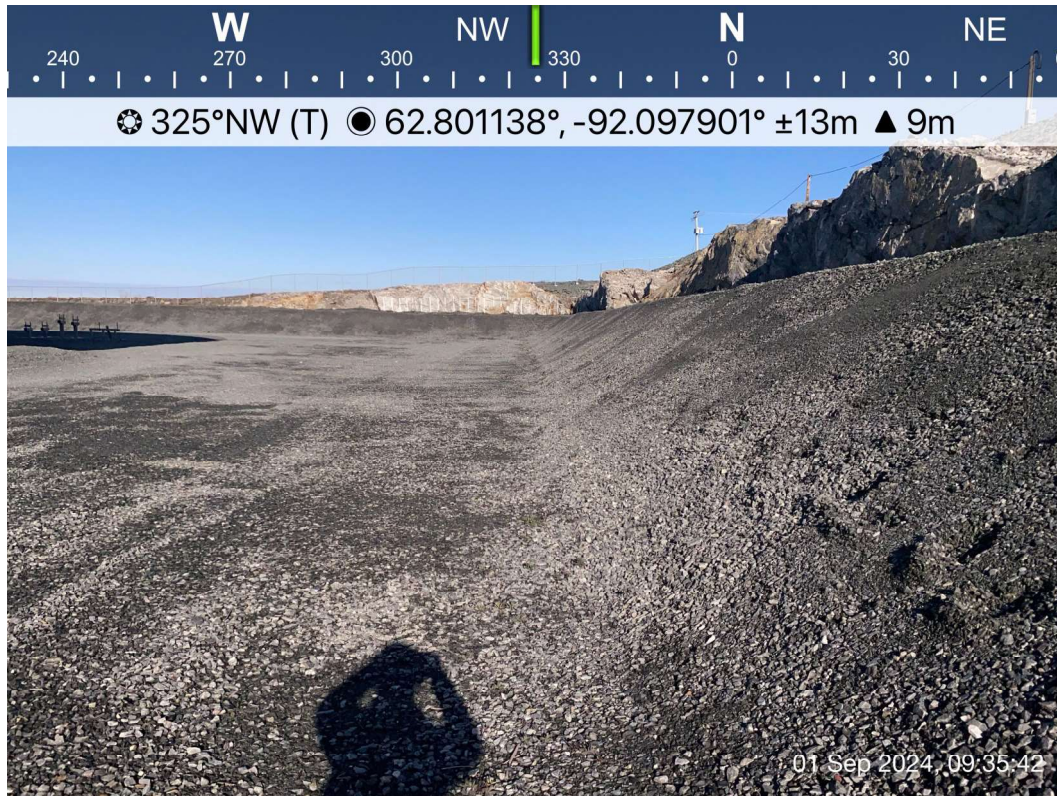
**Itivia Fuel  
Tankfarm - Photo 6:**

Itivia Fuel Tankfarm - Northwest perimeter berm. Facing Northeast.
