Project: CAPR003759
March 25, 2026

Subject Hope Bay – 2025 Annual Geotechnical Inspection – Site-Wide

Agnico Eagle Mines contracted SRK Consulting (Canada) Inc. to conduct the 2025 Annual Geotechnical Inspection for the Hope Bay site in Nunavut. Hope Bay is a gold mine, located in Nunavut Territory 705 km northeast of Yellowknife, NWT and 153 km southwest of Cambridge Bay, NT. The mine is currently in care and maintenance.

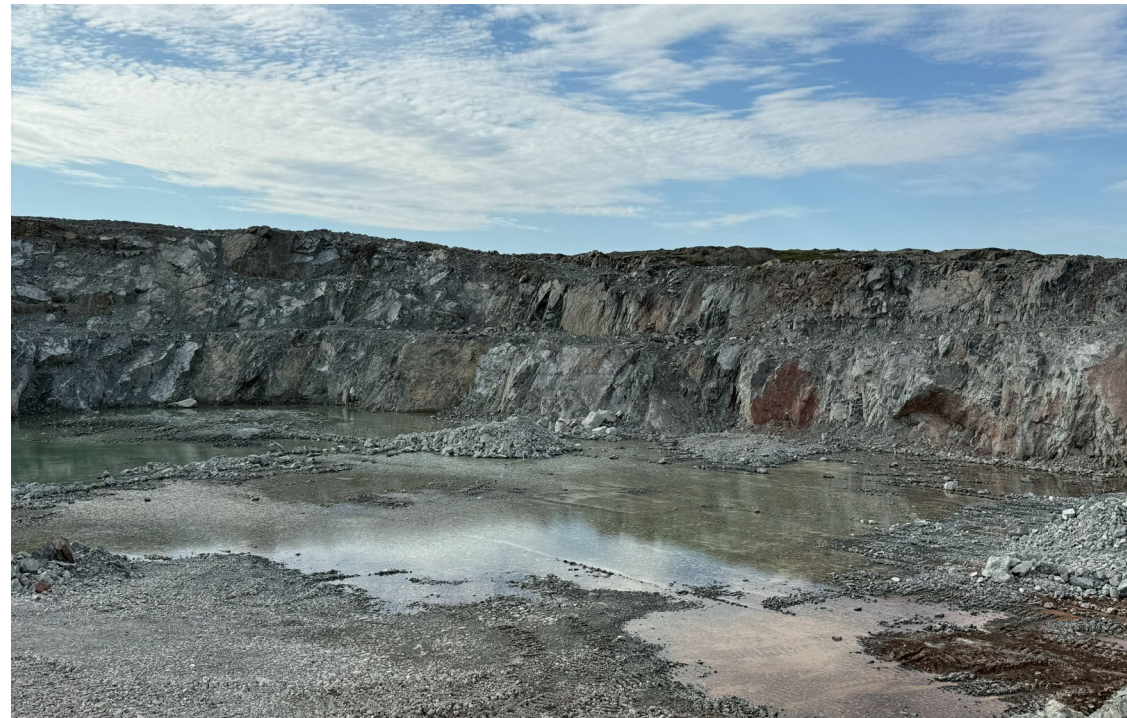
Photo 33: Quarry D overview

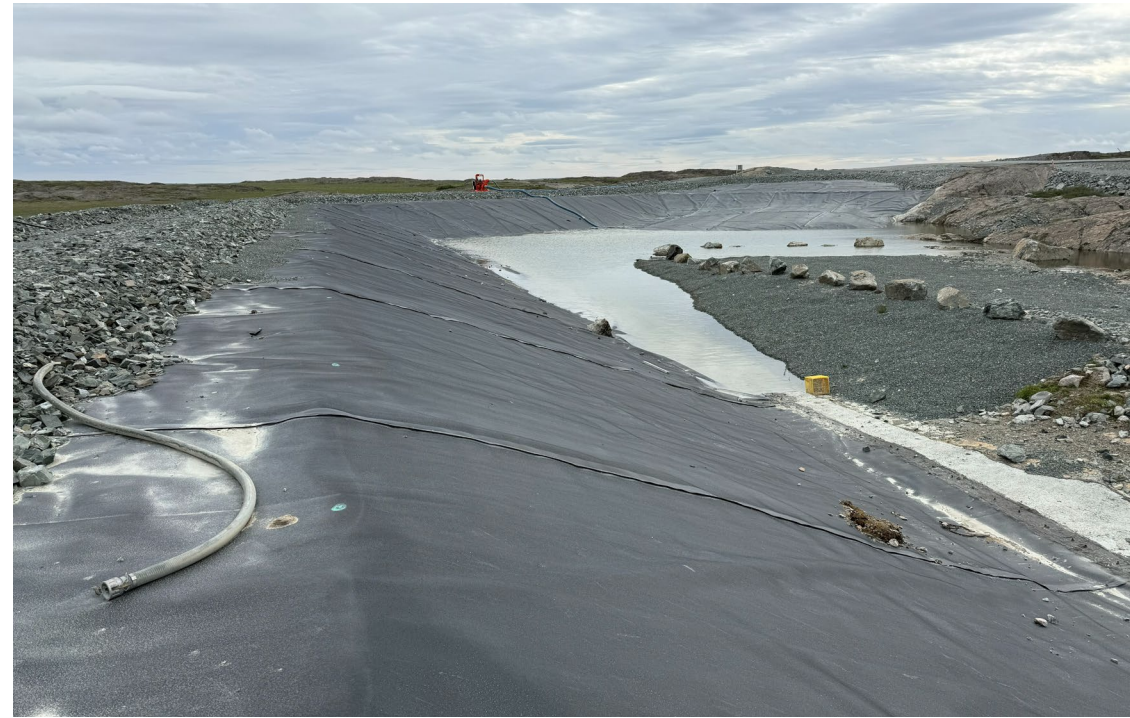
Photo 34: Madrid North CWP inspection

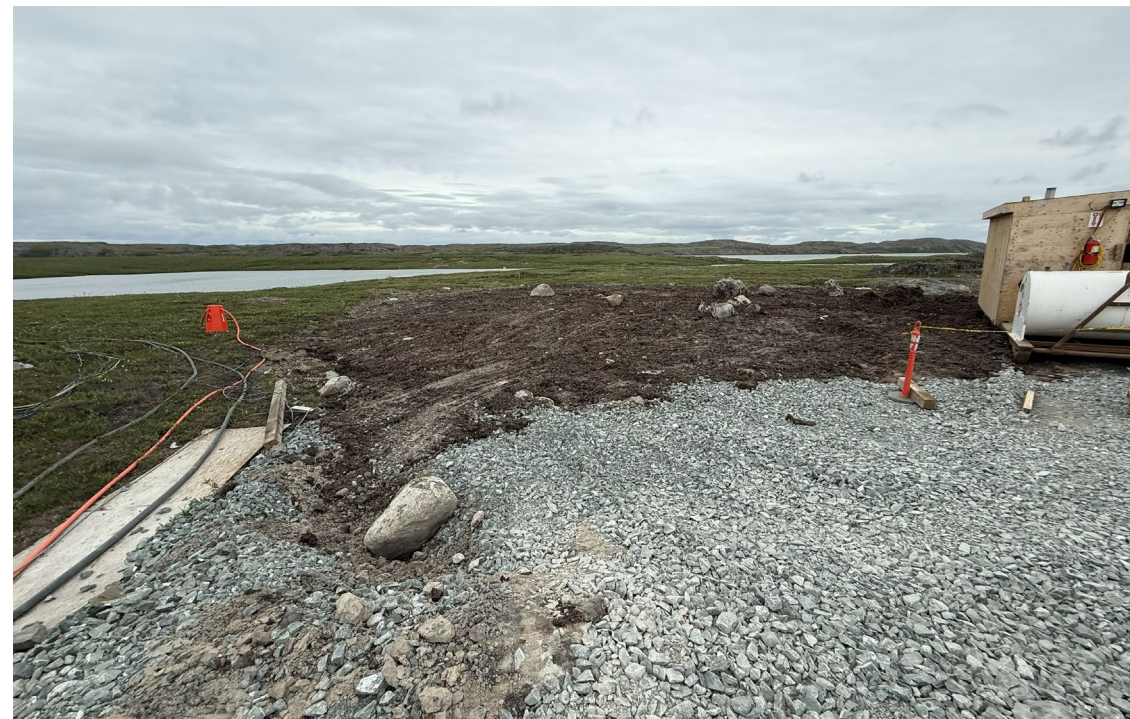
Photo 36: Naartok East tundra remediation

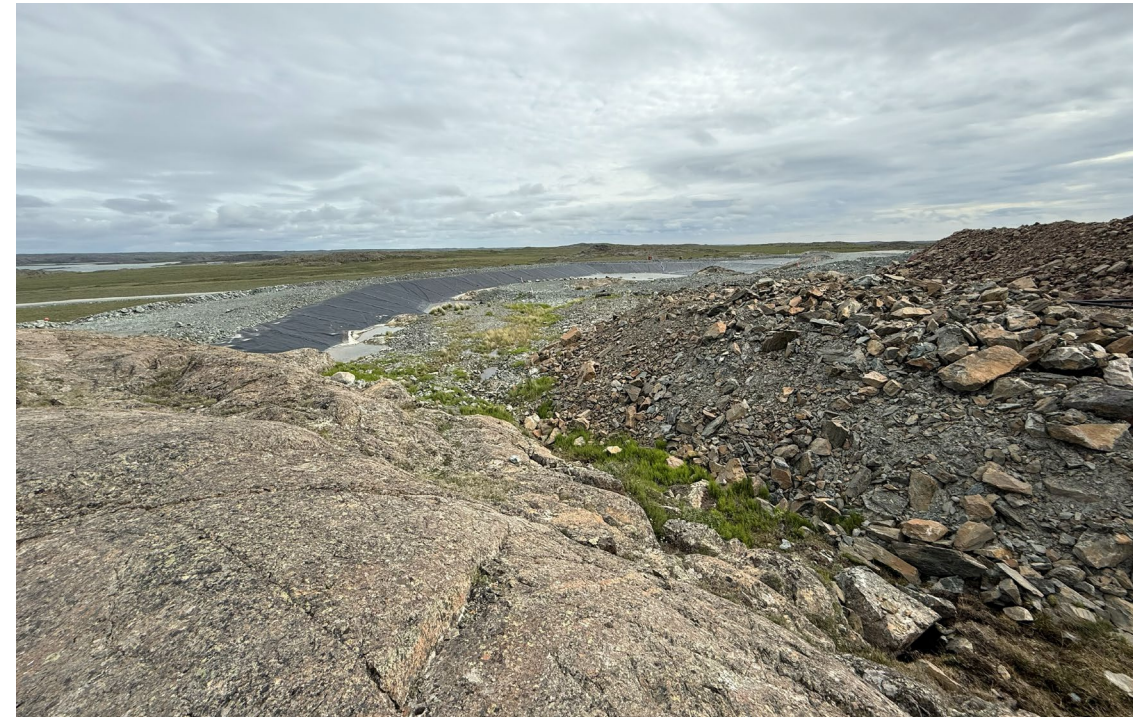
Photo 38: Madrid North CWP inspection

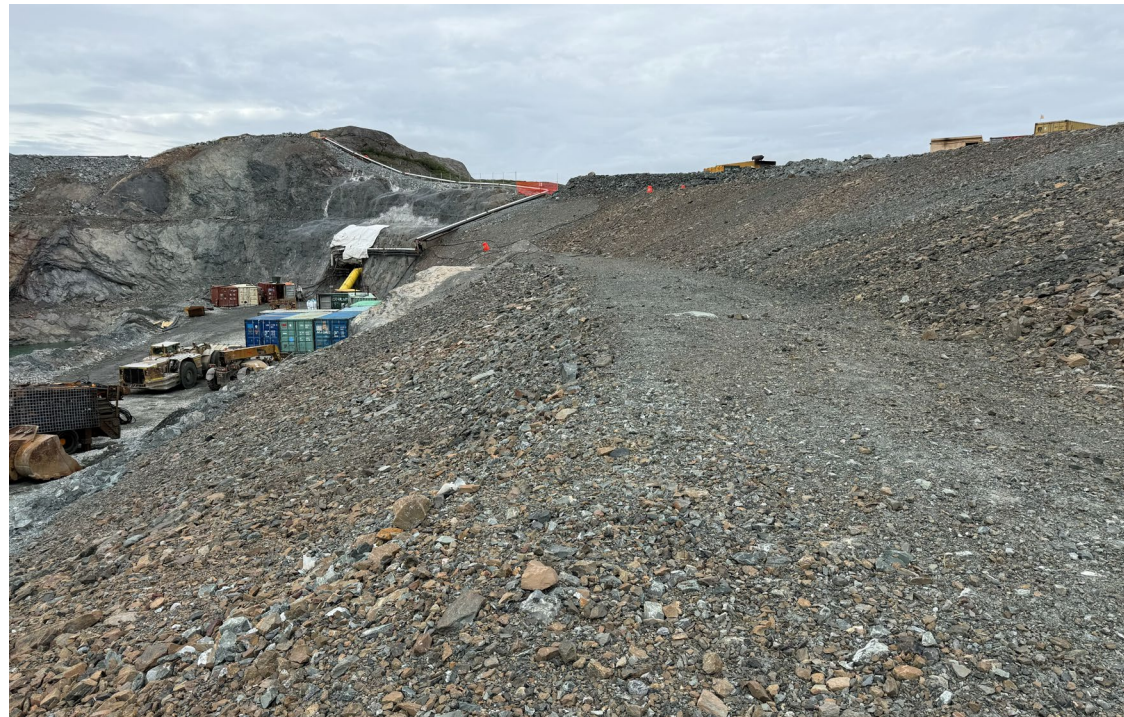
Photo 39: Naartok East inspection

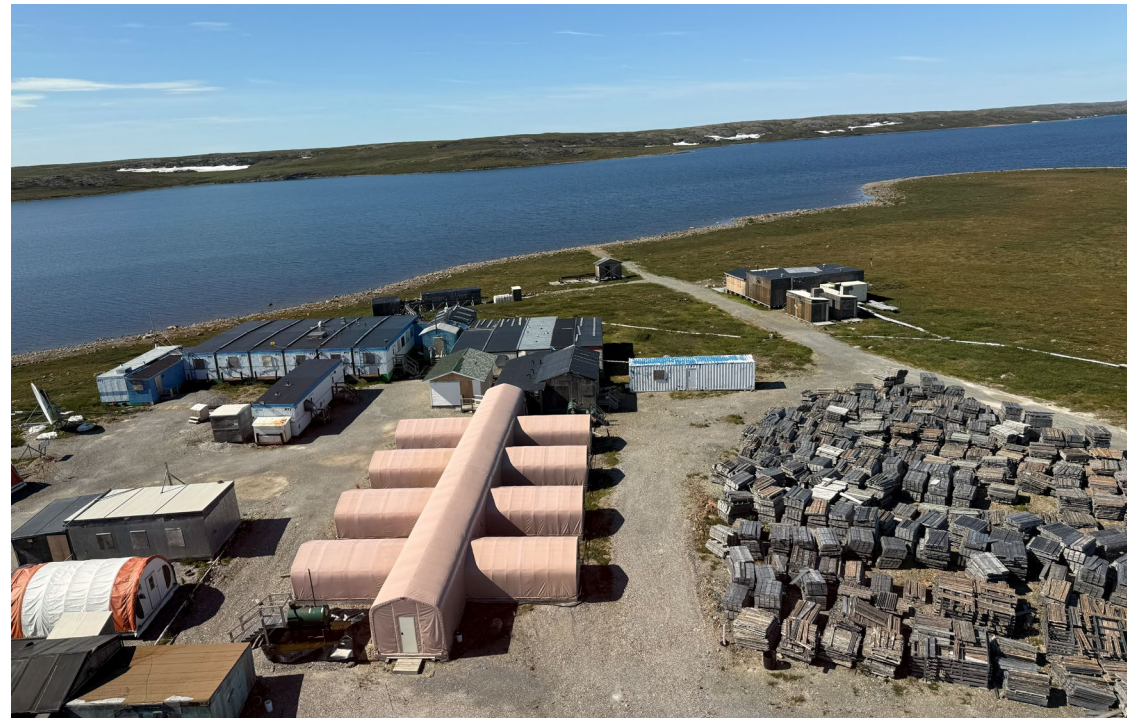
Photo 9: Boston camp overview

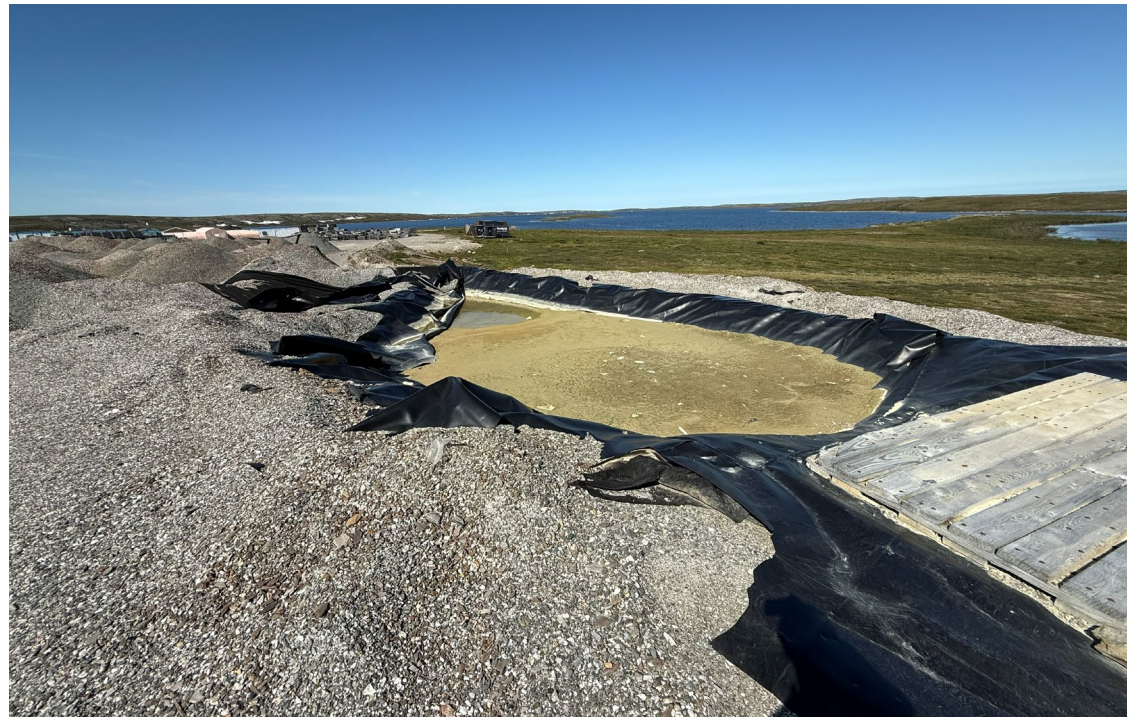
Photo 11: Historic lined area 1

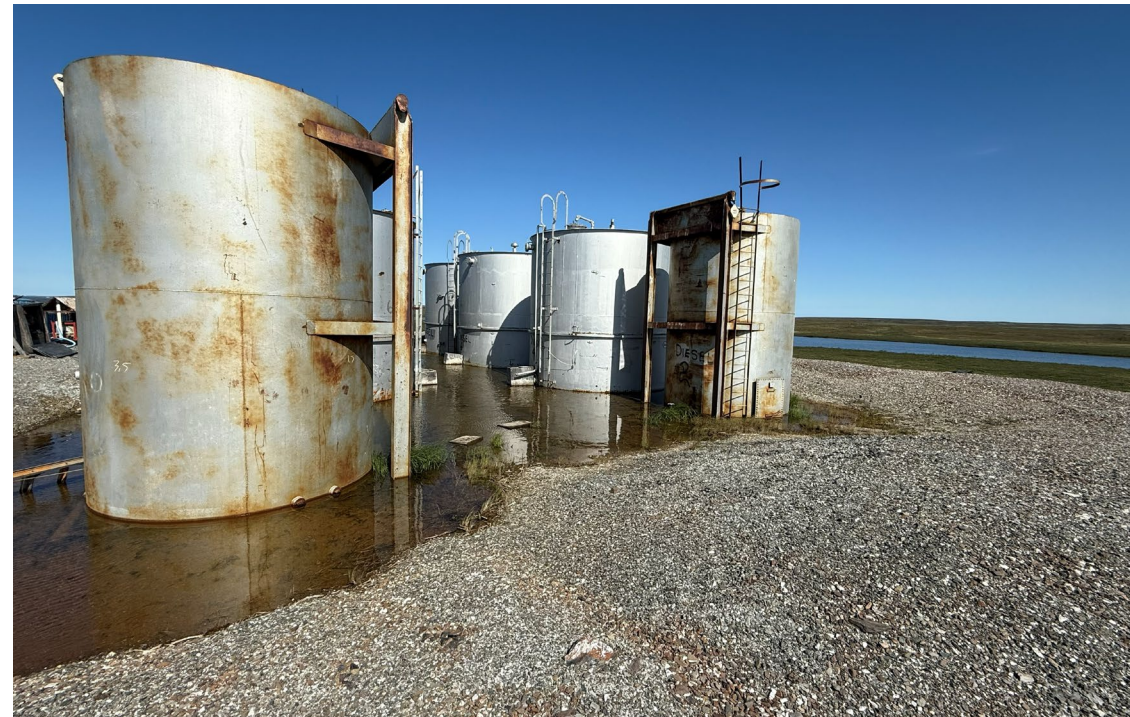
Photo 16: Boston historic tank farm
