2025 Annual Geotechnical Inspection – Doris Tailings Impoundment Area

Hope Bay Mine, Nunavut, Canada
Agnico Eagle Mines Limited

SRK Consulting (Canada) Inc. ■ CAPR003759 ■ March 2026

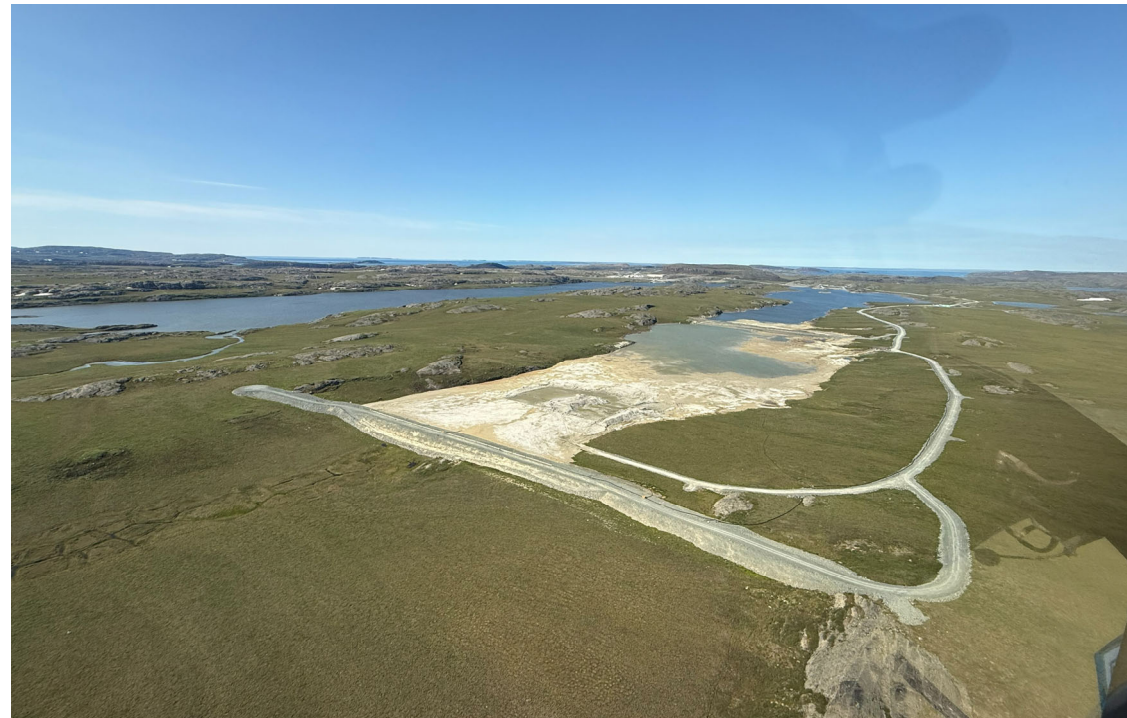
Photo 9: South Dam Overview from the helicopter

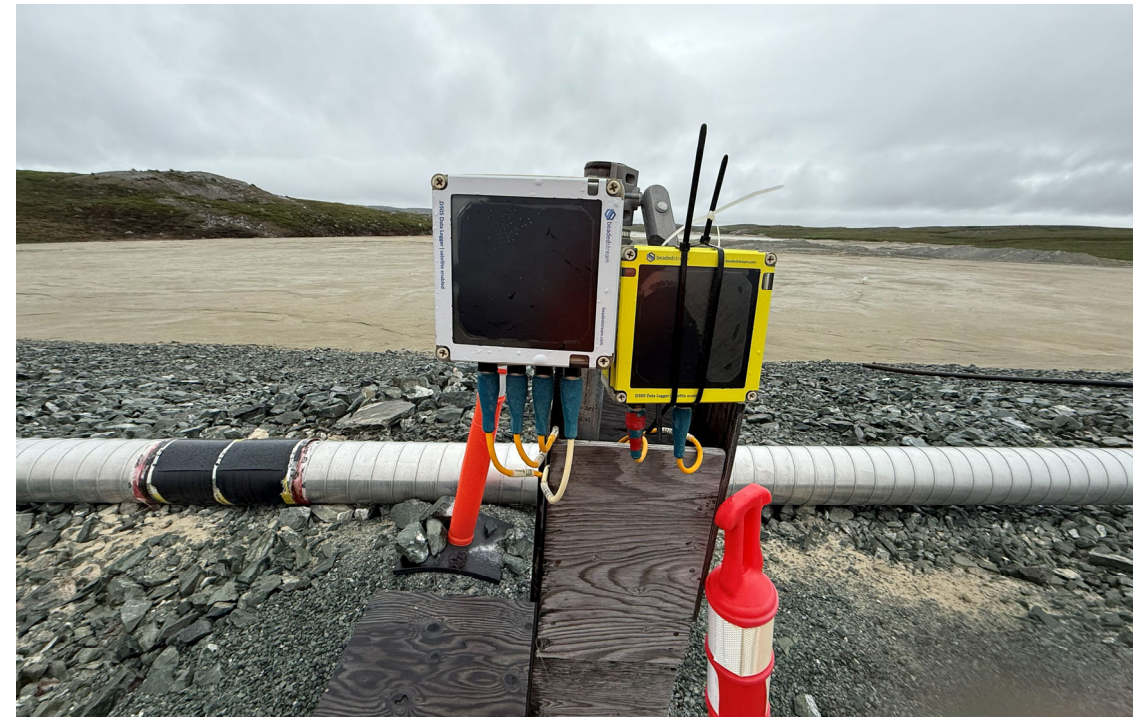
Photo 16: South Dam Instrumentation Inspection

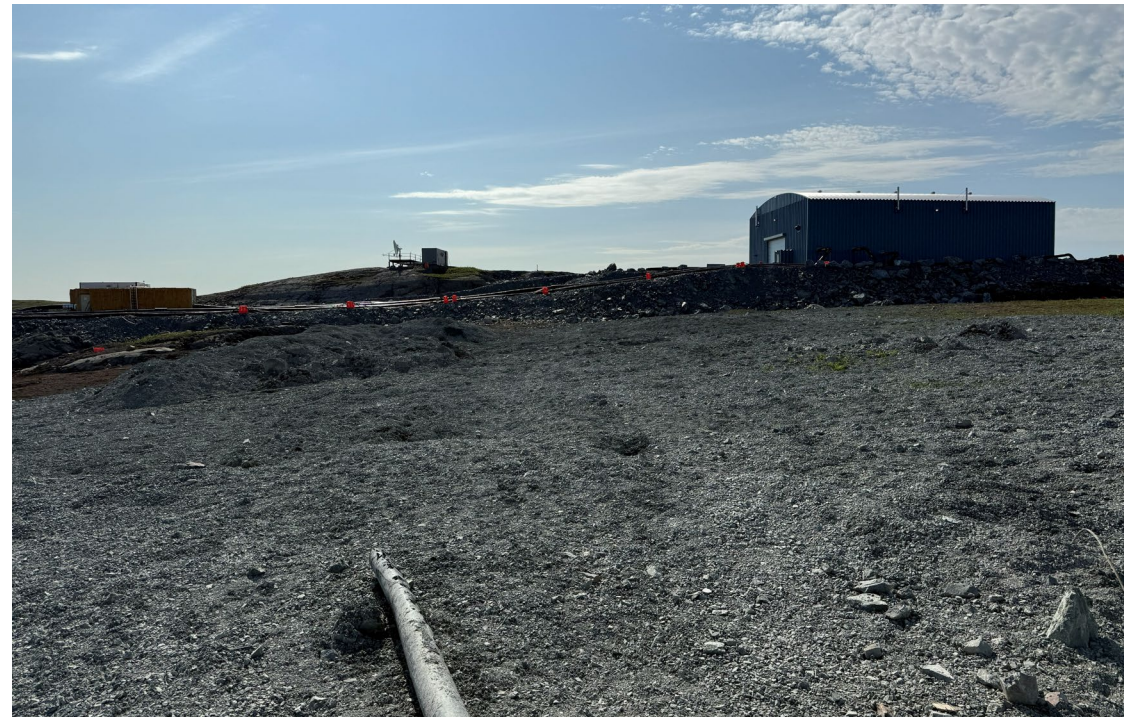
Photo 35: Snow Dump Pile Area with Crushed Rock Remnants.

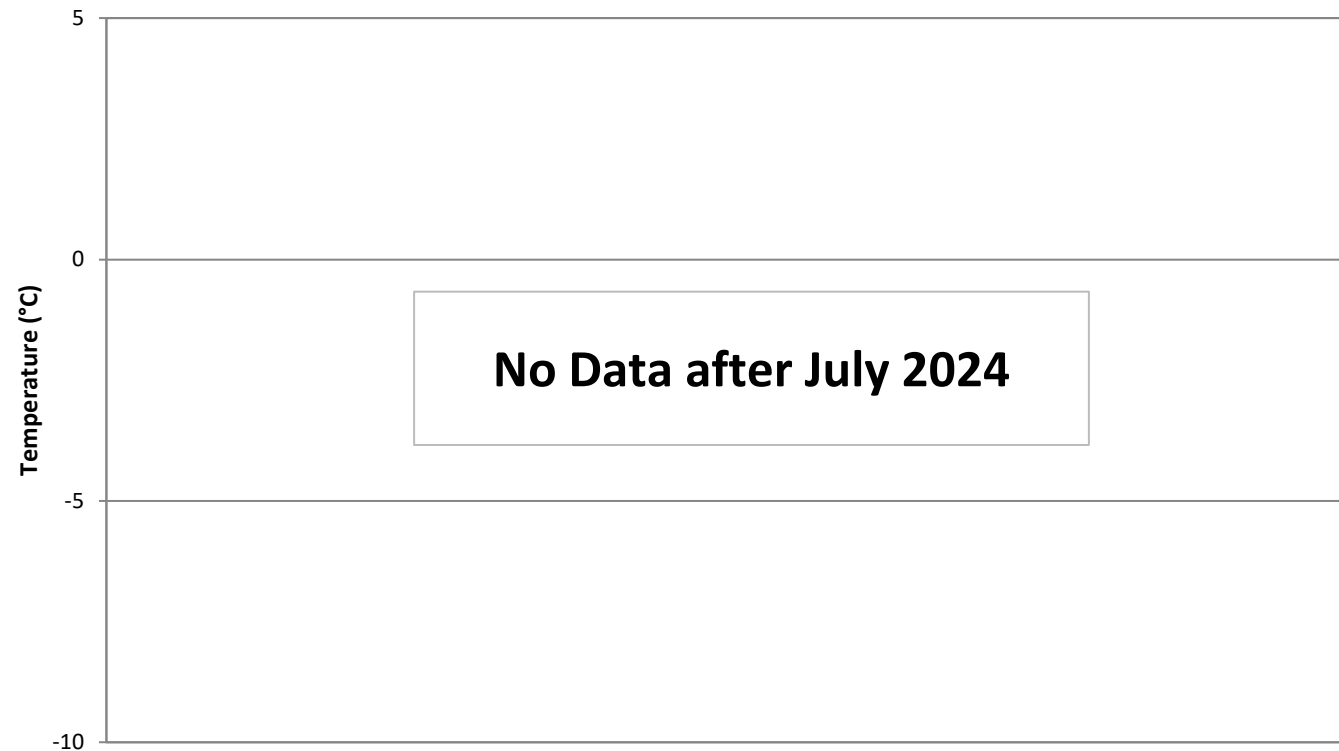
2025 TIA AGI		
		Station 2+40 Ground Temperature Cable Readings by Location		
Job No: CAPR003759	Hope Bay	Date: March 2026	Approved: PDL/AN	Figure: A.24

- Vertical and horizontal offset graphs display data in two-week intervals.
- Previous data were recorded between November 2018 and July 2024.
- SD-VTS-240-US replacement cable installed in late 2023.
- No data collected after August 3, 2024, for SD-HTS-240-US.

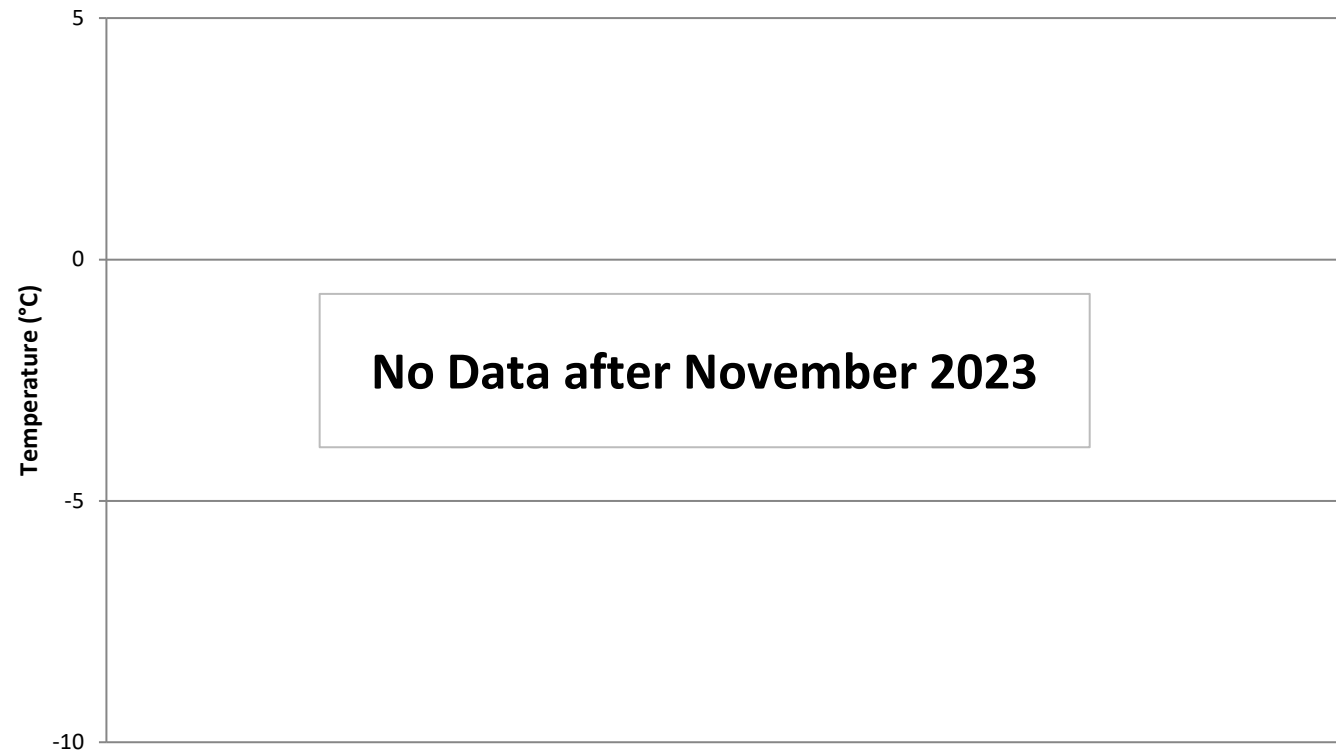
2025 TIA AGI		
		Station 2+40 Ground Temperature Cable Readings by Location		
Job No: CAPR003759	Hope Bay	Date: March 2026	Approved: PDL/AN	Figure: A.26

- Vertical and horizontal offset graphs display data in two-week intervals.
- Previous data were recorded between July 2018 and July 2024 for SD-VTS-240-DS and between April 2018 and July 2024 for SD-VTS-240-KT
- Bead 11 data is unavailable on September 29, 2024, for SD-VTS-240-DS.
