APPENDIX 15 2025 REPORTABLE SPILLS

Re: Follow-up Report Spill #2025-007 – Release of 1,000 L of waste oil at the Meliadine Gold Project

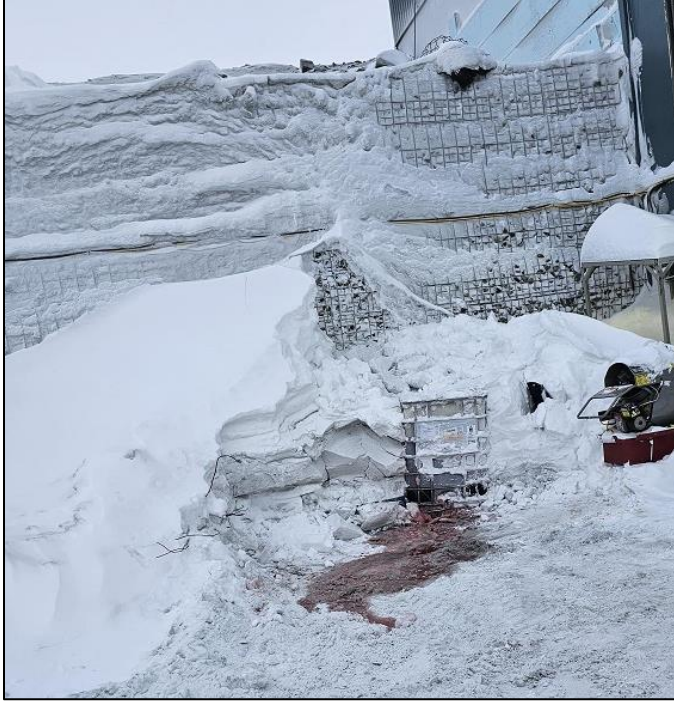
On January 10th, 2025, at approximately 11:00AM, a tote containing glycol was punctured by a skid steer at the primary crusher. The glycol tote was completely buried under snow from a recent blizzard, and the operator of the skid steer inadvertently hit and punctured the tote while performing snow removal. As a result, 200 L of glycol was released from the tote onto the industrial pad.

Photo 1: Spill location before remediation.

The Process Plant employee who was operating the skid steer immediately called their supervisor who then contacted the Environment department to report the spill. The leaking tote was placed on a secondary containment to avoid further spillage. The contaminated snow was then recovered and placed into a hazardous waste drum and stored at the hazmat laydown, to be sent offsite for disposal at a licensed disposal facility.

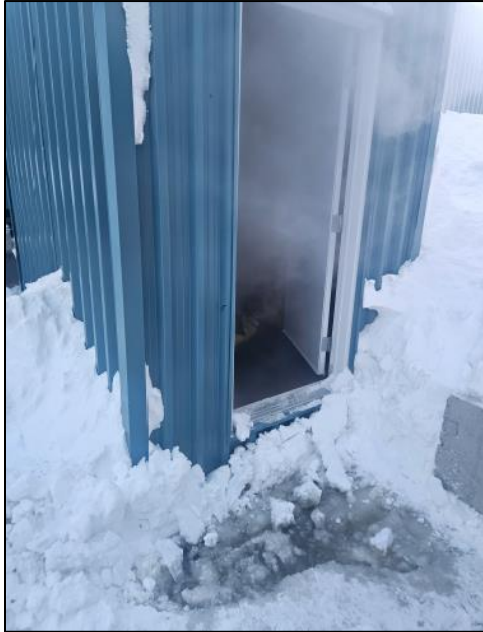
Photo 1: Spill location

On March 30th, 2025, at approximately 06:30, approximately 50 L of sewage spilled onto the industrial pad outside the Wing 16 lift station. Upon inspection, it was discovered the lift station pump impeller was obstructed by non-compliant material, which led to the pump's failure and the lift station to overflow.

- Non-compliant material had been flushed in a toilet at Wing 16, resulting in the pump impeller being obstructed, which led to the pump's failure and the lift station overflow.

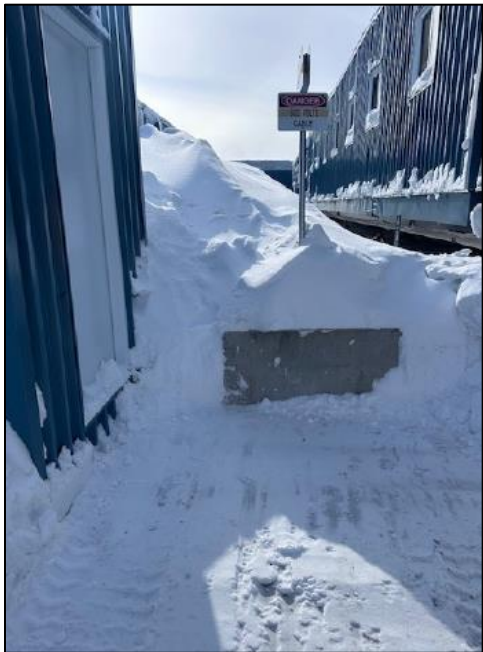
Photo 2: Spill remediation

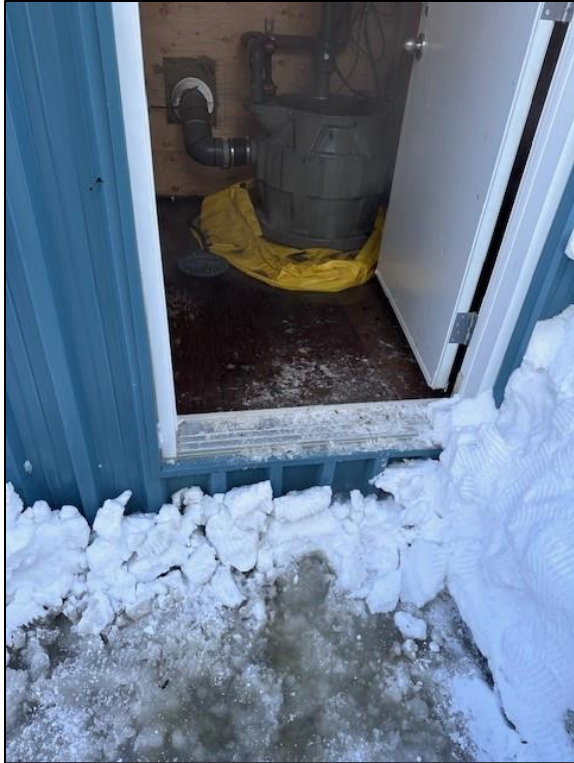
Photo 1: Spill location

On April 2nd, 2025, at approximately 15:30, approximately 30 L of sewage spilled onto the industrial pad outside the Wing 16 lift station. Upon inspection, it was discovered the lift station pump impeller was obstructed by non-compliant material, which led to the pump's failure and the lift station to overflow.

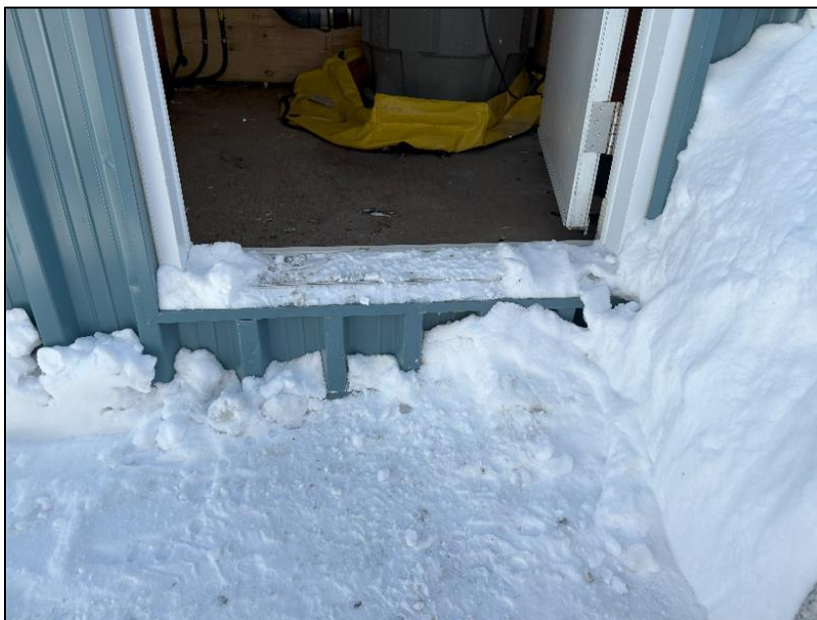
Photo 2: Spill remediation

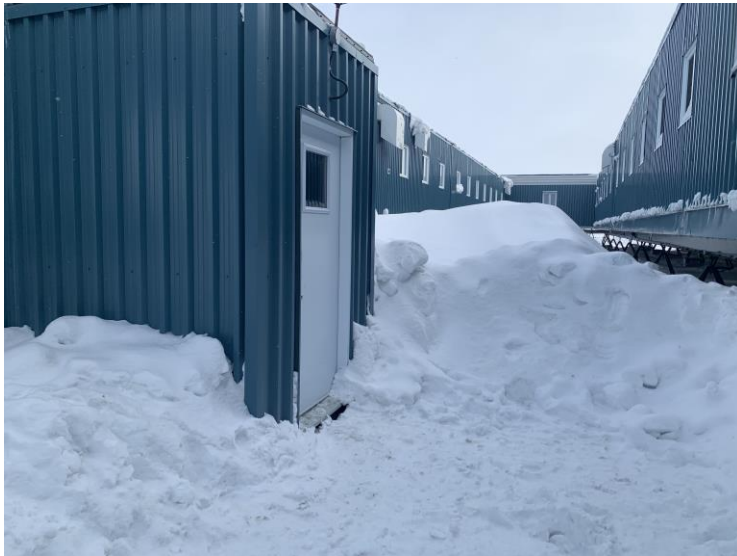
Photo 2: Spill remediation

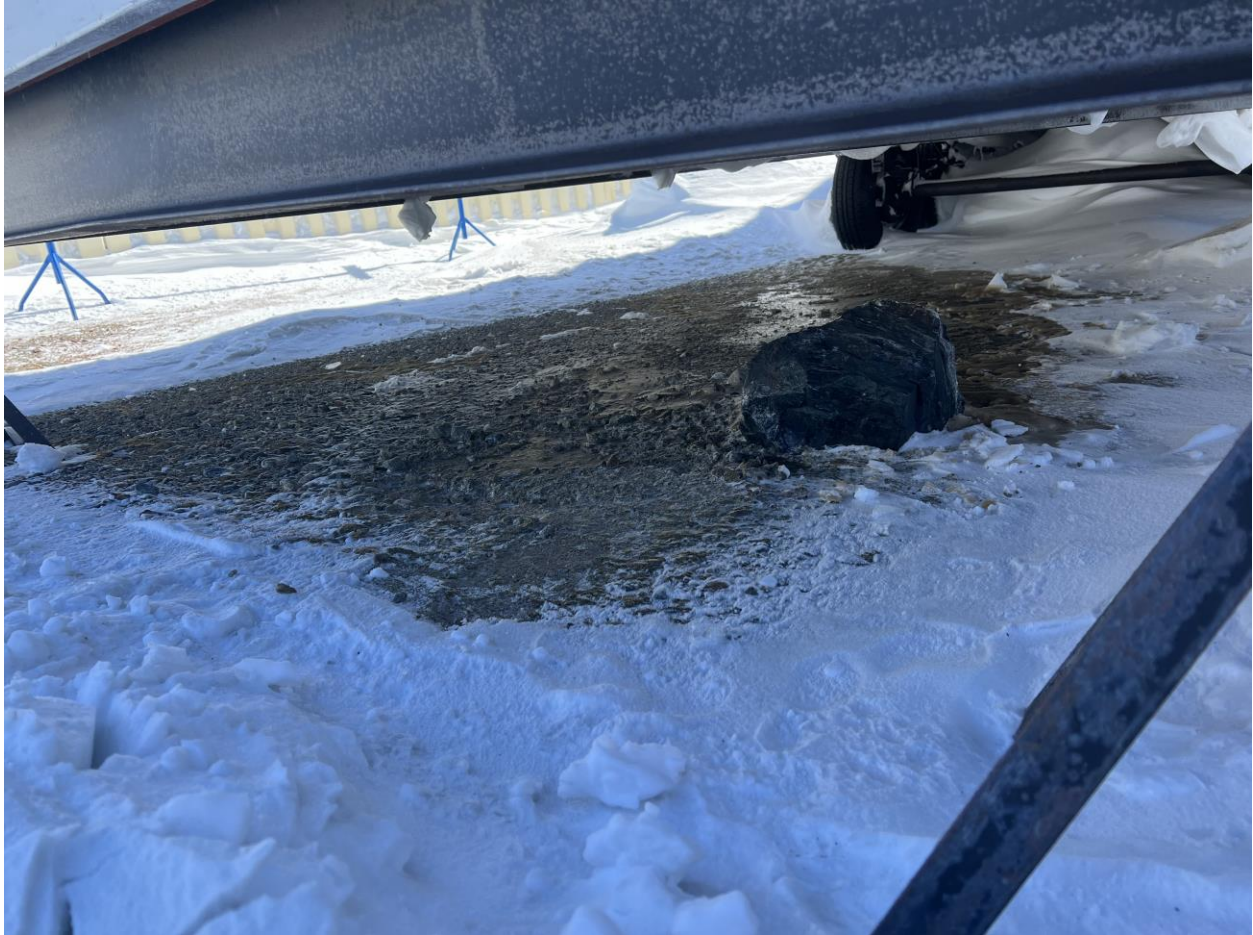
Photo 1: Spill location

On April 24th, 2025, at 09:00, approximately 10 L of sewage spilled onto the ground underneath the Dyno Plant office trailer. An Energy and Infrastructure (E&I) maintenance worker was conducting routine sewage collection at the Dyno Plant sewage holding tank. The employee accidentally opened the incorrect valve on the holding tank, which resulted in the spill.

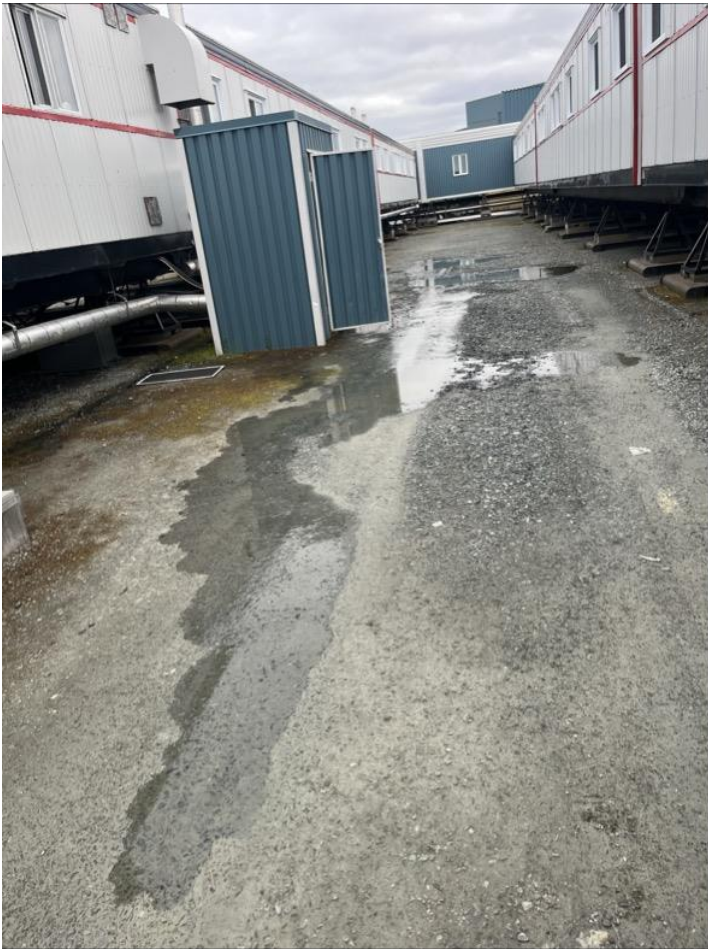
Photo 1: Spill location

On July 17th, 2025, at 18:30, approximately 50 L of sewage spilled onto the industrial pad outside the Wing 2 lift station. Upon inspection, it was determined that this spill was caused by the loss of power at the lift station pump, causing the lift station to back up and overflow.

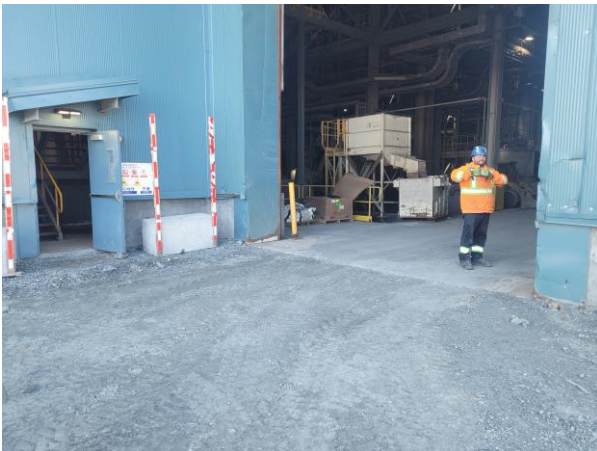
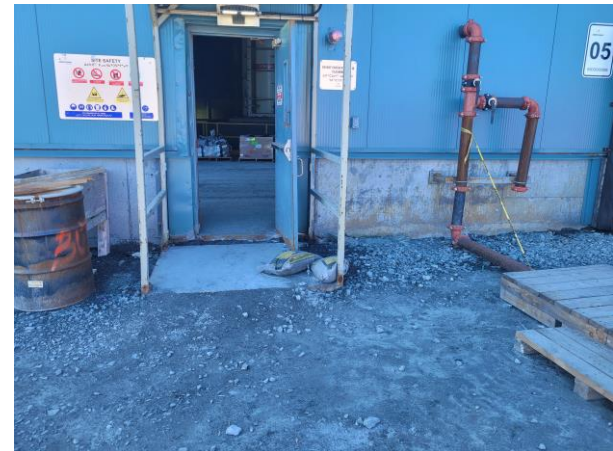
On August 2nd, 2025, at approximately 3:30AM and 7:00PM, water used in the cyclone for primary grinding at the Process Plant started accumulating in the Plant and eventually made its way outside through the garage door and the man door on the south side of the Plant. This resulted in two release events of approximately 25 L of slurry onto the industrial pad.

Photos 3-4: Spill location post-cleanup.

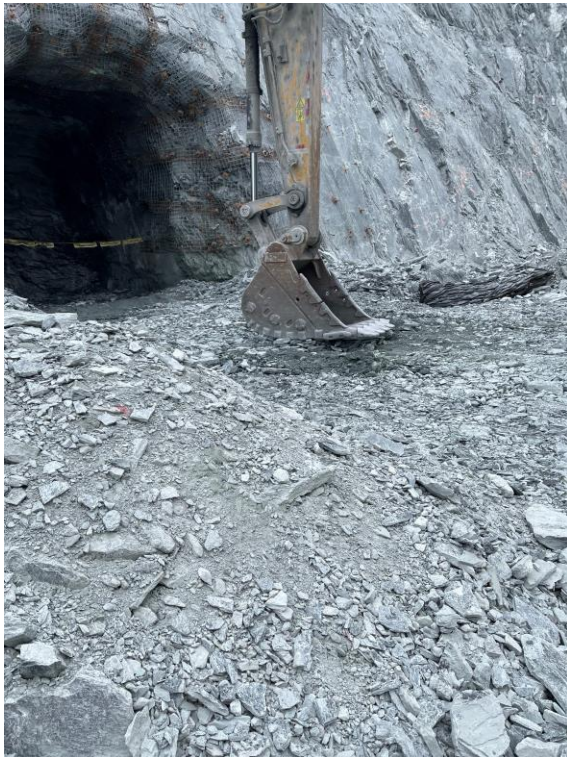
Photo 2: Spill remediation.

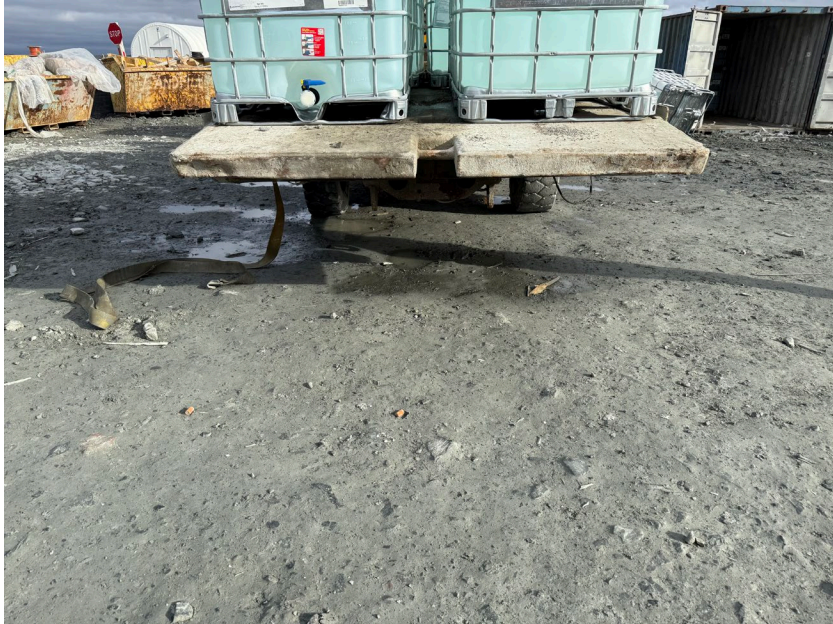
Photo 1: Spill location.

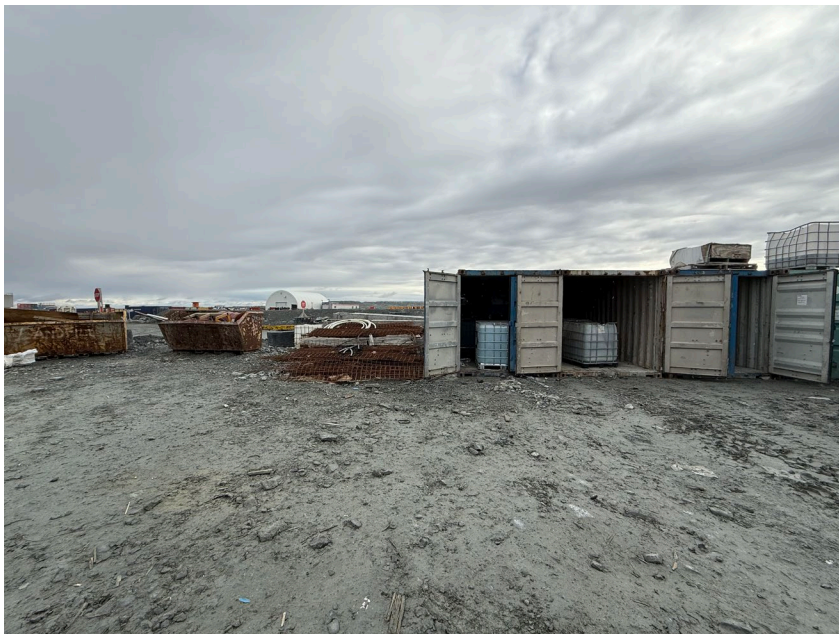
Photo 2: Spill location after remediation.

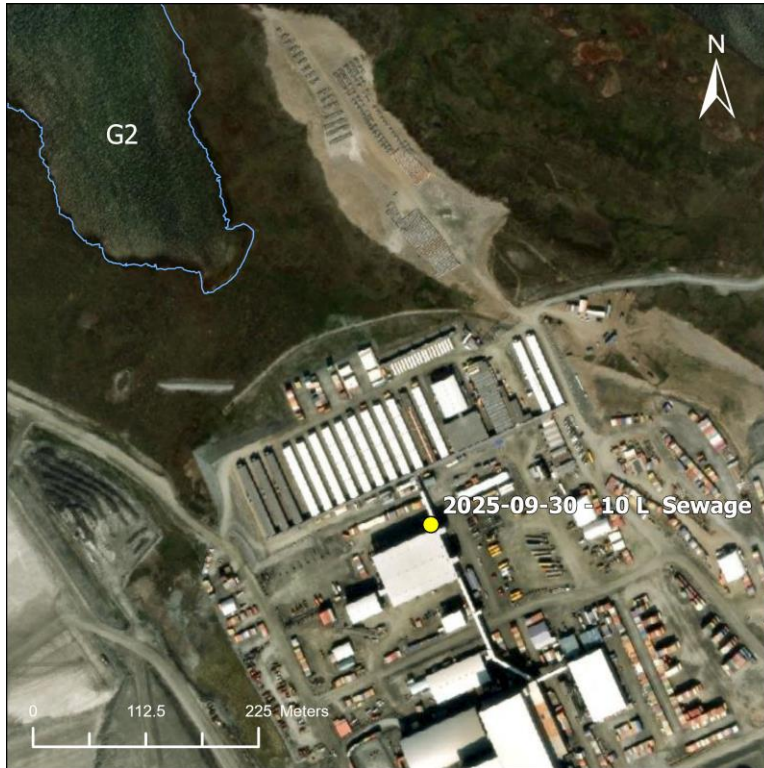
On September 30th, 2025, at approximately 6:30AM, a Surface Operations employee was training another on how to use the vacuum truck to perform a sewage transfer at the MSB lift station. The employee observed sewage leaking from a valve, releasing approximately 10 L of sewage onto the ground.

The spill occurred within the bounds of the site's runoff collection system. No water bodies were impacted by the spill. The closest water body (Lake G2) is approximately 315 meters northwest, as seen in Figure 1.

Figure 1: Location of the spill and proximity to waterbodies.

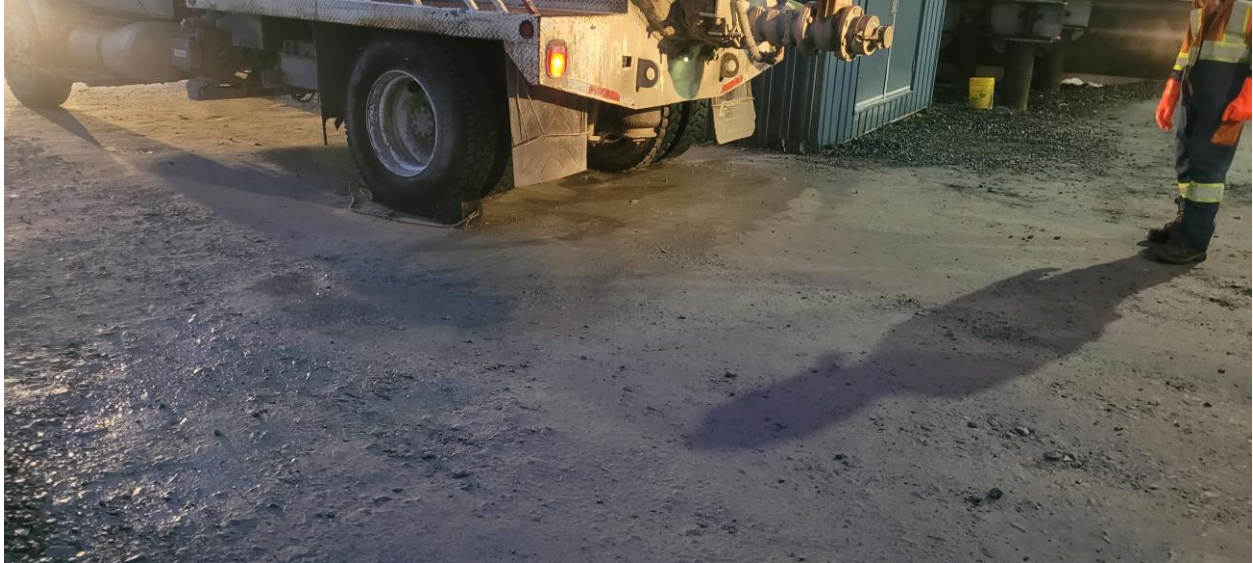
Photo 1: Spill location.

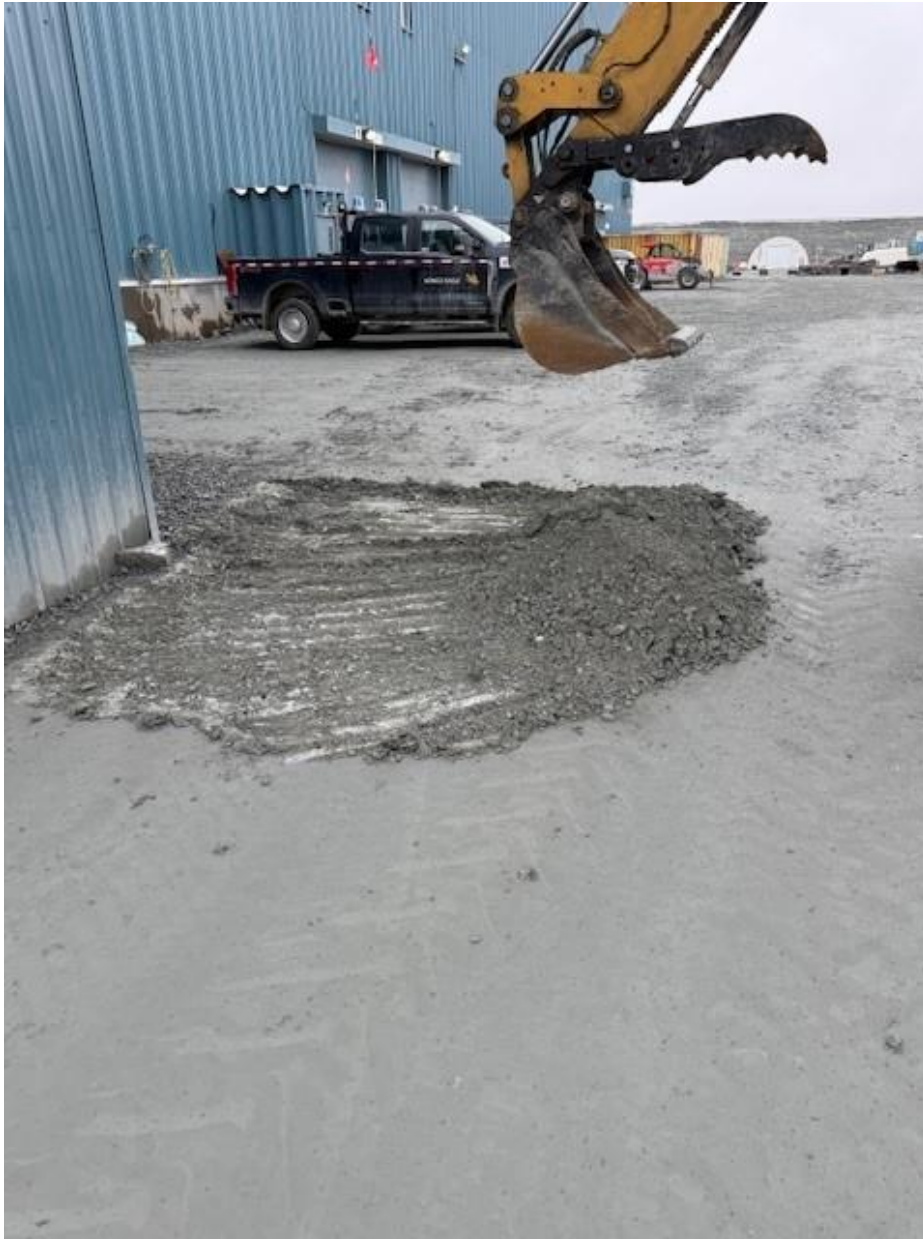
Photo 2: Spill location after remediation.

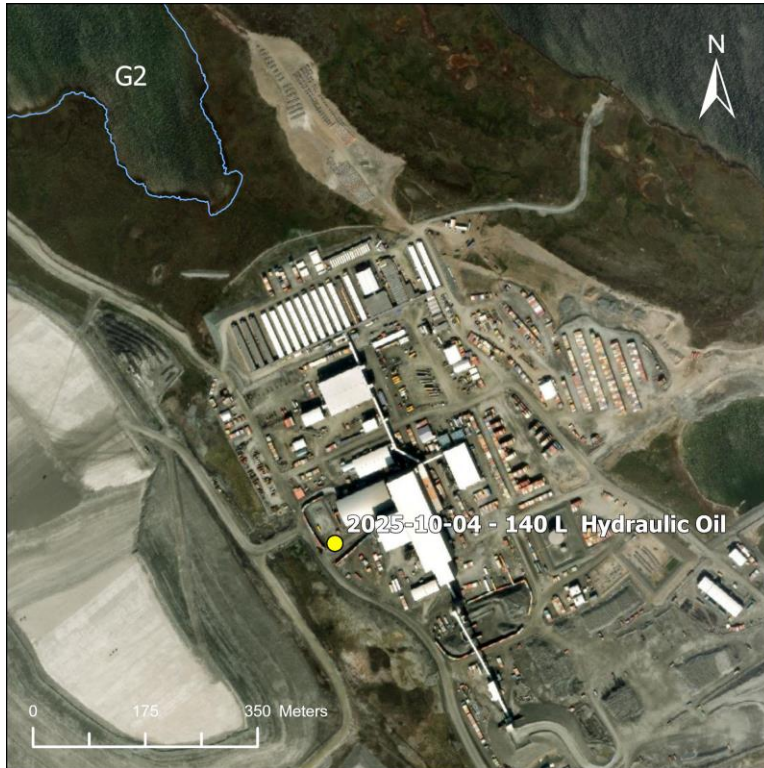
On October 4th, 2024, at approximately 9:00 PM, a worker in the Surface Operations department was operating a loader in the vicinity of the tailings dewatering building when a hydraulic line broke releasing approximately 140 L of hydraulic oil outside of the tailings dewatering building.

The spill occurred within the bounds of the site's runoff collection system. No waterbodies were impacted by the spill. The closest water body (Lake G2) is approximately 550 meters northwest, as seen in Figure 1.

Figure 1: Location of the spill and proximity to waterbodies.

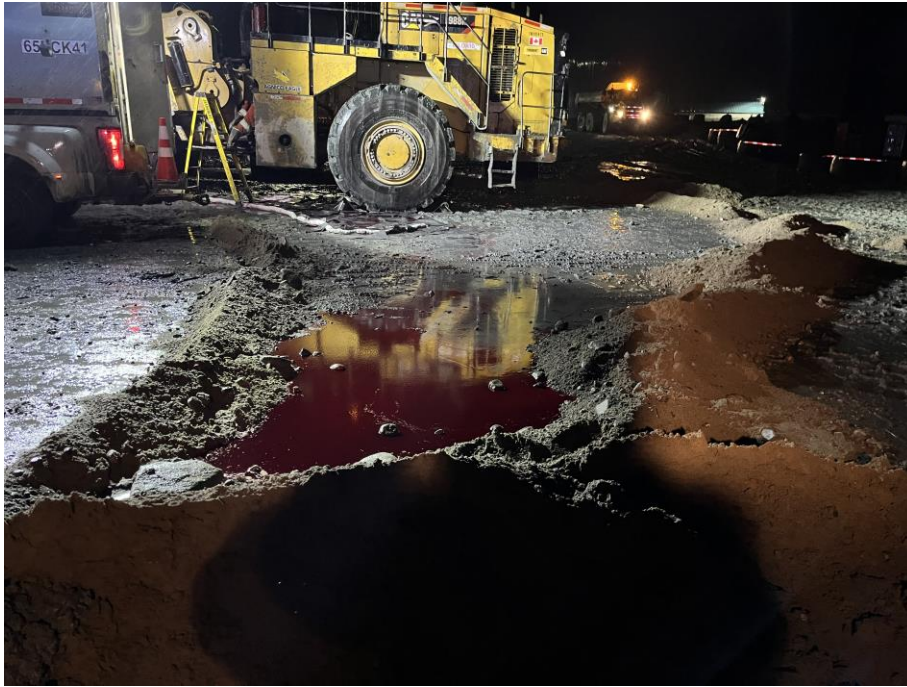
Photo 1: Spill location.

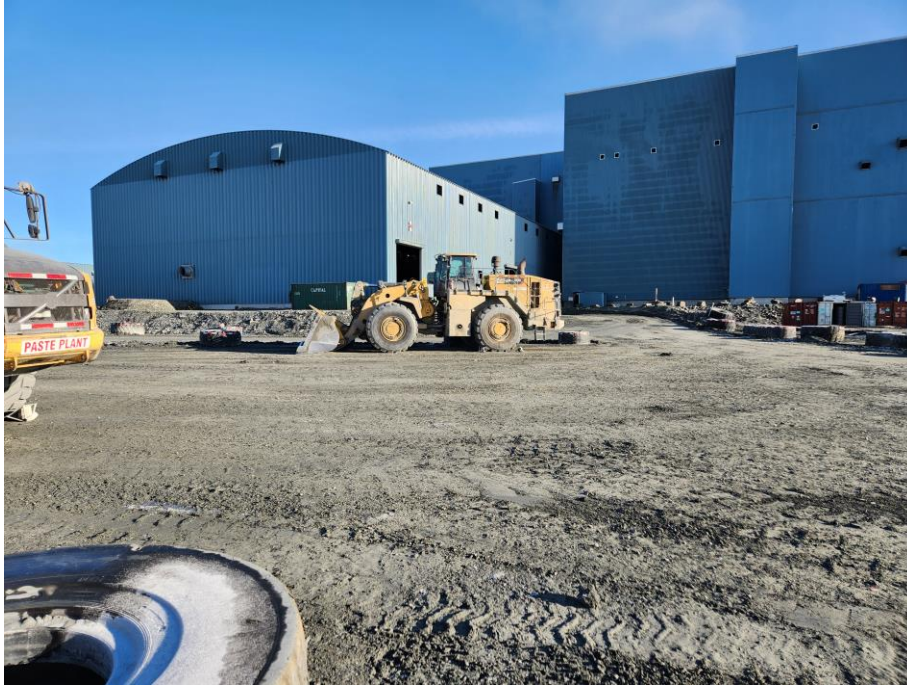
Photo 2: Spill location after remediation.

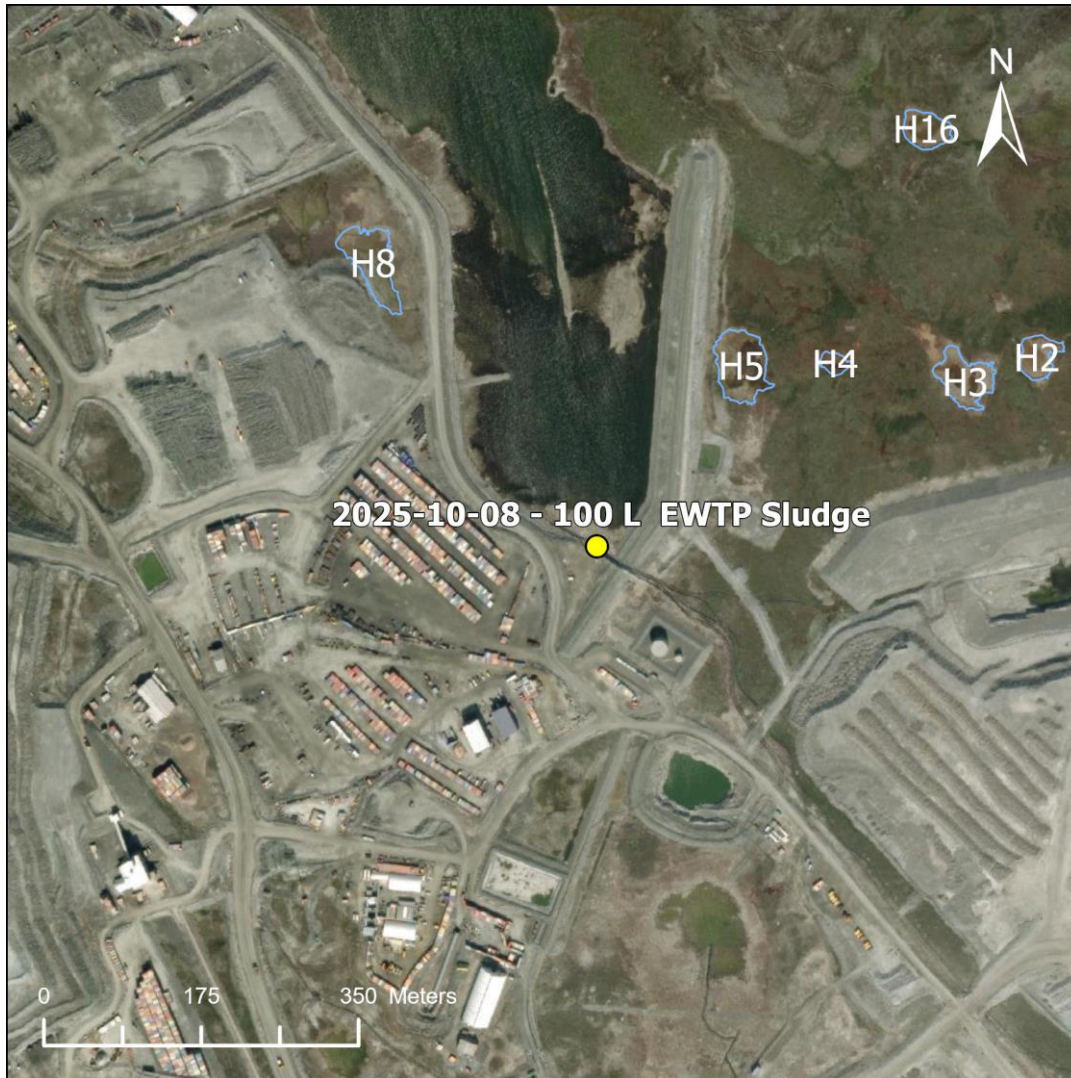
On October 8th, 2025, at approximately 1:30AM, it was noted during an inspection of the EWTP to TIRI02 sludge line that sludge was leaking from a hugger, releasing approximately 100 L of EWTP sludge onto the ground at the southern toe of CP1.

The spill occurred within the site's contact water management system, and as such, no water bodies were impacted by the spill. The closest natural water body, Lake H5, is approximately 220 meters northeast, as seen in Figure 1.

Figure 1: Location of the spill and proximity to waterbodies.

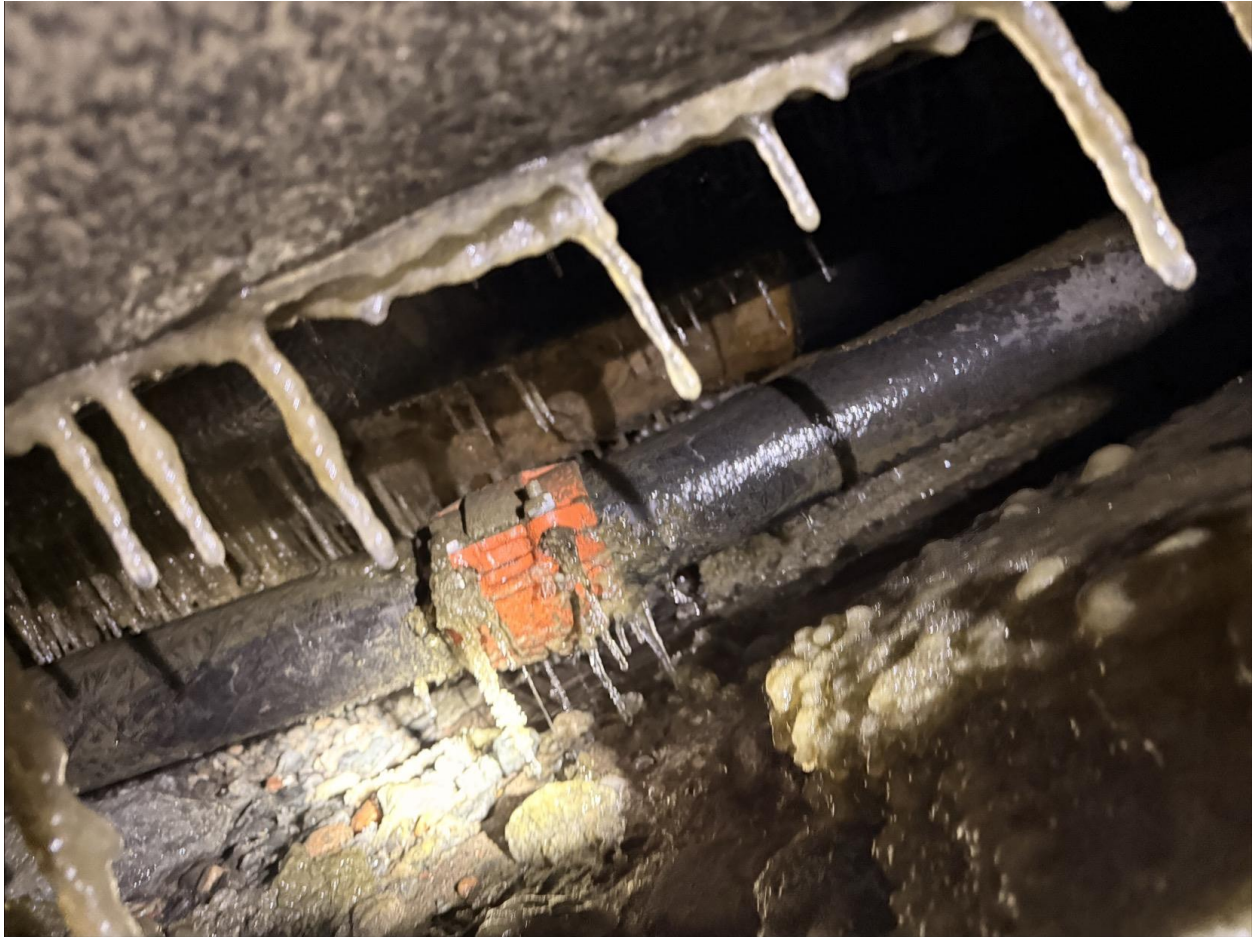
Photo 1: Location of the spill.

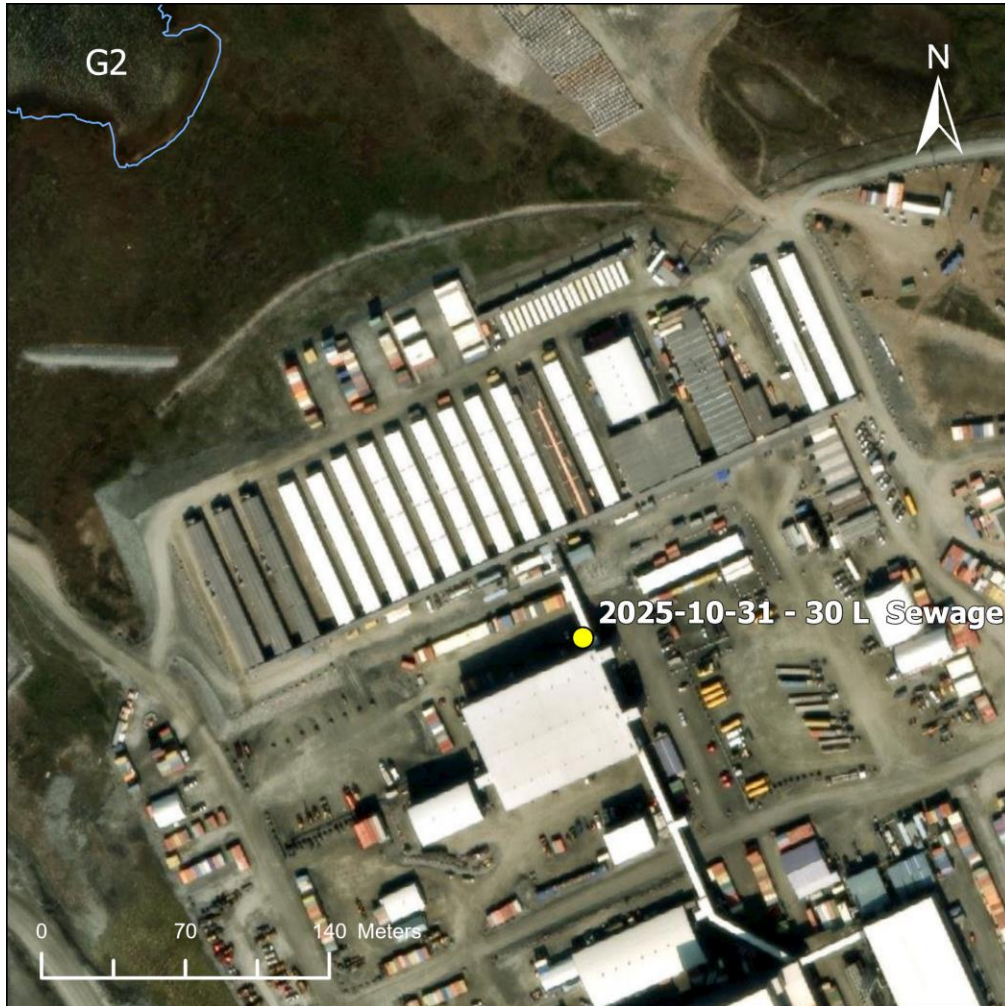
On October 31st, 2025, at approximately 12:30PM, a Surface Operations worker was performing a sewage transfer at the MSB lift station when they saw sewage leaking from around the tank level window at the back of the truck, resulting in a spill of approximately 30 L of sewage onto the industrial pad.

The spill occurred within the bounds of the site's runoff collection system. As such, no water bodies were impacted by the spill. The closest water body (Lake G2) is approximately 315 meters northwest, as seen in Figure 1.

Figure 1: Location of the spill and proximity to waterbodies.

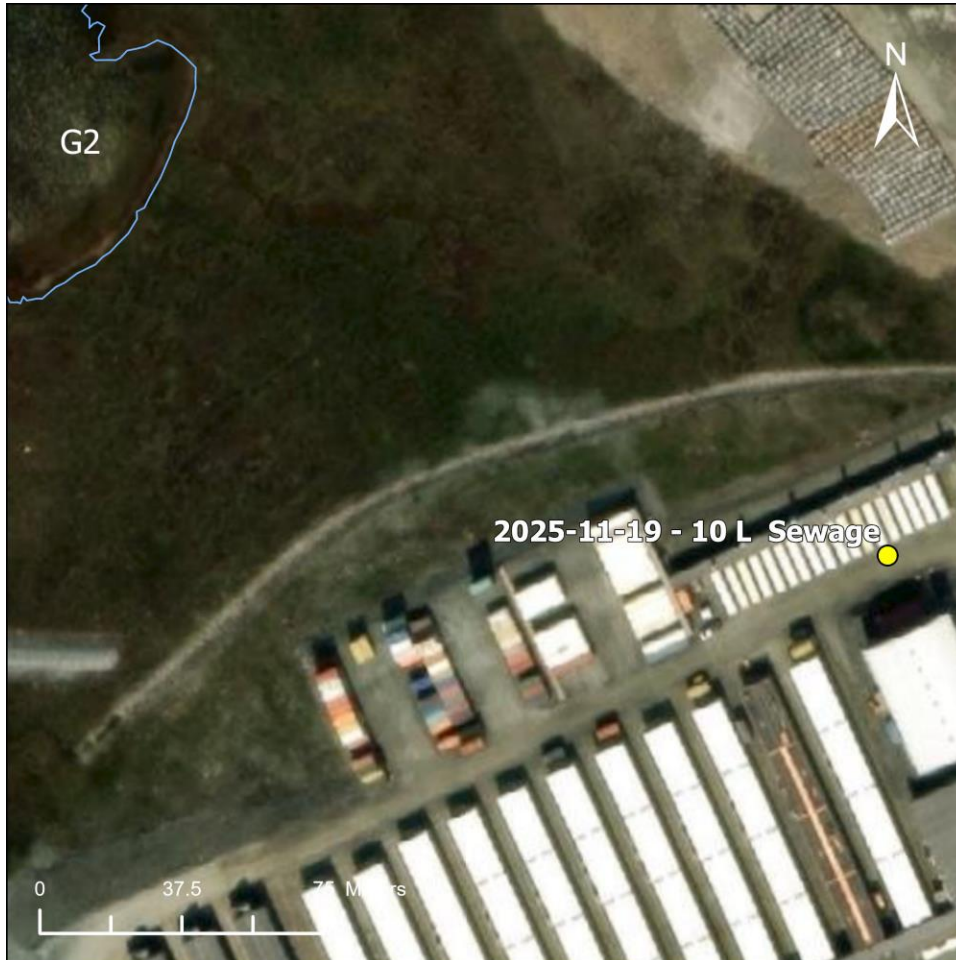
On November 19th, 2025, at approximately 8:30AM, while driving the vacuum truck on his sewage transfer route, a Surface Operations employee noticed that sewage was leaking from the discharge valve behind the truck. The employee stopped the truck and realized that approximately 10L of sewage spilled onto the ground behind the Gymnasium.

The spill occurred within the bounds of the site's runoff collection system; no water bodies were impacted or at risk of being impacted by the spill. The closest water body (Lake G2) is approximately 216 meters northwest (Figure 1).

Figure 1: Location of the spill and proximity to waterbodies.

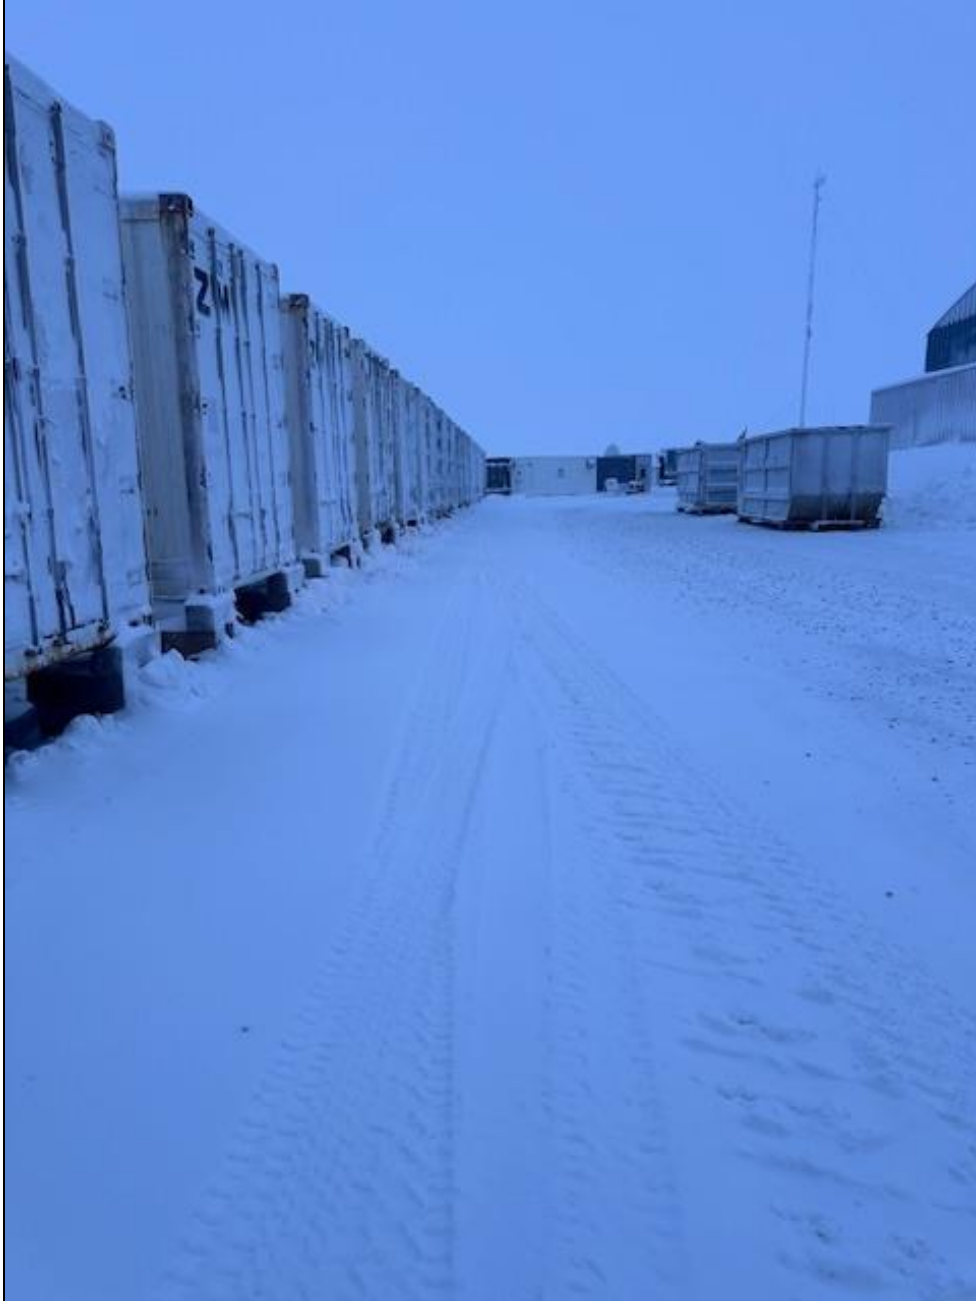
Photo 1: Spill location after remediation.

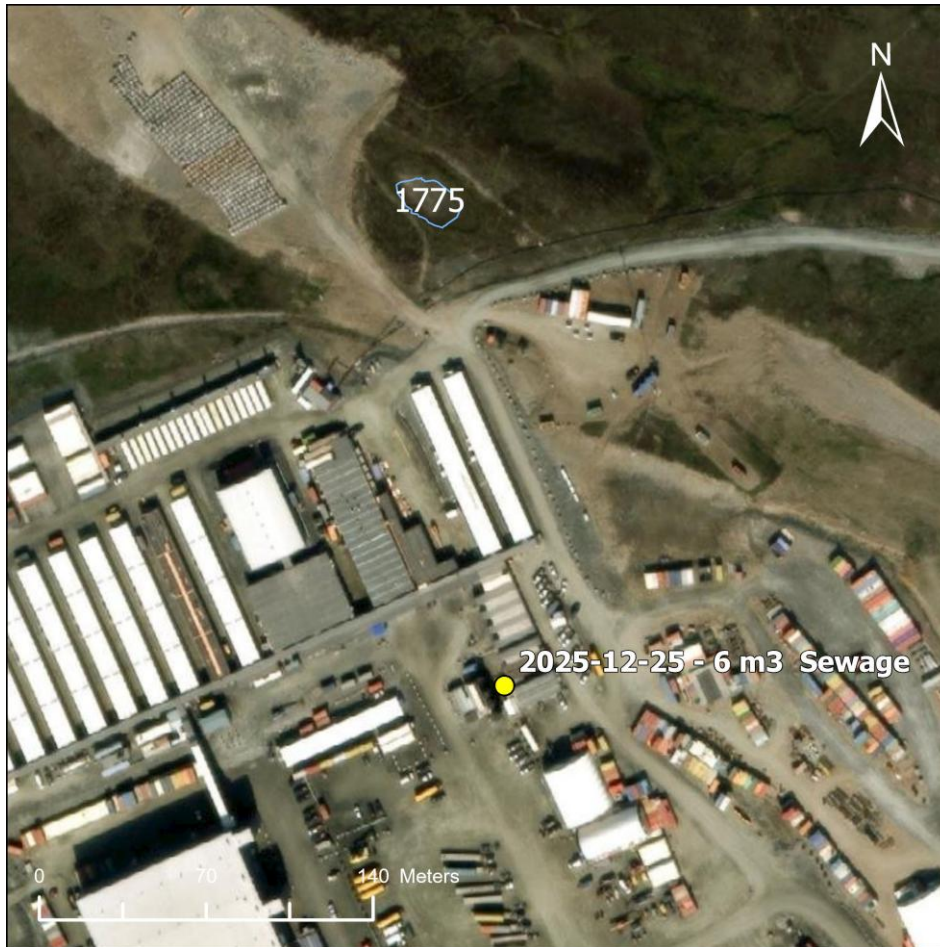
On December 25th, 2025, at approximately 1:00PM, an Energy and Infrastructure (E&I) Maintenance employee was working at the Sewage Treatment Plant (STP) when he noticed sewage was spilling from an external pipe connected to the C-wing lift station building, an emergency wing that is only opened when space at camp is limited. Approximately 6 m³ of sewage over an area of 125 m² spilled onto the ground between the C-wing and the STP.

The spill occurred within the bounds of the site's runoff collection system; no water bodies were impacted. The closest water body (1775) is approximately 187 meters north (Figure 1).

Figure 1: Location of the spill and proximity to waterbodies.

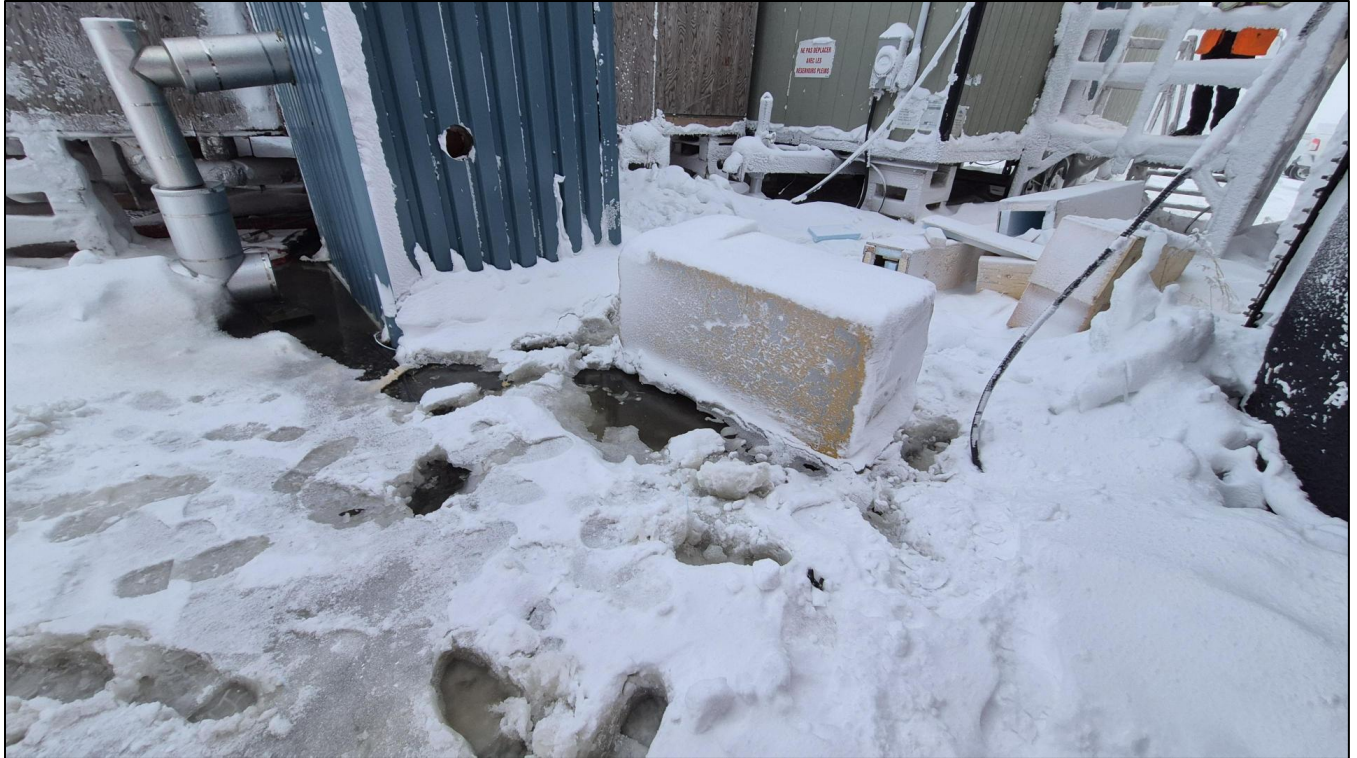
Photo 1: Spill Location

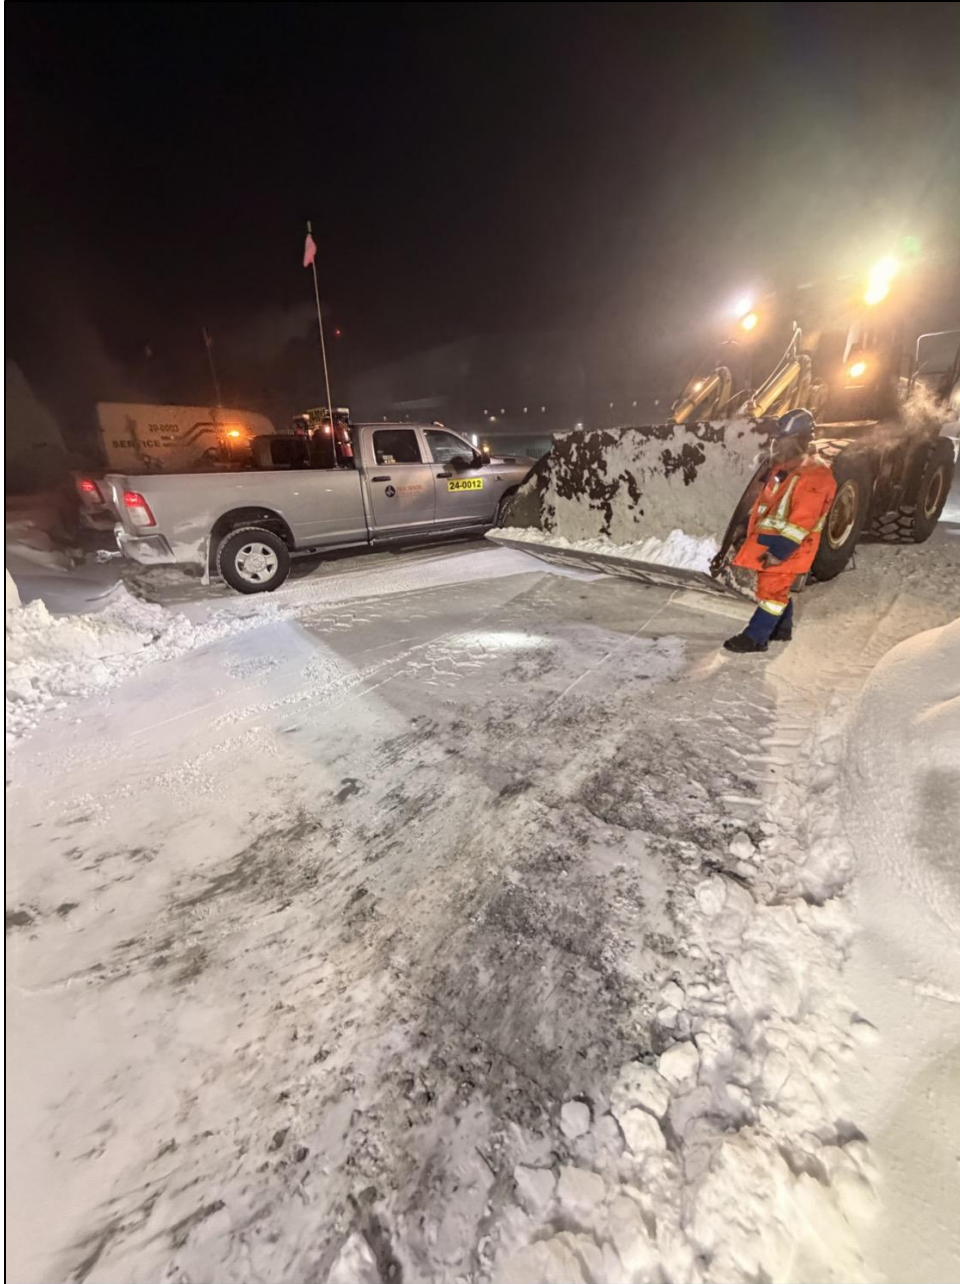
Photo 2: Spill location after remediation

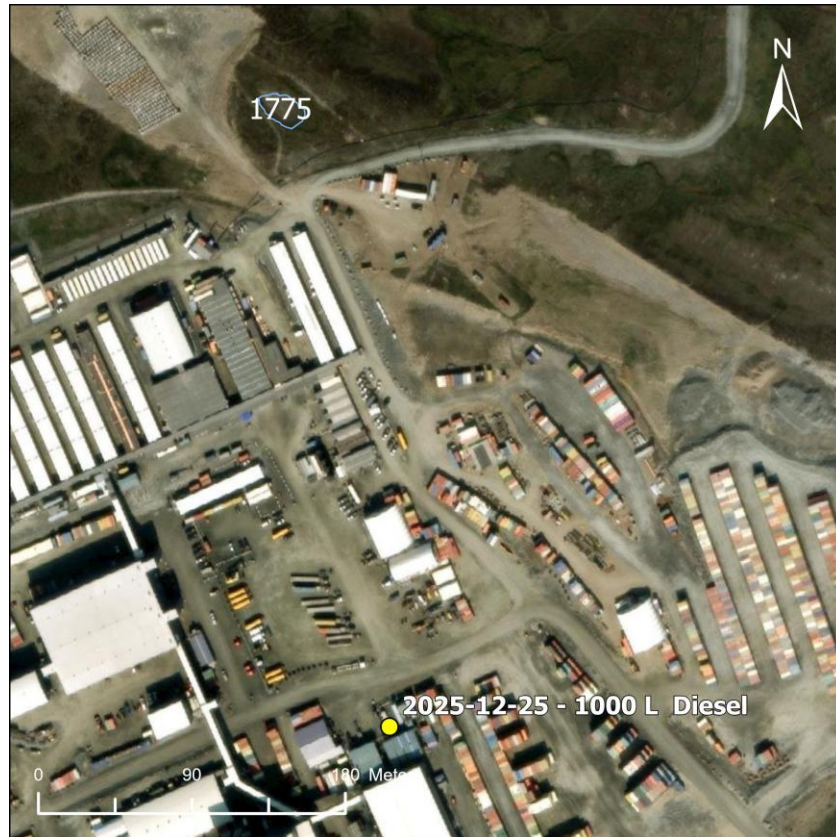
On December 25, 2025, at approximately 7:00 PM, an Energy and Infrastructure (E&I) Maintenance employee received an after-hours notification that a power plant fuel tank alarm had been triggered. Upon arriving at the site, the employee discovered that the diesel tank was overflowing from its vent, and fuel was pooling beneath the tank. The initial estimate of the spilled diesel, based on surface area, was approximately 940 L. Further investigation using the tank's level readings indicated that the estimated maximum amount spilled was up to approximately 3,300 L.

The spill occurred on a concrete pad within the bounds of the site's runoff collection system; no water bodies were impacted. The closest water body (Lake 1775) is approximately 352 meters north (Figure 1).

Figure 1: Location of the spill and proximity to waterbodies.
